Appendix 8 – Arborist report

Hygge Property – Preliminary Arboricultural Tree Assessment Report

Location: Wombat Park, 4719 Midland Hwy, Daylesford
Client: Hygge Property
Date: 18 February 2022

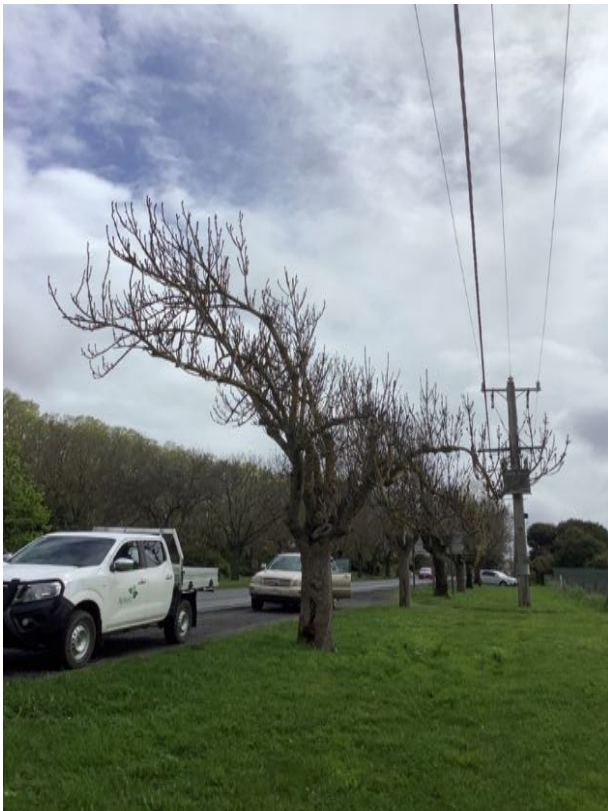
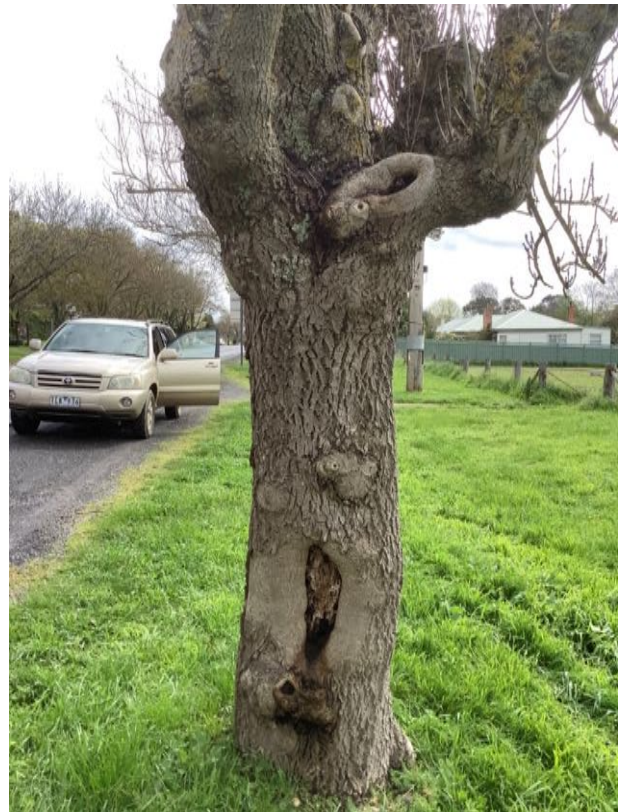
Comment: Trunk damage and heartwood decay.

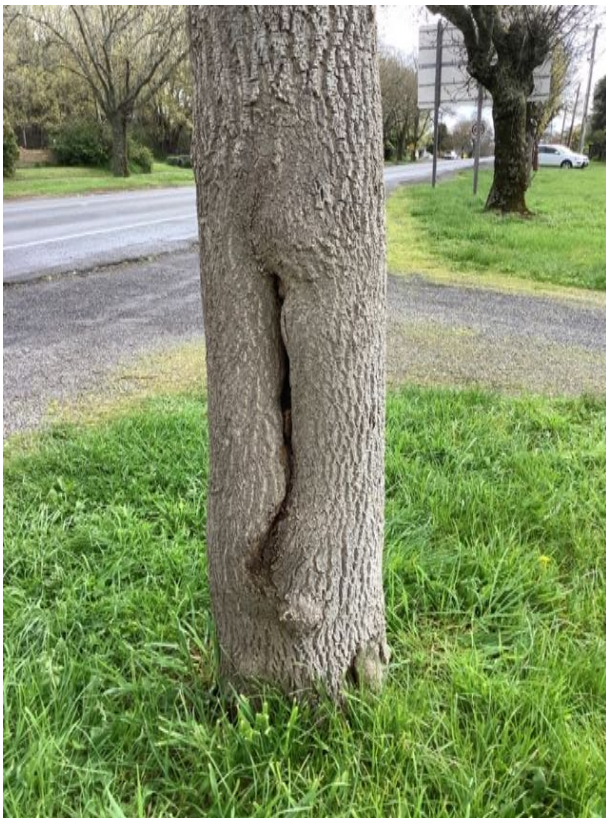
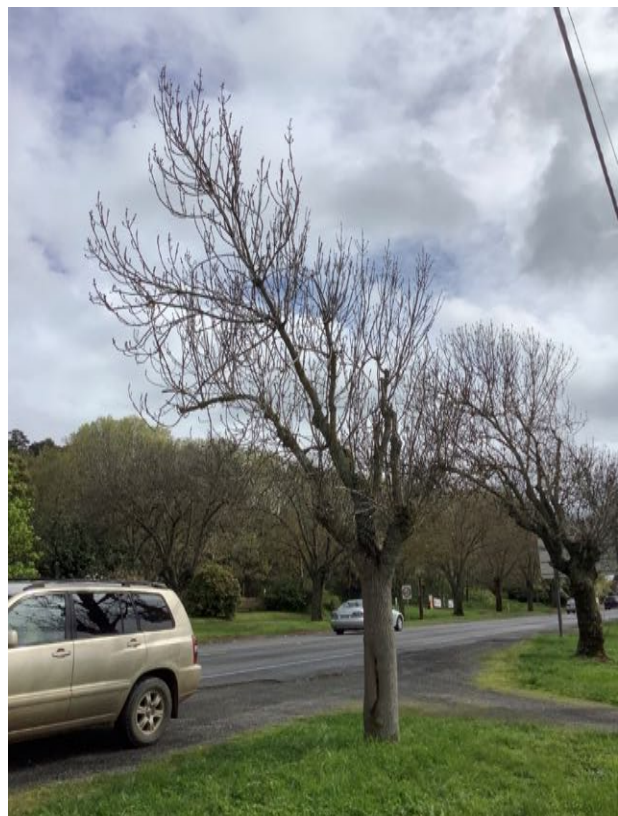
Health: Good
Structure: Fair
Comment: Trunk damage and heartwood decay.

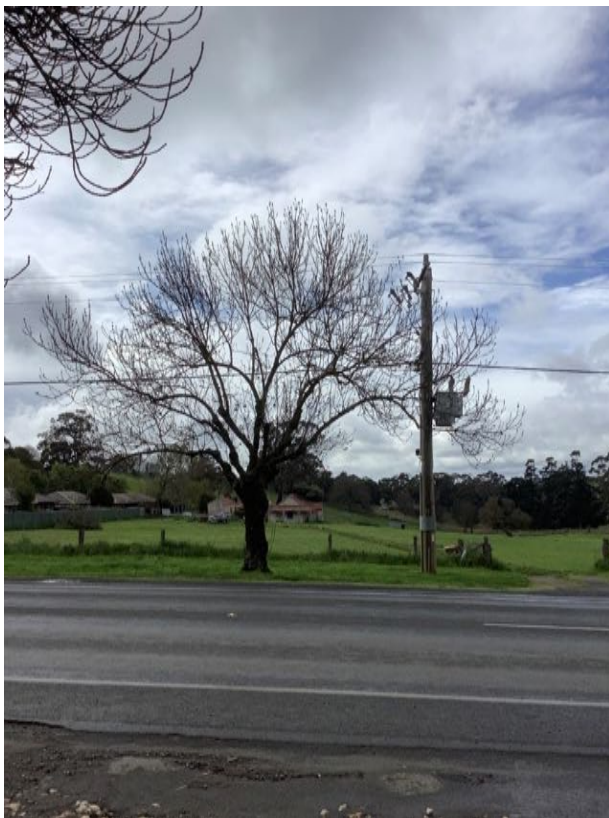
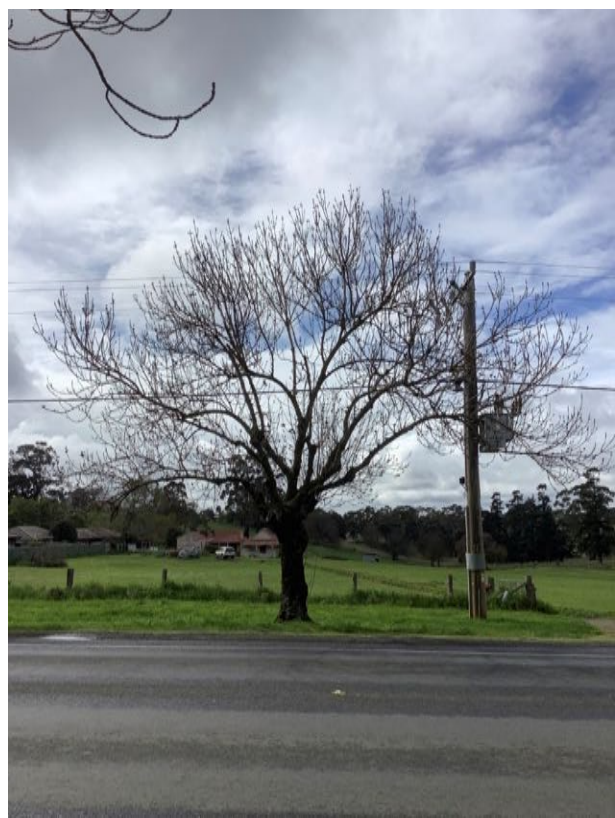
Health: Good
Comment: Minor heartwood decay.

Structure: Good

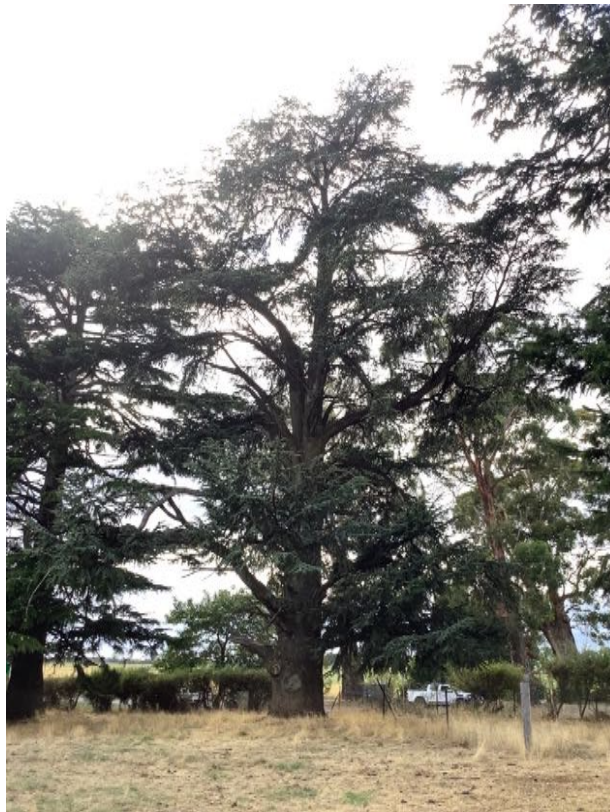
Health: Good
Structure: Good
Comment: Multiple hangers and deadwood throughout canopy

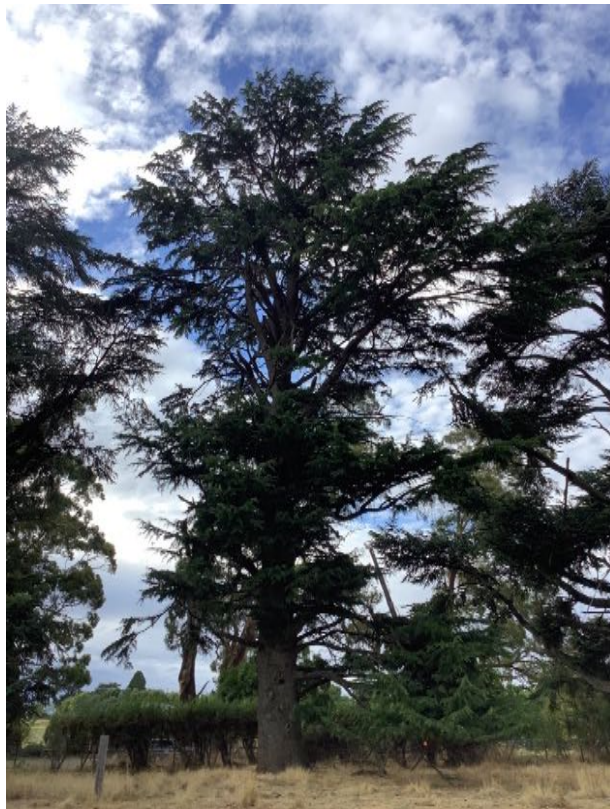
Health: Good
Structure: Good
Comment: Multiple hangers and deadwood throughout canopy

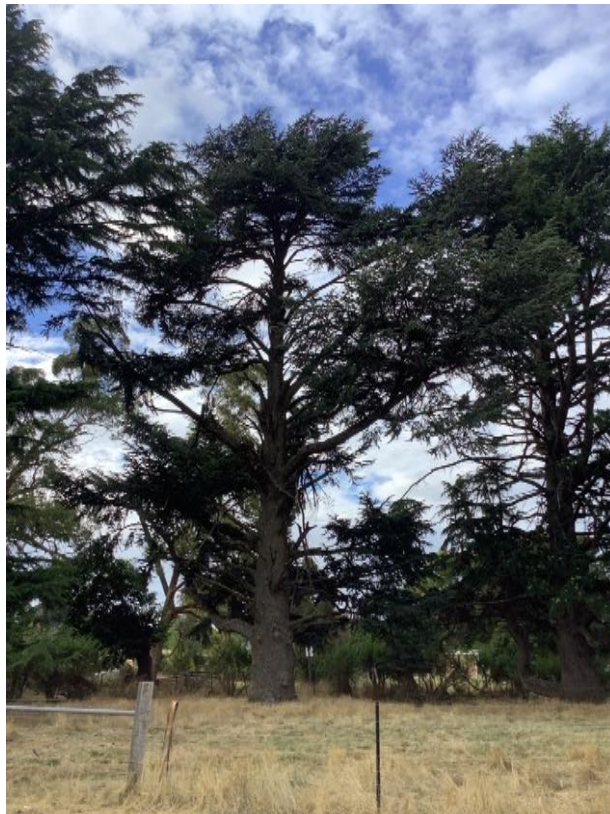
Health: Good
Structure: Good
Comment: Multiple hangers and deadwood throughout canopy

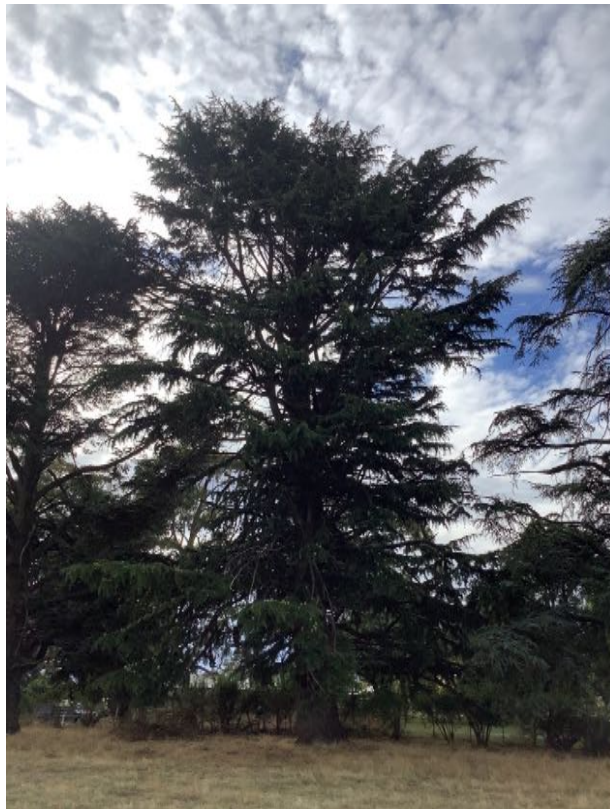
Health: Good
Structure: Good
Comment: Multiple hangers and deadwood throughout canopy

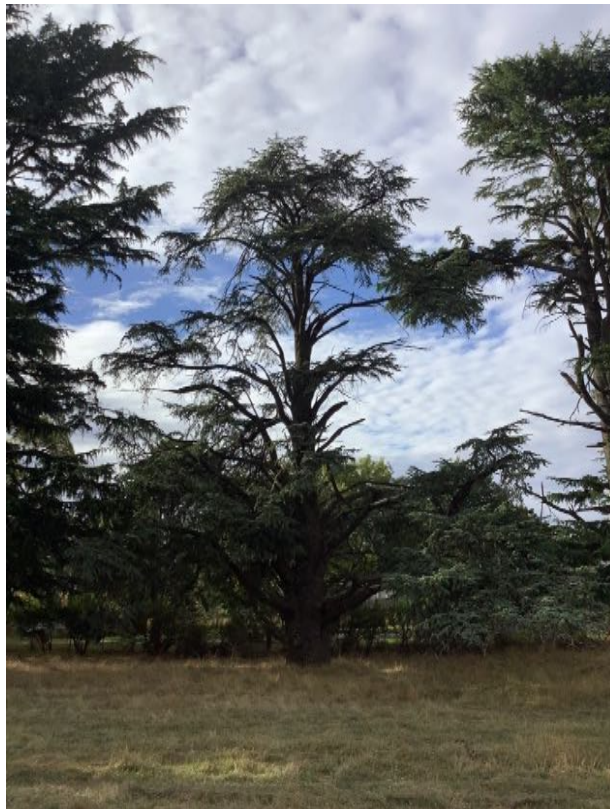
Health: Fair
Structure: Good
Comment: Multiple hangers and deadwood throughout canopy

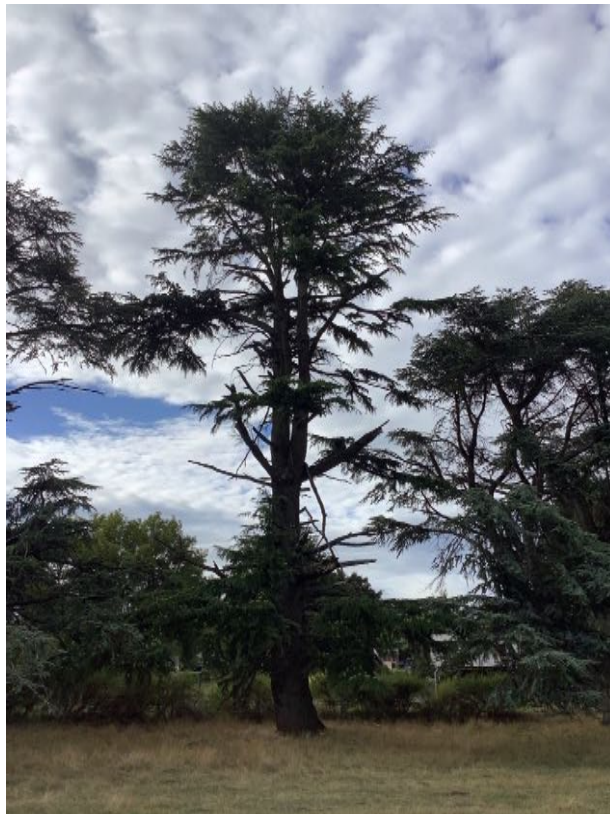
Health: Good
Structure: Good
Comment: Multiple hangers and deadwood throughout canopy

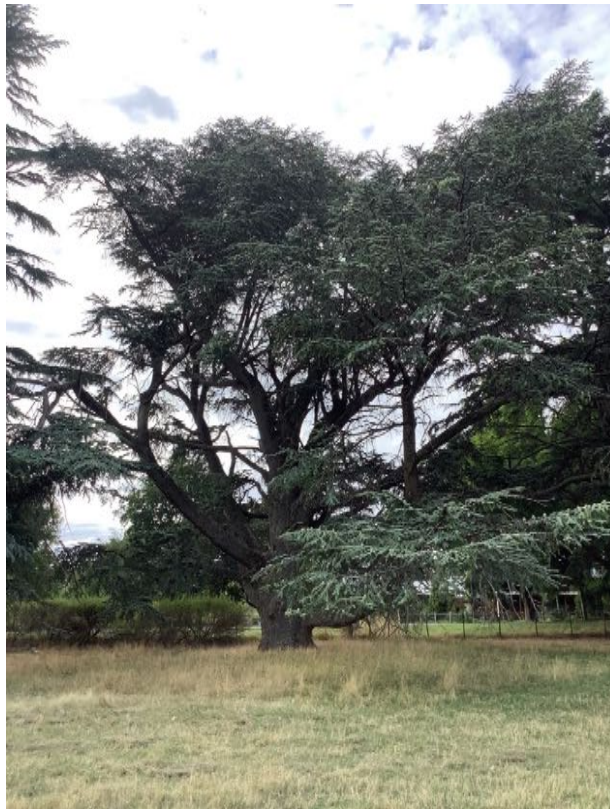
Health: Good
Structure: Good
Comment: Multiple hangers and deadwood throughout canopy

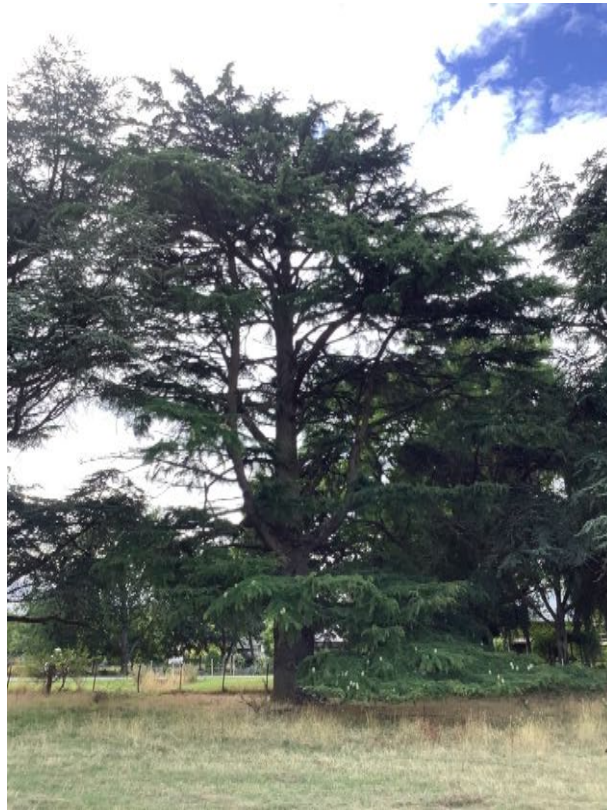
Health: Good
Structure: Good
Comment: Multiple hangers and deadwood throughout canopy

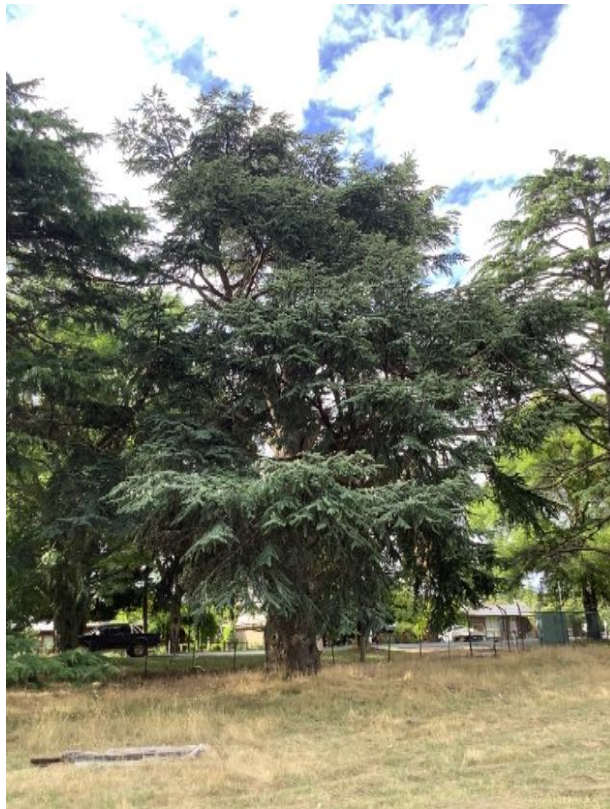
Health: Good
Structure: Good
Comment: Multiple hangers and deadwood throughout canopy

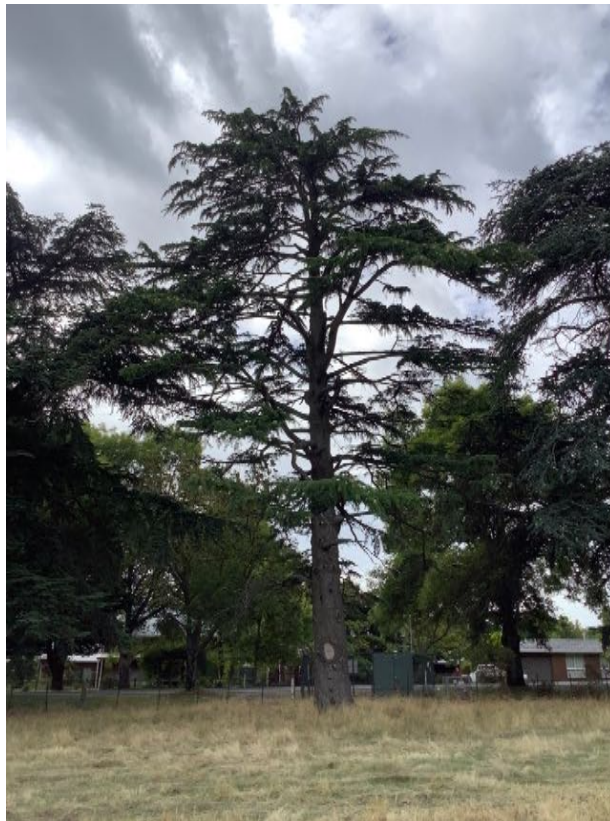
Health: Fair
Structure: Good
Comment: Multiple hangers and deadwood throughout canopy

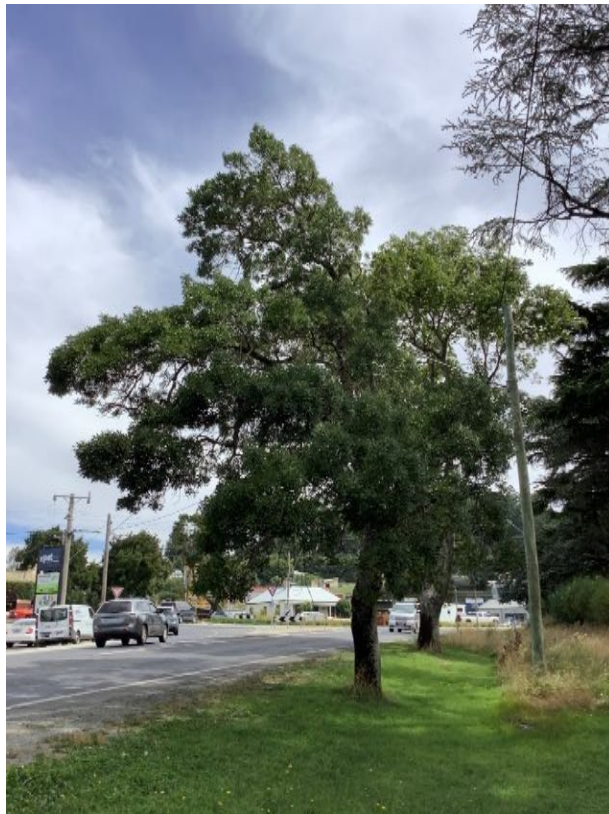
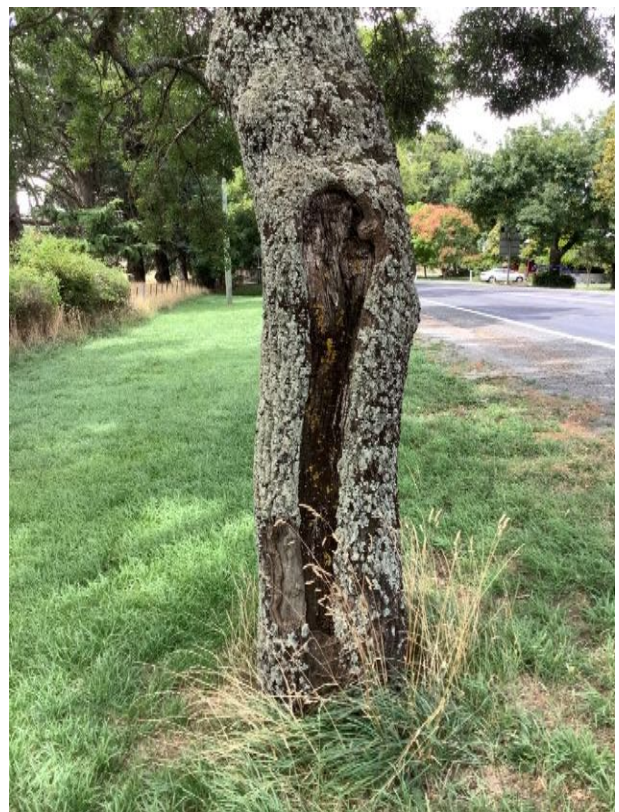
Health: Good
Structure: Fair
Comment: Trunk wound with associated decay.

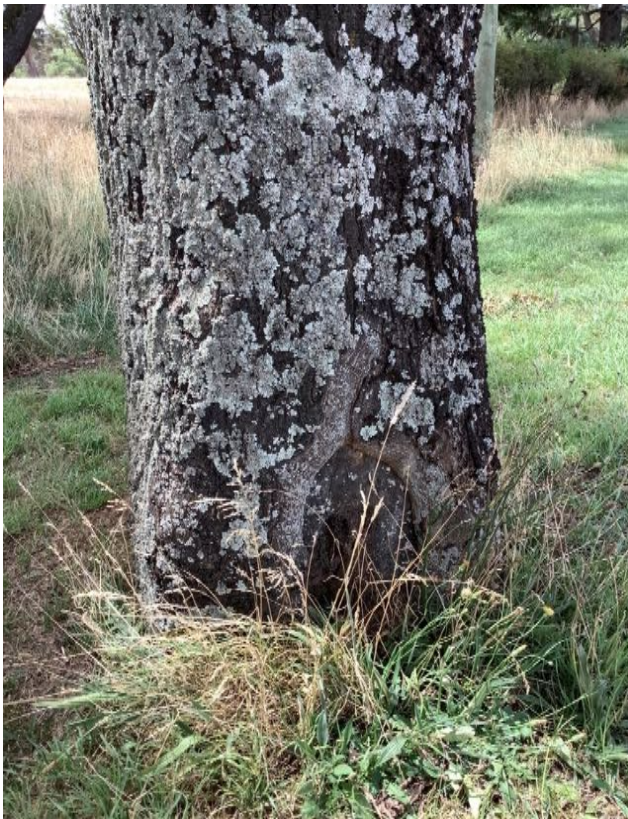
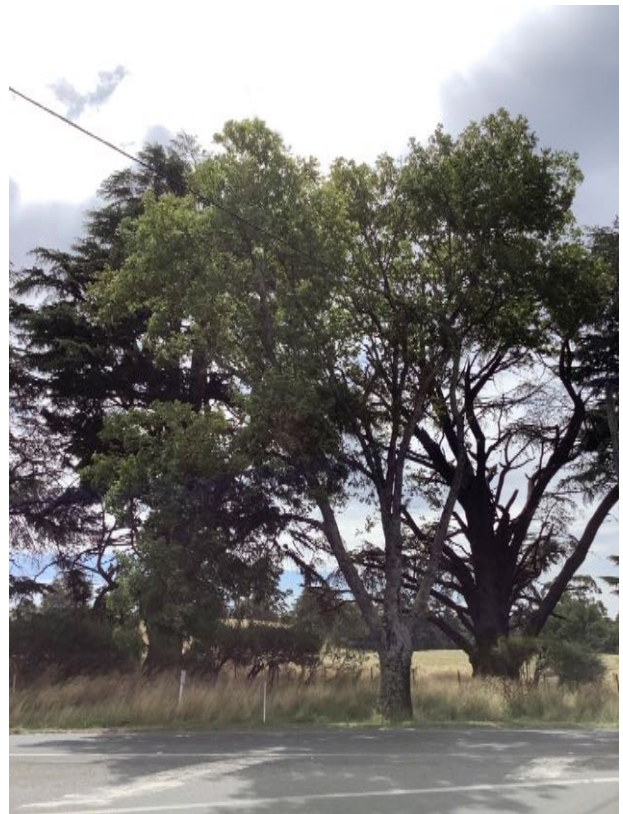
Health: Good
Structure: Good
Comment: Basal wound with some decay but adequated callusing visible.
