# Great Ocean Road Trail

## *Geotechnical Hazard Assessment*

**Golder Associates Pty Ltd**

21468192-001-R-Rev0

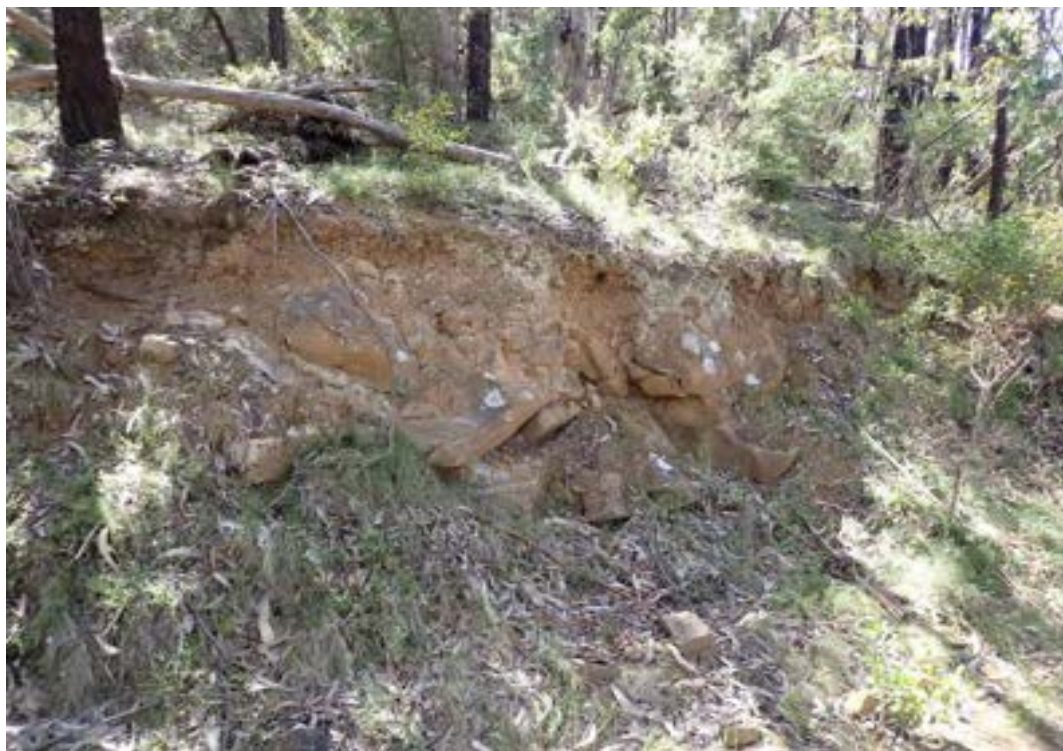
**Figure 6: Colluvium overlying distressed sandstone exposed in a cut at the north east abutment**

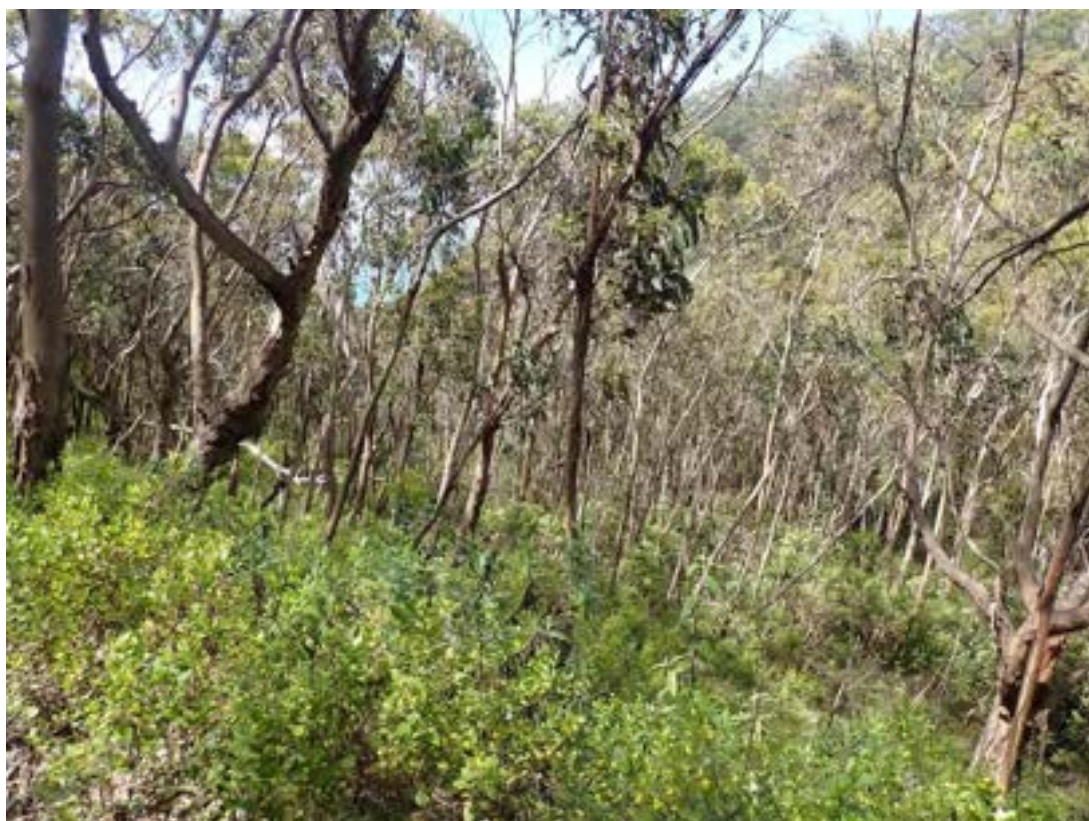
Downslope of the track, the ground slopes into the valley at an angle ranging from 25° to 35°. Relatively young trees were observed to be tilting downslope, as indicated in Figure 7, suggesting ongoing active creep or shallow slope movements.

**Figure 7: Trees tilting downslope at the north east abutment, indicating ongoing shallow soil movement**

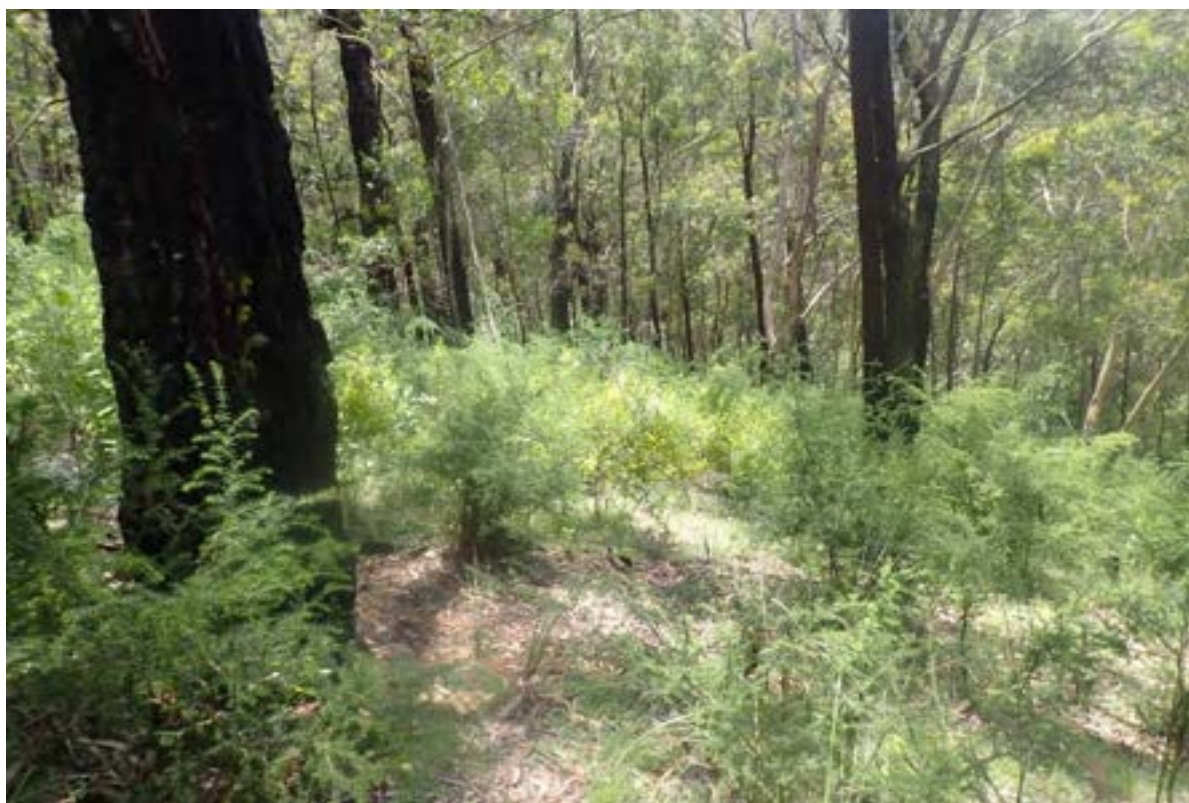
**Figure 8: General slope characteristics at the south west abutment preferred location**

Due to the proximity of the observed landslide features, it is recommended the south west abutment is moved further upslope. A preferred location was assessed, approximately 20 m upslope from the escarpment on the creek flank. Slope angles in this location are more consistent and lack undulations, hummocks or distinct breaks in slope, as indicated in Figure 8. However, a lack of outcrops or cuttings anywhere in the vicinity of the abutment made it difficult to assess the depth to rock, although an estimate is provided in Table 7.

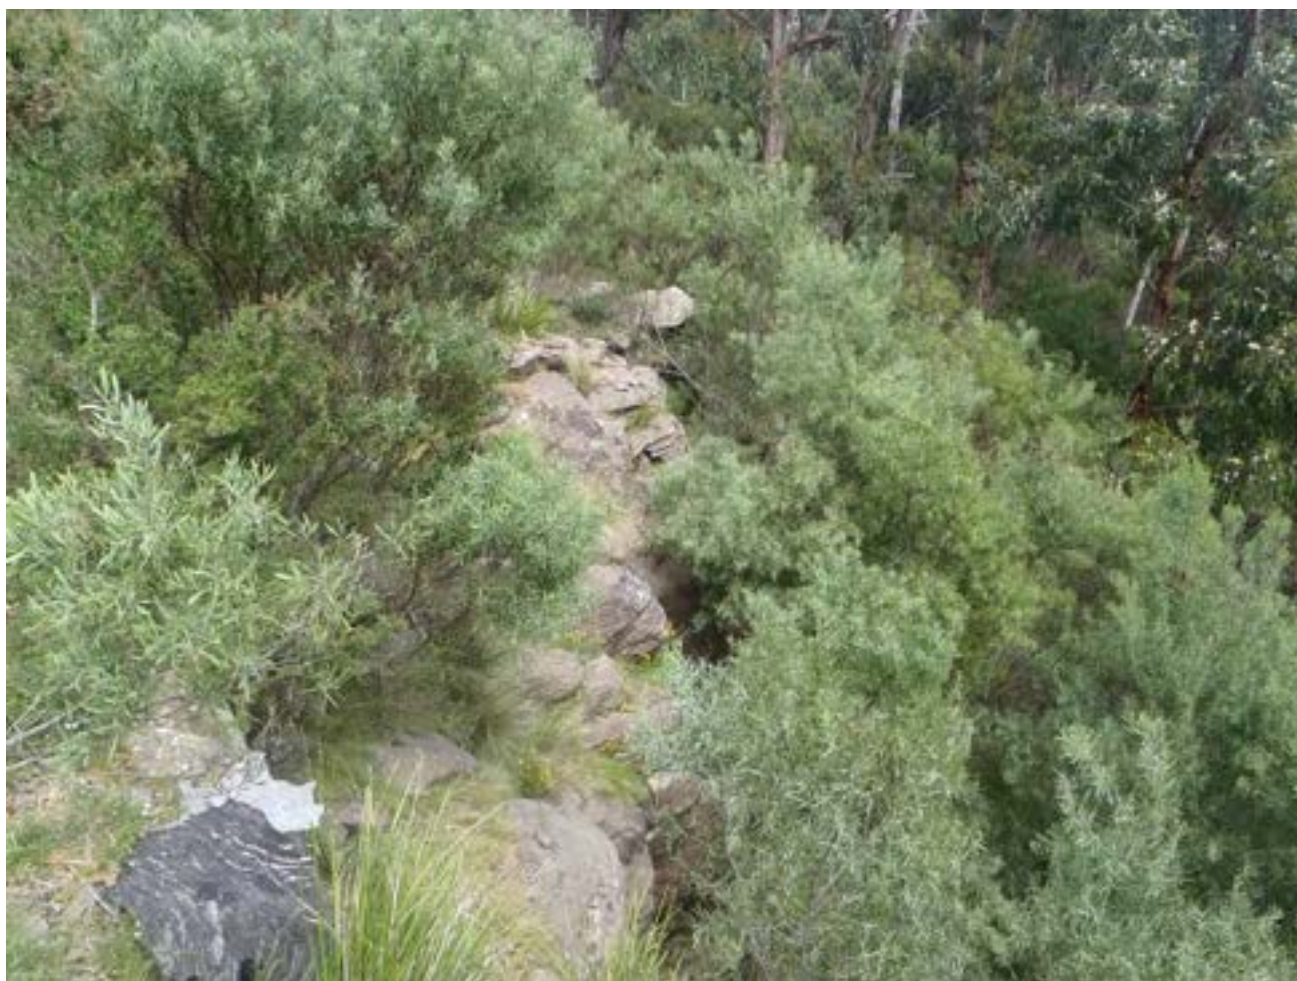
The landslide hazard map indicates the valley to be susceptible to landslides as indicated in Figure 20. This observation was confirmed by site observation, with the prominent landslide scarp as indicated in Figure 20 observed in the field.

**Figure 15: Headscarp of landslide to east of proposed north east bridge abutment**

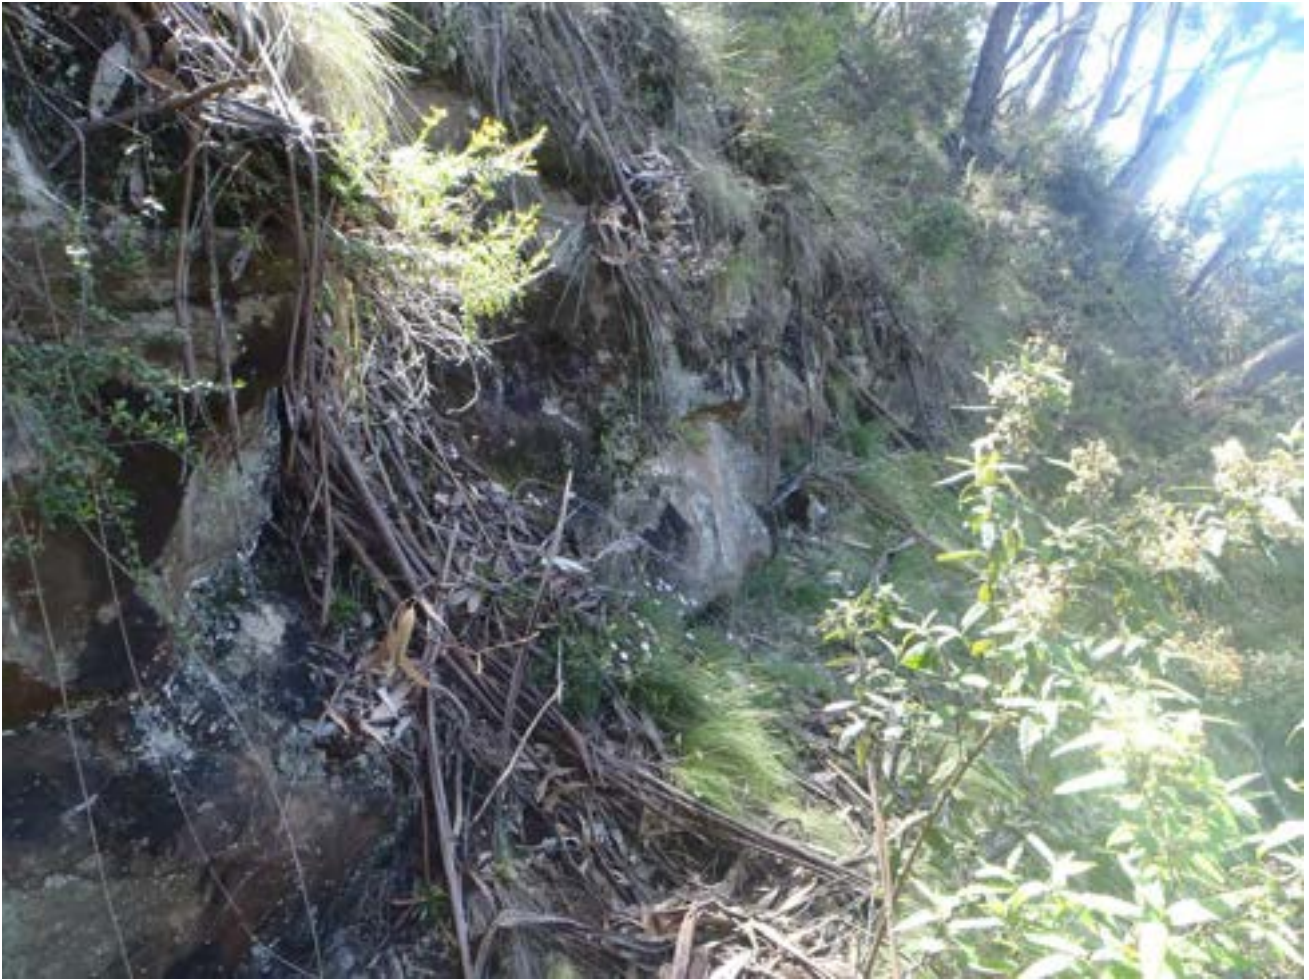
**Figure 16: Sandstone exposed on side of valley, below proposed north east abutment**

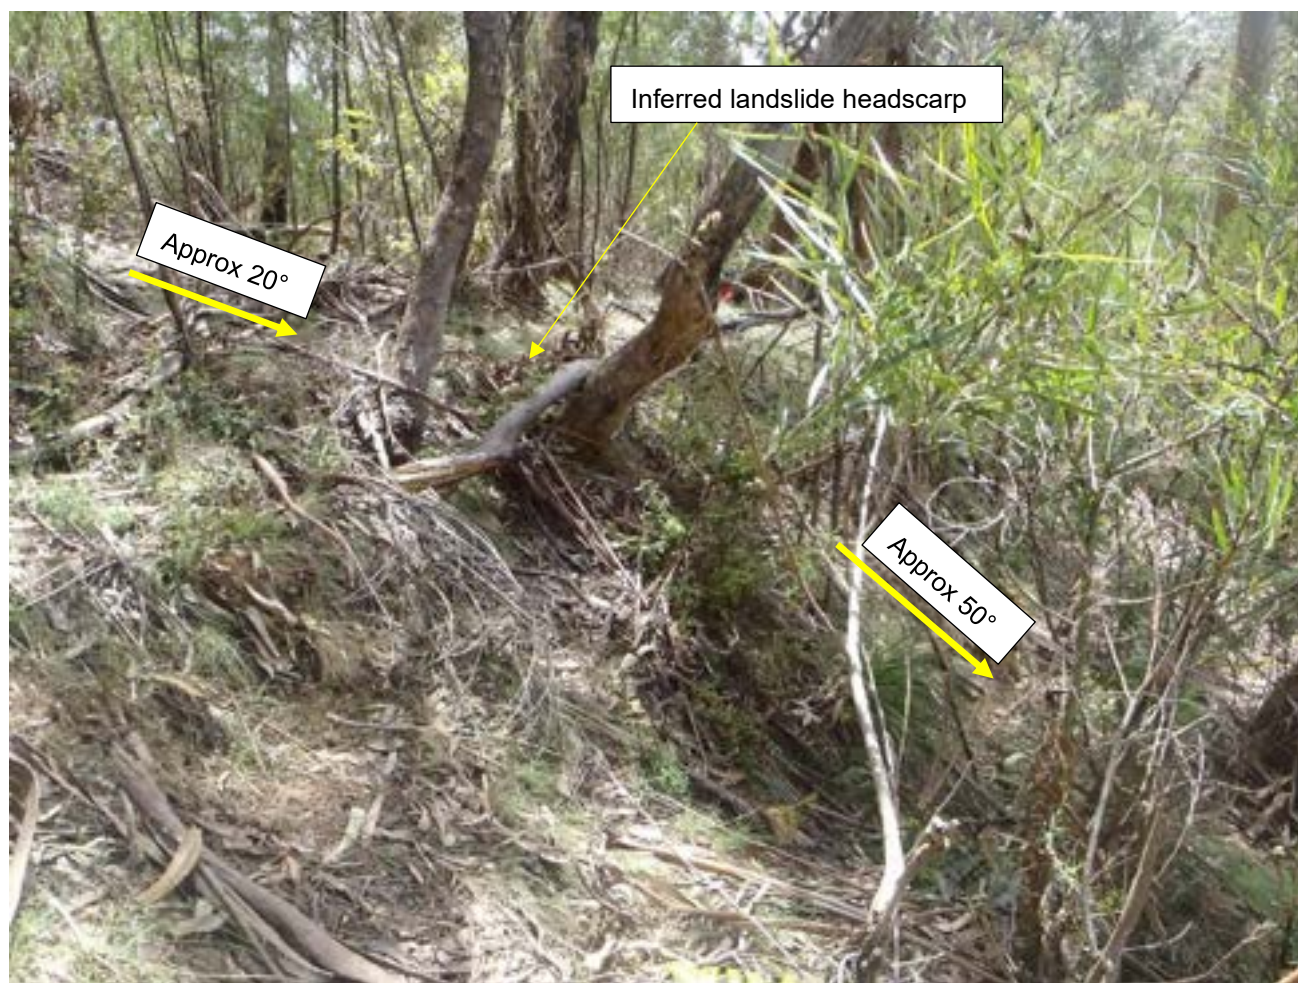
There is a similar, but less pronounced, break in slope at the south west bridge abutment with slope angle upslope of the break in slope of about  $20^\circ$  and below the break in slope of about  $50^\circ$ . The break in slope appears to be a landslide headscarp as indicated in Figure 17.

**Figure 17: Break in slope at south west bridge abutment**

A potential bridge abutment location was identified approximately 20 m upslope of the break in slope at a location that does not appear to be disturbed by past ground movement and is sufficiently offset from the landslide headscarp such that the likelihood of landslide regression up to the abutment location within the lifetime of the bridge is assessed to be insignificant.

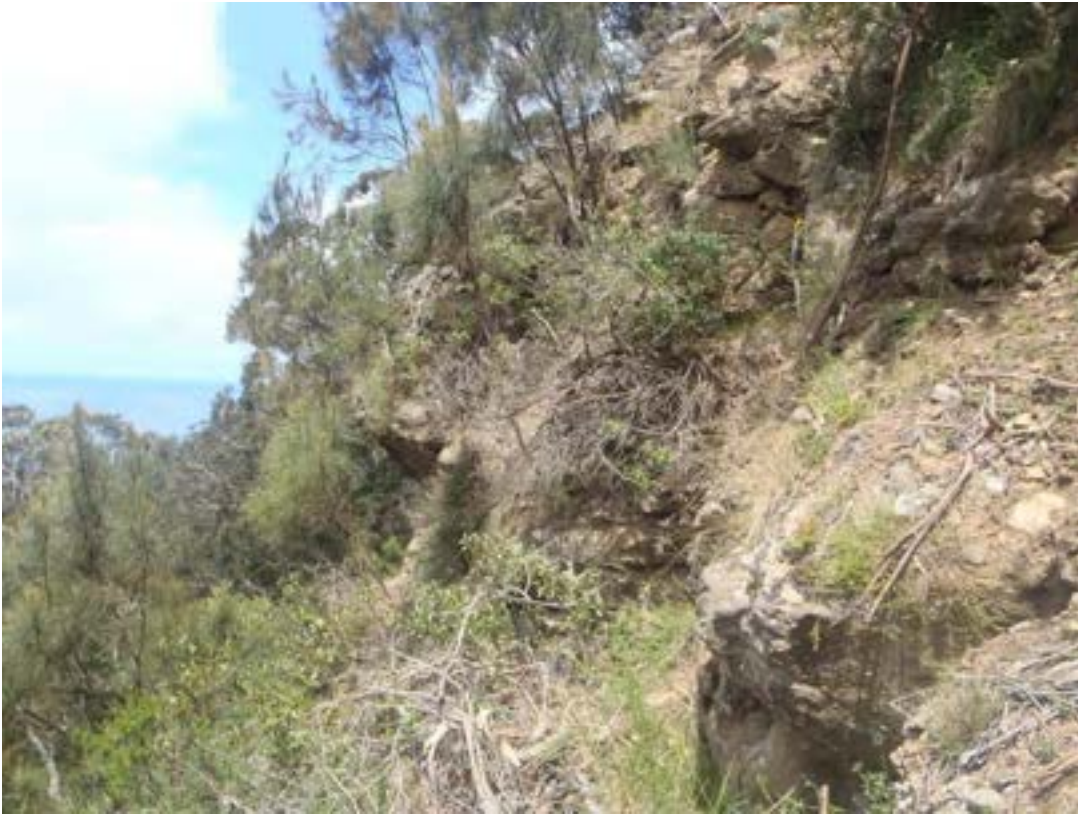
**Figure 18: Sandstone beds located about 20 m from proposed abutment location**

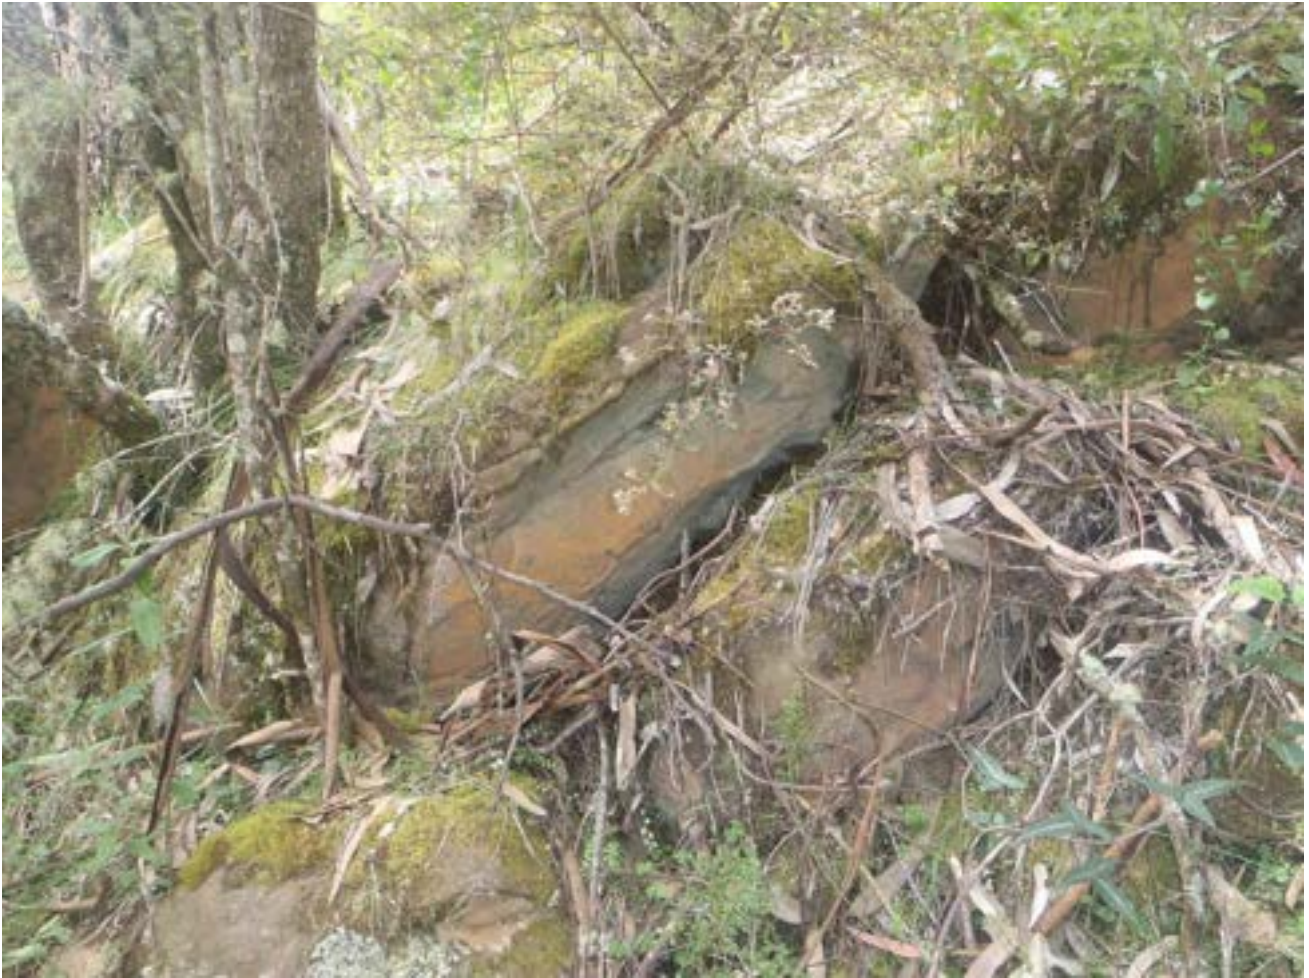
The headscarp of landslides on the western side of the proposed bridge exposes rock as indicated in Figure 24. The exposed rock is dilated, with open defects between joints and bedding planes. Upslope of the inferred landslide headscarps, the soil appears to be relatively thin (Figure 24).

**Figure 24: Rock outcrop on western side of proposed bridge**

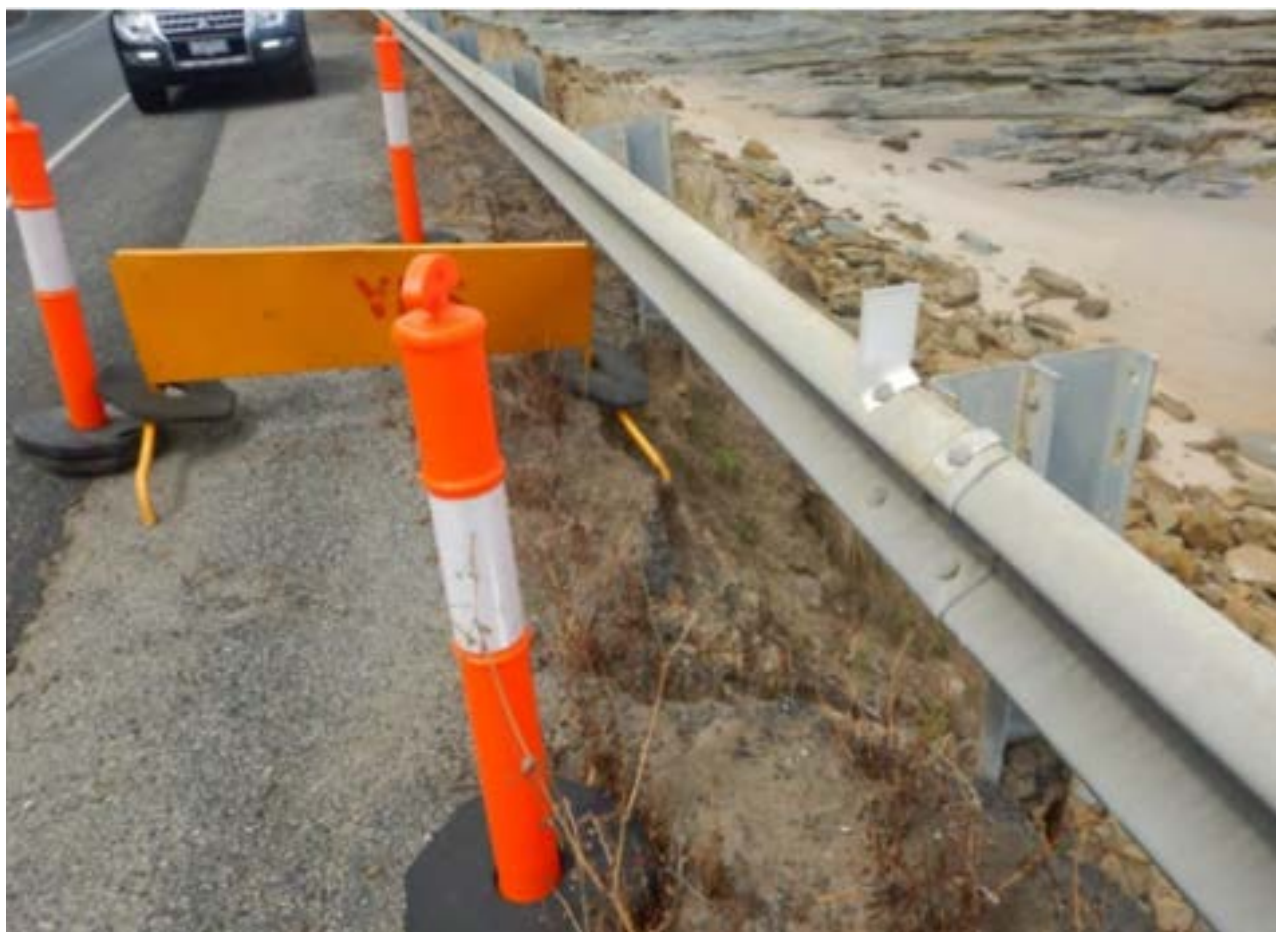
Failures are usually in the form of landslides which can be either rotational and/or translational depending on the material composition and the preparation of the underlying foundation slope. They rarely affect more than a 5 m to 10 m length of the embankment. For this assessment a 10 m failure length of batter has been assumed. Key causal factors involved in fill failures include the overall geometry of the fill (batter slope angles and height), the steepness of the natural slopes upon which they are constructed, the strength and nature of the fill and underlying natural materials, the presence of subsurface water being either groundwater or surface water infiltration and the drainage provisions provided upslope of the fill. Many failures have occurred where uncontrolled flows transit across the pavement and spill over the fill during times of prolonged or intense rainfall. An example of an embankment failure is presented in Figure B19.

**Figure B19: Example of fill batter failure on Great Ocean Road, Cathedral Rocks**

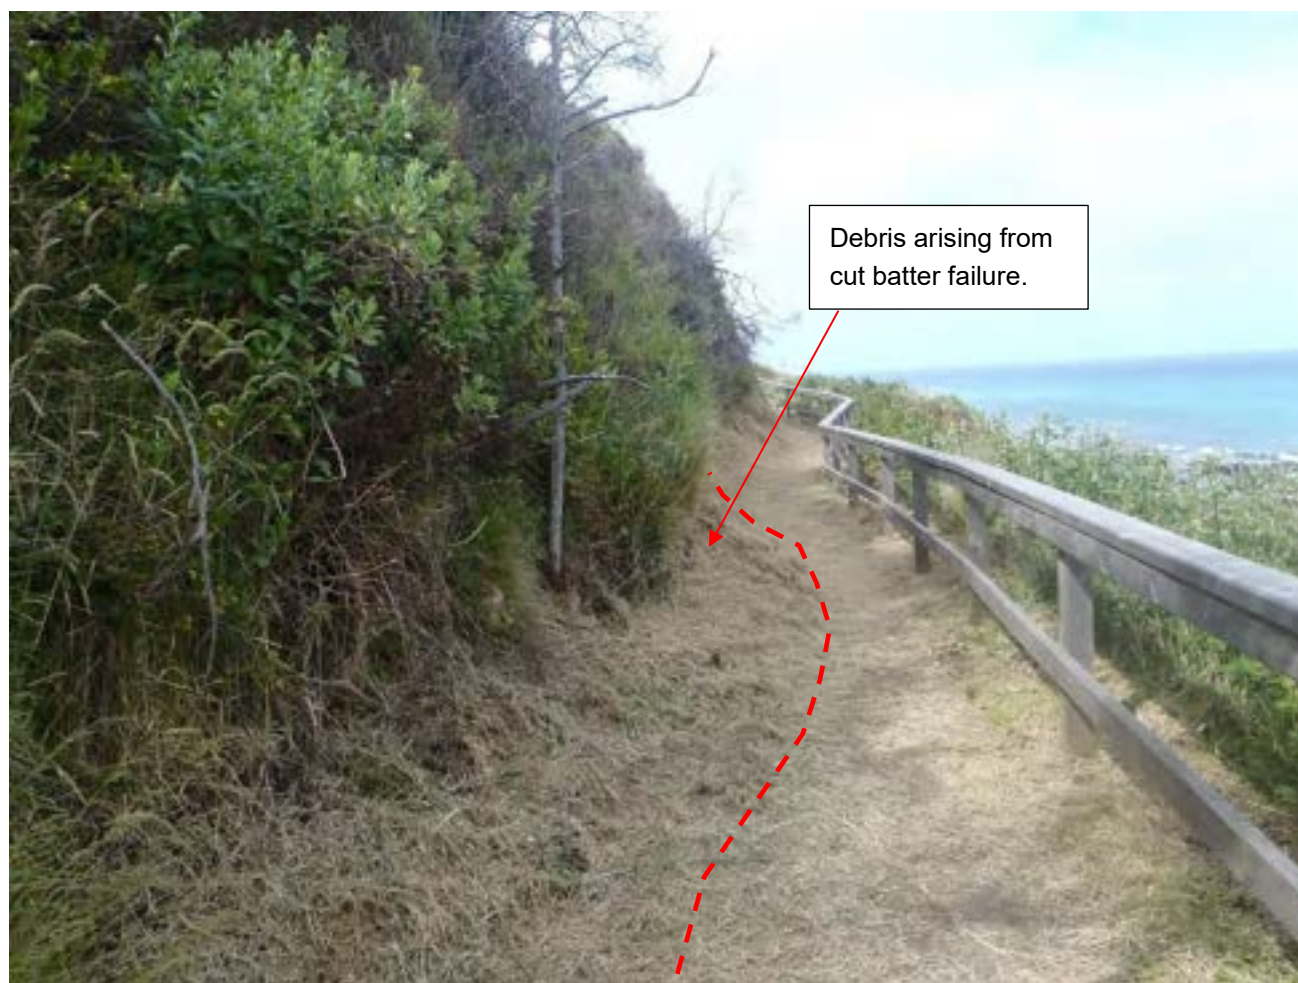
Most of the cuttings along the Great Ocean Road and existing tracks and trails within the vicinity of the proposed trail are within the Cretaceous age Eumeralla Formation and expose the bedded sedimentary rock of this unit. Some cuttings are within colluvial material derived from the Eumeralla Formation. Failure of cuttings resulting in mixed soil and rock debris impacting the roads and trails is a relatively frequent occurrence, leading to extensive risk mitigation measured on parts of the Great Ocean Road. Failures from cuttings can have a width of about 10 m, similar to that which occurs in fill batters. Figure B20 presents an example of a failure from a cutting on Paddy's Path between Wye River and Separation Creek.

**Figure B20: Cutting failure, on Paddys Path between Wye River and Separation Creek which has caused debris to be deposited on track**

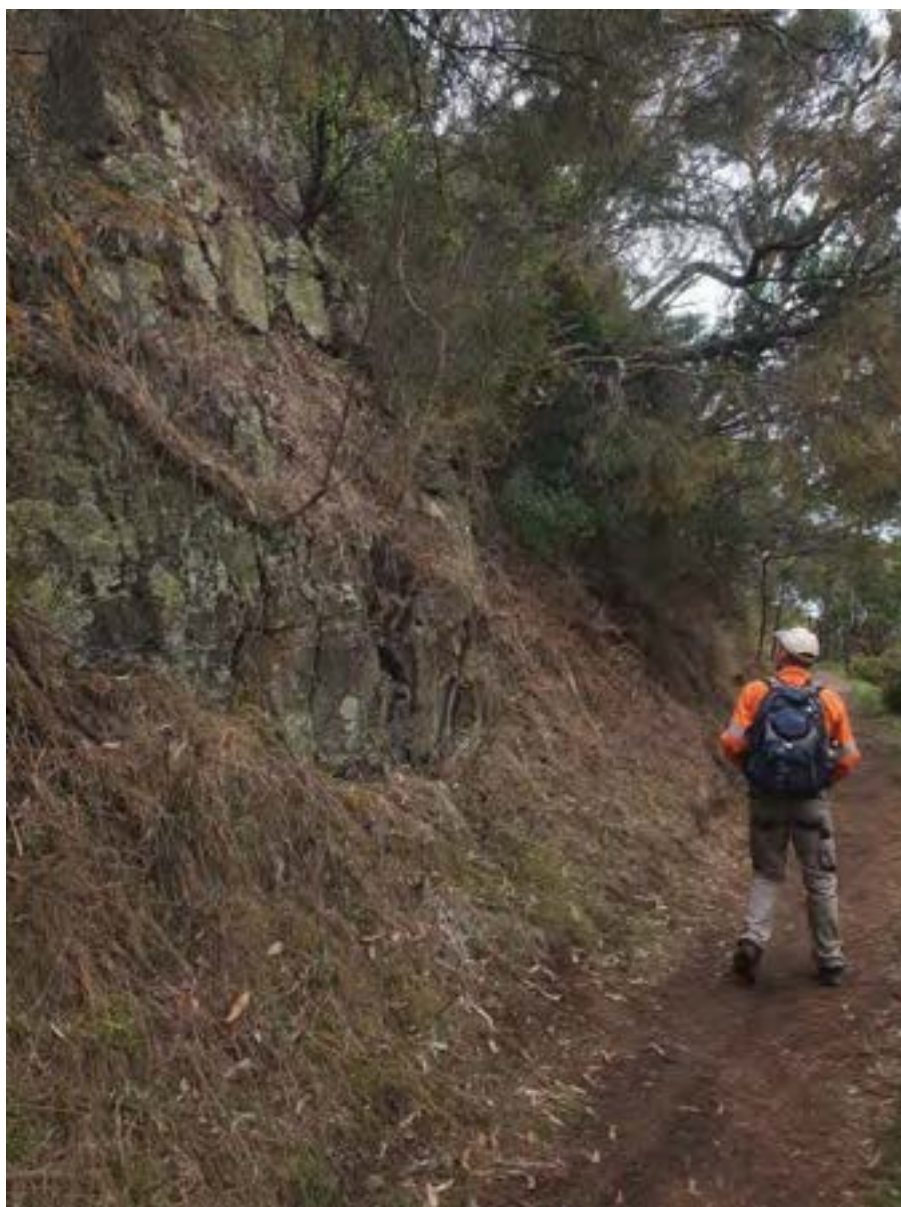
**Figure B21: Example of rockfall hazard on tramway route, Queens Park, Lorne**

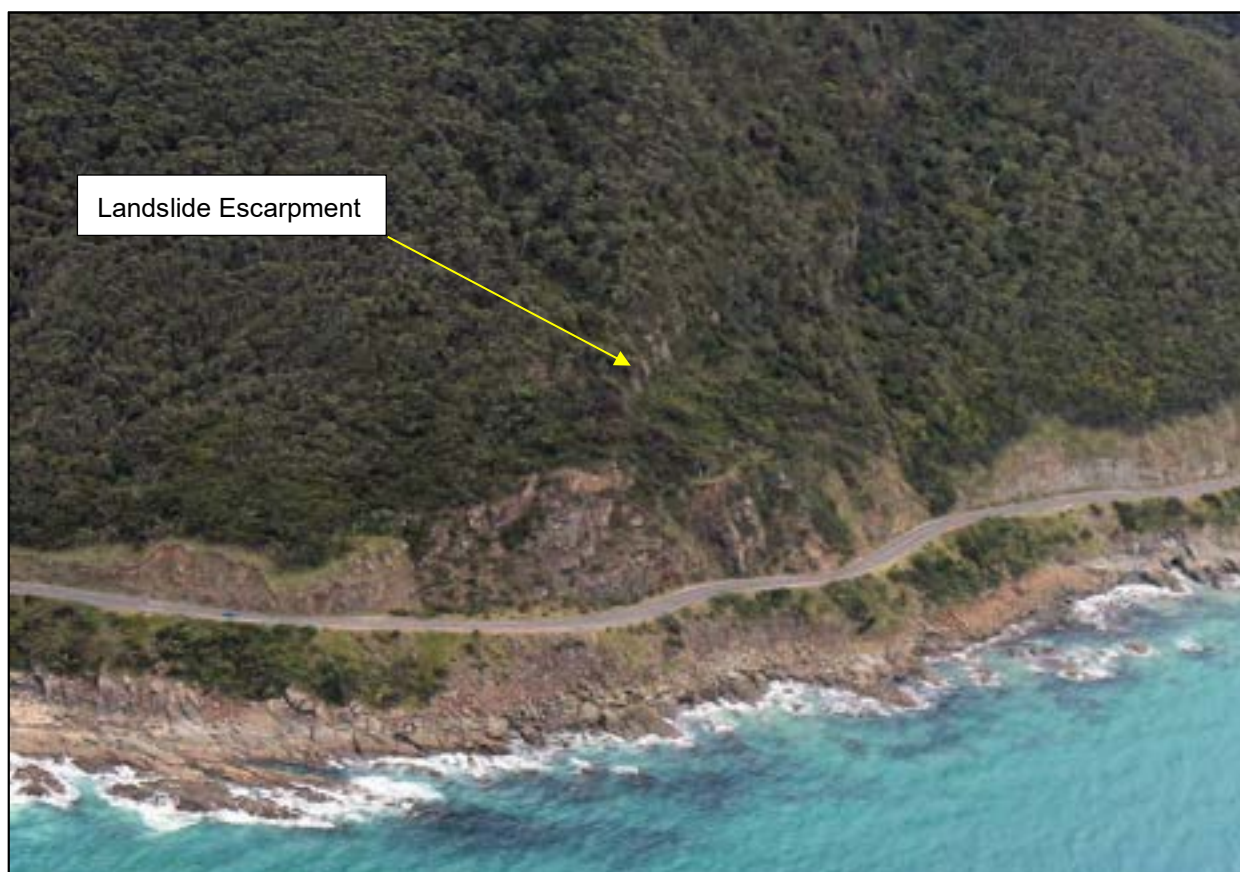
An example of a deep-seated landslide in rock (where construction of the Great Ocean Road is likely to have contributed to the landslide) at Windy Point between St Georges River and Sheoak Creek at Lorne is shown in Figure B23. Note bedding dipping towards the ocean. Works were undertaken in the 1970's to anchor this landslide and control further movement.

**Figure B23: Example of deep-seated landslide in rock at Windy Point (Photo EGS)**

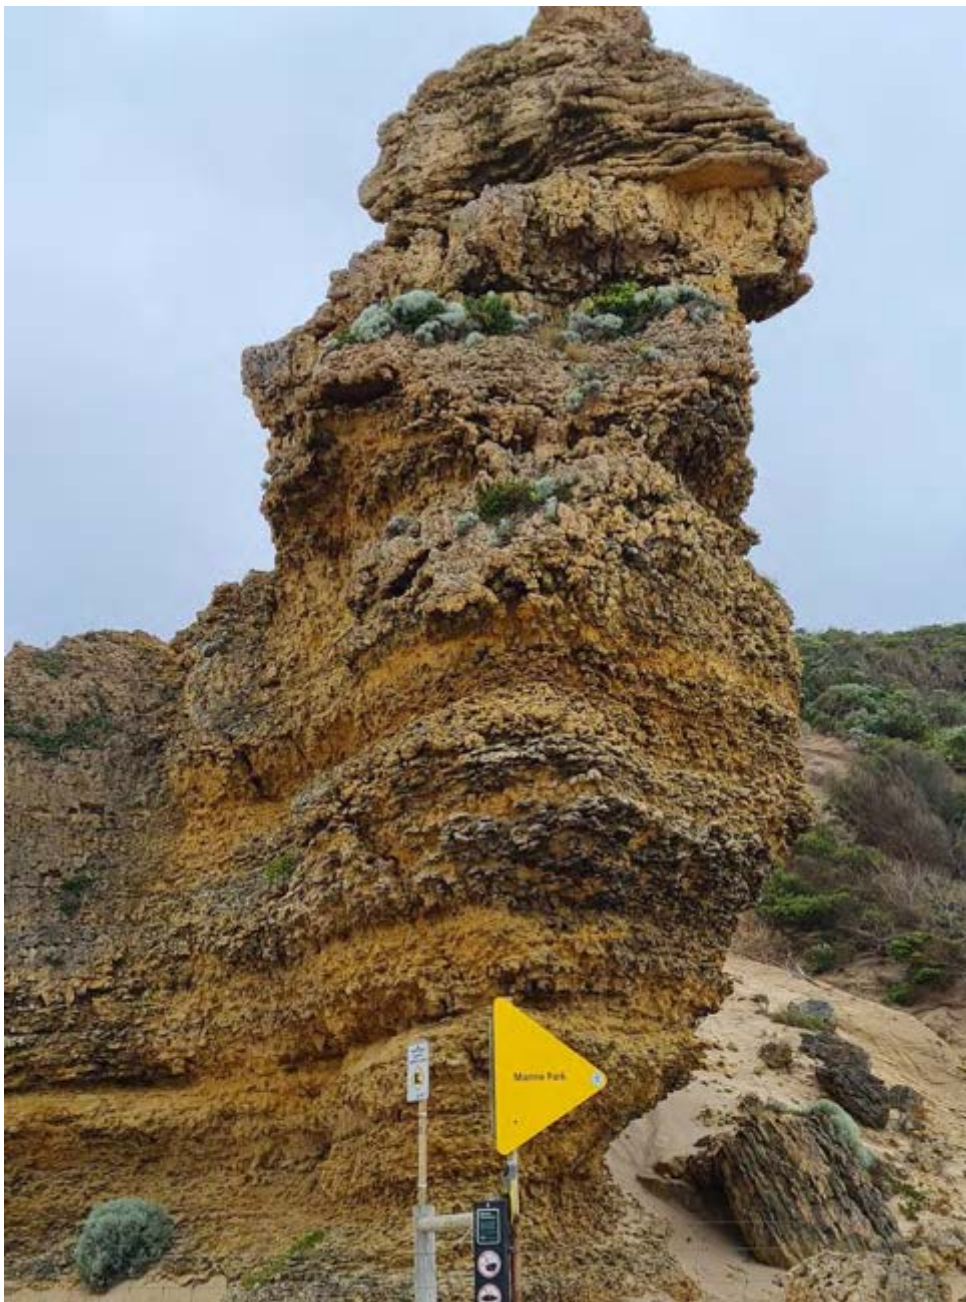
**Figure B24: Example of episodic erosion, a rock stack formed from erosion and collapse of the surrounding rock at the lagoon mouth at Aireys Inlet**

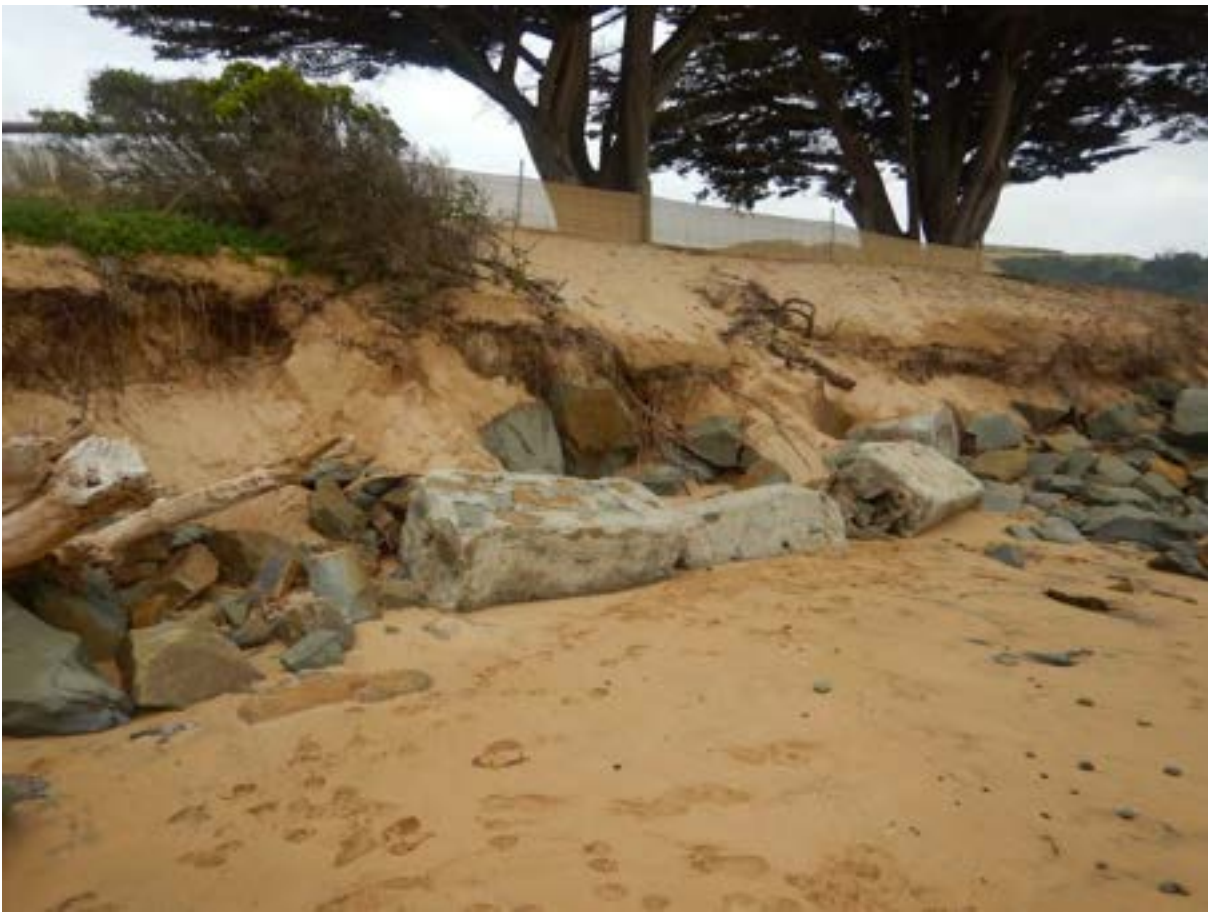
**Figure B25: Example of progressive erosion at Apollo Bay**
