Mt Buller and Mt Stirling Alpine Resort Management Board (RMB)

Mt Buller Sustainable Water Security | Off Stream Storage Project

Geotechnical Risk Assessment

August 2016

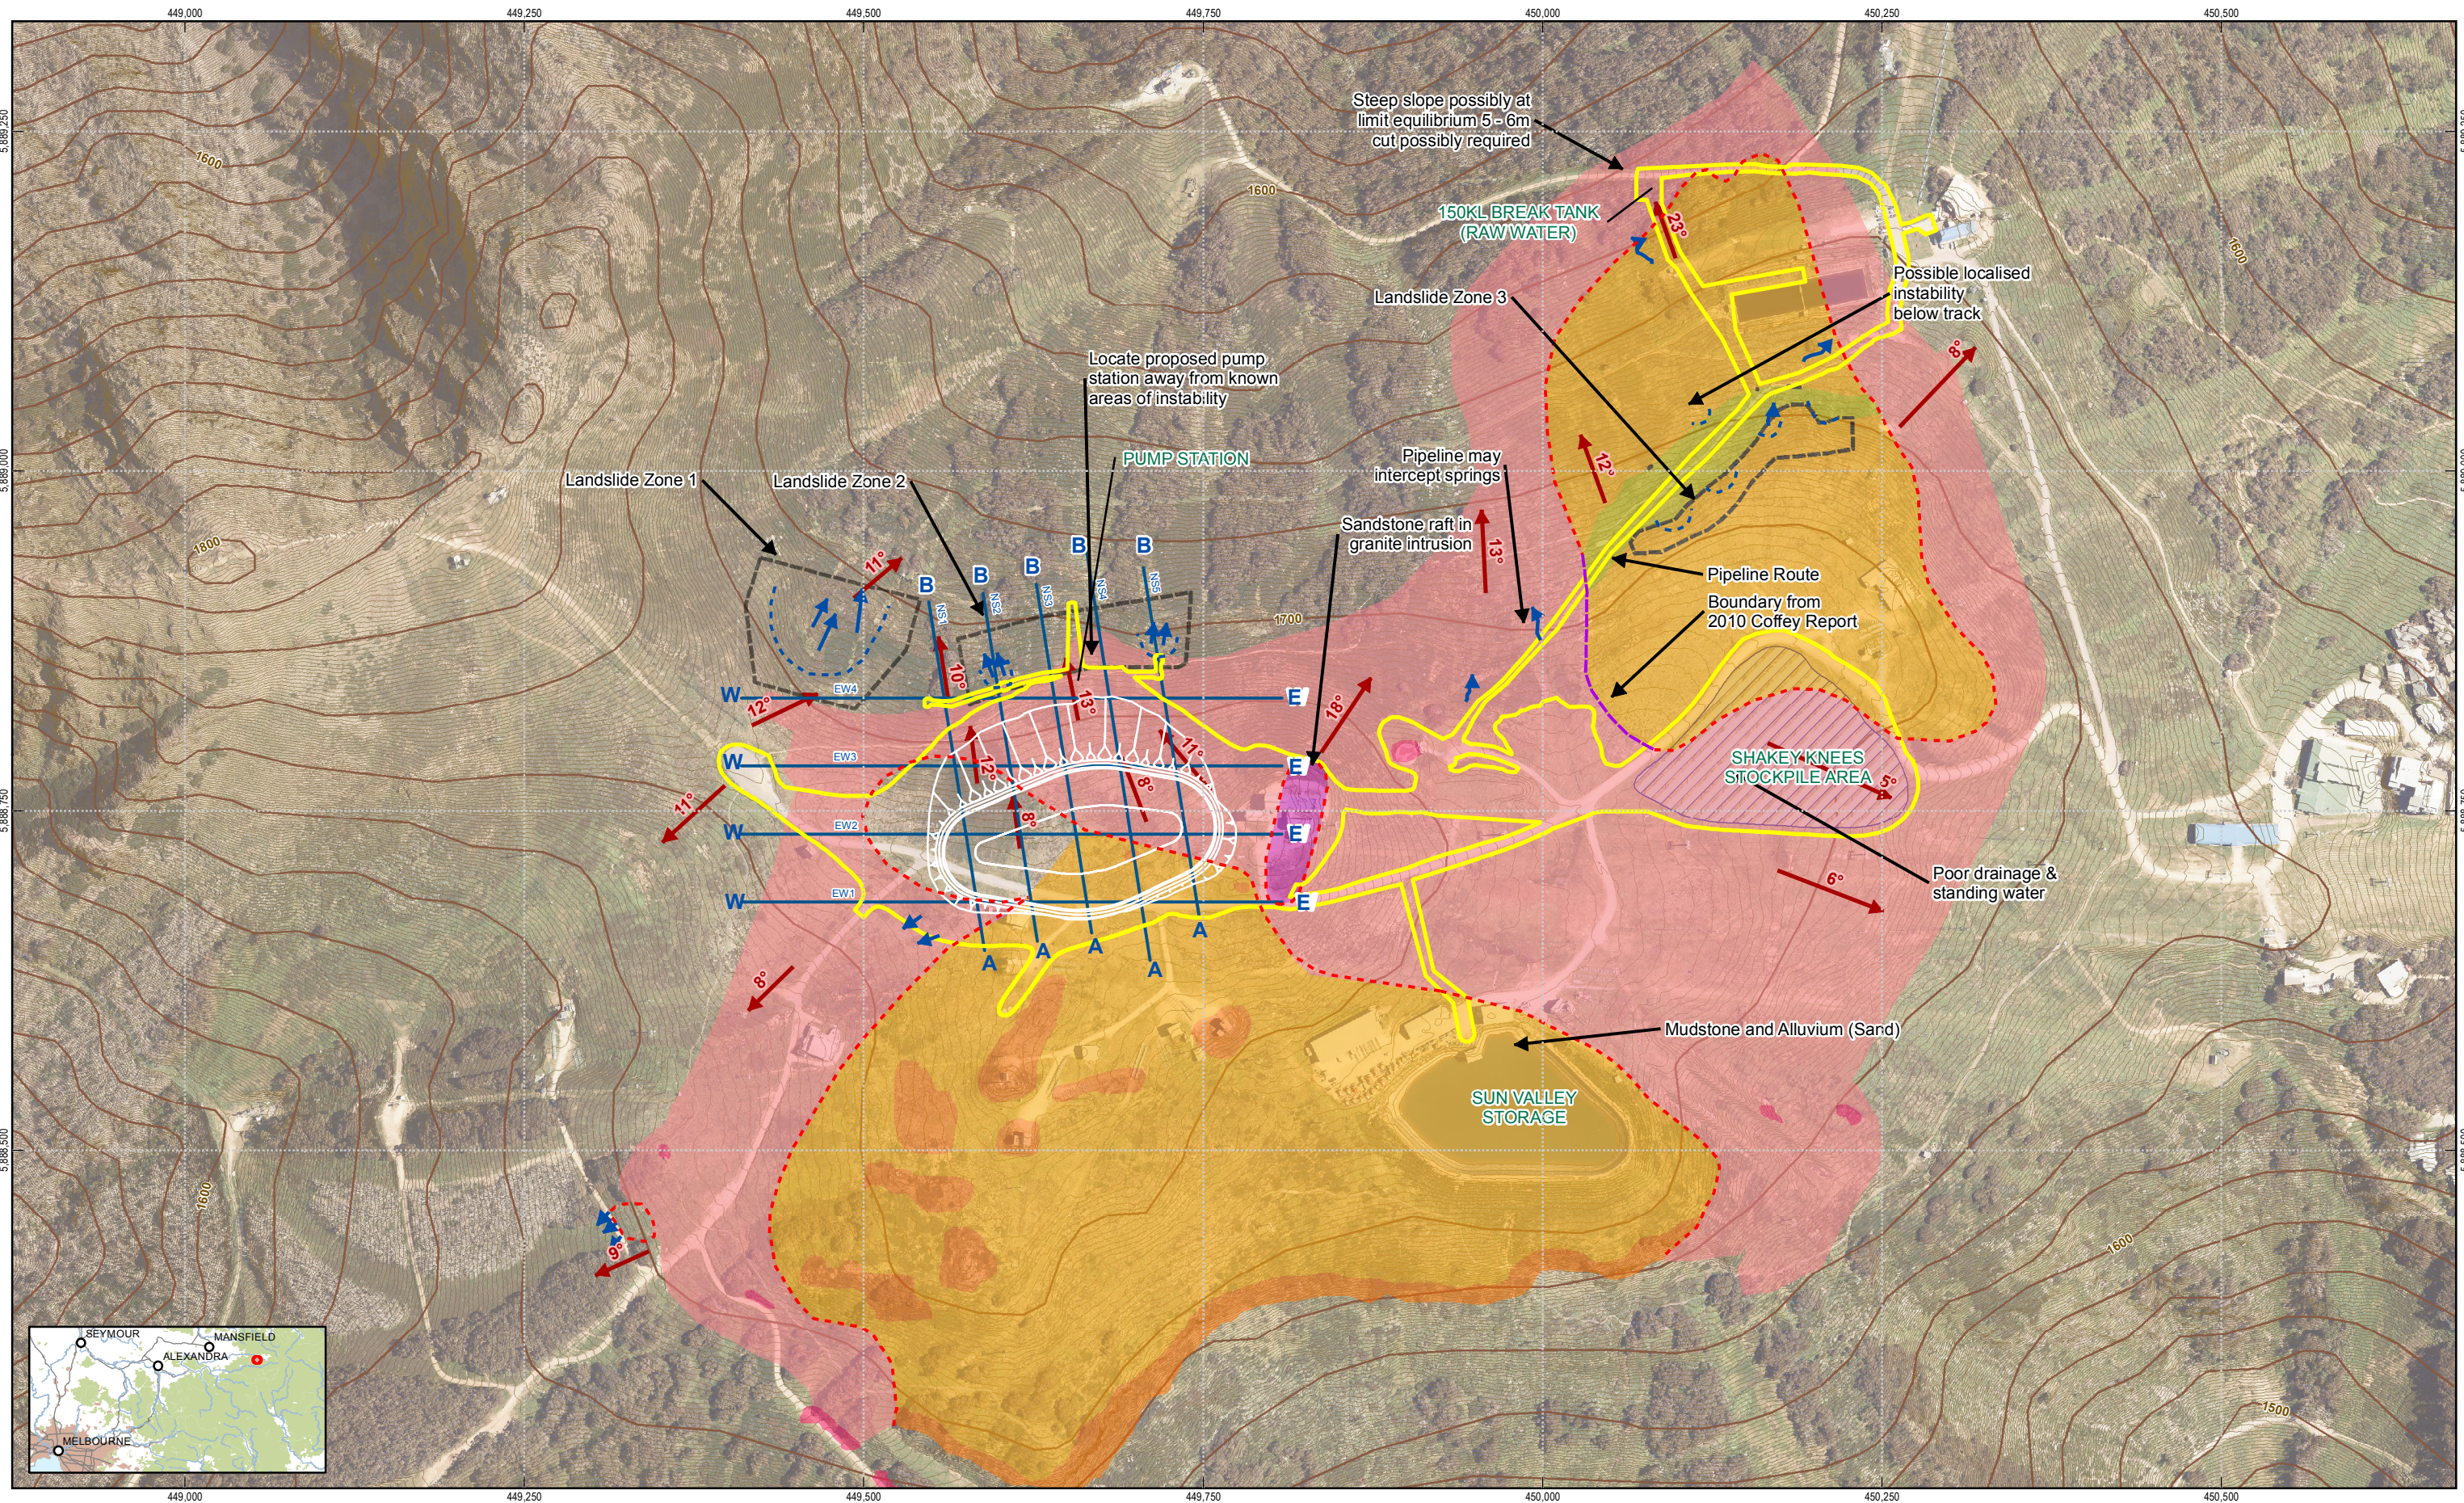
Additional springs were located along the proposed main pipeline alignment. Minor seeps or springs were observed on the southern (upper) parts of the proposed pipeline alignment. Significant flowing springs transmitting considerable water were observed exiting the surface of the track adjacent to the existing treatment plant. The location of mapped springs or seeps are presented on Figure 1.

Springs are found frequently across the project area. This is thought to be primarily controlled by intersection of lithological boundaries and the surface. Whilst no springs have been encountered within the proposed storage area footprint, springs have been found near where excavations for the header tank, main pipeline and pipeline to the Stage 1B tank are planned. Instability of excavations may result from intersection of groundwater springs and should be controlled by battering back trenches or via the use of trench shields. Construction of pipelines should include provision of water stops to prevent the migration of spring water along a backfilled trench. These springs are marked on Figure 1.

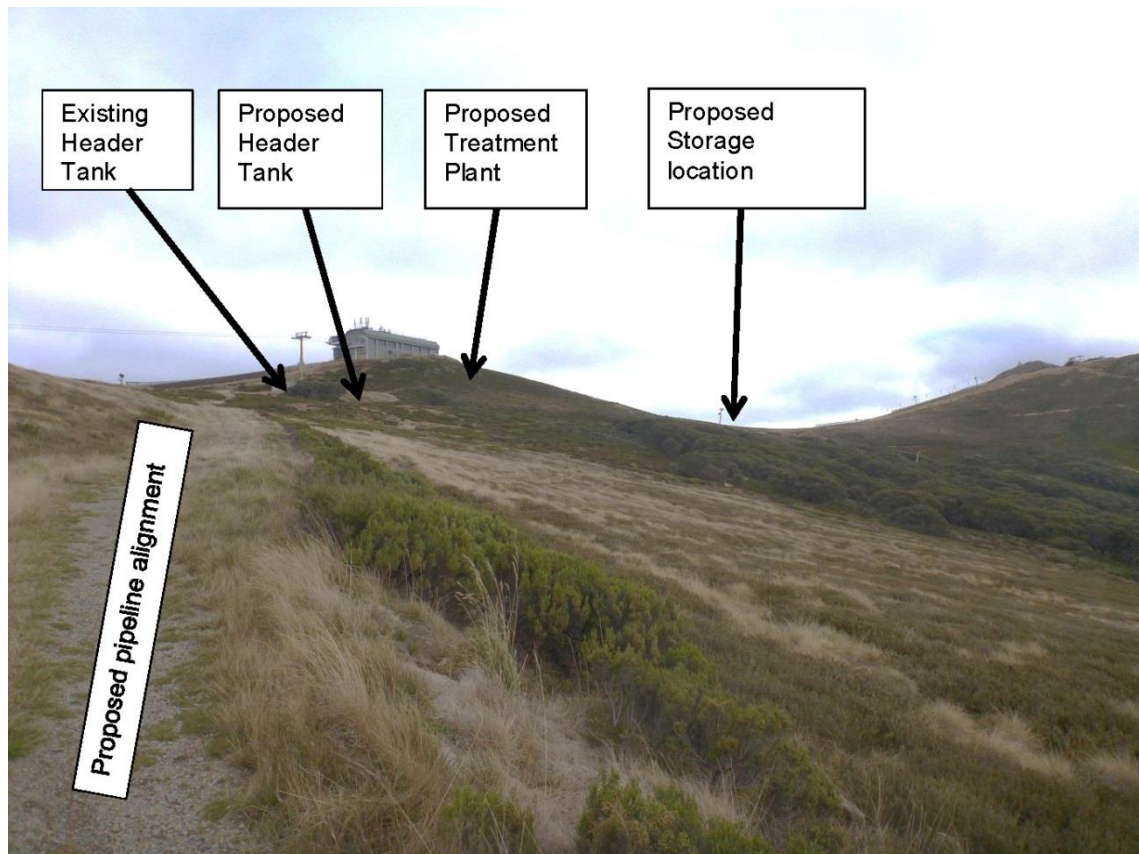
Plate 1. Looking southwest along proposed main pipeline alignment.

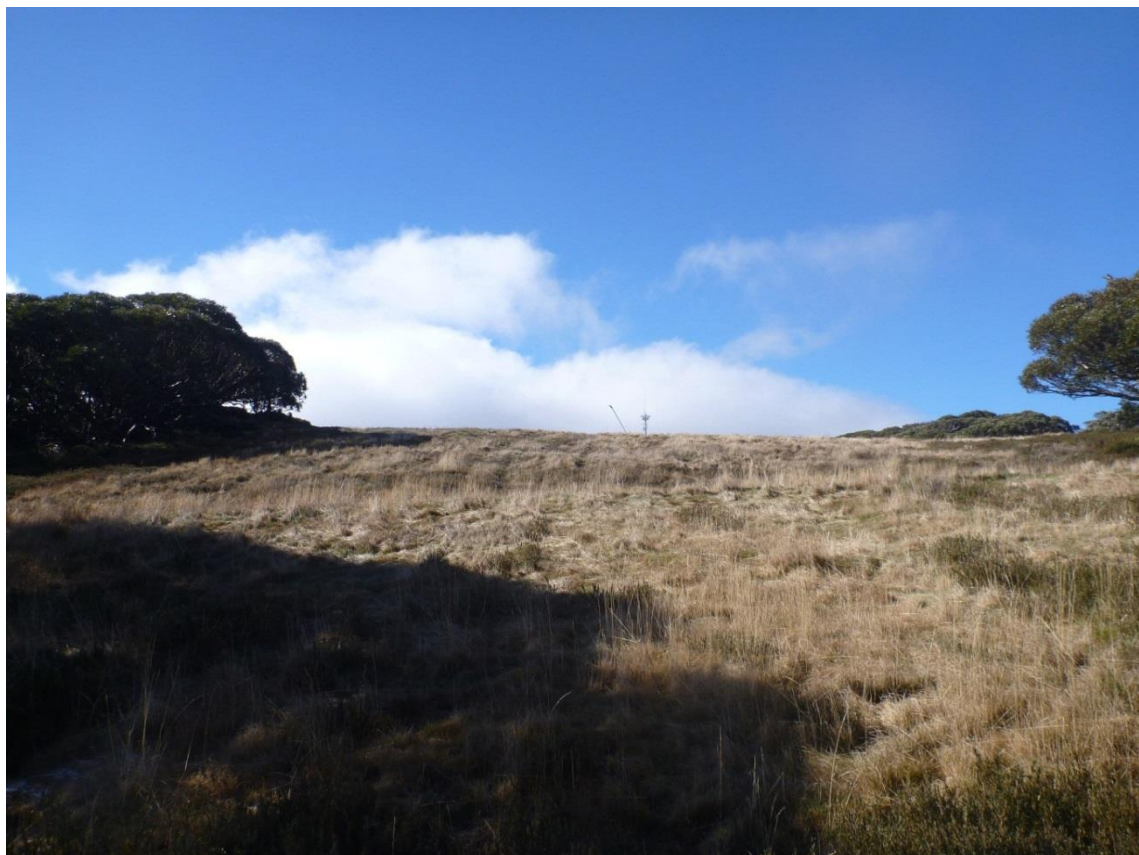
Plate 2. Area of sloping and possibly unstable ground at southern edge of Koflers Stockpile area.

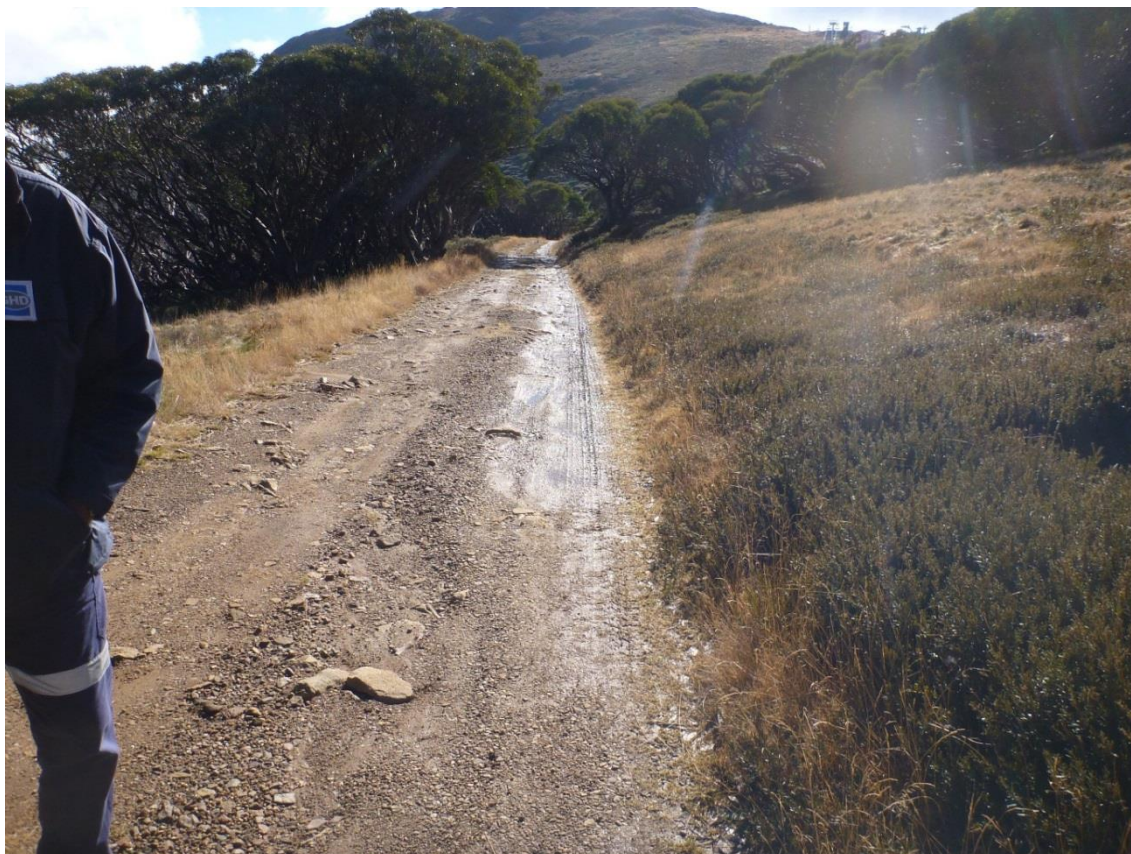
Plate 3. Groundwater Seepage at lowest point of proposed Koflers Stockpile area.

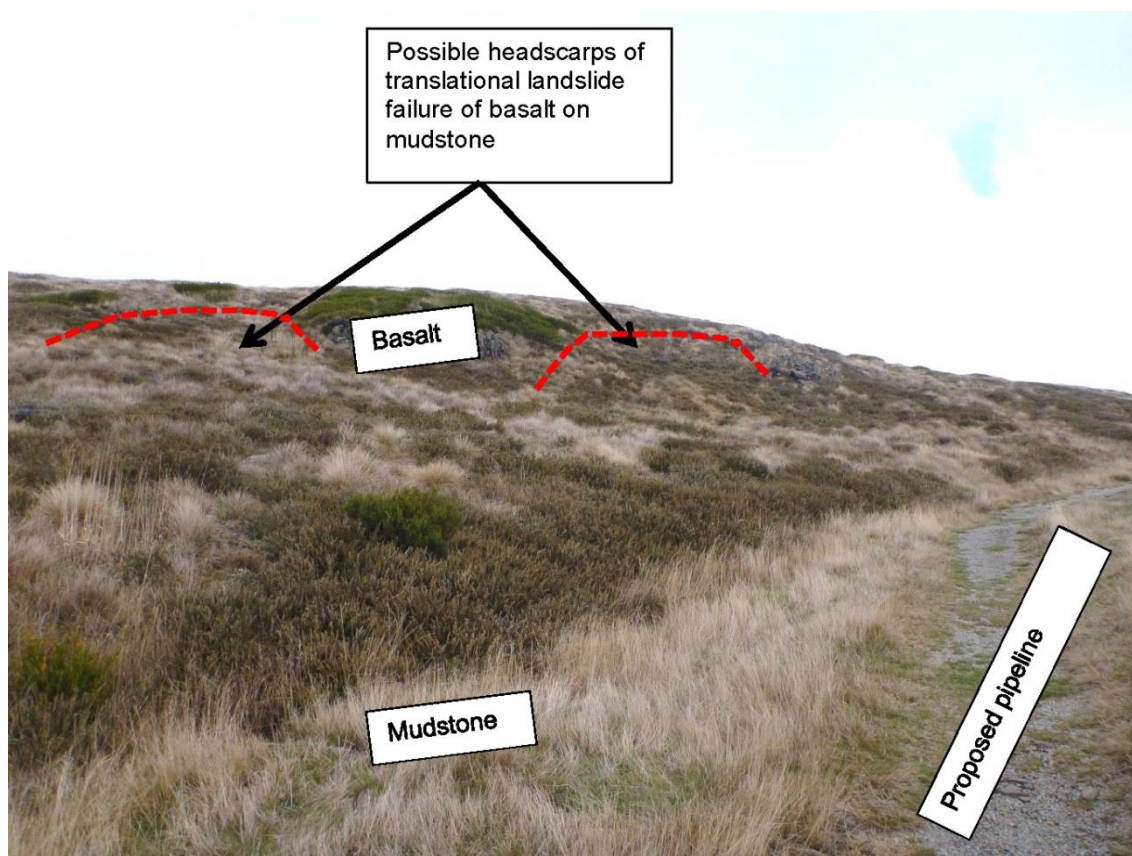
Landslide Zone 3: Small relict features were identified to the south of the proposed main pipeline alignment. These areas are thought to be due to localised translational failure of the basalt rock on top of the carbonaceous mudstone geology. These locations may however also represent areas that have been informally quarried for aggregate since the commencement of ski-field operation. The shallow (assumed less than 1.5 m depth) pipeline construction is not anticipated to have a significant effect on the slope stability within this zone.

Plate 4. Possible areas of instability to south of main pipeline alignment.

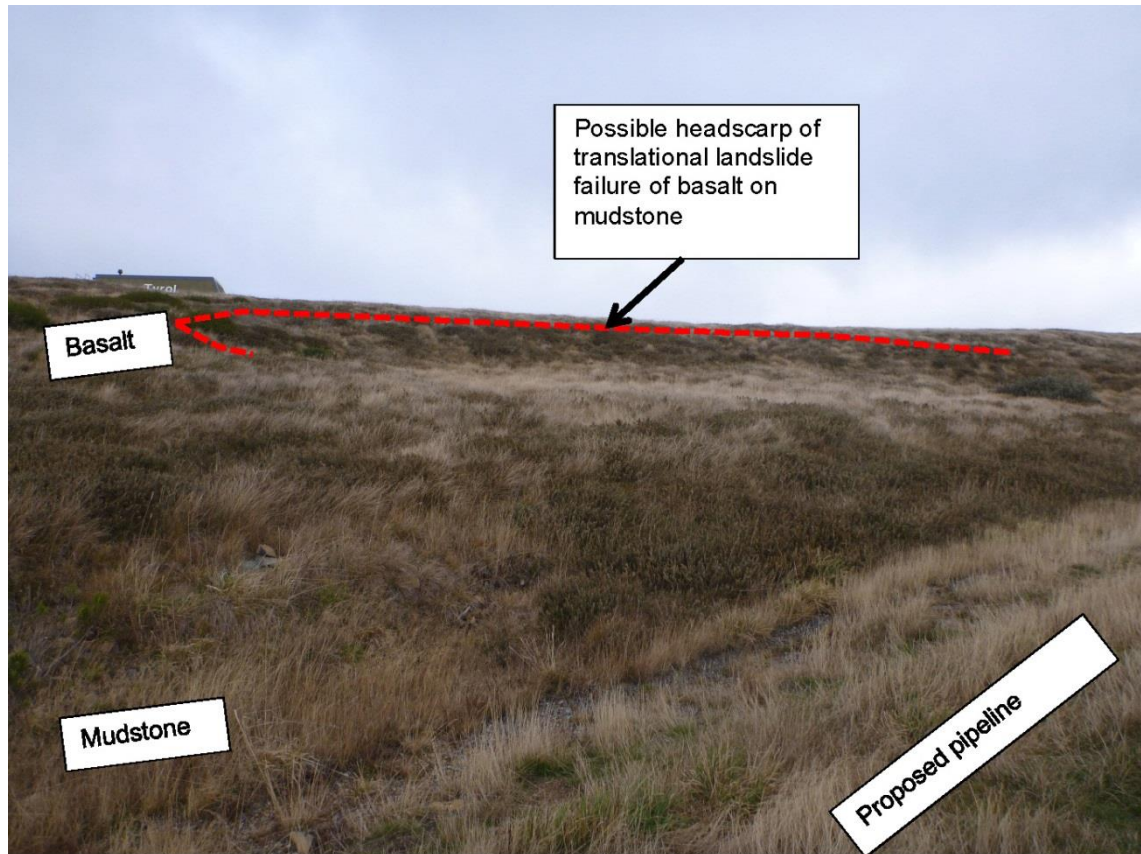
Plate 5. Possible area of instability to south of main pipeline alignment.
