## Great Ocean Road Trail

**Geotechnical Risk Mitigation**

May 2024

#### Great Ocean Road Trail Geotechnical Risk Mitigation

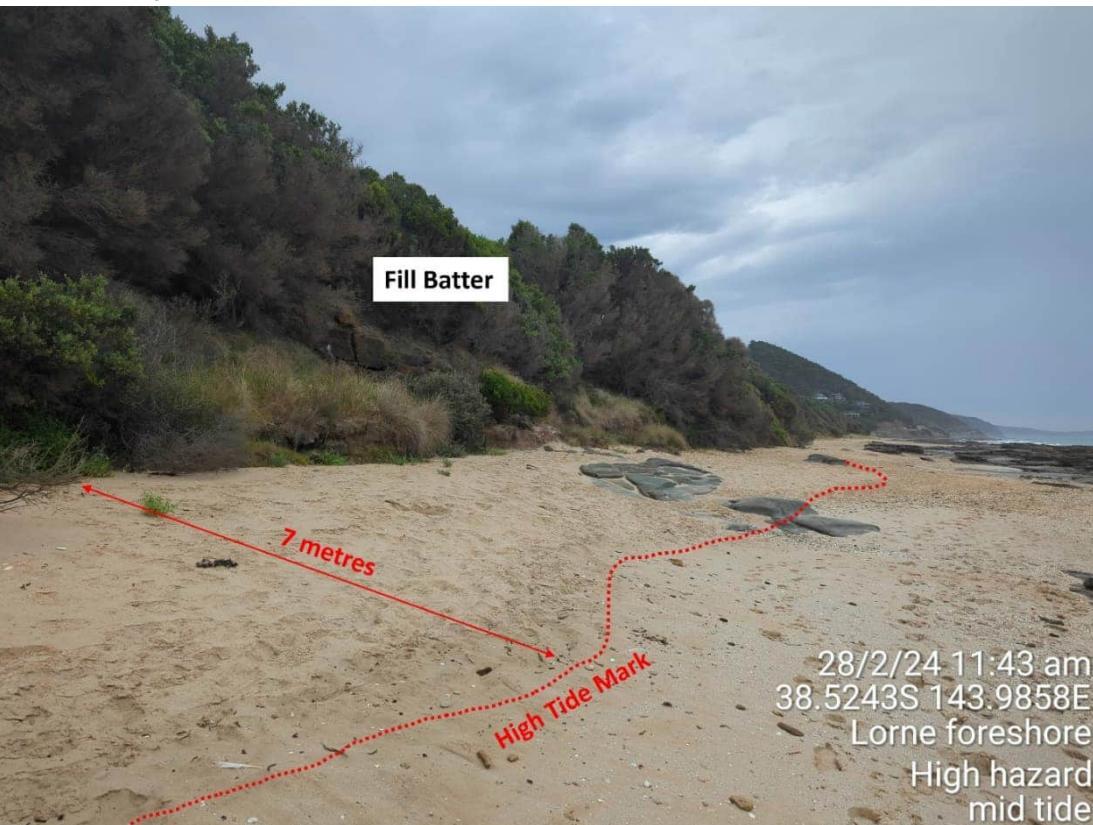
The fill batter hazard along the Lorne foreshore and Shipwreck Trail is associated with the Great Ocean Road fill batter which has been constructed directly above the beach and trail. Between CH25600 and CH26400, the proposed walking trail alignment is along a section of North Lorne beach where a medium to high hazard associated with collapse of the upslope road fill batter (Figure 4.4) has been identified. The fill batter along this section is typically 4 m to 5 m in height with a slope angle of between 45° and 70°. The batter face is well vegetated with very few areas of exposed soil. Based on the field observations, it is expected that the fill batter hazard would only affect the 10 m to the rear of the beach. People walking along the lower reaches of the beach are not exposed to the hazard.

#### Figure 4.4 Fill batter along North Lorne beach.

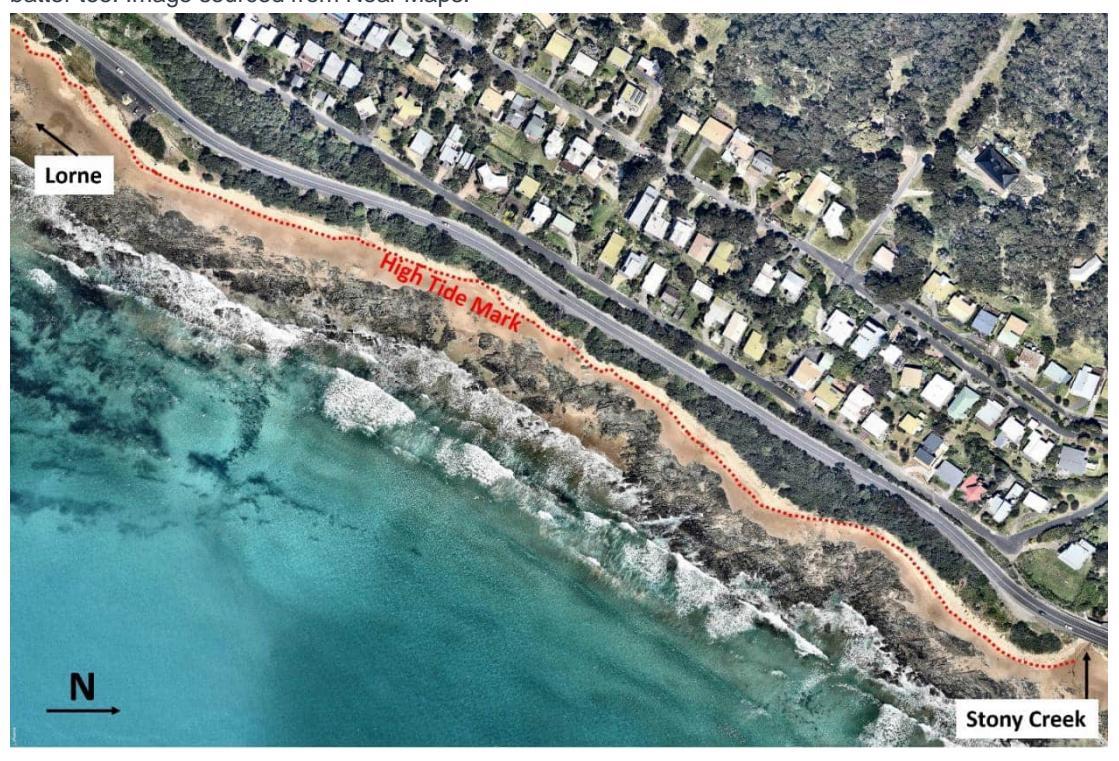
The site visit was undertaken during low to mid-tide, it was observed that all beach walkers were walking along the nearshore to avoid the soft sand closer to the fill batter. Following the site visit, a review of aerial imagery was used to determine the tidal range at North Lorne beach. As presented in Figure 4.5, at high tide the width of passable beach is 0 m to 10 metres at the base of the fill batter.

Figure 4.5 High tide mark as observed in aerial imagery, indicating high tides comes within 0 m to 10 m of the fill batter toe. Image sourced from Near Maps.

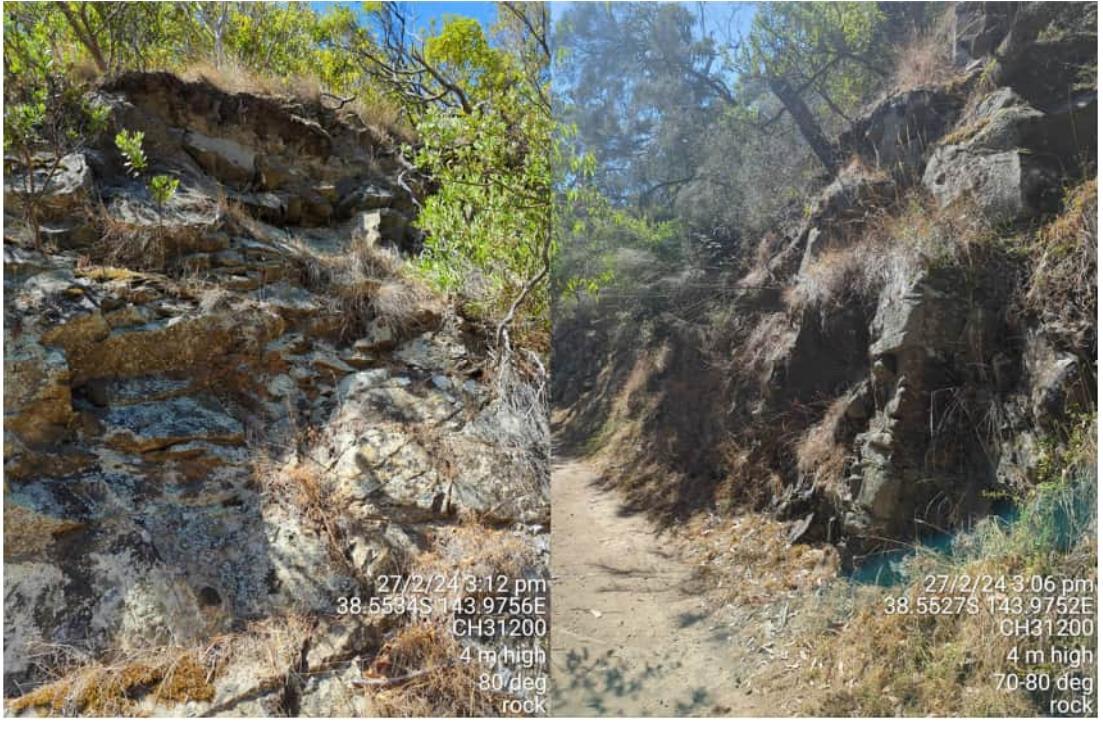
The lower old tramway cut ranges in height between 2 m and 5 m. The cuts are typically comprised of near vertical rock (slope angles between  $70^{\circ}$  and  $80^{\circ}$ ) with persistent defects resulting in fractured blocks of rock sitting loosely on the cut face or fallen to the ground (Figure 4.8, Figure 4.9). Fresh rockfall up to 200 mm in diameter was observed on the outer edge of the 1 m wide track. At some locations, there is a soil layer up to 1.5 m thick mantling the rock within the cut face. Evidence of previous slumping was observed in the soil (Figure 4.10).

Figure 4.8 Lower old tramway cut. Left 4 m high, 80° slope angle with overhang. Right: 4 m high, 70° slope angle.

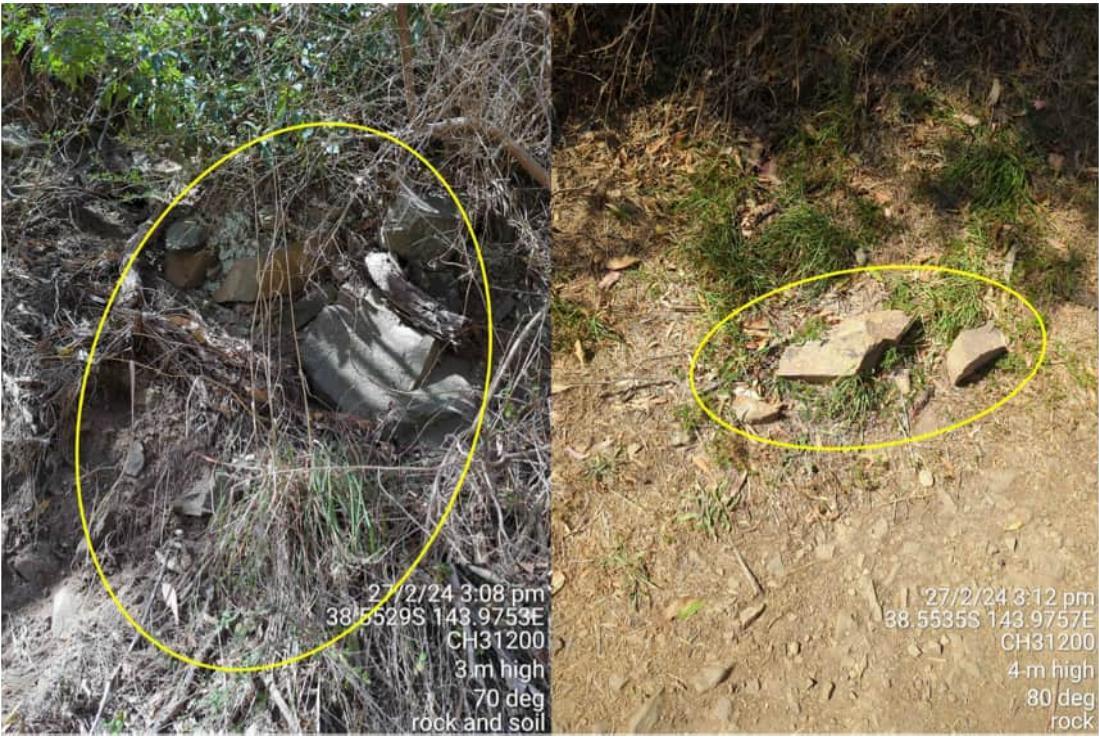
Figure 4.9 Lower old tramway cut. Left: Loose blocks sitting on slope. Right: Fresh rockfall on walking trail.

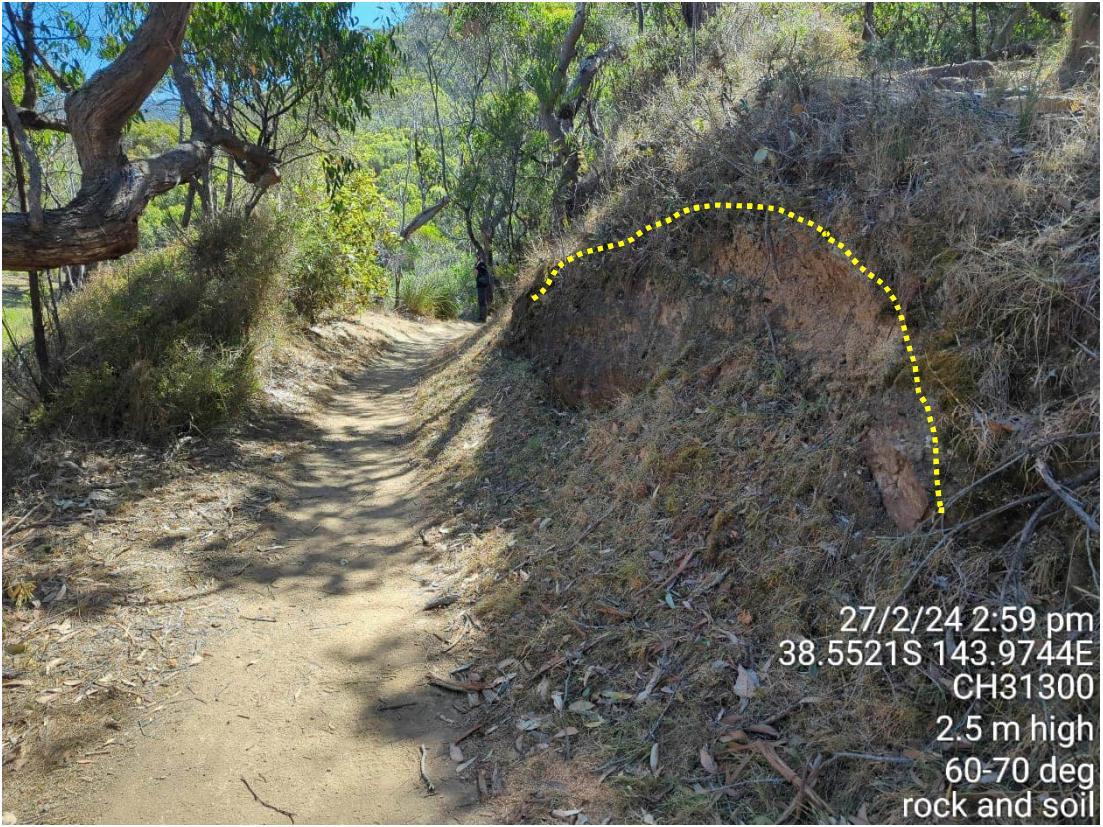
Figure 4.10 Lower old tramway cut. Soil cut with evidence of previous slumping.

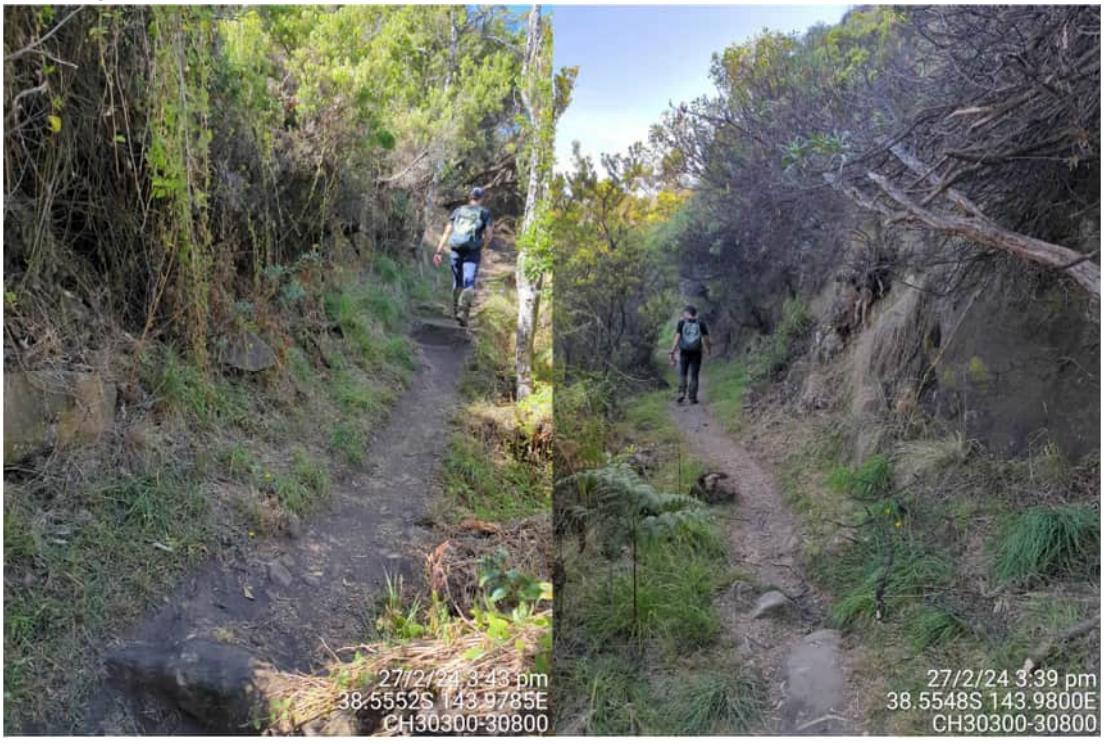
Figure 4.11 Upper old tramway cut. Left: 2 m high soil and boulder cut, 55° slope angle. Right: 4 m high rock cut, 70° slope angle.

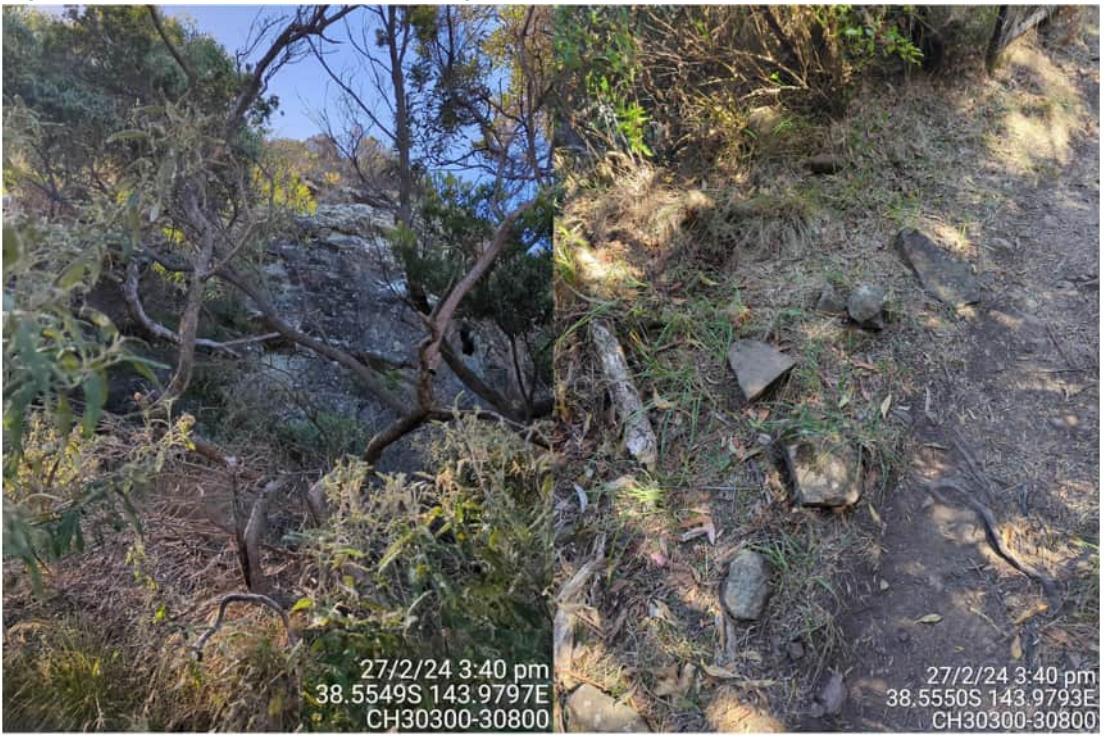
Figure 4.12 Upper old tramway cut: Left: Sandstone bluff above cut possibly contributing to rockfall on walking track. Right: Historic and newer rockfall on walking track.

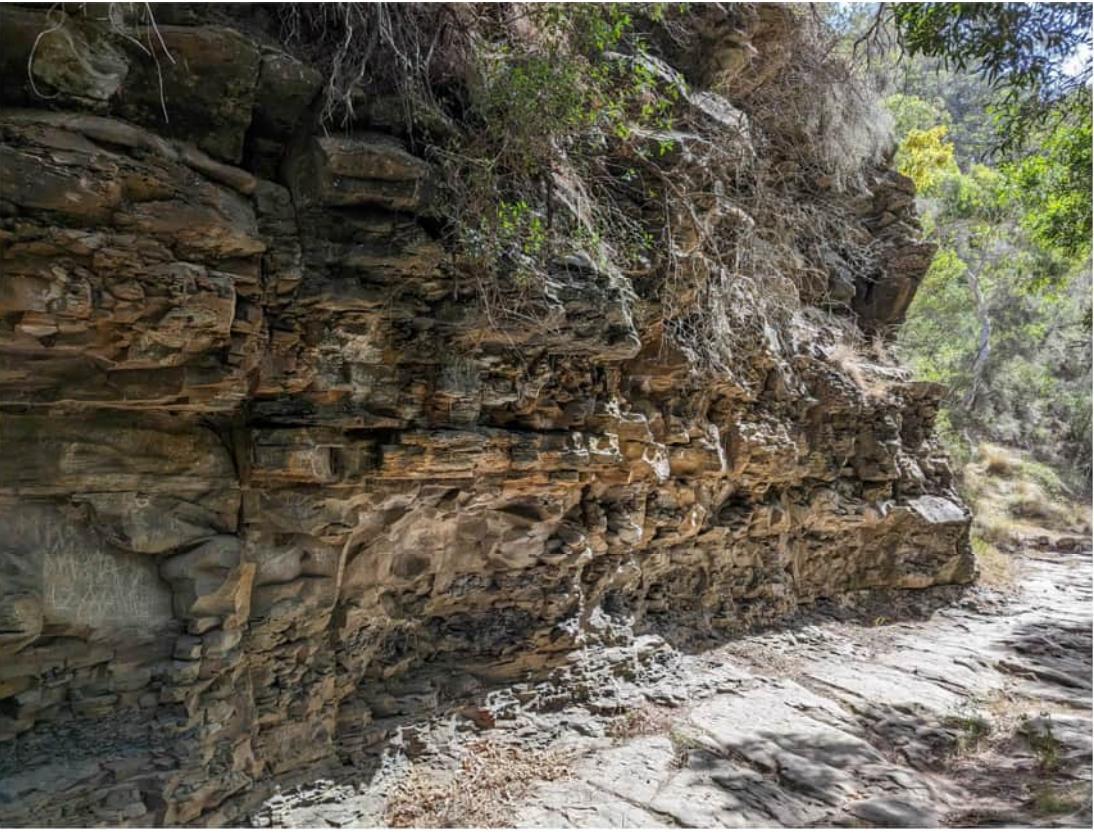
Figure 4.13 Five-metre-high cliff with orthogonal jointing and significant overhangs.

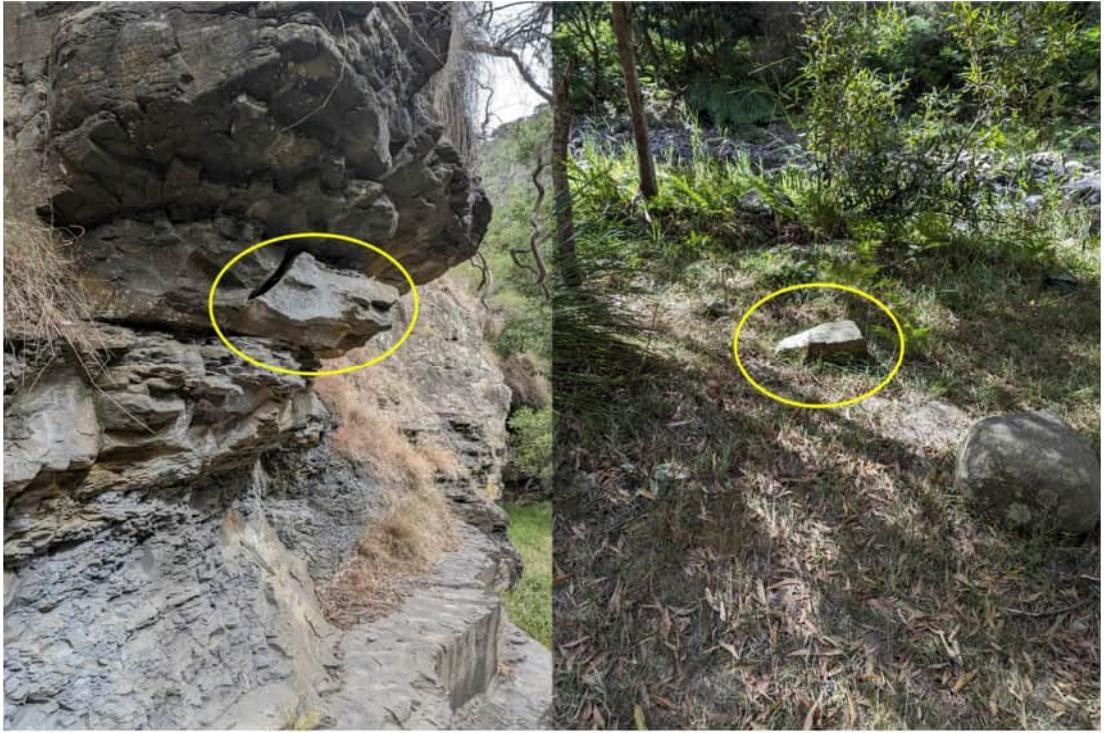
Figure 4.14 Left: Orthogonal jointing and undercutting resulting in rockfall hazard. Right: Angular piece of rockfall, inferred to have been moved off the walking trail during maintenance.

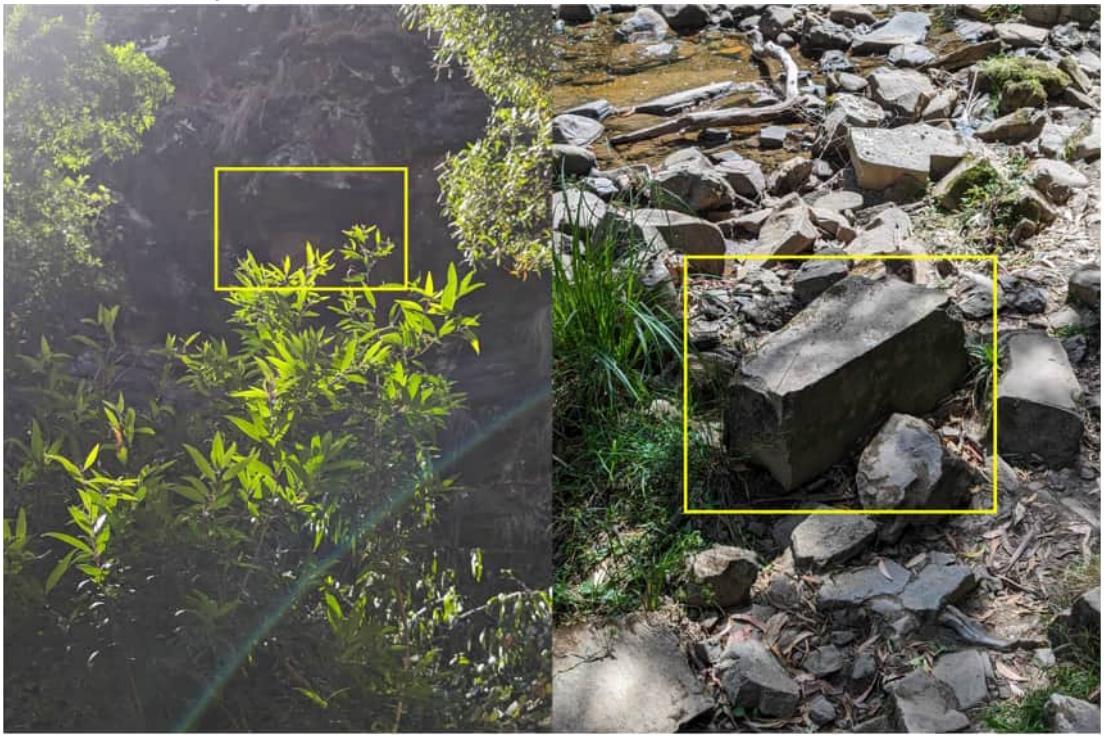
The rockfall hazard between CH42520 and CH42620 is associated with a 5 m to 10 m high near vertical cliff directly above the walking trail. A relatively fresh rockfall block up to 900 mm in diameter was observed on the outer edge of the

Figure 4.15 Left: Rockfall scarp exposed in cliff face about 5 m above the ground. Right: Detached block between the river and walking trail.

This section of trail is not suitable for soft engineering mitigation concepts. The trail cannot be re-routed to avoid the rockfall risk without adding an additional two river crossings to the alignment, nor is there sufficient space available to shift the trail away from the base of the cliff. Hard engineering mitigation measures, such as rock netting or canopies, could be implemented, however are unlikely to be economically feasible. It is recommended that signage is implemented alerting the walkers to the rockfall hazard and advising them to move quickly through this section of trail. Based on the rockfall mitigation measures recommended for the Cumberland River Campground and Cumberland Hill rockfall hazards, the cumulative rockfall risk for this broader section of trail has adequately reduced without the need to provide further mitigation measures to address the Cumberland River rockfall hazard, as presented in Figure 5.15.

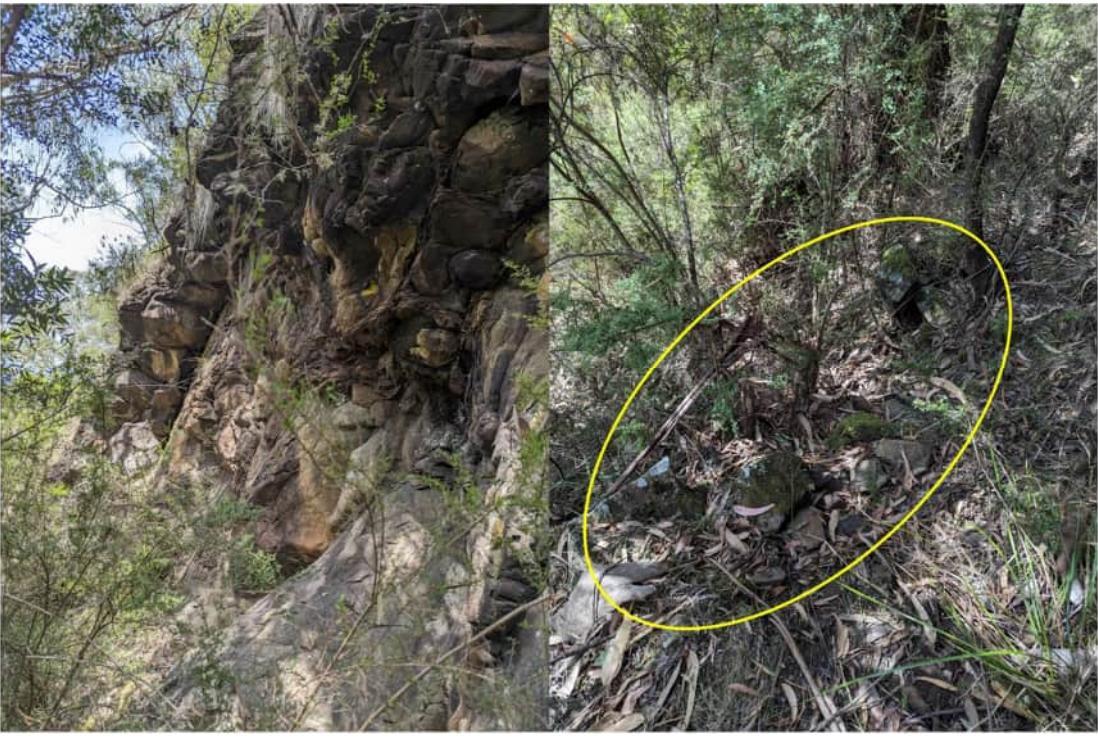
The rockfall between CH43350 and CH43500 is associated with a 5 m high bluff of sandstone that outcrops along a ridgeline. The outcrop is near vertical and has significant over-hangs. Orthogonal jointing and spheroidal weathering have made this outcrop susceptible to rockfall. Historical and more recent rockfall was observed up to 50 m downhill from the bluff, many of the detached rocks are now sitting loosely on the 35° slope.

Figure 4.16 Left: Sandstone outcrop at ridgeline. Right: Rockfall on slope observed up to 50 m downslope of the sandstone outcrop.

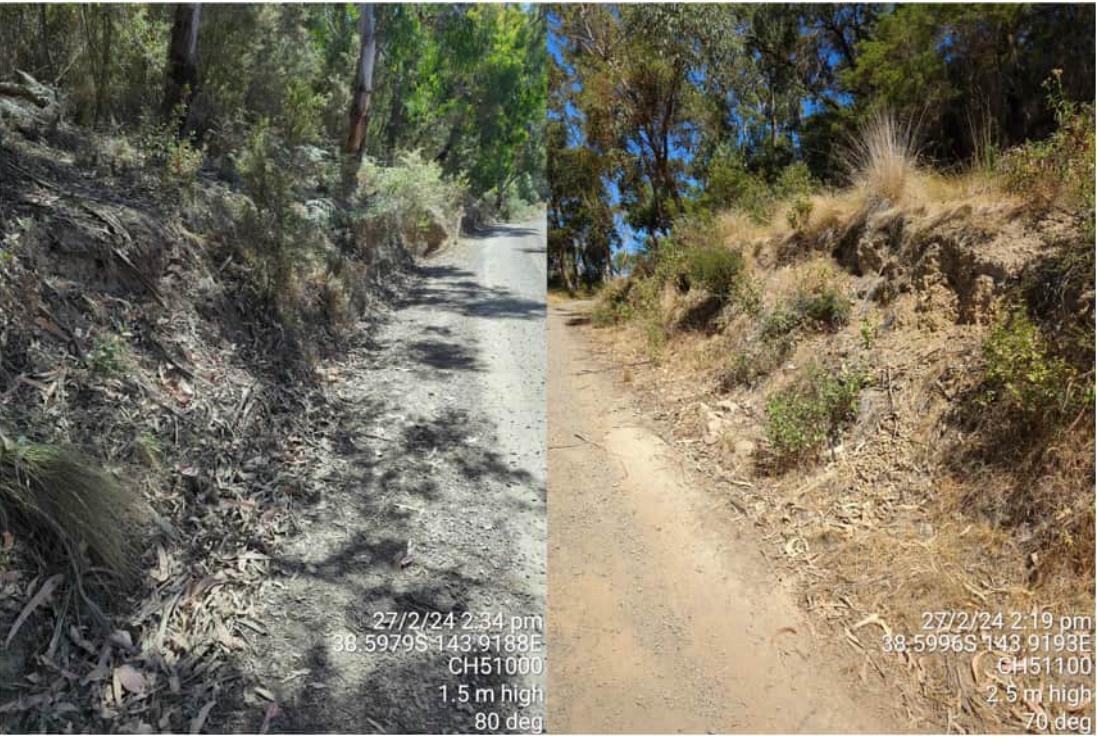
The Jaimeson Creek Campground cut is a 1 m to 2.5 m high cut that leads up to and beyond the campground from the Great Ocean Road. The cut is comprised of soil with cobbles and ranges in slope angle between 45° and 80° (Figure 4.17). Evidence for minor slumping and erosion was observed in the cut face. Locally, large trees within the cut face appear to be contributing to instability via loading and root jacking. The walking trail at this location also serves as an access road to the campground and is about 3 m wide.

Figure 4.17 Left: 1.5 m high soil cut, 80° slope angle. Right: 2.5m high soil cut, 70° slope angle, minor instability and slumping observed.

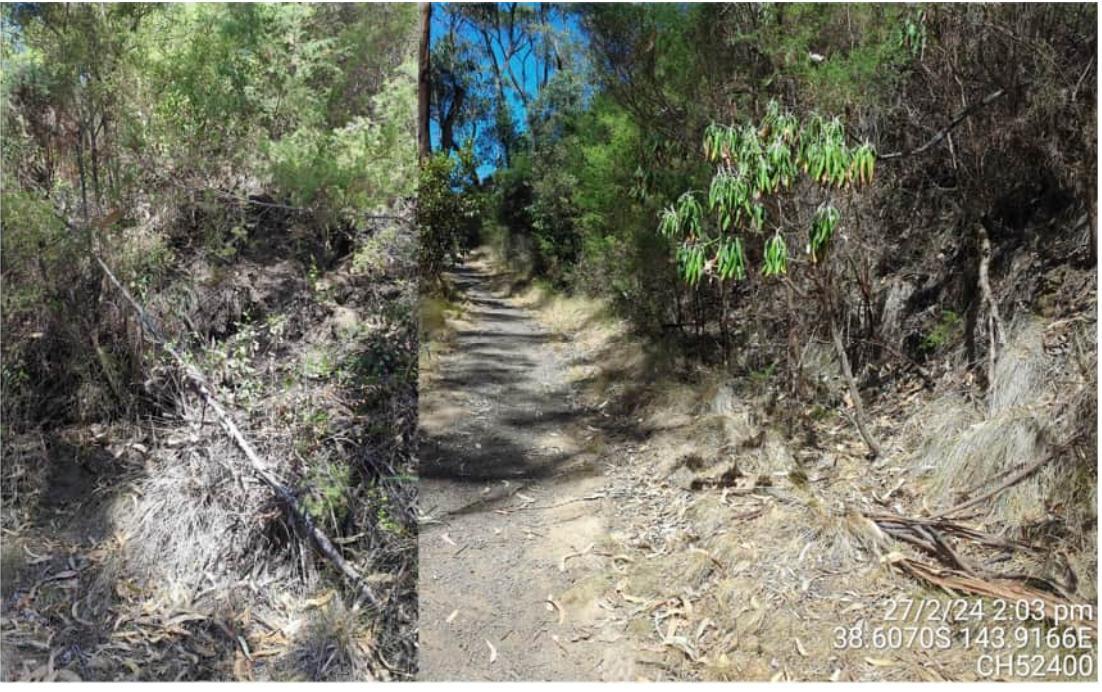
The cut between CH52350 and CH52420 along Godfrey Track is up to 2 m in height with an average slope angle of 55°. The cut is comprised of soil with some cobbles and boulders. Localised instability and slumping were observed although there was no evidence this had impacted the trail. In some locations, trees near the cut face are likely causing further instability due to root jacking.

Figure 4.18 Left: Cut face showing minor instability in the soil. Right: 2 m high soil cut, 55° slope angle.

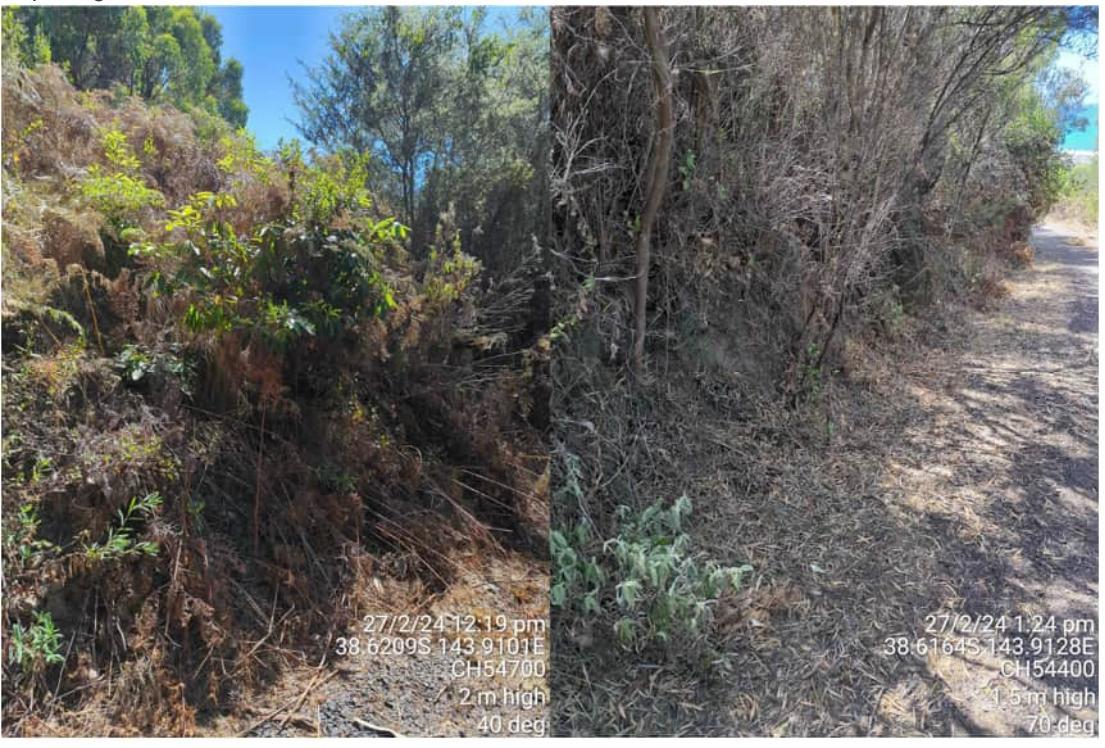
Between CH53990 and CH56280, east of Separation Creek, there are multiple cuts along the walking trail identified as low to moderate cut-soil hazards and cut-rock hazards. This section of the trail was assessed to understand the characteristics of the cuts. The cuts along this segment of trail were observed to be between 0.5 m and 3 m high, with slope angles varying between 40° and 85° (Figure 4.20, Figure 4.21). The cuts are typically comprised of soil with minimal rock observed in the cut faces. The cuts that presented the more significant hazards appeared to be more recently constructed and are typically over 1.5 m in height, with slope angles greater than 70° (Figure 4.22). Evidence for erosion of the cut face was observed on some of these steeper cuts. The walking trail was 1 m to 1.5 m in width along this segment of track.

Figure 4.19 Various cuts east of Separation Creek. Left: 2 m high cut, 40° slope angle. Right: 1.5 m high cut, 70° slope angle.

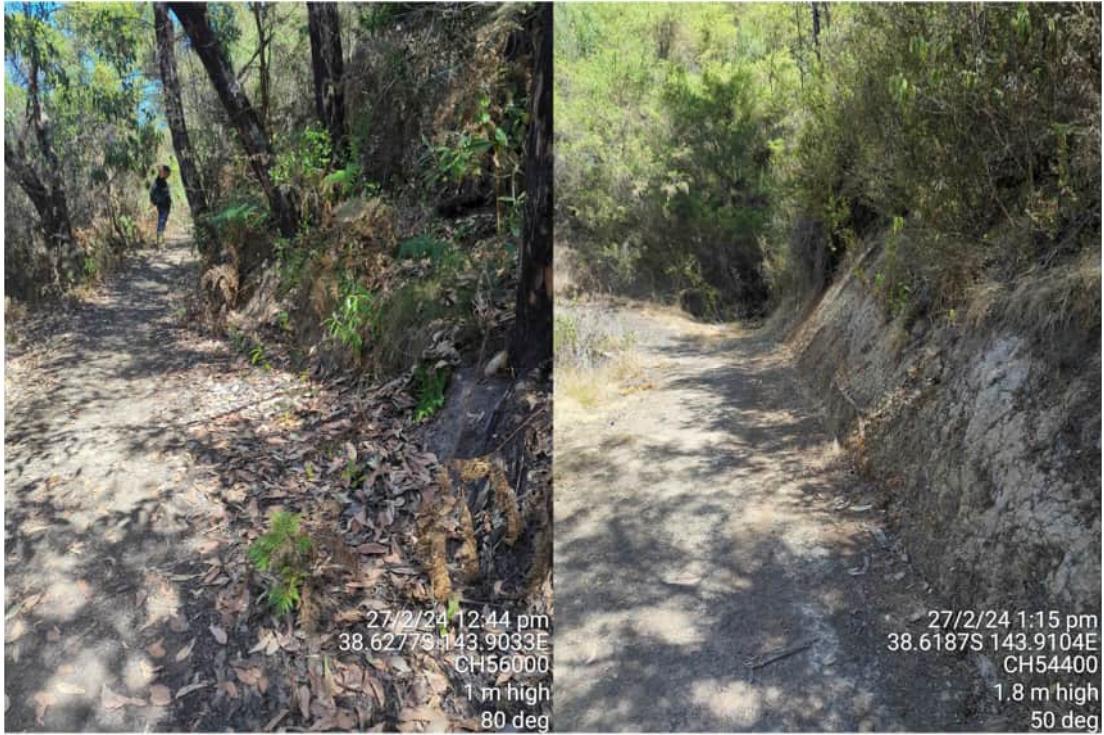
Figure 4.20 Various cuts east of Separation Creek. Left: 1 m high cut, 80° slope angle. Right: 1.8 m high cut, 50° slope angle.

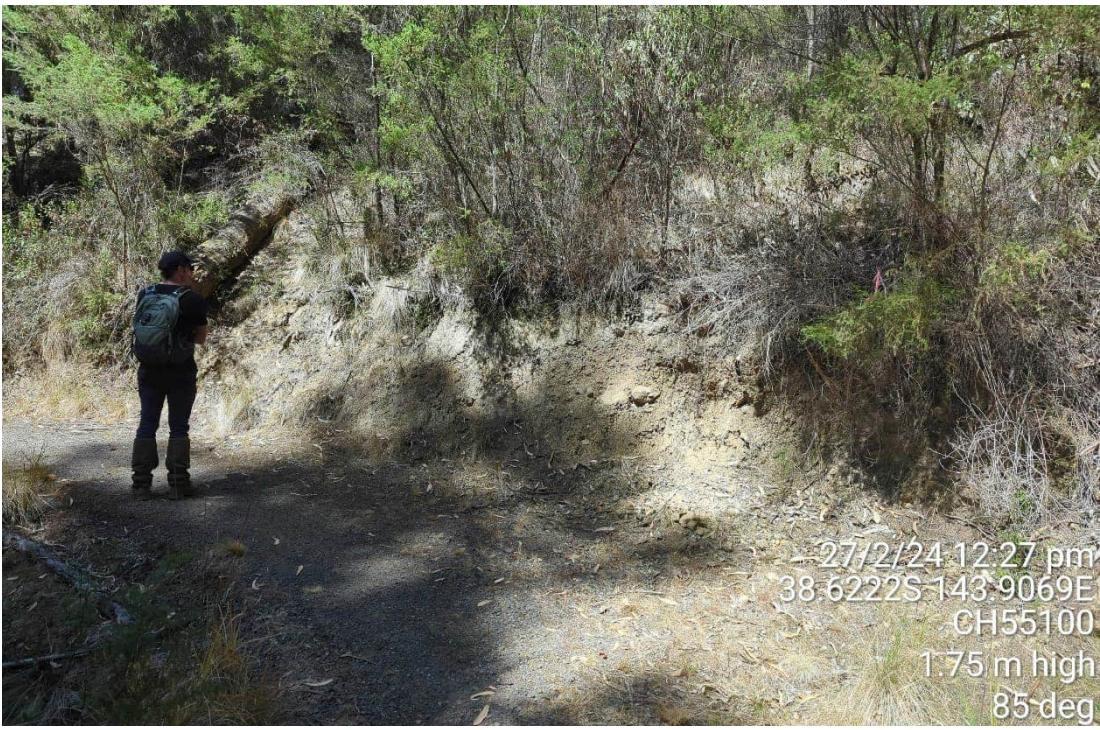
Figure 4.21 Overstepped cut east of Separation Creek, 1.5 m high cut, 85° slope angle, erosion of cut face observed.

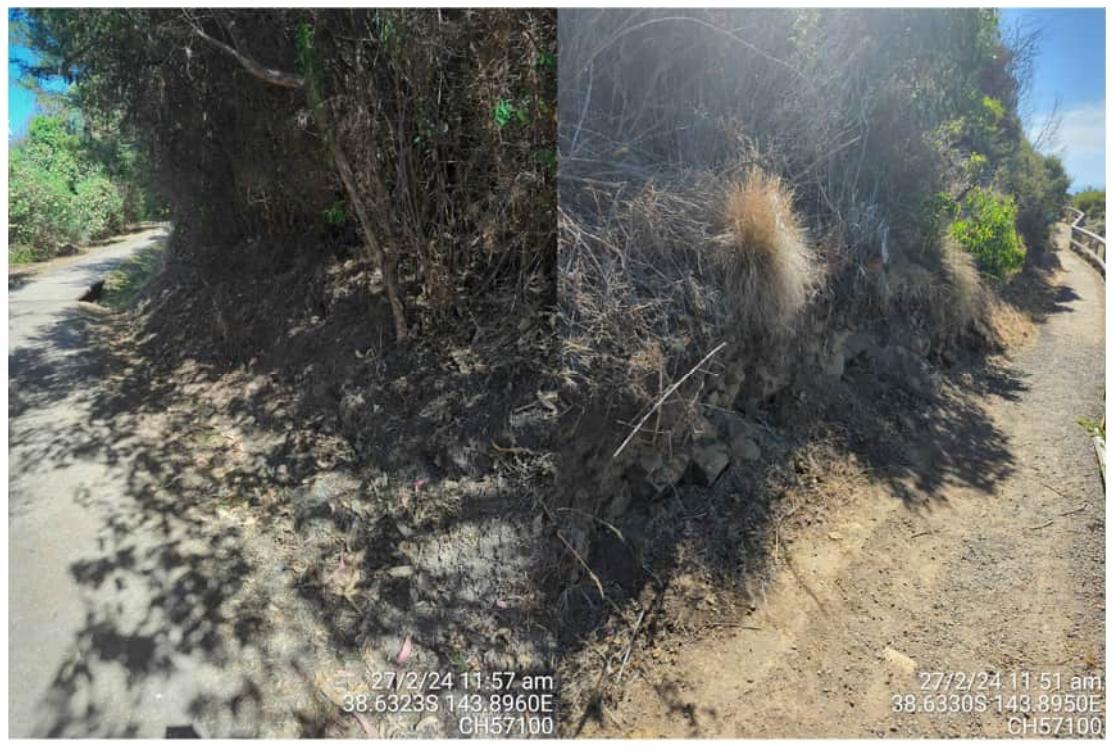
Between CH56770 and CH57000 the cut is comprised of soil with some boulders and is about 1 in high with slope angles of  $40^{\circ}$  to  $60^{\circ}$  (Figure 4.22). Between CH57000 and CH57200, the cut is comprised of highly fractured rock with soil and is up to 2 m high with slope angles of between  $50^{\circ}$  and  $80^{\circ}$ . Above the cut is a relatively steep ( $60^{\circ}$ ), well vegetated natural slope. The highly fractured rock is dipping unfavourably out of the cut face which makes it susceptible to rockfall. The walking track along this section is about 1 m wide and is bound on its outer edge by the rock netting for the Great Ocean Road cut below, constraining options to relocate the trail away from the base of the cut.

Figure 4.22 Left: 1 m high soil cut between CH56770-CH57000. Right: Up to 2-m high fractured rock cut between CH57000-CH57200.
