# Hygge Property – Preliminary Arboricultural Tree Assessment Report

Project: Middleton Field Estate Tree Assessment  
Location: Daly Street Daylesford  
Client: Hygge Property  
Date: 19 November 2021

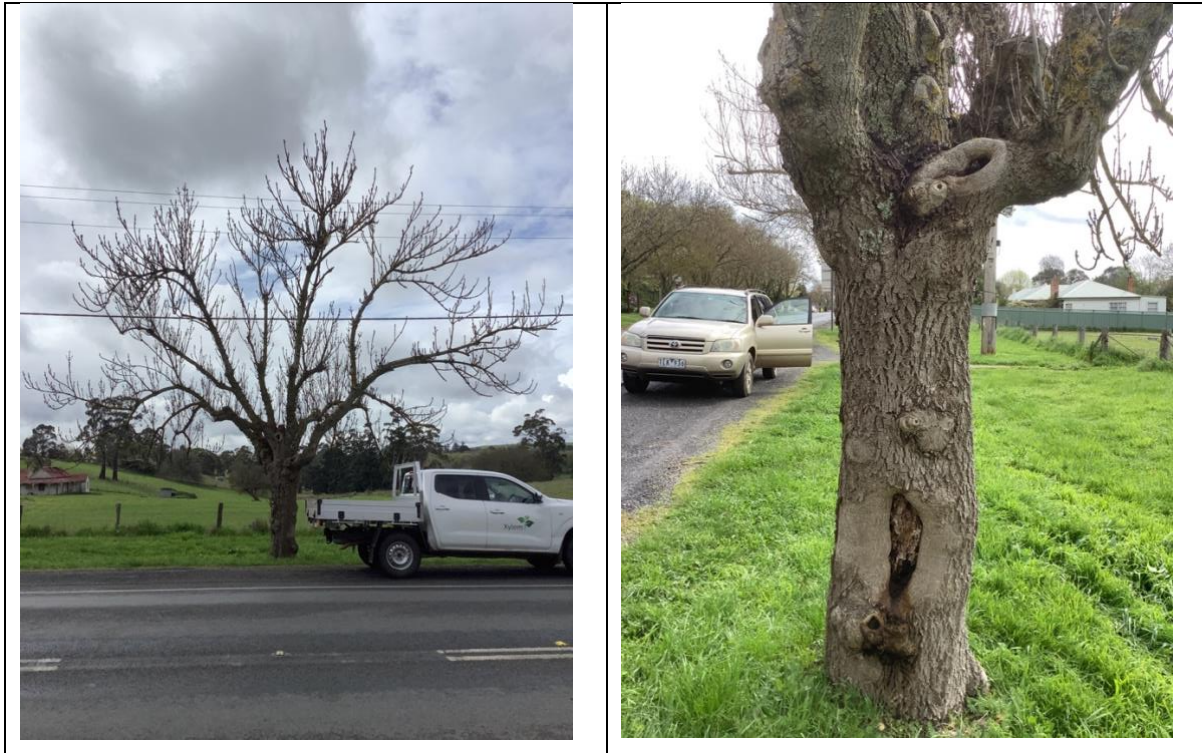
### Tree ID: 1

Health: Good

Structure: Fair

Comment: Avenue of honour planting.

Specific design considerations should be made to the proposed site entrance to ensure trees 1, 2, 3 (*Fraxinus angustifolia subsp. angustifolia*) are not adversely affected by the construction of the site entrance. As indicated in condition 12 of the planning permit this entrance must be constructed to the absolute minimum width possible. All excavation should be avoided by building up soil and constructing above natural grade. If construction is required within the tree protection zones of the subject trees, a maximum 10% encroachment into the TPZ would be allowed but an offset must be demonstrated in accordance to AS 4970-2009 (refer to APPENDIX A for TPZ dimensions). Tree sensitive construction techniques such as an air-spade or hydro vacuum excavation can only be undertaken under project arborist direction and at a pressure not greater than 400psi to ensure root cambium remains intact.

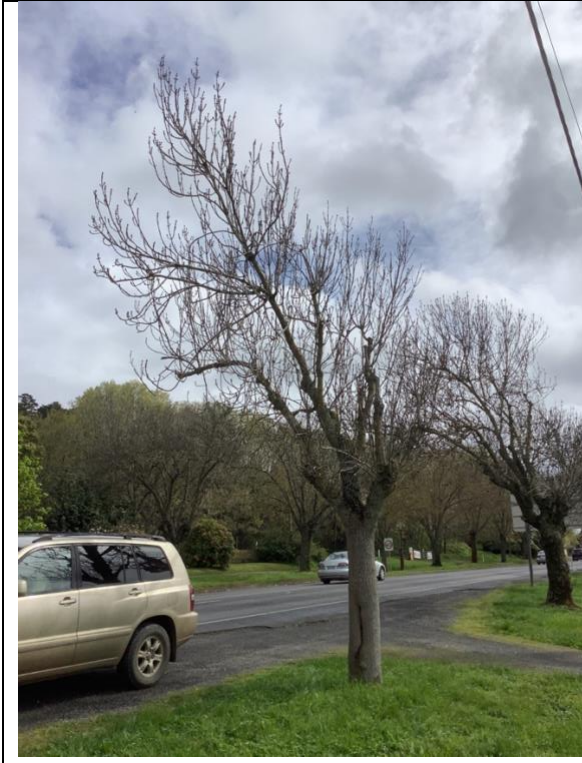
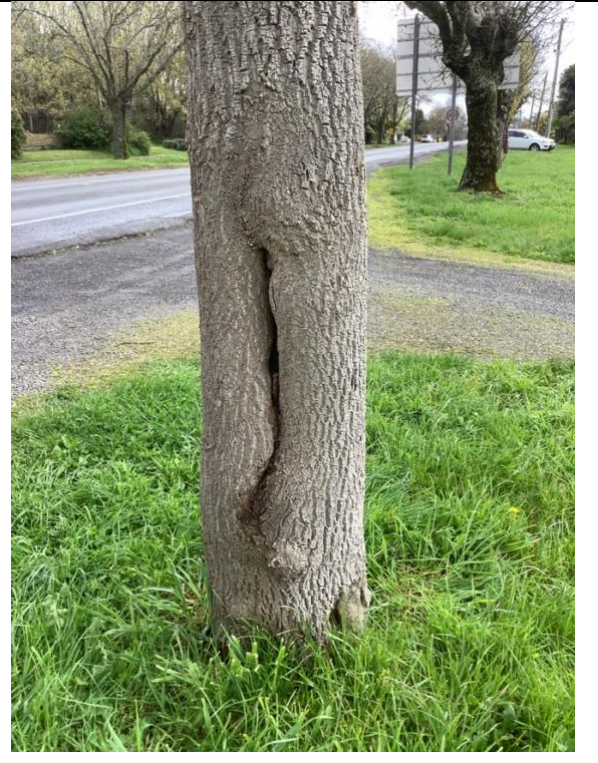
**Tree ID: 2**

Health: Good

Structure: Fair

Comment: Avenue of honour planting.

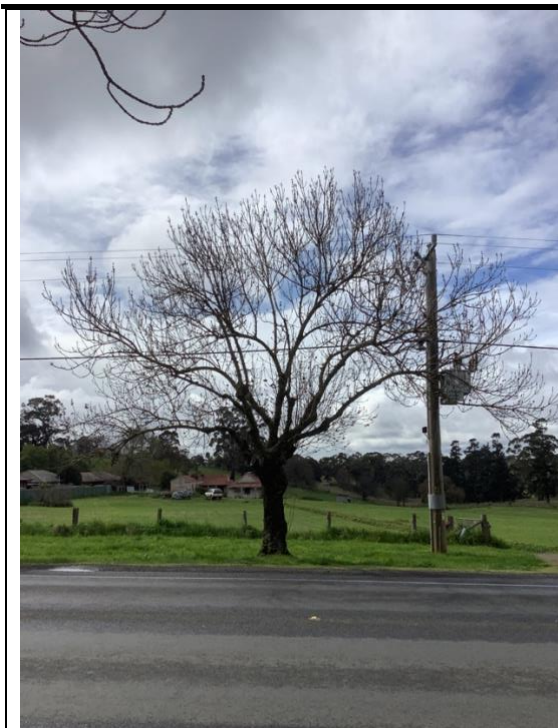
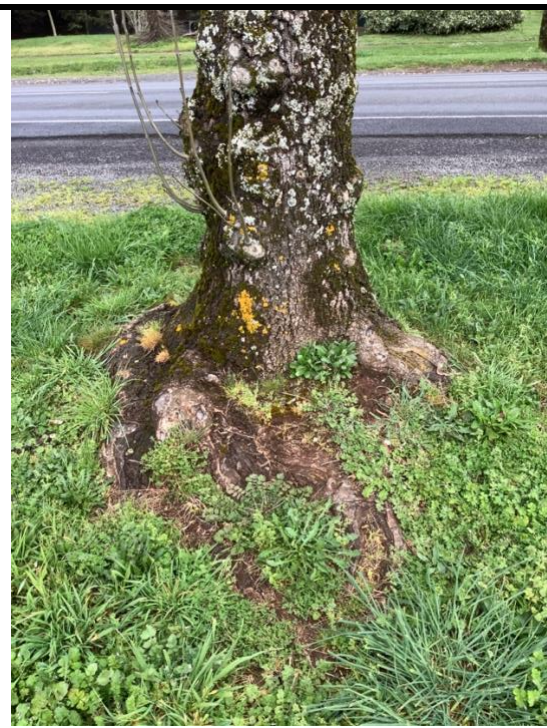
**Tree ID: 3**

Health: Good

Structure: Good

Comment: Avenue of honour planting.

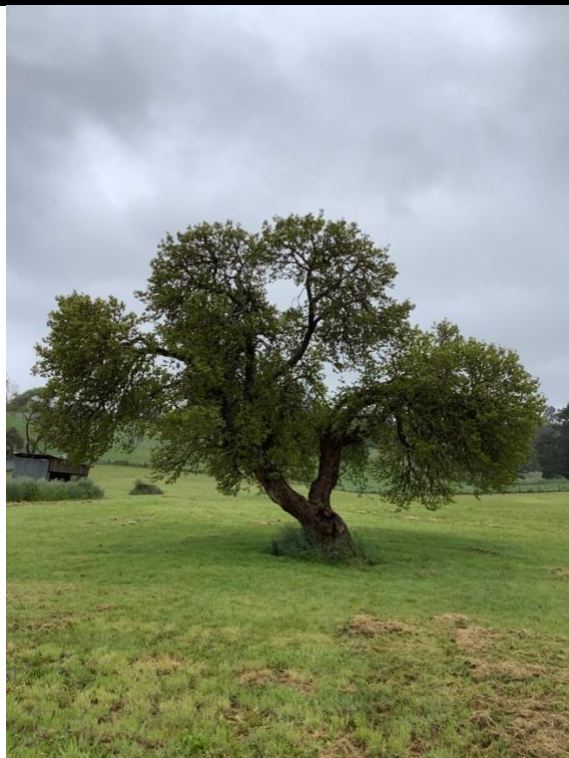
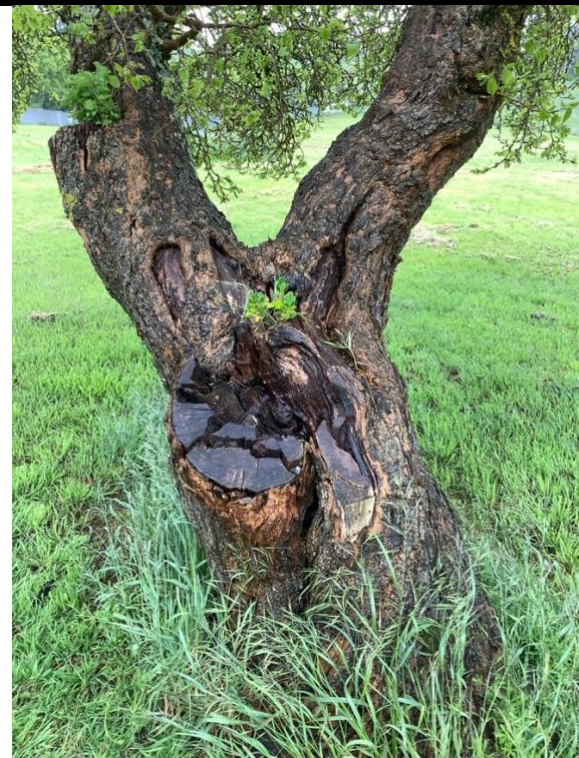
**Tree ID: 4**

Health: Fair

Structure: Fair

Comment: Mature mulberry with compromised structure due to previous significant failure.

These are healthy semi-mature and mature fruit trees and provide aesthetic value, appeal and are easily manageable species that should be retained.

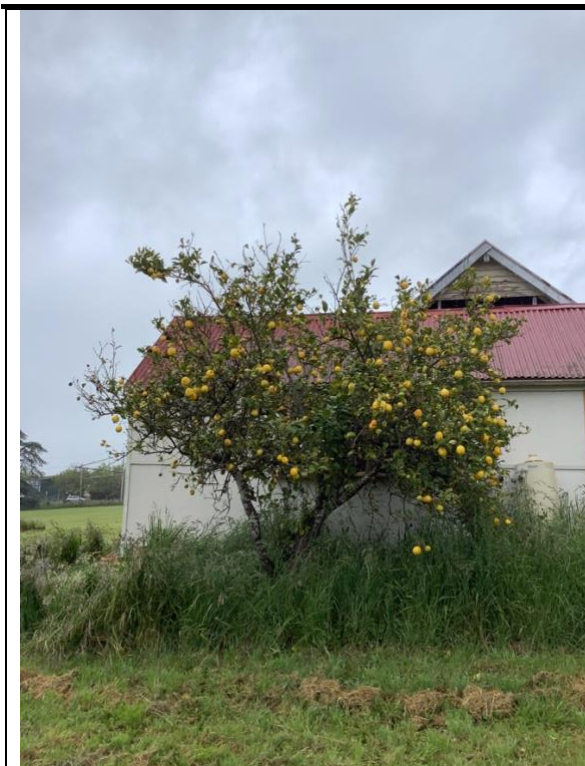
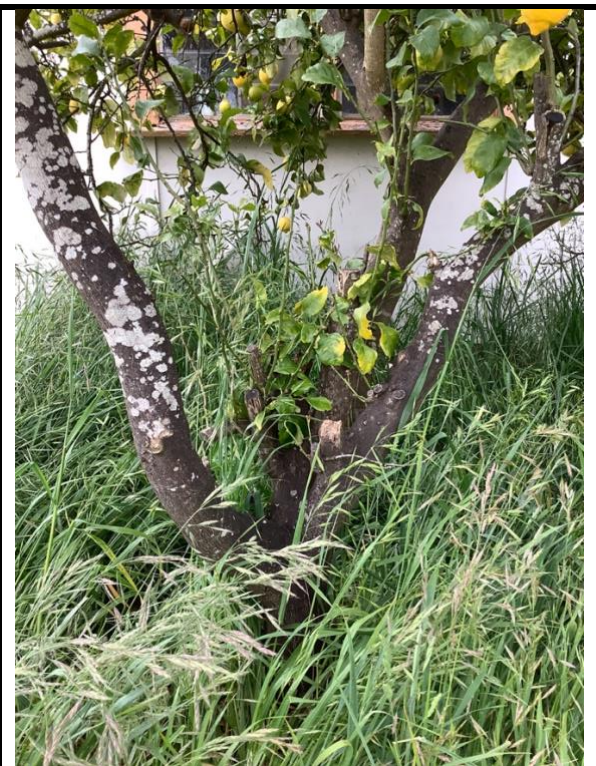
**Tree ID: 5**

Comment: Healthy lemon tree with a yielding a high quantity a well-developed fruit.

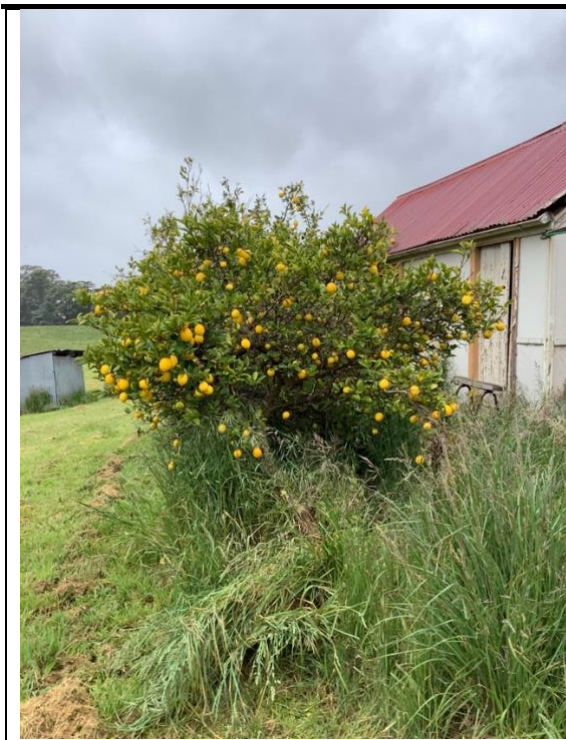
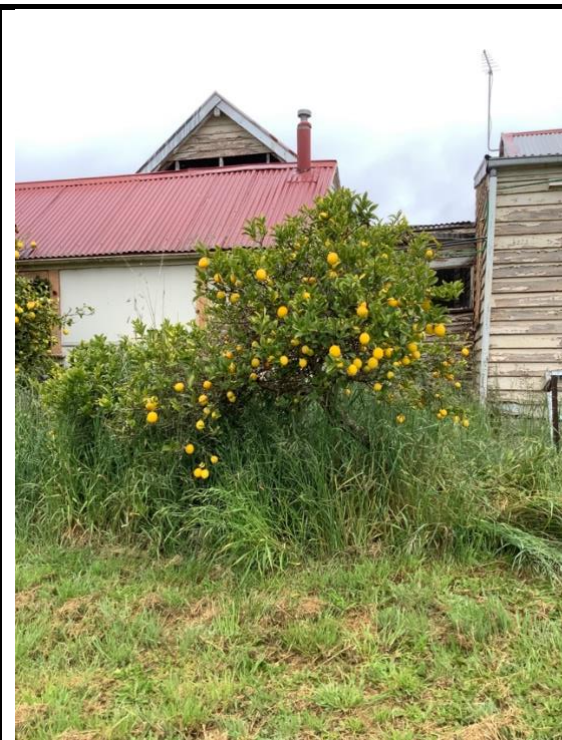
**Tree ID: 6**

Comment: Healthy lemon tree with a yielding a high quantity a well-developed fruit.

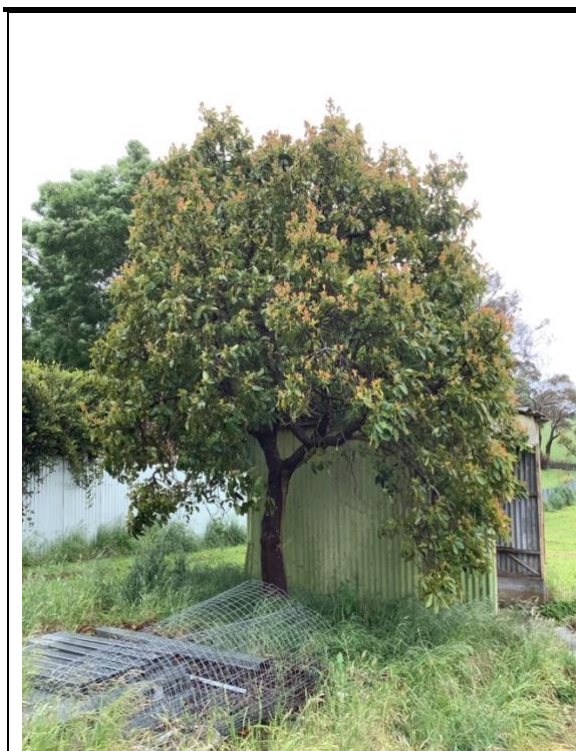
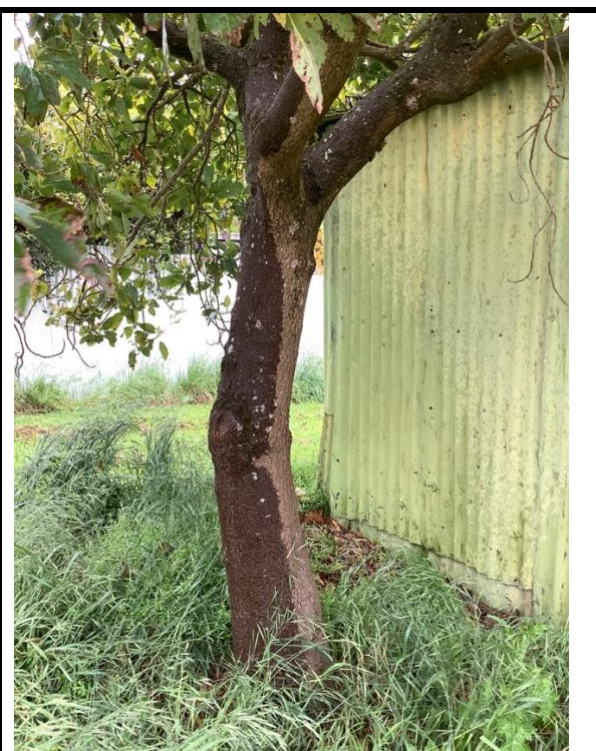
**Tree ID: 7**

Comment: Avocado tree in good condition will unlikely bare significant amount of fruit do to climate.

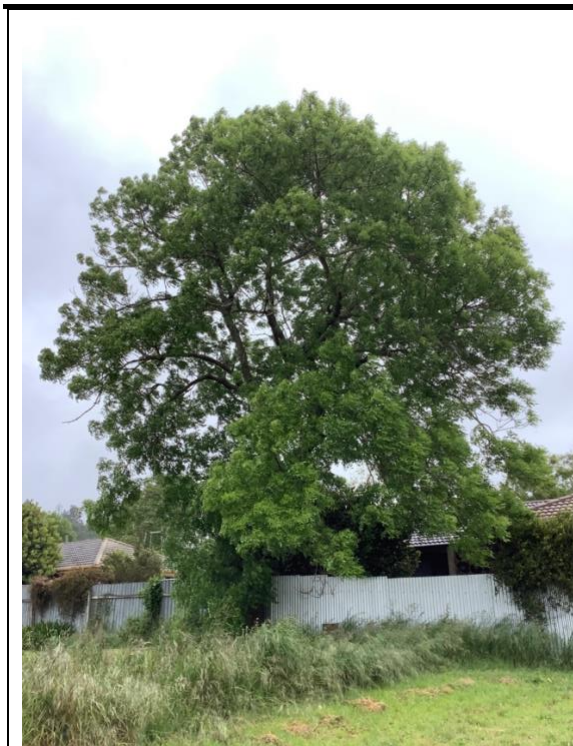
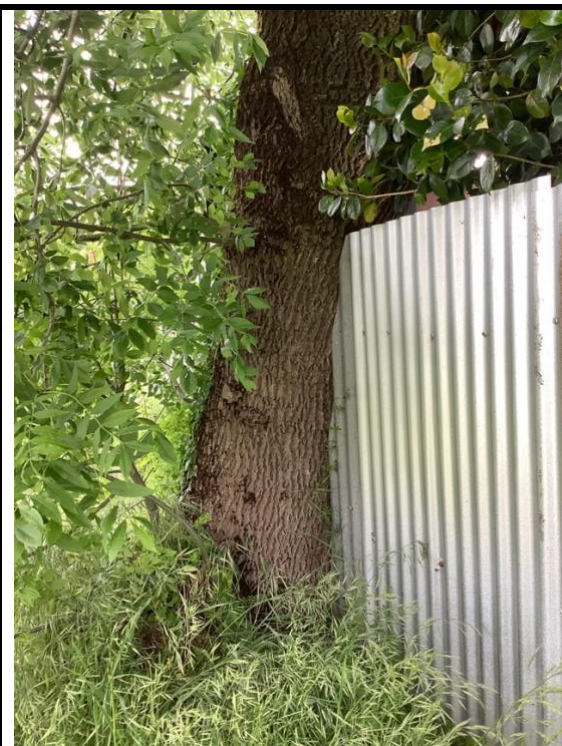
**Tree ID: 8**

Comment: Unable to measure DBH as tree is on fence line, see photo.

This mature specimen provides significant canopy cover and is a dominant tree in the landscape and should be retained.

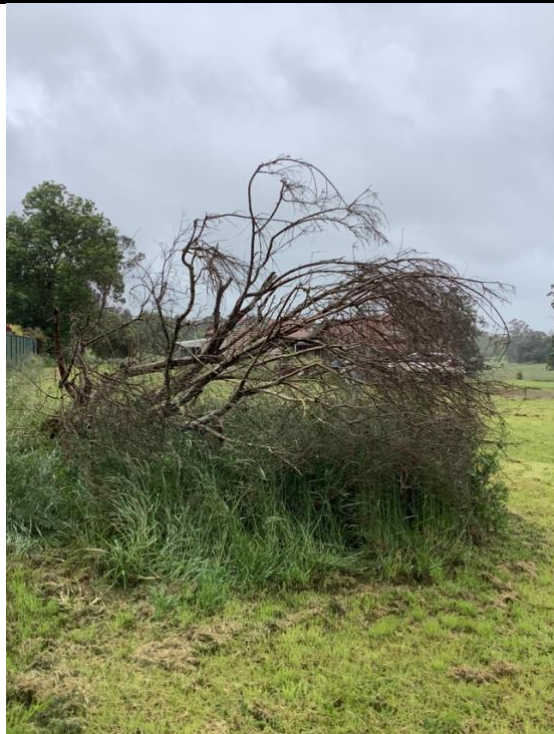
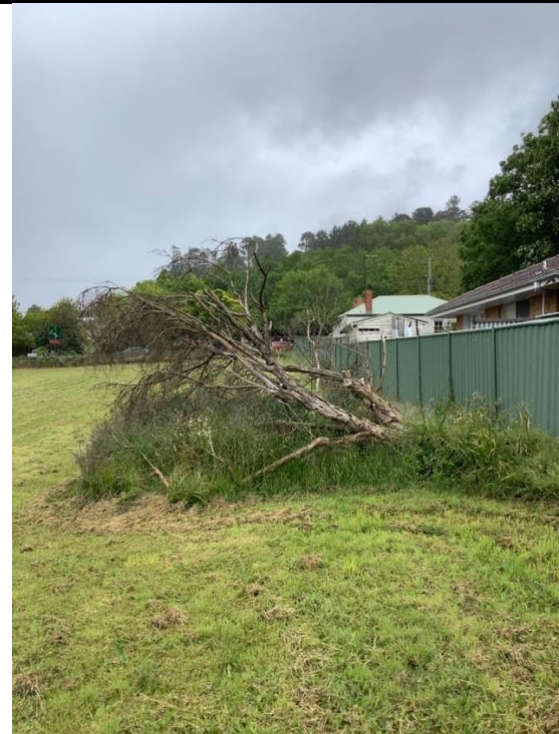
**Tree ID: 9**

Health: Poor

Structure: Poor

Comment: Tree is dead or in poor health and will not recover. Remove

Entire root plate is uprooted and exposed, this tree should be removed.

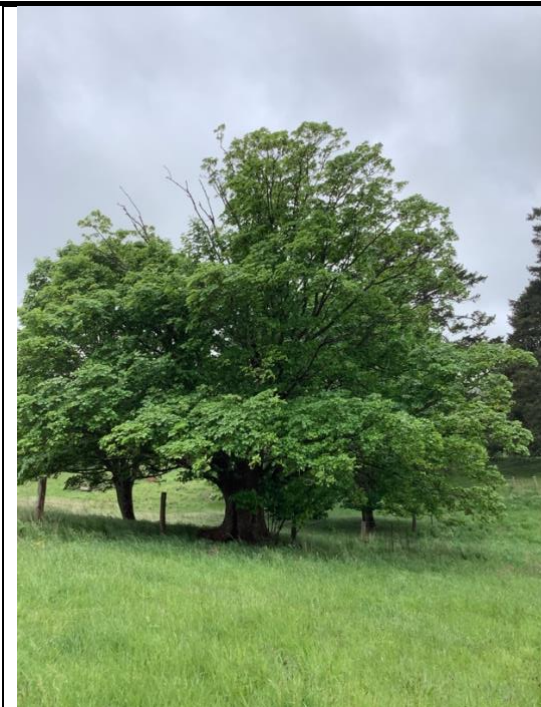
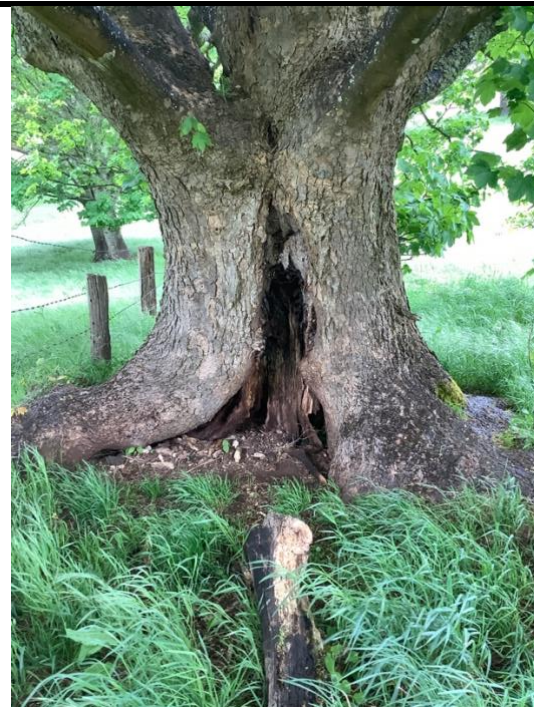
**Tree ID: 1**

Health: Fair

Structure: Fair

Comment: Adjacent to fence line, located on 17 Smith Street. Design considerations should be made to ensure minimal impact to tree protection zone. Significant basal wound with associated column of decay. Appears structurally sound.

These trees are structurally sound and provide benefits in canopy coverage, aesthetic value and habitat potential and should be retained. Tree 1 is located adjacent the fence line on 17 Smith Street. Design considerations should be made to ensure this significant tree isn't adversely impacted by proposed development.

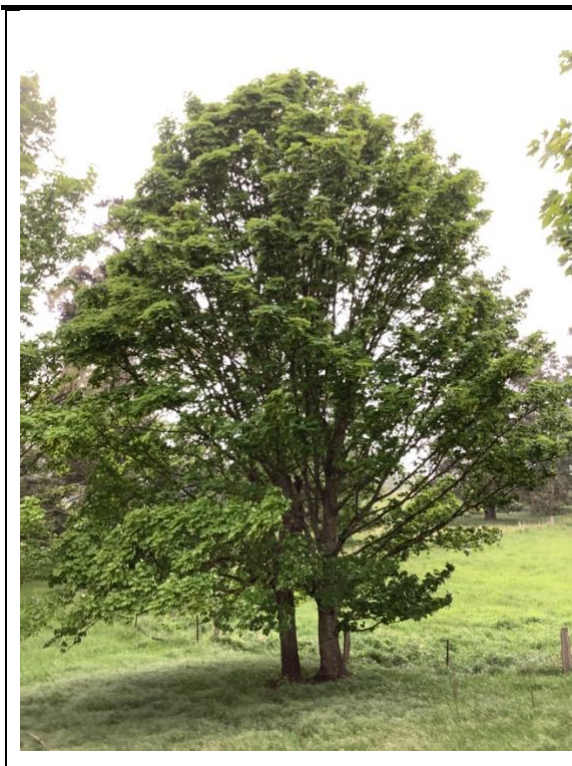
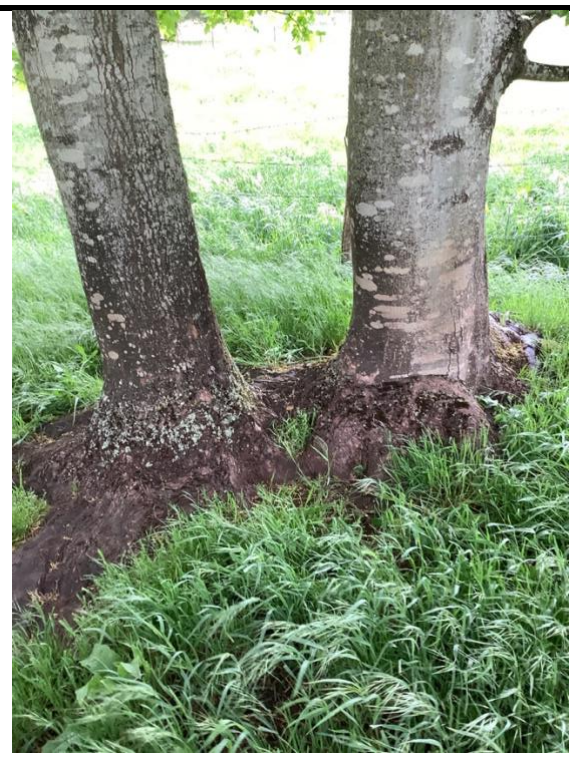
**Tree ID: 2**

Comment: Tree not viable for retention due to impacts from proposed drainage basin. Two trees with grafted roots.

These trees should be considered for removal due to the impacts of construction of a proposed drainage basin.

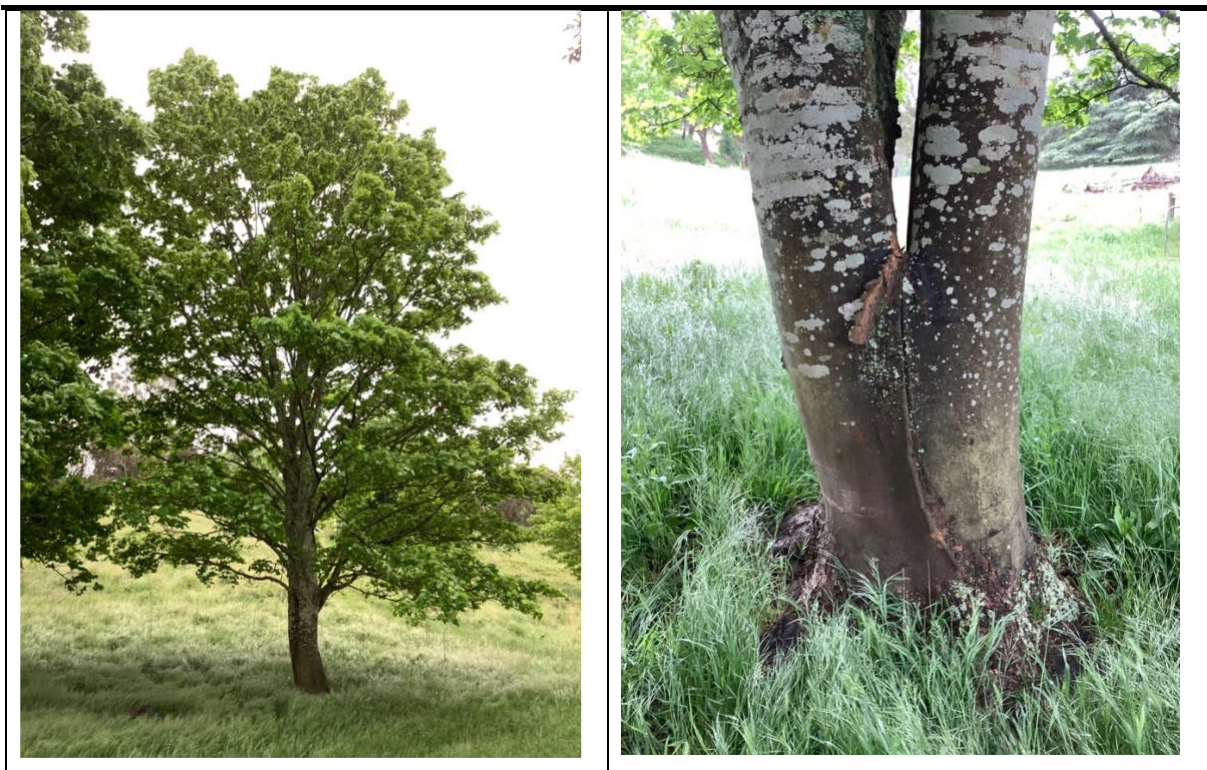
**Tree ID: 3**

Structure: Fair

Comment: Tree not viable for retention due to impacts from proposed drainage basin. Included bark union
