Golden Plains Wind Farm

WestWind Energy Pty Ltd (WestWind)

Preliminary Geomorphology Assessment

26 May 2017

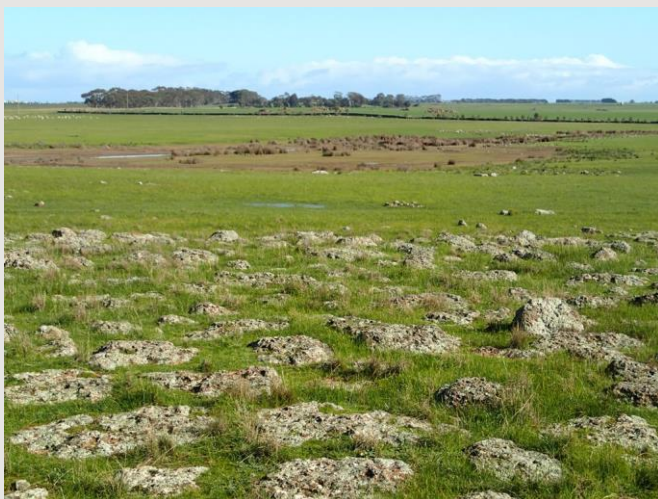
Larva ridge in foreground with basal boulders covering the surface sloping towards semi-enclosed wetland that forms part of Mia Mia Creek in background (West of Eastern Access Road)

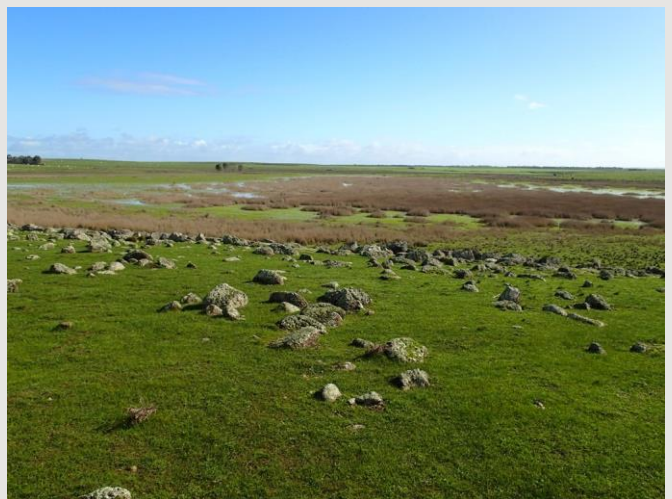
Closed drainage depression containing wetland, referred to as Baths Swamp (West of Bells Road)

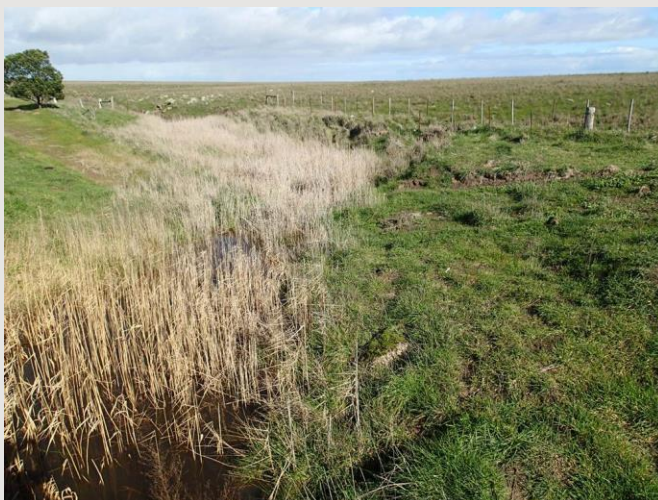
Ferrers Creek, a relatively small stream incised into the volcanic plains (West of Geggies Road)

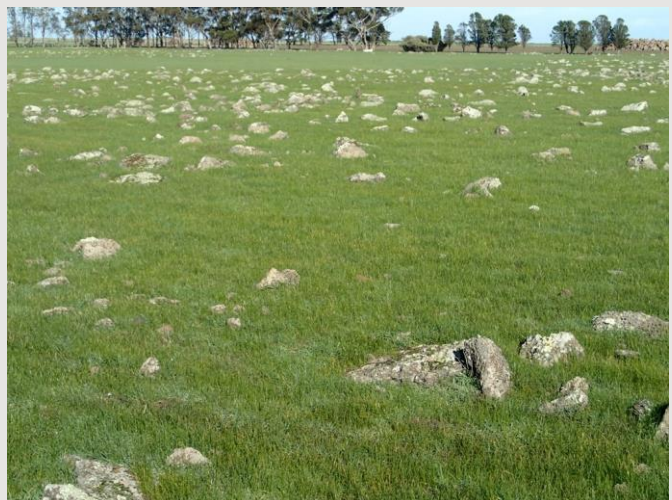
Flat volcanic plains. Basalt boulders are scattered across the surface in foreground but absent in background, most likely removed to improve the productivity of agricultural land (West of Wingeel Road)

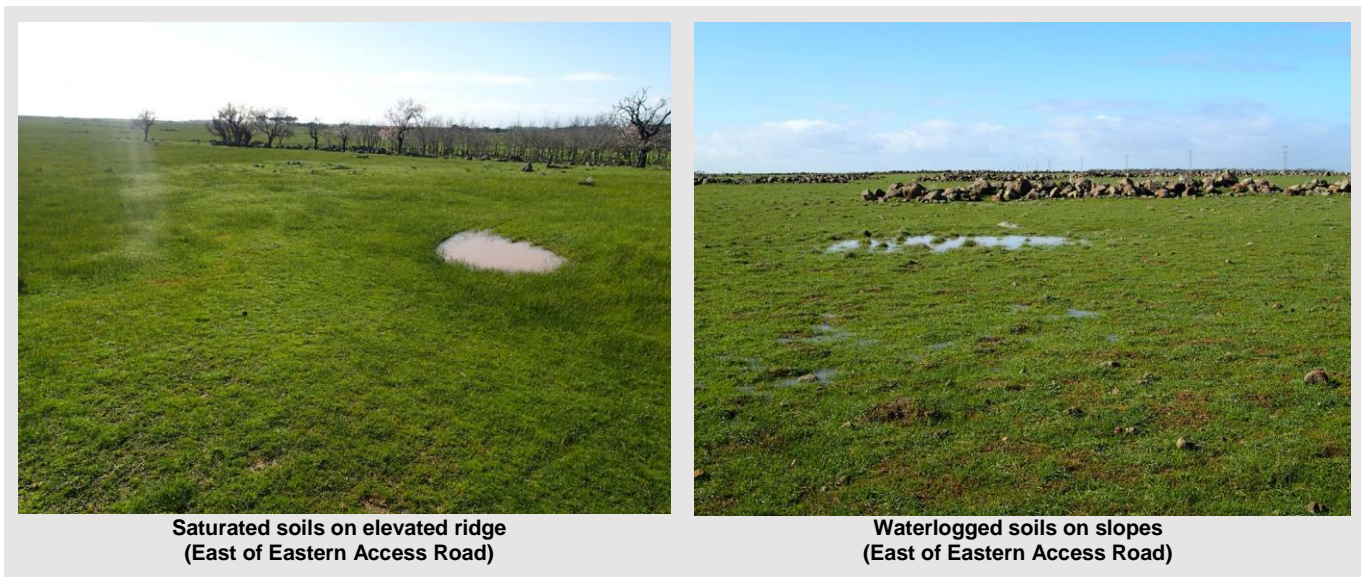
At the time of the field inspection in August 2016 the soils were visibly noted as being saturated with water, this even being observed on the high points of the landscape and sloping areas. The saturated conditions are likely a response to a recent period of increased rainfall combined with generally shallow water tables that characterise the region and higher potential for waterlogging that is typically associated with clayey soils.

Figure 2.3 : Selection of photographs showing condition of saturated soils at the project site at the time of the field inspection (August 2016). **Source, Jacobs**

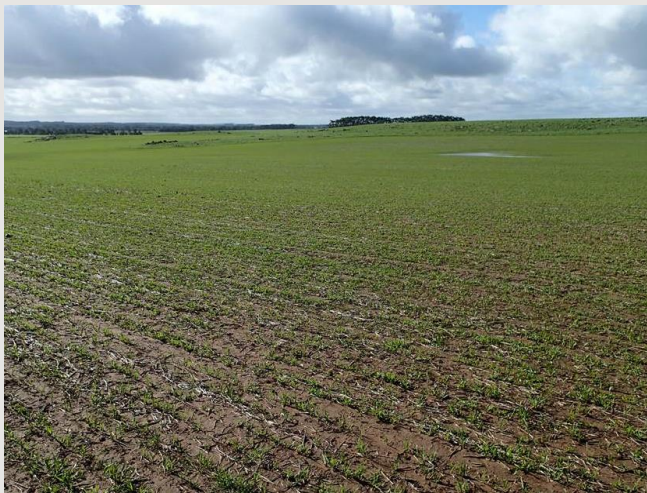
Lava ridge and lobe formations, the overall morphology of these features are preserved in the landscape. Note also standing water (East of Meadows Road)

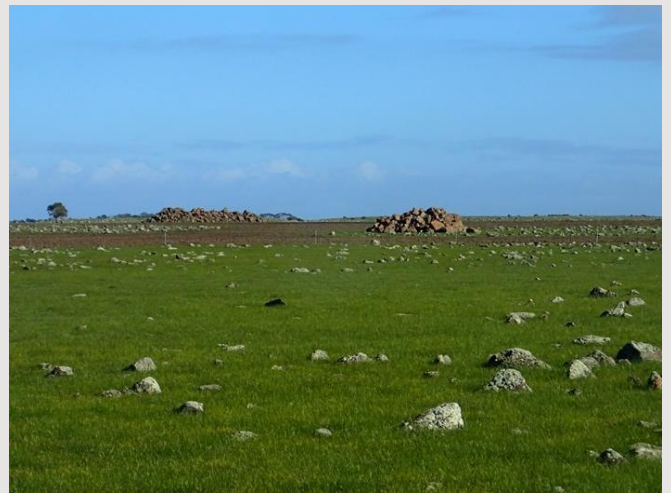
Harvesting of basalt boulders from volcanic plains and formation of rock piles (West of Wingeel Road)

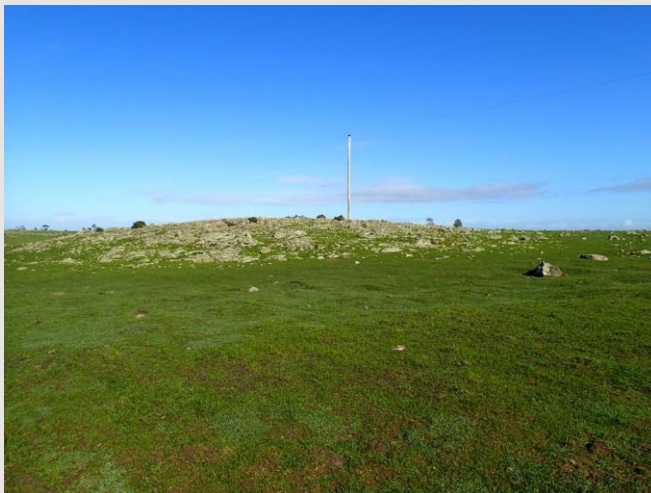
Stony rise (West of Wingeel Road)

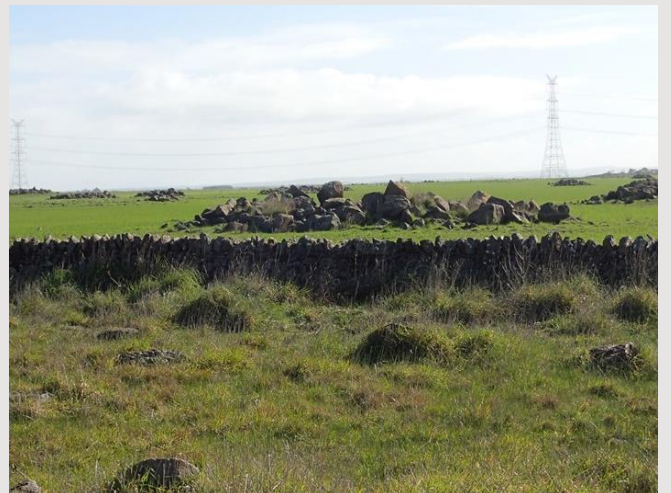
Rock wall in foreground and piles of harvested basalt boulders distributed across plains (North of Cressy Shelford Road)

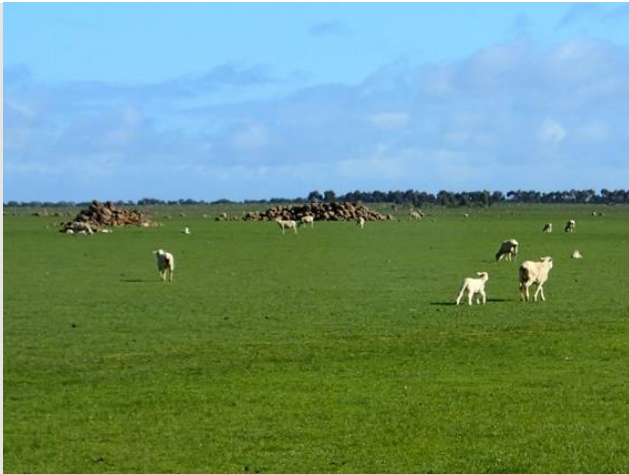
Some larva ridge and lobe features still remain in the landscape as high points. The project site is subject to extensive grazing and cropping (Figure 3.2). In order to improve the agricultural productivity of the area, rock boulders have been removed and these areas levelled. Harvested rock has been used to form rock walls or stored in rock piles. The natural surface topography and landforms have been markedly altered through this process.

Rock piles harvested from plains providing pasture for stock (West of Bells Road)

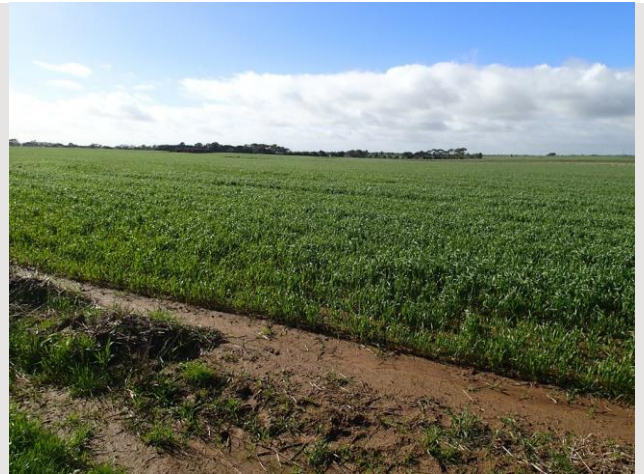
Cropped area, with notable absence of basalt boulders. It is likely that these have been removed and the land levelled. (East of Geggies Road)

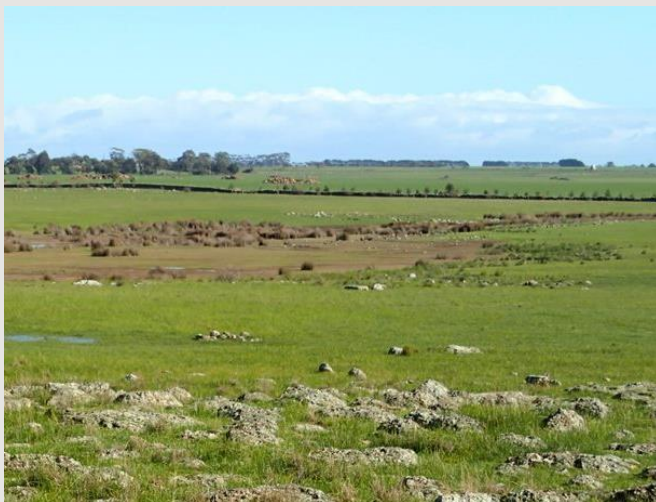
Mia Mia Creek comprises a series of wetlands and connecting channels (West of Eastern Access Road)

Figure 3.3 : Selected photographs of Mia Mia and Kurac a Rac Creek which are fairly representative of the condition of waterways across the project site. Wetland and stream corridors are unfenced, the vegetation and channel form are in a degraded state. **Source, Jacobs**

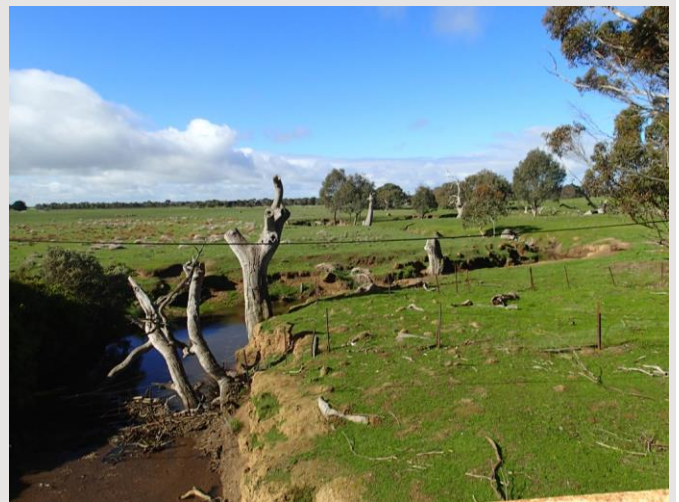
Degraded section of Kurac a Rac Creek (also referred to as Meadows Creek) incised through alluvial floodplain (East of Meadows Road)

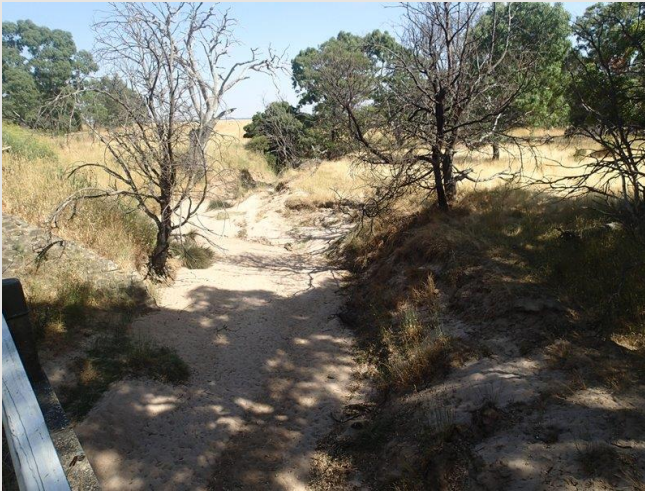
Woody Yaloak River, looking upstream from Gilletts Road bridge at channel with sand bend and degraded channel banks.

Figure 3.4 : Woody Yaloak River looking upstream and downstream from Gilletts Road bridge at degraded channel conditions. **Source, Jacobs**

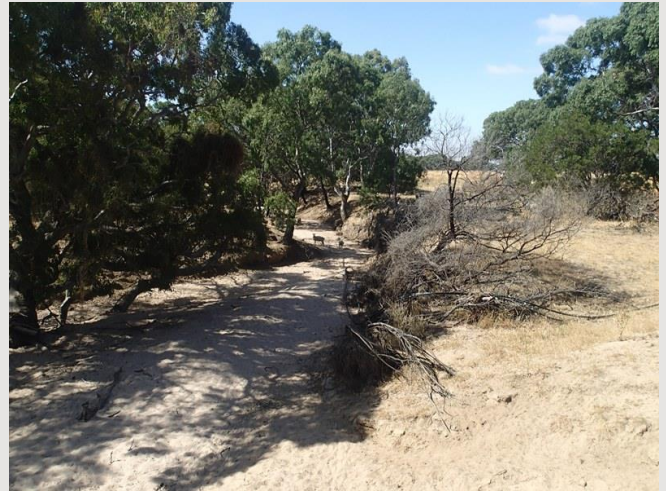
Woody Yaloak River, looking downstream from Gilletts Road bridge at channel. Stock were observed grazing within the channel.

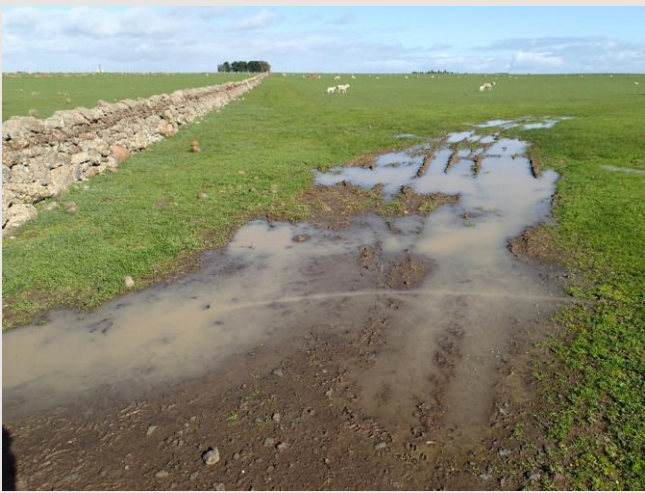
Ground conditions at the time of the field inspection in August 2016 were very wet, with saturated soils and standing water observed across the project site, in depressions, on sloping ground as well as on tops of lava ridges. Public roads traversing the site were still trafficable, although slippery in some locations, with water collected in drains or adjacent berms running alongside the roads. Informal tracks heading off into pasture and cropped fields lack drainage works. Water was ponded at the surface and the presence of wheel ruts attests to waterlogged soils and generally boggy conditions limiting vehicle movements (Figure 3.1).

**Waterlogged soils, boggy conditions and wheel ruts
(West of Bells Road)**

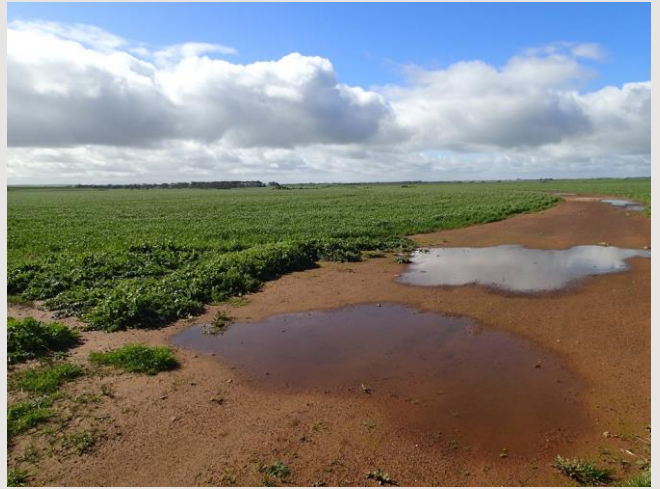
**Ponded water on track through cropped area
(East of Meadows Road)**

Figure 3.5 : Observed saturated soil conditions and ponding of water at surface of tracks traversing pasture and cropped fields at the project site when inspected (August 2016). **Source, Jacobs**
