13th July 2023

Re: Response to email, Subject: 9 Raglan Street – Avenue of Honour Tree

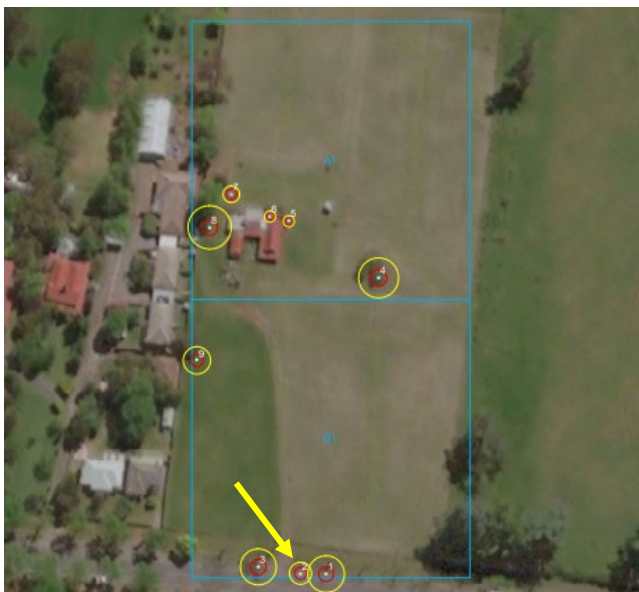
According to the Xylem TreeCare – Preliminary Arboriculture Tree Assessment Report for Raglan and Smith Street Daylesford, issued on the 19th November 2022 (PATA) the tree is Tree ID:2 not Tree ID:1 as outlined above. This tree is located at the front entrance of the property. The subject tree is *Fraxinus angustifolia* subsp. *angustifolia* (Desert Ash) and at the time of assessment the tree received a health rating of 'Good' and structure rating of 'Fair'.

Figure 1, Direct extract from the Preliminary Arboriculture Tree Assessment Report for Raglan and Smith Street Daylesford, issued on the 19th November 2022 Tree ID:2 located at the entrance of the property

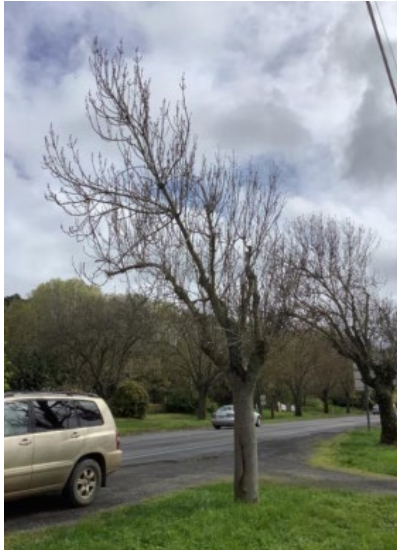
Figure 2 show the subject tree at the existing entrance of the property. There has been an approximate 50% reduction in the tree canopy to allow for cyclic pruning away from the overhead powerlines.

Figure 2, Subject Tree, note the reduction in canopy due to cyclic pruning from overhead powerlines.

As outlined within the Xylem TreeCare PATA Report the subject tree was given a health status of 'Good'. This was based on the tree demonstrating extension growth with little to no canopy dieback (deadwood present). The tree has however lost approximately 50% of its canopy due to the Power Distribution Business (PDB) cyclic pruning program (refer Figure 2). In the trees current state without significant root loss the subject tree is able to provide sufficient carbohydrates and starches through photosynthesis to maintain the trees normal functions i.e. growth, root development, fruit development and wound occlusion etc. In the event where this tree was to be transplanted, it is expected that there would be >50% viable root surface removed to accommodate a manageable root ball for the purpose of moving the tree. It is likely that due to the already reduced canopy, the capacity for the tree to re-establish a viable root system would be compromise, therefore causing the tree health to decline. The likelihood of this tree ability to survive the trauma associated with tree transplanting is quite low.

It is recommended that an advanced tree of the same species be planted in an appropriate location determined by the relevant authority.

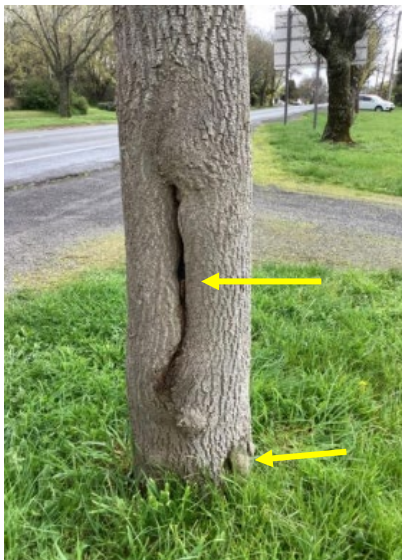
Figure 3 shows a cavity within the lower and mid-trunk regions, it is likely that there is connectivity between the two cavities outlining the likelihood that the trunk is hollow between these two points, and this may continue up past the larger cavity into the primary limb region.

Figure 3, Subject tree, the yellow arrow shows cavities within the lower and mid-trunk regions.

The subject tree also has a compromised trunk region due to the level of decay present (refer Figure 3). There is a likelihood that the tree may fail during the transplanting process due to the mechanical strain placed on the tree while being lifted. This provides an unnecessary risk to those performing the transplanting.
