Report on  
Soil Contamination and Baseline Groundwater  
Investigation

Melbourne Energy and Resource Centre  
510 Summerhill Road, Wollert

Prepared for  
Cleanaway Operations Pty Ltd

Project 211616.01  
March 2023

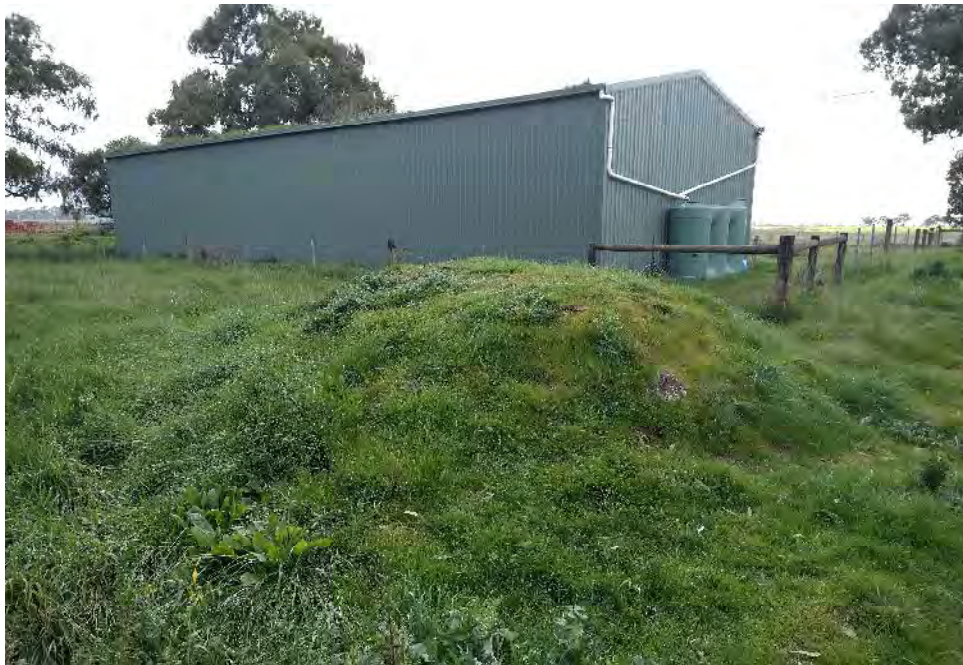
- A septic tank was located to the west of the main residential building
- A small stockpile (Approx. 10 m<sup>3</sup>) was noted south-west of the main shed

The soils contained within the stockpile comprised gravelly clay and were considered to comprise reworked local soils. No signs of potential soil contamination were noted.

Photo 1 – View of main shed with stockpile in foreground (View to the north-east)

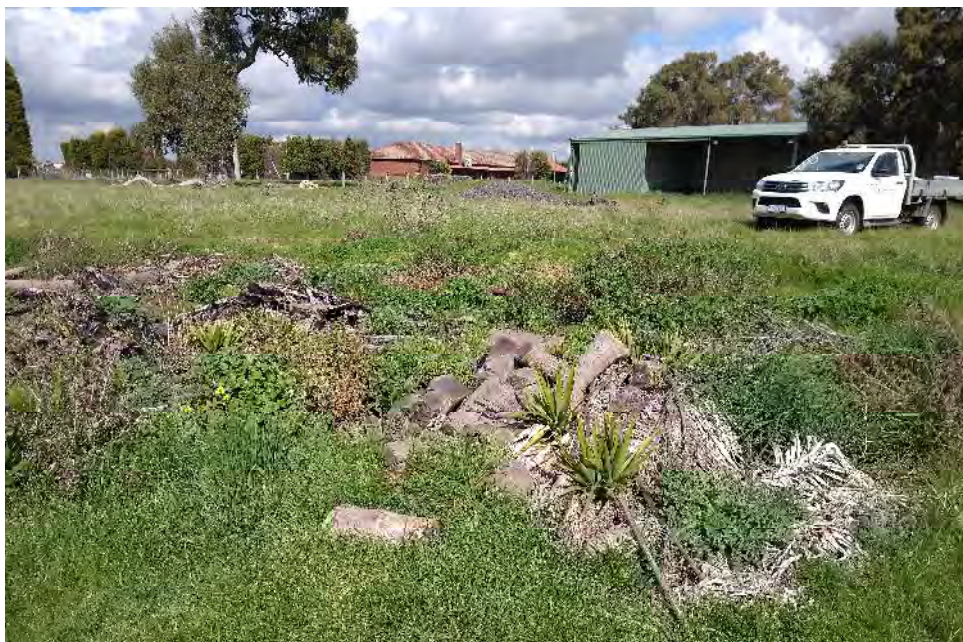
- An area which appeared to have been excavated and used as a burn-off area was identified north-east of the residential buildings. Minor amounts of burnt wood was present overlying scoria gravel

- Sample HA01-0.0 which was collected from within basaltic gravel fill within a burn-off area recorded nickel concentrations of 170 mg/kg
- Sample HA03-0.0 which was collected from within basaltic gravel fill at the vehicle entrance to the shed recorded nickel concentrations of 85 mg/kg
- Samples TP19-1.0 and TP20-0.05 both of which were collected from within the fill area located in the south-eastern portion of the site reported nickel concentrations of 67 mg/kg and 73 mg/kg respectively.

Photo 2 – Burn-off area with dwelling in background (view to the south-west)

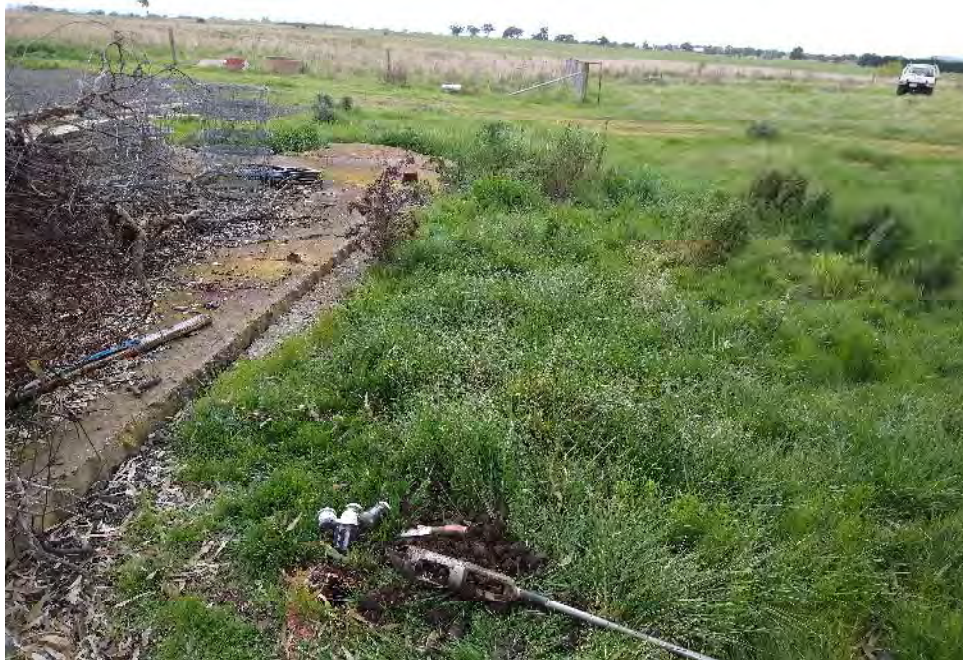
- The Study Area was being utilised for cattle grazing
- Two brick residential buildings and associated steel sheds (empty) were present
- A concrete slab with evidence of minor filling, indicative of a former building, was noted north of the main shed, located adjacent to a crushed rock vehicle parking area

Photo 3 – View edge of former building footing and HA03 (view to the east)

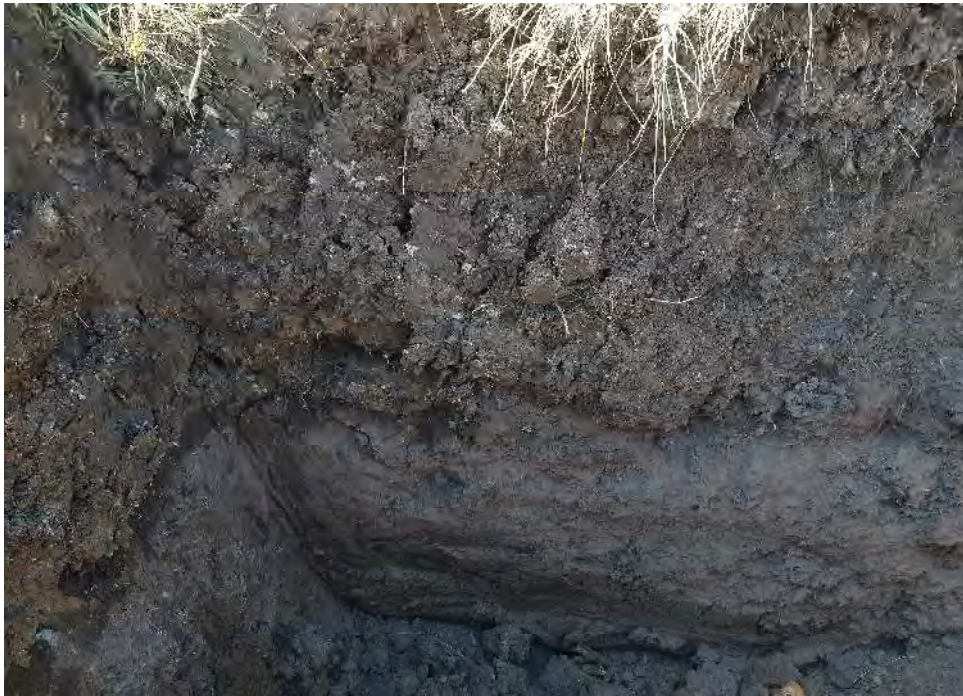
Exception to this is noted in the south-east area of the site where up to 2.3 m of imported fill was located, and in the vicinity of the existing site buildings where between 0.2 m and 0.7 m of fill (predominantly comprising reworked natural soil) was encountered.

Photo 4 – Fill overlying natural clay (Test Pit TP24)

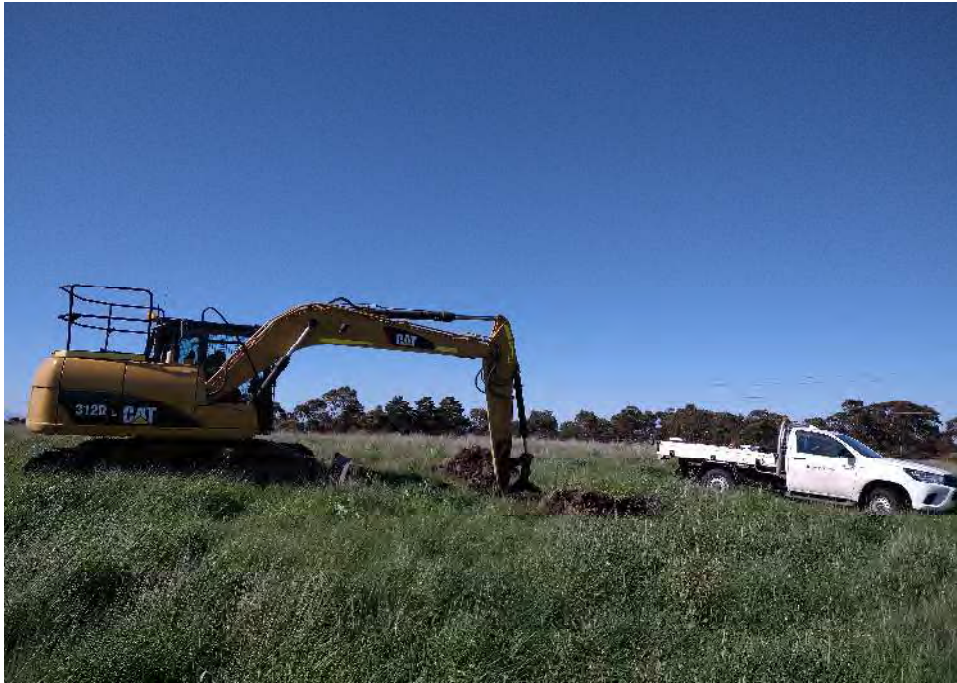
Photo 5 – Typical test pit operation

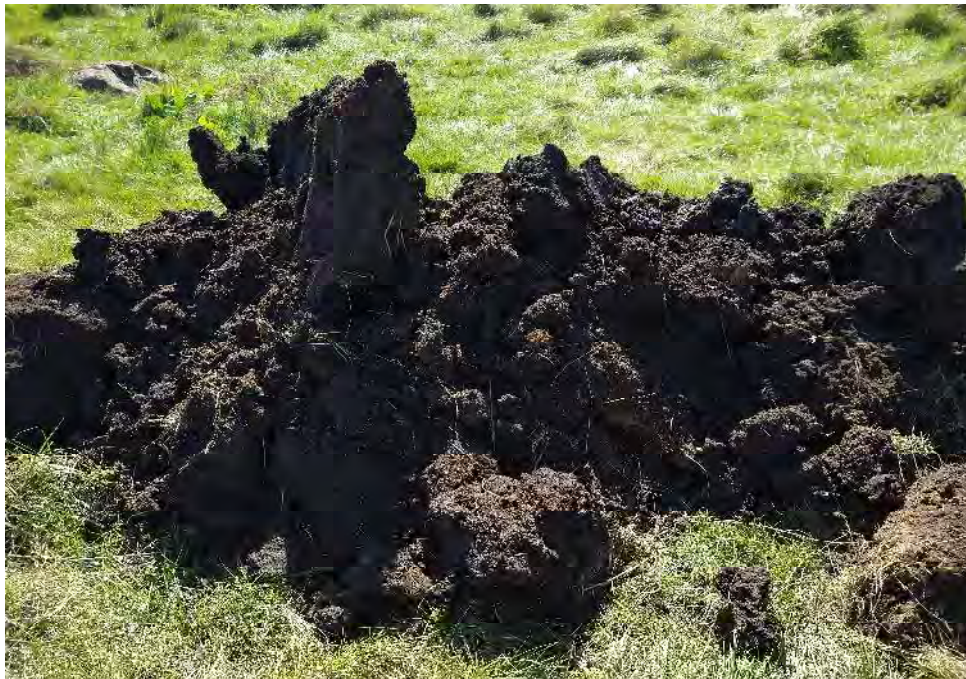
Soil conditions at the site typically comprise a 0.2 m to 2.9 m thick layer (average thickness of 1.0 m) of very stiff and hard, high plasticity, silty clay overlying basalt rock.

Photo 6 – Natural site soils typically encountered in the test pits.
