PRELIMINARY Geotechnical Investigation Report

McGregor Road Automotive Destination

Reference No. 30041864
Prepared for Podium One
7 June 2019

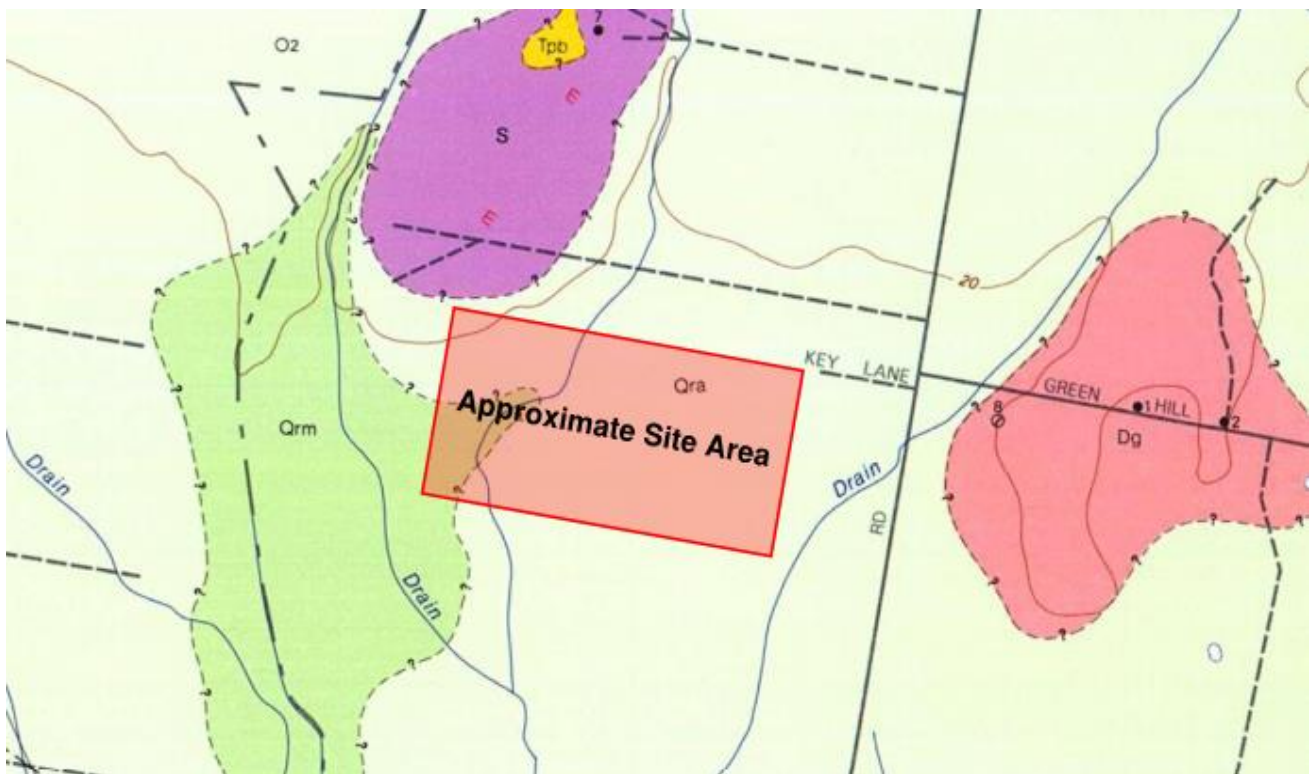
Reference to the Geological Survey of Victoria 1:25,000 scale 'Pakenham' map indicates that a majority of the site is underlain by Quaternary aged alluvial-colluvial deposits (Qra) that consists of sands, silts and clays. The geological map indicates that the far western side of site is expected to be underlain by Quaternary aged lacustrine deposits (Qrm) that consists of clays, sandy clays and silts. An extract of the geological map is shown in Figure 2.

Qrm Recent Quaternary Aged Lacustrine Deposits: Clays, Sandy Clays and Silts

Qra Recent Quaternary Aged Alluvial/Colluvial Deposits: Sands, Silts and Clays

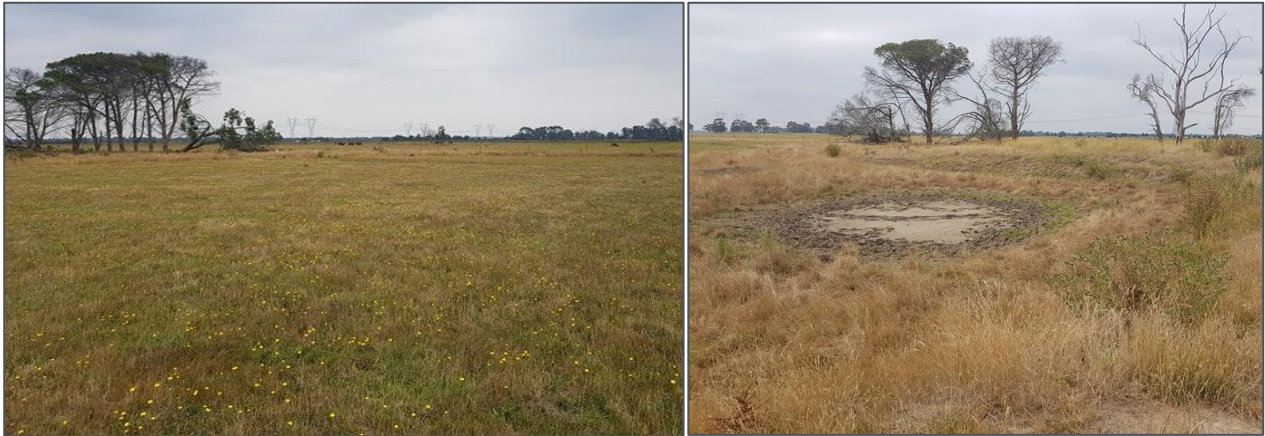
Observations from the site walkover found that the site was split roughly down the centre along a north-south orientation by a creek line. The east side of the creek line consisted of farmland paddocks with low-lying, green grasses. The grass was maintained at relatively short lengths due to grazing from cattle that were kept within the paddocks. The surface was relatively flat with some scattered dams located regularly across site and sparse trees residing along some sections of paddock boundaries. Figure 3 presents site photographs showing the typical surface to the east of the creekline.

Figure 3: Site photographs of the typical surface profile to the east of the creekline (left) and a dry dam located on site (right)

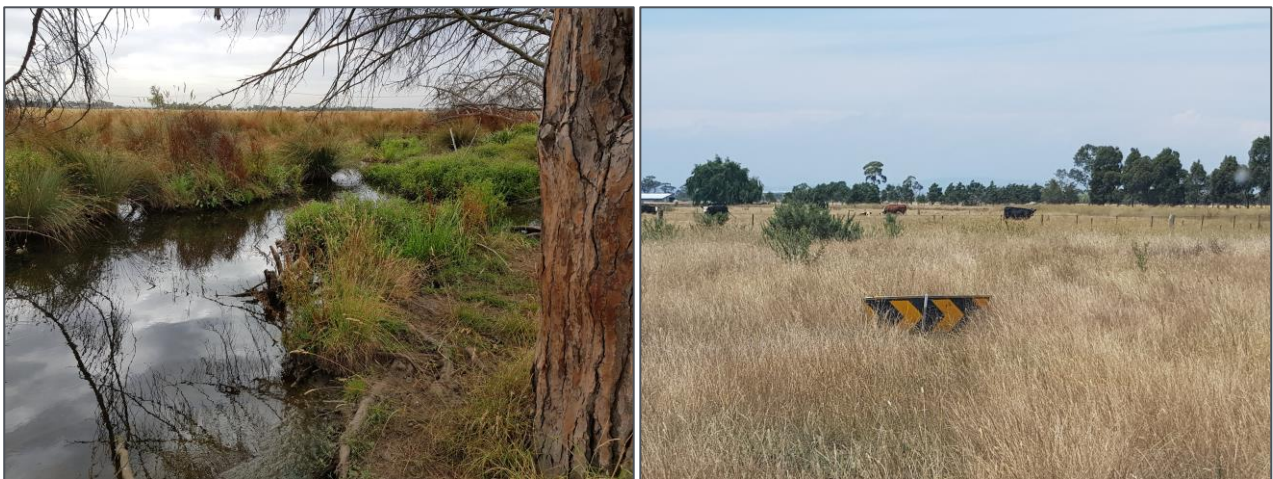
The west side of the creek line and the surrounding surface of the creekline itself was covered with thick, tall reeds, dry wheat crops, and large bushes. This area of site was once used as a motorcycle course with heavily undulating bumps and berms across the surface. A majority of the surface was observed to be natural with the exception of built-up earth mounds on some corners of the old motorcycle track. Figure 4 presents site photographs showing the typical surface along and to the west of the creekline.

Figure 4: Site photographs of the creekline (left) and typical surface profile to the west of the creekline (right)

Due to the thick vegetation observed on the western side of the creekline, it would be ideal to perform vegetation removal prior to construction works to allow full access to the site. Only one safe access over the creekline was observed during the geotechnical site visit and is situated on the south side of site near the old motorcycle race track. Access to surrounding farmland paddocks or construction of bridges over the creekline may be required if more access is required between the eastern and western side of site.

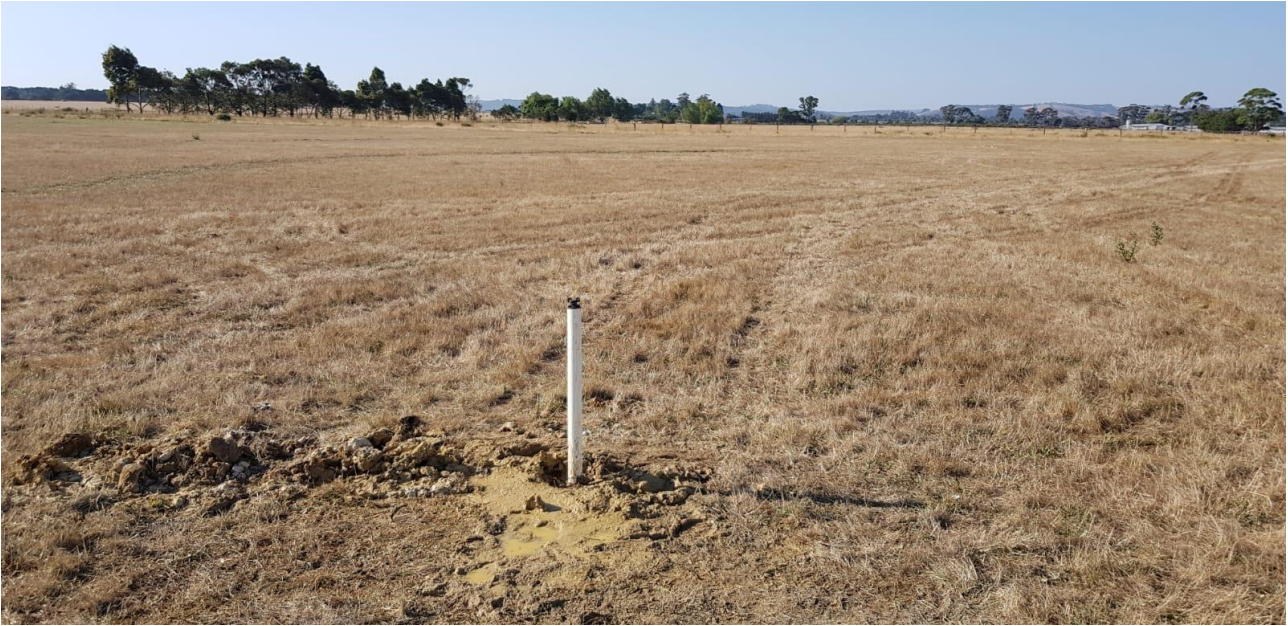
Figure 5: Site Photograph of Standpipe Monument

It should be noted that all boreholes and test pits aside from BH05 were not opened long enough and did not have appropriate casing support to establish accurate groundwater readings. However, approximate groundwater levels were recorded on all borehole logs that was inferred from observations made on the recovered samples.

* Groundwater levels were measured during drilling. Further groundwater checks are recommended to determine groundwater levels following establishing the groundwater equilibrium state.

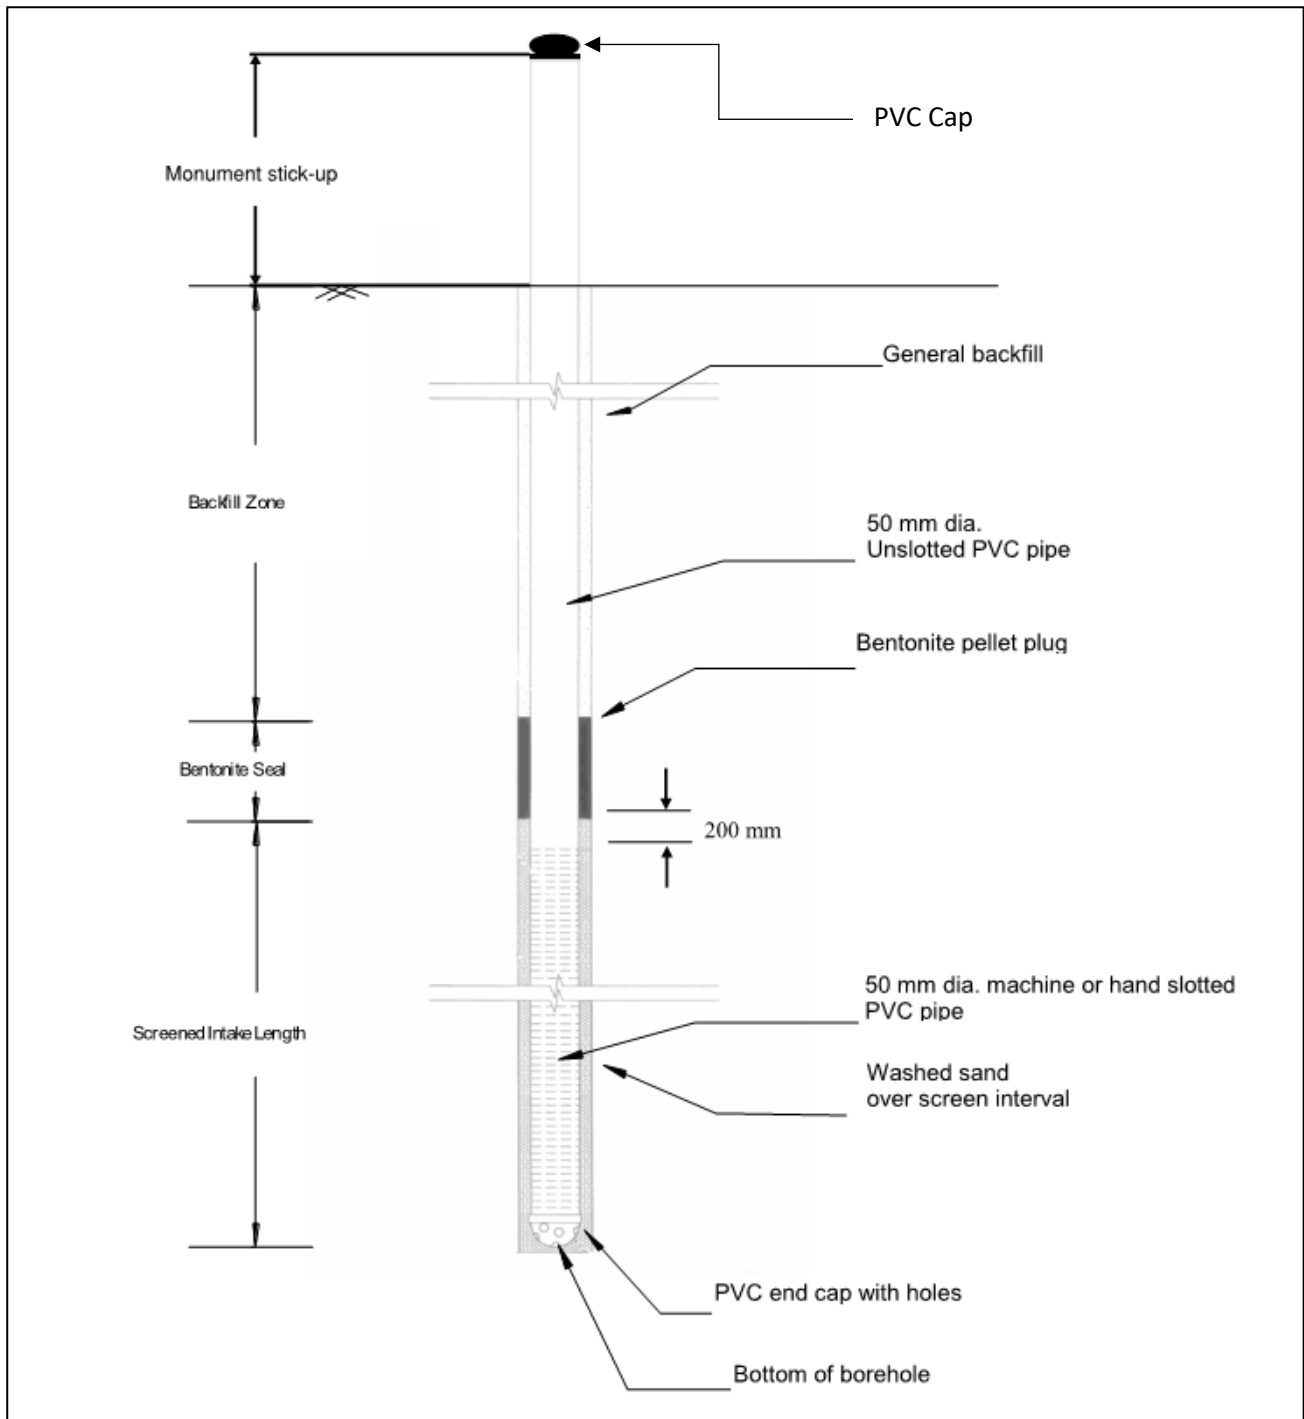
As Constructed	Depth Interval (m) Below Surface		Ground Surface RL	
BORE	From	To	15.6 m AHD	
Monument stick-up	-0.75	0		
Backfill zone	0	5.5		Note: Standpipe installed as a monument
Bentonite seal	5.5	6.5		
Unslotted PVC section	0	8		
Washed sand backfill	6.5	20		
Screened intake section	8	14		
Borehole toe level		20

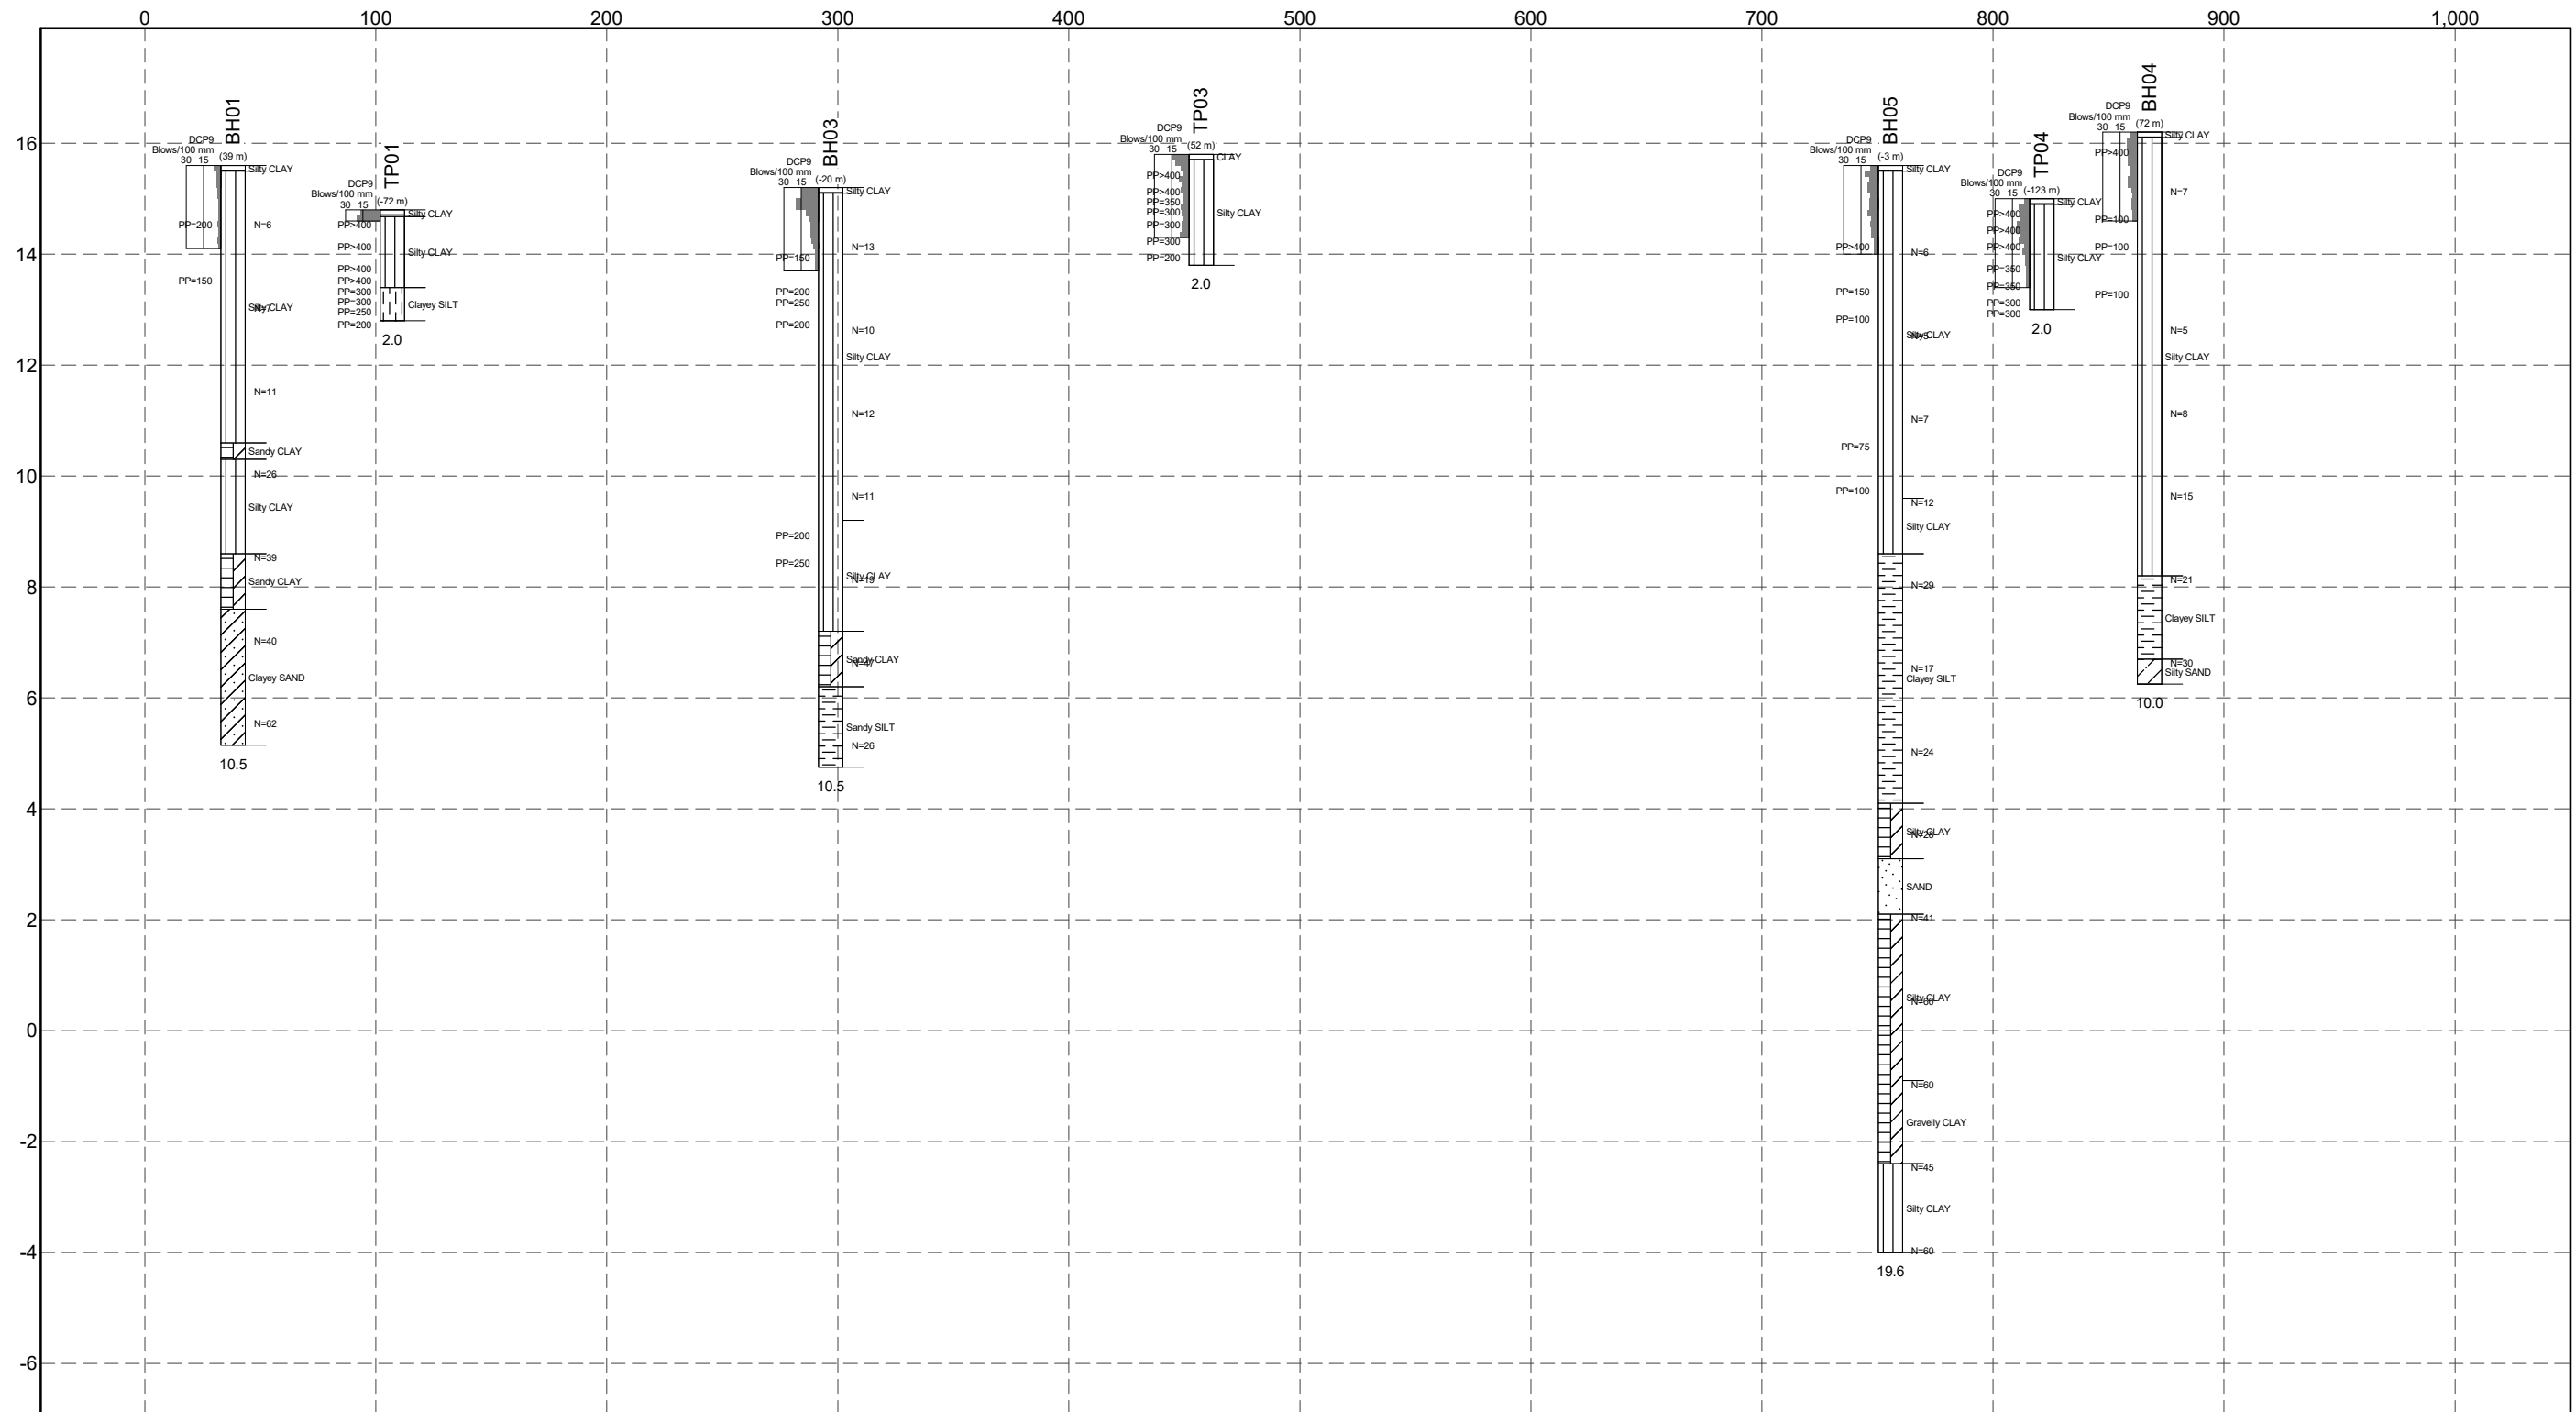
A summary of the generalised geotechnical ground model is presented in Table 6-1 and an inferred geological section is presented in Appendix C. Soft to firm silty clays were recovered within BH02 which is near the expected transition from alluvium to lacustrine deposits and where groundwater infiltration from the nearby creekline is evident.

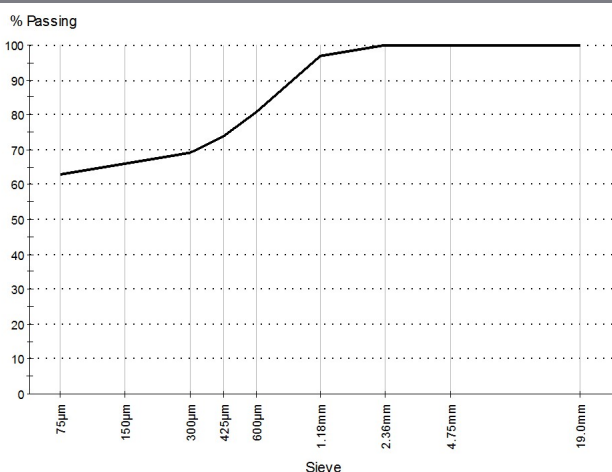
Particle Size Distribution

AS 1289.3.6.1

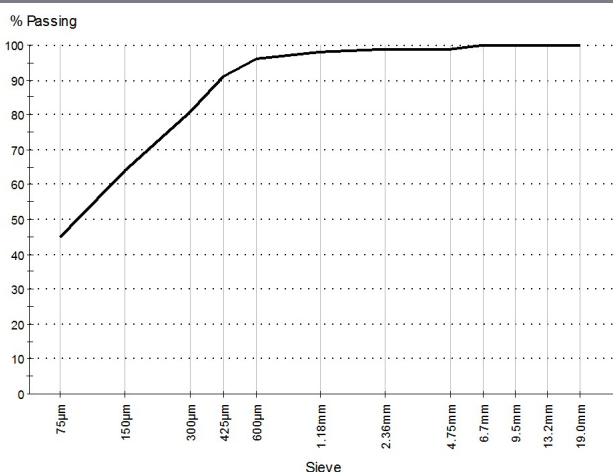
Particle Size Distribution

AS 1289.3.6.1

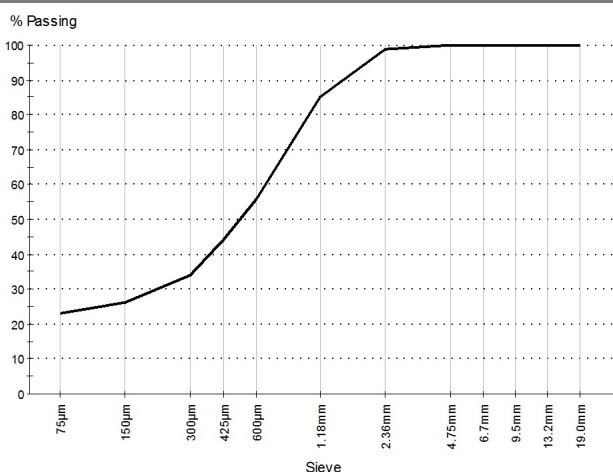
Particle Size Distribution

AS 1289.3.6.1

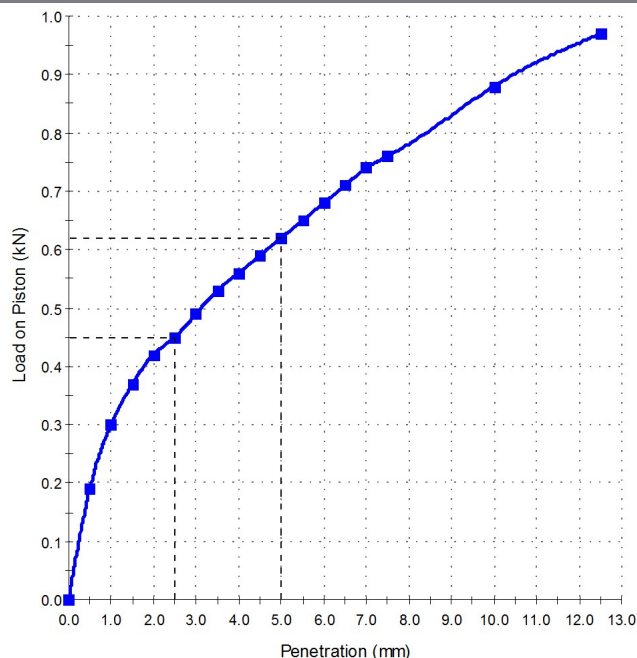
Load vs Penetration

AS 1289.6.1.1 - 2014

For preliminary designs SMEC recommends a design CBR value of 2.0% for clay subgrade soils may be adopted. Site specific CBR testing to confirm the assumed design values is recommended for any critical or highly trafficked sections of pavement. Consideration could be given for subgrade treatments for the clay subgrade materials to allow more economical pavement design. Site clays must be treated as expansive.

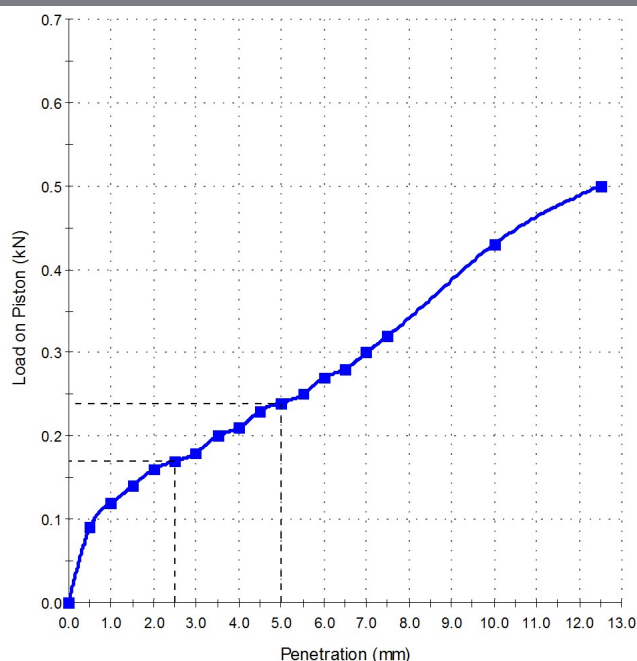
Load vs Penetration

AS 1289.6.1.1 - 2014
