# SDL Adjustment Supply Measures Concept Design

## Geotechnical Investigation Report

IS079600-002 | 2

Mallee Catchment Management Authority

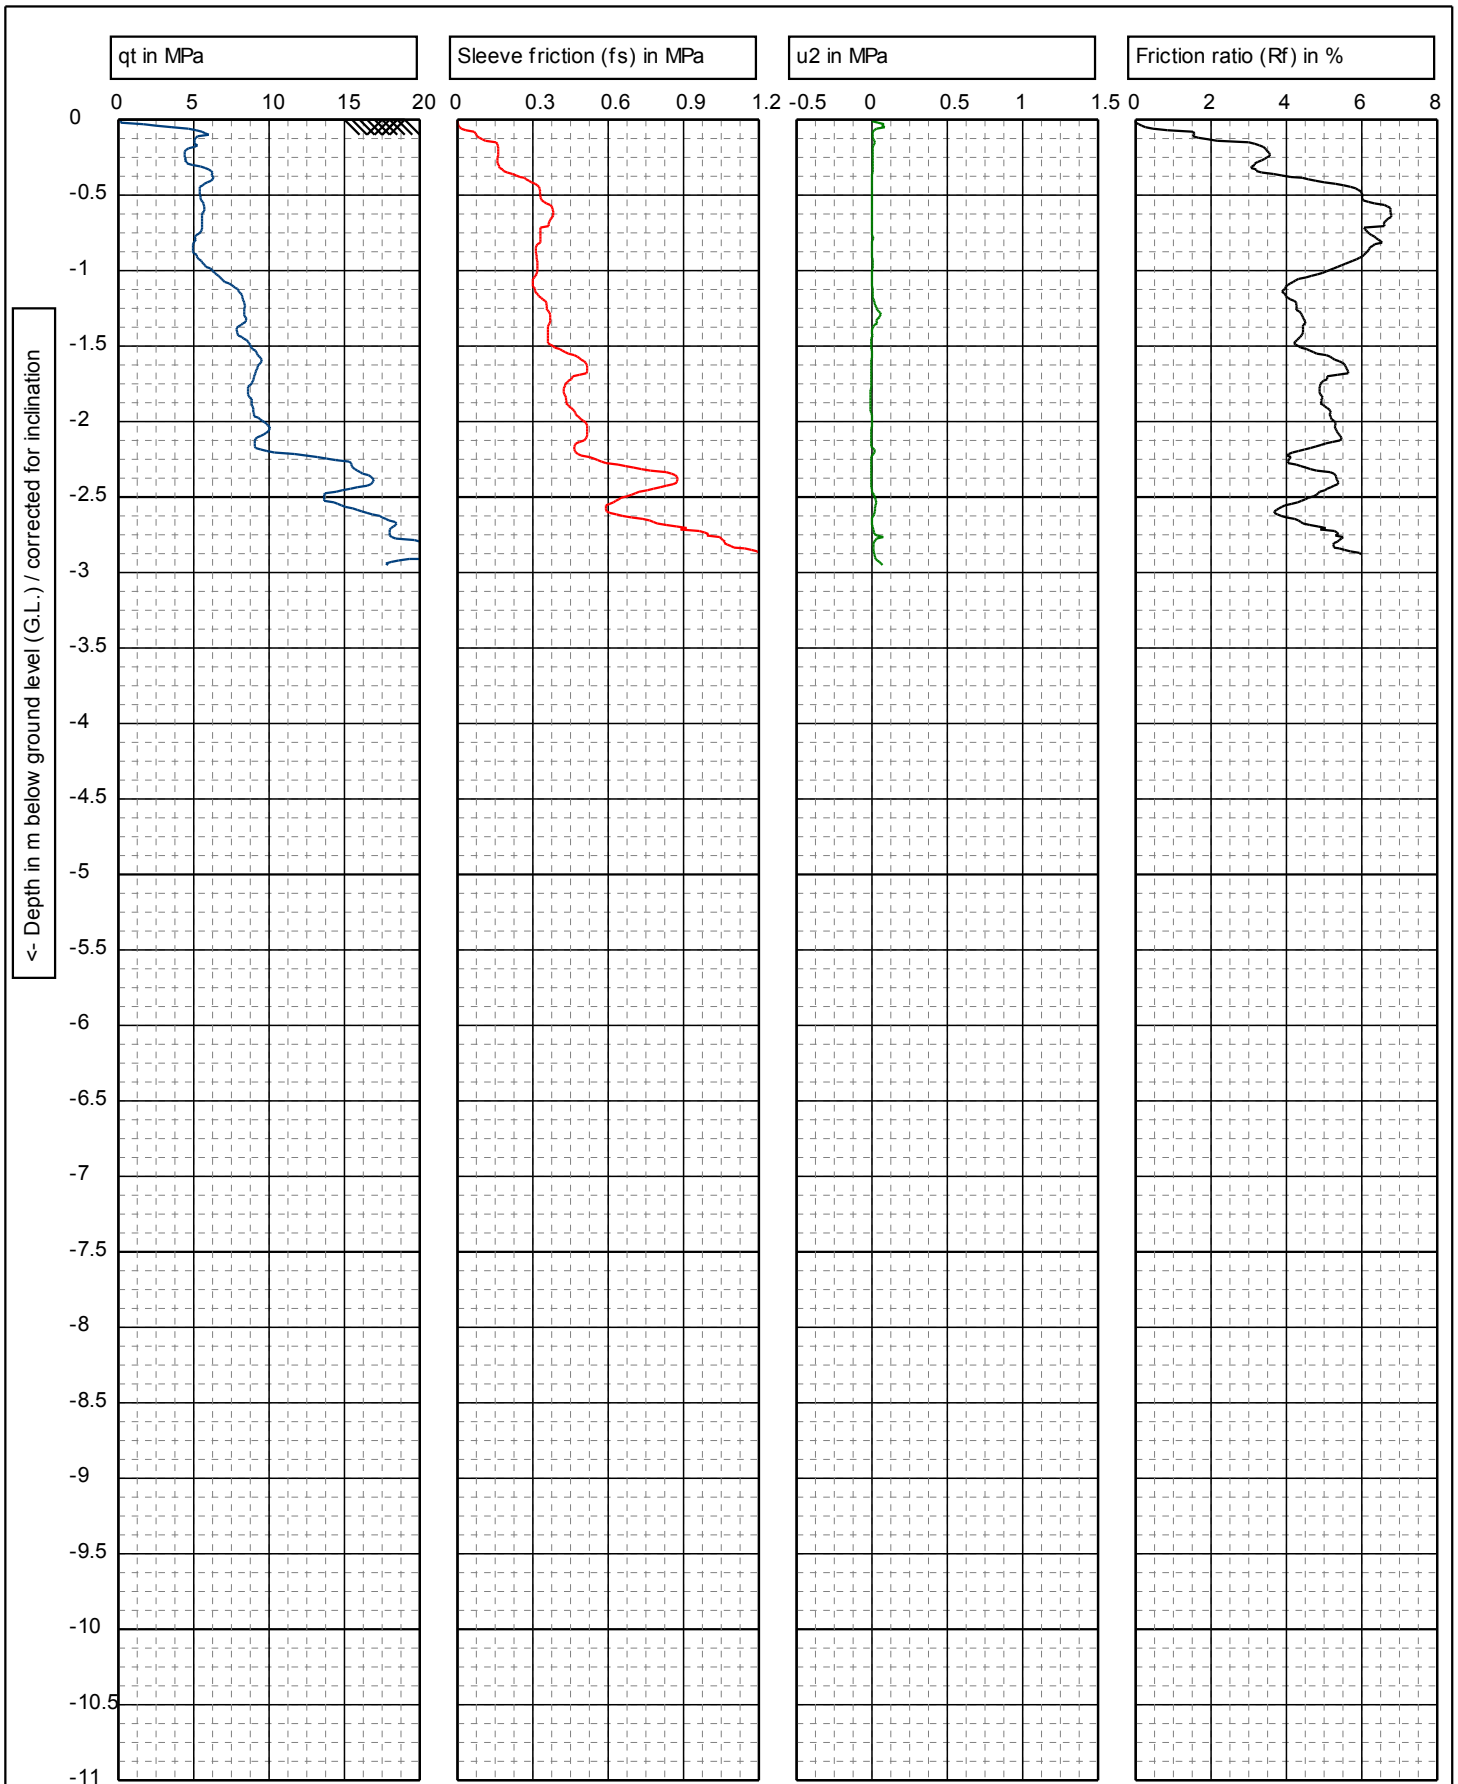
Refusal at 2.96m Lifting Truck

It should be noted that CPT refusal was encountered at a depth of 2.96m (RL 53.7) at location BCN-CPT02 and this may be indicative of a cemented horizon, which could act to be restrictive for driving of sheet piles at this location.
