EES Cultural Heritage Report

Report on Assessment for Aboriginal and Historic Sites for Mid-West Options 2A to 2D Second Murray River Crossing at Echuca-Moama

Report Prepared for VicRoads
November 2012

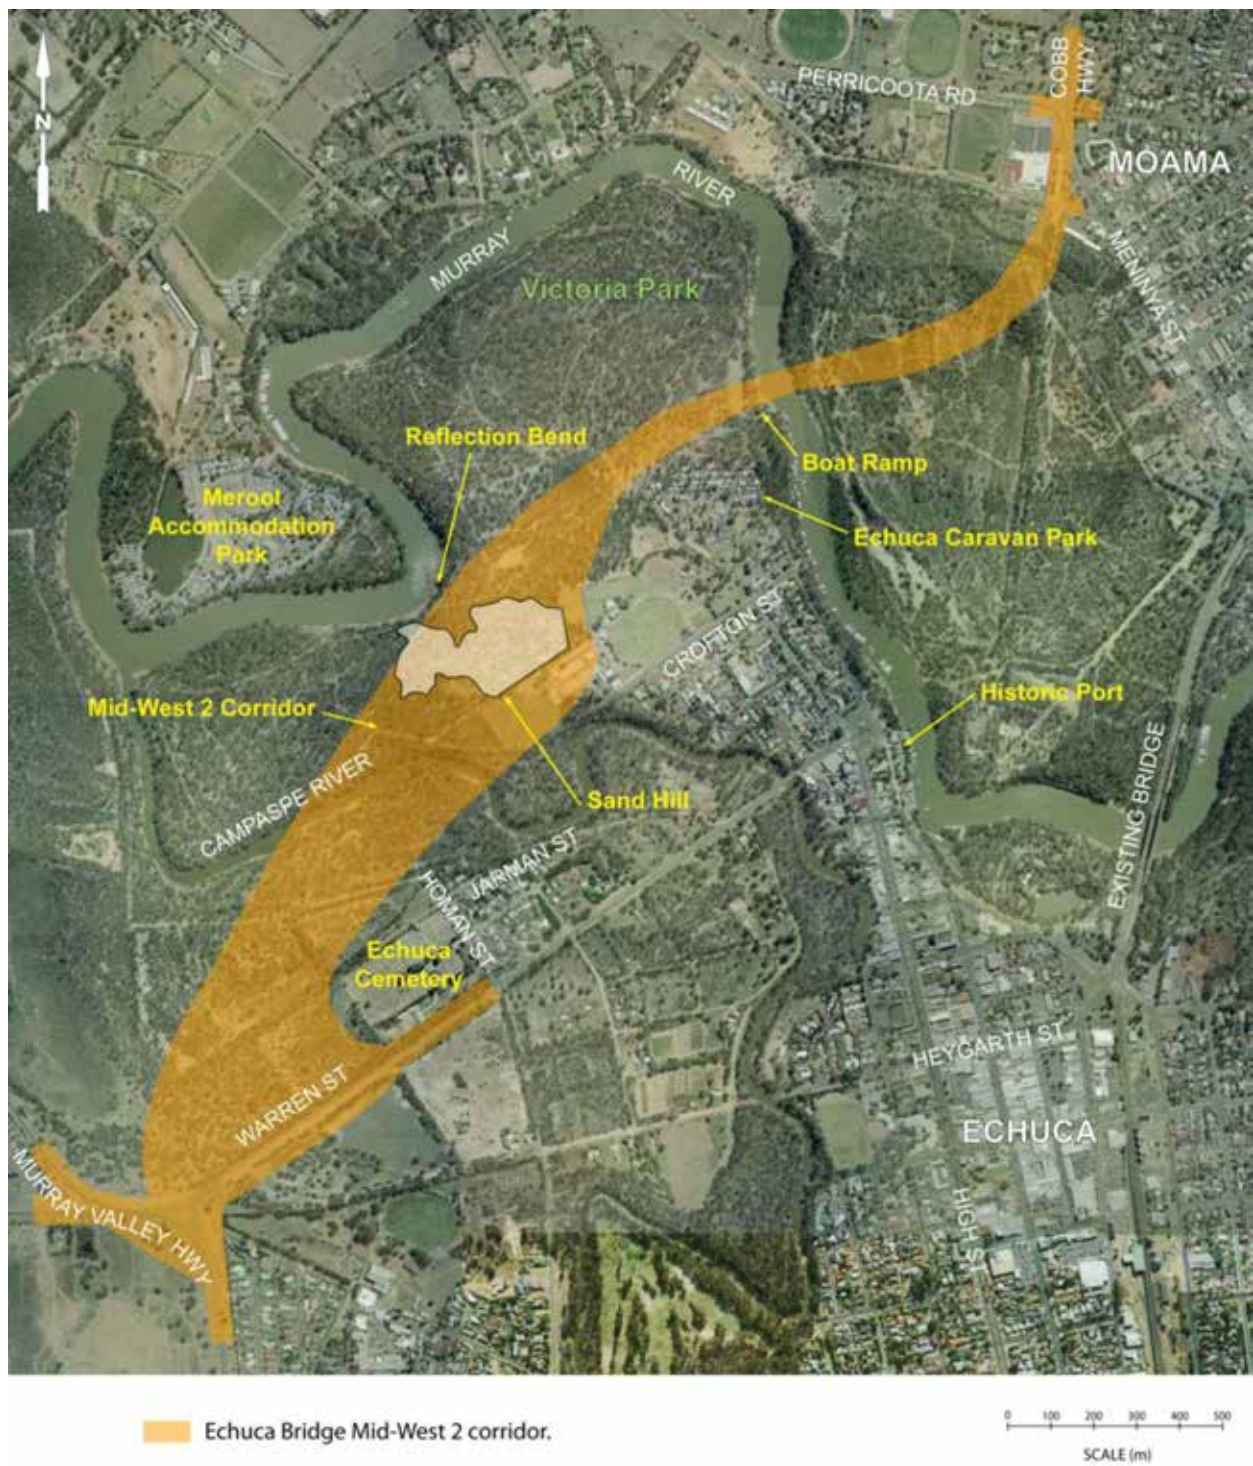
Map 6: Echuca Mid-West 2 Corridor

The study corridor shown in Map 6 was subject to an archaeological survey on 30/5/2011. The total survey area was approximately 93.25ha. The purpose of the initial survey was to locate any previously unrecorded Aboriginal archaeological sites within the study corridor and to identify any landforms of potential archaeological sensitivity. It was intended to provide site locations and sensitive landform locations as GIS data to VicRoads, in order to assist them with the design of specific alignments within the road corridor. As was noted earlier, portions of the study corridor had been surveyed in previous surveys for the Murray River Crossing and these areas were not reinspected.

The sandhill was also mapped during the fieldwork (Map 6). The sandhill extends from the site of the former Echuca Secondary College in Crofton Street to Reflection Bend on the Murray River. A section of the sandhill is visible in the bank of the river. The perimeter of the sandhill is approximately 712m. The area of land covered by the sandhill is approximately 25.033ha. A small natural levee on the north bank of the Campaspe River was also noted. This would have been a suitable location for campsites during times of high floodwater.

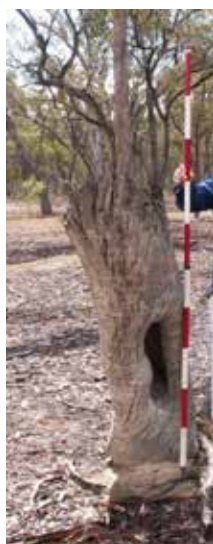
There are eight scarred trees within the ROW for Option 2A (Table 3, Map 9). None of the trees are directly impacted on by the alignment. Site 7825-0398 will be retained in a roundabout. Site 7825-0386 is a dead scarred tree (Plate 1) and is in an embankment. This site would be adversely impacted on by construction of the road if mitigation measures were not adopted. Provided mitigation measures recommended in Section 7.0 are adopted, Option 2A will not impact on any known Aboriginal cultural heritage.

There are six scarred trees within the ROW for Option 2C (Table 5, Map 11). Site 7825-0398 will be retained in a roundabout. Site 7825-0386 is a dead scarred tree (Plate 1) and is in an embankment. This site would be adversely impacted on by construction of the road if mitigation measures were not adopted. Provided that mitigation measures recommended in Section 7.0 are adopted to protect the scarred trees, this option will not impact on the trees. Option 2C also crosses the sandhill in the same location as Option 2A with the same potential impacts and requirements for additional heritage investigation.

Plate 1: Site 7825-0386 scarred tree which would be located in a road embankment

The scarred tree 7825-0386 is situated within an embankment adjoining the north side of the road on all road options. A retaining wall must be built within the embankment around the tree. A qualified arborist must be employed to advise on the construction of the embankment, the most appropriate method of conservation and drainage of the tree, lopping of branches and treatment for insects. The arborist's report should contain recommendations for the long term management and maintenance of the tree. VicRoads must implement the maintenance schedule.
