# Woori Yallock Quarry

## Geotechnical Assessment

Dandy Premix Quarries Pty Ltd

22 January 2024

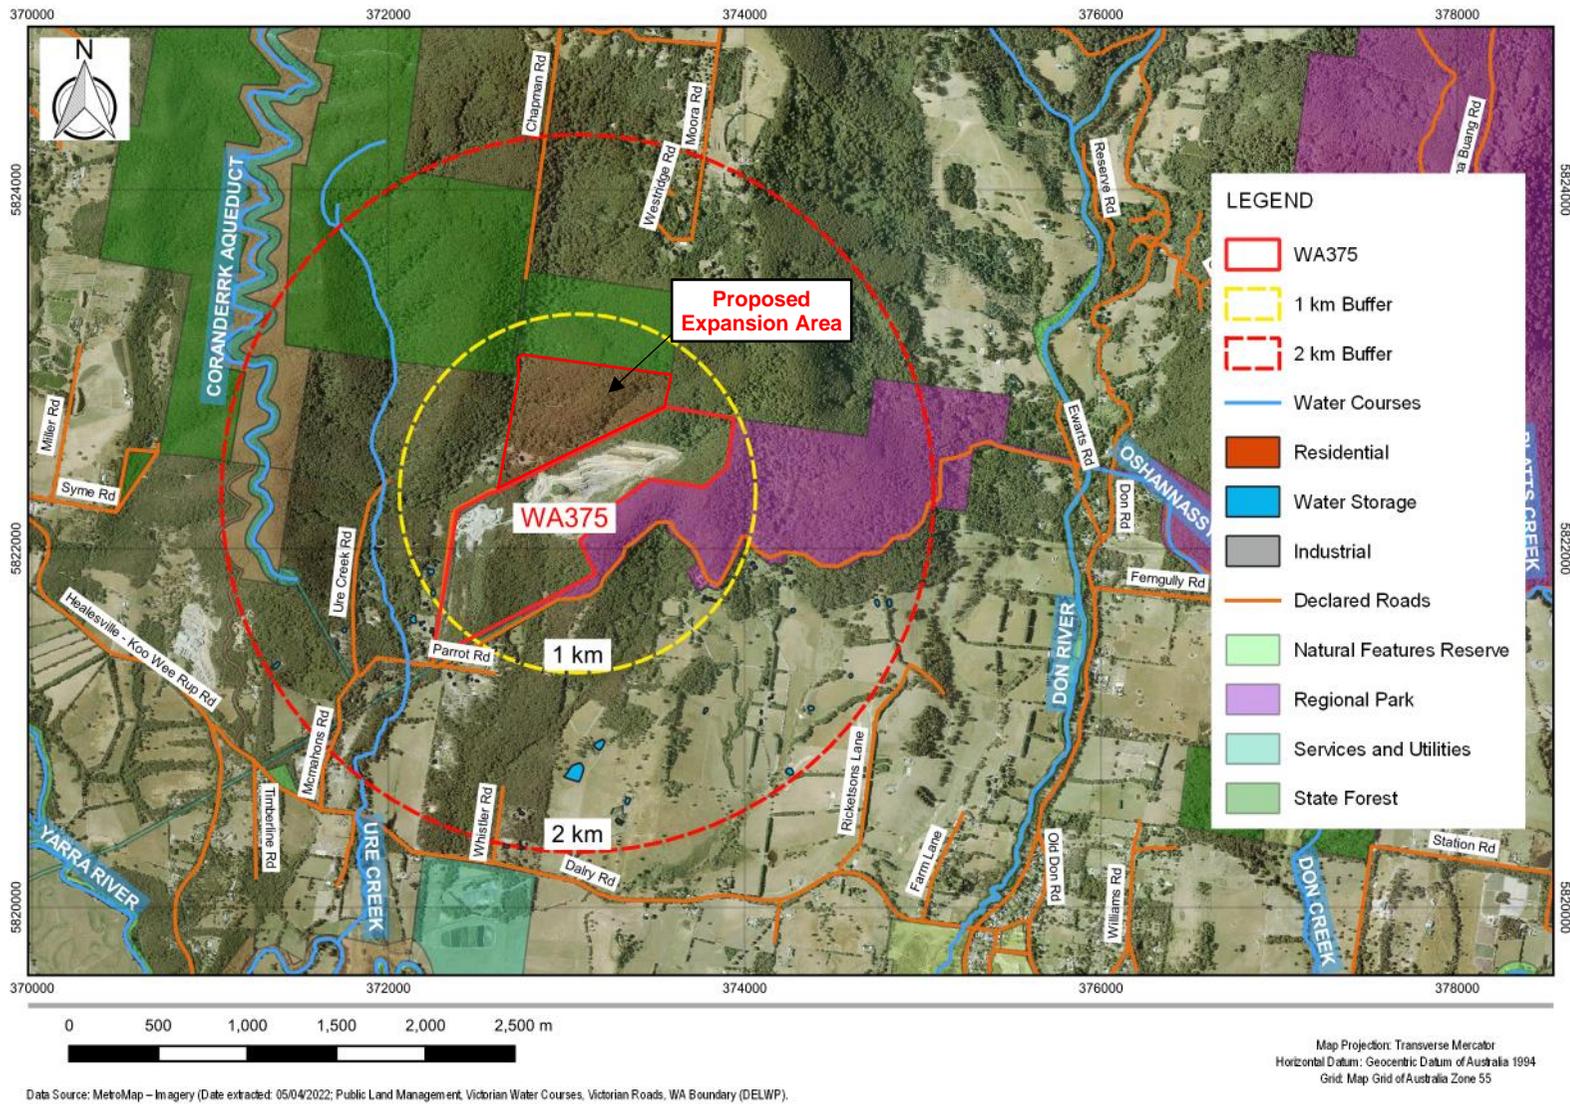
Figure 4 Plan View of the Woori Yallock Quarry (WA375) Site Depicting Nearby Receptors.

Receptors within 1 km of the site is presented in Figure 4.

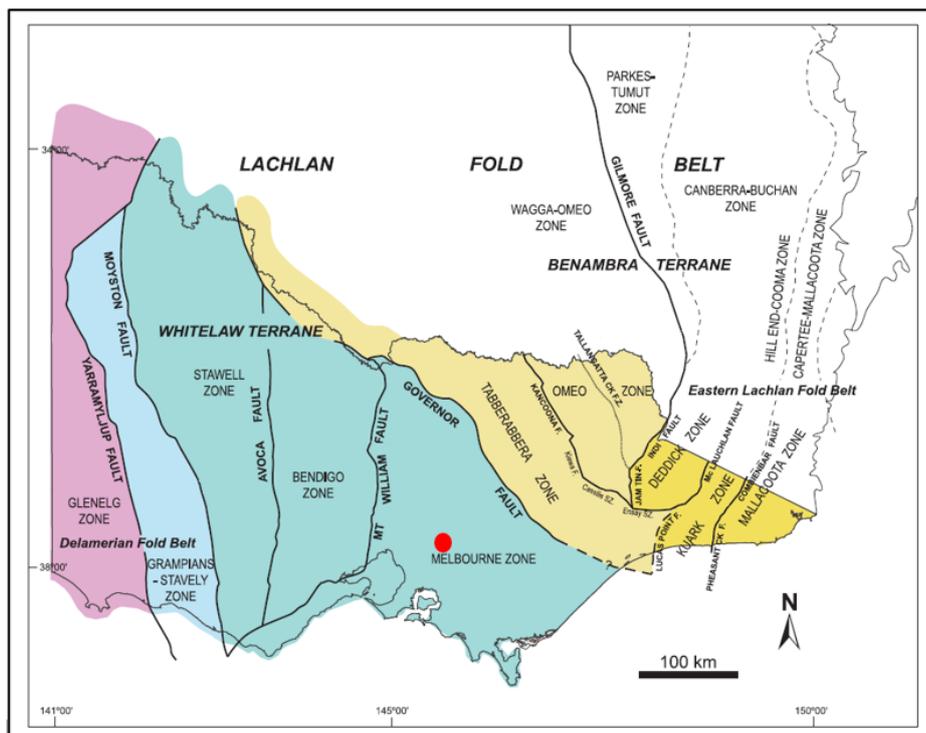
Figure 5 The zone and terrane subdivisions of the Lachlan Fold Belt (VandenBerg et al., 2000), and the approximate location of the Woori Yallock Quarry (red)

WA375 is located within the Melbourne Structural Zone, the easternmost zone of the Whitelaw Terrane of the Lachlan Fold Belt (Figure 5) (Willman, 2002). The Melbourne Zone is a complexly deformed tectonic zone which has undergone multiple deformation events, resulting in a series of large-scale north-south trending structures combined with the intrusion and extrusion of igneous rock units (VandenBerg et al., 2000).

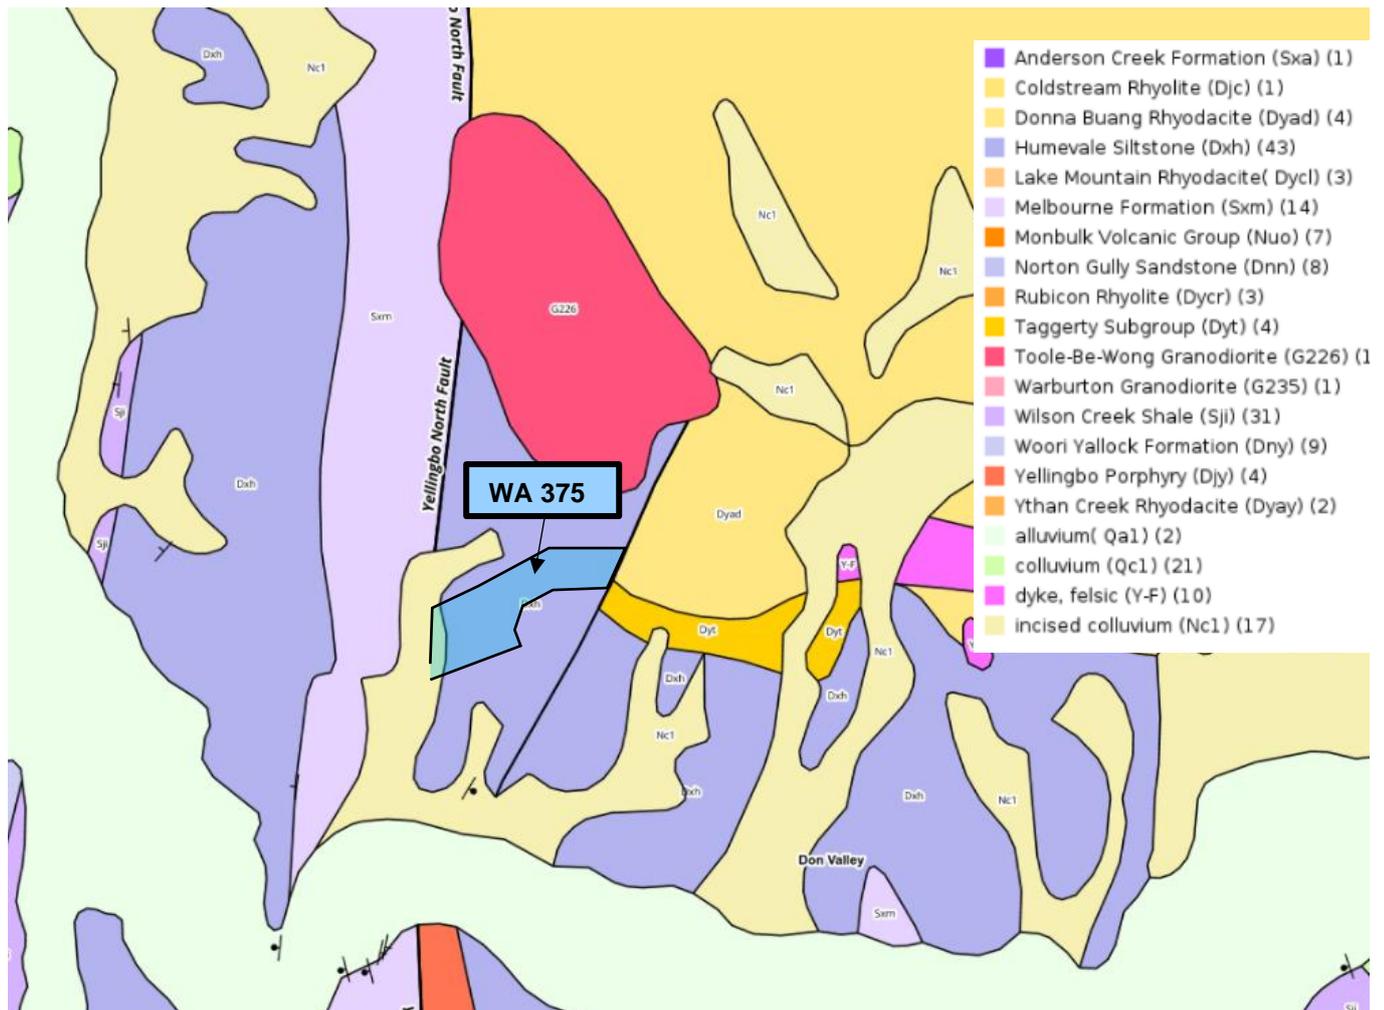
Figure 7 Simplified Geological Map of the Woori Yallock Quarry Site

The outcropping geology in the vicinity of the Woori Yallock Quarry consists predominately of Humevale Siltstone (*Dxh*) and overlain by Neogene-aged incised colluvium (*Nc1*) towards the west of the quarry. While the GeoVic database (2014) indicates that the Humevale Siltstone in the area is characterised by a series of laminated brown siltstones, with minor very fine to fine grained sandstone laminae, site observations indicate that this area has been subject to contact metamorphism caused by the intrusion of the Toole-be-wong Granodiorite (G226), resulting in the rock within the contact aureole being altered to hornfels.

Other units within the area but outcropping outside of the WA375 boundary include the Melbourne Formation (*Sxm*), the Taggerty Subgroup (*Dyt*) and the Donna Buang Rhyodacite (*Dyad*). Figure 7 displays a simplified geological map of the Woori Yallock region.

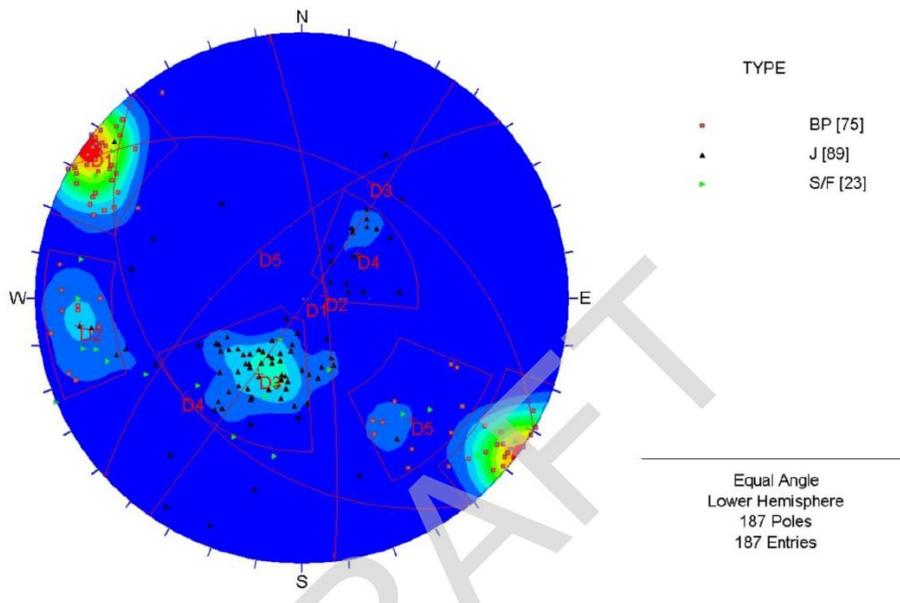
Figure 8 Stereographic Projection of Identified Defect Sets after GHD (2007) and GHD (2009)

Discontinuity Set	Mean Dip/Dip Direction (Mine Grid)	Description
D1	88°/125°	Bedding
D2	80°/083°	Bedding
D3	36°/030°	Major structural set
D4	30°/231°	Major structural set
D5	63°/318°	Bedding

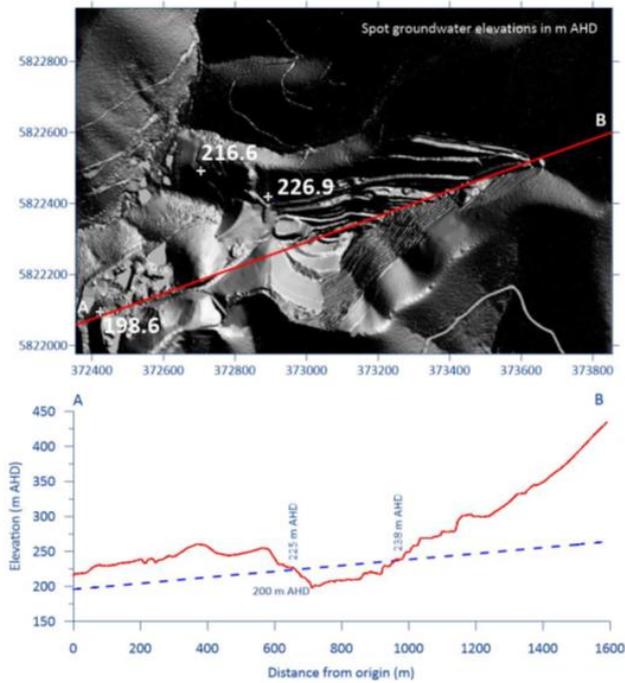
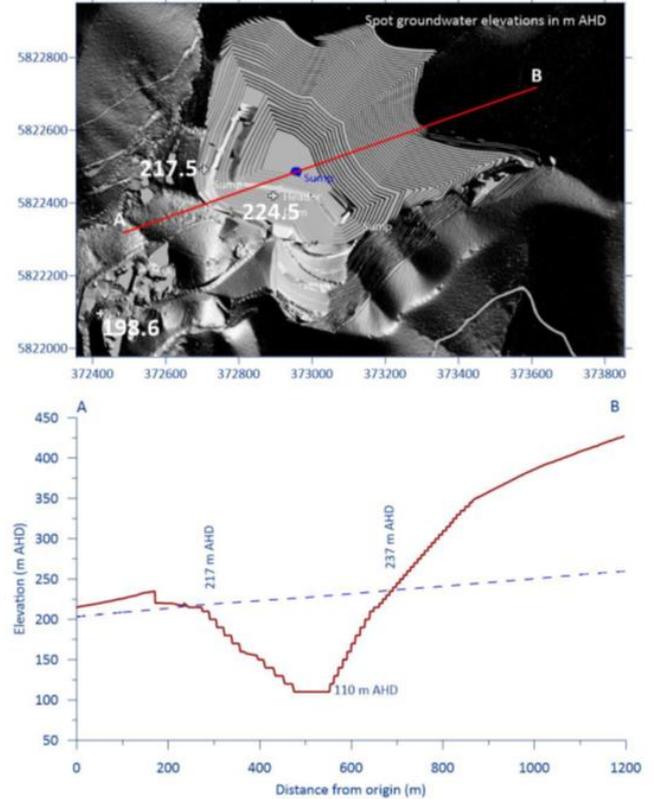
**Figure 10** *Approximate Far-field Groundwater Profiles (ENE to WSW direction) relative to the July 2022 and proposed Stage 4 pit design (not considering cone of depression) (JLCS, 2023).*

**Approximate GW Profile Through July 2022 Pit**

**Approximate GW Profile Through Stage 4 (Final) Pit**

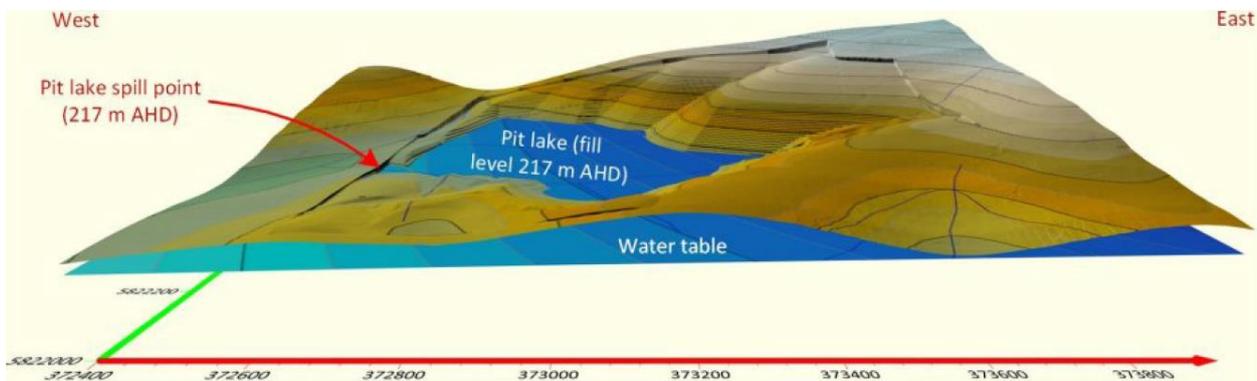
**Figure 11** *WA375 Terminal Pit Lake Visualisation (JLCS, 2023)*

When quarrying of the site ceases, the pit will be predominately filled by surface water, forming a final pit lake. The final pit lake level will be controlled by the elevation of the ‘pit lake spill point’ (RL 217 m), which is located at the west of the site (see Figure 11). As noted by JLCS (2023) ‘when the lake water level reaches the spill point elevation, it will become a surface water dominated groundwater throughflow lake with groundwater flowing into the lake from up-hydraulic gradient to the northeast and out of the lake to the southwest’ (see Figure 12).

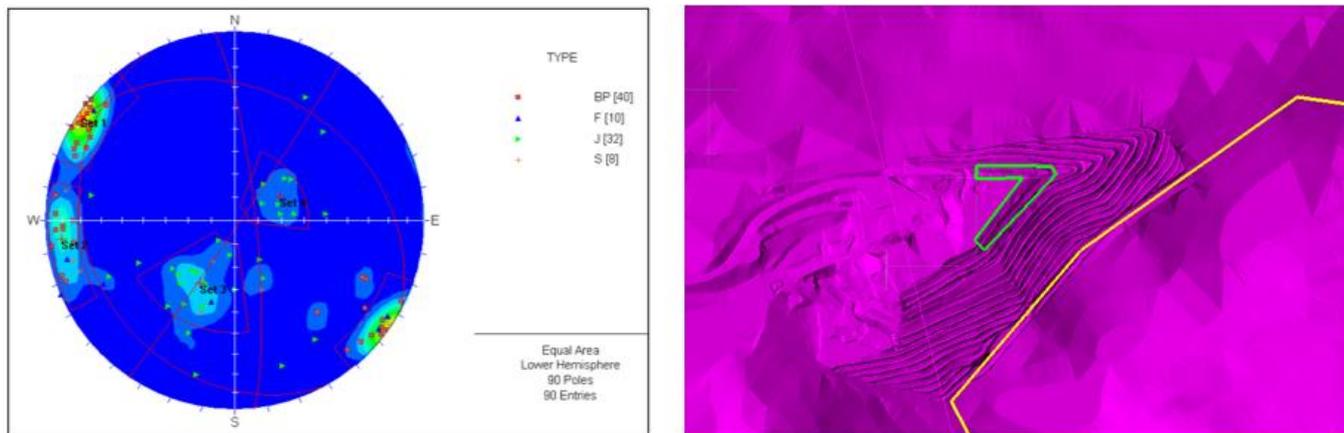
Figure 16 Southern Hemispherical Stereonet Projection of Mapped Discontinuities, after GHD (2007)

Defect Set ID	Mean Dip Angle (°)	Mean Dip Direction (°)	Description
D1	88	124	Bedding
D2	81	84	
D3	31	29	Joint
D4	22	242

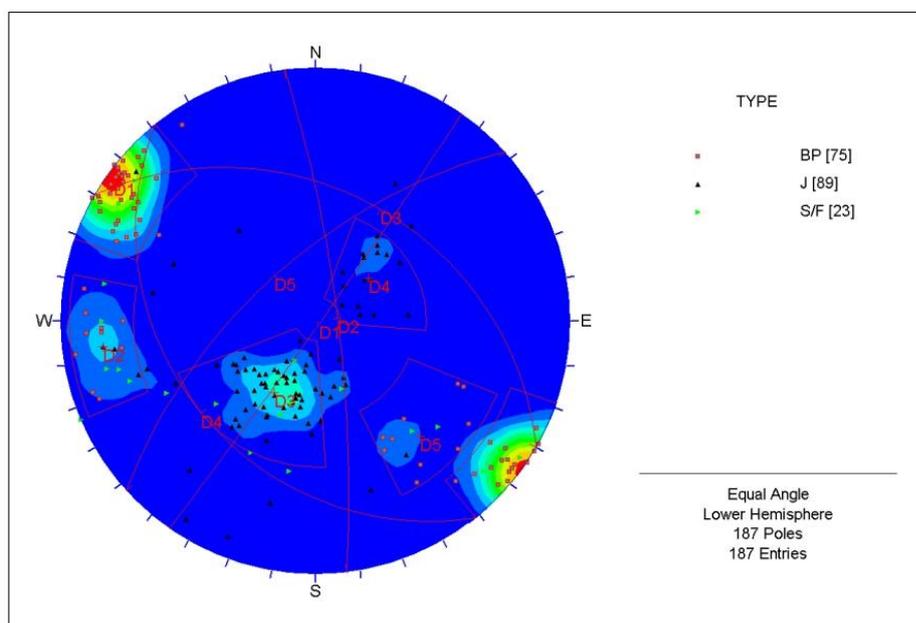
**Figure 17** Southern Hemispherical Stereonet Projection of Mapped Discontinuities, after GHD (2009)

Defect Set ID	Mean Dip Angle (°)	Mean Dip Direction (°)	Description
D1	88	125	Bedding
D2	80	83	Bedding
D3	36	30	Joint
D4	30	231	Joint
D5	63	318	Bedding

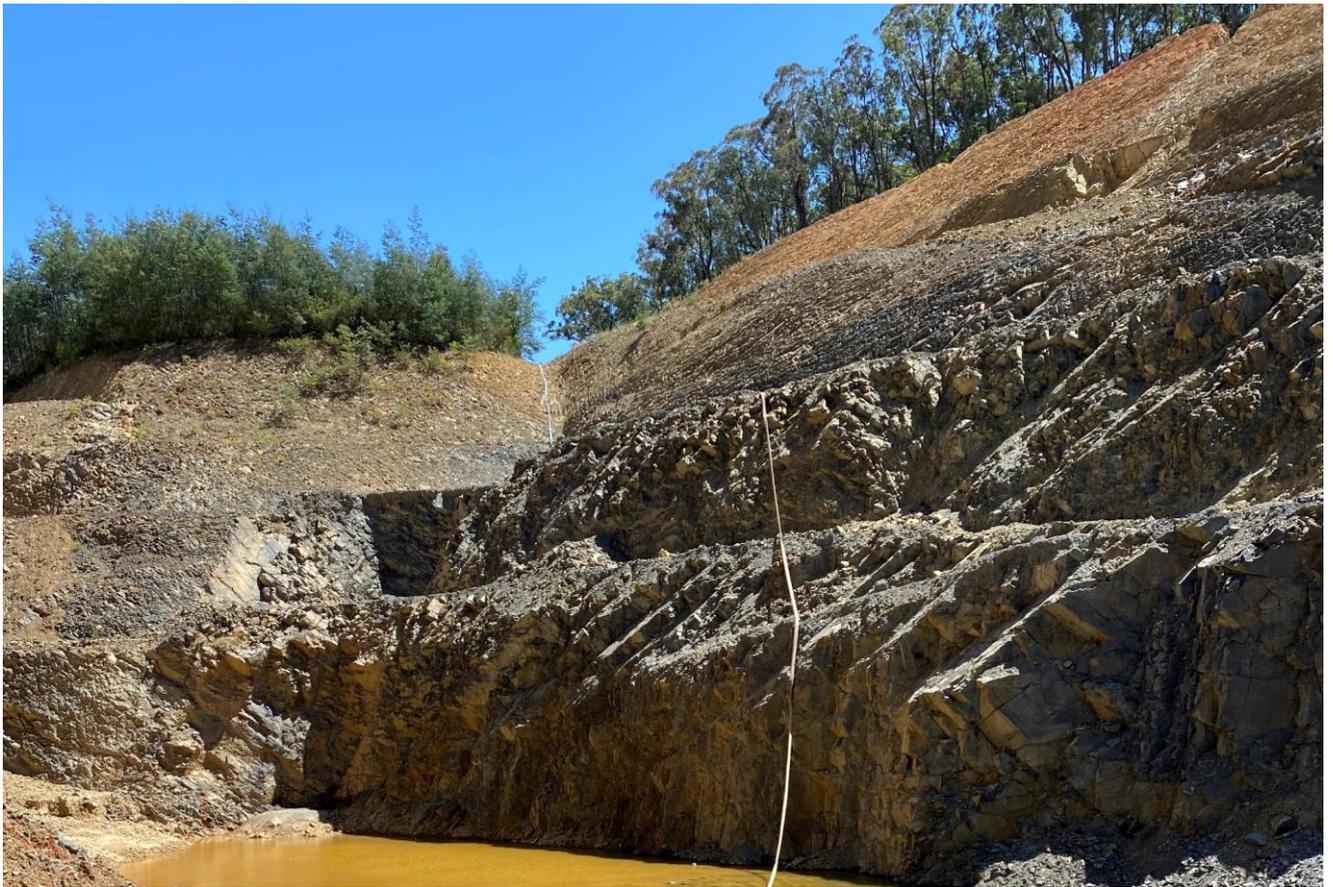
**Figure 19** Existing Quarry Wall – Northern Wall

Existing quarry slopes were observed to be at sub-vertical batter face angles within the moderately weathered to fresh Hornfels and 45° in the extremely to moderately weathered Hornfels, for bench heights in the order of 5 to 10 m and bench widths in the order of 5 m.

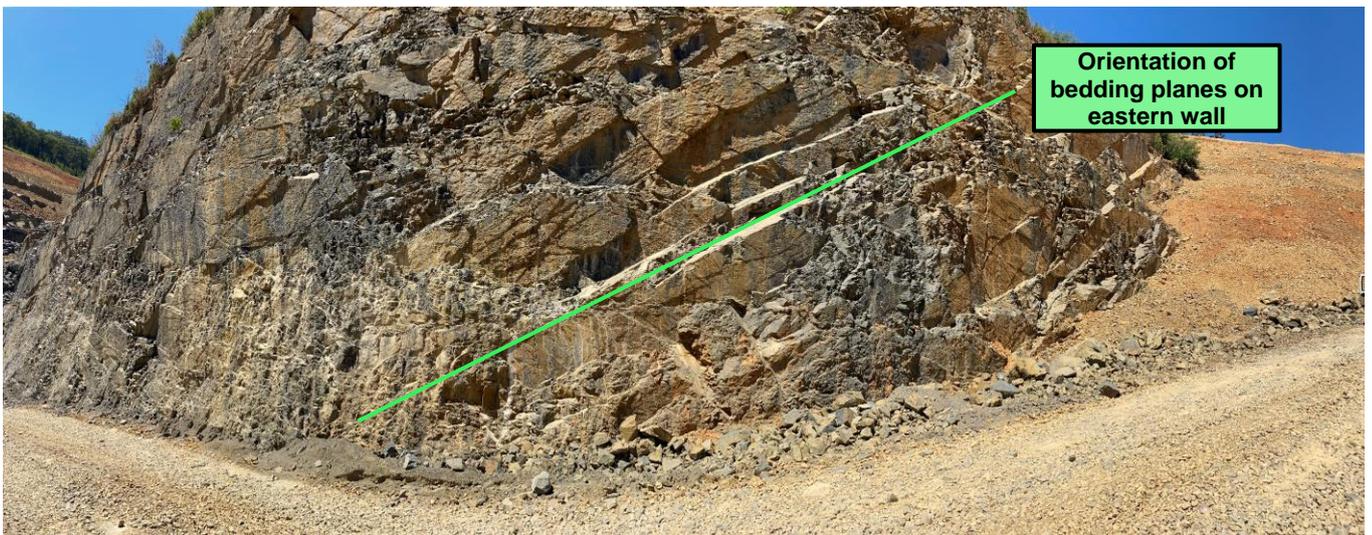
**Figure 20** Photograph depicting Interbedded Rock Mass – Eastern Wall

The intact rock mass was observed to be inter-bedded which are typically very thin (< 1 mm) where the spacing between the bedding planes varies in thickness. Along the eastern wall bedding planes are shallow dipping, daylighting along the slope face, as shown in Figure 20 and steepen up along the northern wall, as shown in Figure 21, which is likely a result of the late-stage granite intrusion on the local geology.

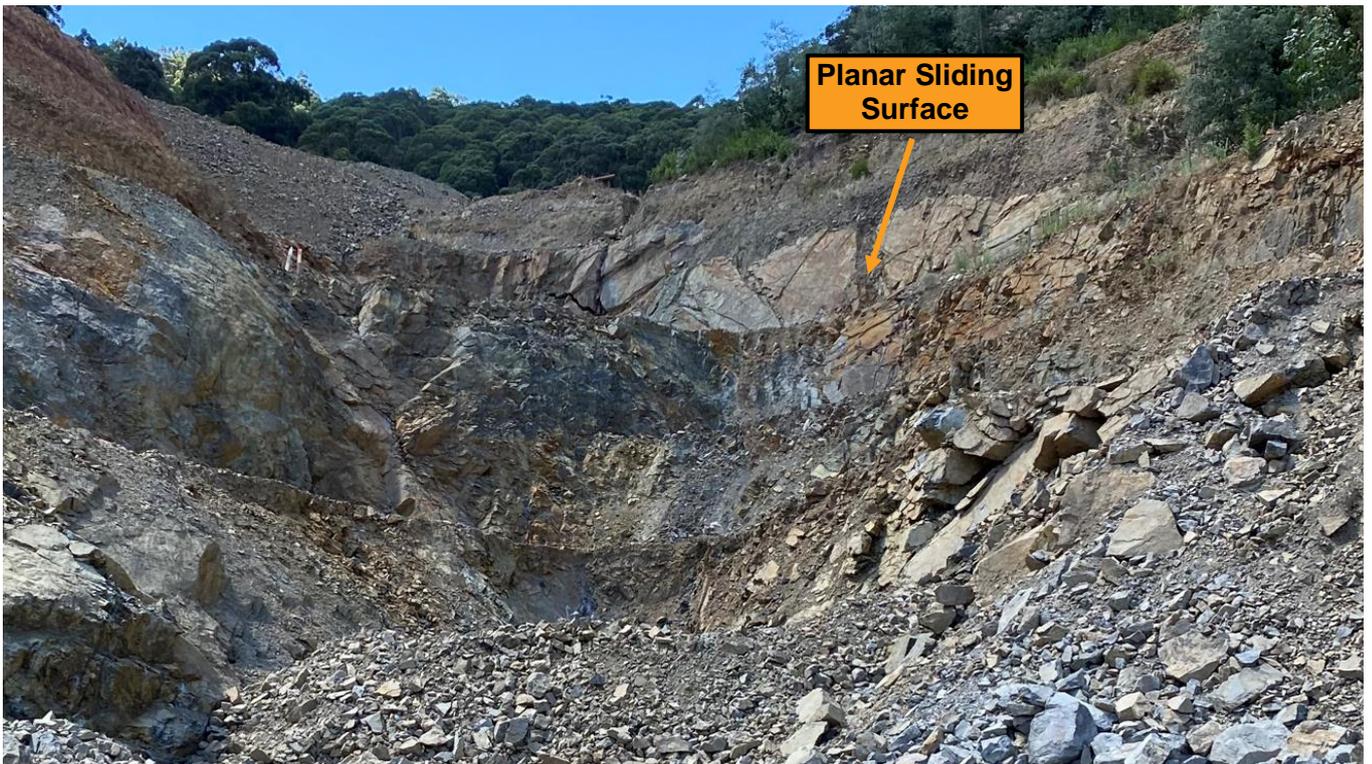
Figure 22 Photograph Depicting Planar Sliding Surface – North East Corner

There is evidence that suggests that where blasting has occurred along slopes oriented in the same direction as discontinuity planes that planar sliding has occurred as shown in Figure 22.

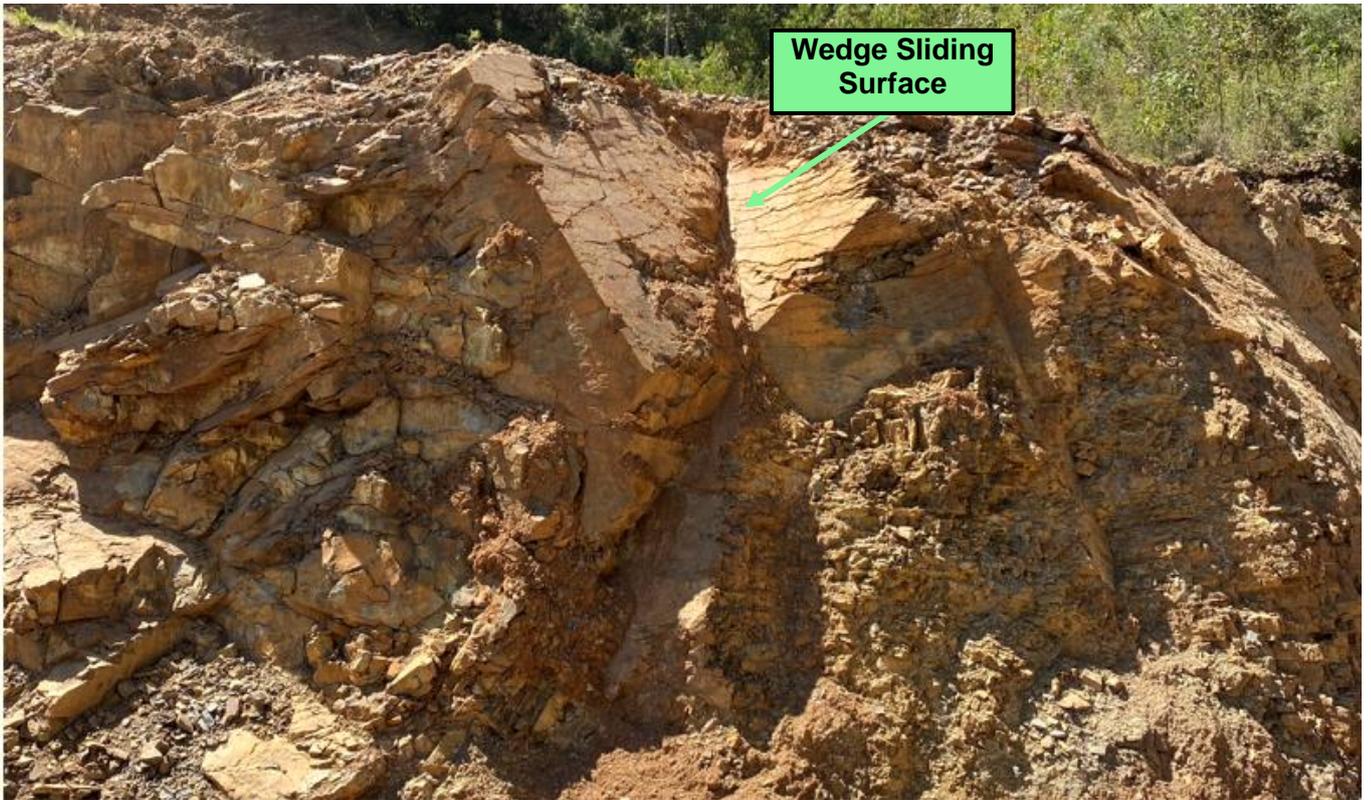
Figure 23 Photograph of Minor Wedge Formation – Northern Corner

Evidence of minor structural instability in the form of tetrahedral wedge sliding was observed along exposed quarry slopes as shown in Figure 23. In certain areas, larger wedge type instabilities were observed as shown in Figure 24 and Figure 25. It should be noted that wedge type instabilities in Figure 25 are likely to have been promoted as a results of water ingress through defect planes.

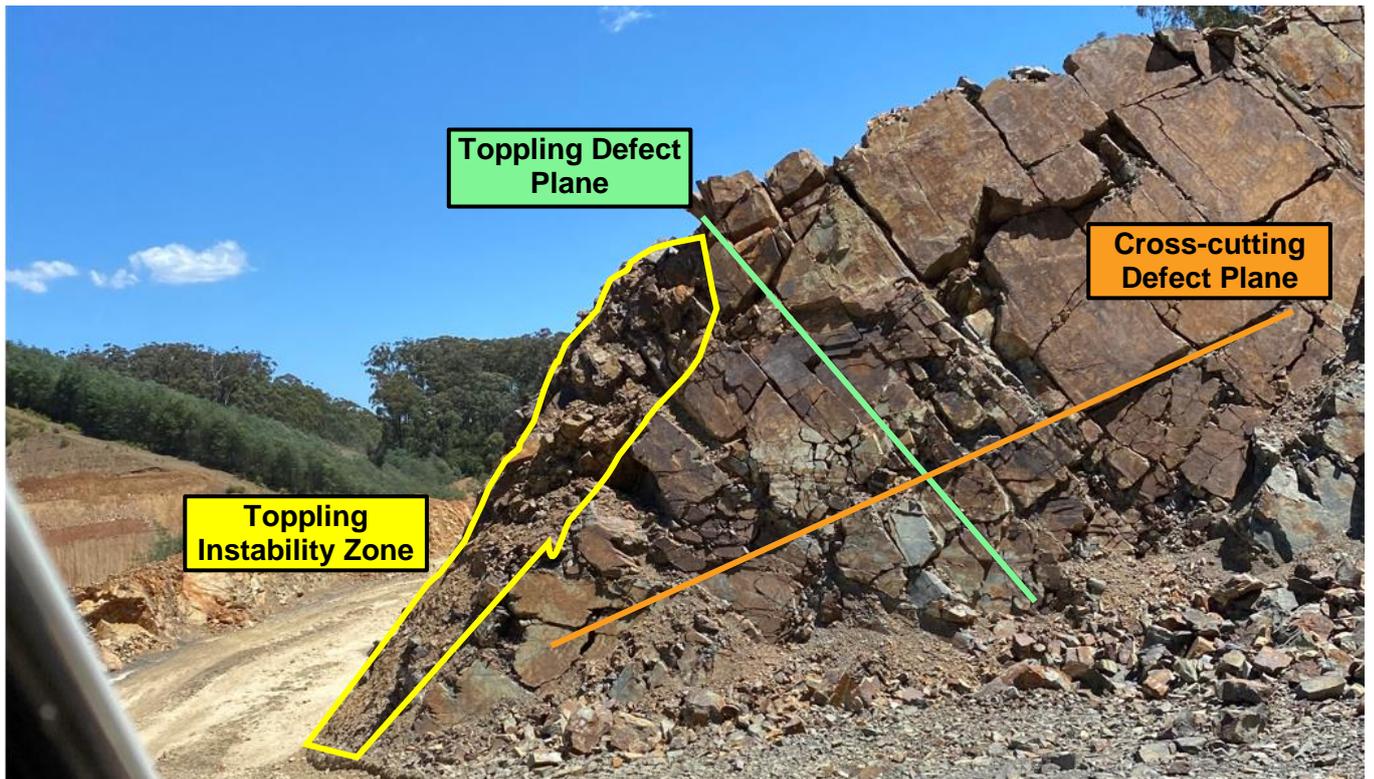
Figure 26 Photograph of Toppling Joints – North Wall

There is evidence to suggest minor instability in the form of flexural block toppling has occurred along excavated quarry slopes. Depicted in Figure 26 are the defect planes that form the flexural toppling mechanism and a zone of instability where toppling has likely occurred.

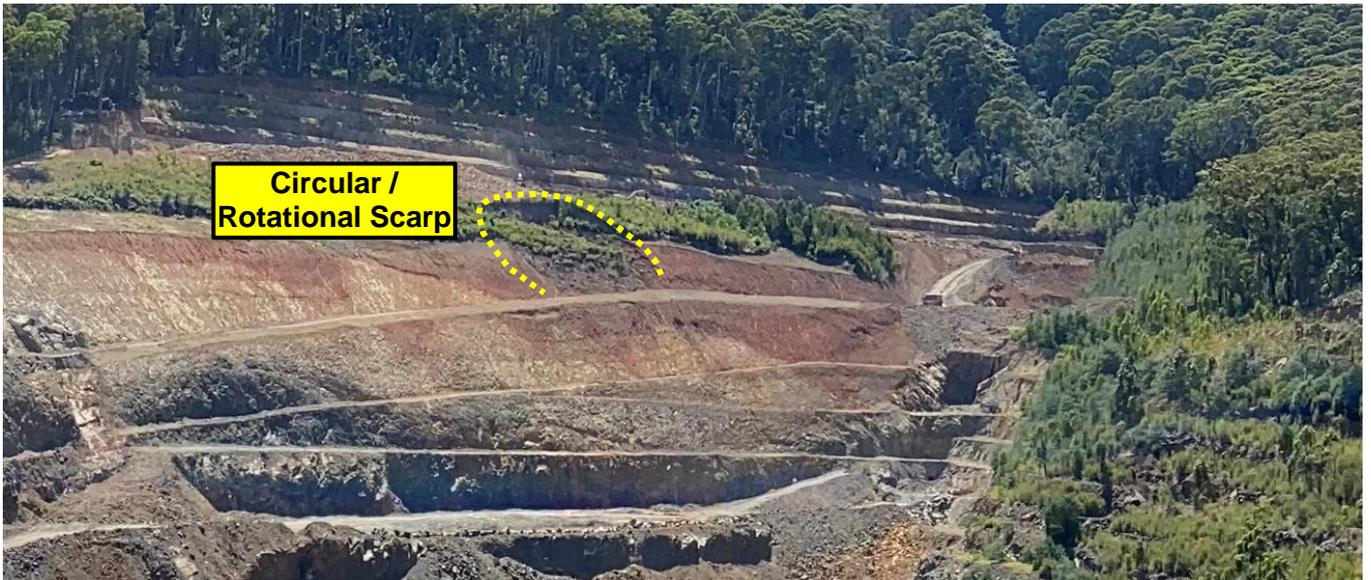
**Figure 27** *Photograph Depicting Circular/Rotational Type Instability – Northern Wall*

Evidence of minor circular/rotational type instability was observed within the extremely weathered unit along the upper slopes of the northern wall as shown in Figure 27.

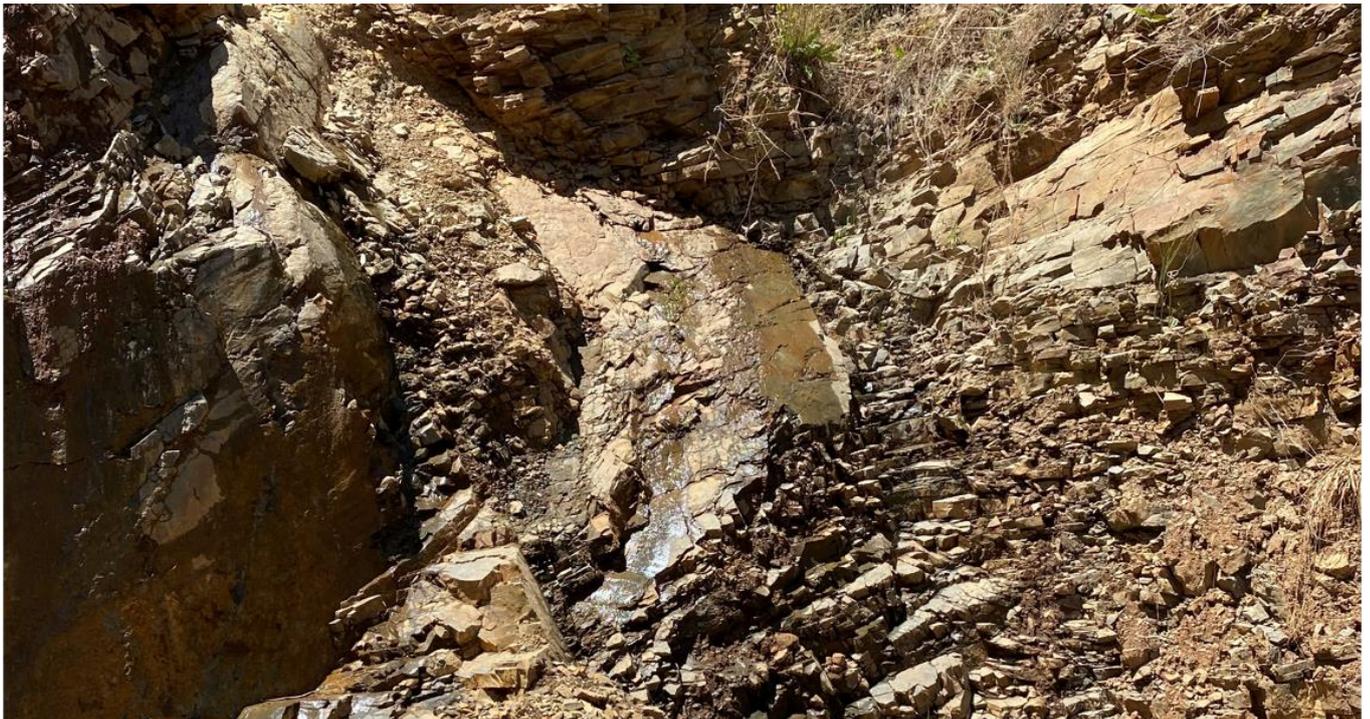
**Figure 28** *Photograph Depicting Groundwater Seepage - North East Corner – Upper Level*

Seepage flows through the excavated batter face were observed on the upper level and pit floor as shown in Figure 28 and Figure 29 respectively. Seepage flows were estimated to be very low in the order of 0.5 L to 1 L per minute.

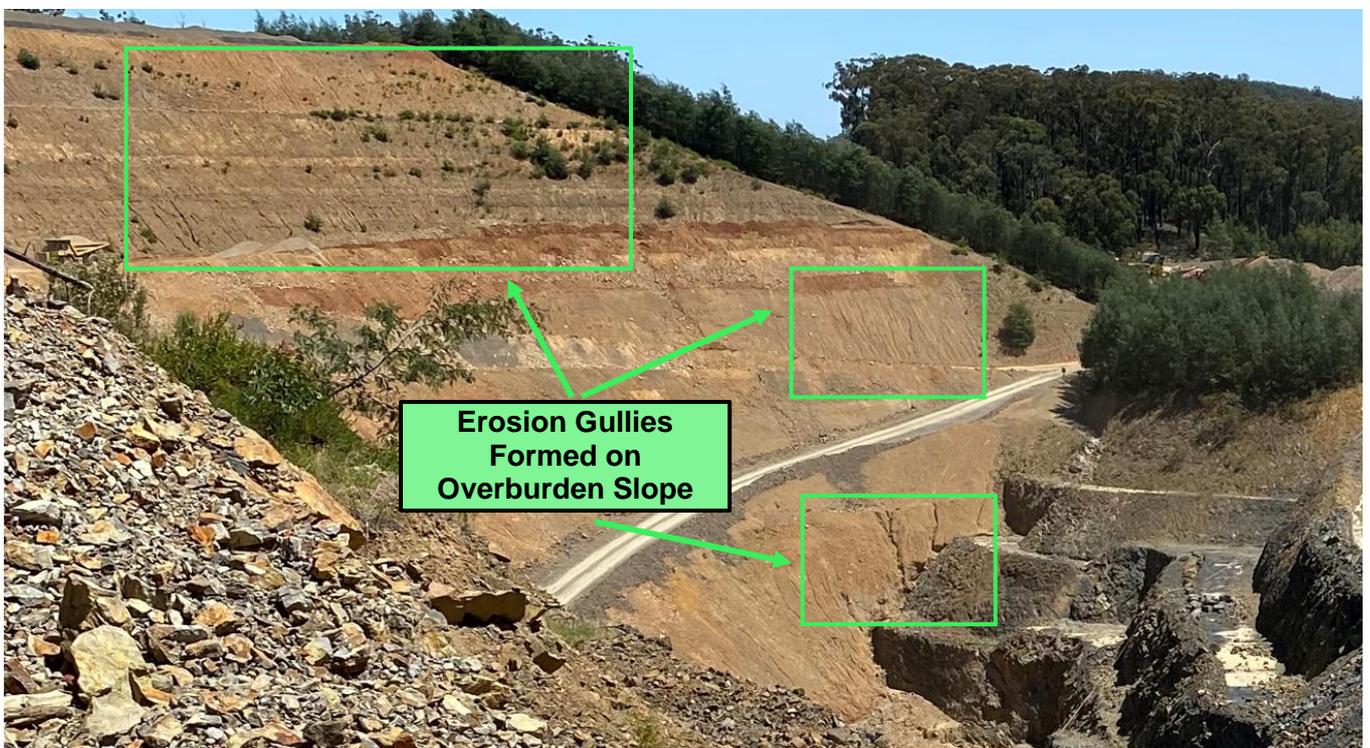
**Figure 30** Photograph Depicting Erosion Gullies Along Weathered Rock (Overburden) Slope

No major signs of major instability were observed with the overburden placement along the south wall for bench face angles in the order of 36° and maximum bench heights of 50 m. However, evidence of erosion gullies was readily observed across the slope face as shown in Figure 30. Table 1

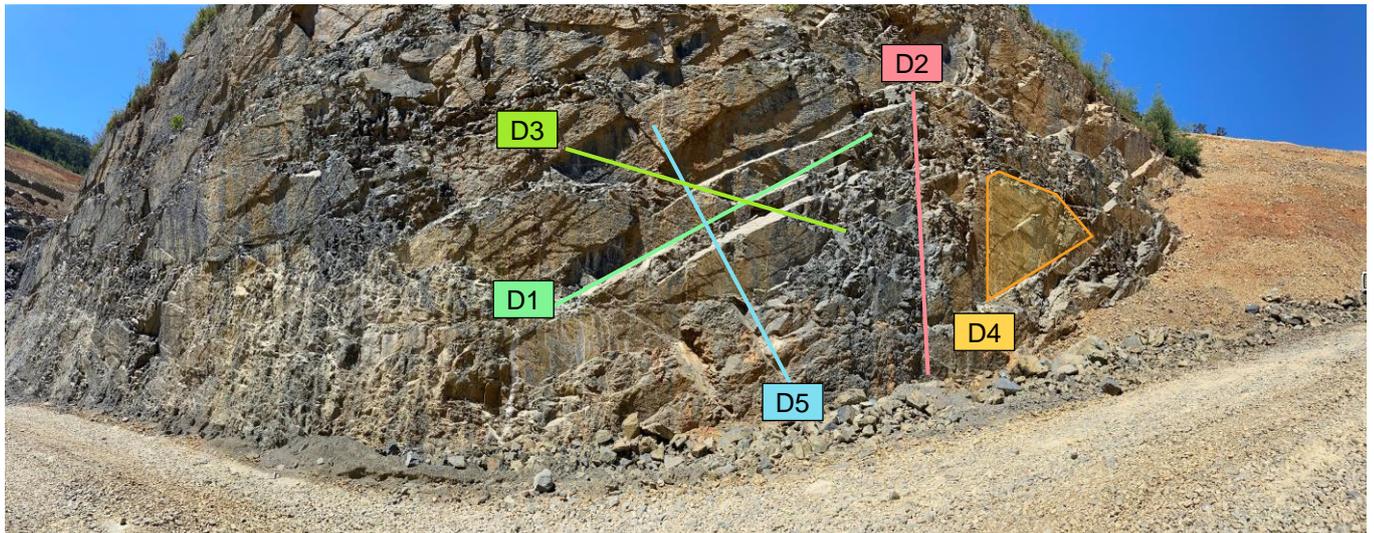
Figure 31 Photograph Depicting Example of Mapped Defect Sets- Eastern Wall

Defect ID	Dip Angle (°)	Dip Direction (°)
D1	25	42
D2	63	73
D3	26	299
D4	49	347
D5	56	273
D6	90	107
D7	49	182
D8	56	313
D9	33	346
D10	86	276

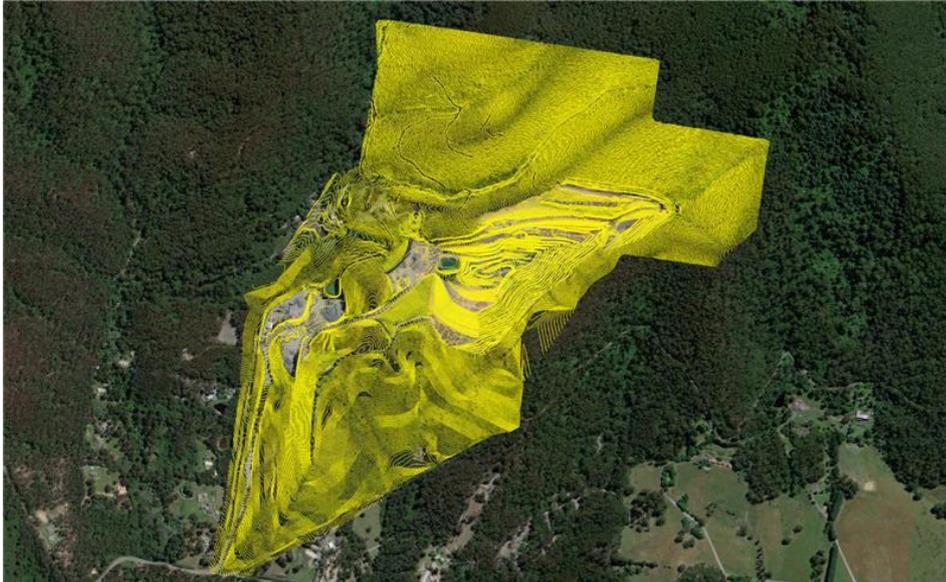
*Figure 33 Contour Map Depicting Current Quarry Geometry*

The current maximum depth of the quarry pit is in the order of 151 m below the top of crest. Typical slope geometries consist of overall slope angles in the order of 40° along operational slopes, 34° along terminal/rehabilitated slopes with the exception of weathered rock stockpile slope which has an overall slope angle of 24°.

Contour files provided to GHD of the as-excavated geometry, as depicted in Figure 33, were queried to examine the current 'as constructed' slope profiles.

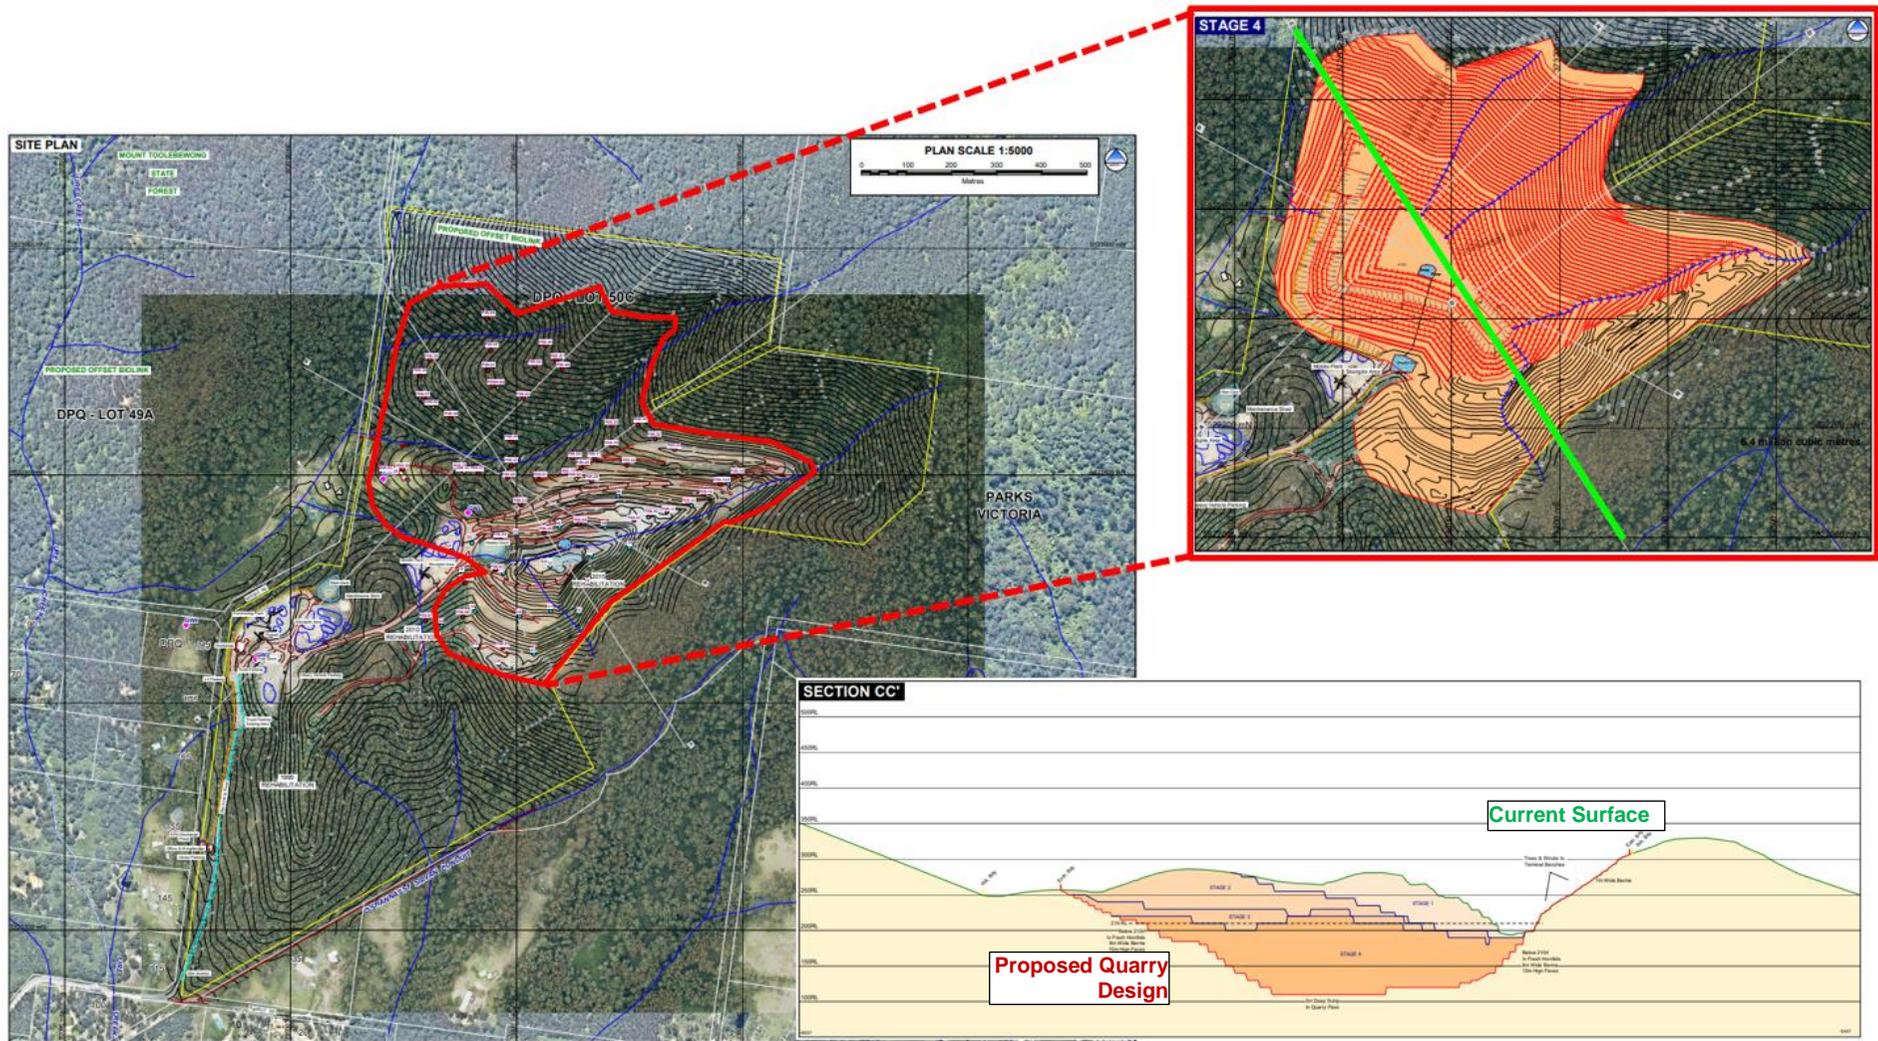
Figure 34 Contour Map Depicting Proposed Quarry Expansion

Figure 34 shows the model of the quarry profile as proposed for the WPV.

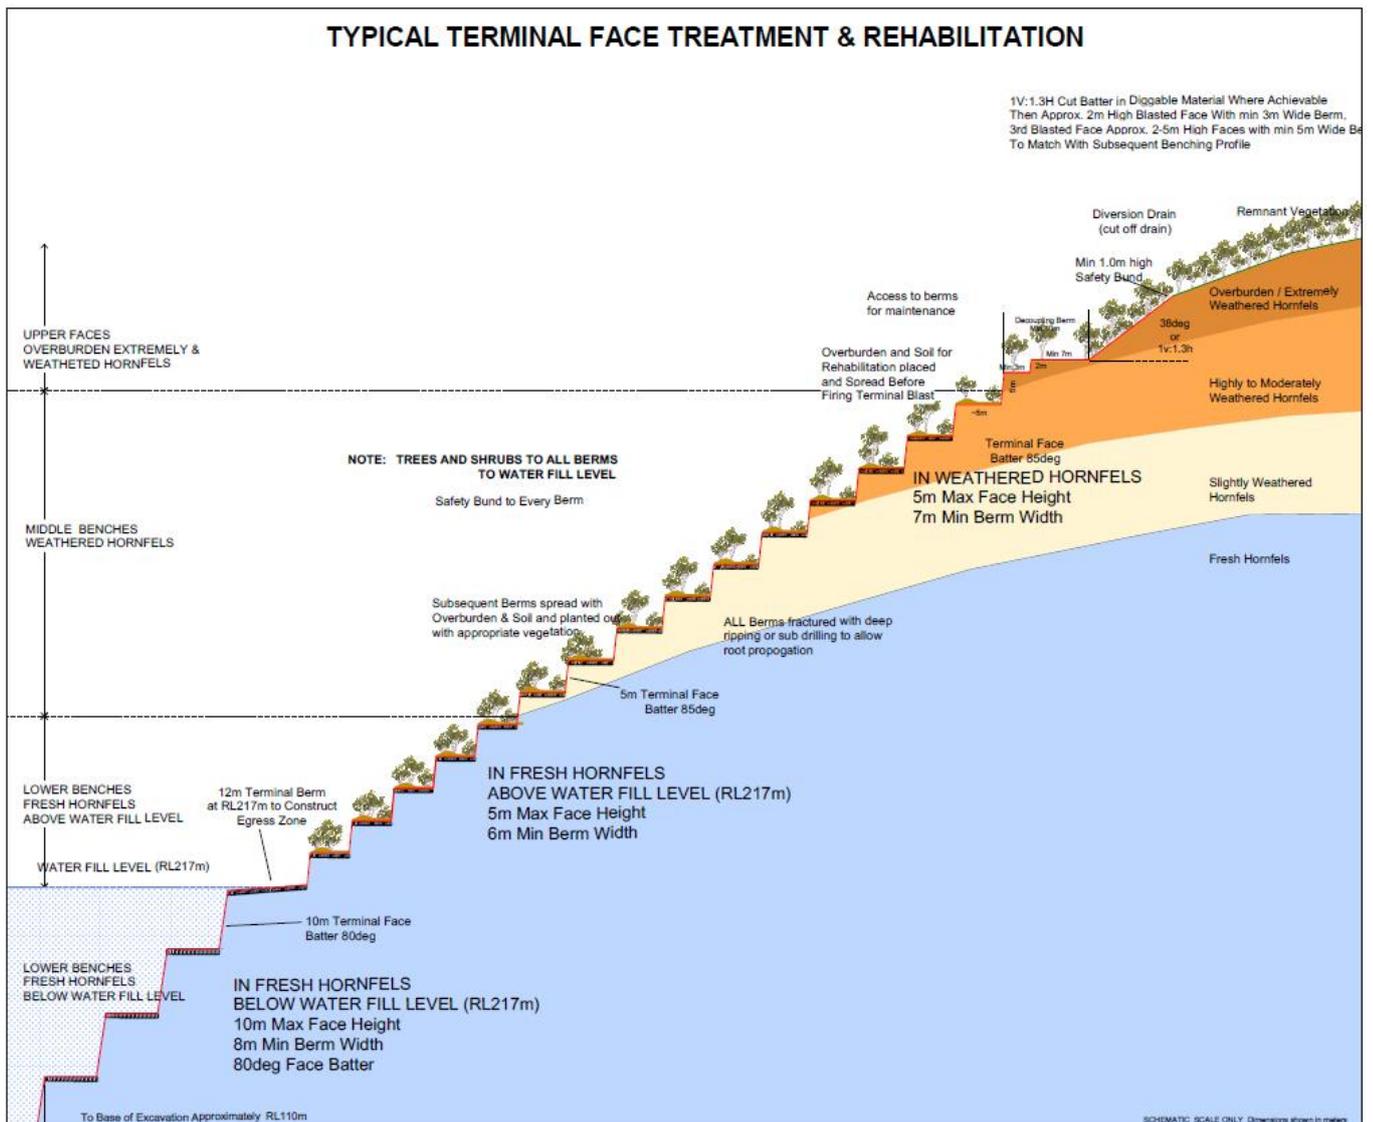
Figure 35 Schematic Depicting Typical Terminal Face Treatment and Rehabilitation (BCA Site Layout Plan, 2023)

A schematic depicting the typical terminal face treatment and rehabilitation is presented in Figure 35.

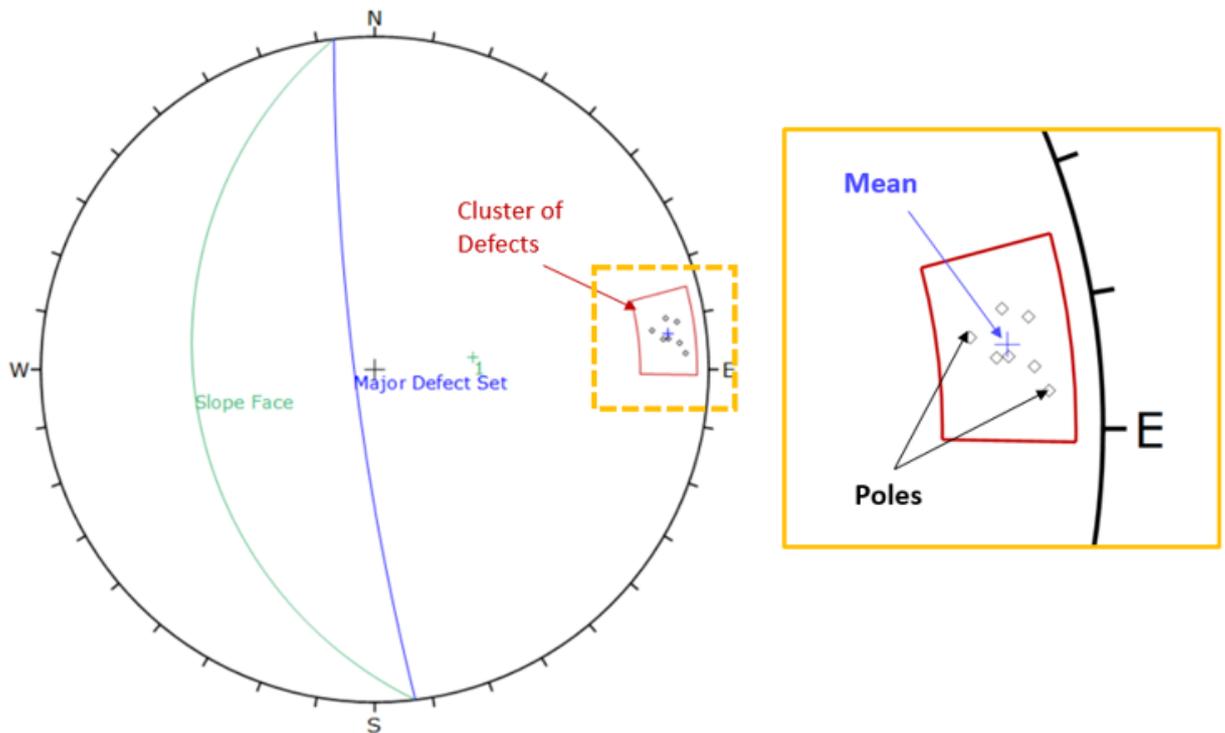
Figure 37 Stereonet Depicting Key Features

which statistical parameters that define the variability in orientations can be derived. An example of a lower hemisphere stereonet projection highlighting the key features is presented in Figure 37.
