# Woori Yallock Quarry

## Geotechnical Assessment

Dandy Premix Quarries Pty Ltd

22 January 2024

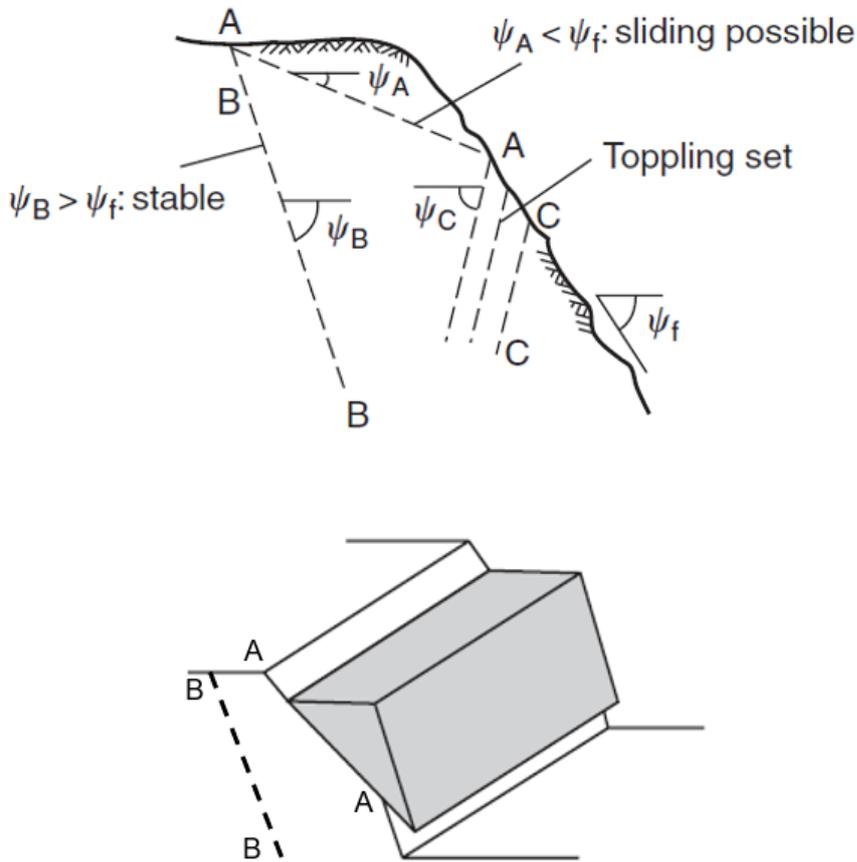
Figure 38 Planar Sliding Instability Schematic

Planar sliding instability occurs when structural defects e.g., bedding planes, which are sub-parallel to the slope face become exposed during mining development and ‘daylight’ in the slope face. Figure 38 depicts a kinematically feasible instability where the angle of the instability plane (ΨA) dips at a flatter angle than the slope face (Ψf) – plane ‘A-A’ (ΨA < Ψf).

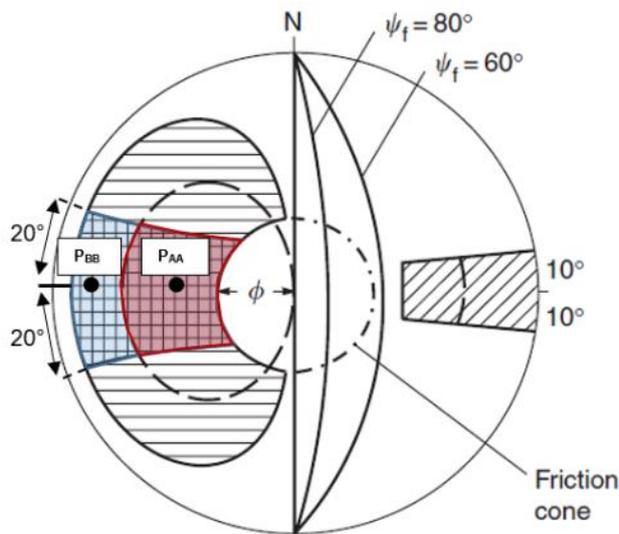
Figure 39 Stereographic Projection Depicting Daylight Envelope and Friction Cone – Planar Sliding

The mechanical principles discussed above are used to define a 'zone of feasibility' on stereonet projections, which are commonly referred to as the 'daylight envelope'. The daylight envelope for planar sliding is highlighted for a  $60^\circ$  (red) and  $80^\circ$  (blue) slope face in Figure 39.

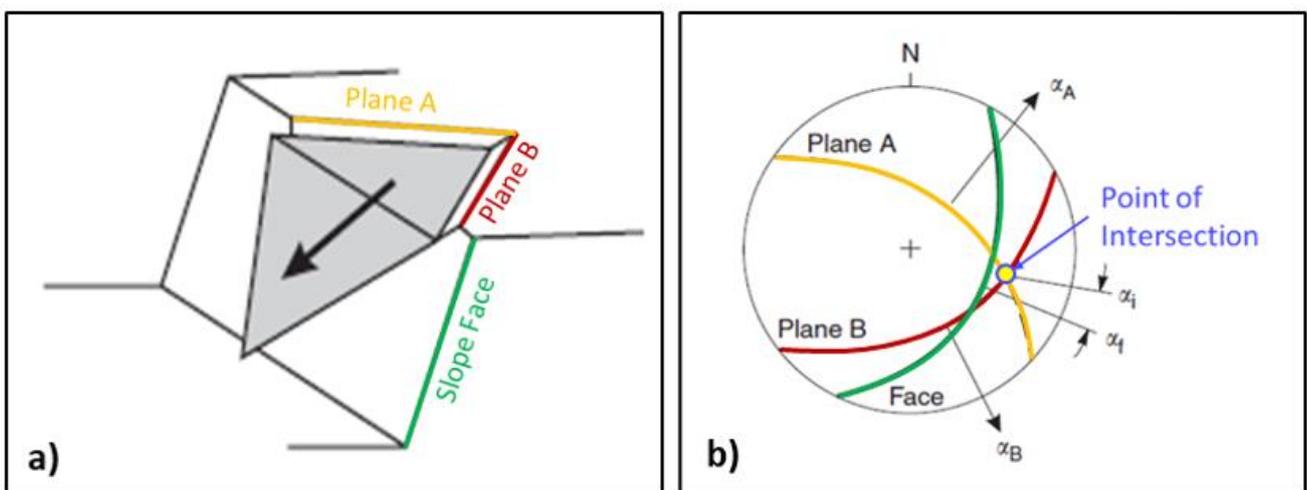
Figure 40 Schematic of a) Kinematically Feasible Wedge, and b) Corresponding Stereographic Projection

A generalised depiction of tetrahedral wedge sliding is presented in Figure 40 along with the corresponding stereographic projection.

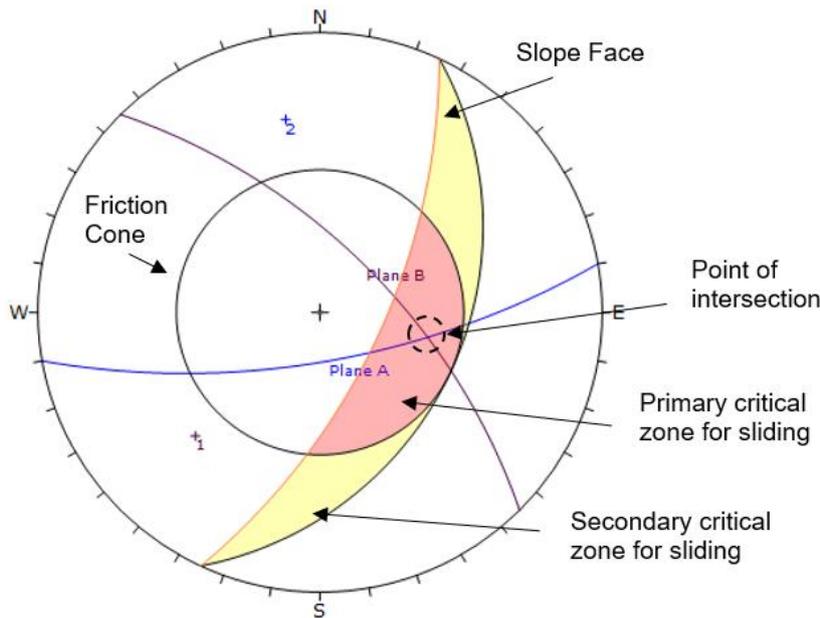
Figure 41 Stereographic Projection Depicting Daylight Envelope – Wedge Sliding

surfaces. The daylight envelope for wedge formations is the locus of all poles representing lines of intersection whose dip directions lie in the plane of the slope face as shown in Figure 41.

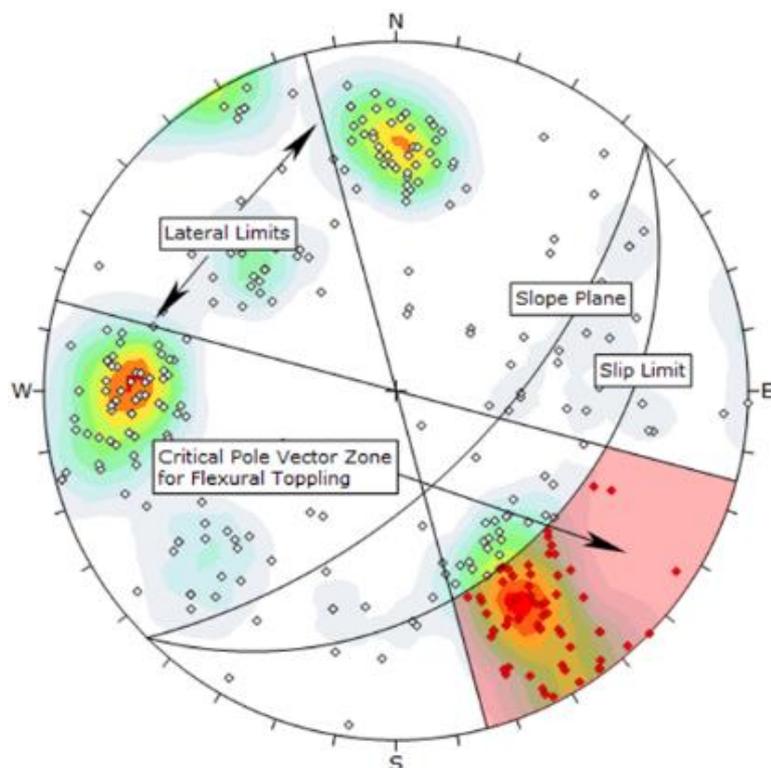
Figure 43 Stereographic Projection Depicting Daylight Envelope – Flexural Toppling

In such instances, columns formed by sub-vertical structures break in flexure as they bend forward, where characteristics of the defect system and intact rock mass strength govern the potential for toppling to occur. According to Goodman (1980), blocks cannot topple if they cannot slide with respect to one another, and for a slip to occur, the discontinuity system must have a dip angle that is less than a line inclined at an angle equivalent to the friction angle above the slope, which is termed the 'slip limit'. Additionally, flexural toppling cannot occur when the dip direction of the discontinuity system differs from the slope orientation by more approximately 10° to 15°. A daylight envelope showing the zone for which the flexural toppling mechanism is feasible is presented in Figure 43.

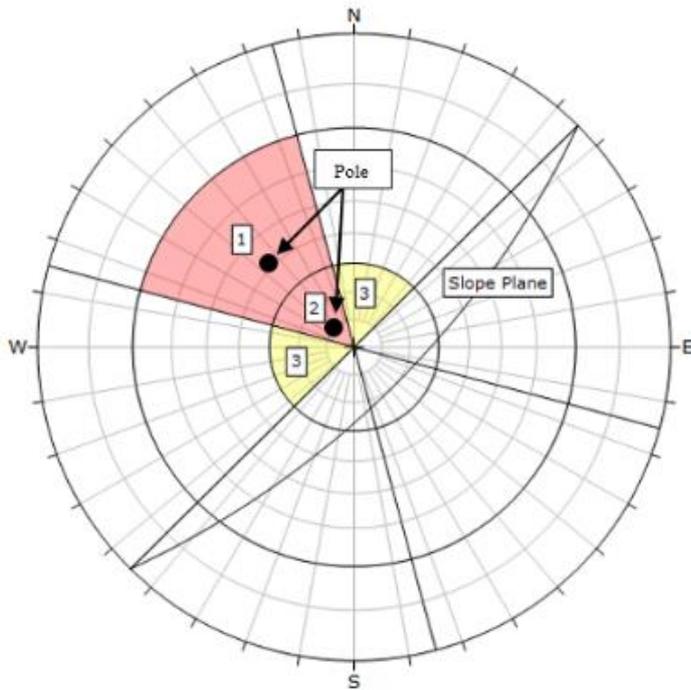
**Figure 44** Stereographic Projection Depicting Daylight Envelope – Block Toppling

Block toppling occurs where rock columns created by sub-vertical defect systems, are intersected by cross-cutting defect systems. At the toe of the slope where the columns are shorter, load from upper (and larger) columns thrust toe columns forward permitting further toppling. In order for block toppling to be kinematically feasible, two discontinuity systems must intersect such that the intersection line dips into the slope and can form discrete toppling blocks, and a third discontinuity system e.g., cross cutting plane, that acts a release plane or release and sliding plane. Similarly, to flexural toppling, the feasibility of block toppling to occur requires the dip direction of intersecting discontinuity systems to occur within approximately 10° to 15° of the slope dip direction. A daylight envelope showing the zone for which block toppling instability mechanism is feasible is presented in Figure 44.
