Iluka Resources Limited

Wimmera Project Baseline Vibration Assessment

April 2019

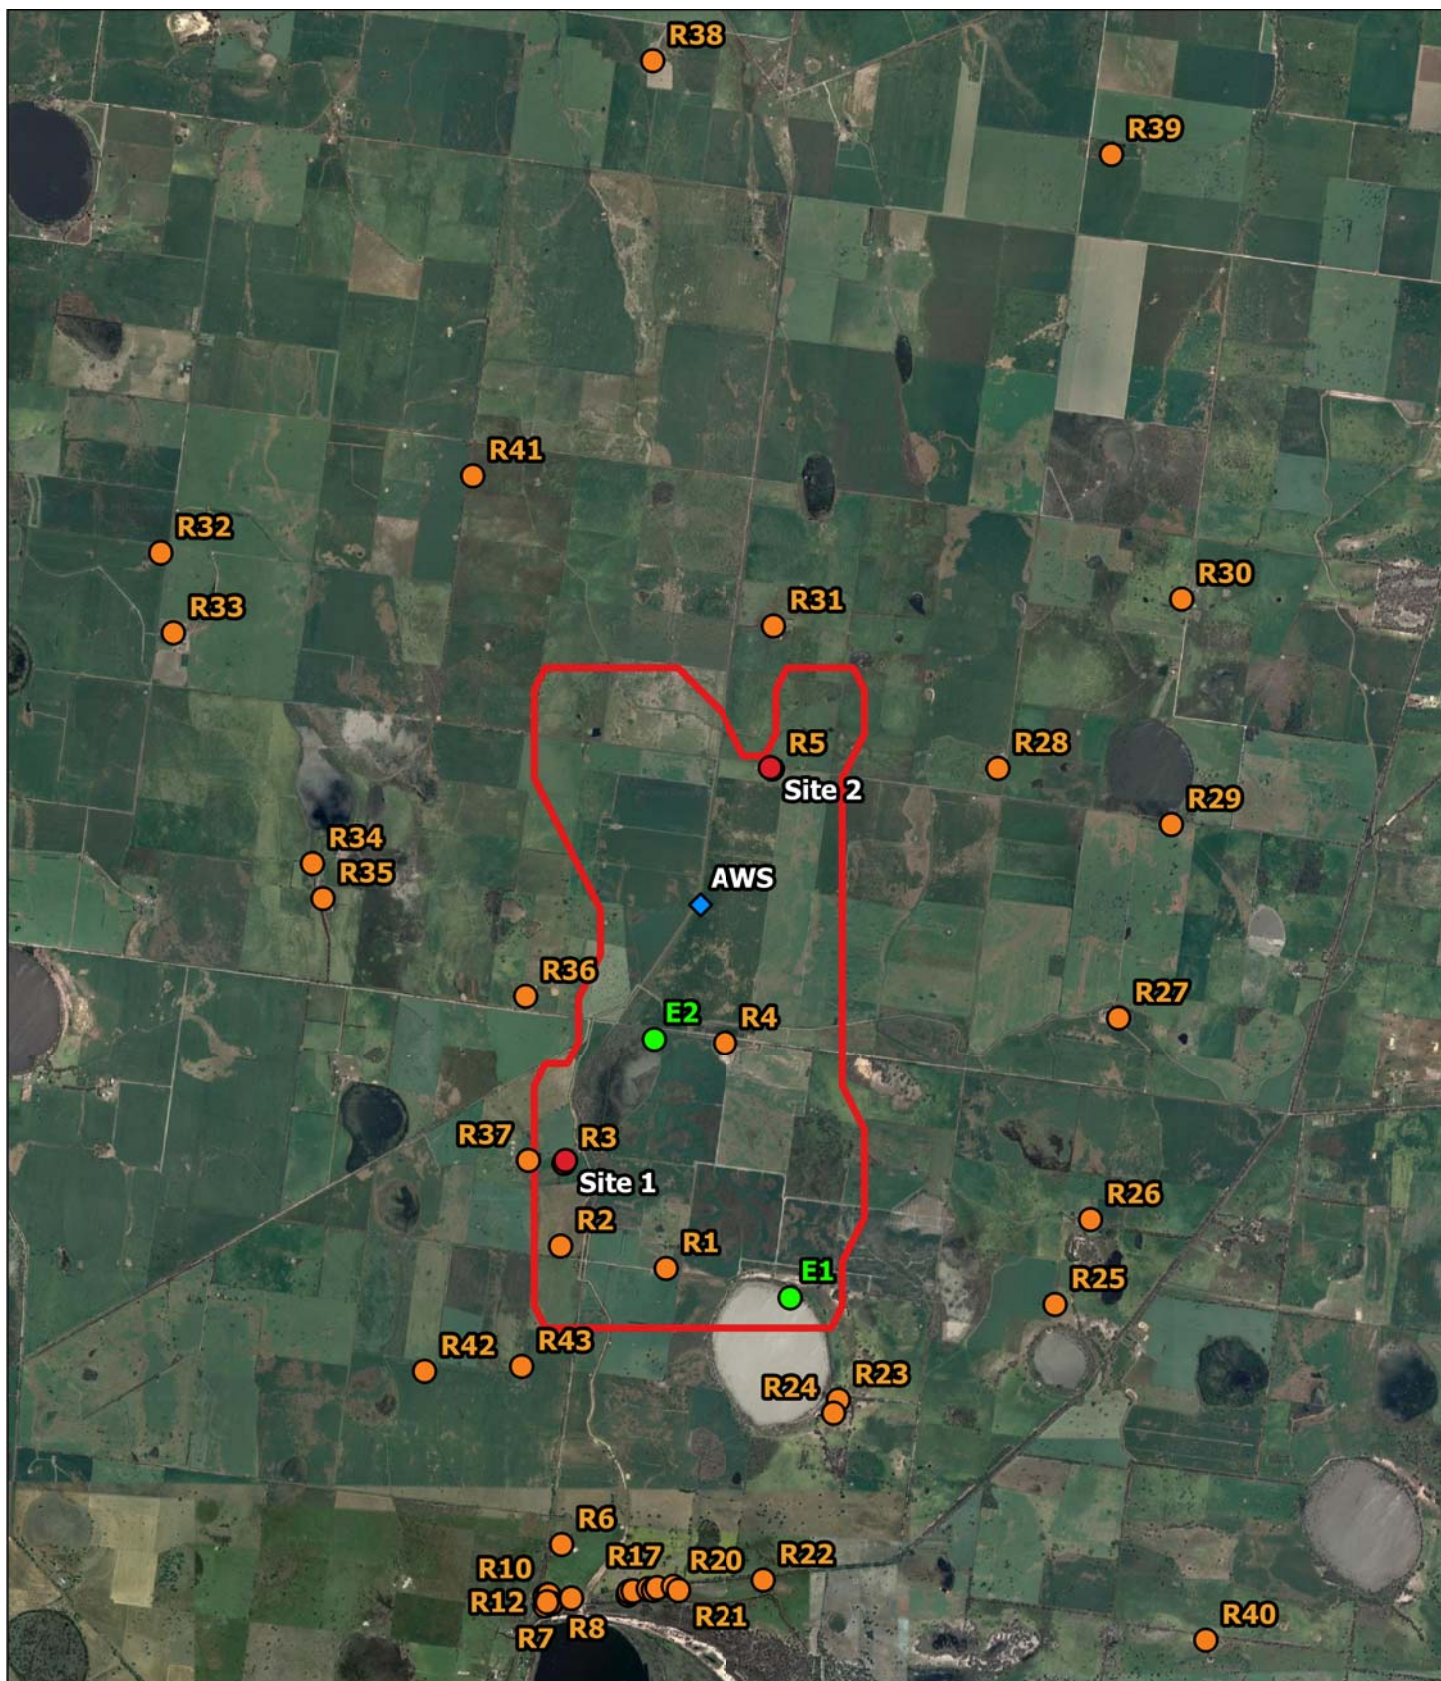
FIGURE 1

Iluka Resources Limited
 WIM100
 Baseline Noise Assessment
 Site and identified
 vibration sensitive
 receivers

The Project site is to be located within Clear Land and will be surrounded mainly by farming land, with some residential premises located nearby. The Project site is located on land zoned as Farming Zone (FZ), Public Conservation, and Resource Zone. The Indicative Project Extent with respect to the surrounding land uses are shown in Figure 1. The mine layout and footprint will be determined during the Pre-feasibility Study (PFS).

Relevant vibration sensitive receivers at various distances are identified in Table 1 and shown in Figure 1. Vibration sensitive receivers are typically considered as follows:

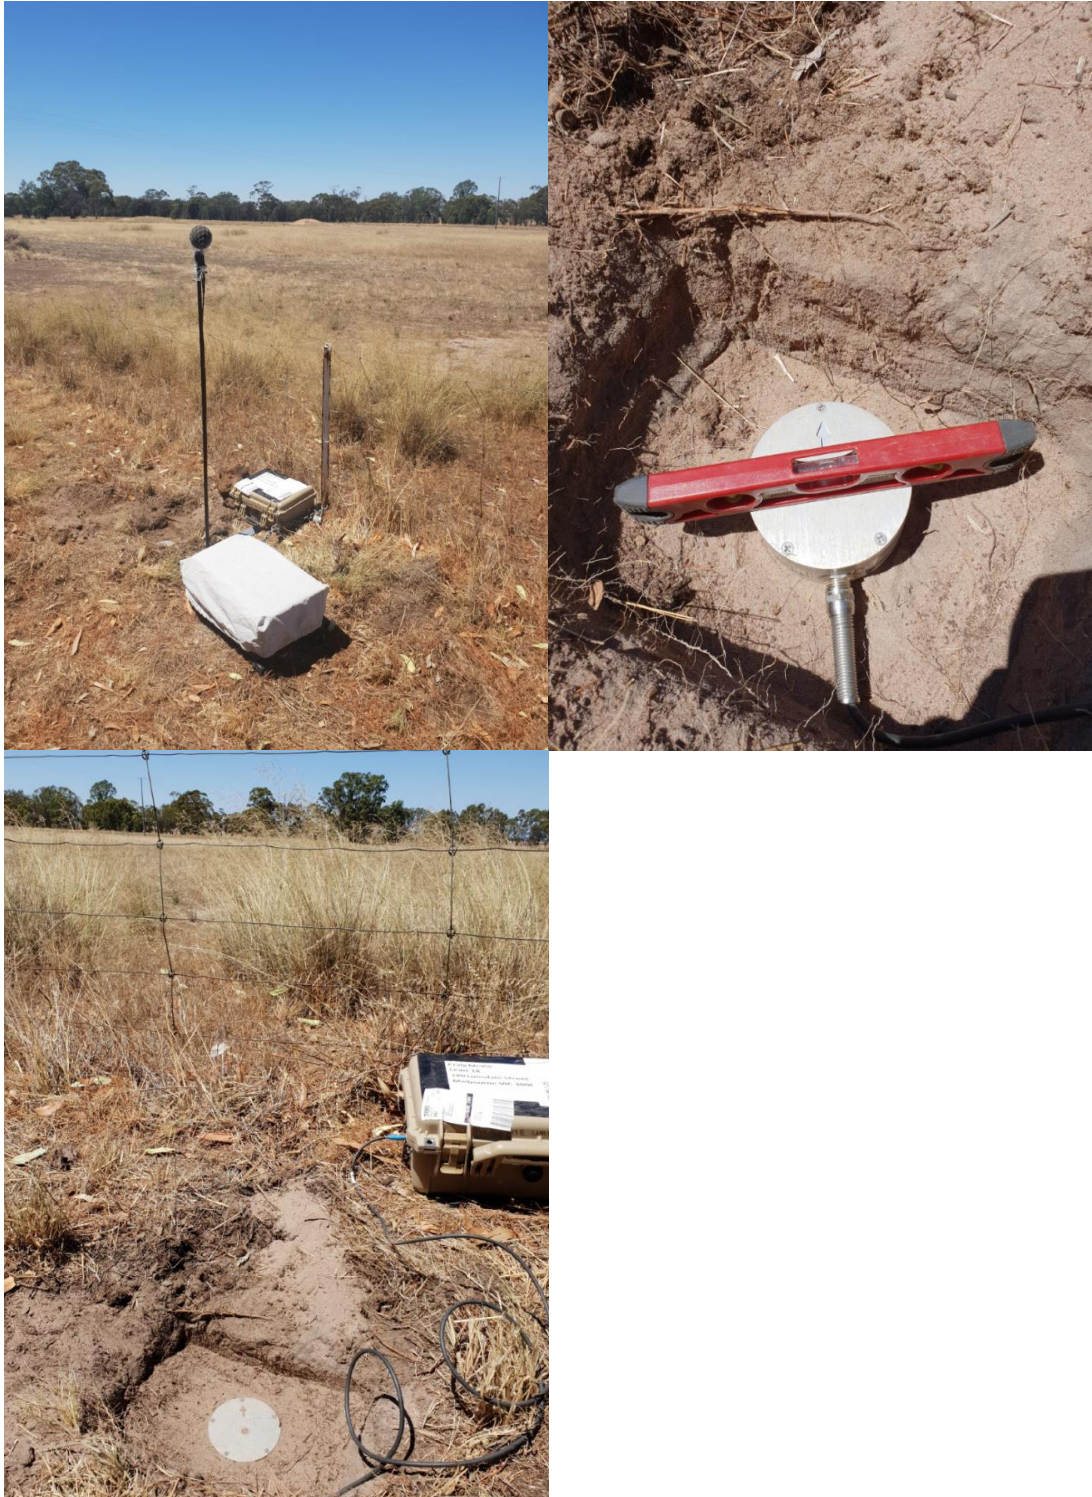
Site 1 - Residence located off Natimuk-Hamilton-Natimuk Road

Peak Particle Velocity (PPV) vibration levels were measured in 10 second intervals and in tri-axial directions (i.e. longitudinal, transverse and vertical) at each monitoring location. The geophones were mounted 10 cm below ground level using ground spikes to set the sensor firmly into the ground. The area around the geophone was then backfilled and lightly compacted allowing for good coupling of the vibration geophone with the ground as shown in figures in Appendix A.

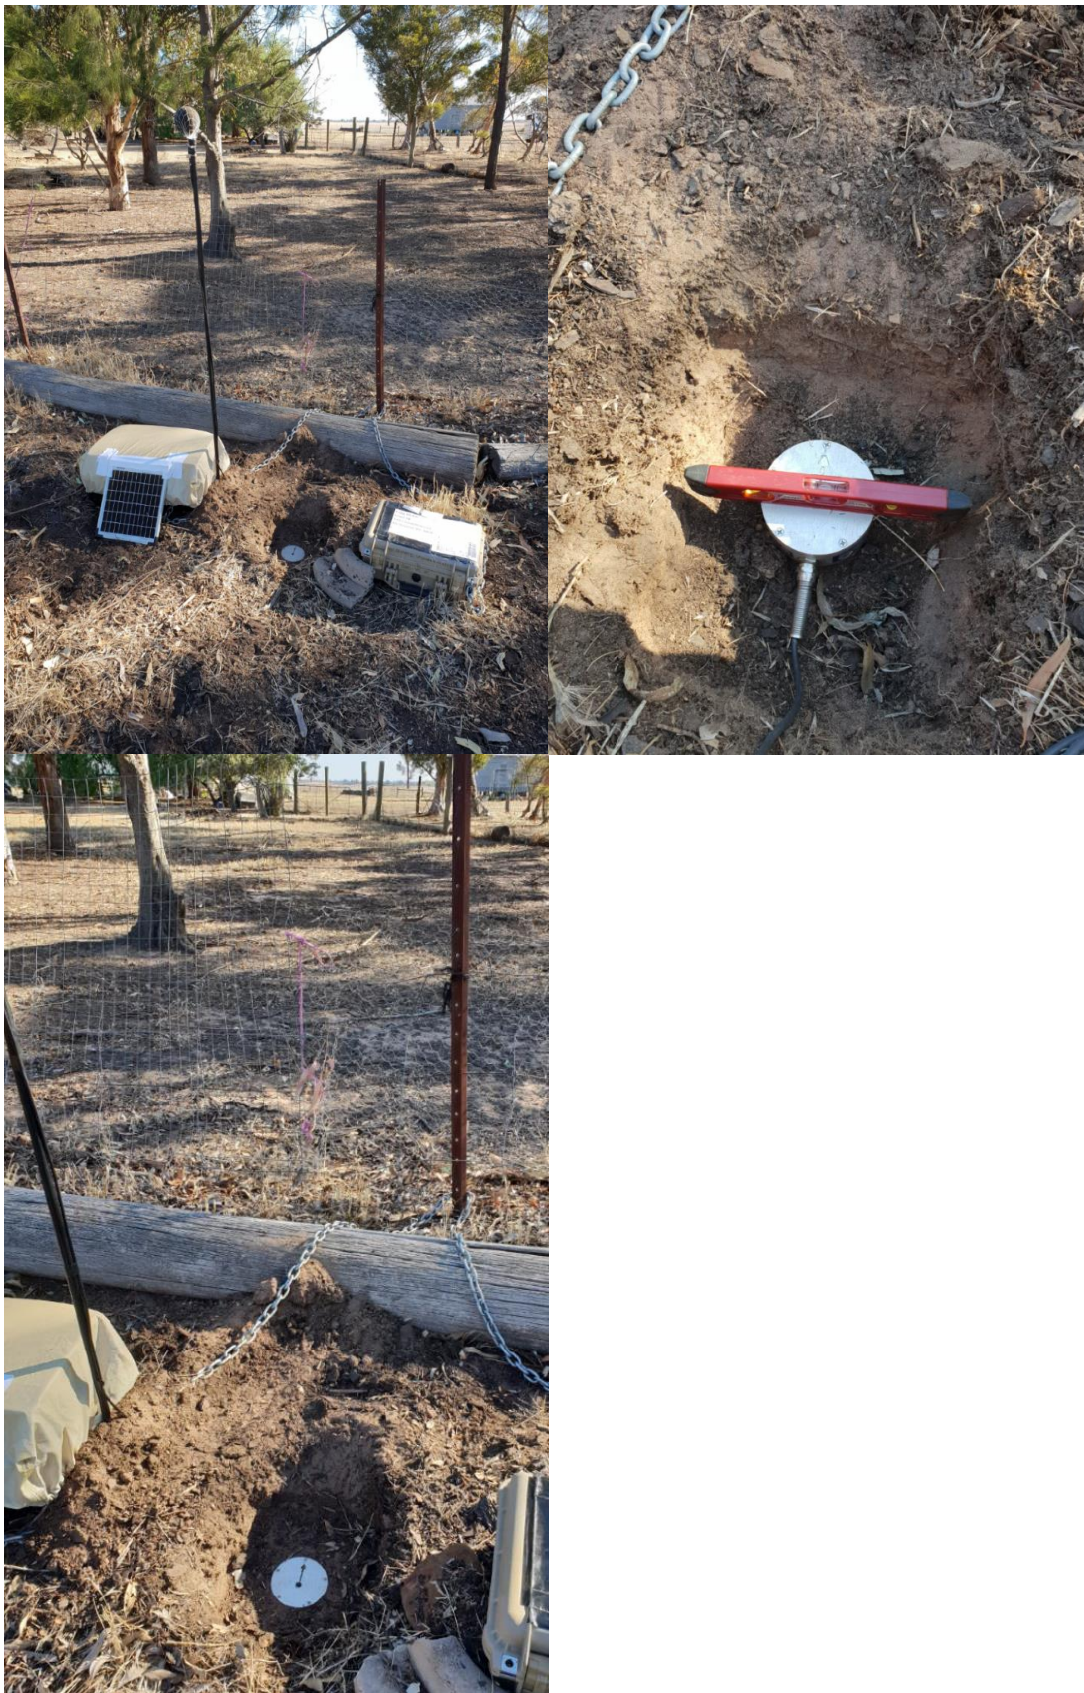
Site 2 - Residence located at 66 Nurrabiel Church Road

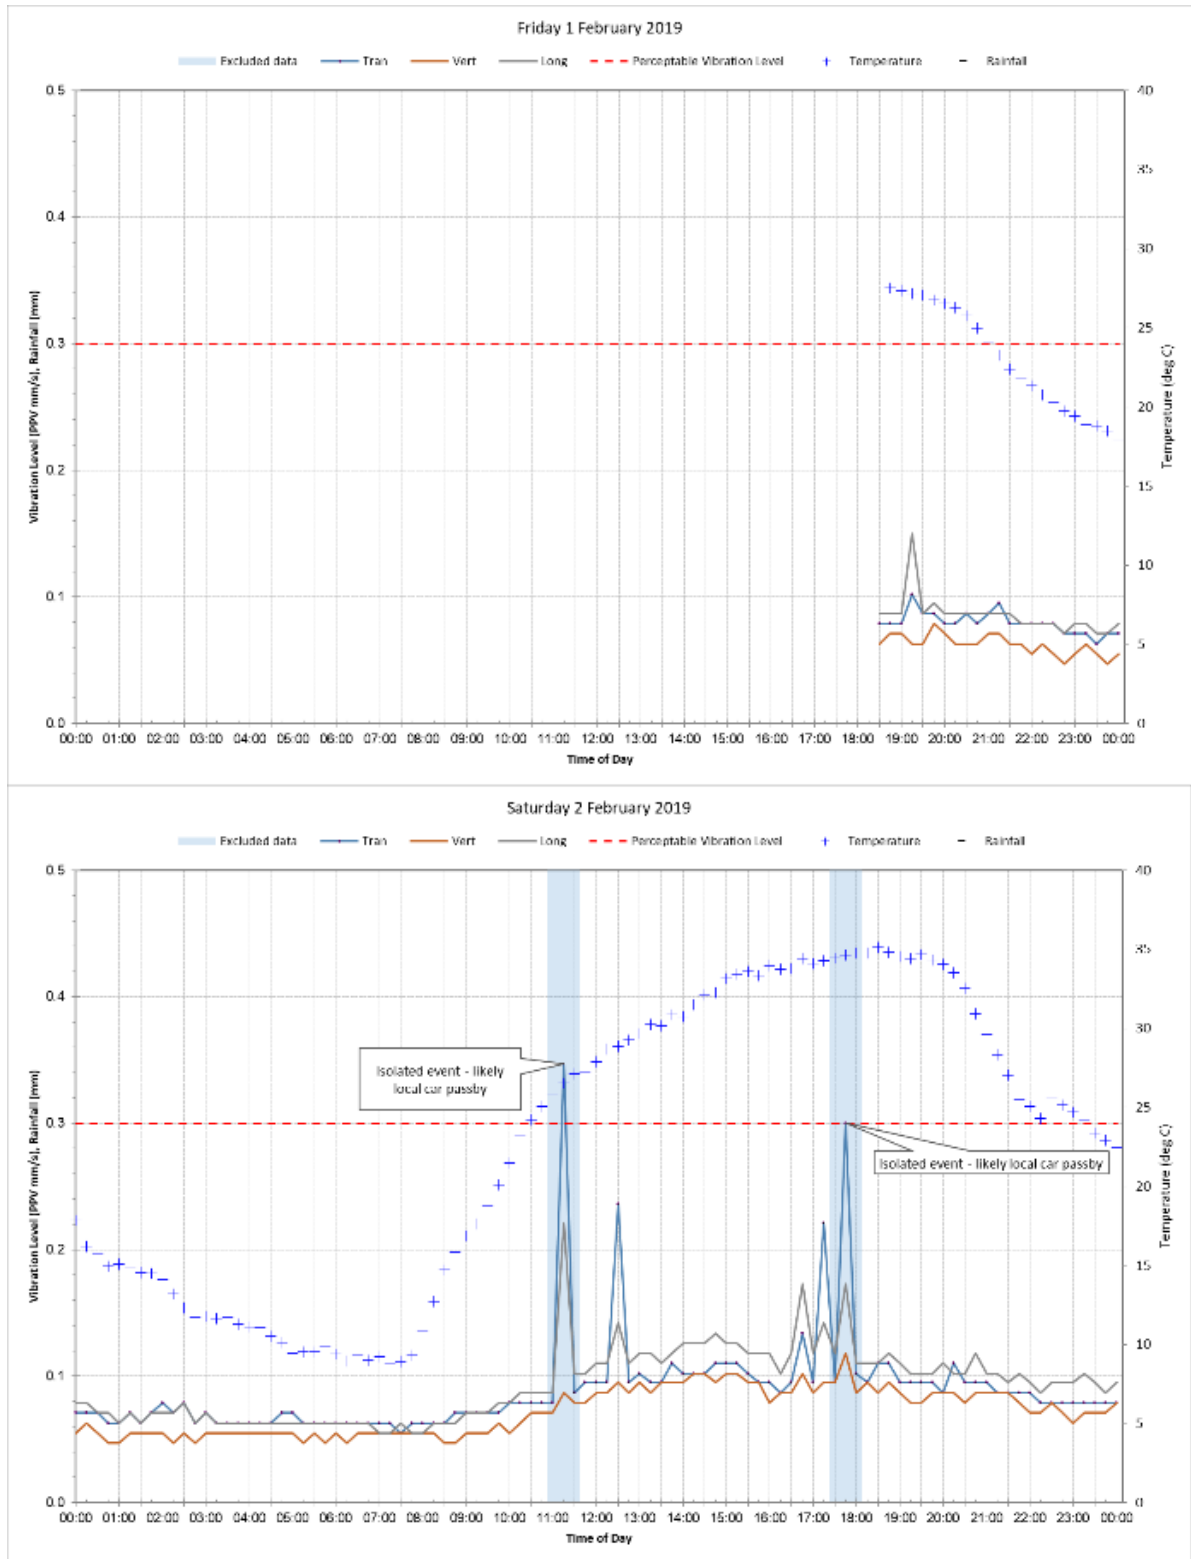
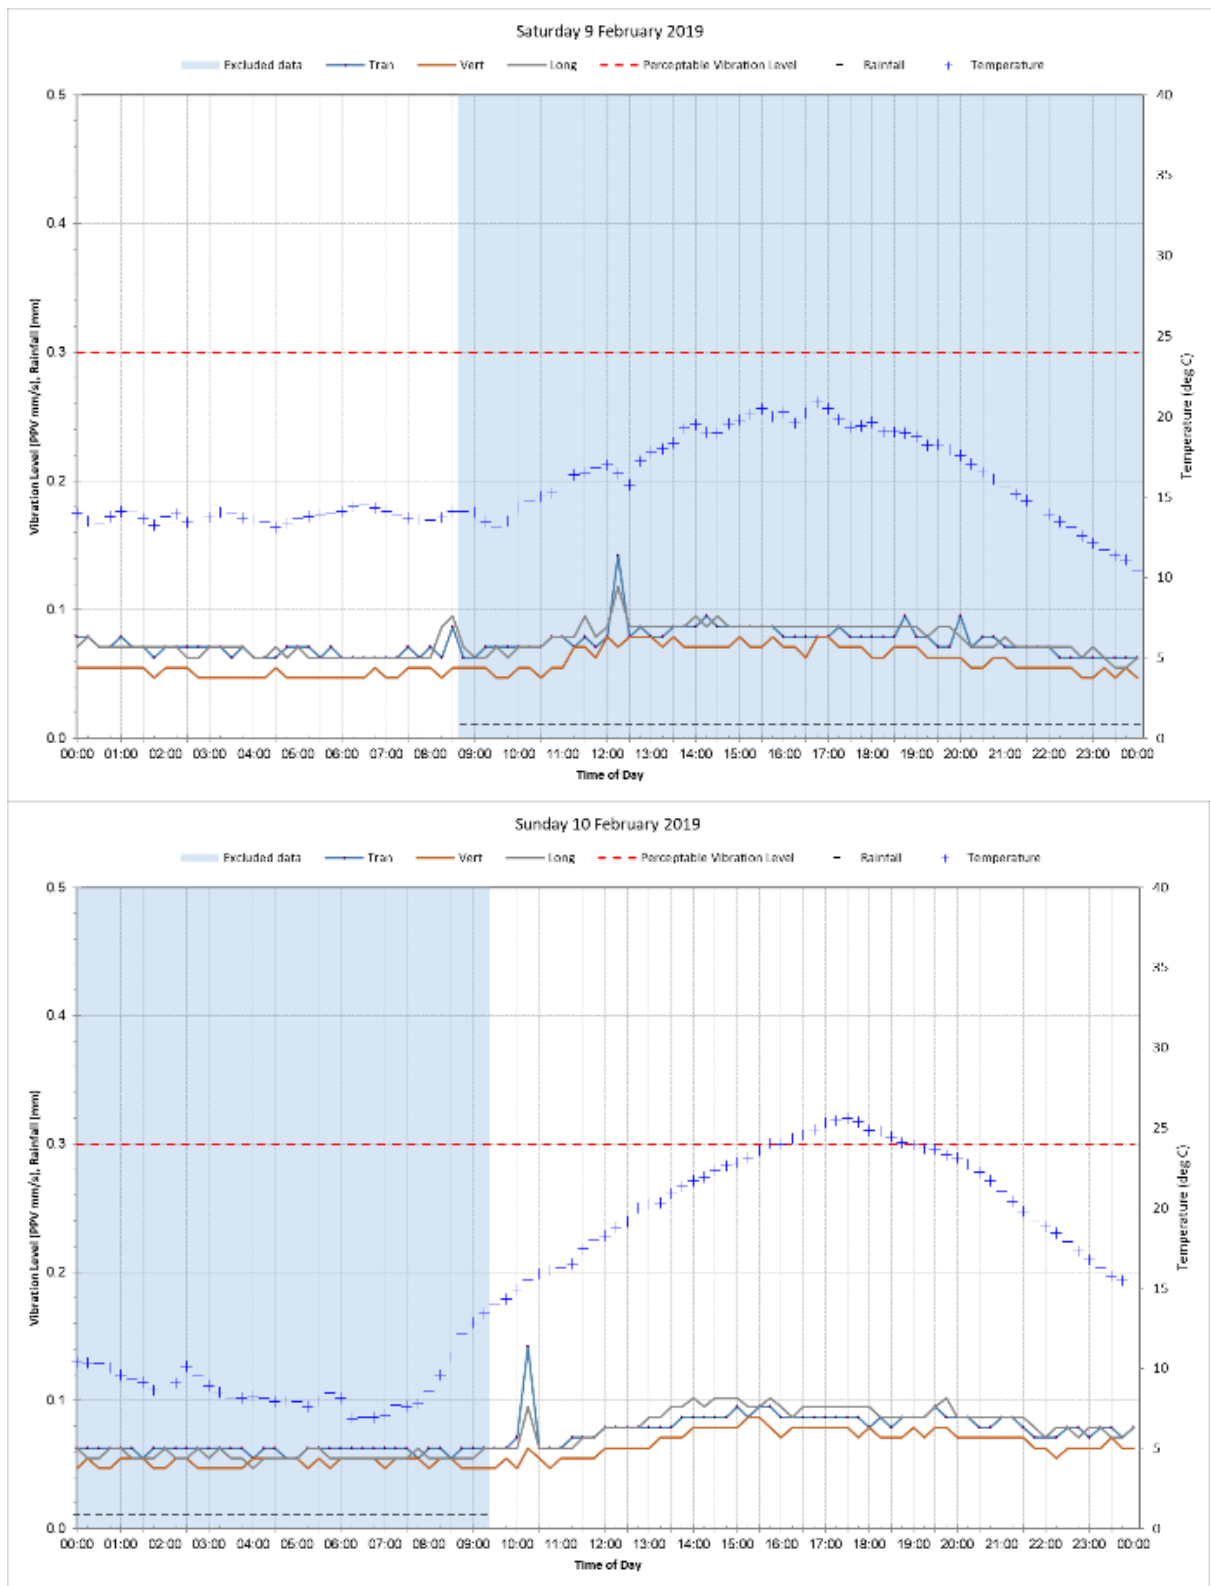
The baseline vibration levels measured at monitoring locations are summarised in Appendix B and Table 8. The data in Appendix B represent maximum Peak Particle Velocities (PPVs) during 15 min periods. The measured short term vibration levels were analysed and seven isolated events were identified across two sites as extraneous (non-background) vibration which were excluded from the analysis of results. These periods are highlighted in the vibration result graphs presented in Appendix B.

Statistical Descriptor	Highest of tri-axial PPV vibration levels mm/s	
	Site 1	Site 2
Maximum ambient	0.221 mm/s (221 µm/s)	0.292 mm/s (292 µm/s)
90 th percentile (level exceeded 10 % of the time)	0.150 mm/s (150 µm/s)	0.118 mm/s (118 µm/s)
Average	0.102 mm/s (102 µm/s)	0.085 mm/s (85 µm/s)
10 th percentile (level exceeded 90 % of the time)	0.063 mm/s (63 µm/s)	0.063 mm/s (63 µm/s)
Minimum	0.047 mm/s (47 µm/s)	0.047 mm/s (47 µm/s)
