Warburton Mountain Bike Trails: Historic Survey Report

DRAFT REPORT

Prepared for: Yarra Ranges Shire

Date: 11 November 2019

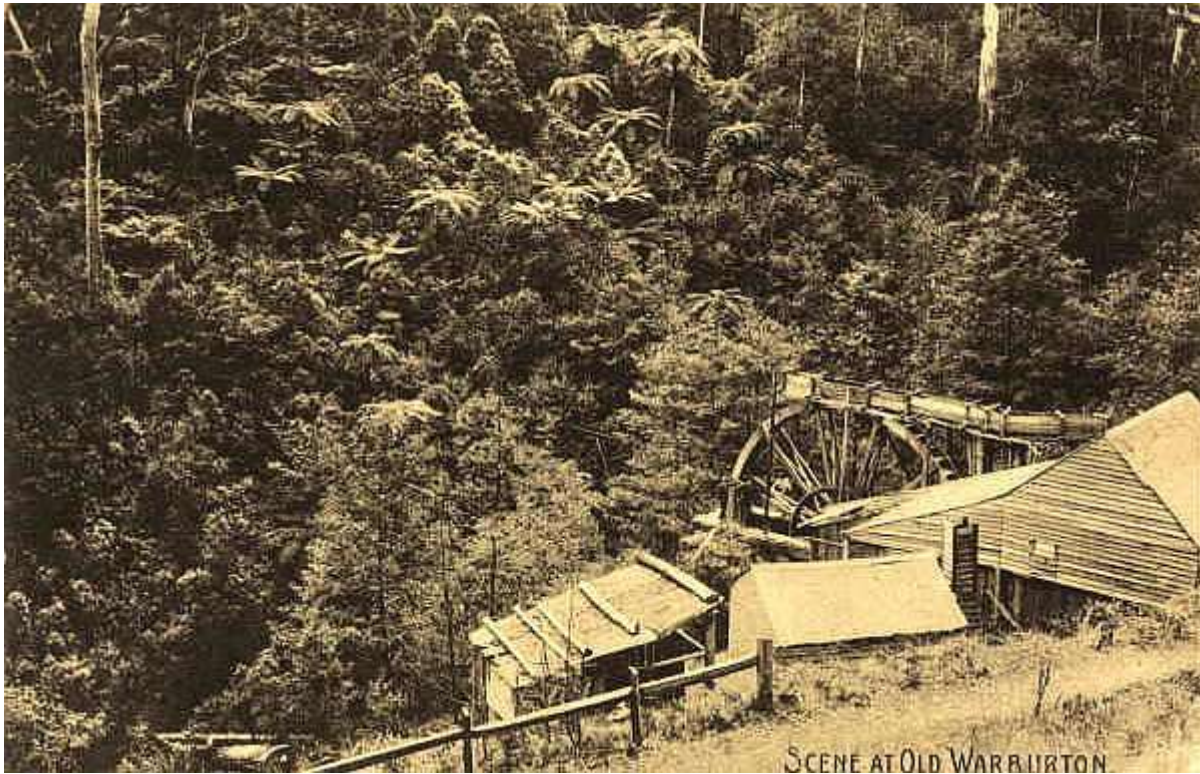
In 1870 a waterwheel was built at Warburton to drive a battery to crush gold bearing rock. This was located at the Shining Star mine near Mount Little Joe, one of the few reef mines (Parkinson, 2017). Walter Fisher a master carpenter from Walhalla, was commissioned to build a large over-shot wheel to drive a crushing battery. A water race was constructed around the hillside to deliver water from the upper section of Big Pat's creek to supplement the water from Yankee Jim's creek. On completion of the project the wheel was "christened" with a bottle of whisky and set in operation (Geof, 2019); (The Water Wheel Gold Crusher Mill at Old Warburton, 1904).

Plate 1 Watermill and house at Old Warburton, 1904

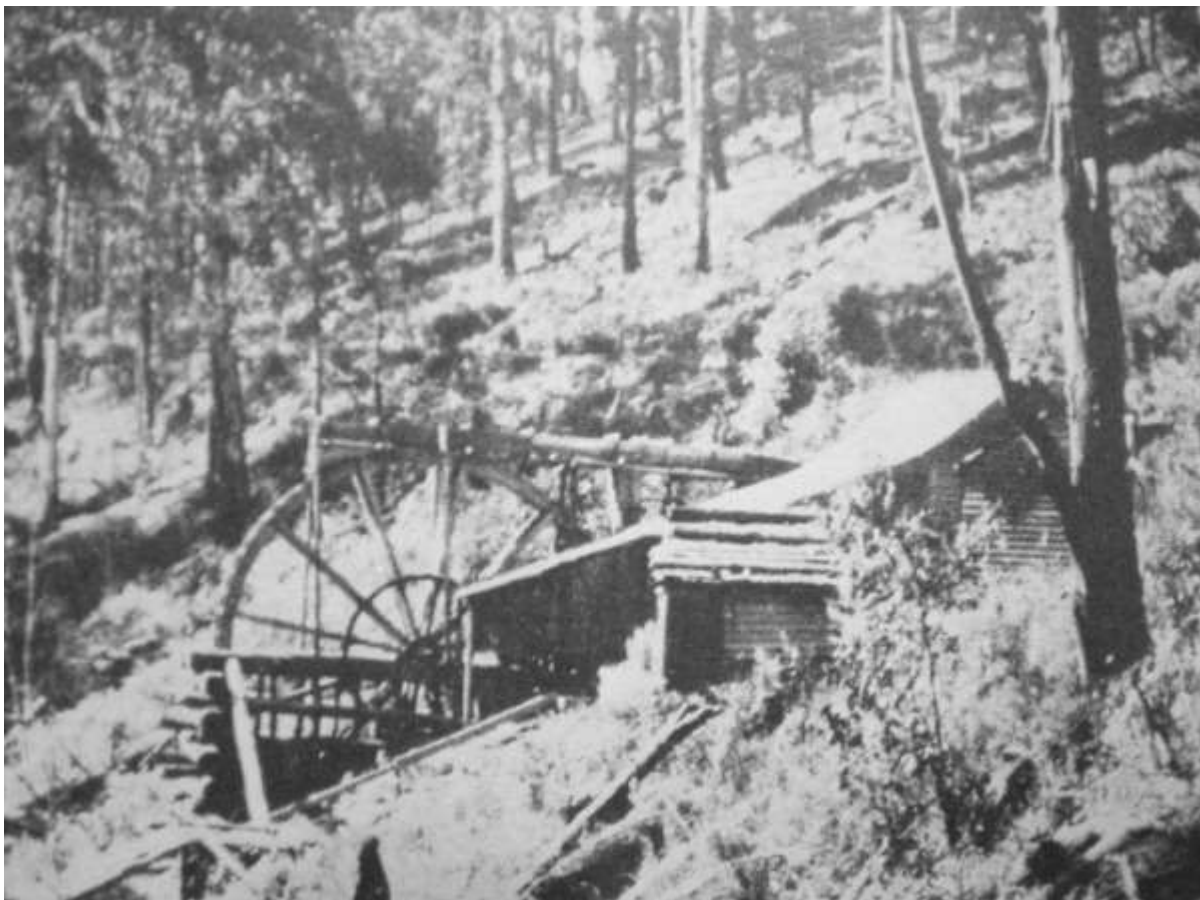
Plate 2 Shining Star mine water wheel

The creek bank in the Old Warburton area is heavily eroded, and deeply incised. Vegetation on the banks is very dense. No clear evidence of the mine or crushing plant was noted during the survey, although uneven ground with pits and mounds could be seen in most of the alluvial areas.

A geocaching site was established in the area, with concrete foundations noted, which were described as remnants of the Shining star mine. However, it is unclear if this actually depicts structures on Yankee Jim Creek.

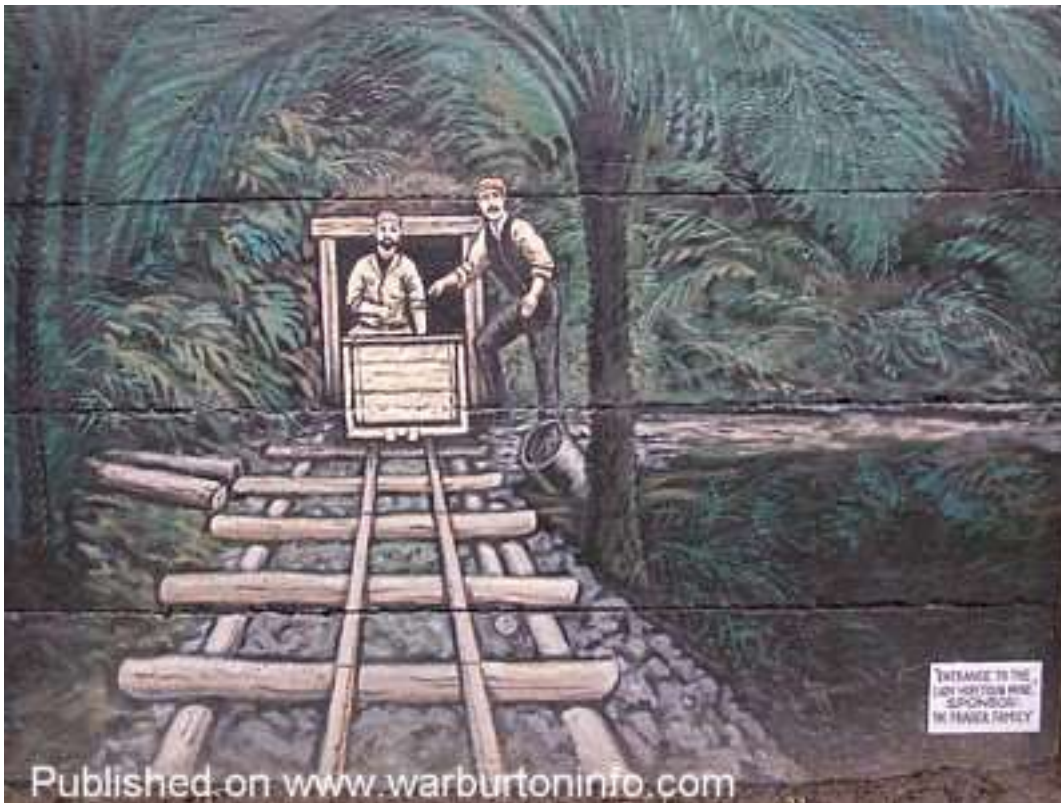
The Lady Hopetoun Mine was established in about 1889, when W Wye found gold at the head of Scotchman's Creek and formed a small company called the Lady Hopetoun gold Mining Company which was managed by Mr W Murphy. They initially drove a tunnel into the hill side and flowed this with another 75 feet lower down, and erected a 10 head battery, which was run by water from the 'old water race' which they cleaned out.¹ The mine had to cut through granite boulders to reach the dyke 5 feet wide, while the cost of the race was put at £10,000. However, in October 1890 the shareholders met to consider winding the company up.²

Plate 6 Lady Hopetoun Mine (Station Mural from photograph)

Plate 28 Looking towards collapsed adit at Lady Hopetoun Mine (compare with Plate 6)

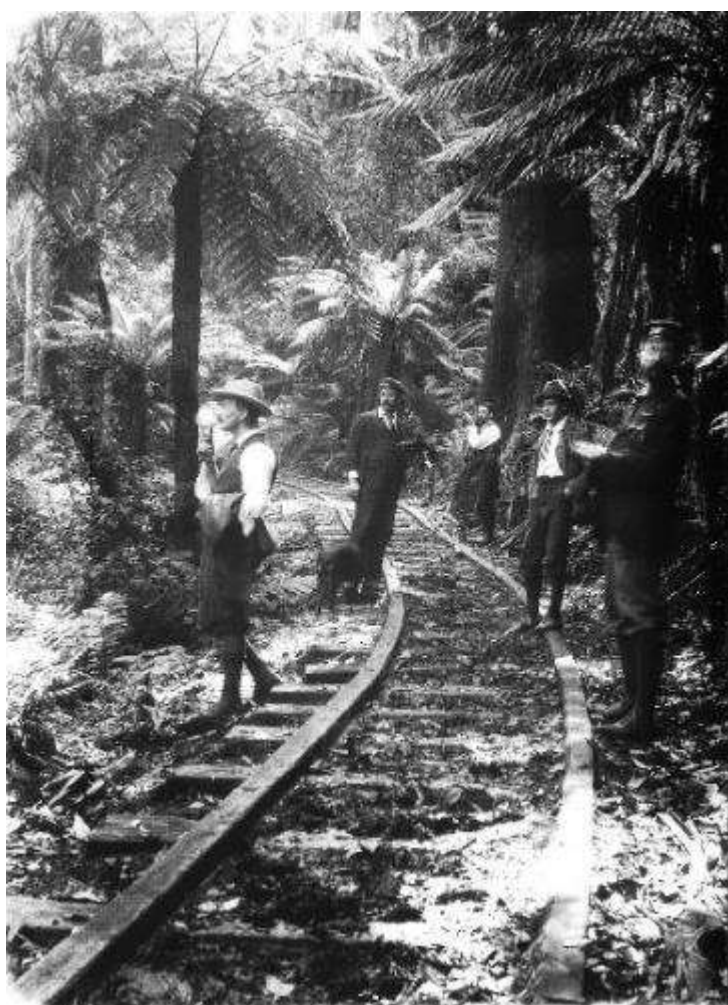
In 1901 the railway line was extended to Warburton that helped strengthen the growing timber industry. Sawmills and timber tramways were constructed throughout the area that fed to the train line that supplied timber to Melbourne. These narrow gauge lines (Plate 10) were called tramways due to an Act of Parliament preventing anyone other than the government from operating train lines (Parkinson, 2017). The main tramways were located from Mount Bride, in Yankee Jim's Creek Gully, and along Britannia Creek that carried timber to Wesburn. The rail line to Warburton ceased operations in 1965 and is now the Warburton Rail Trail.

Plate 10 Timber tramway along Yankee Jim Creek (Padula B. , 2018)

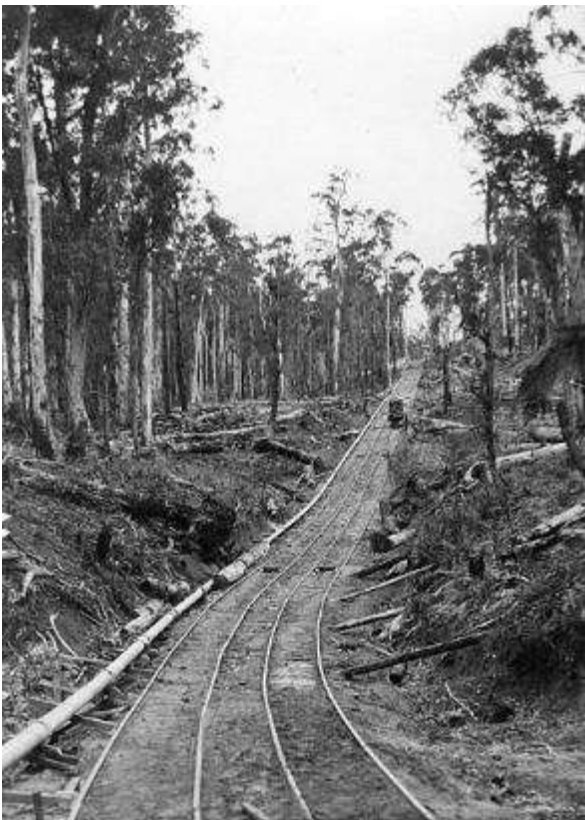
Steam and diesel engines were used to power the sawmills and haul the logs. In some cases the logs were lifted by cable and pulley high above the ground to transport them to the tramways, where narrow gauge engines hauled them to mills and railheads. In more remote areas, horses were used to pull empty bogies up graded tines. When loaded, the logs would run downhill under the control of braking systems. The mills provided work for all who wanted it and towns (such as Powelltown) sprang up around the mills. Some of the timber tramways still remain open to walkers but chainsaws, bulldozers and timber jinkers replace the old method of getting timber.

Plate 11 Cable hauled incline tramway Warburton 1907 (Padula B. , 2018)

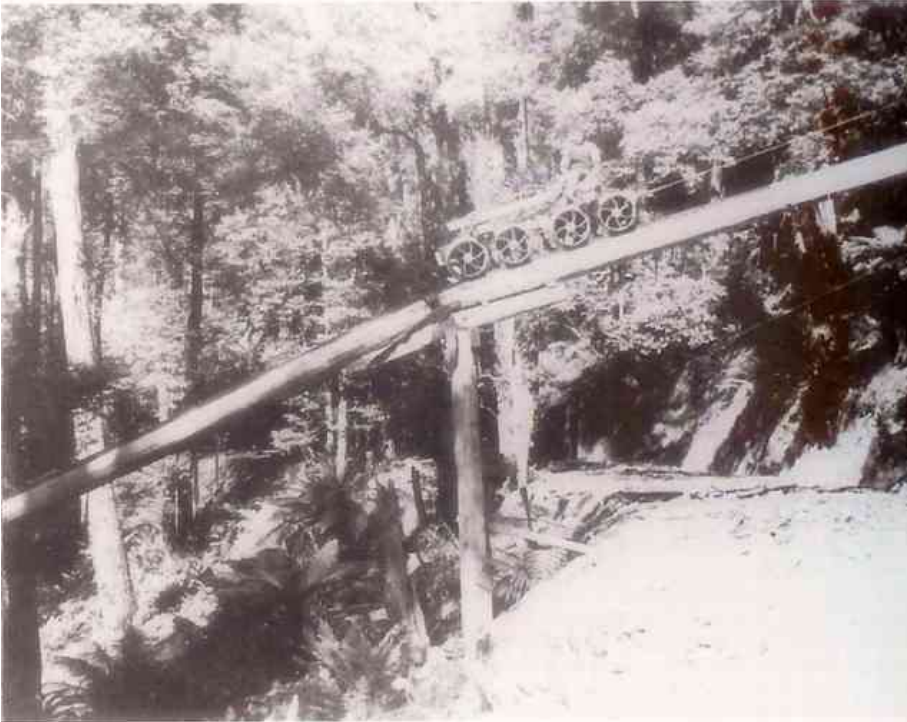
Plate 12 Ben Cairn incline crossing Mt Baw Baw road.

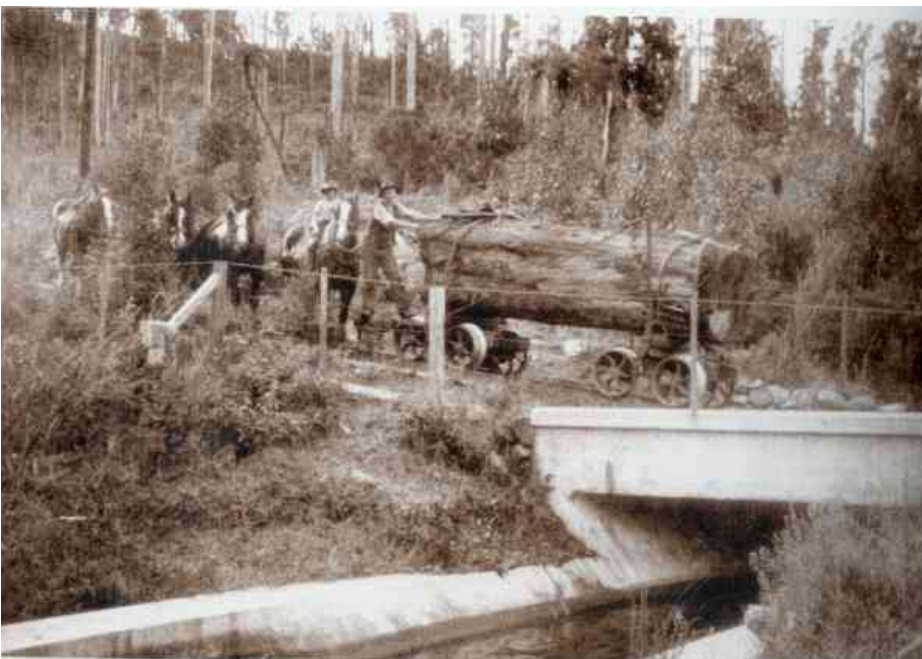
Plate 13 Timbert tramway crossing over O'Shannassy Aqueduct (Padula B. , 2018)

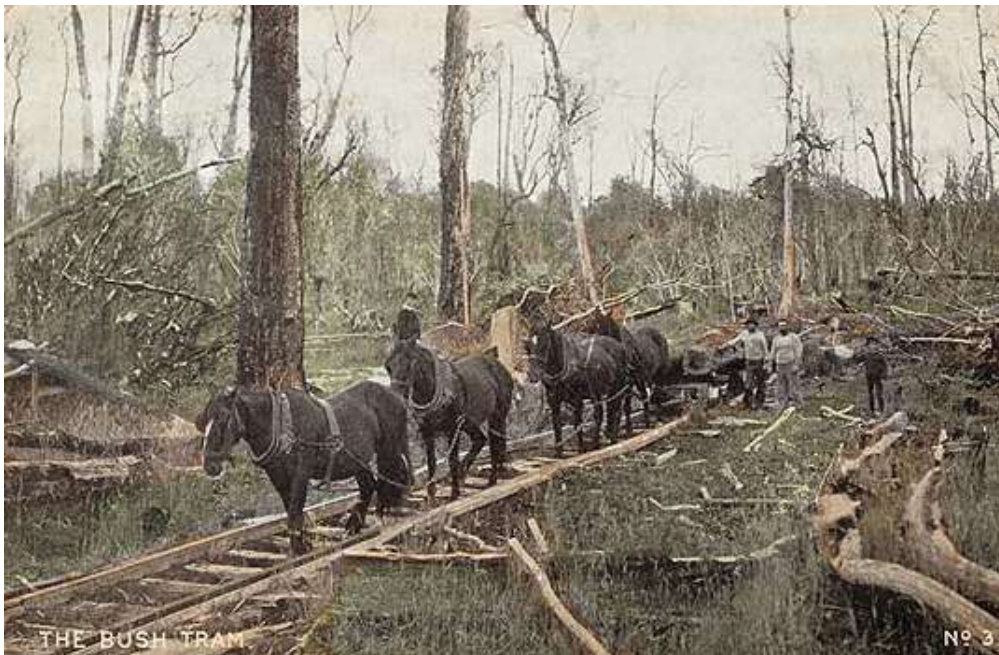
Located within the present day Warburton was the Anderson Sawmill, which was in operation from 1901 to 1905 and then taken over by a Mr Parbury in 1905, and became the Brookfield Sawmill. Timber from the mill were transported by tramway over the Yarra in order to meet the railway. The mill was built on the north side of the Yarra River, situated near the bottom of the present day Warburton Golf Course and nearby the part of the study area. Logs were delivered to the mill from the near the summit of Mount Donna Buang, crossing a concrete bridge spanning the O'Shannassy Aqueduct (discussed below). The tramway was dismantled in 1929, following the closure of the mill in 1928, but may have been reconstructed for Horner's Mill at the top of the line in the 1930s. (Padula B. , 2018).

Plate 14 Anderson's Mill bush tram, 1906 (Padula B. , 2018)

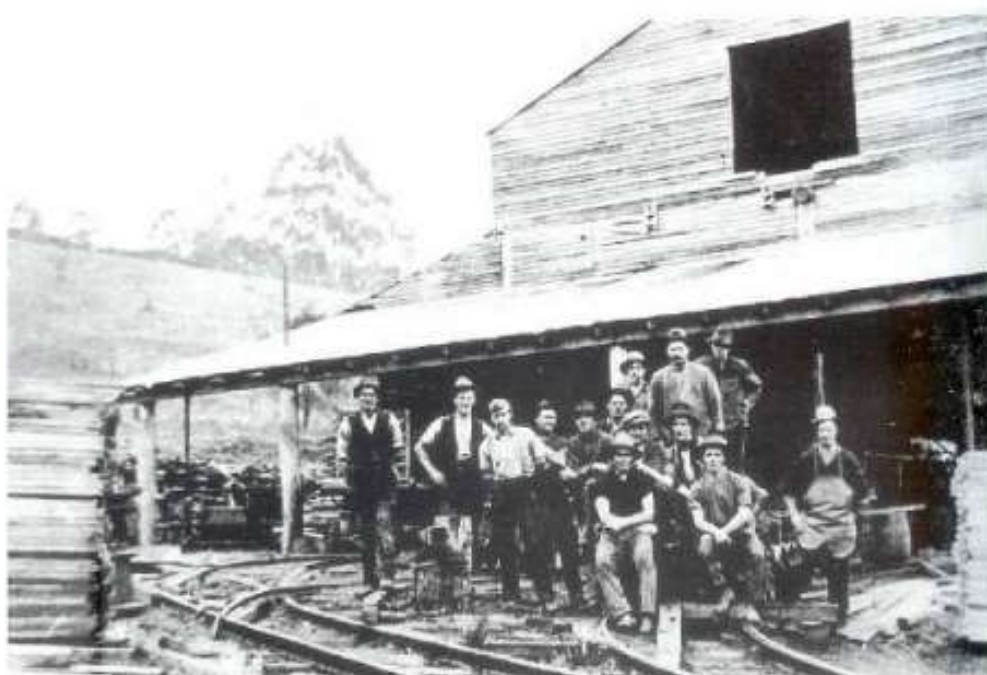
Plate 15 Parbury's Brookfield Mill, 1922 (Padula B. , 2018)

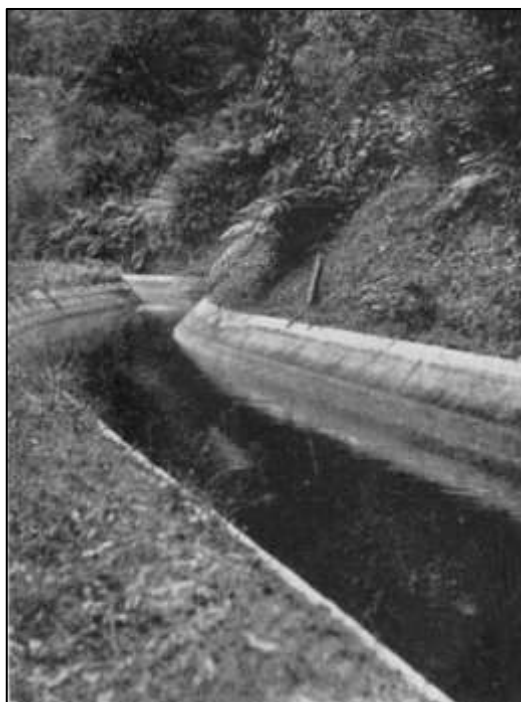
The aqueduct was to carry water from the O'Shannassy Reservoir in the Yarra Ranges to the Silvan Dam holding Reservoir in Silvan (Plate 16). The aqueduct consisted of 37 kilometres of open or covered concrete channels with three tunnels and 40 kilometres of steel pipes and delivered 20 million gallons of water daily (Rithie, 1934) (Plate 17). Many of the logging trails and tramways intersected the aqueduct where concrete bridges with rails were constructed for access to the logging trains and farming properties. The aqueduct was decommissioned in 1997 and is now a walking/cycling trail (Padula B. , 1911 to 1915- The O'Shannassy Aqueduct and Weir, 2017).

Plate 17 The O'Shannassy Aqueduct in Warburton (accession no. H96. 136/17) (Valentine Publishing Co, 1940)

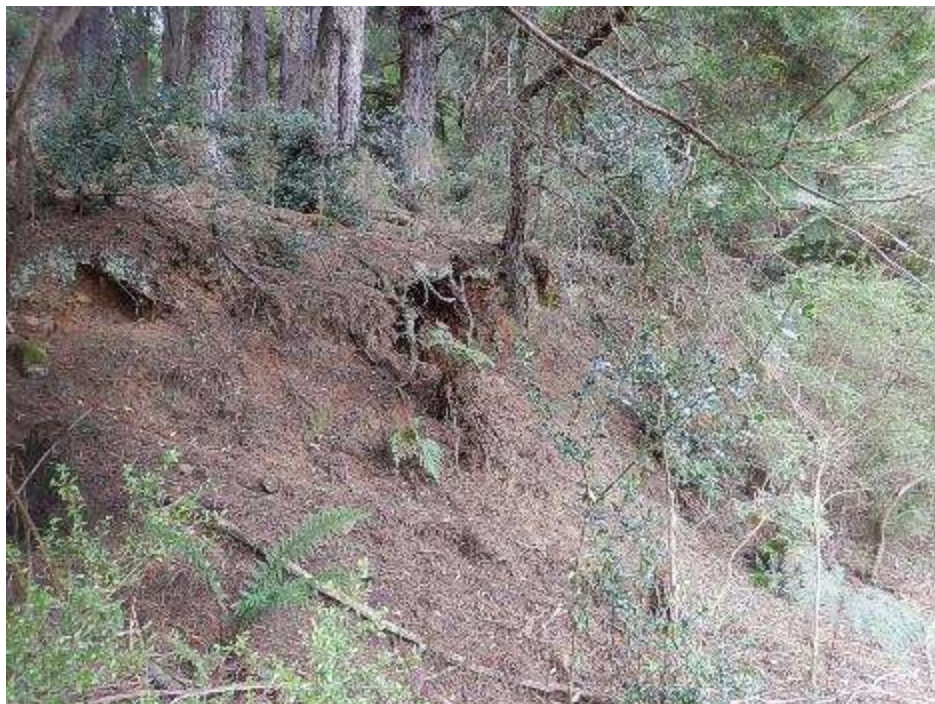
The Yarra Yarra Hydraulic Sluicing Company undertook works in previously mined areas along creeks in the Old Warburton area. One area is included in the Yarra Ranges Heritage Overlay (HO342) which is located near the junction of Old Warburton Road and Mt Bride Road. Evidence of gold working by sluicing methods can be seen, however, along several of the tributary creeks both upstream and downstream of the Heritage Overlay area (Plate 18). One such location is just off the south side of the Old Warburton Road immediately east of the Cemetery reserve (see Plate 19).

Plate 18 Sluced bank on tributary to Yankee Jim Creek (G.Vines 15/01/2019)

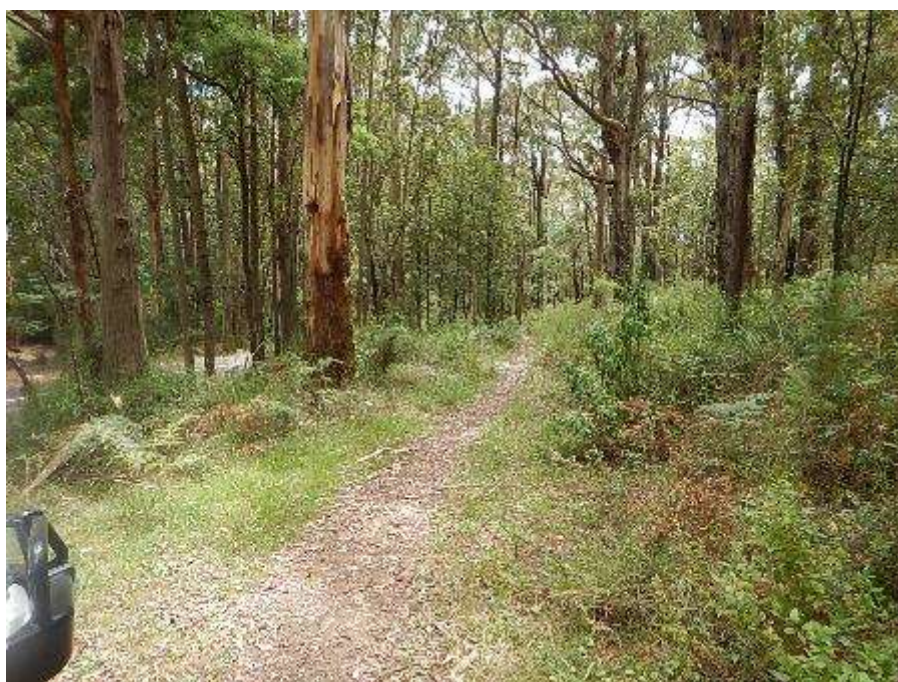
Plate 19 Looking east along water race that leads from Big Pats Creek to the Yankee Jim's Creek sluicing area (G.Vines 15/01/2019)

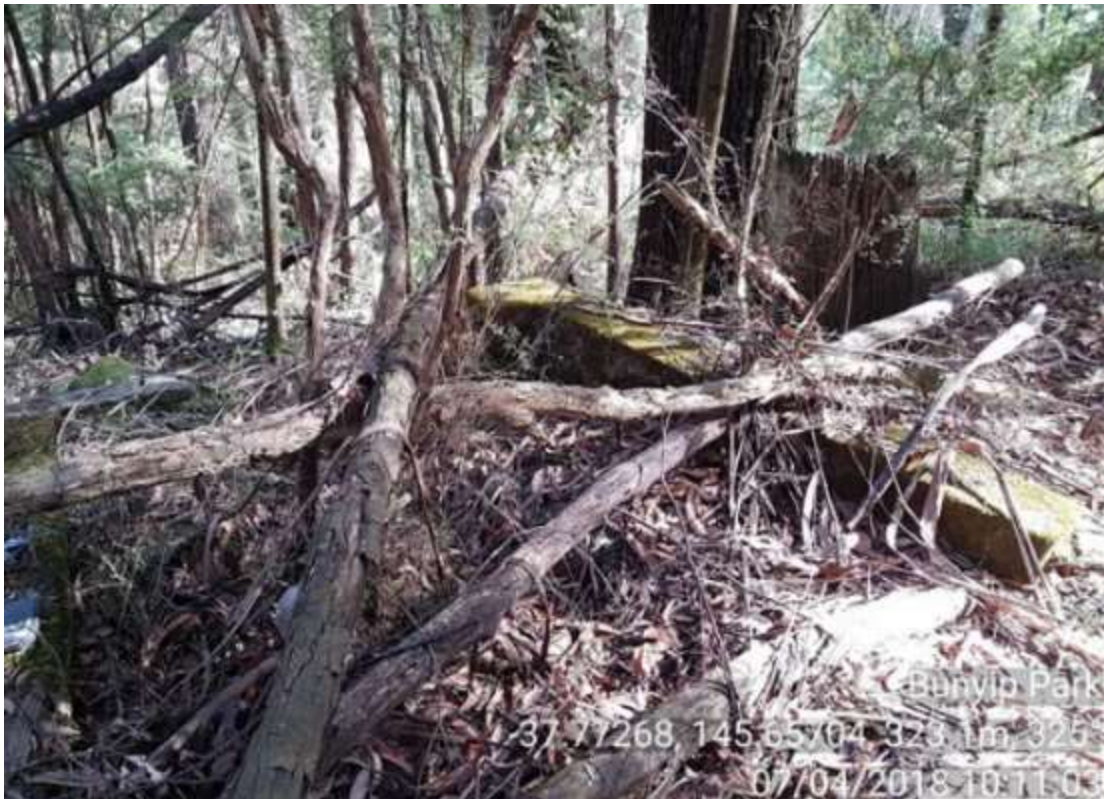
Plate 20 Possible mining remains near Old Warburton (Geof, 2019)

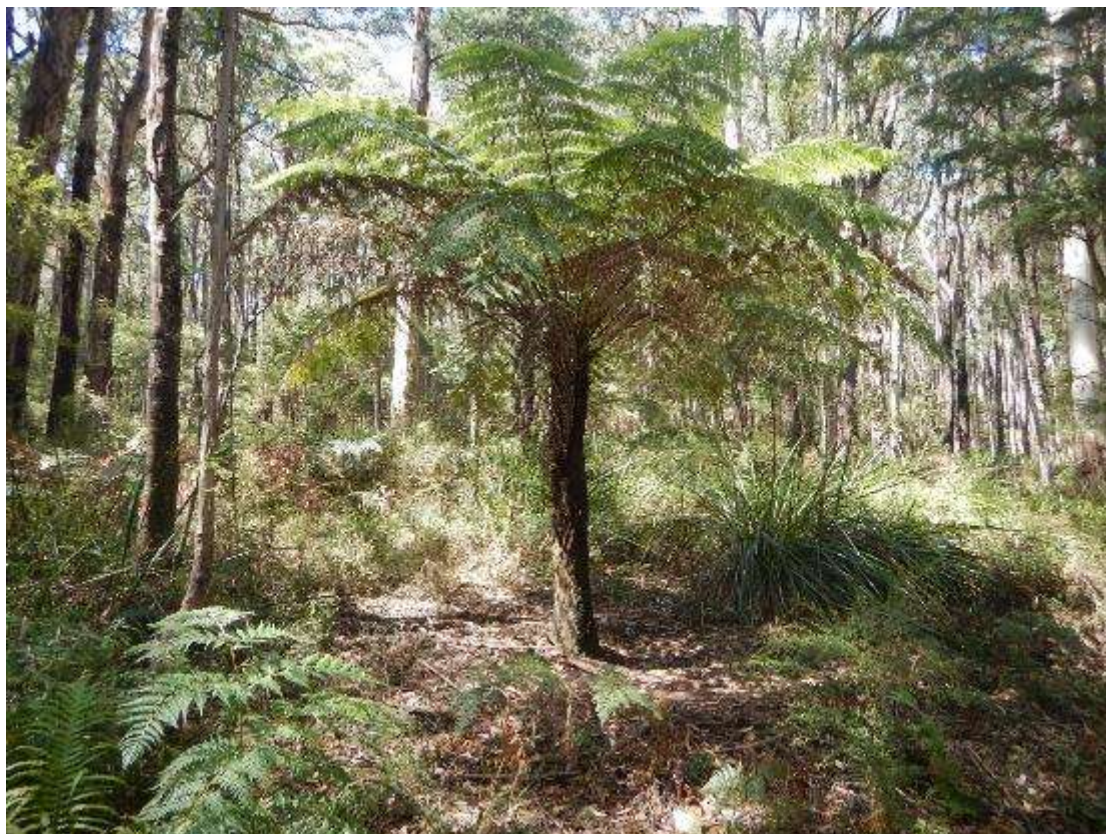
One unusual feature was a large single tree fern growing on an exposed north-west facing ridge some distance from any gully. While isolated tree ferns can be found throughout the forest, they generally occur in the wetter gullies and more sheltered sites. They do, however, tend to colonised artificial depressions such as drains and other excavations, so it is possible this fern has grown on one of the grave sites.

Plate 21 Single isolated tree fern on exposed ridge in the cemetery reserve (G.Vines 15/01/2019)

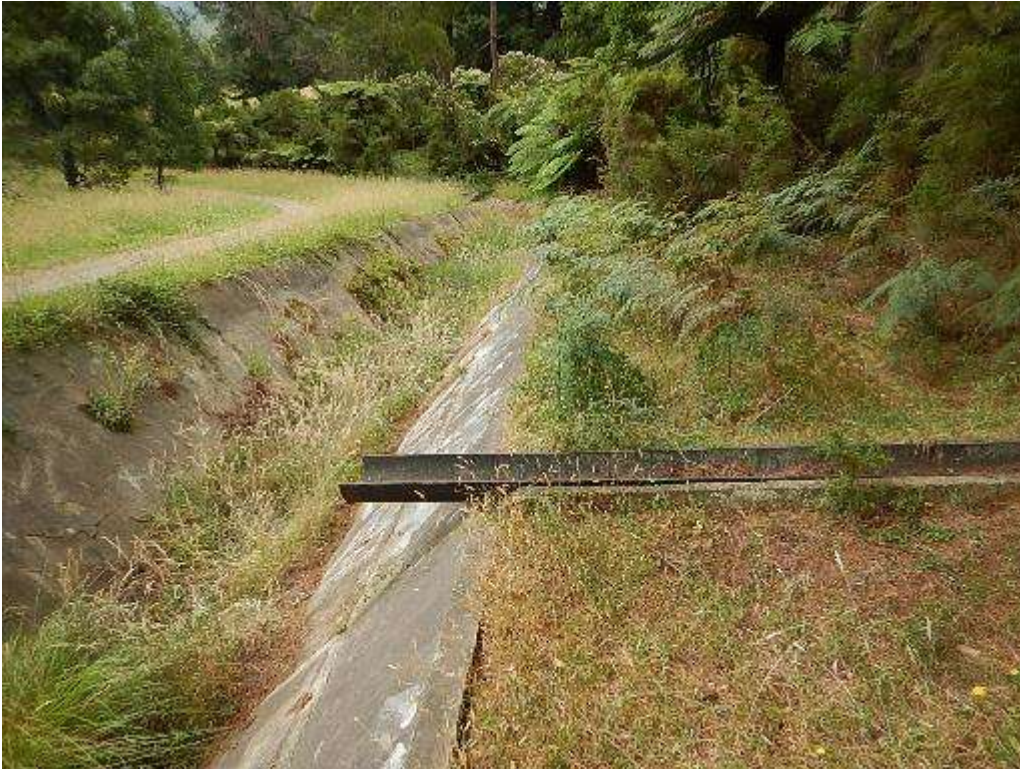
Plate 22 Surface diversion channel at O'Shannassy aqueduct (G.Vines 16/01/2019)

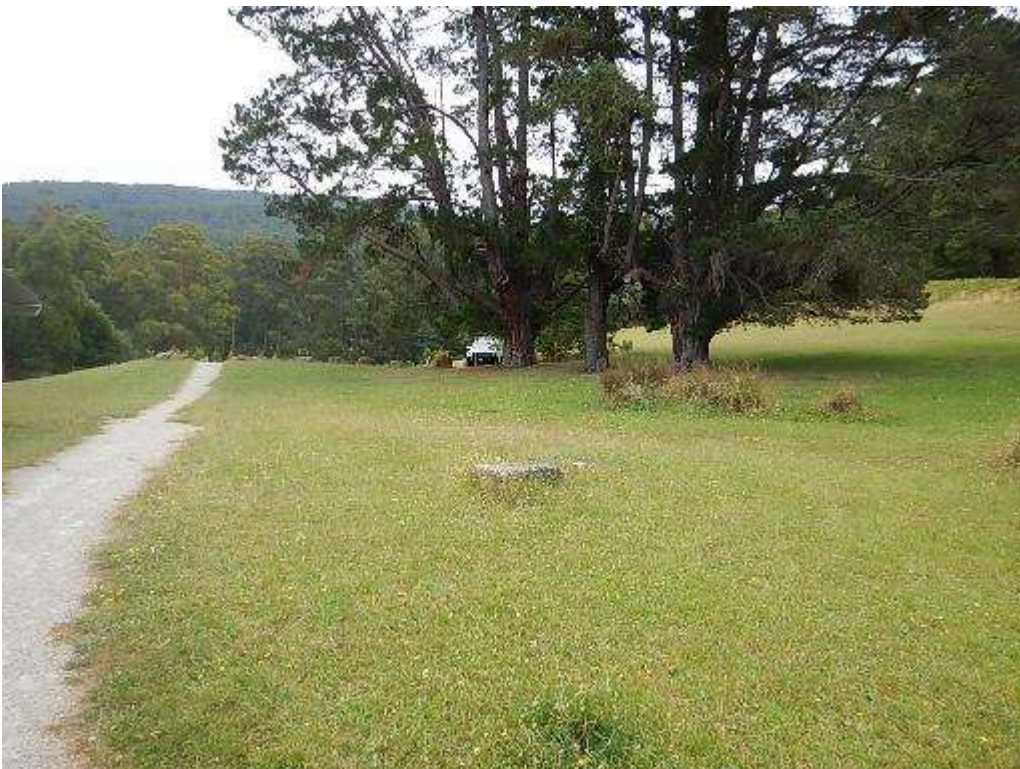
The O'Shannassy trail access carpark at the north end of Dee road appears to be at the site of a former MMBW maintenance camp. This area has a number of levelled benches and large concrete foundations remaining from former buildings. The Henry and Walker tramway can be discerned running across the site.

Plate 23 Concrete block at O'Shannassy Aqueduct car park (G.Vines 16/01/2019)

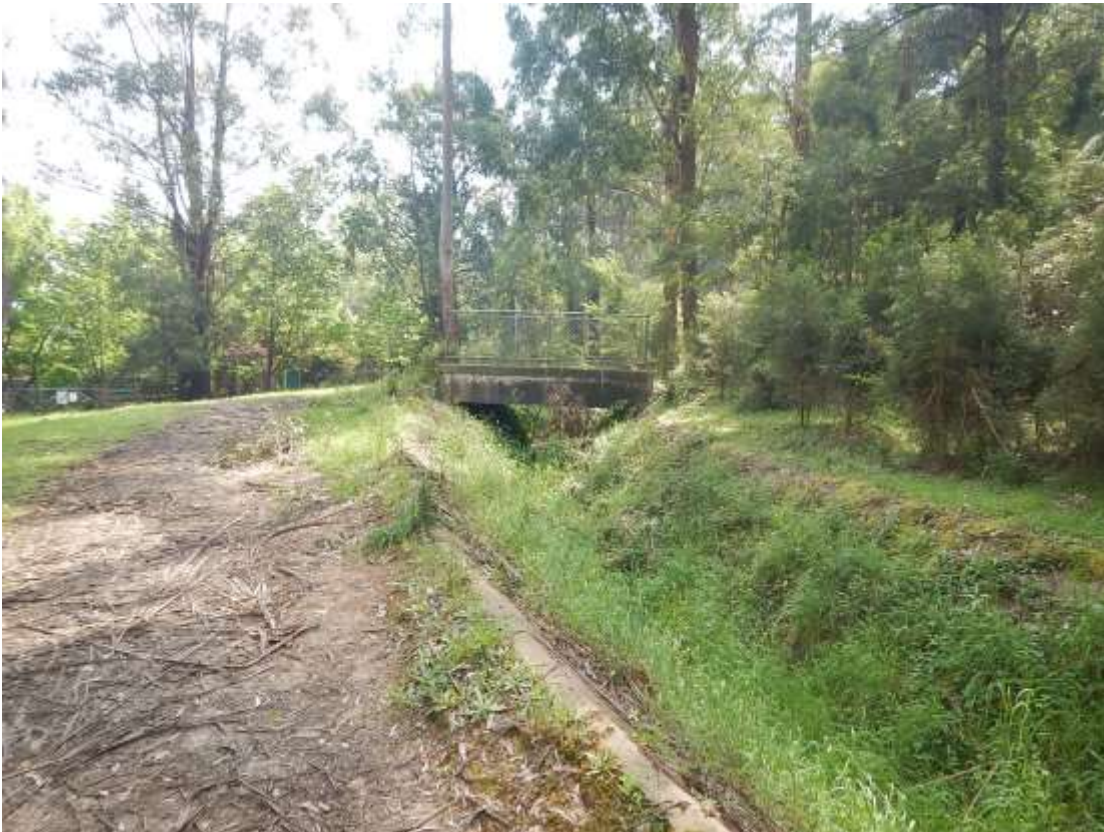
Plate 24 Concrete bridge over O'Shannassy Aqueduct at Andersons Tramway crossing (G.Vines 1/11/2019)

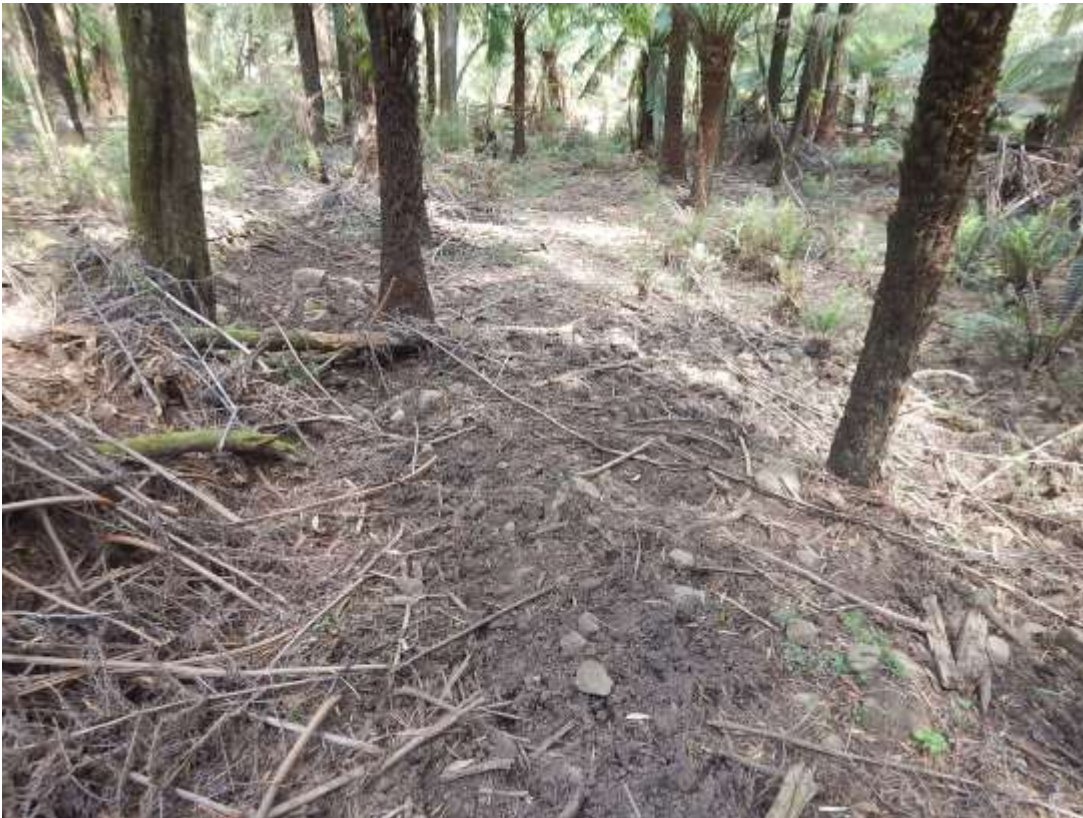
Plate 25 Alignment of Anderson & Barbury tramway looking south from near aqueduct (G.Vines 1/11/2019)

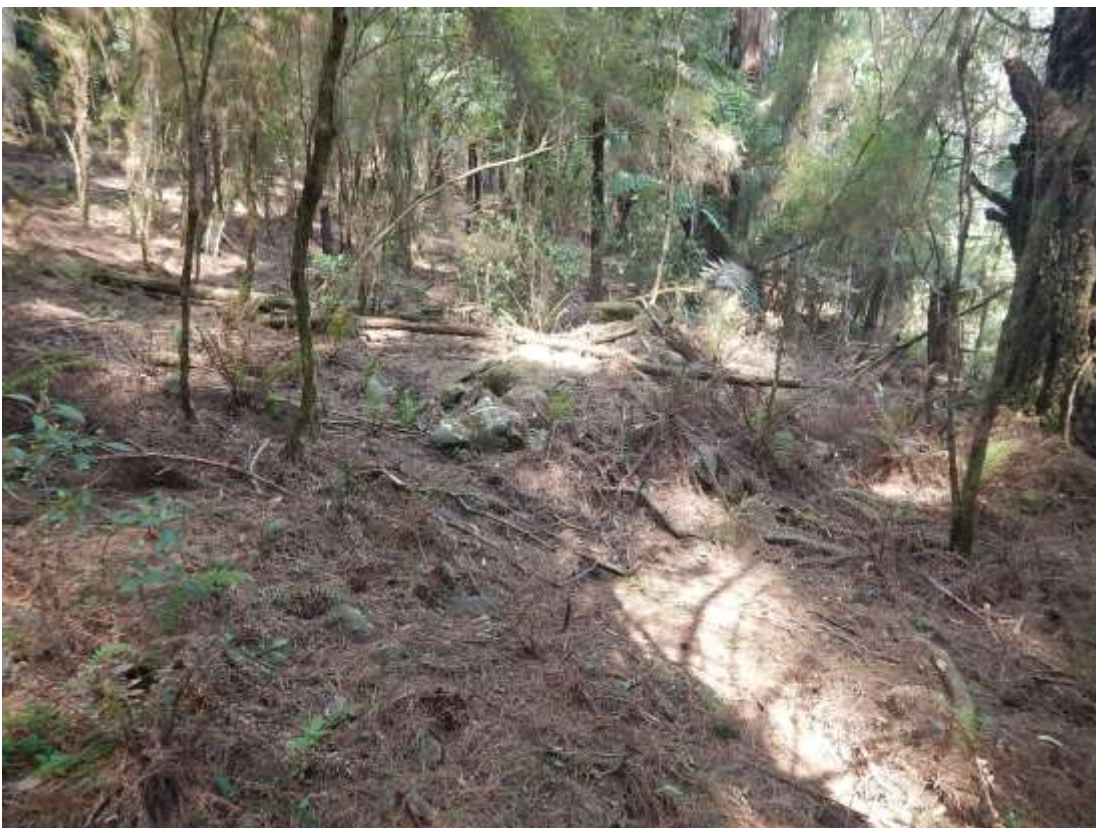
Plate 26 Rock piles in opine forest near andersons Tramway (G.Vines 1/11/2019)

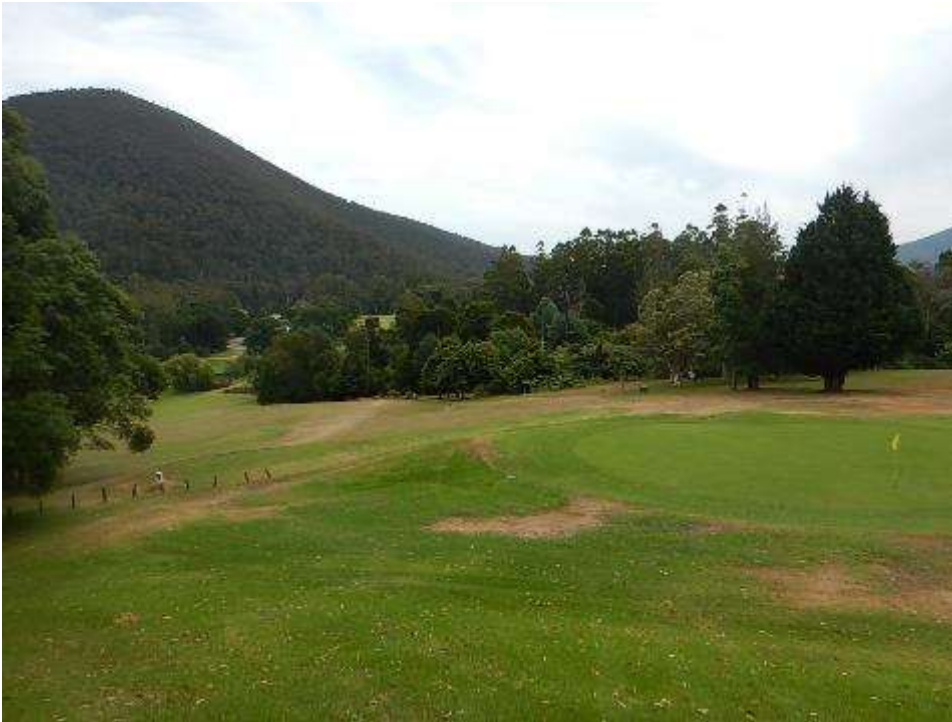
Plate 27 Looking towards the site of Anderson's and Parbury's mill on the golf course (G.Vines 16/01/2019)

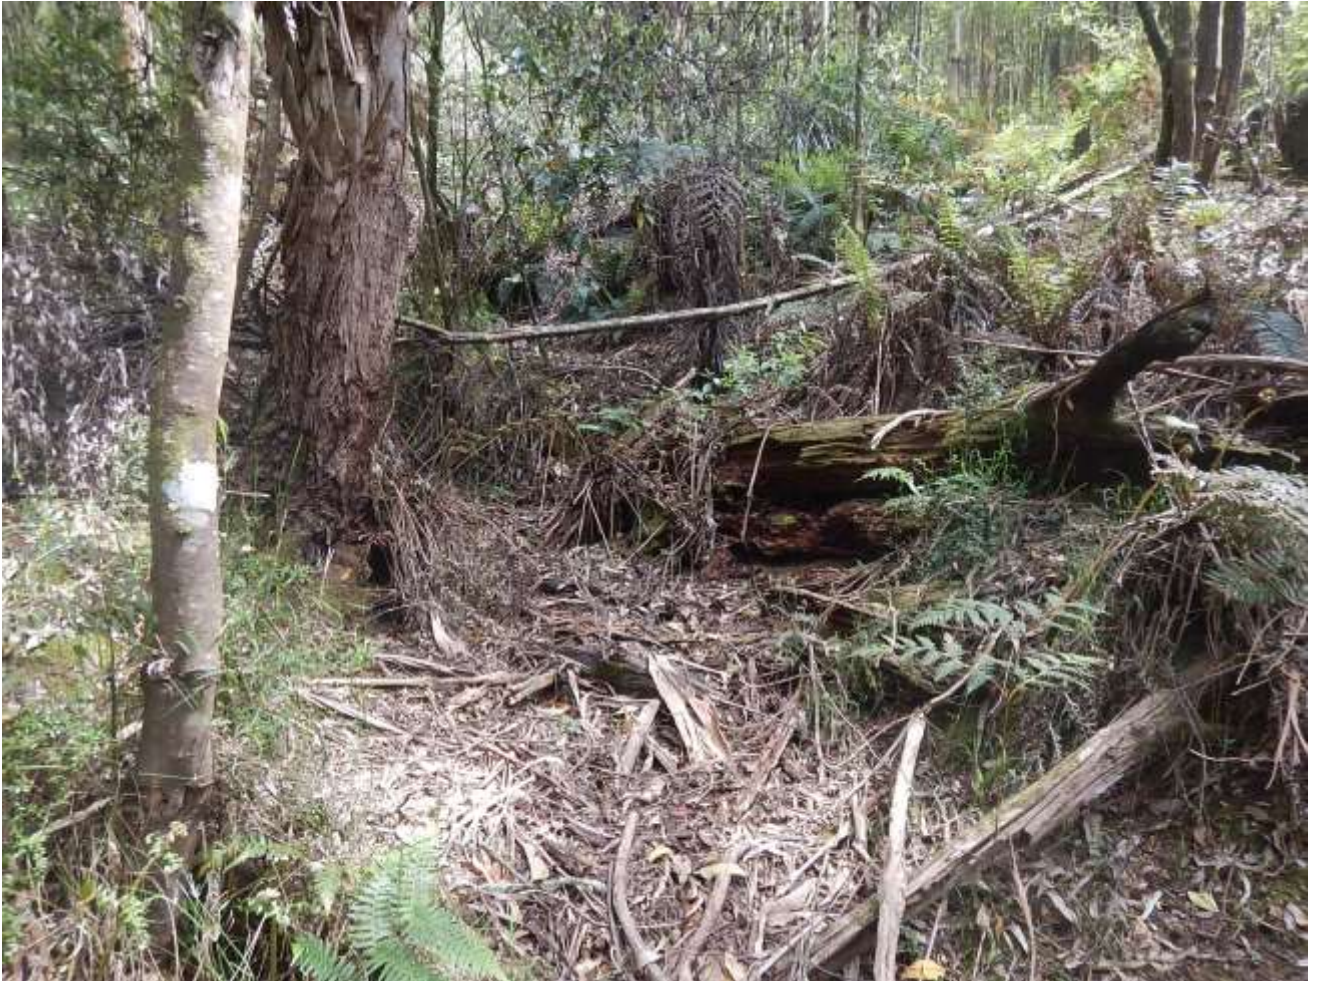
The site of the Lady Hopetoun Mine is marked on Geovic mapping, but appears to be slightly off the actual location. Site inspection revealed extensive areas of benching on the steel slopes, at least two levels of tramway and/or water race, and the excavation for a mine adit (Plate 28), and rock and earth spoil heaps extending north from the mine, standing up to 20 metres above the bottom of the gully. The mine is known to have been supplied with water from a renovated race, which is clearly that constructed originally for the Yankee Jim Mine, and this is clearly on the upper level.

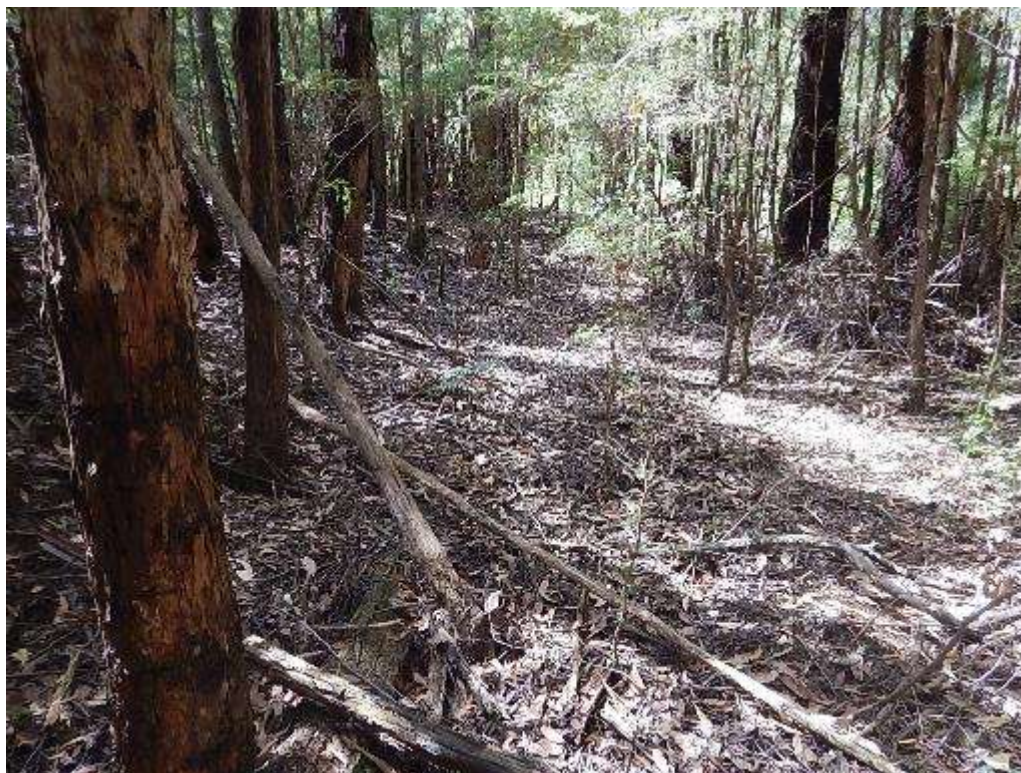
Plate 29 Tramway formation near Yankee Jim Creek along the east side of the Old Warburton Cemetery Reserve (G.Vines 15/01/2019)

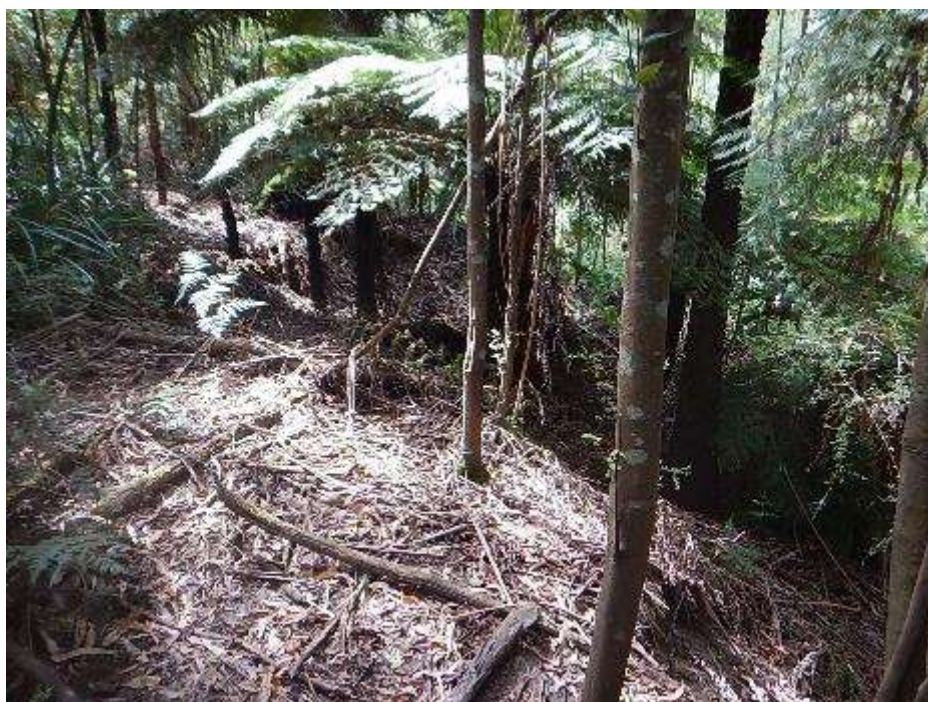
Plate 30 Mining bench near Backstairs Creek (G.Vines 15/01/2019)
