Dwelling Analysis

Appendix A Character of nearby dwellings (Map Source: VicPlan 2022)

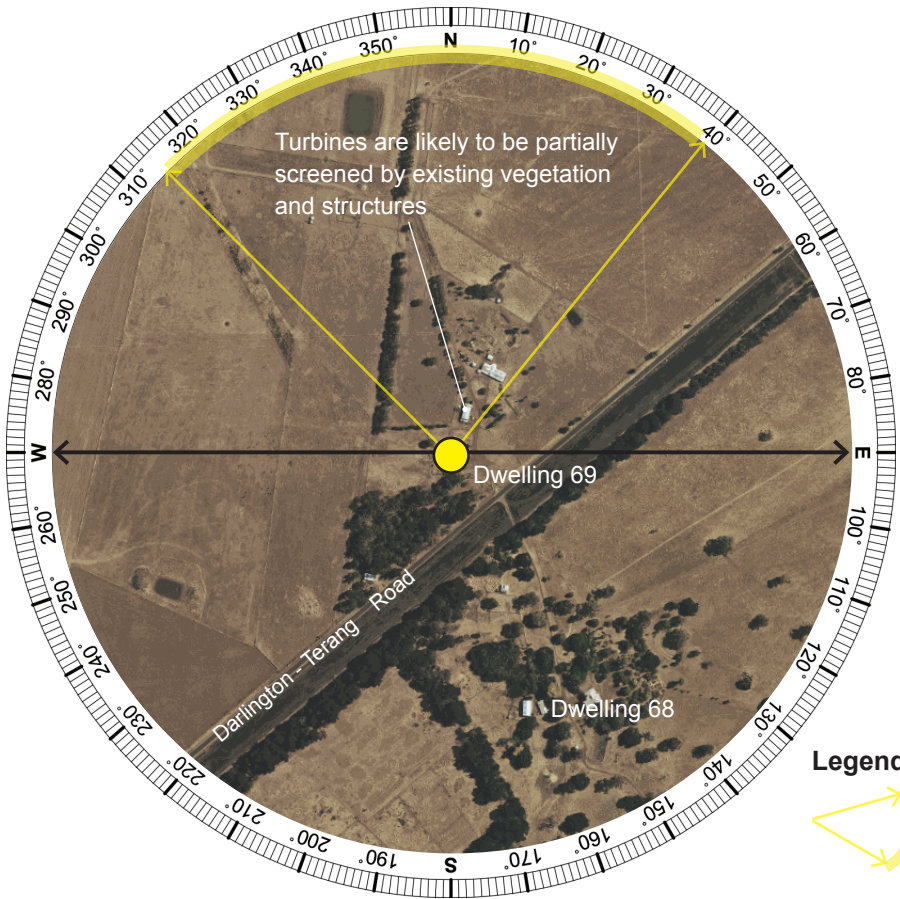
Dwelling 69 - Aerial Image
Location Plan (Image Source: VicPlan 2022)

An assessment based on topography alone suggests that all turbines are likely to be visible from Dwelling 69 which is located within 2000 m of the nearest turbine. Majority views of the Project are likely to be available in the north. The dwelling is located on a flat terrain in the Darlington plains, and therefore, topographic character will not contribute towards screening. Aerial imagery indicates that existing vegetation in the residence's foreground to the north will partially help in limiting some views. Gaps in the windbreak plantation will, however, allow some views of the turbines, given that the nearest turbine is 1.64 km from this dwelling.

Distance to Nearest Turbine:	1.64 km
Number of potentially visible turbines (based on topography alone):	61 turbines (All at tip height)

It is likely that views of most of the Project will be screened by existing vegetation. However, the close proximity of the Project is likely to allow views of tips of some turbines. If deemed necessary, additional screening can be provided to the north. Consultation with the landowner will be required for recommending additional screen planting.

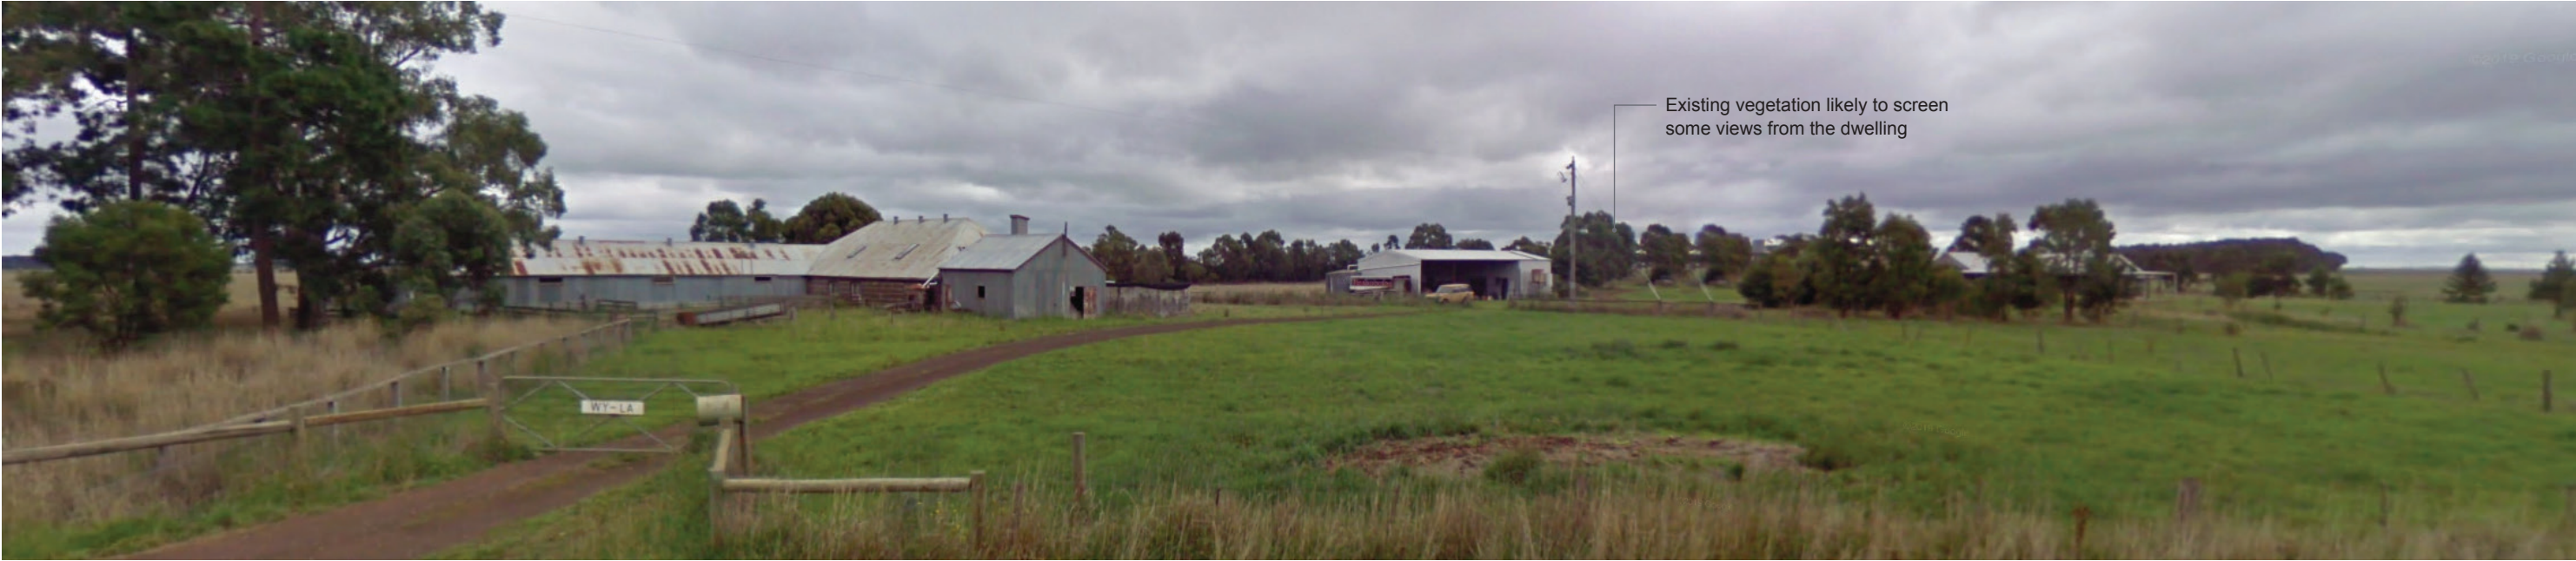
Dwelling 69 - Existing View
View from Darlington-Terang Road near mailbox of Dwelling 69 (Image Source: Google Street View 2021)

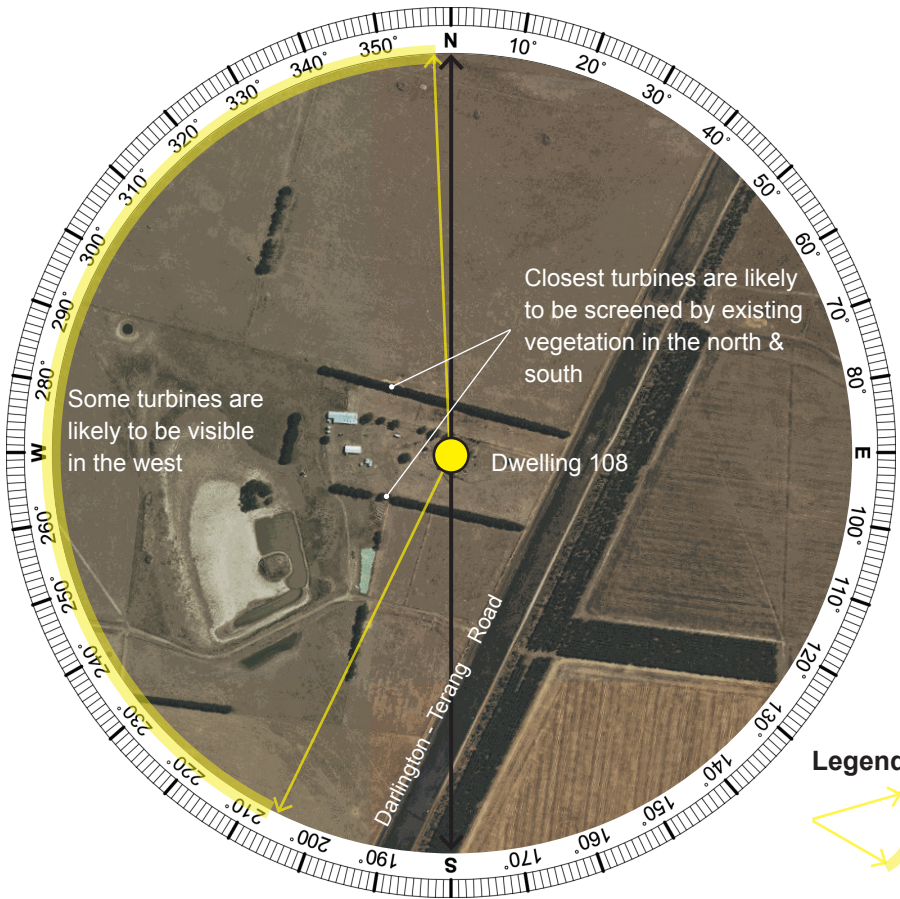
Dwelling 108 - Aerial Image
Location Plan (Image Source: VicPlan 2022)

An assessment based on topography alone suggests that all turbines are likely to be visible from Dwelling 108 which is located within 2000 m of the nearest turbine. Majority views of the Project are likely to be available in the north, west and southwest. The dwelling is located on a flat terrain in the Darlington plains, and therefore, topographic character will not contribute towards screening the Project. Aerial imagery indicates that existing windbreak plantation on the northern and southern sides of the residence will help in limiting majority of the views towards the Project. Gaps in the windbreak plantation will, however, allow visibility of some turbines and it is likely that most trubines will be visible in the west. The nearest turbine in the western direction is located at a distance of 2 km from the dwelling.

Distance to Nearest Turbine:	1.30 km
Number of potentially visible turbines (based on topography alone):	61 turbines (All at tip height)

It is likely that views of most of the Project will be screened by existing vegetation on the northern and southern sides. However, lack of dense vegetation in the west is likely to allow views of some turbines in this direction. If deemed necessary, additional screening can be provided in the immediate foreground of this dwelling. Consultation with the landowner will be required for recommending additional screen planting.

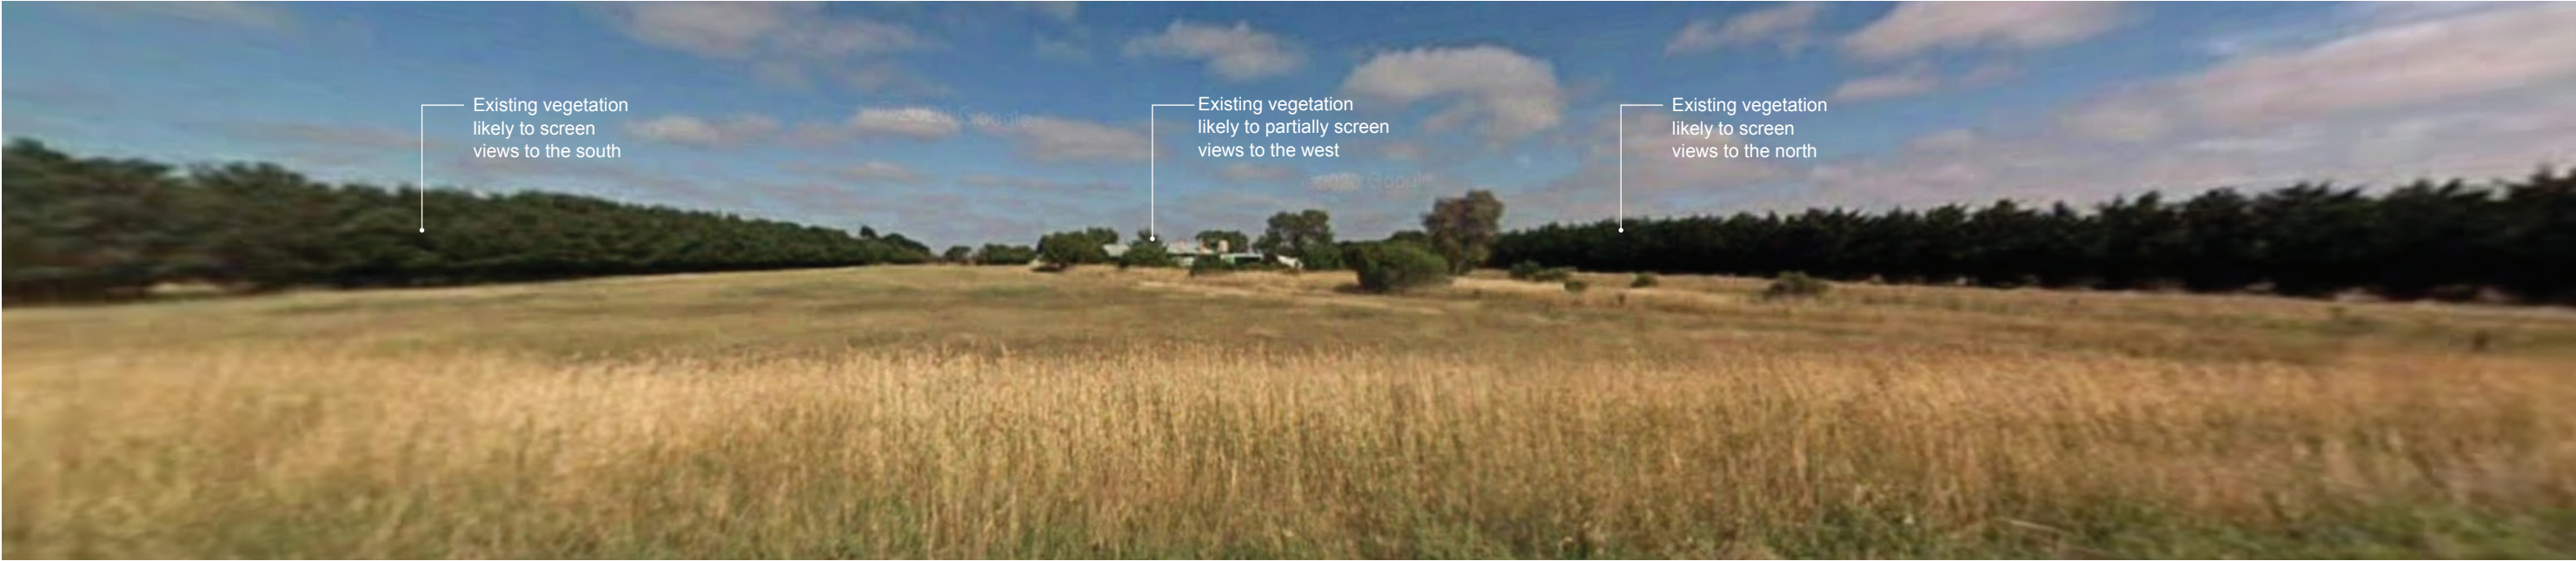
Dwelling 108 - Existing View
View from Darlington-Terang Road near mailbox of Dwelling 108 (Image Source: Google Street View 2021)

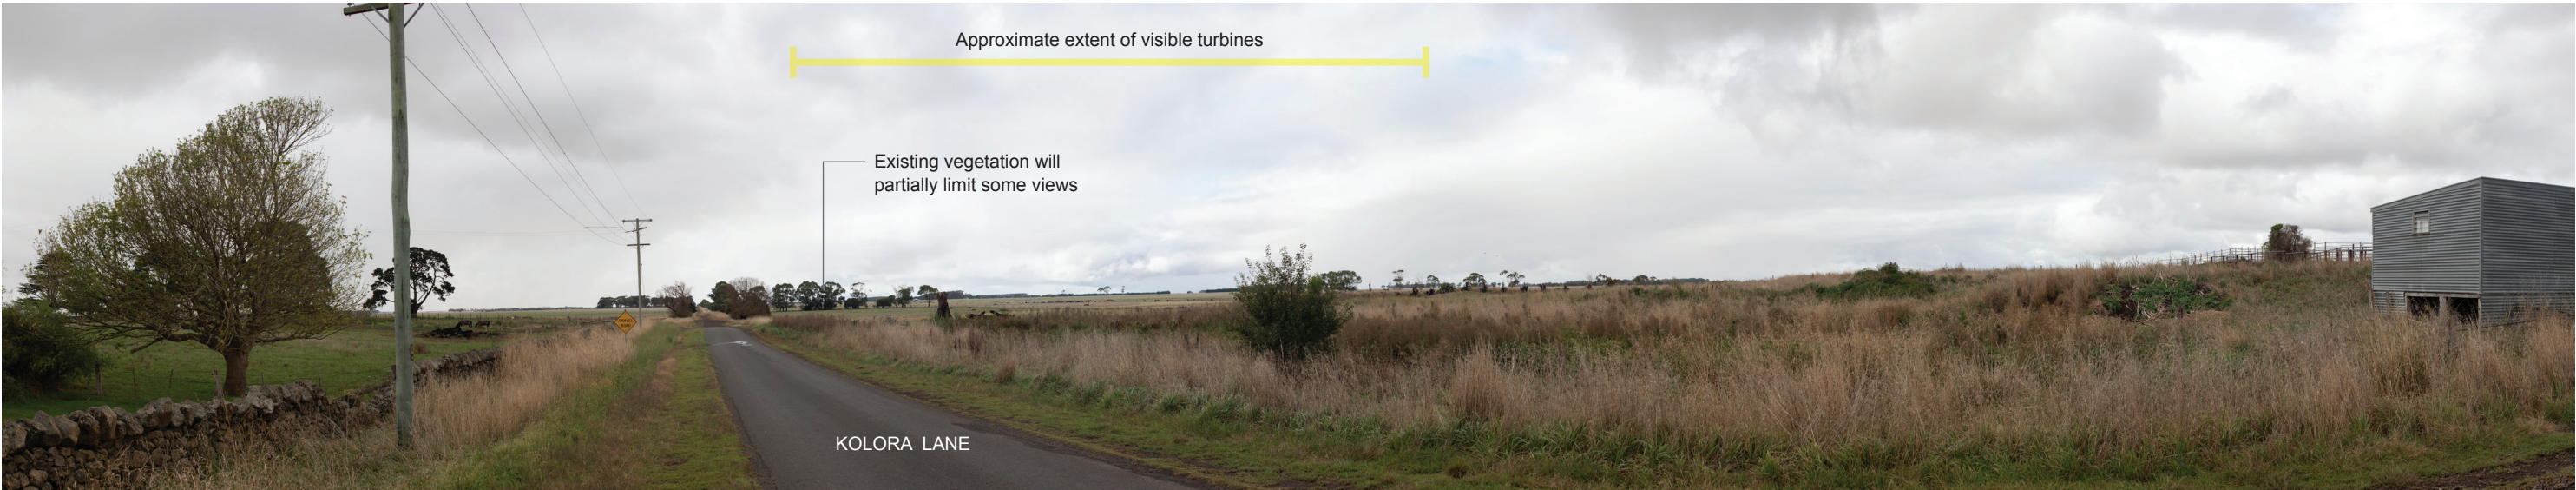
Dwelling 30 - Existing View
View from Kolora Lane near mailbox of Dwelling 30

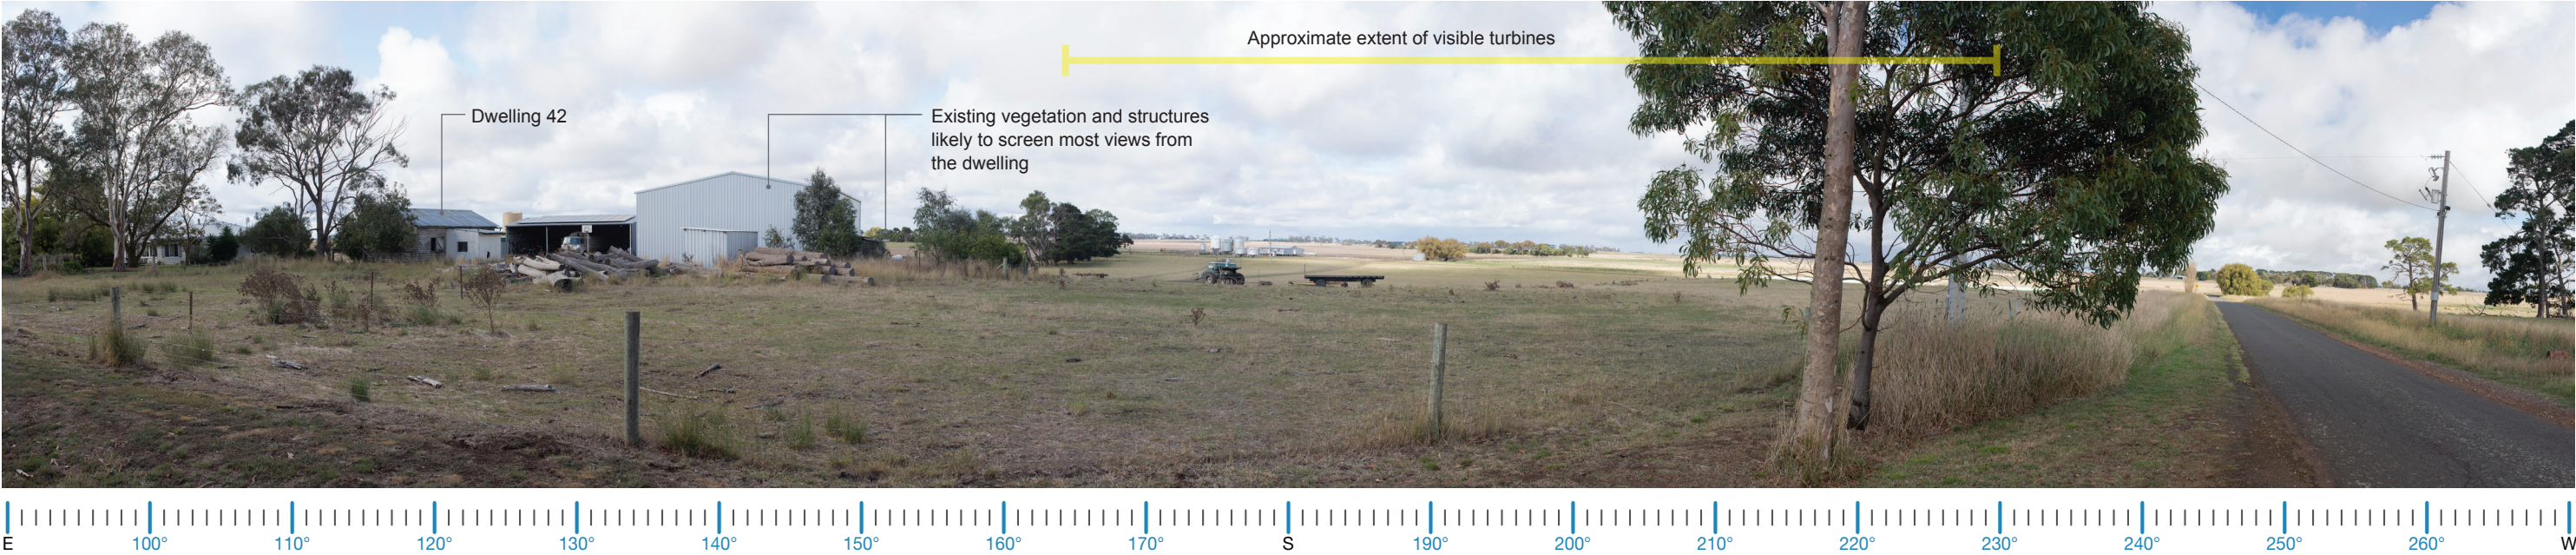
Dwelling 42 - Existing View
View from Mount Fyans Lane near mailbox of Dwelling 42

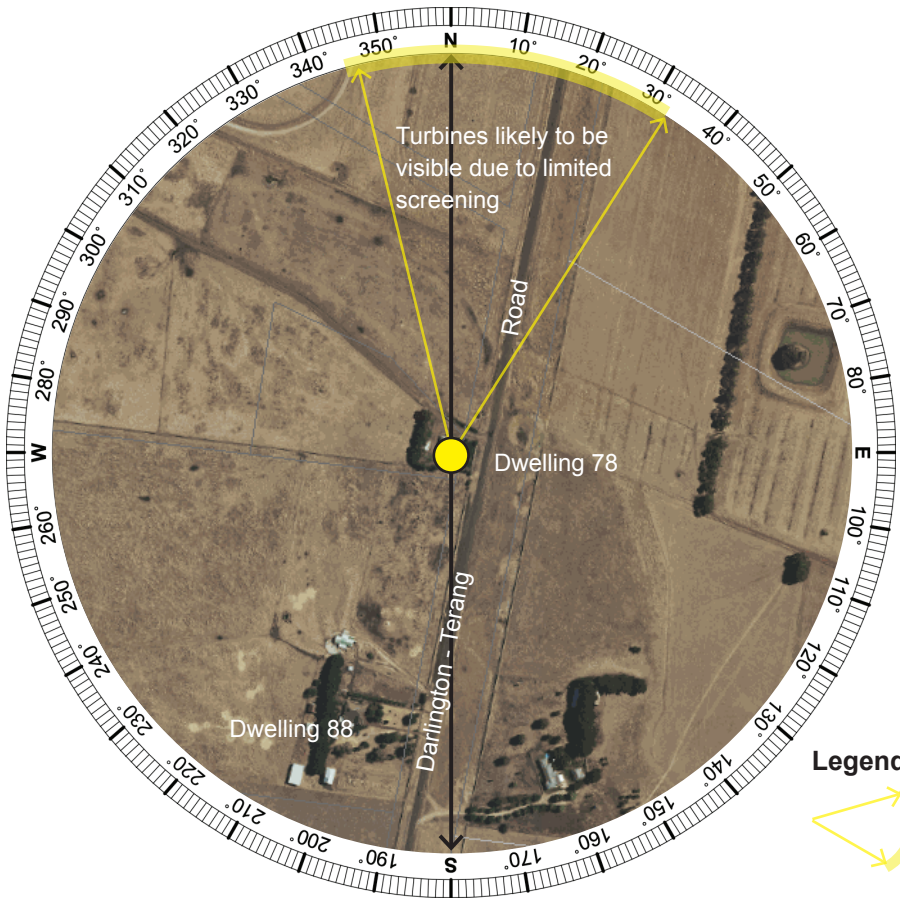
Dwelling 78 - Aerial Image
Location Plan (Image Source: VicPlan 2022)

An assessment based on topography alone suggests that all turbines are likely to be visible from Dwelling 78 which is located within 4000 m of the nearest turbine. Majority views of the Project are likely to be available towards the north. The dwelling is located on a flat terrain, and therefore, topographic character allows clear, open views of the Project. Aerial imagery indicates a lack of vegetation in the northern direction and therefore, it is likely that views of most of the Project will be available from this dwelling. Clear, open views of the Project are likely to be available at this location.

Distance to Nearest Turbine:	3.78 km
Number of potentially visible turbines (based on topography alone):	61 turbines (All at tip height)

Additional screening on the northern side of the dwelling will help reduce potential visual impact. Consultation with the landowner will be required.

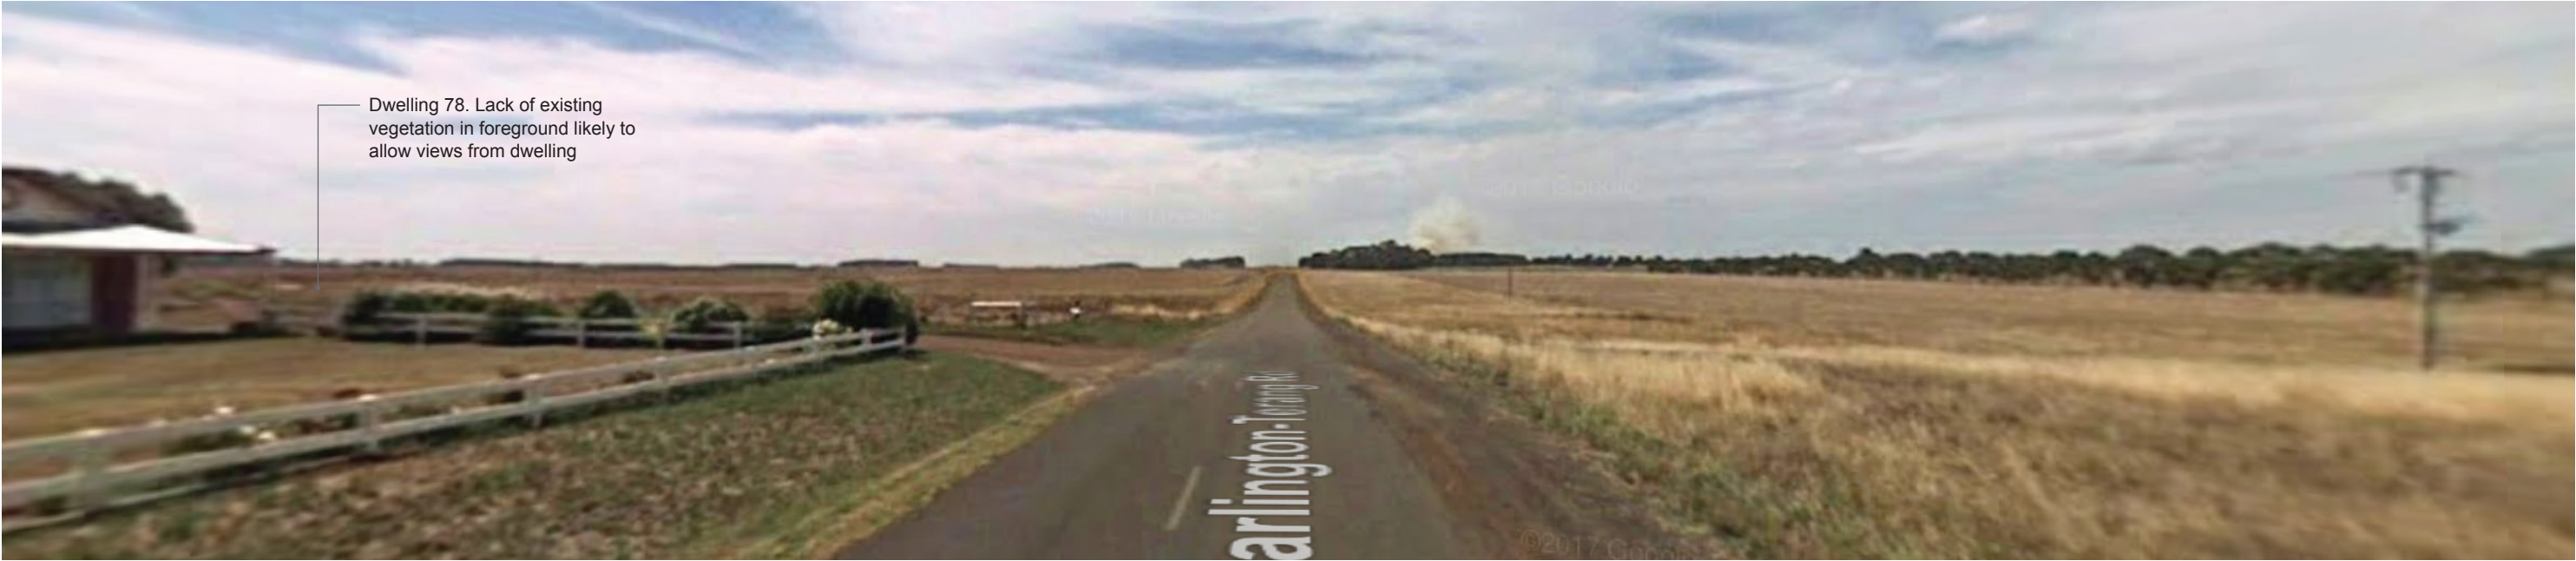
Dwelling 78 - Existing View
View from Darlington-Terang Road near mailbox of Dwelling 78 (Image Source: Google Street View 2021)

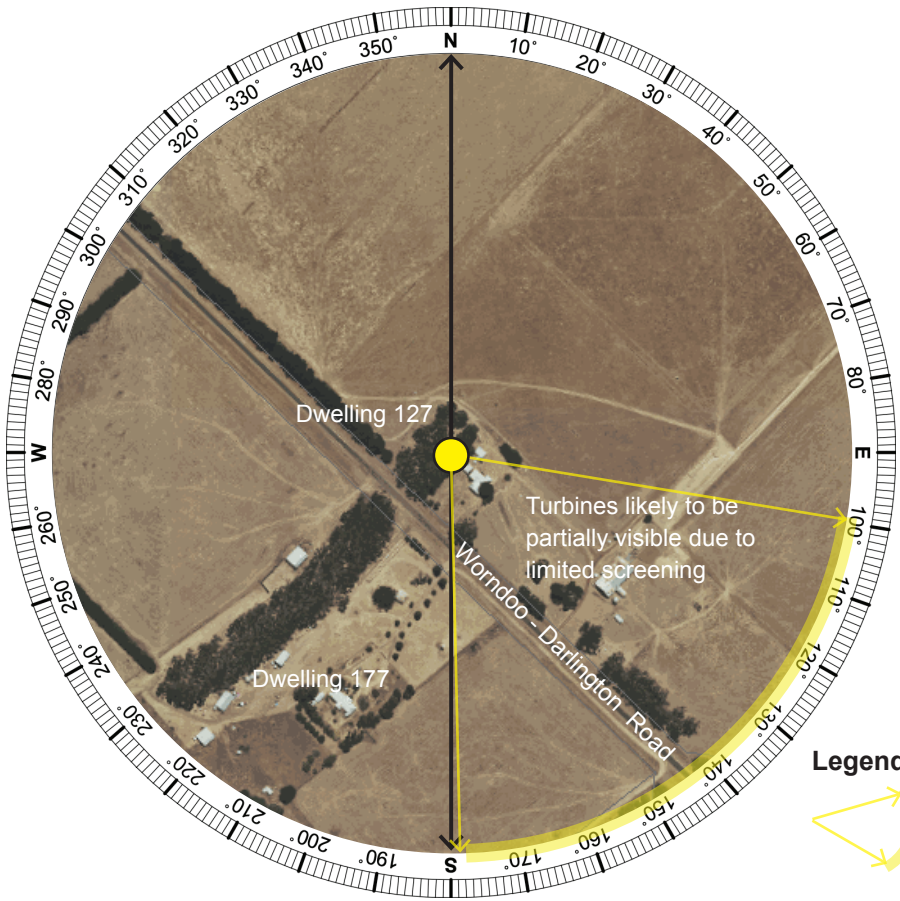
Dwelling 127 - Aerial Image
Location Plan (Image Source: VicPlan 2022)

An assessment based on topography alone suggests that all turbines are likely to be visible from Dwelling 127 which is located within 4000 m of the nearest turbine. Majority views of the Project are likely to be available in the southeast. The dwelling is located on a flat terrain, and therefore, topographic character allows clear, open views of the Project. Aerial imagery indicates that a row of patchy to dense roadside vegetation along Worndoo - Darlington Road runs along its course. Existing vegetation is likely to assist in partially screening views towards the southeast. A combination of distance from the Project and existing screening elements along the road suggest that distant views of the Project are likely to be available at this dwelling.

Distance to Nearest Turbine:	3.11 km
Number of potentially visible turbines (based on topography alone):	61 turbines (All at tip height)

It is likely that some views of the Project will be screened by roadside vegetation. If deemed necessary, additional screening can be provided in the immediate foreground of this dwelling on the south eastern side. Consultation with the landowner will be required before recommending any additional planting.

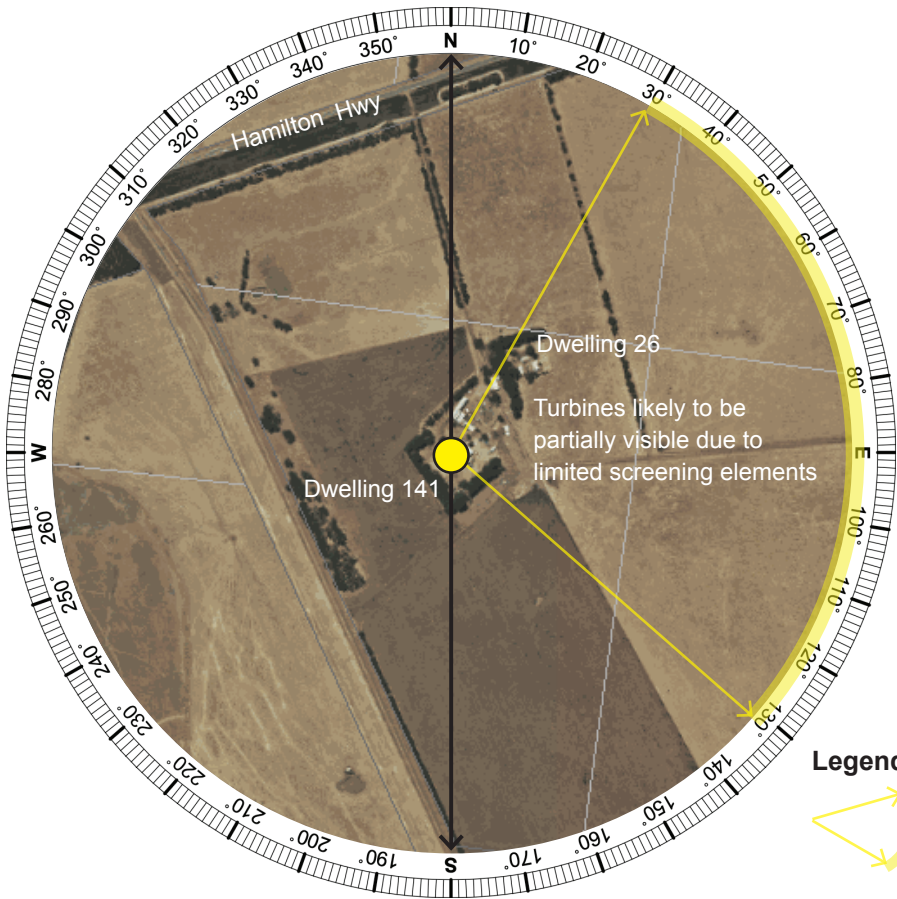
Dwelling 141 - Aerial Image
Location Plan (Image Source: VicPlan 2022)

An assessment based on topography alone suggests that all turbines are likely to be visible from Dwelling 141 which is located within 4000 m of the nearest turbine. Maximum views of the Project are likely to be available in the east. The dwelling is located on a flat terrain, and therefore, topographic character allows clear, open views of the Project. Aerial imagery indicates that existing sheds are located in the dwelling’s foreground to the east. The dwelling is orientated to the southeast so it is likely that some views of the Project will be partially screened by existing structures.

Distance to Nearest Turbine:	3.72 km
Number of potentially visible turbines (based on topography alone):	61 turbines (All at tip height)

It is likely that some views of the Project will be screened by existing structures. If deemed necessary, additional screening can be provided in the immediate foreground of this dwelling on the eastern side. Consultation with the landowner will be required before recommending any additional planting.

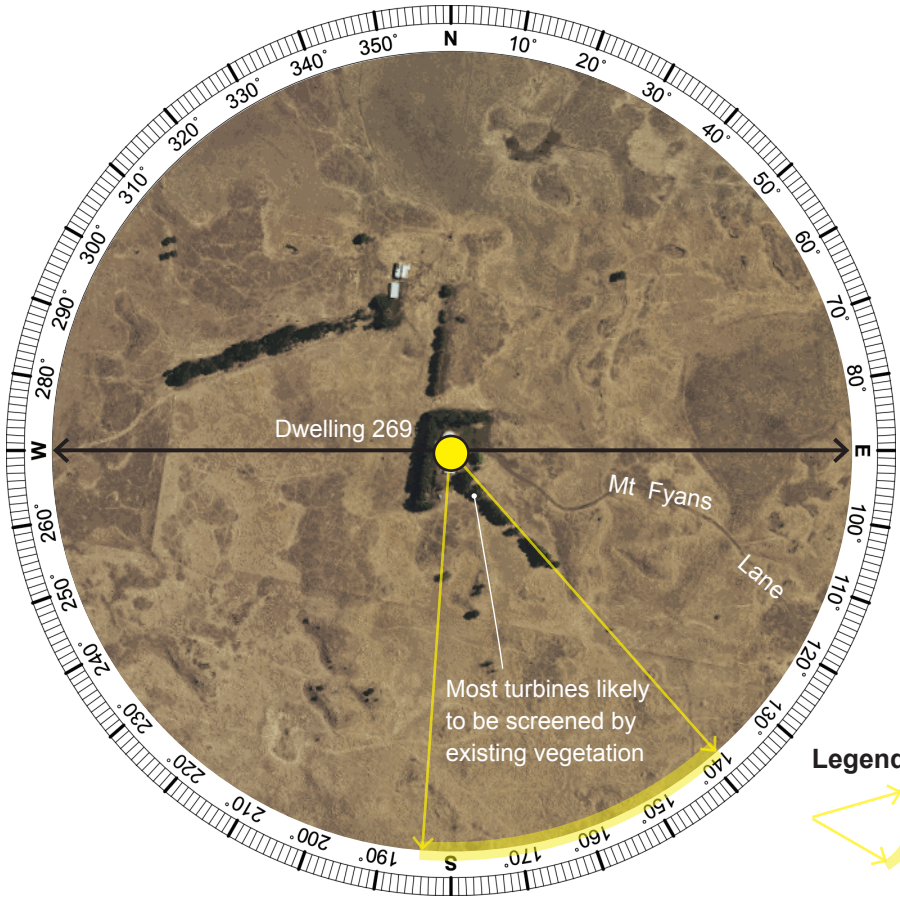
Dwelling 269 - Aerial Image
Location Plan (Image Source: VicPlan 2022)

An assessment based on topography alone suggests that all turbines are likely to be visible from Dwelling 269 due to the surrounding topographic character. The dwelling is located within 4000 m of the nearest turbine. Most views of the Project are likely to be available in the southeast. Aerial imagery indicates that the residence is surrounded by dense windbreak plantations in the southeast. This vegetation will help in screening maximum views of the Project. However, it is possible that the tips of some turbines would be visible at this location. It is also likely that some turbines will be visible further in the southern direction due to gaps in the windbreak vegetation.

Distance to Nearest Turbine:	2.67 km
Number of potentially visible turbines (based on topography alone):	61 turbines (All at tip height)

It is likely that views of most of the Project, especially the closest turbine, will be screened by existing vegetation. If deemed necessary, gaps in the existing vegetation can be filled to mitigate all views of the Project. Consultation with the landowner will be required before recommending any additional planting.

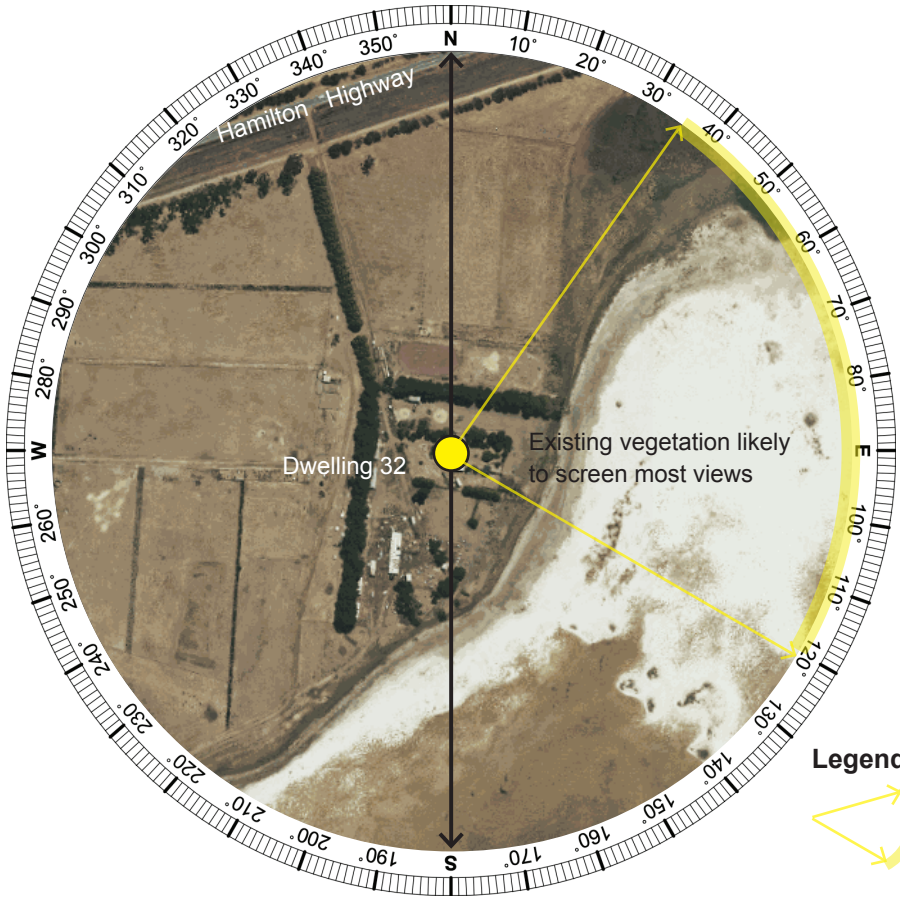
Dwelling 32 - Aerial Image
Location Plan (Image Source: VicPlan 2022)

An assessment based on topography alone suggests that all turbines are likely to be visible from Dwelling 32 which is located within 6000 m of the nearest turbine. Majority views of the Project are likely to be available in the east. The dwelling is located on a flat terrain, and therefore, topographic character allows clear, open views of the Project. Aerial imagery indicates that dense row of screening vegetation runs along the north eastern boundary of the dwelling. Most views in this direction are likely to be screened. Views towards the southeast, however, are likely to be filtered or available. A combination of distance from Project and existing screening elements suggest that partial views of the Project are likely to be available in the east.

Distance to Nearest Turbine:	5.14 km
Number of potentially visible turbines (based on topography alone):	61 turbines (All at tip height)

It is likely that views of most of the Project will be screened by existing vegetation. If deemed necessary, additional screening can be provided in the immediate foreground of this dwelling to completely screen views of the Project. Consultation with the landowner will be required before recommending any additional planting.

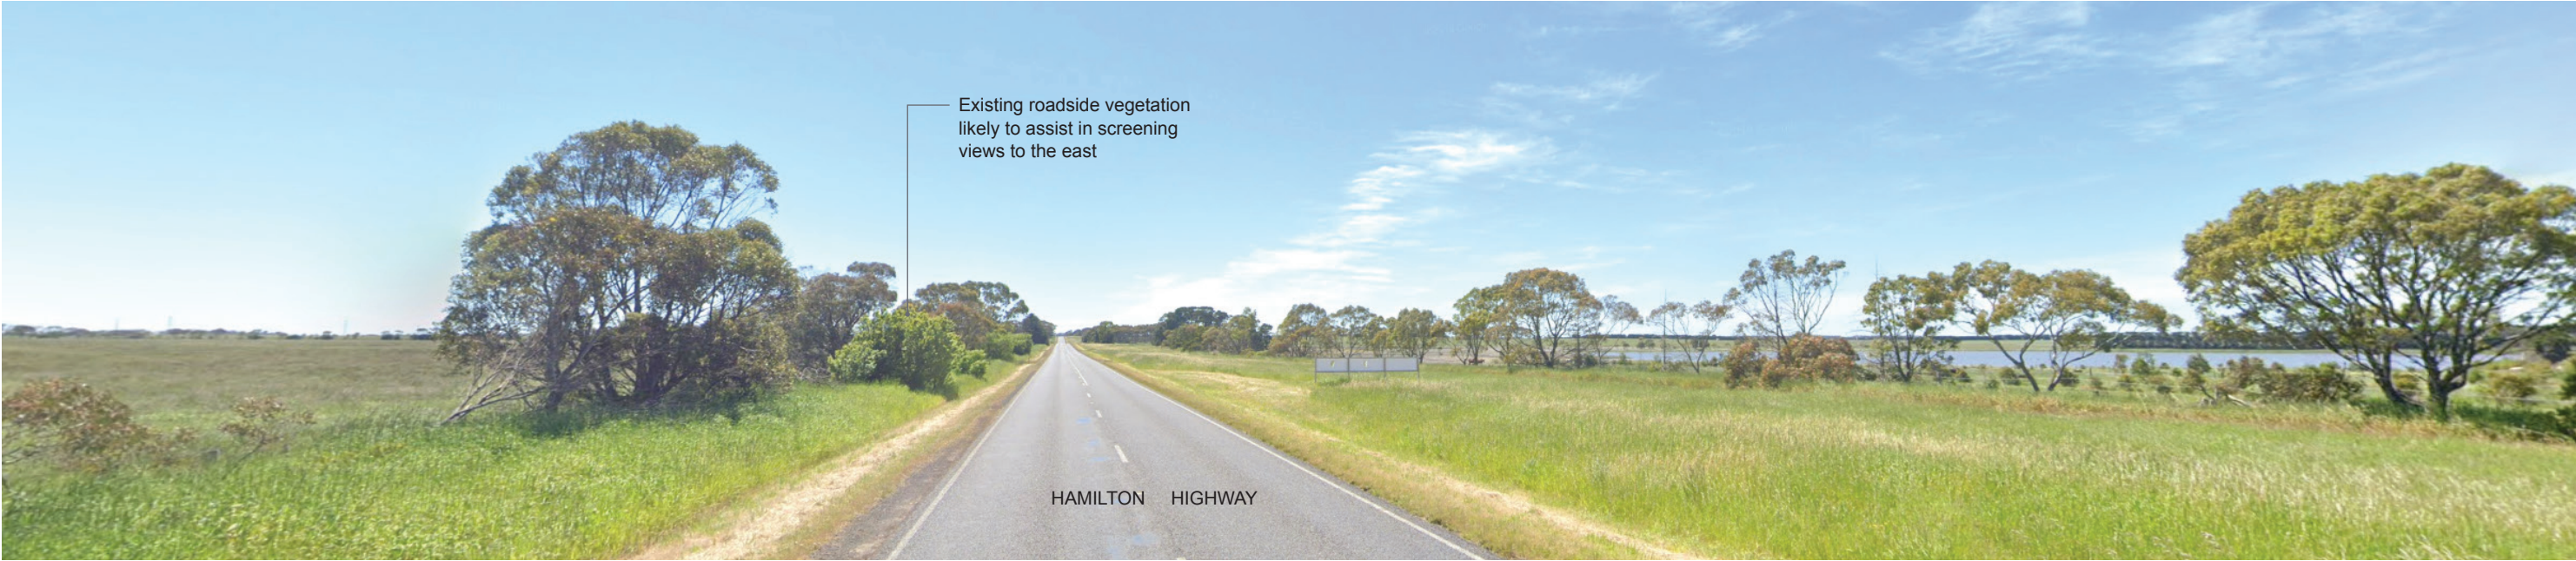
Dwelling 32 - Existing View
View from Hamilton Highway near mailbox of Dwelling 32 (Image Source: Google Street View 2021)

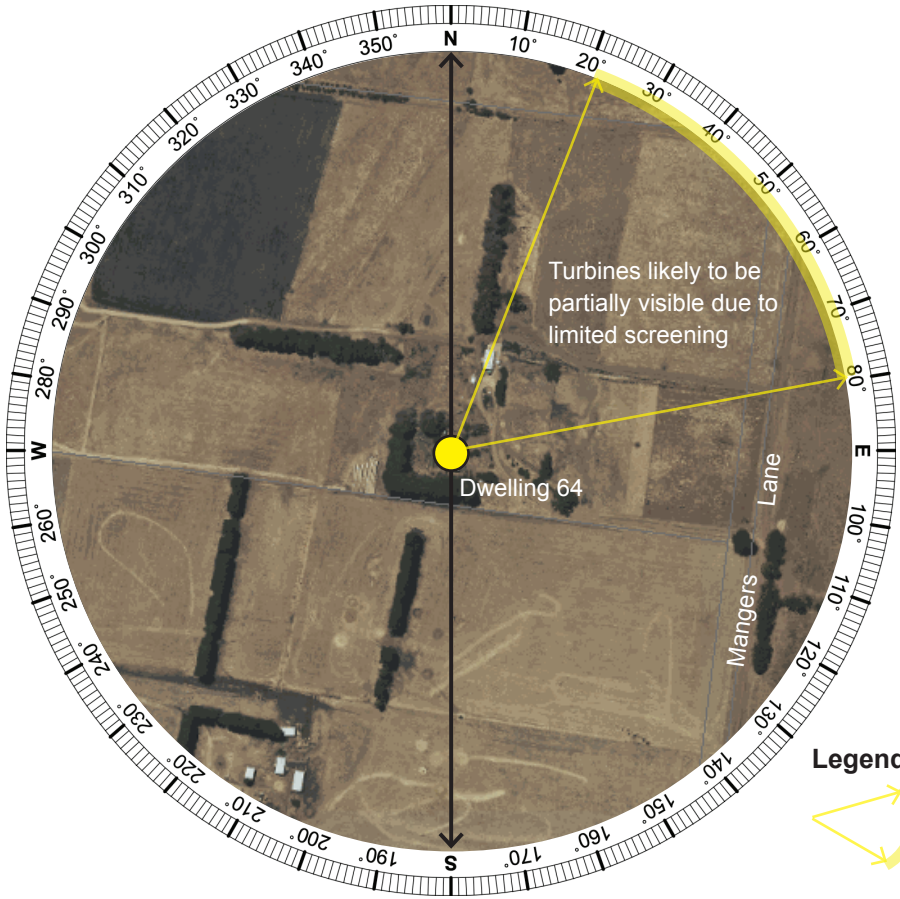
Dwelling 64 - Aerial Image
Location Plan (Image Source: VicPlan 2022)

An assessment based on topography alone suggests that all turbines are likely to be visible from Dwelling 64 which is located within 6000 m of the nearest turbine. Majority views of the Project are likely to be available in the northeast. The dwelling is located on a flat terrain, and therefore, topographic character allows clear, open views of the Project. Aerial imagery indicates that farm infrastructure and tracts of windbreak vegetation are dispersed in the dwelling’s foreground in the northeast. It is likely that most views in this direction will be available and some views may be screened. A combination of distance from Project and existing screening elements suggest that distant views of the Project are likely to be available at this dwelling.

Distance to Nearest Turbine:	4.66 km
Number of potentially visible turbines (based on topography alone):	61 turbines (All at tip height)

It is likely that views of most of the Project will be screened by structures and some vegetation belts. If deemed necessary, additional screening can be provided in the immediate foreground of this dwelling on the north eastern side. Consultation with the landowner will be required before recommending any additional planting.

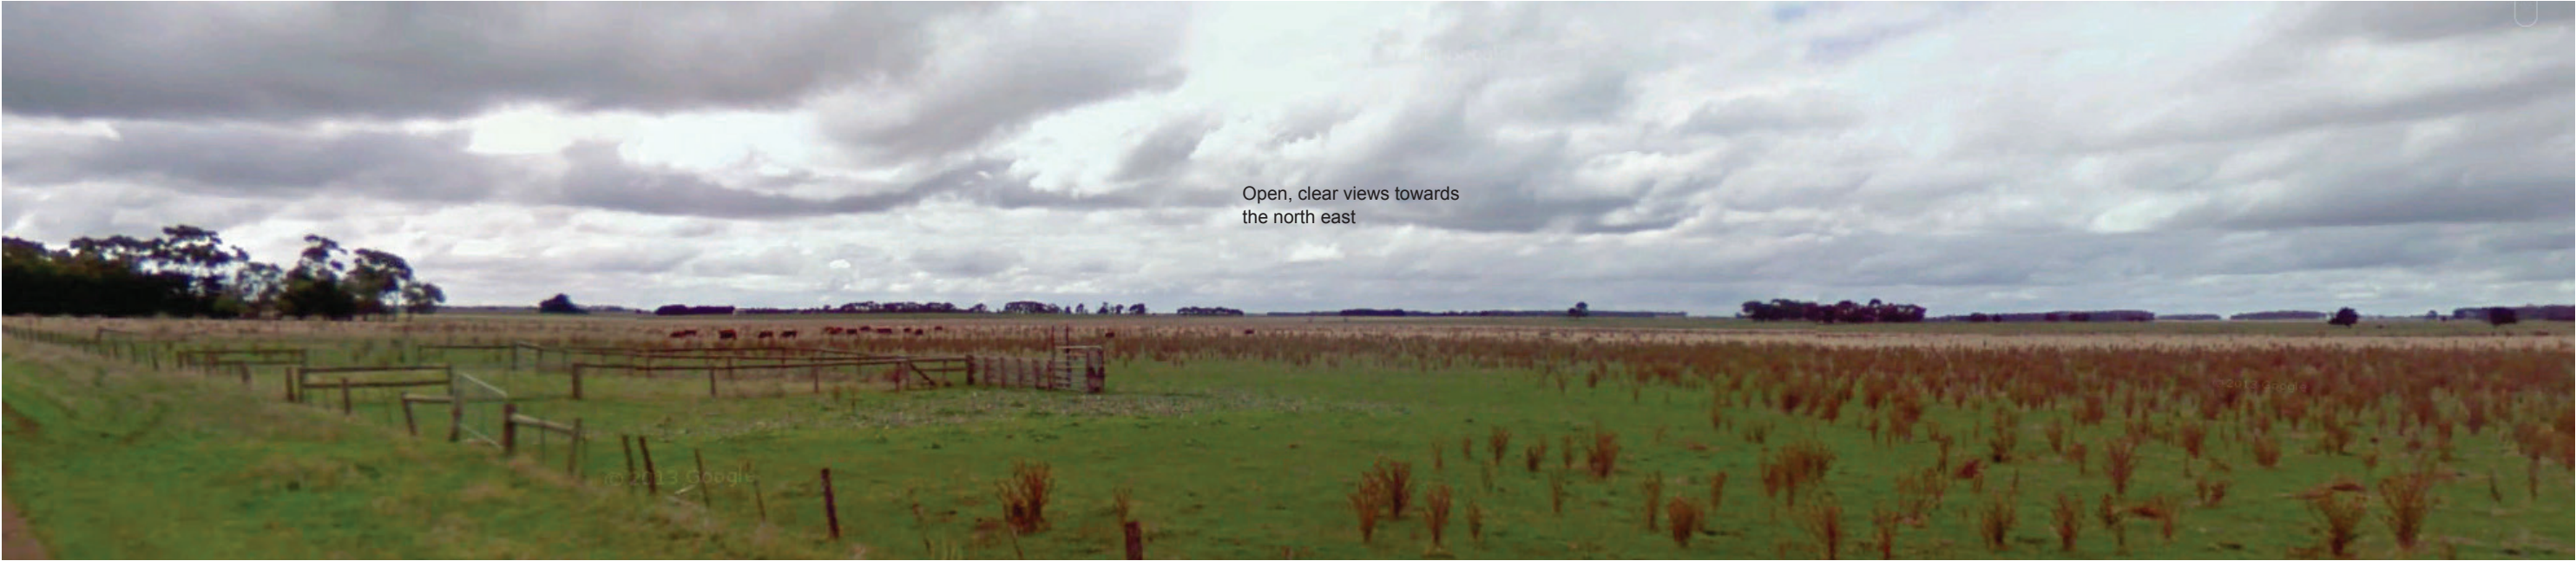
Dwelling 64 - Existing View
View from Mangers Lane near mailbox of Dwelling 64 (Image Source: Google Street View 2021)

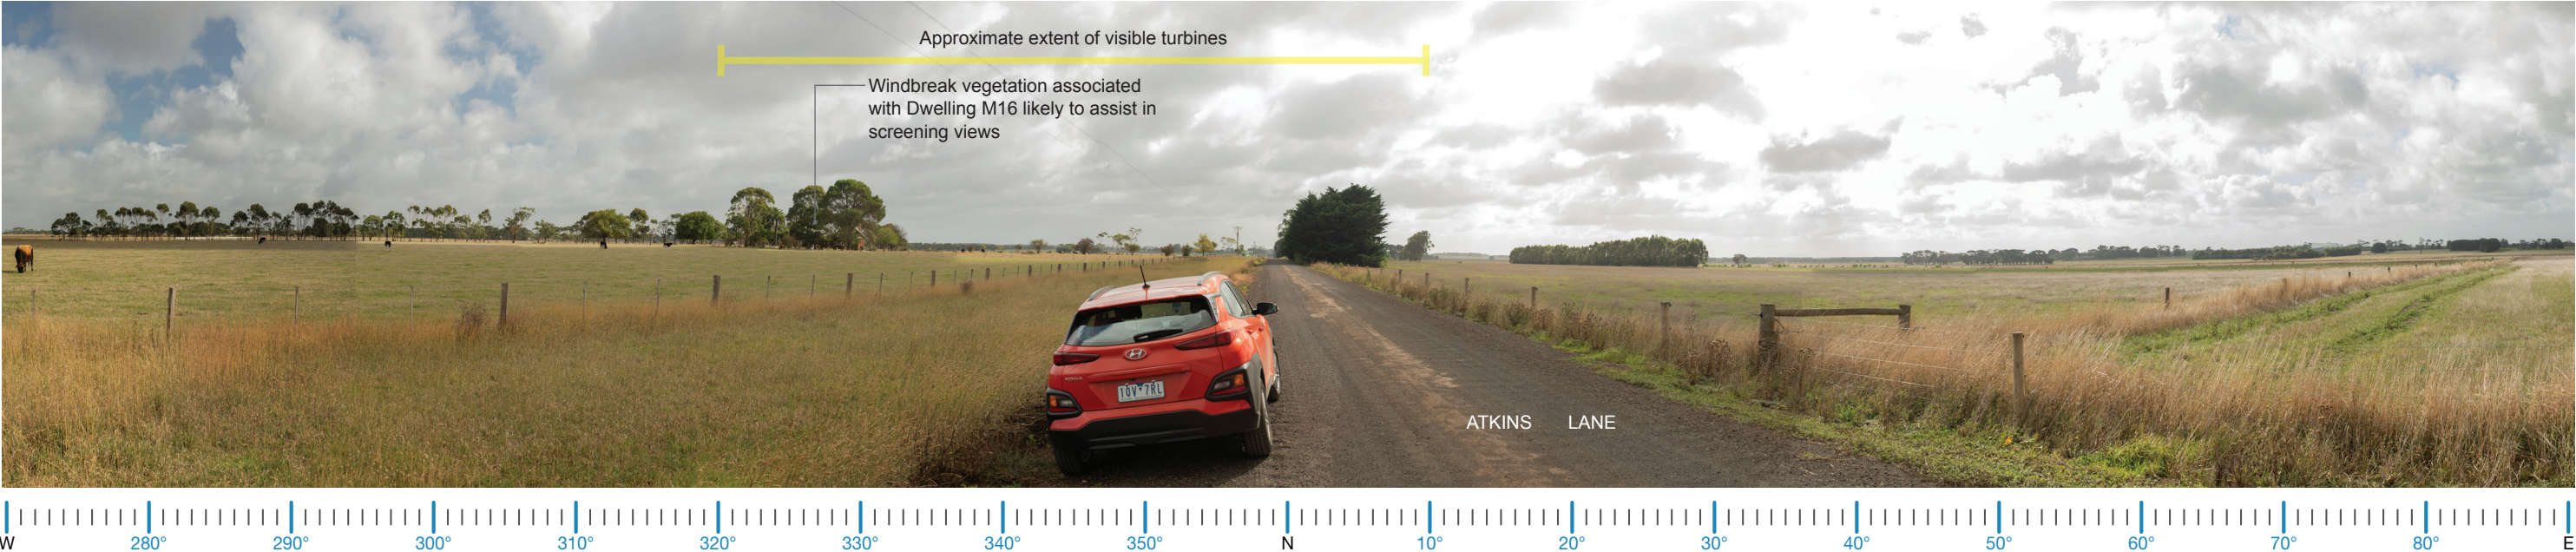
Dwelling 81 - Existing View
View from Atkins Lane looking on to Dwelling 81

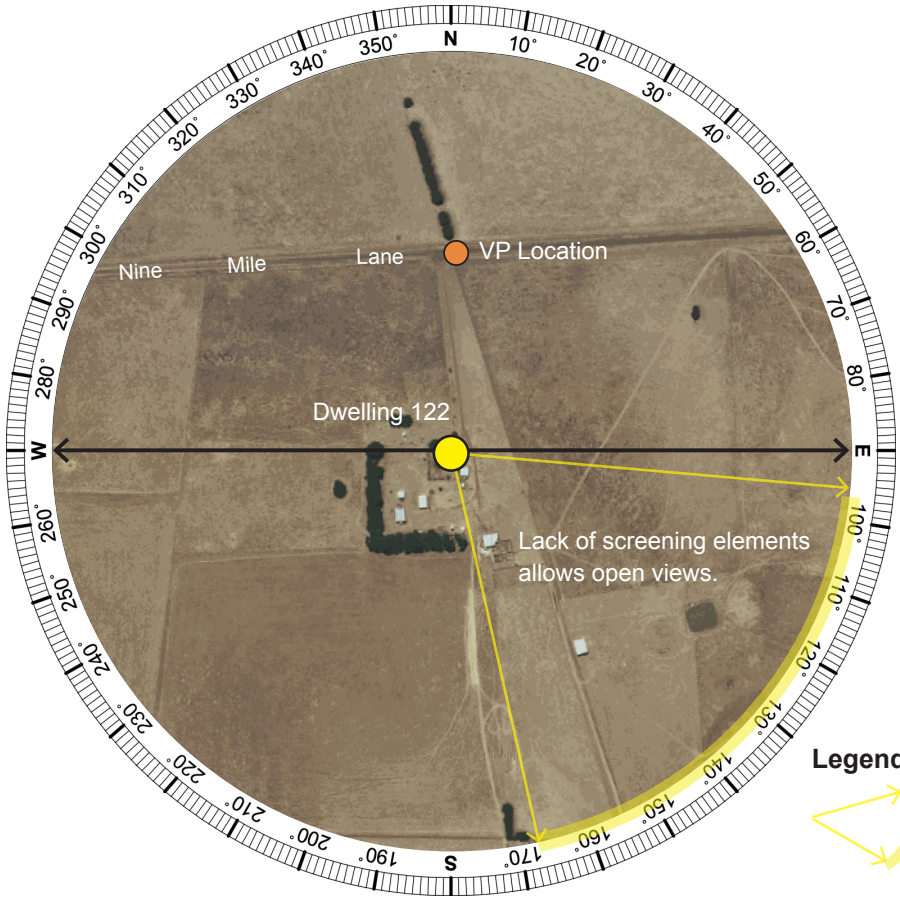
Dwelling 122 - Aerial Image
Location Plan (Image Source: VicPlan 2022)

An assessment based on topography alone suggests that all turbines are likely to be visible from Dwelling 122 which is located within 6000 m of the nearest turbine. Majority views of the Project are likely to be available in the southeast. The dwelling is located on a flat terrain, and therefore, topographic character allows clear, open views of the Project. Aerial imagery indicates that lack of existing vegetation or structures in the residence's foreground to the southeast will allow open, clear views of the Project. A combination of distance from Project and existing screening elements suggest that distant views of the Project are likely to be available at this dwelling.

Distance to Nearest Turbine:	5.07 km
Number of potentially visible turbines (based on topography alone):	61 turbines (All at tip height)

Lack of screening elements allows open and expansive views in the southeast. Screening vegetation is recommended for dwelling 66 in order to limit views of the Project. Consultation with the landowner will be required.
