Dwelling Analysis

Appendix A Character of nearby dwellings (Map Source: VicPlan 2022)

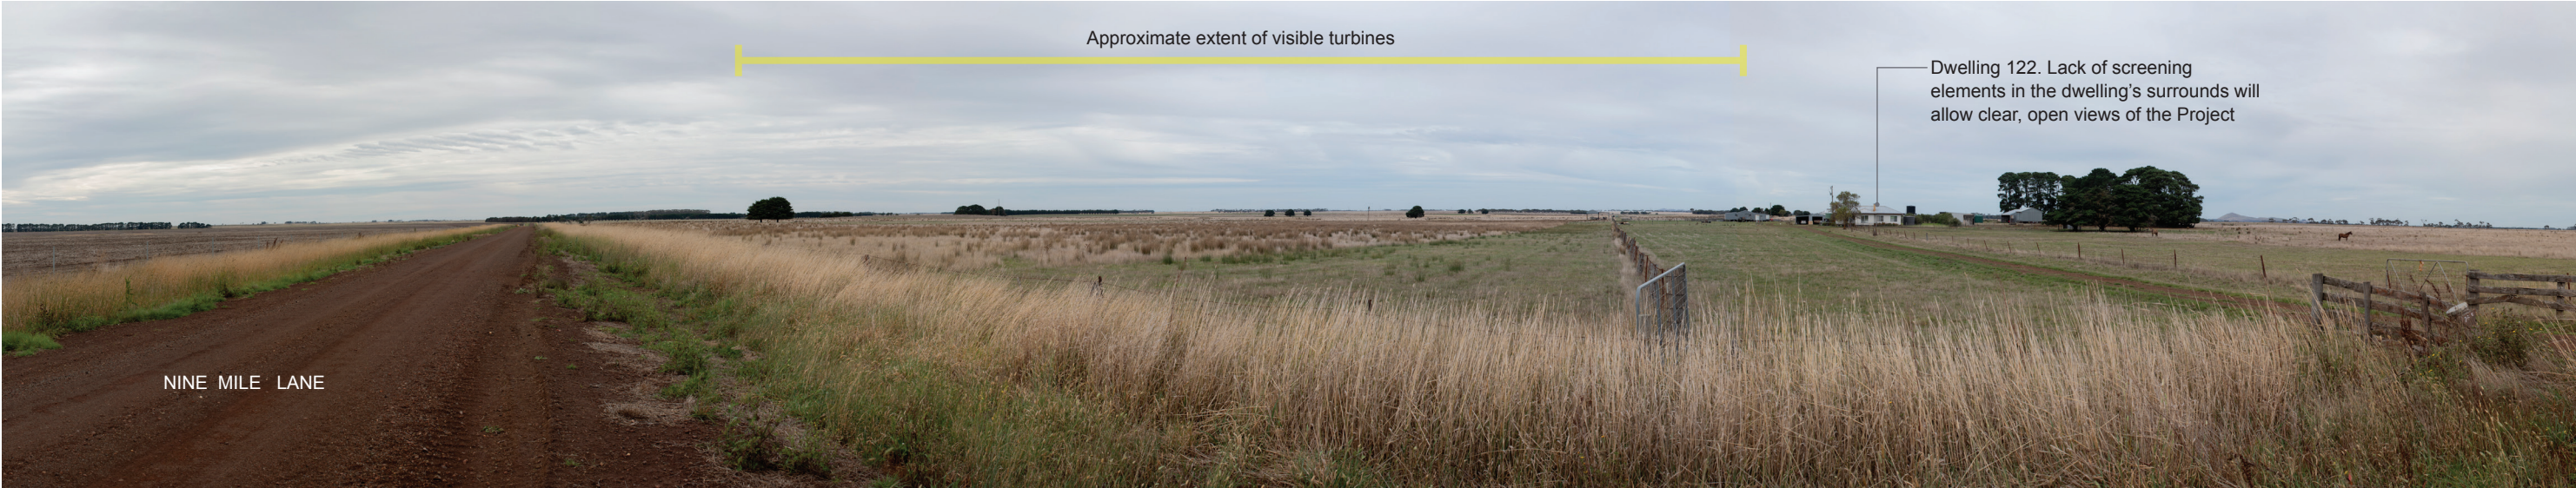
Dwelling 122 - Existing View
View from Nine Mile Lane near mailbox of Dwelling 122

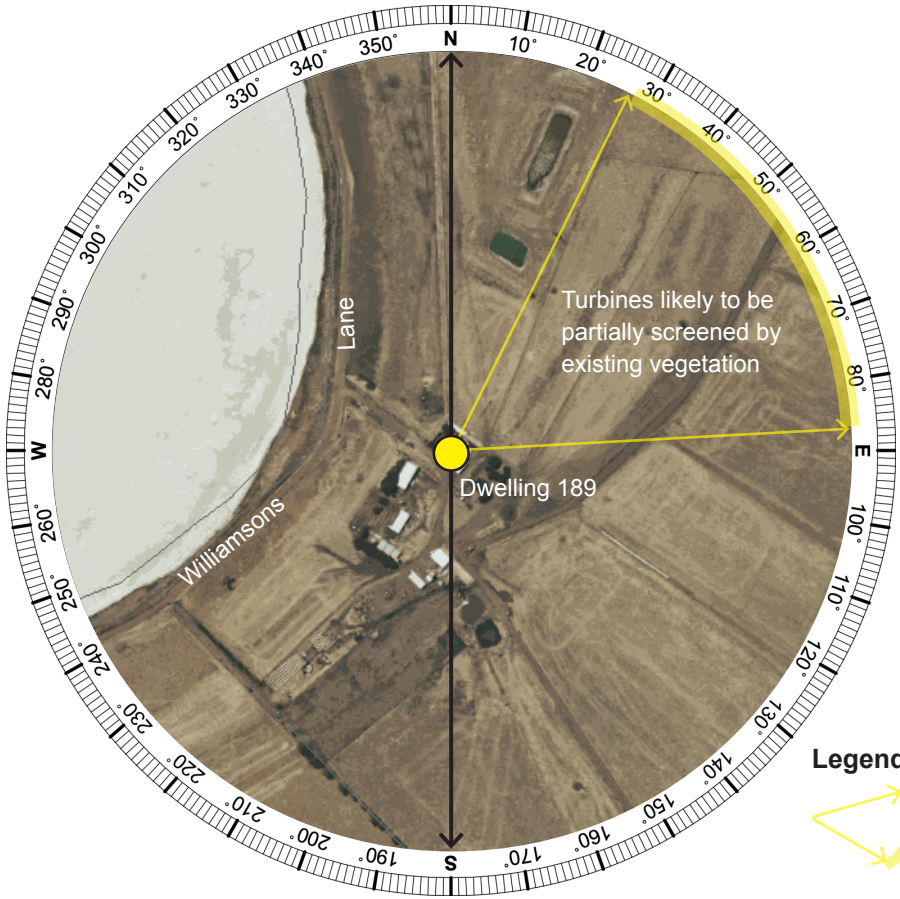
Dwelling 189 - Aerial Image
Location Plan (Image Source: VicPlan 2022)

An assessment based on topography alone suggests that all turbines are likely to be visible from Dwelling 189 which is located within 6000 m of the nearest turbine. Majority views of the Project are likely to be available in the northeast. The dwelling is located on a flat terrain, and therefore, topographic character allows clear, open views of the Project. Aerial imagery indicates that the dwelling's north eastern boundary is characterised by a dense row of vegetation. It is likely that most views in this direction will be partially screened. A combination of distance from Project and existing screening elements suggest that distant views of the Project are likely to be available at this dwelling.

Distance to Nearest Turbine:	5.47 km
Number of potentially visible turbines (based on topography alone):	61 turbines (All at tip height)

It is likely that views of most of the Project will be screened by existing vegetation.

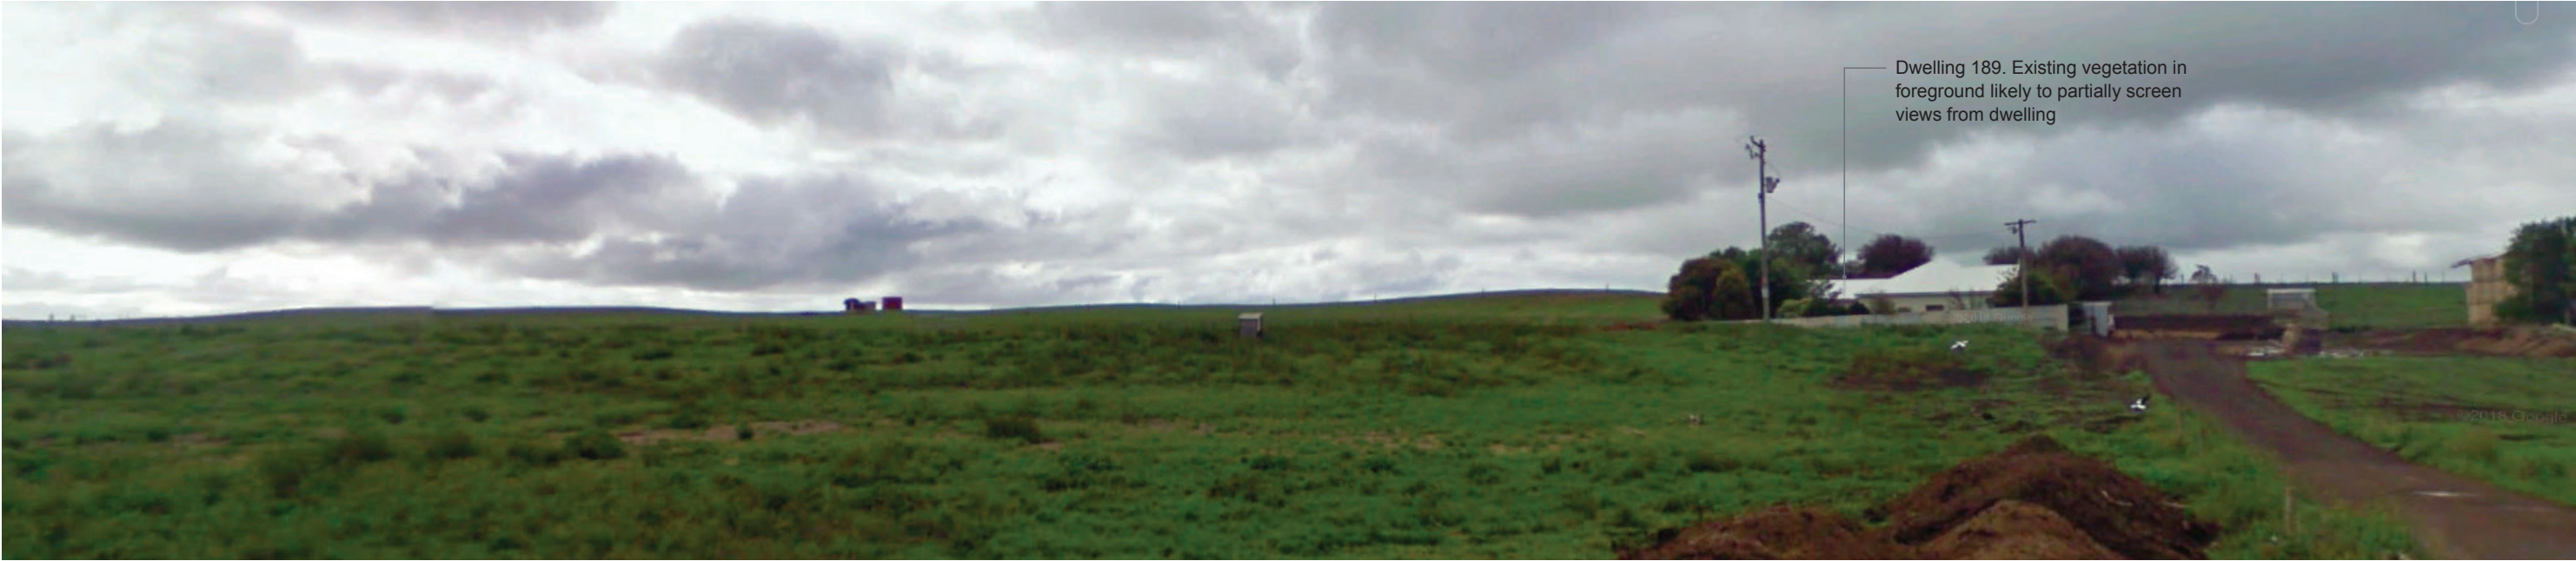
Dwelling 189 - Existing View
View from Williamsons Lane near mailbox of Dwelling 189 (Image Source: Google Street View 2021)

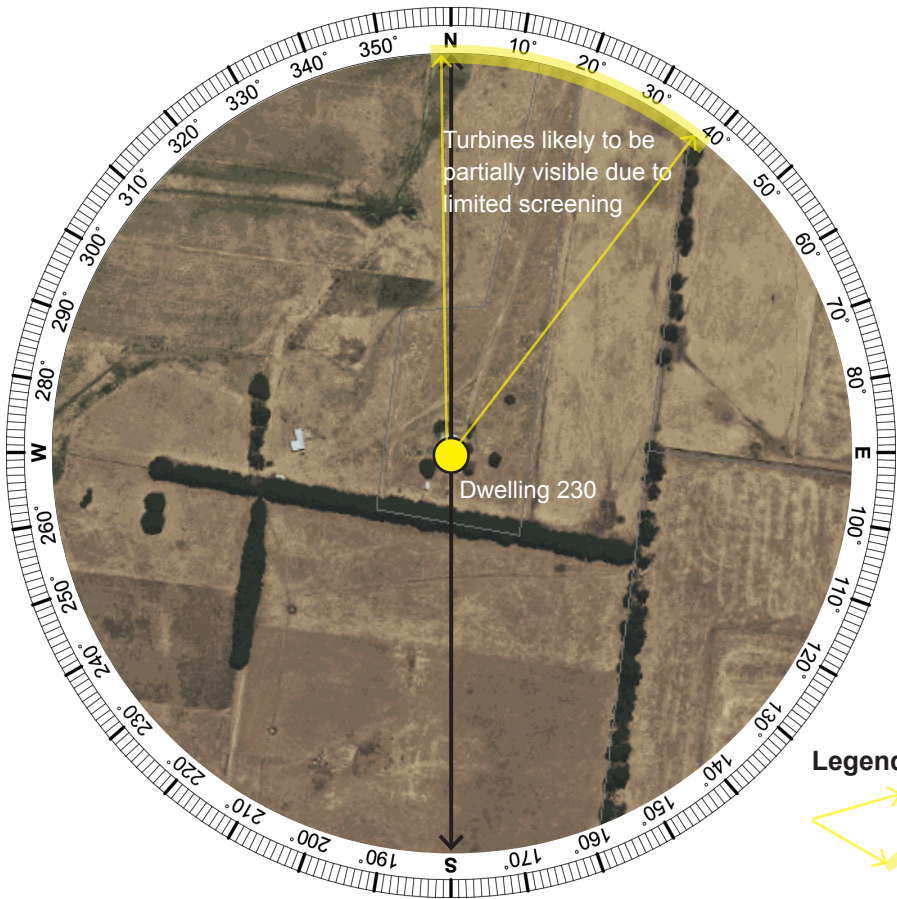
Dwelling 230 - Aerial Image
Location Plan (Image Source: VicPlan 2022)

An assessment based on topography alone suggests that all turbines are likely to be visible from Dwelling 230 which is located within 6000 m of the nearest turbine. Majority views of the Project are likely to be available in the north / north east. The dwelling is located on a flat terrain, and therefore, topographic character allows clear, open views of the Project. Aerial imagery indicates that the dwelling is orientated north-south and the dwelling's surrounds are sparsely vegetated. It is likely that most views in this direction will be available. A combination of distance from the Project and existing screening elements suggest that distant views of the Project are likely to be available at this dwelling.

Distance to Nearest Turbine:	5.29 km
Number of potentially visible turbines (based on topography alone):	61 turbines (All at tip height)

It is likely that views of most of the Project will be available. Additional screening is recommended for the dwelling's immediate foreground on the northern side. Consultation with the landowner will be required before recommending any additional planting.

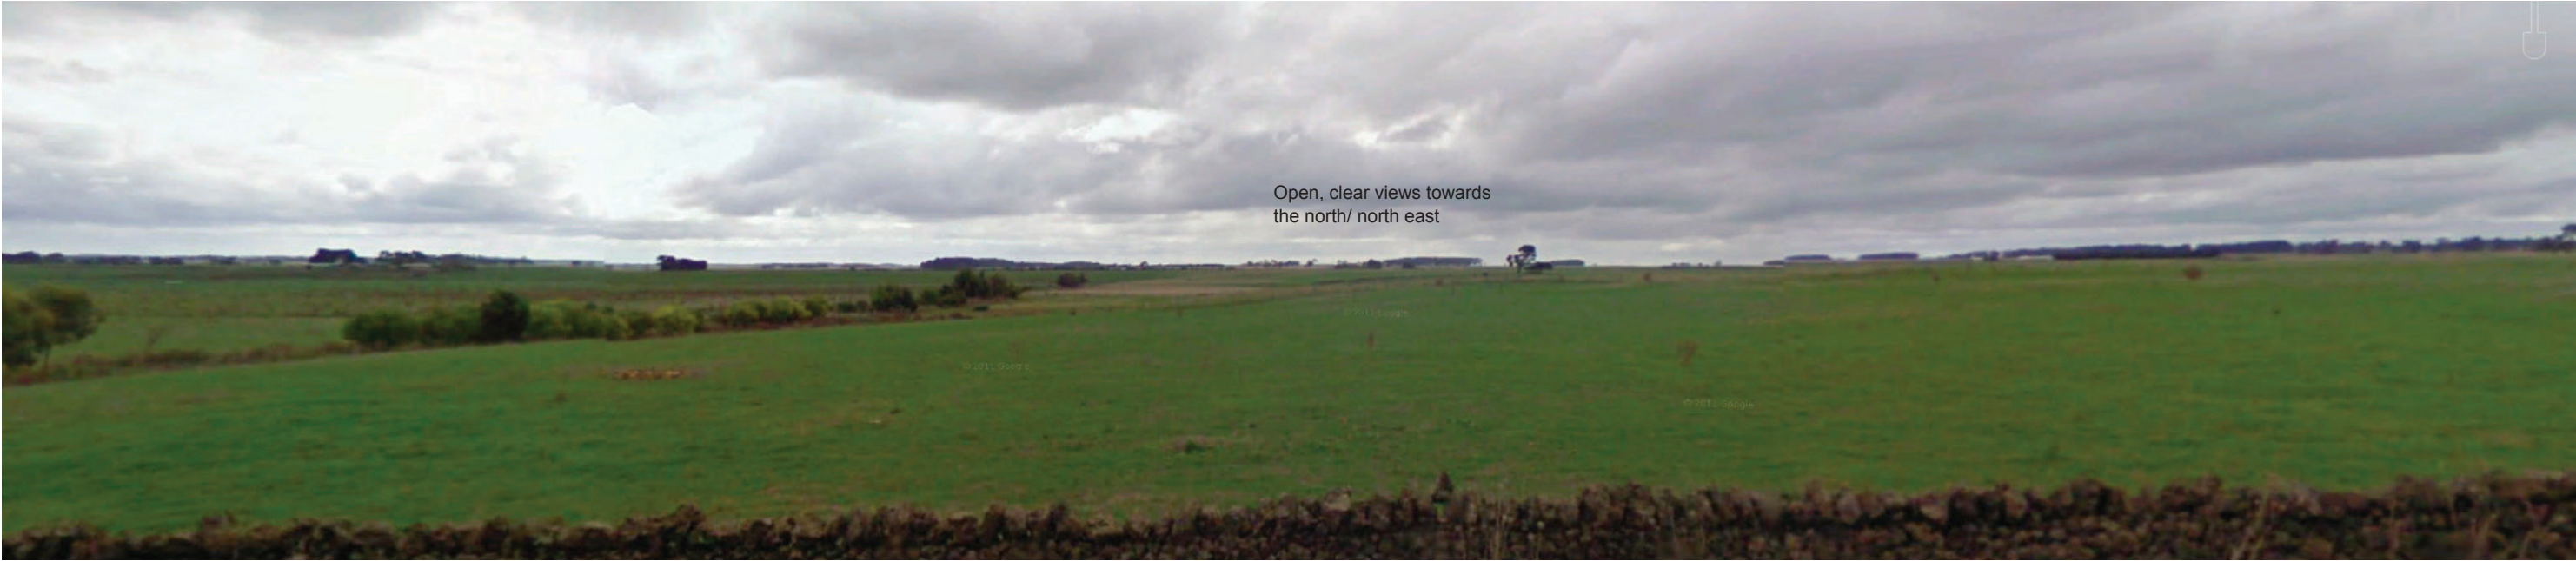
Dwelling 230 - Existing View
View from Moloneys Road near mailbox of Dwelling 230 (Image Source: Google Street View 2021)
