Stage 1 - Scoping Report

Bendigo Creek Huntly Common Reserve

Huntly Common Pty Ltd

10 September 2020

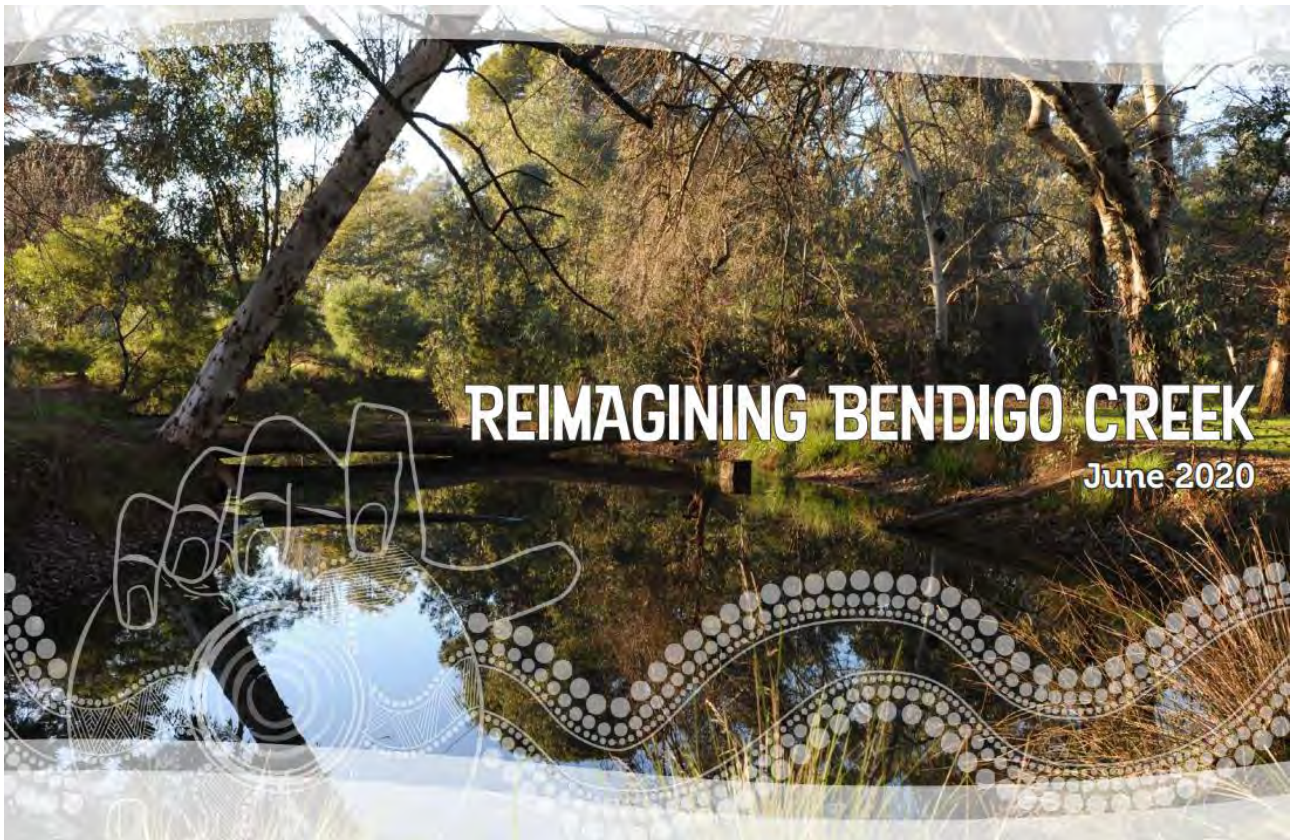
FIGURE 2-1 REIMAGINING BENDIGO CREEK DRAFT PLAN (CITY OF GREATER BENDIGO, 2020).

The Re-imagining Bendigo Creek Plan (Figure 2-1) is a strategic plan that was adopted by the City of Greater Bendigo Council in June 2020 that will be of guidance to the proposed works arrangements. The Draft Plan can be accessed from the City of Greater Bendigo's web site here (<https://www.bendigo.vic.gov.au/sites/default/files/2020-06/Reimagining-Bendigo-Creek.pdf>).

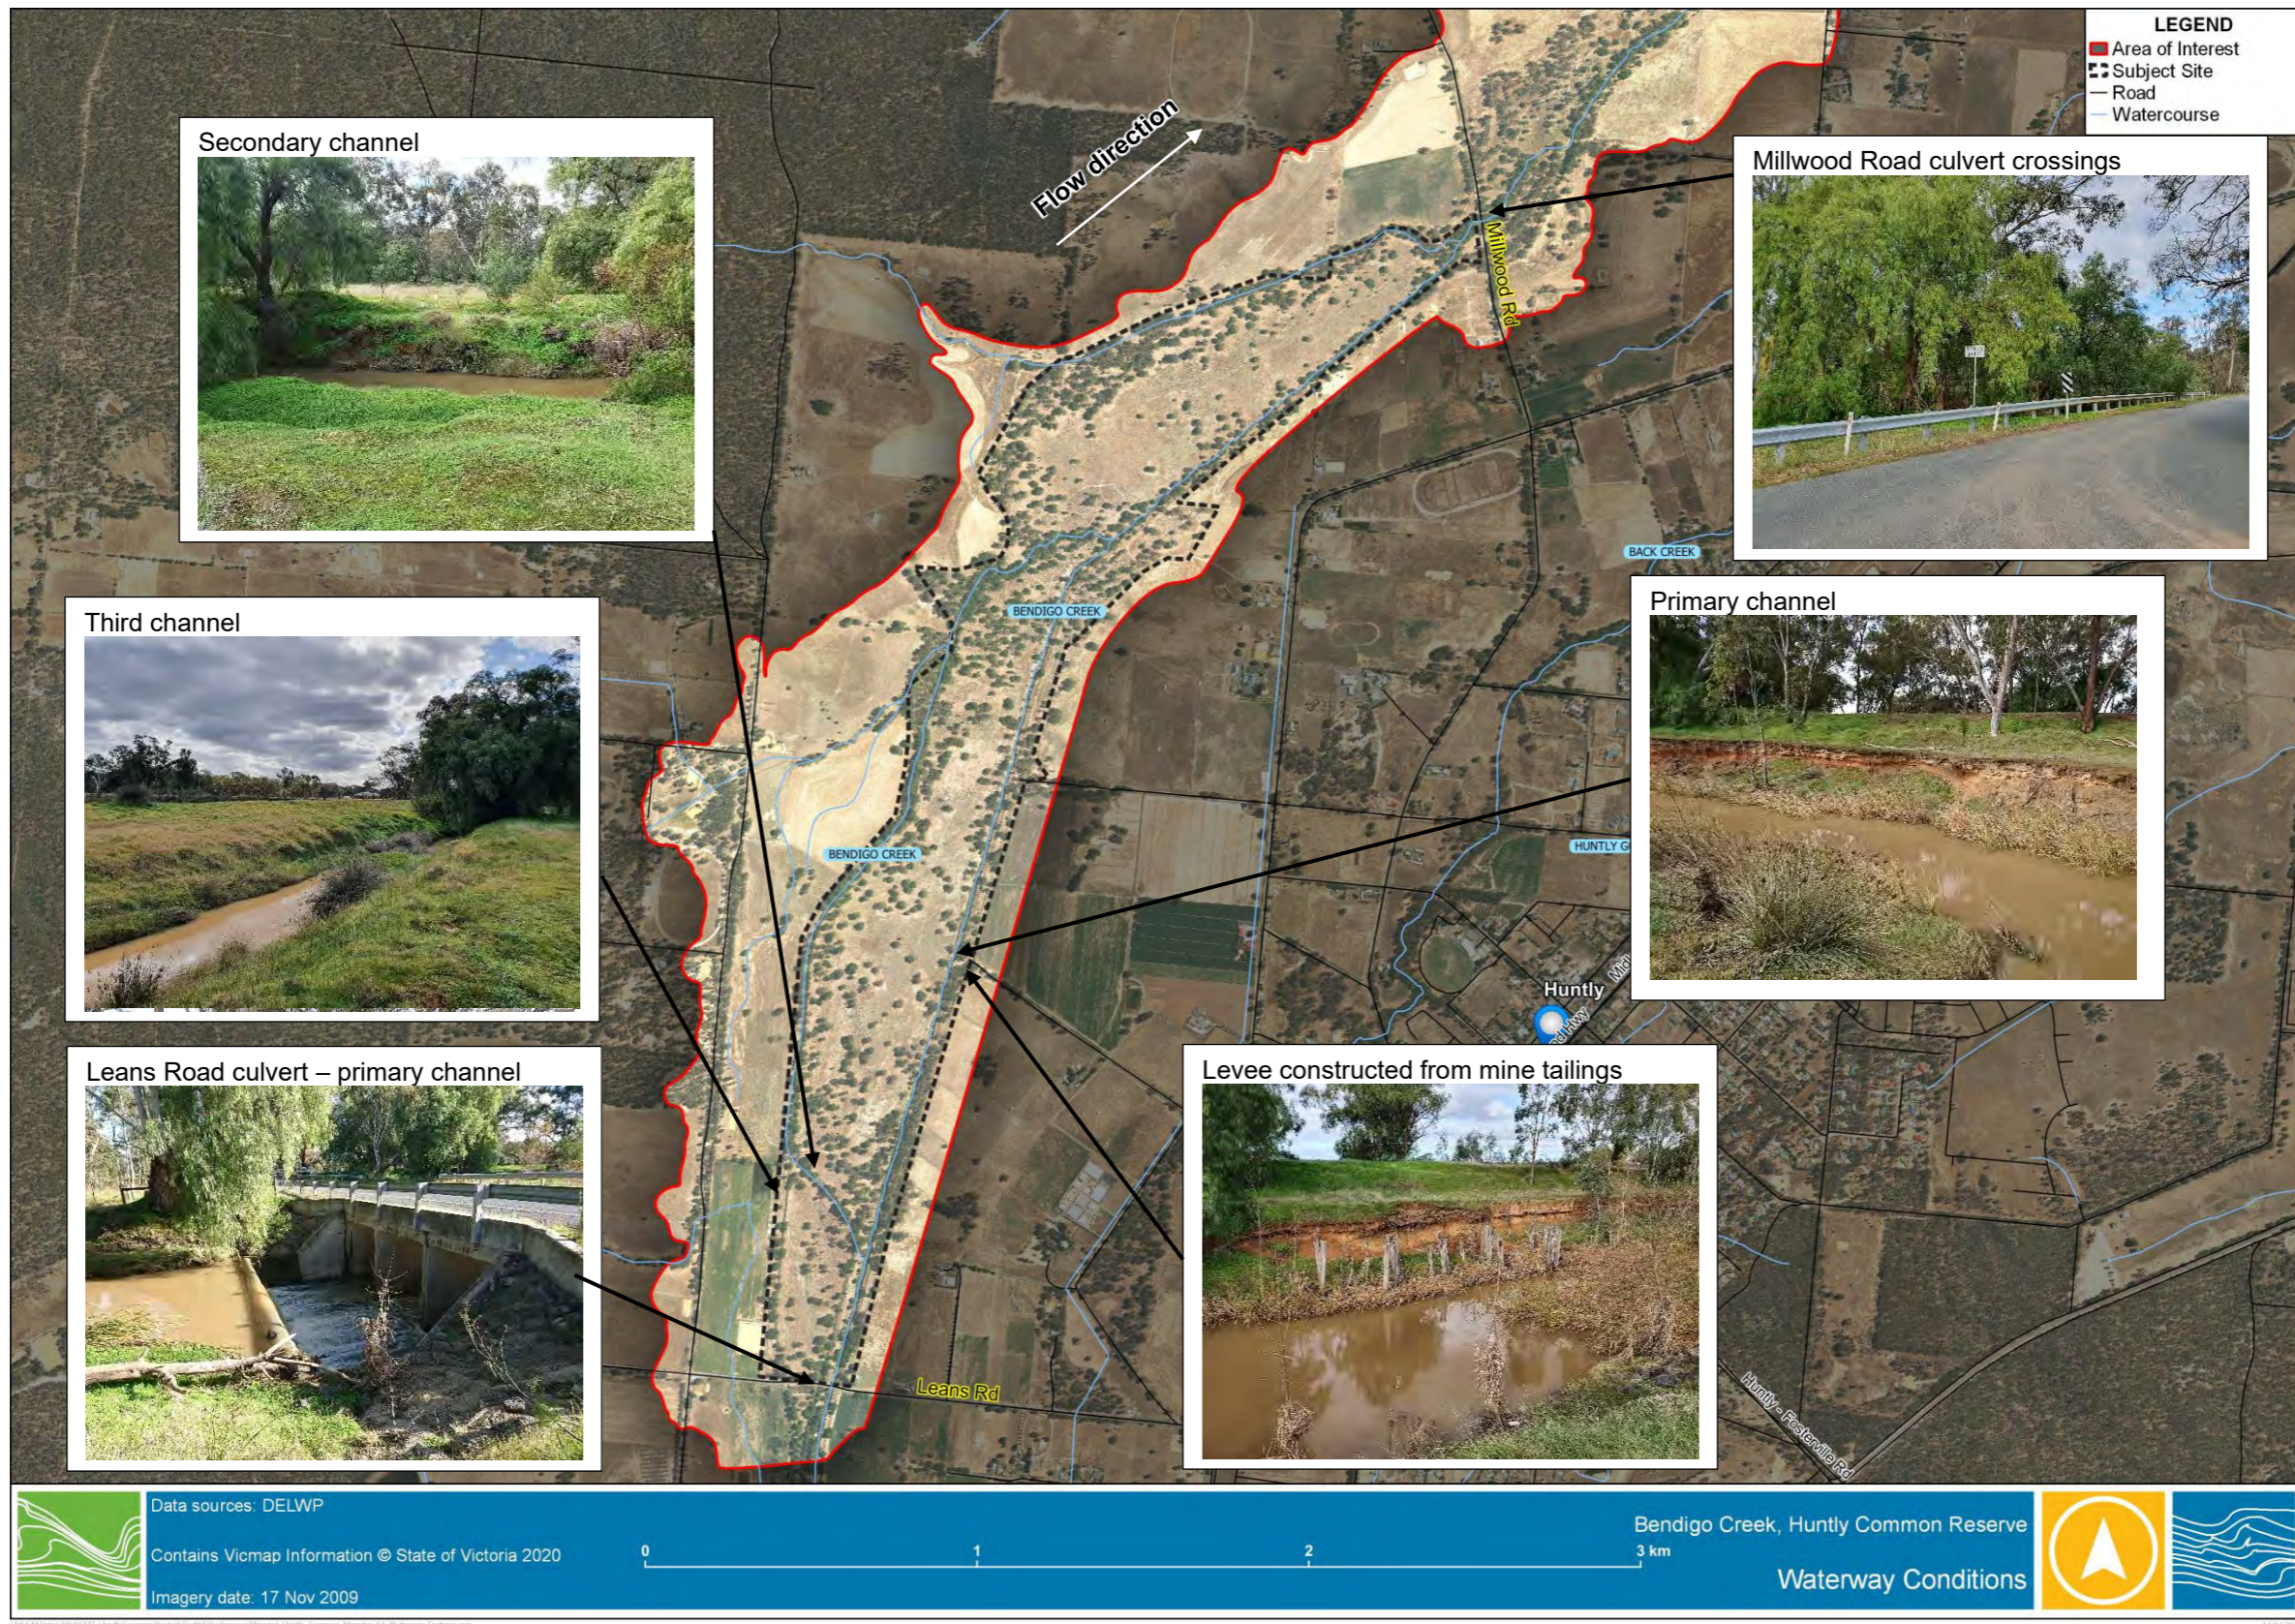
FIGURE 3-1 SITE LAYOUT.

- The third channel is positioned against the western boundary of the Streamside Reserve. The channel extends for approximately three kilometres in length, before entering the Bendigo Creek primary channel. This channel receives inflows from the local catchments/tributaries on the western side of the creek. A pipe outlet was observed on the bank face. The outlet appears to discharge flows from a dam on the western side of the channel, a short distance downstream of Leans Road.

- A small tributary stream, originating within the Greater Bendigo National Park, enters the Reserve from the western side towards the downstream end of the reach. This tributary subsequently joins Bendigo Creek approximately 140m upstream of Millwood Road.

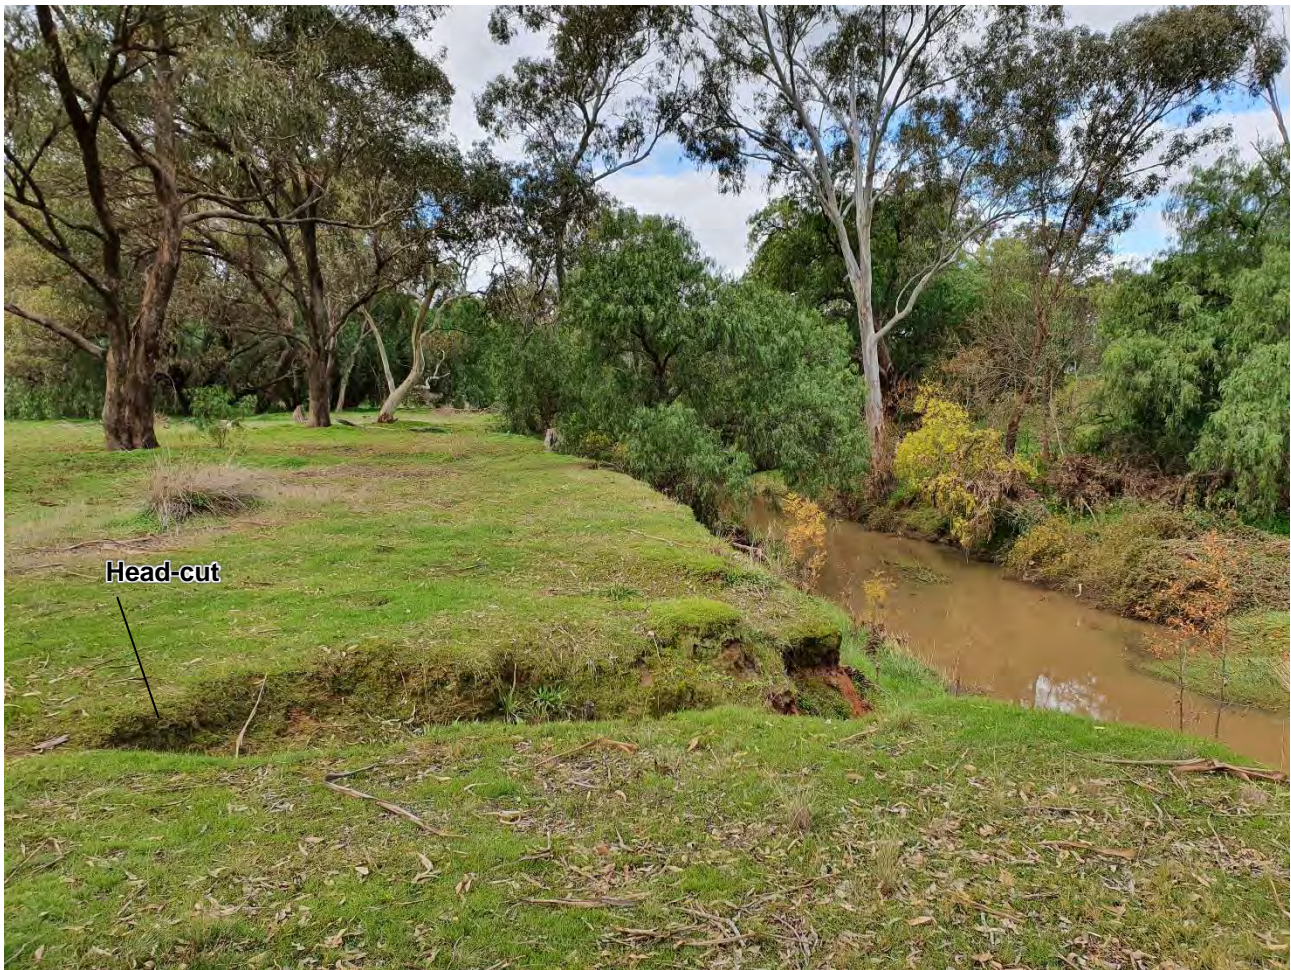
FIGURE 3-5 AN EXAMPLE OF A HEAD-CUT OCCURING INTO THE FLOODPLAIN IN RESPONSE TO DEEPENING WITHIN THE TRUNK STREAM.

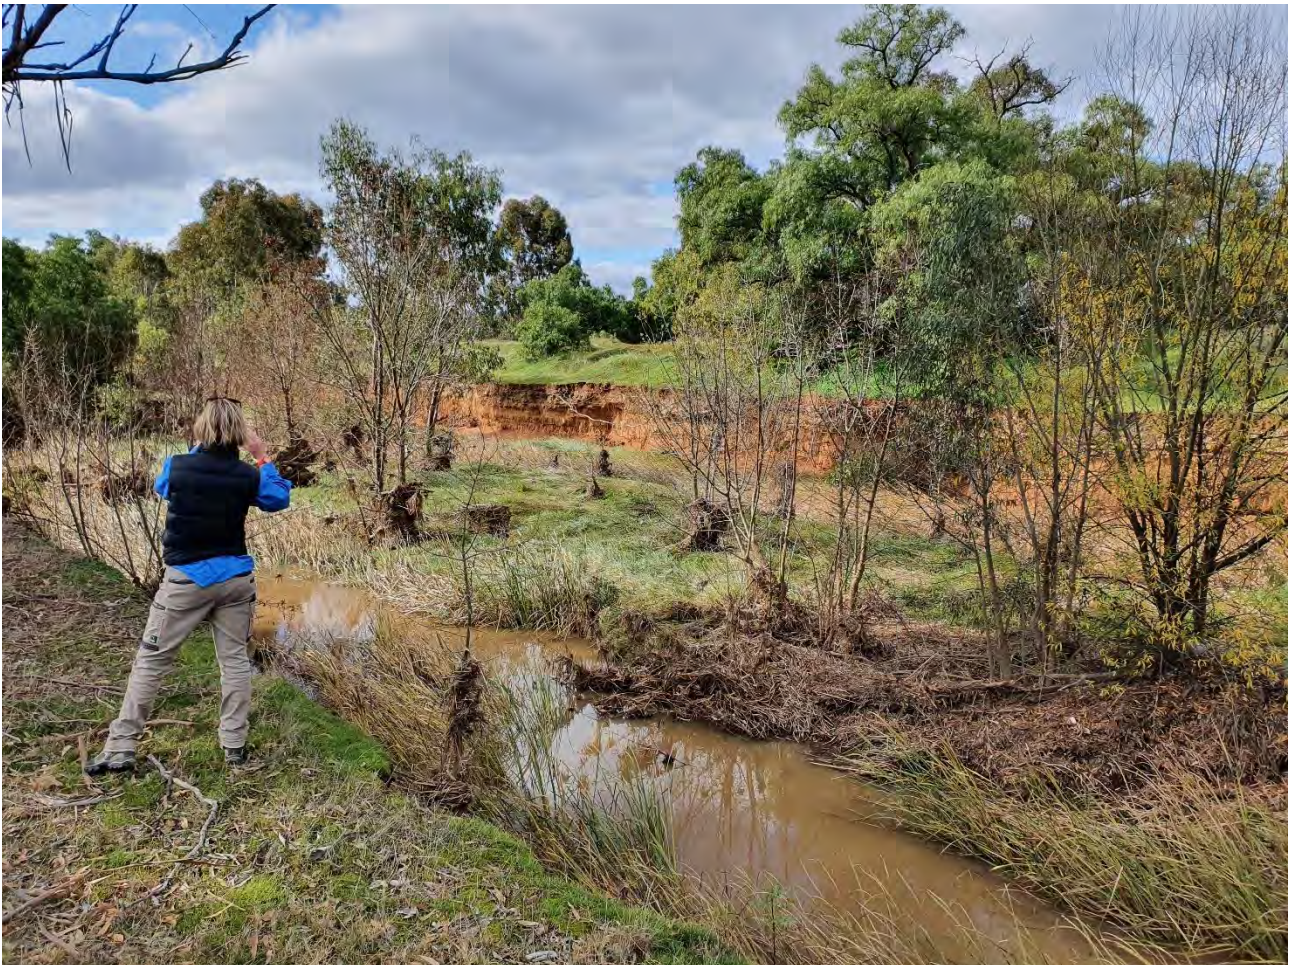
Channel enlargement primarily occurs through bed level lowering, a process in which the bed-level is lowered through erosion (Section 3.2.3.1). This can occur for many reasons and can have several effects on bank stability, in-stream geomorphic diversity and floodplain hydrology. It is almost always accompanied by channel widening as the steepening banks collapse (Figure 3-7). Hence, bed level lowering combined with channel widening results in the enlargement of the overall channel area. As a consequence of the increased channel capacity within this reach, flow events of considerable magnitude remain in-channel, resulting in increased hydraulic forces (stream powers and shear stresses) that are expended as erosive energy on the channel bed and banks.

FIGURE 3-7 DOWNSTREAM VIEW OF BENDIGO CREEK WHERE CHANNEL WIDENING HAS OCCURRED.

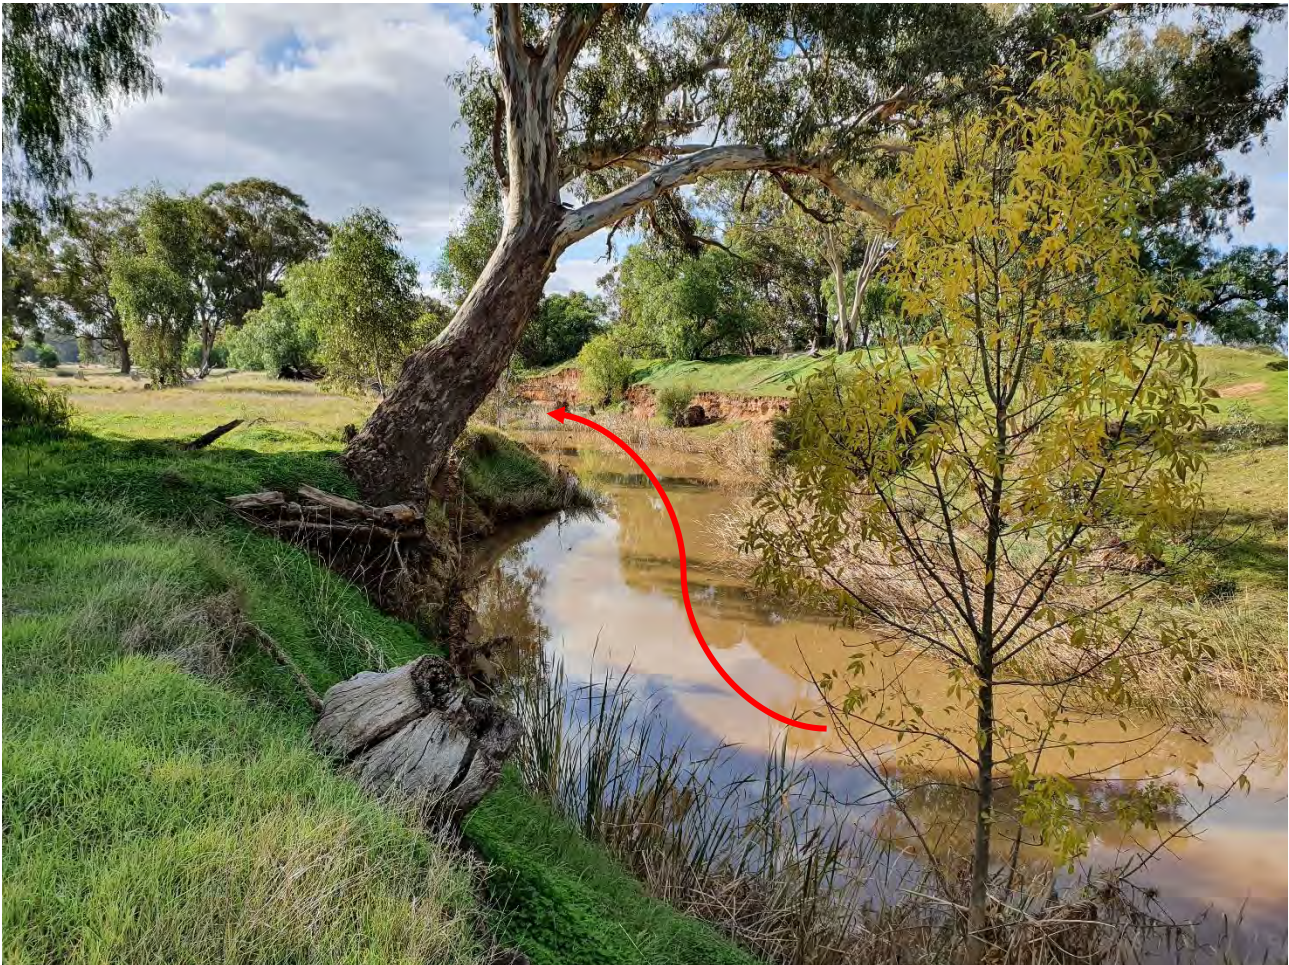
Bank erosion can occur in response to several different processes and can present in a variety of forms. Toe erosion of banks, particularly on the outside of meander bends (meander extension), was a commonly observed form of bank erosion and is occurring in response to channelisation, whereby the stream channel attempts to reduce its bed slope and thus its erosive power (Section 3.2.3.1) and Figure 3-8.

channel planform change. Erosion is expected at the outside of bends, as it is an area in increased flow velocity. Likewise, deposition is expected on the inside of the bend, as it is an area of reduced flow velocity.

FIGURE 3-8 DOWNSTREAM VIEW OF BENDIGO CREEK DEMONSTRATING MEANDER EXTENSION, OCCURRING IN RESPONSE TO CHANNELISATION, WHERE THE CREEK ATTEMPTS TO REDUCE ITS EROSION POWER BY DECREASING ITS BED SLOPE.

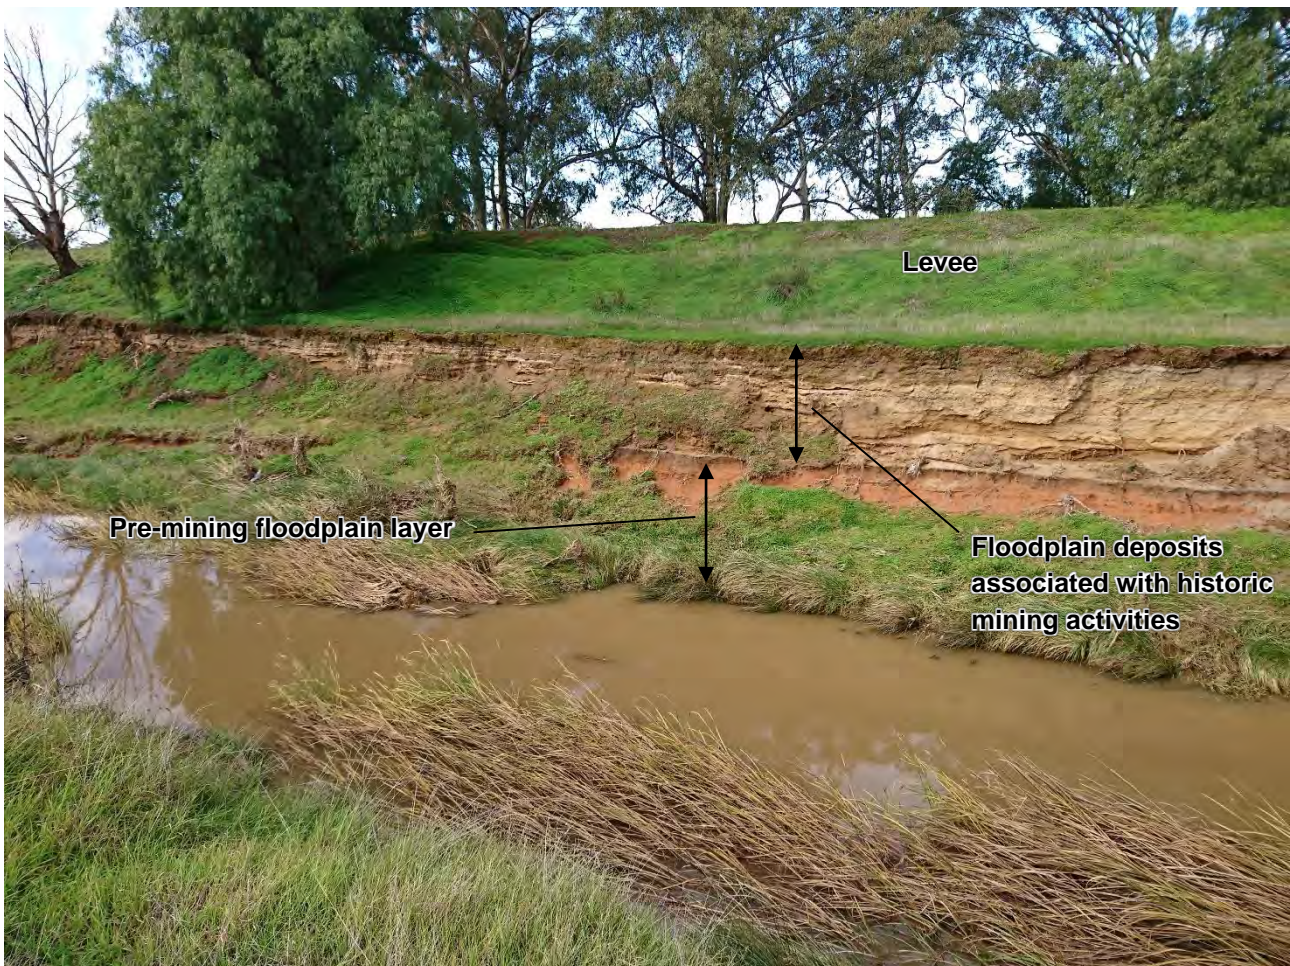
Like the primary Bendigo Creek channel course, the remaining channels within the Reserve have been artificially constructed through the historic floodplain deposits. Whilst these channels have deepened and likely widened in response to the artificial channelisation, the contemporary bank erosion is less common in these channels compared to the primary Bendigo Creek channel course.

FIGURE 3-9 THE DISTINCT FLOODPLAIN DEPOSITS ASSOCIATED WITH HISTORIC MINING OVERLYING THE PRE-EUROPEAN FLOODPLAIN LEVEL. NOTE THE LEVEE A SHORT DISTANCE BEHIND THE CHANNEL.

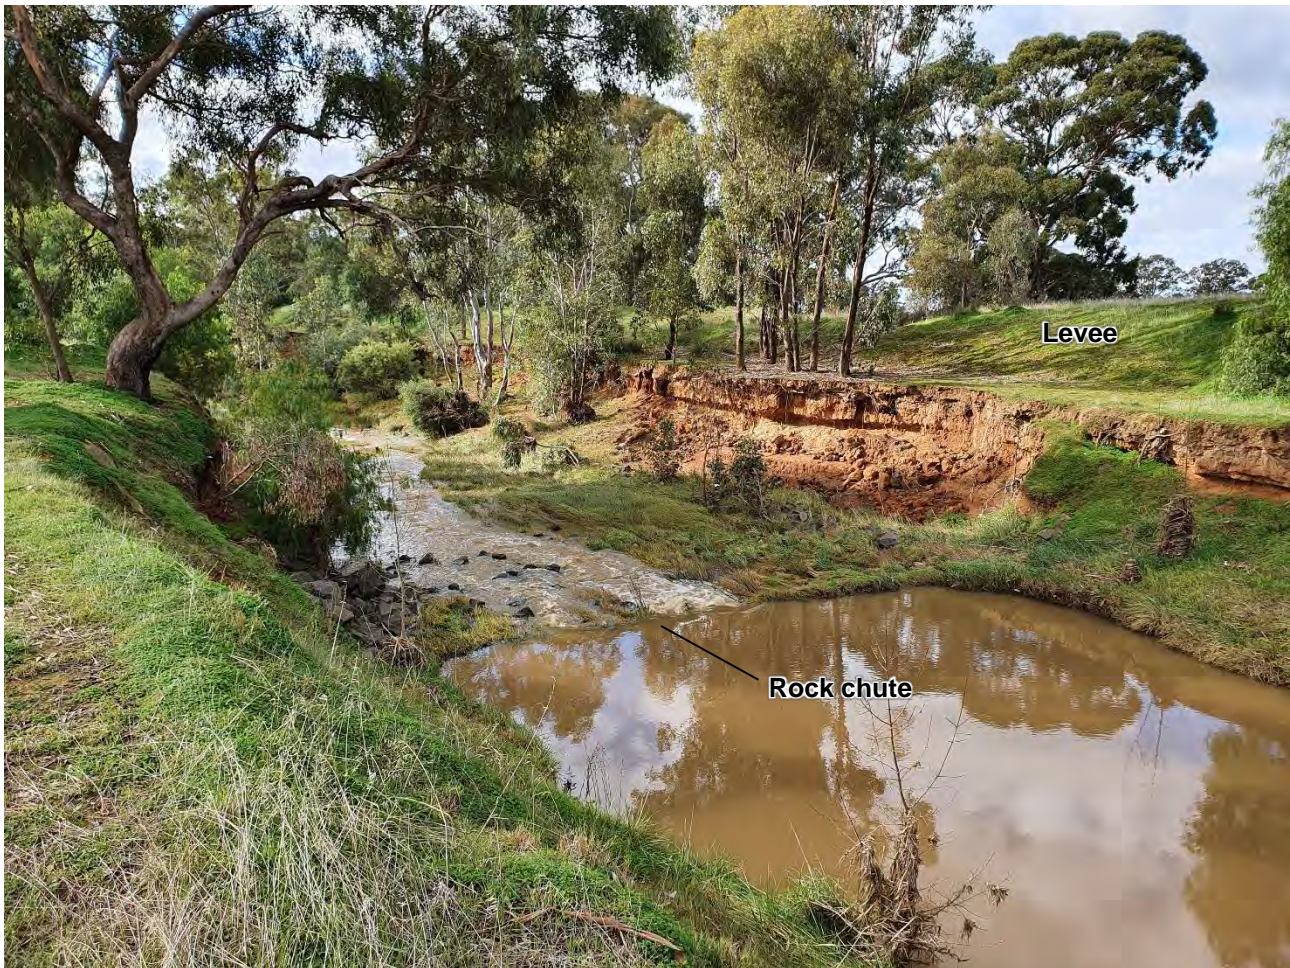
There is evidence of past erosion control works within Bendigo Creek through the presence of a failed pile field structure and a rock chute situated approximately 1.5km downstream of Leans Road (Figure 3-10). Whilst the rock chute is in poor condition, it still provides a form of longitudinal bed control.

FIGURE 3-10 DOWNSTREAM VIEW OF THE ROCK CHUTE. WHILST IN POOR CONDITION THE STRUCTURE PROVIDES LONGITUDINAL BED GRADIENT CONTROL.

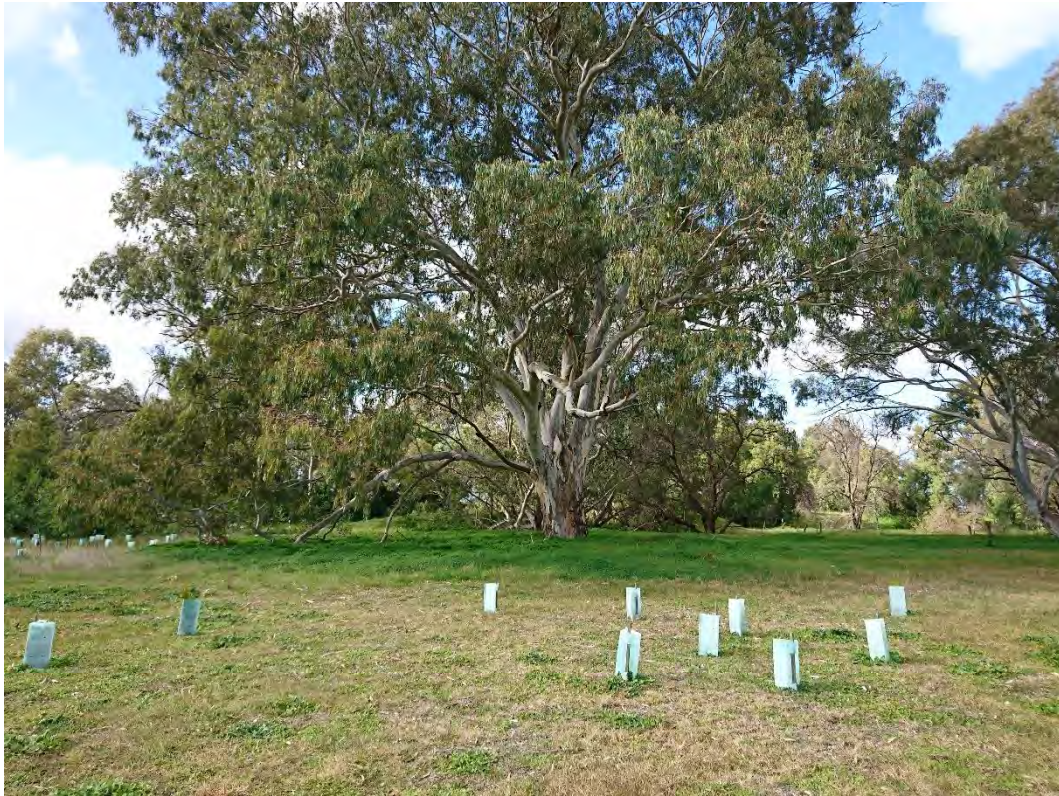
FIGURE 3-13 LARGE RIVER RED GUM

Some of the River Red Gum trees on site are classified as 'Large Old Trees' for this EVC as they exceed 80 cm in diameter at breast height (DBH, measured at 1.3 m above the ground). There are several trees on site which exceed 130 cm DBH (e.g. 138 cm, 140 cm and 167 cm DBH). These trees are located near the entrance to the reserve on Leans Road. Large old trees such as these often bear hollows and provide habitat for birds, arboreal mammals and other fauna species. They are a source of seed, as well as fallen timber and organic litter for ground dwelling fauna and invertebrates (Figure 3-13).

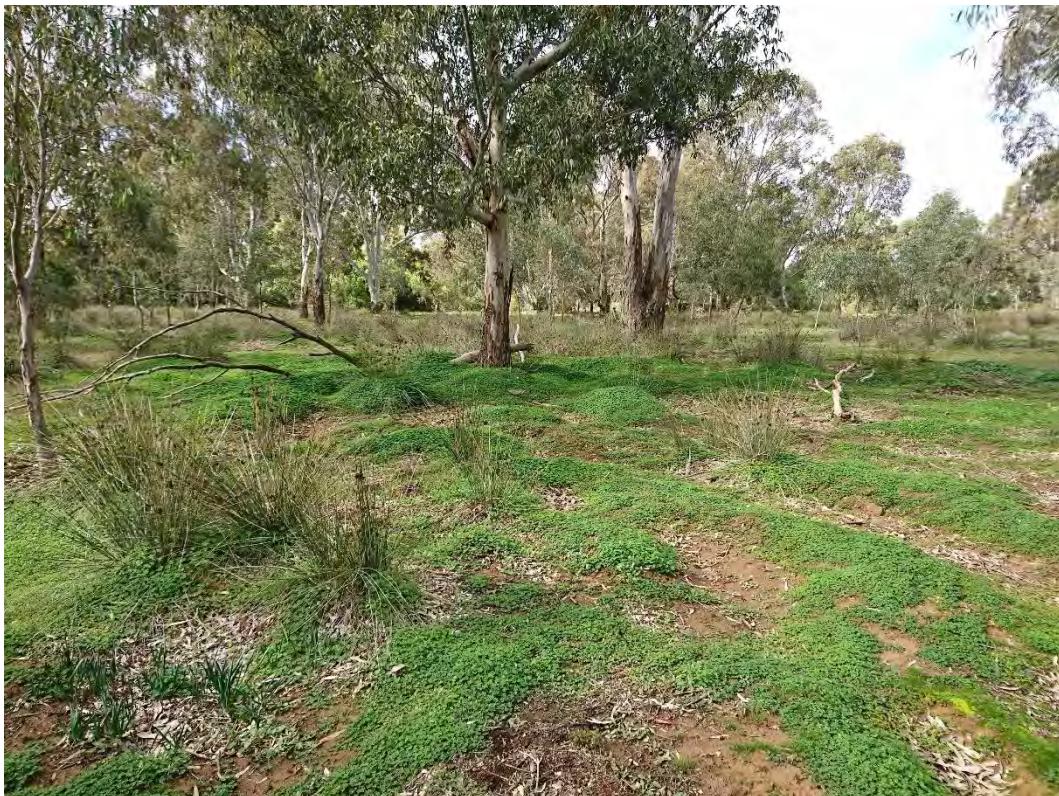
FIGURE 3-14 MIXED AGE RIVER RED GUMS, WITH WEEDS SOURSOB AND SPINY RUSH ON THE FLOODPLAIN

The native understorey vegetation on site generally consists of scattered patches of juvenile River Red Gums and native grasses such as Wallaby Grasses (*Rytidosperma* spp.), Spear grasses (*Austrostipa* spp.) and Common Wheat grass (*Anthosachne scabra*) (Figure 3-14). A few wattles (*Acacia* sp.) were observed along the banks of the main Bendigo Creek channel on site. Native sedges, rushes and reeds were also observed in the bed and on the banks of this channel.

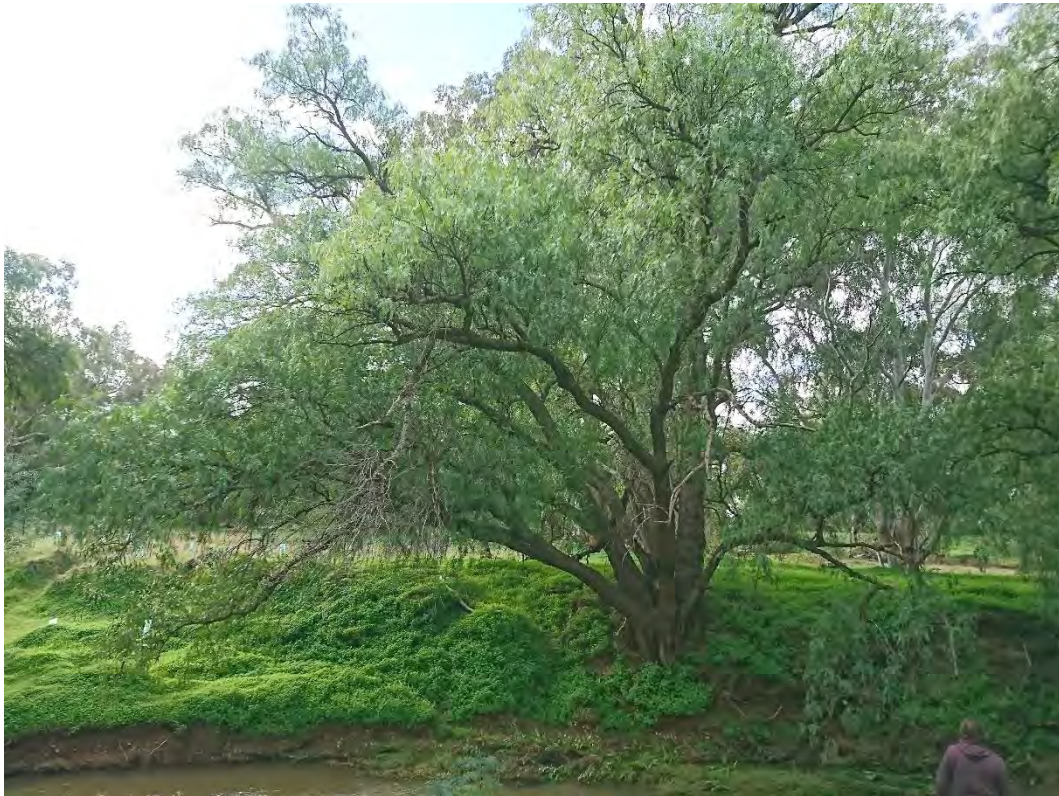
FIGURE 3-15 PEPPERCORN TREE ON THE BANK OF THE CHANNEL

The primary threat to the native vegetation condition at the site is the presence of weeds. Weeds along the banks of the waterways at the site include Peppercorn trees (*Schinus molle*), Soursob (*Oxalis pes capre*) and Spiny Rush (*Juncus acutus*) while young Willows (*Salix* sp.) and Ash (*Fraxinus* sp.) trees were observed in the Bendigo Creek channel (Figure 3-14 to Figure 3-17). Spiny Rush is also present in great numbers in some areas of the floodplain, along with Capeweed (*Arctotheca calendula*), Horehound (*Marrubium vulgare*) and scattered shrubs such as Sweet Briar rose (*Rosa rubiginosa*) and African Boxthorn (*Lycium ferocissimum*). Exotic grasses such as Wild Oat (*Avena fatua*) and Great Brome (*Bromus diandrus*) are also present at the site.

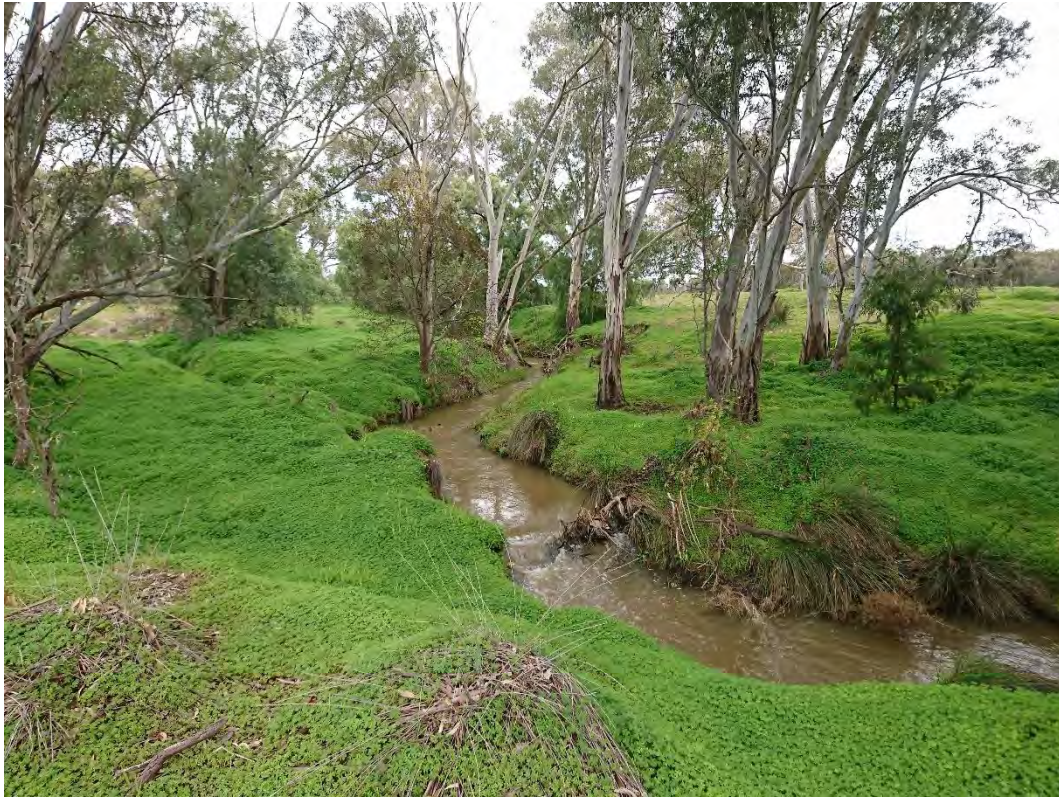
FIGURE 3-16 SOURSOB COVERING THE BANKS OF THE CHANNEL ON THE WESTERN SIDE OF THE SITE

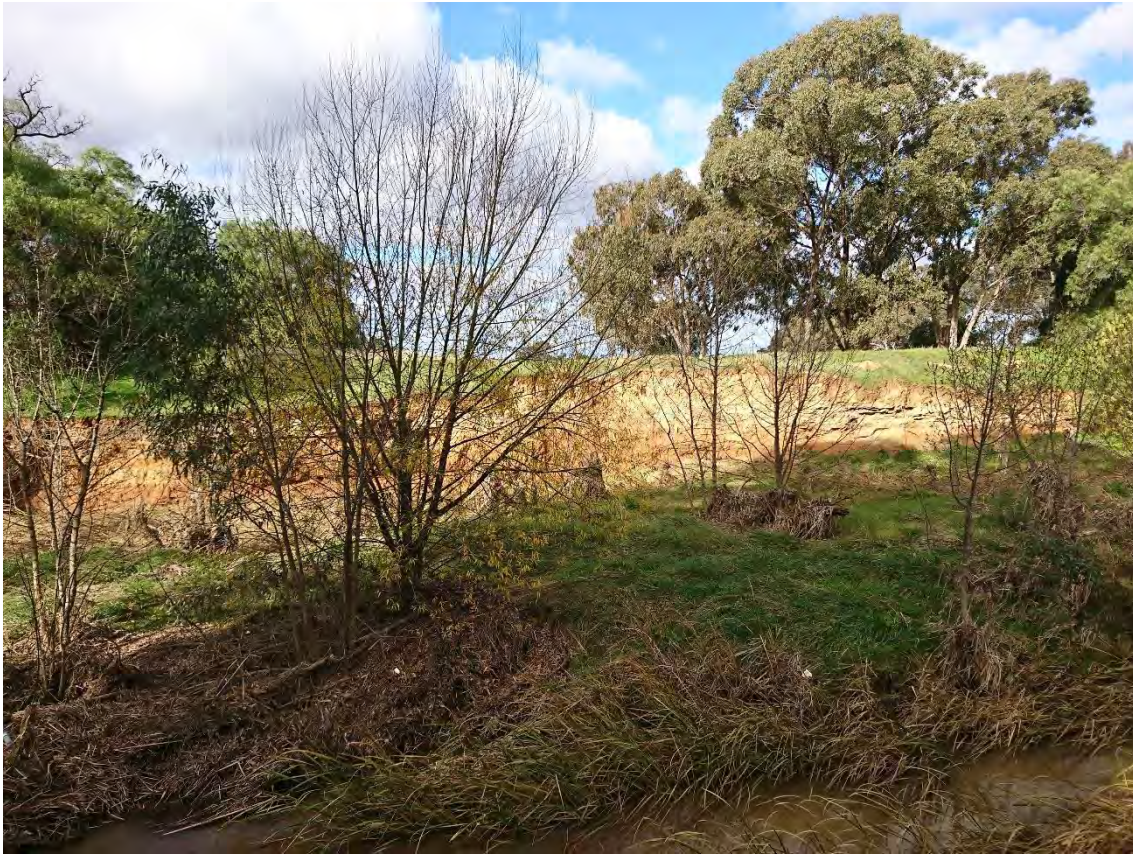
FIGURE 3-17 WILLOWS AND ASH IN THE MAIN CHANNEL

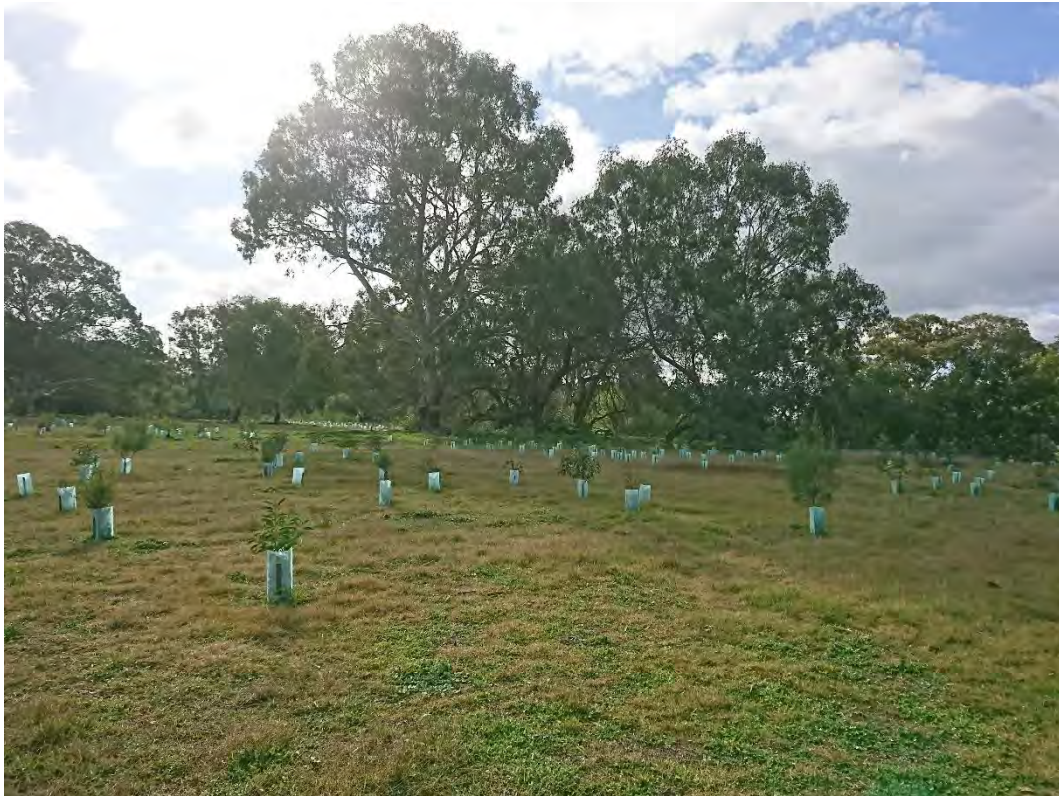
FIGURE 3-18 REVEGETATION ON THE FLOODPLAIN

As of February 2017, the Landcare group had installed 50 nest boxes with a range of designs to suit different species including: Brush-tailed Phascogale, Sugar Glider, Pardalote, Ducks, Lorikeets, Brown Treecreeper, Owlet-nightjar and Microbats. Monitoring has found at least one of each type of box has been used by all these except for Lorikeet, Brown Treecreeper and Owlet -nightjar (SWIFT 2020). Other activities include community plantings, weed & rabbit control, educational activities and nest box monitoring. Northern Bendigo Landcare Group has the support of Parks Victoria, local primary schools, Bendigo TAFE Conservation & Land Management and other community groups (SWIFT 2020) (Figure 3-18 to Figure 3-21).

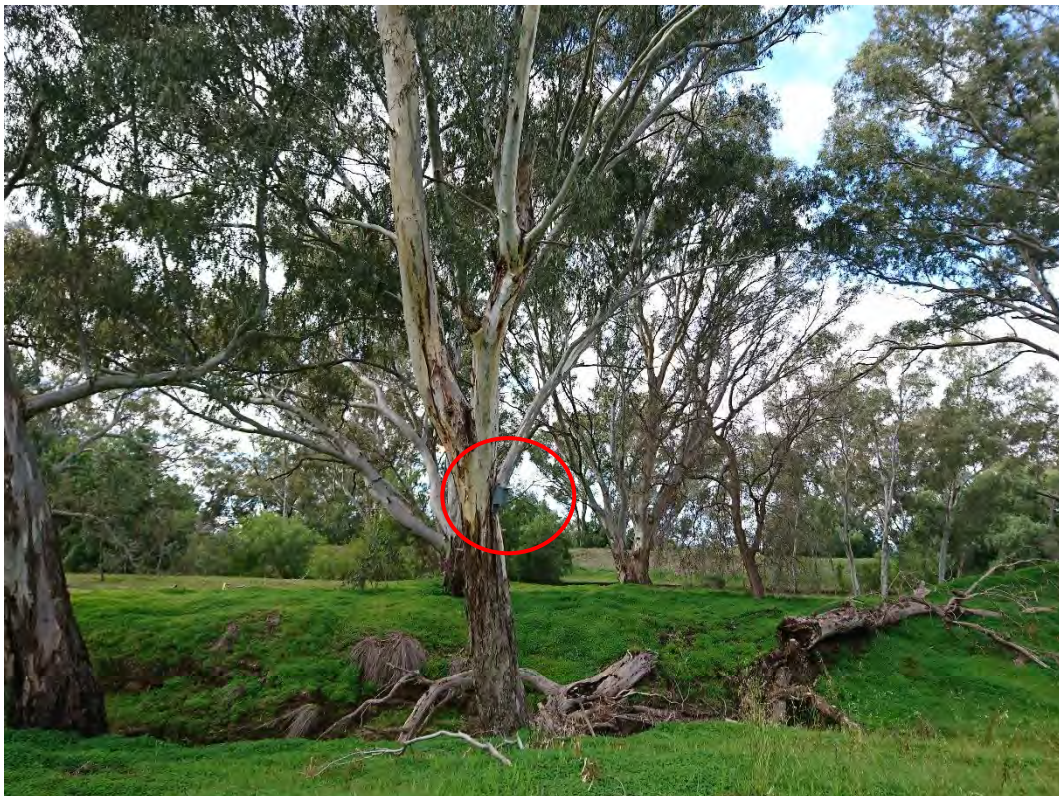
FIGURE 3-19 NESTBOX IN A EUCALYPT

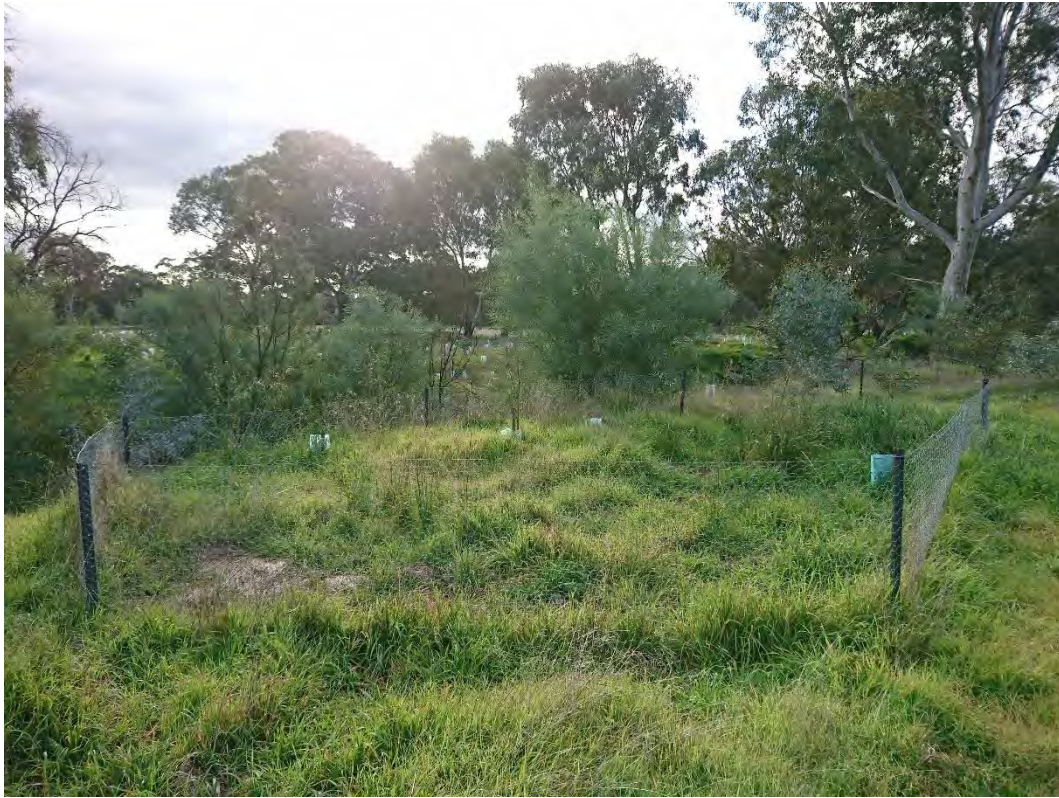
FIGURE 3-20 RABBIT EXCLOSURE FENCE AND OLDER REVEGETATION AT THE SOUTHERN END OF THE SITE

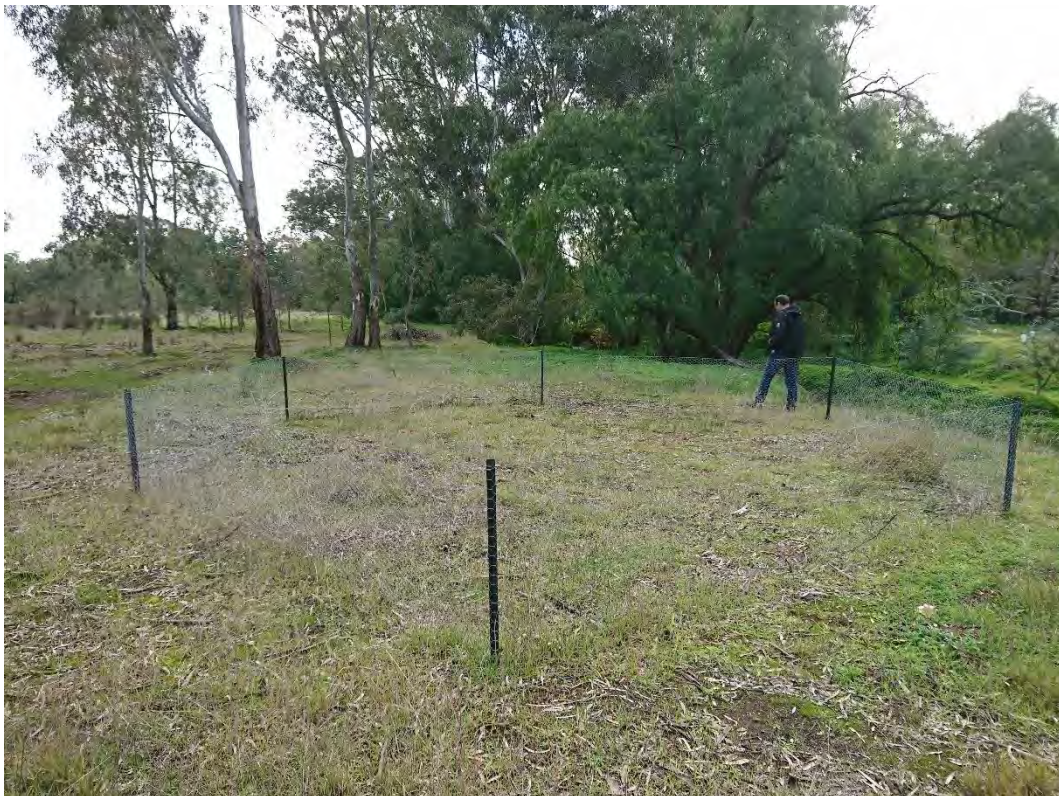
FIGURE 3-21 RABBIT EXCLOSURE CONTAINING NATIVE GRASSES

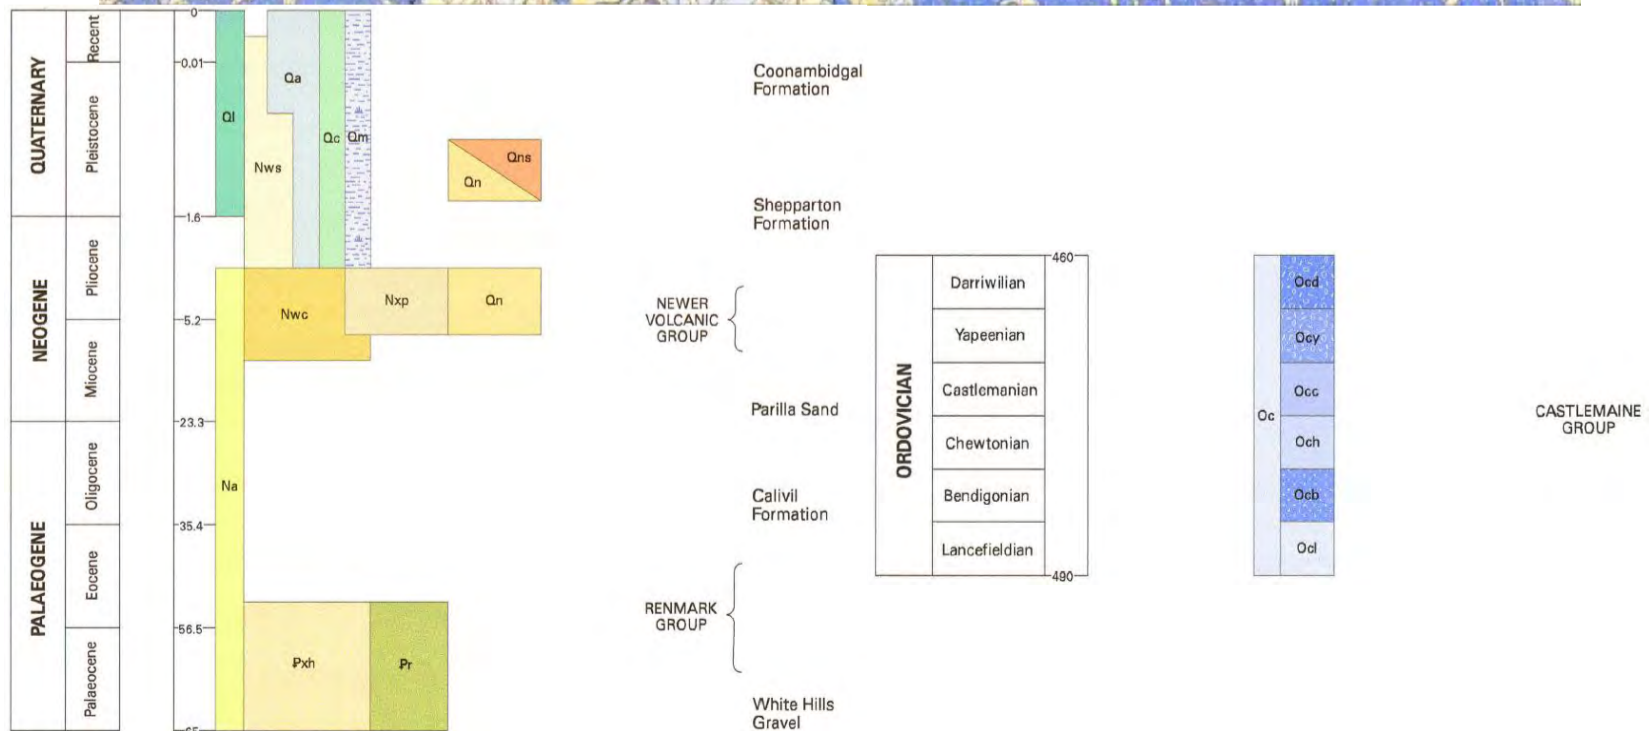
FIGURE 3-26 EXTRACT FROM HUNTLY 1:50,000 GEOLOGICAL MAP SHEET (PARENZAN ET AL., 2001)

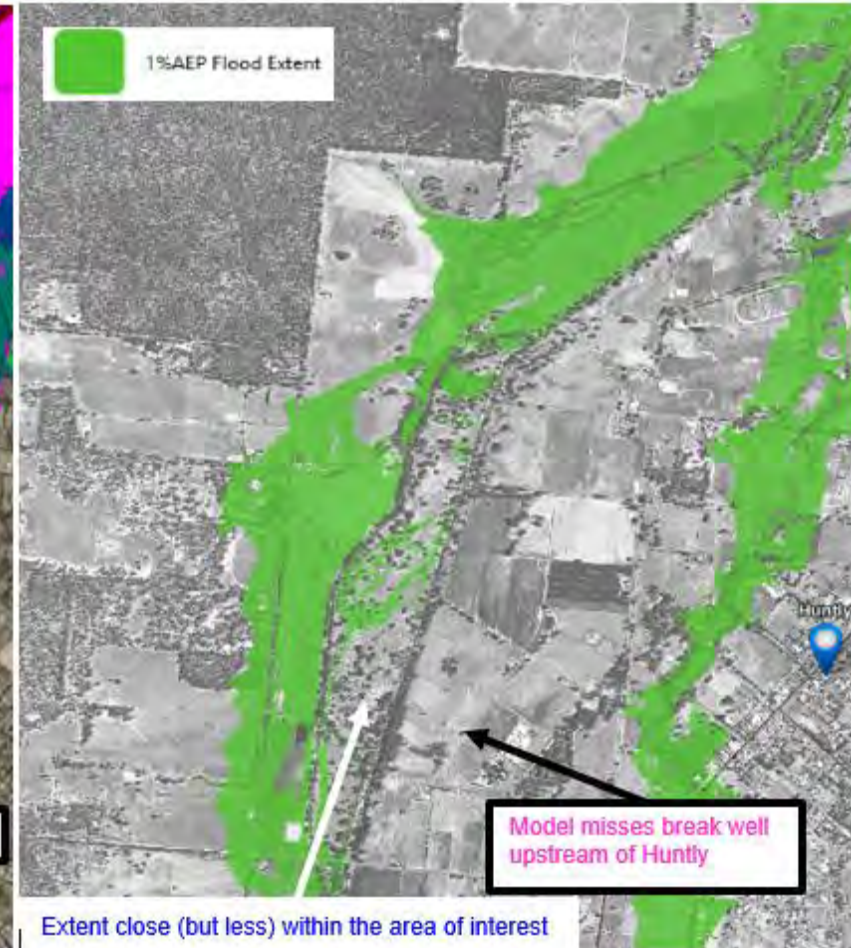
BMT (2019) - Mitigated Conditions (opt 1) – 1%AEP

WT (2020) - Existing Conditions – 1%AEP

FIGURE 5-4 COMPARISON OF MODEL RESULTS: EPSOM ASCOT HUNTLY FLOODPLAIN MANAGEMENT STUDY (2019) (LEFT), CURRENT MODEL (RIGHT)
