“COMMERCIAL IN CONFIDENCE”
Huntly Common
Preliminary Environmental Site Assessment
Huntly Streamside Reserve, Victoria

58207 - 131,111 - Rev0

JBS&G Australia Pty Ltd

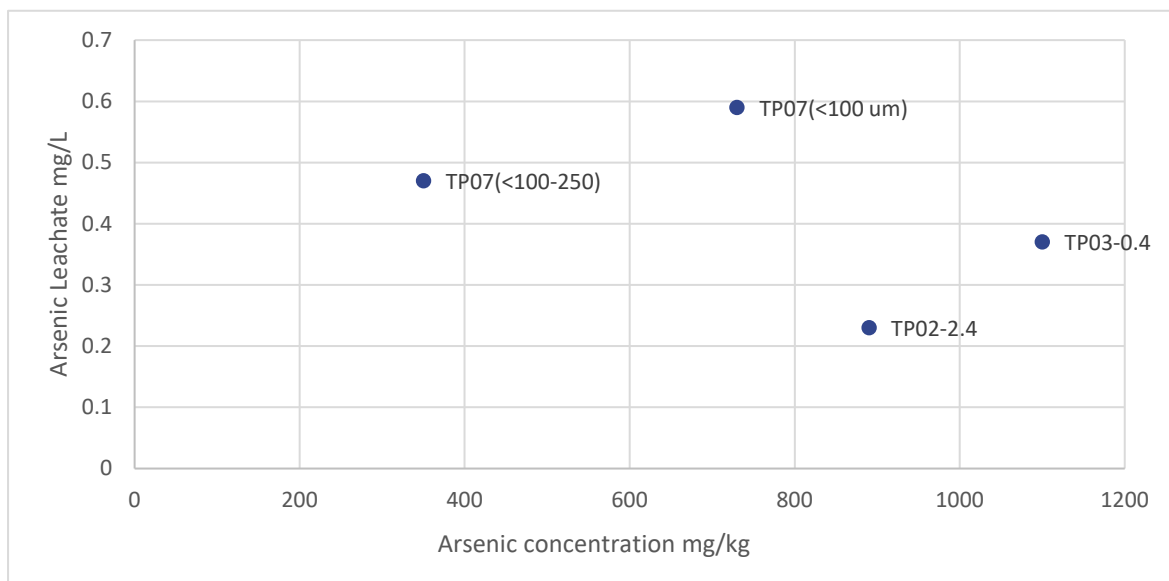
Plate 1: Correlation between arsenic concentration in soil and arsenic leachate level

Plate 1 below indicates there is no particular trend between arsenic concentration and arsenic leachability in the select samples test, however all samples had some degree of reported leaching.

The results from the leachability undertaken indicated that arsenic is potentially leachable from the site soil. All sediment samples subject to ASLP testing were found to have a leachate with detectable level of arsenic. The highest leachate result was found from TP07 (<100 um), with an arsenic leachate concentration of 0.59 mg/L. The highest degree of leachability was from TP07 (100 – 250 um) (at pH 5).

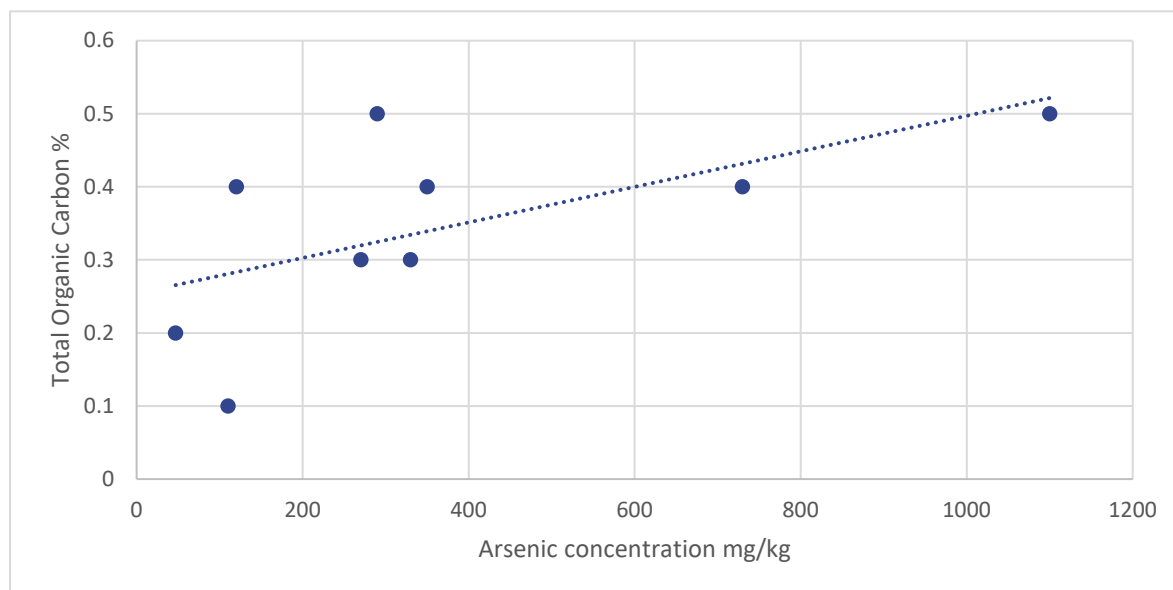
Plate 2: Correlation between arsenic concentrations in select soil samples and total organic carbon levels.

It was found that the highest TOC level in the soil assessment was 0.5 % and occurred at TP03-0.4, which is the location of the highest arsenic concentration of 1,100 mg/kg. TOC levels (expressed as a percentage) and arsenic concentrations were subsequently plotted to evaluate whether this potential trend further, and this is shown in **Plate 2** below.

As indicated by **Plate 2** above, and acknowledging that there is only limited data available, there appears to be a slight positive correlation between arsenic concentrations in soil and TOC levels, suggesting that elevated arsenic concentrations are associated with higher TOC levels.

Total Organic Carbon testing found that there is a slight positive correlation between arsenic concentrations in soil and TOC.
