# **Victorian Murray Floodplain Restoration Project**

## **Desktop Historical Heritage Assessment - Burra Creek**

IS297752-CH-CH-RP-0001 | Rev 0

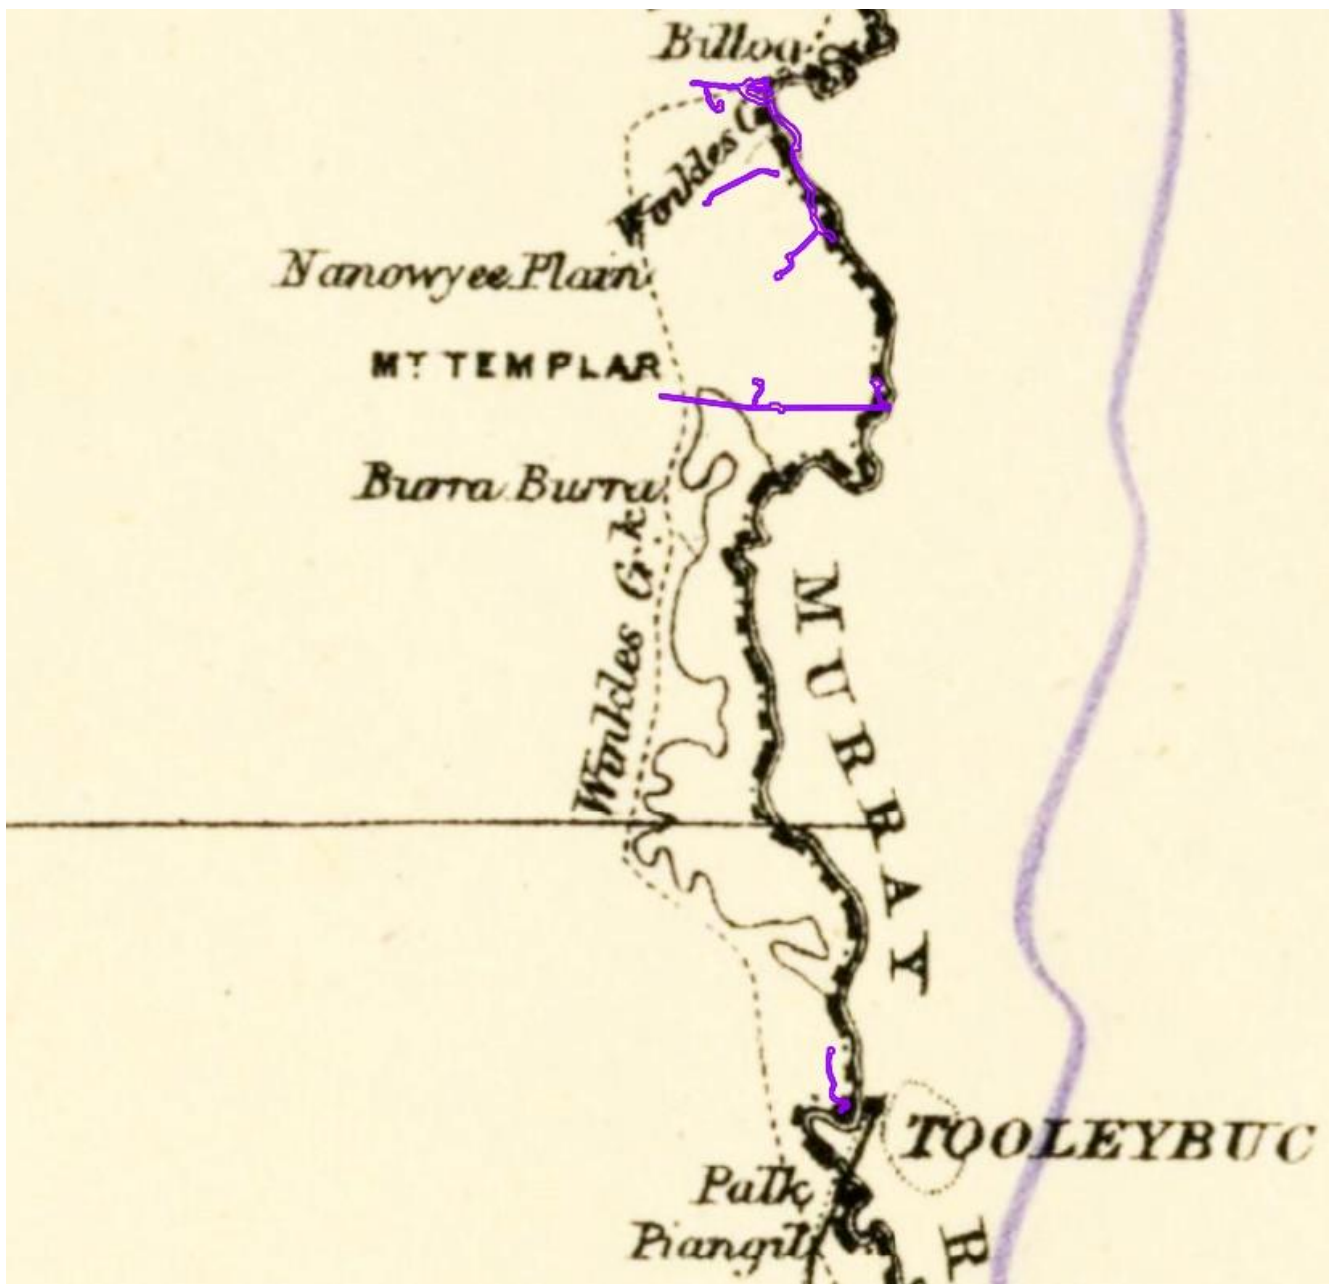
The County of Tatchera map from 1884 shows that there were townships extant along the Murray River, including Piangil, on the road to Tooleybuc in NSW, and a smaller roadway to the west of Winkles Creek (Burra Creek) leading to Burra Burra, which was situated to the south of Mount Templar and the Nanowye Plain. Biloo is noted on the map in the north, adjacent to the roadway which generally follows the alignment noted in 1851 (Figure 2.2). Both the Murray River and Burra Creek appear to have changed courses somewhat since this map was produced.

Figure 2.2: 1884 Tatchera county map, with the area of investigation outlined in purple; the Murray River appears to have changed course since this map was created (Department of Lands and Survey 1884)

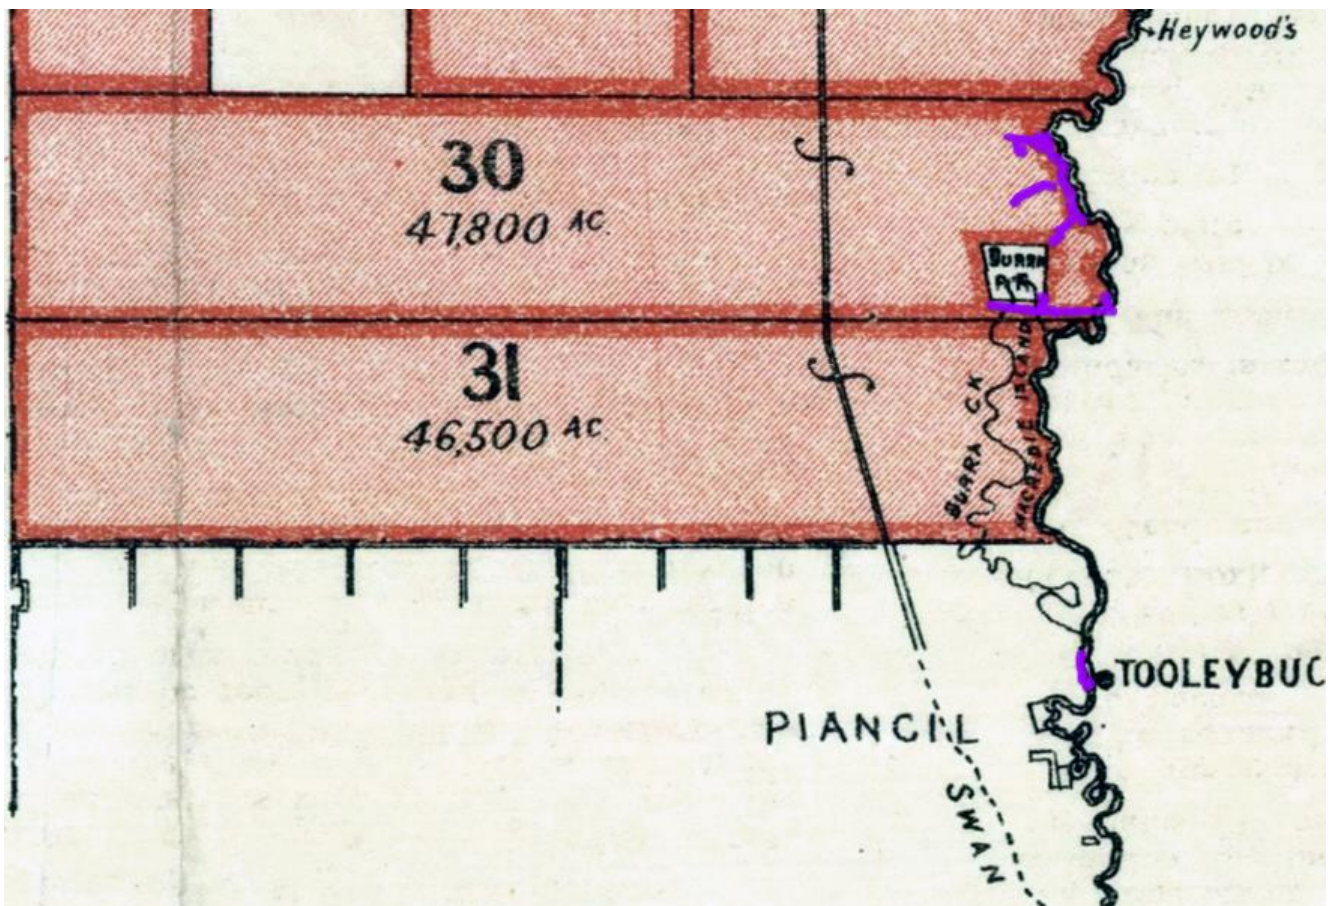
A 1912 map of Murray River frontage grazing blocks shows that the area of investigation intersected with two large allotments used for grazing: allotments 30 and 31. The Burra pre-emptive rights land is excluded from grazing block allotment 30. While several buildings are included in the map near Piangil, there are no structures mapped within proximity to the area of investigation (Figure 2.3).

Figure 2.3: 1912 Grazing Blocks Murray River Frontages tender map, with the area of investigation outlined in purple (Butson 1912)

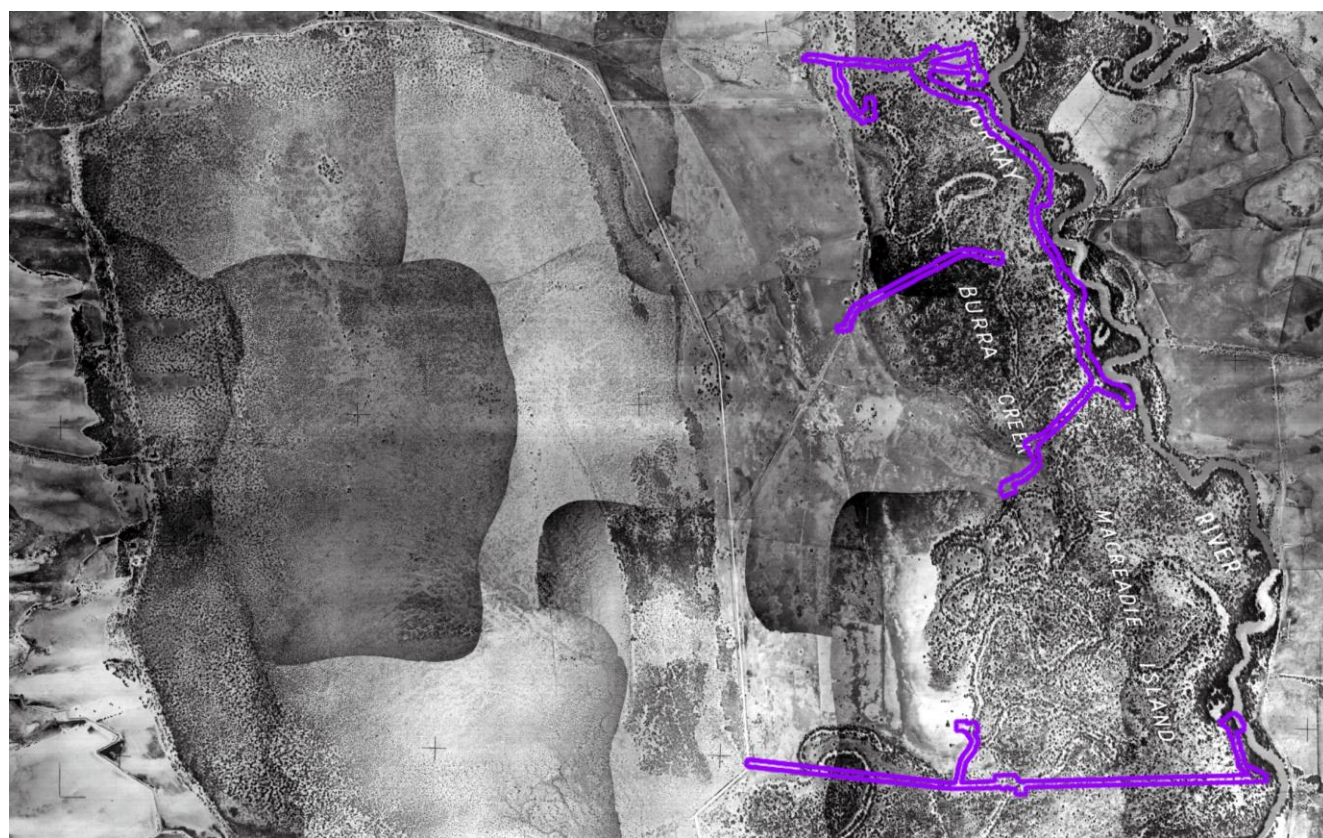
Figure 2.8: 1946 aerial imagery, northern part of area of investigation outlined in purple (Aerial Survey of Victoria 1946)

Aerial imagery from 1946 shows that the northern section of the area of investigation follows an unnamed road leading to what is now the southern end of the State Forest (in the south). It also appears to follow access tracks

through parts of the State Forest, where the tracks are not obscured by tree cover. There are no obvious structures within the area of investigation, although bridges are likely to have been present where tracks cross Burra Creek (Figure 2.8).

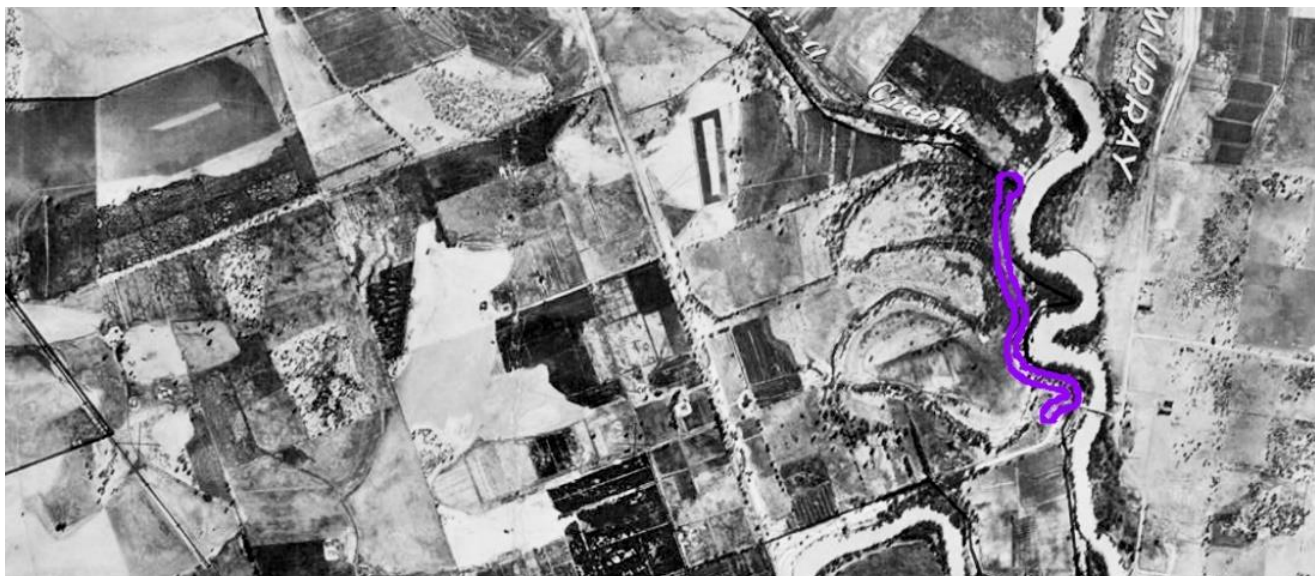
Figure 2.9: 1947 aerial imagery, area of investigation near Tooleybuc outlined in purple (Victoria State Rivers and Water Supply Commission 1947)

Aerial imagery dating to 1947 shows that the southern part of the area of investigation crosses a predominantly tree-covered area between Burra Creek and the Murray River. The road to Tooleybuc is on the same alignment as that used today, at the south end of the area of investigation. There is little open space, and no evidence of cultivated land within the area of investigation, although farmland is visible to the west of Burra Creek. However, there appears to be a roadway adjacent to the Murray River in alignment with the area of investigation, heading northwards from Tooleybuc Road. There are no obvious structures within the area of investigation (Figure 2.9).
