Surface Water Assessment

Goschen Mineral Sands and Rare Earths Project (Goschen Project)

VHM Exploration Pty Ltd

30 May 2018

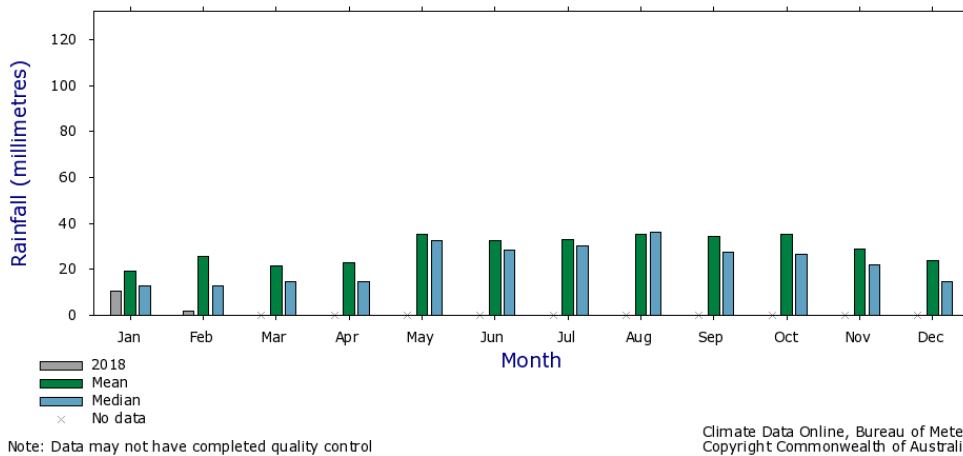
FIGURE 4-4 ULTIMA (POST OFFICE) MEAN AND MEDIAN RAINFALL OVER RECORD PERIOD

The semi-arid climate has a mean annual rainfall of 300 to 400 mm as shown in Figure 4-3, with the typical rainfall distribution across the year shown in Figure 4-4. Note the relatively consistent spread across the year, with higher totals in the winter-spring months. The average evaporation rates are 1400 to 1600 mm per annum, shown in Figure 4-5. The climate zones based on temperature and humidity is considered to be hot dry summer and cold winter, shown in Figure 4-6, this characterises much of central Australia.

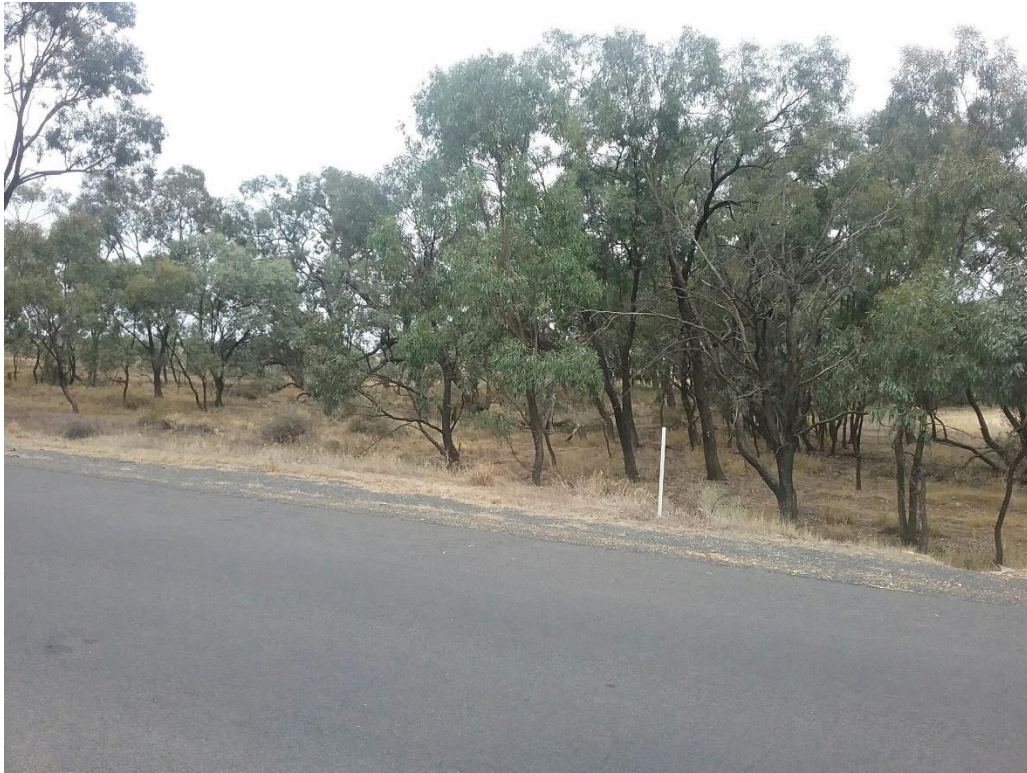
FIGURE 4-8 SMALL DEPRESSION IN LANDSCAPE

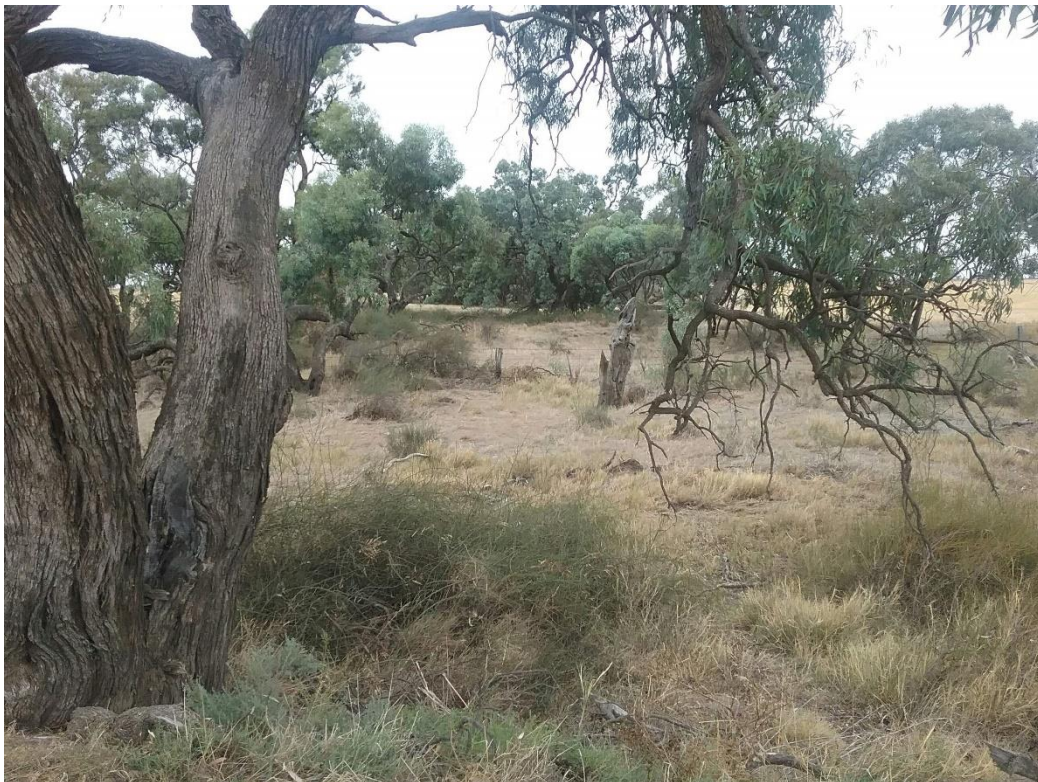
FIGURE 4-9 ECOLOGICAL NICHE ZONE IN TOPOGRAPHIC DEPRESSION

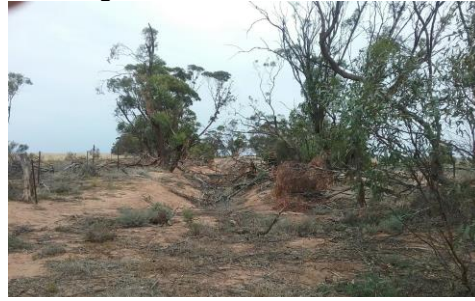
Main Cannie Channel Decommissioned

There were many stock and domestic channels that bisected the tenement areas, once delivering water to the region. The larger channels included the Witchetella, Harpers, Nullawil, Kings and Kalpienung Channels, all with small spur channels which were used to connect to farm dams. The majority of these channels have now been decommissioned, with water supplied to the area via pipeline. The channels have mostly been filled in, but some channels remain and may be blocked at road crossings, or do not receive any stock and domestic water supply. The channels across the tenements and throughout the catchments were historically for stock and domestic purposes. These channels were fed from the Grampians-Wimmera-Mallee Water Storages as well as runoff from the nearby tributaries during flooding events. The channels were typically distribution channels and although they cover a large area do not have their own catchments.

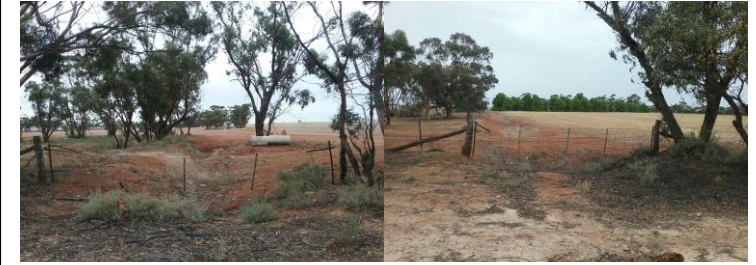
Wycheproof Goshen Channel Decommissioned

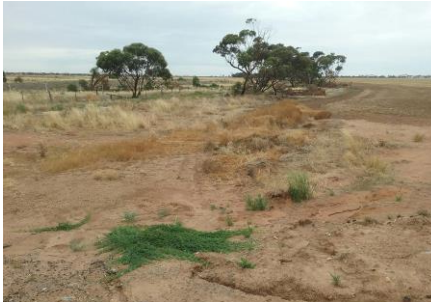
Wycheproof Goshen Channel Decommissioned— no structures

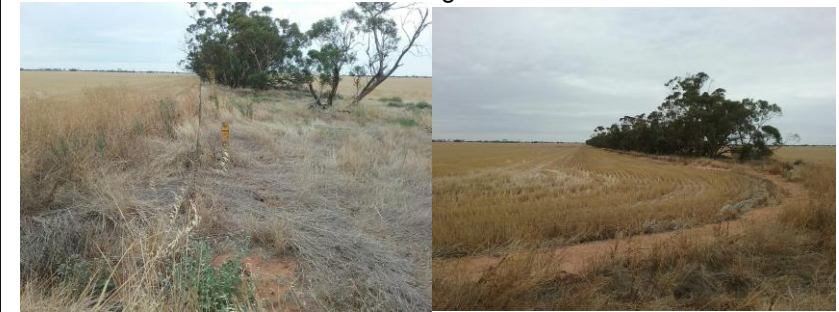
Decommissioned Talgitcha East Channel
