Little Murray Weir Pool - Aquatic and  
Semi-aquatic Flora Survey and  
Assessment Following Weir Pool  
Lowering: 2011 Revision

August 2011

ECOLOGICAL ASSOCIATES REPORT EI003-1-A

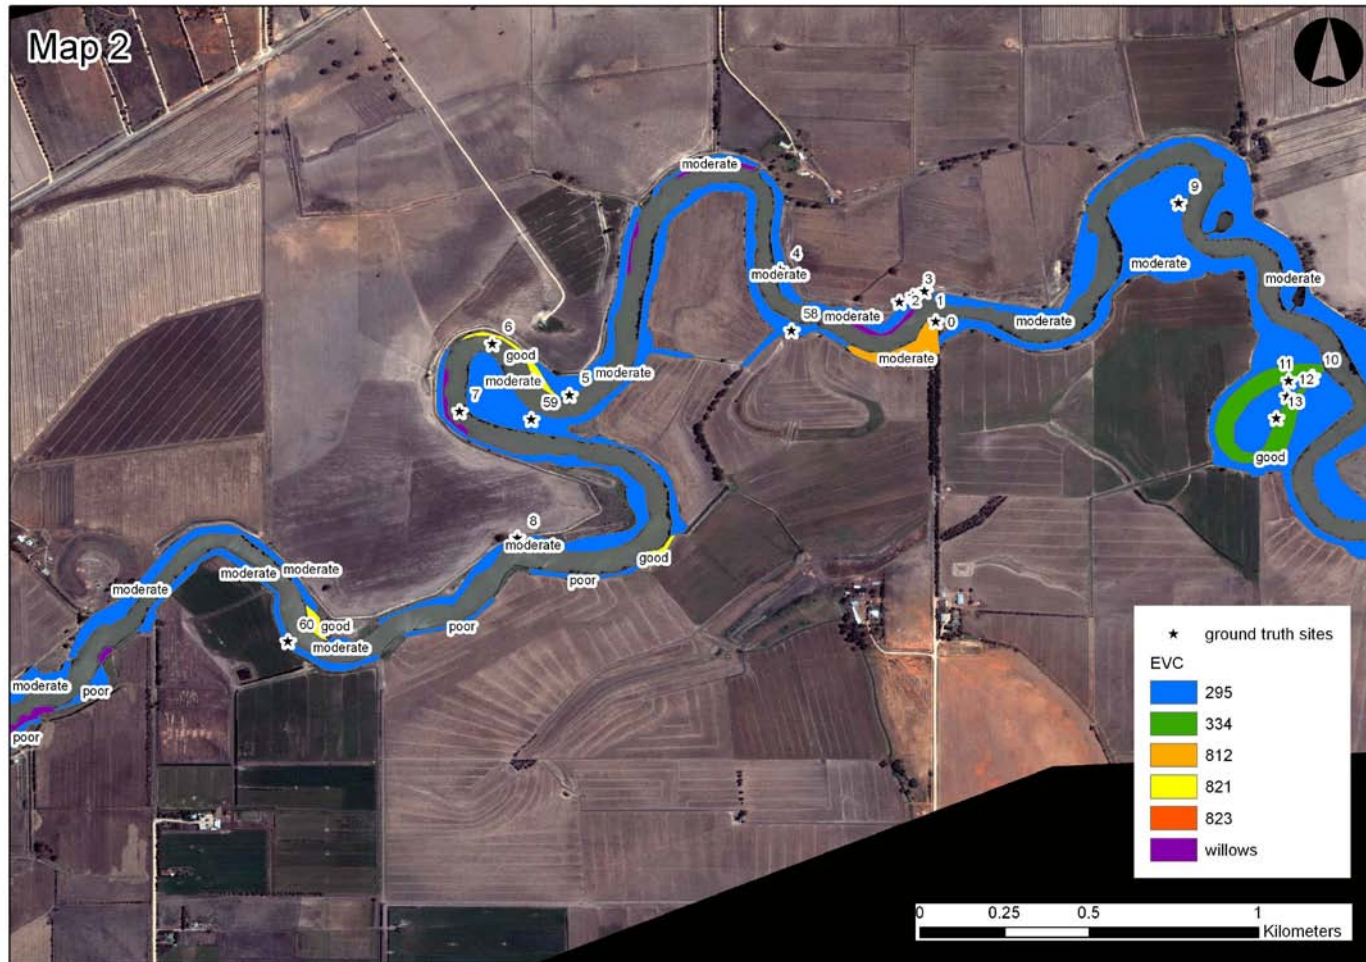
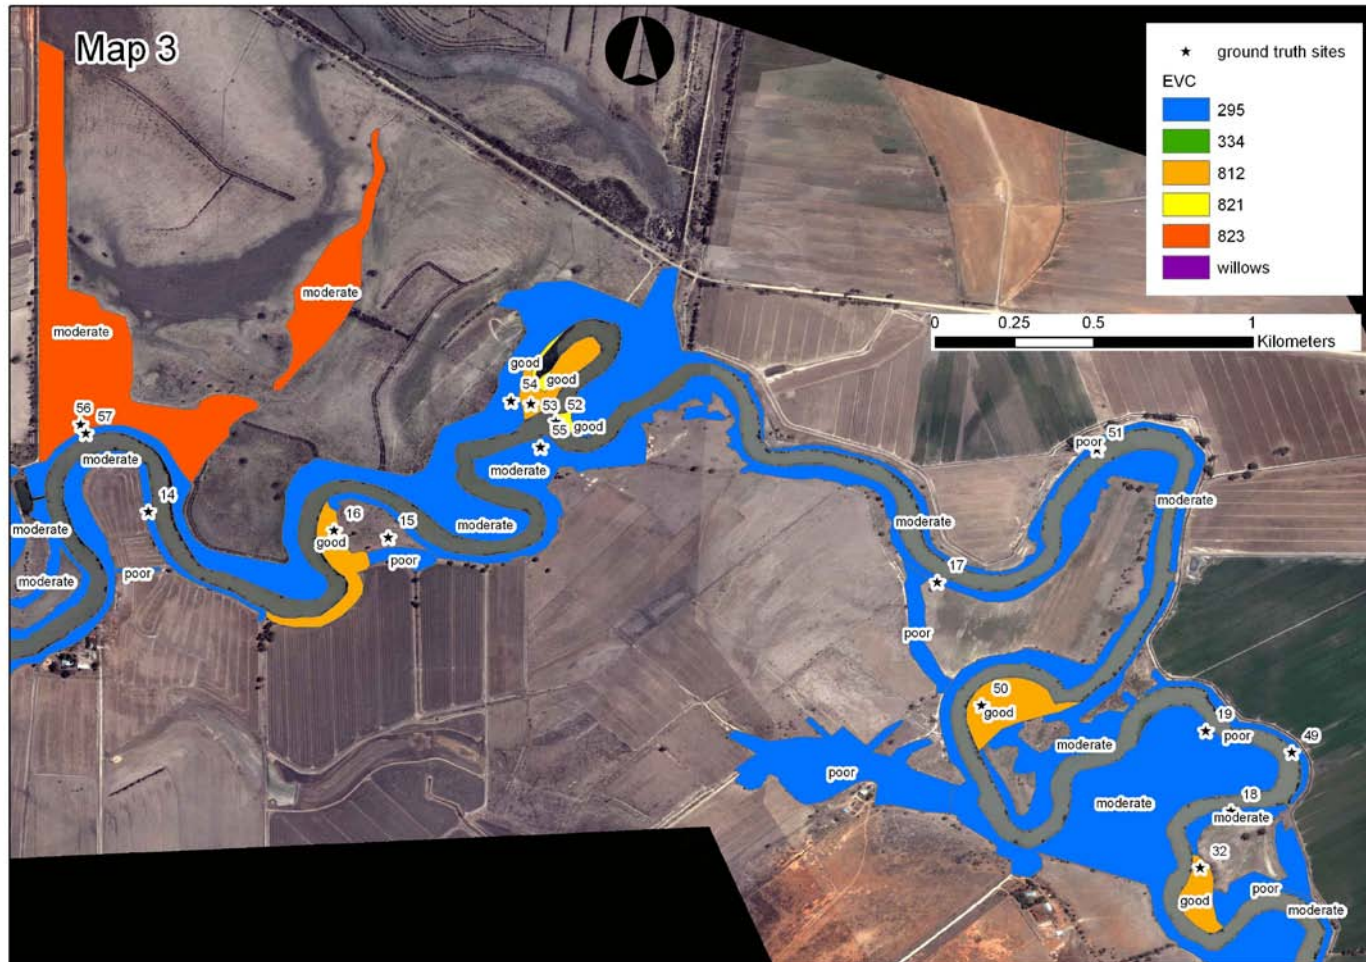
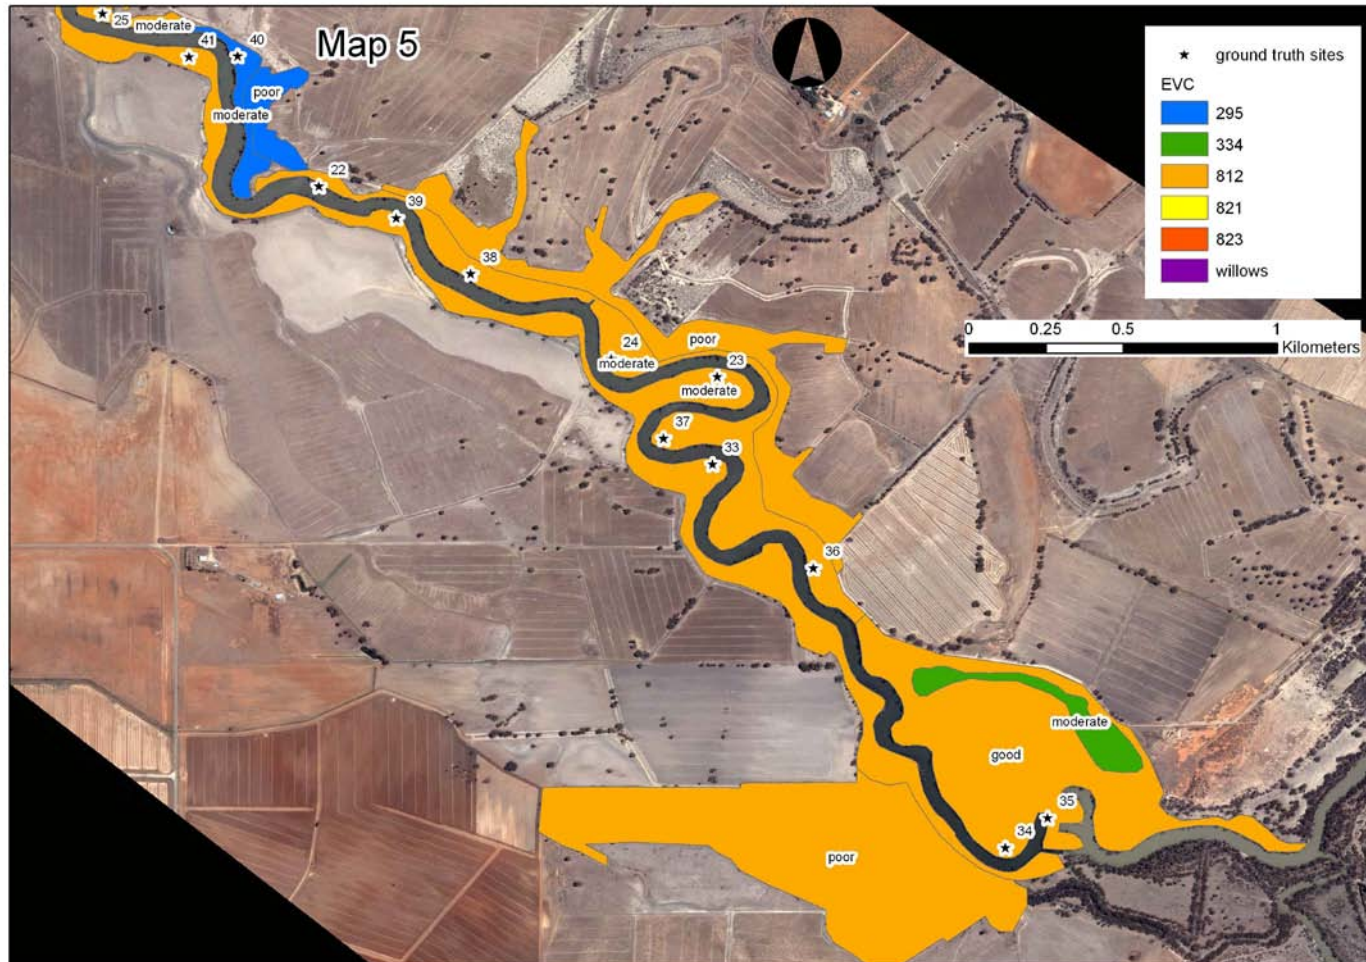
Maps showing the position and extent of the different EVCs, their condition categories and assessment waypoints (Appendix B) are presented in Figure 2 – Figure 6.

Figure 2. Map of the Little Murray heading east from the Little Murray Weir showing EVCs of the aquatic and riparian zones.

Figure 3. Map of the Little Murray continuing from Map 1 showing EVCs of the aquatic and riparian zones.

Figure 4. Map of the Little Murray continuing from Map 2 showing EVCs of the aquatic and riparian zones.

Figure 6. Map of the Little Murray at the eastern end at Fish Point Weir, showing EVCs of the aquatic and riparian zones.

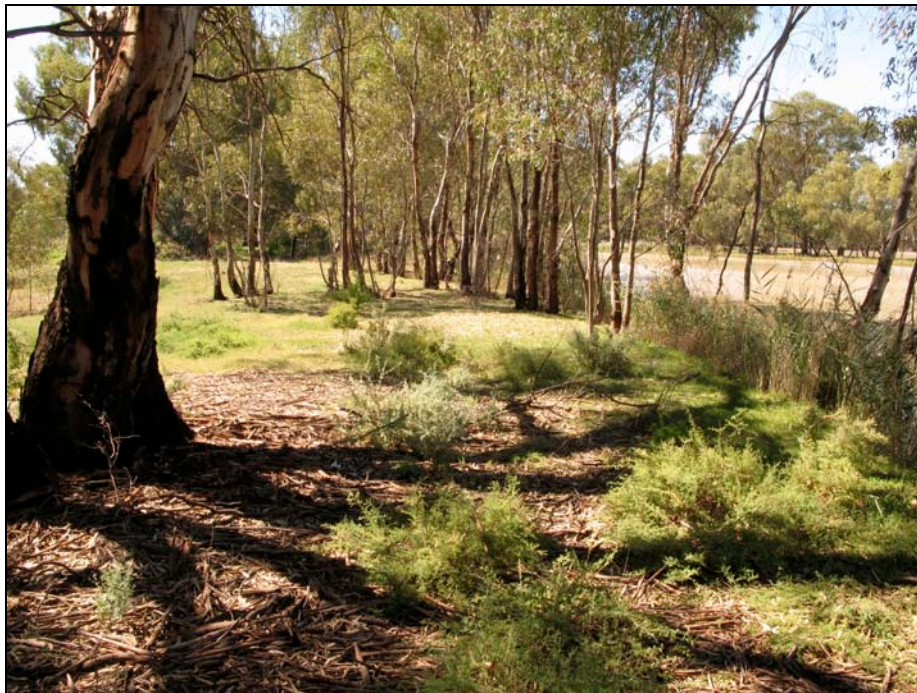
This EVC is generally in moderate condition, with a depleted understorey, but most of the mature *Eucalyptus camaldulensis* trees are in reasonable health. The understorey is severely degraded in some areas where plants are totally lacking from understorey and ground layers due to heavy grazing.

This EVC generally contains many weeds and a species dominating the ground layer in most parts of the site is *Phyla canescens*. Other common weeds include *Cirsium vulgare*, *Lycium ferocissimum*, *Helmintotheca echioides*, *Paspalum distichum* and *P. dilatatum* (Appendix A).

**Figure 7. Riverine Grassy Woodland on the Little Murray River**

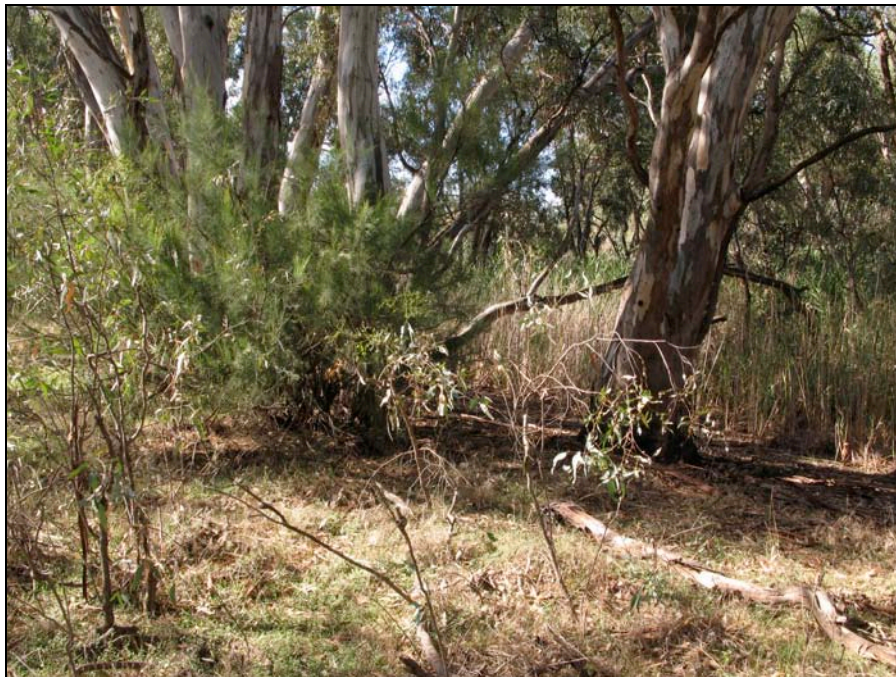
Condition of this EVC is mostly moderate, with a large area of good quality vegetation at the eastern end surrounding Fish Point Weir. An area of poor quality vegetation is also present at the eastern end of the Little Murray. Several smaller patches of this EVC along the main body of the river are in good condition (Figure 2 – Figure 6).

Many weeds occur in this EVC. Common species include *\*Phyla canescens* and *\*Paspalum* spp. Other species present include *\*Gnaphalium polycaulon*, *\*Rumex crispus*, *\*Bromus diandrus*, *\*Sonchus* spp., *\*Hypochaeris* spp., and *\*Xanthium* spp.

**Figure 8. Grassy Riverine Forest/Riverine Swamp Forest Complex on the Little Murray River**

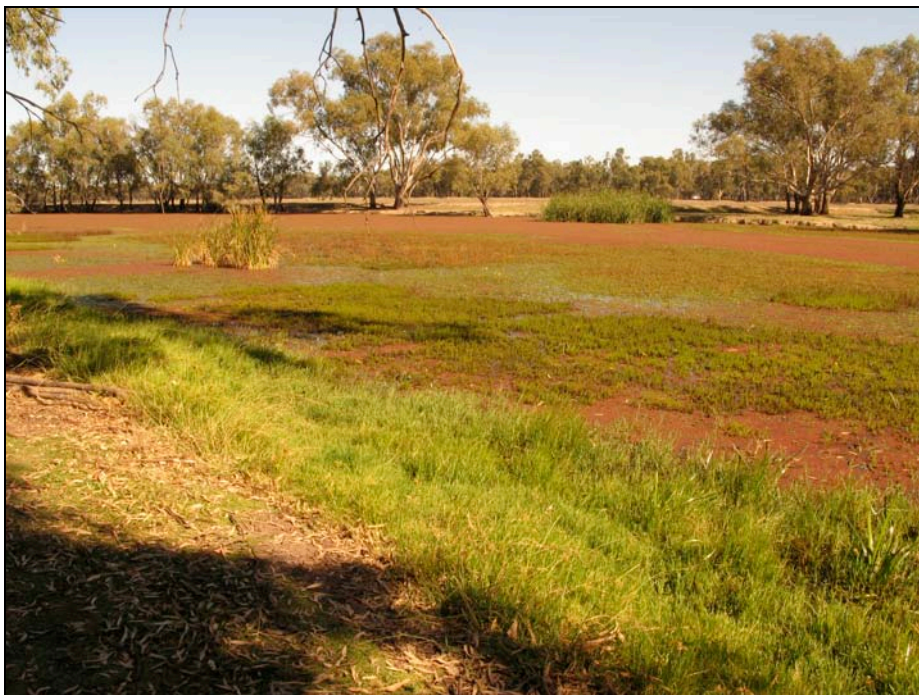
Billabong Wetland Aggregate is mostly in good condition along the Little Murray.

Weed species present include *\*Trifolium* sp., *\*Lactuca serriola* and *\*Citrullus lanatus*.

**Figure 9. Billabong Wetland Aggregate on a billabong adjoining the Little Murray River**

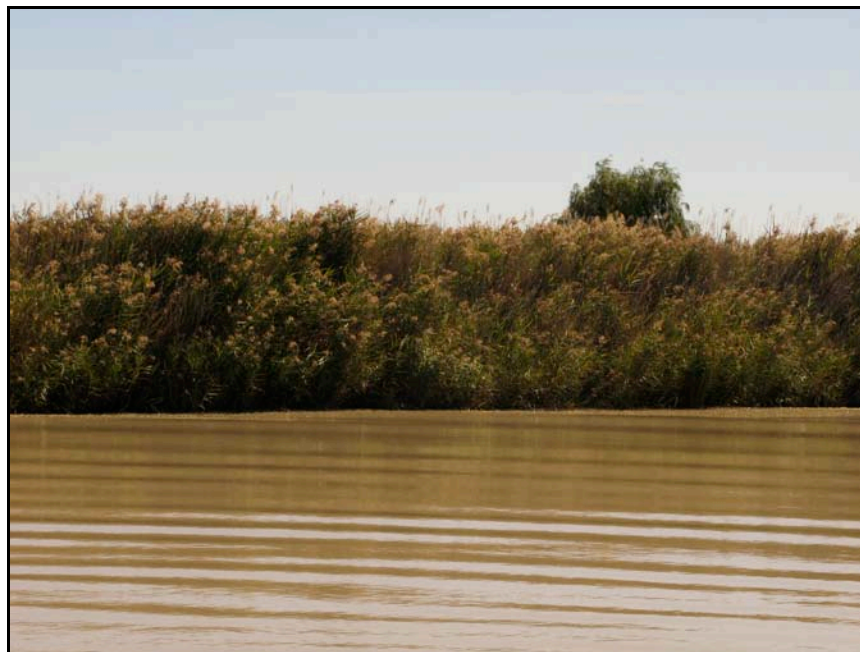
Dominant species include *Phragmites australis*, *Typha domingensis*, *Juncus* spp. and *Cyperus* spp. (Figure 10). Sparse *Muehlenbeckia florulenta* is often present among the *P. australis* and *T. domingensis*. *Calystegia sepium* is often found climbing on *P. australis*. Sedges include *Juncus* spp., *Cyperus sanguinolentus* and *Schoenoplectus validus*. Other species include *Epilobium hirtigerum* and the aquatic species *Persicaria* spp., *Myriophyllum* spp. and *Crassula helmsii*.

Tall Marsh is in good condition throughout the site. The cover of *Phragmites australis* and *Typha domingensis* is particularly dense along the water's edge. No species of conservation significance were found in this EVC during the survey.

**Figure 10. Tall Marsh along the banks of the Little Murray River**

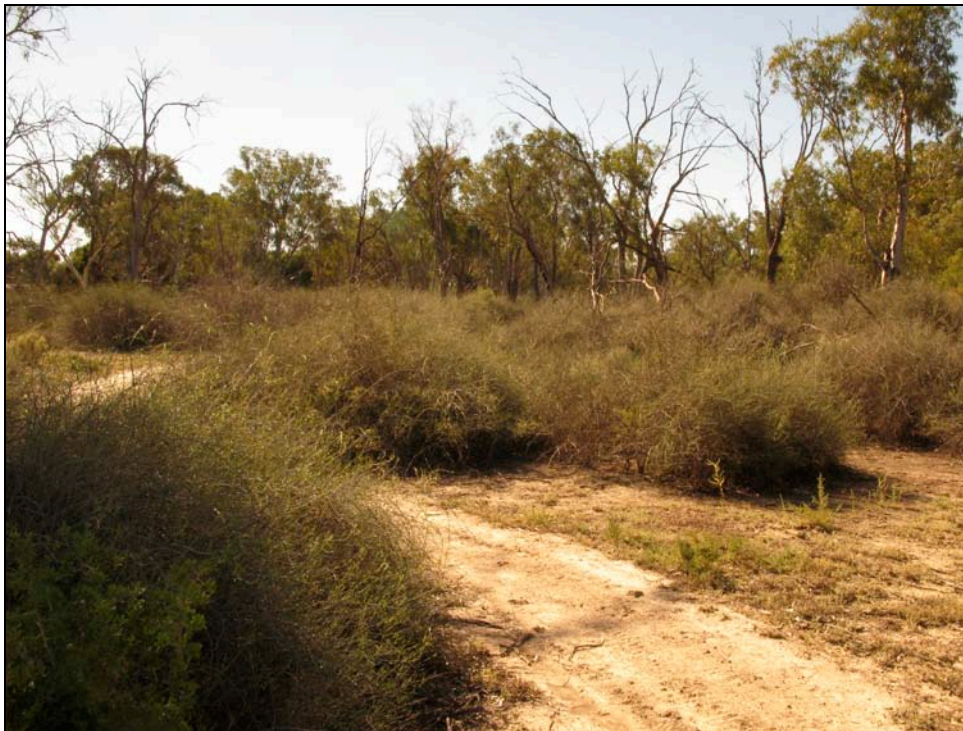
Lignum Swampy Woodland is in moderate condition at the study site with some evidence of tree felling and moderate to heavy grazing.

**Figure 11. Lignum Swampy Woodland on the Little Murray River**

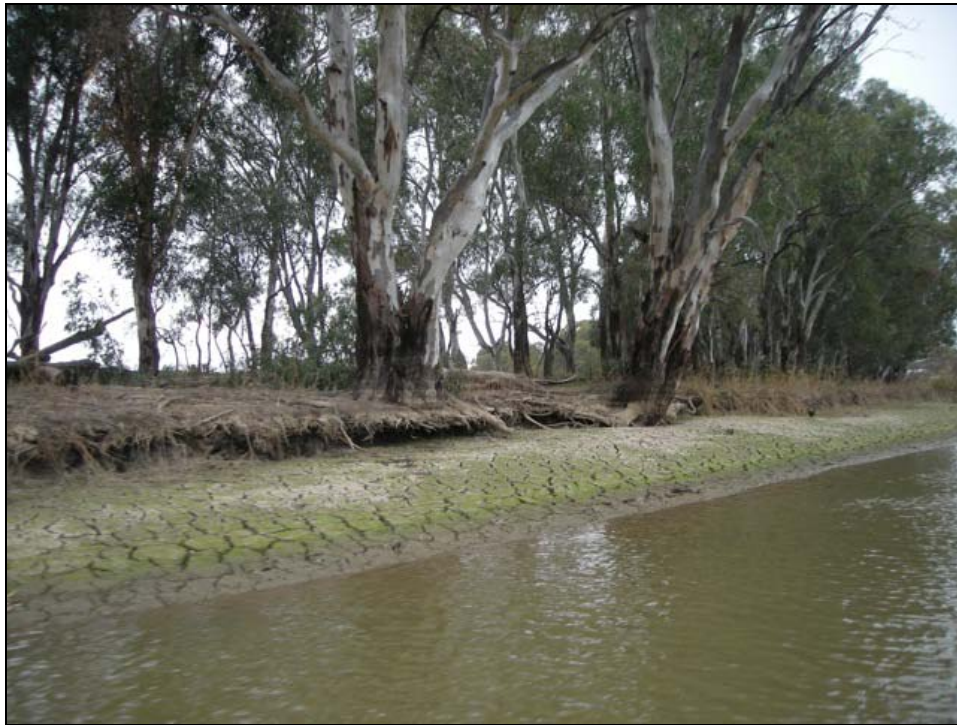
Most of the established plants were recorded along the banks of the western section of the Little Murray River, downstream of Waypoint 1 to the Little Murray Weir (Figure 3). Parts of this river section consist of gradually sloping banks with up to 2 – 3 m of bank exposed below the high water level, mostly covered in moss and algae (Figure 12), or highly disturbed through trampling by cattle. These areas were usually adjacent to Riverine Grassy Woodland (EVC 295). Plant establishment was very sparse, and often highly disturbed by trampling or grazed by stock (Figure 13, Figure 14). No plant establishment was observed beneath stands of willows.

**Figure 12. Exposed river bank along western section of Little Murray River**

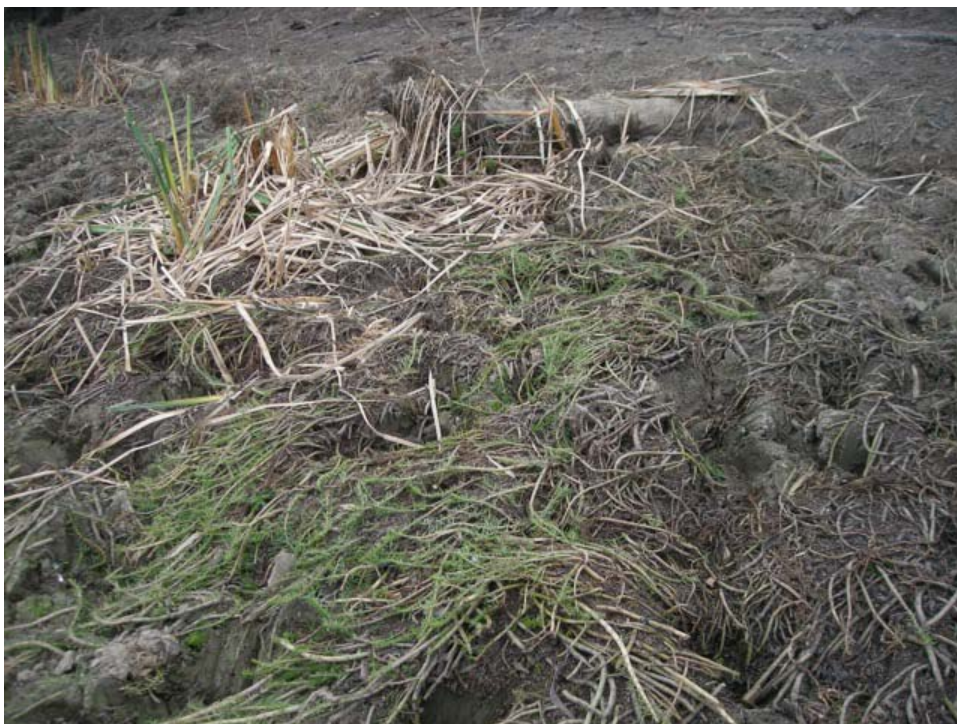
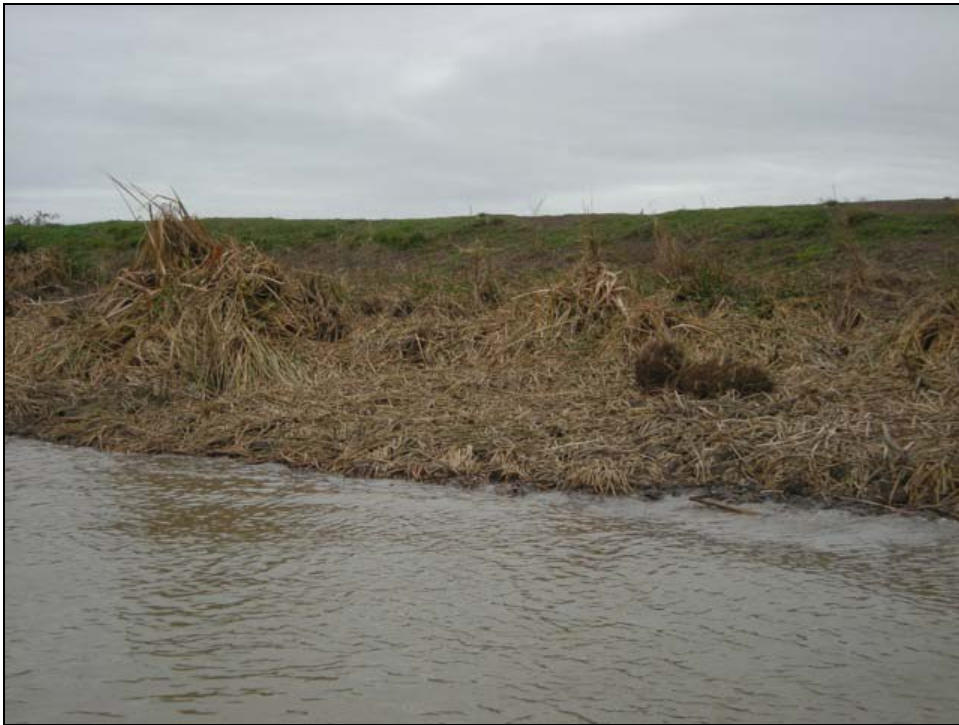
**Figure 13. *Myriophyllum papillosum* highly disturbed by cattle trampling**

**Figure 14. *Eleocharis sphacelata* trampled and grazed by stock**

Much of the riverbank along the Little Murray River is highly degraded due to trampling by livestock, particularly cattle. This activity damages established plants, restricts the colonisation of new plants, and can promote the spread of environmental weeds that readily invade disturbed sites. Lowering the water level may provide even greater stock access to the water's edge and limit the potential for revegetation of the newly exposed banks.

Stock impact significantly on the quality and extent of riparian vegetation. Unrestricted stock access will limit the potential for vegetation to establish on the banks exposed by a lower water level and will promote bank erosion. It is recommended that stock access to the channel is restricted.

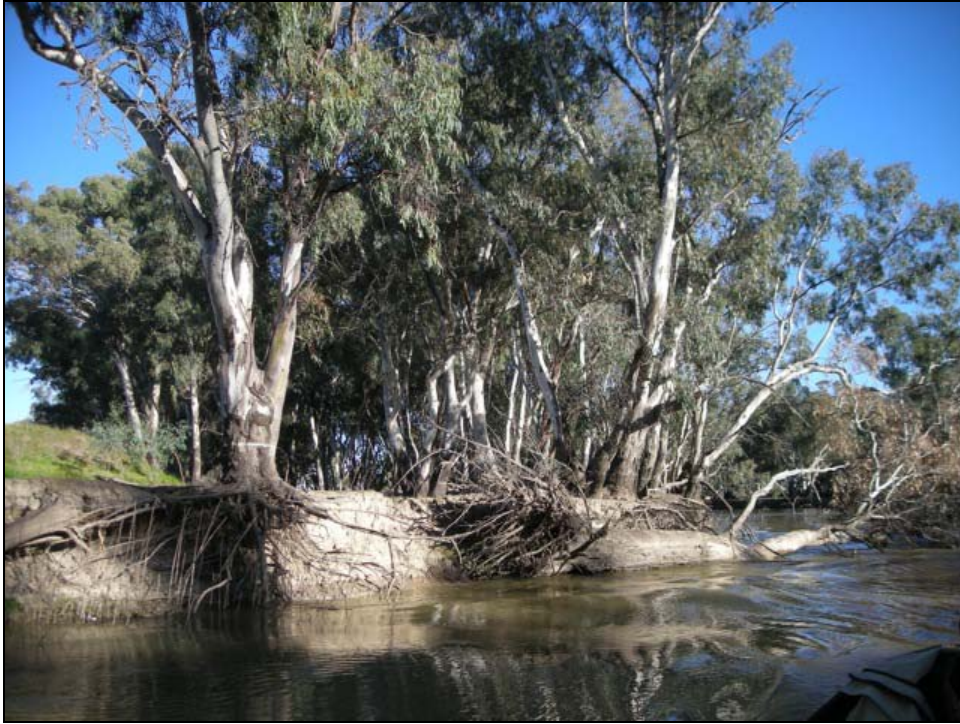
**Figure 15. Eroded riverbank with undercut and fallen eucalypt trees**

The banks along the eastern section of the Little Murray are highly eroded and undercut. As a result, many large eucalypt trees along this stretch of the river are extremely unstable or have fallen into the river. Furthermore, continual erosion and the steepness of the bank has prevented the establishment of aquatic and semi-aquatic vegetation. Streambank erosion can be caused through a number of mechanisms, including flood events, soil characteristics, removal or disturbance of protective riparian vegetation, or wave action when water levels are kept stable. Lowering the weir pool to a new stable level may lead to further bank erosion and undercutting, causing further loss of large eucalyptus trees along the water's edge, and limiting revegetation of the riparian zone.

It is therefore recommended that the new water level for the Little Murray is not held constant, but involves a seasonal water fluctuation that reduces bank erosion and promotes diversity in riparian vegetation.
