Epworth HealthCare

Environmental Site Assessment

1000 Whitehorse Road, Box Hill, Victoria 3128 22 March 2017

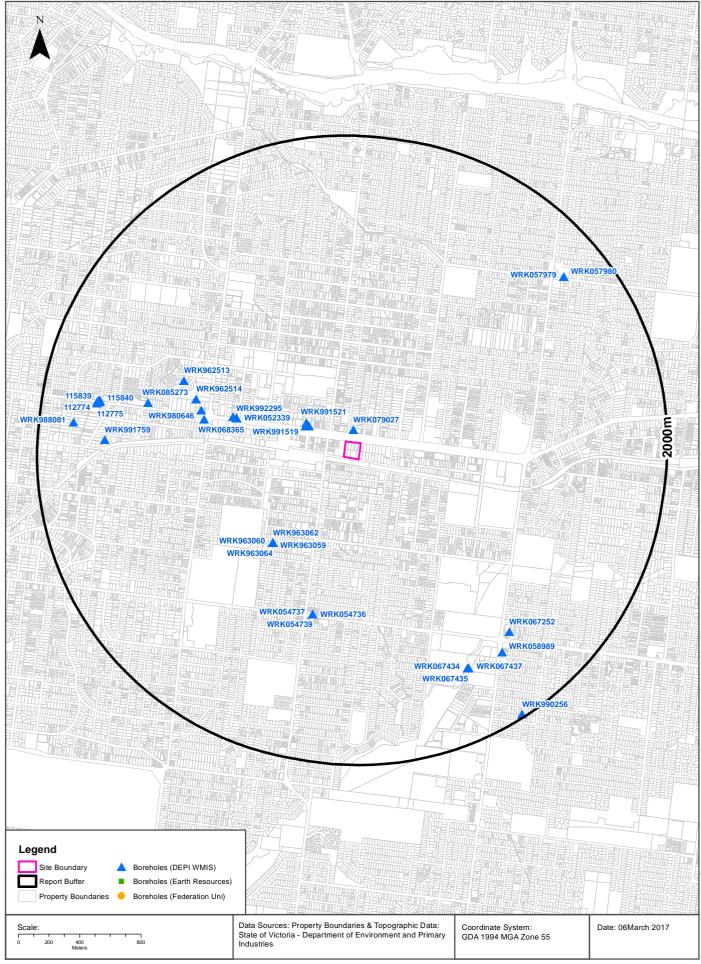
Groundwater Boreholes

115840	Groundwater Investigation	0.00m-0.15m CONCRETE 0.15m-2.10m FILL SAND BROWN POORLY GRADED 2.10m-2.25m LAYER OF CONCRETE 2.25m-4.50m SAND BROWN MOIST FINE TO MEDIUM	-0.10m-1.00m INNER LINING - CASING = Pvc Class 18 4.00m-4.50m INNER LINING - SCREEN = Pvc Class 18 0.00m-0.75m OUTER LINING - GRAVEL = Cement 0.75m-1.00m OUTER LINING - GRAVEL = Bentonite 1.00m-4.50m OUTER LINING - GRAVEL = Gravel			1993-05-04	1624	West
115838	Groundwater Investigation	0.00m-1.10m FILL BROWN GRAVELLY SAND 1.10m-2.20m SILTY SAND ORANGE/BROWN 2.20m-5.00m MUDSTONE/SILTSONE ORANGE/BROWN MOIST 5.00m-5.70m SANDSTONE SOFT LAYERS	0.10m-1.70m INNER LINING - CASING = Pvc Class 18 1.70m-4.00m INNER LINING - SCREEN = Pvc Class 18 0.00m-1.45m OUTER LINING - GRAVEL = Cement 1.45m-1.60m OUTER LINING - GRAVEL = Bentonite 1.60m-5.70m OUTER LINING - GRAVEL = Gravel			1993-05-04	1627	West
115841	Groundwater Investigation	0.00m-1.10m FILLBROWN CLAYEY SAND 1.10m-2.00m SILTY SAND BROWN MOIST 2.00m-7.50m MUDSTONE/SILTSTONE LIGHT BROWN MOIST	-0.10m-2.30m INNER LINING - CASING = Pvc Class 18 6.70m-7.50m INNER LINING - SCREEN = Pvc Class 18 0.00m-2.00m OUTER LINING - GRAVEL = Cement 2.00m-2.30m OUTER LINING - GRAVEL = Bentonite 2.30m-7.50m OUTER LINING - GRAVEL = Gravel			1993-05-04	1632	West
