Victorian Murray Floodplain Restoration Project

Lindsay Island Historical Heritage Desktop Assessment

IS297792-CH-CH-RP-0001 | REV 1

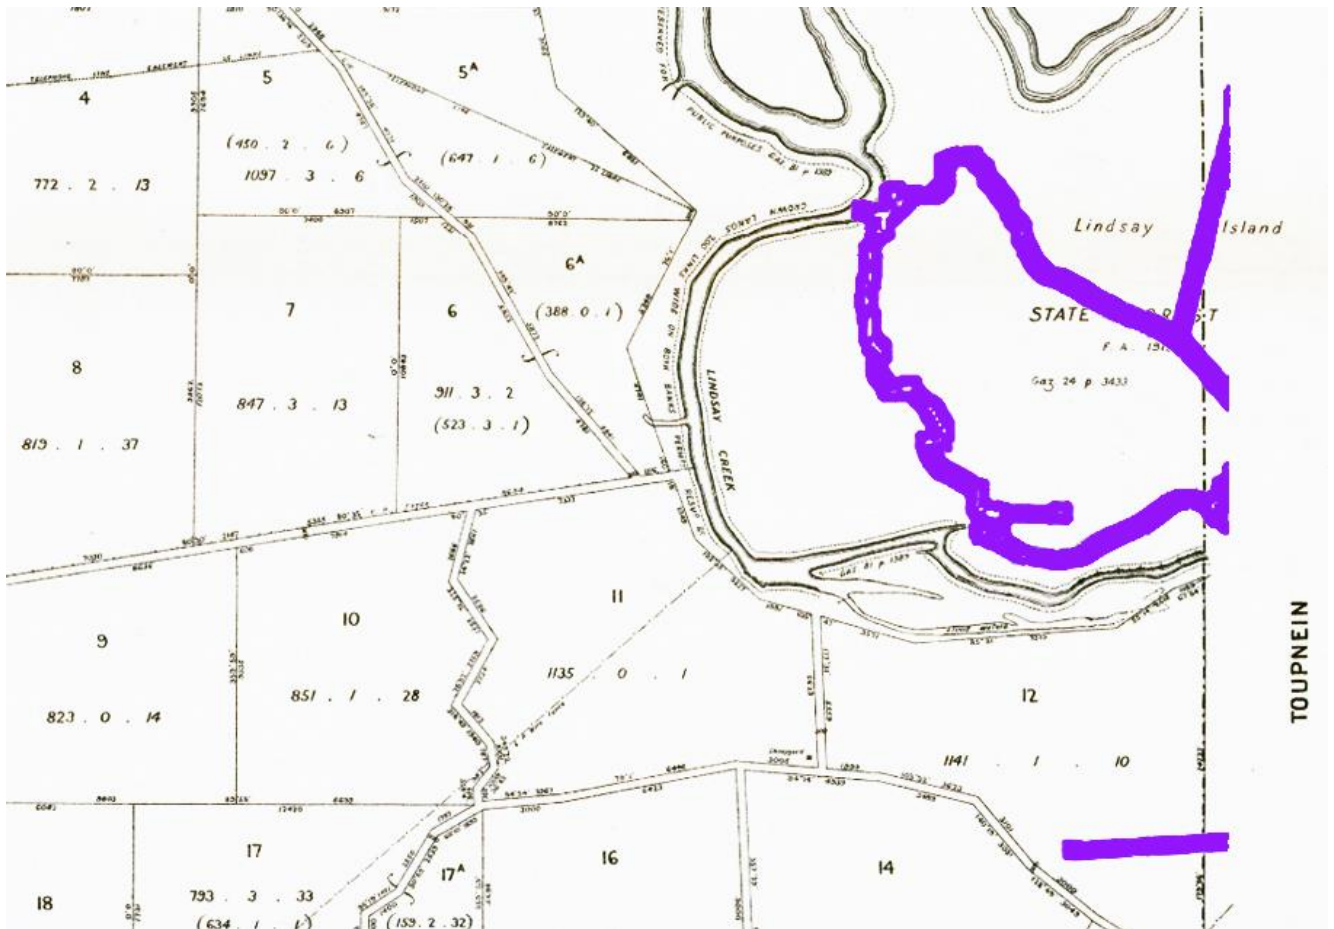
By the mid-1920s, historical maps show that only the Parish of Olney (immediately west of Lindsay Island) had been subdivided into smaller allotments for sale, with a telephone line established across the northern section of the Parish (Figure 2.4).

Figure 2.4: 1925 Parish of Olney map, with approximate location of the area of investigation outlined in purple (Victoria Department of Crown Lands and Survey 1925)

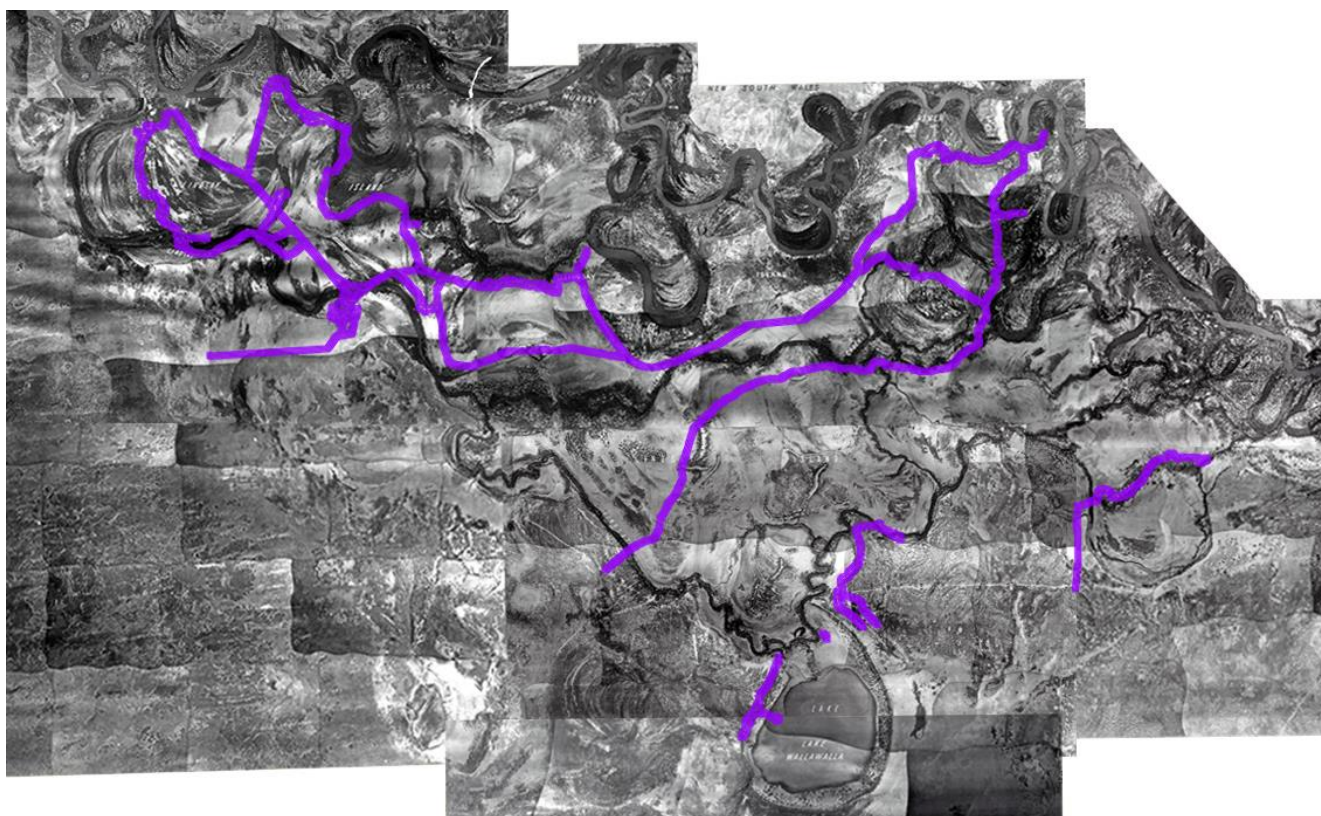
Aerial imagery from 1945 shows that area of investigation comprises floodplain between the Murray River and the Lindsay River, with smaller waterways between the two, including Toupnein Creek towards the west, Mullaroo Creek bisecting the area in the centre, and lagoons and billabongs throughout. Lake Wallawalla is visible to the south of Lindsay Island. Lindsay Island appears to be relatively treeless, except along waterways, and within allotment A. Some tracks are visible on Lindsay Island, with further tracks clearly visible to the south of Lindsay River on what appears to be scrubland. There may have been bridges present where tracks cross creeks and other waterways (Figure 2.8).

Figure 2.8: 1946 aerial imagery with approximate location of the area of investigation outlined in purple (Aerial Survey of Victoria 1946a; 1946b; 1946c; 1946d; 1946e; 1946f; 1946g; 1946h)

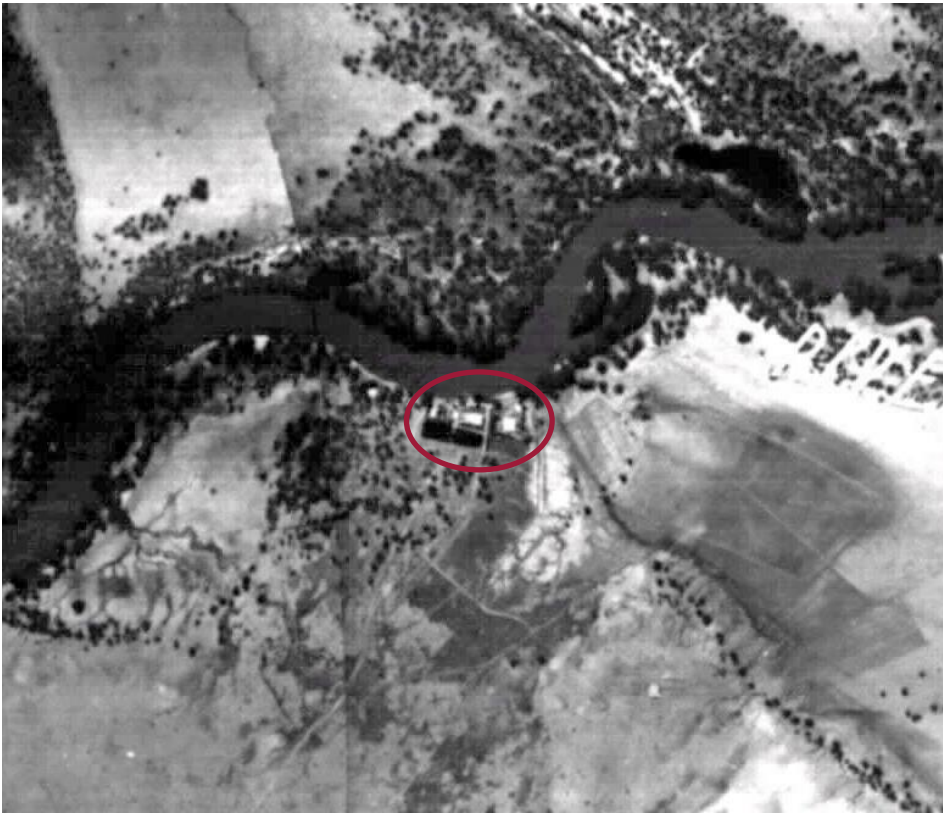
Figure 2.9: 1946 aerial imagery showing Berribee Homestead Complex (buildings indicatively circled in red) (Aerial Survey of Victoria 1946b)

There are no clearly visible structures that intersect with the area of investigation, except at the extant Berribee Homestead Complex (Figure 2.9), and those at Lock 7 (Figure 2.10). A sand dune is visible in the location of the former Baggot's Cattle Station (Figure 2.11).

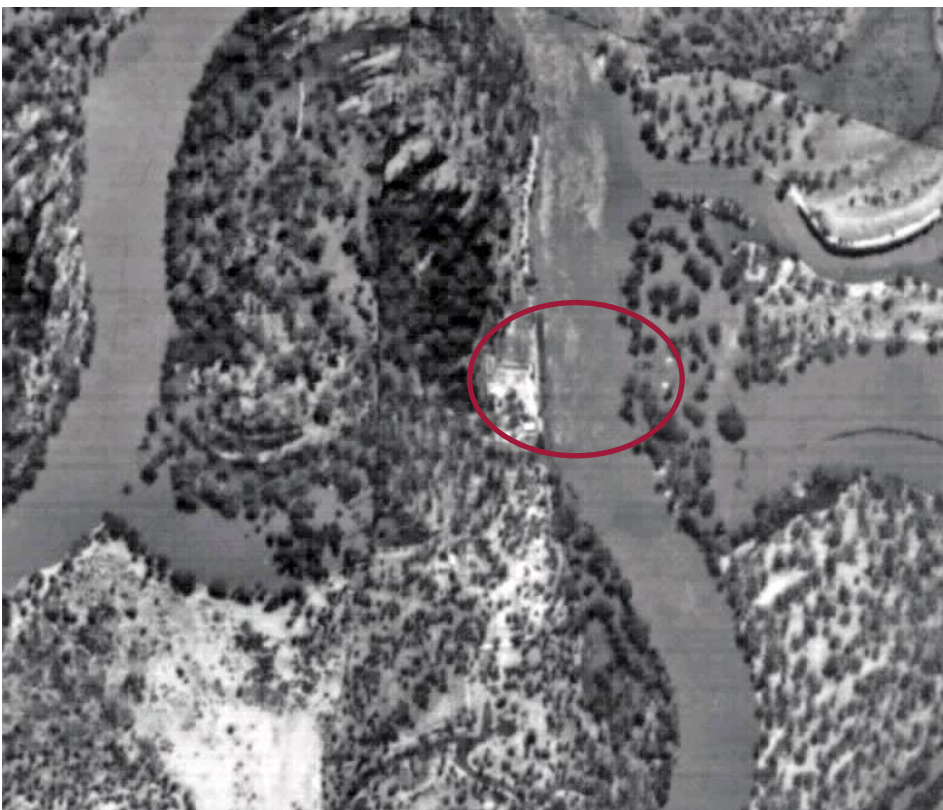
Figure 2.10: 1946 aerial imagery showing Lock 7 near the confluence of Rufus River and the Murray River (Lock 7 and associated land-based facilities indicatively circled in red) (Aerial Survey of Victoria 1946c)

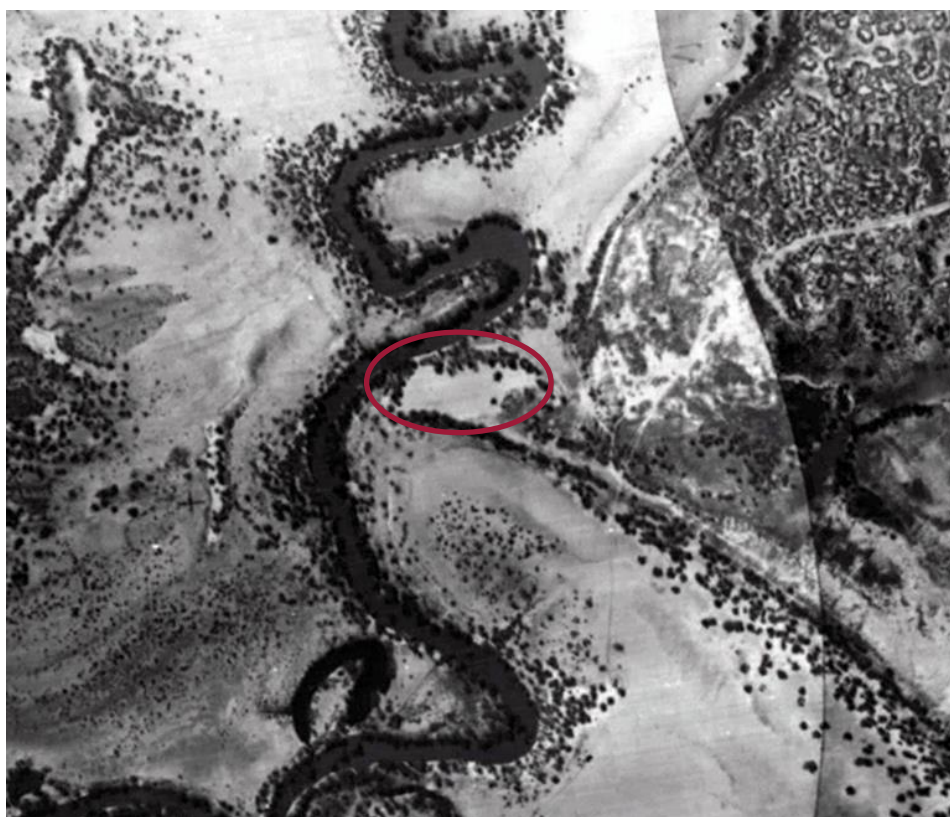
Figure 2.11: 1946 aerial imagery showing the sand dune where several structures associated with the former Baggot's Cattle Station appear to have once been located (area of interest indicatively circled in red) (Aerial Survey of Victoria 1946f)
