WIN LAND CAPABILITY ASSESSMENT  
**Western Water**

**Property name: Parwan Pty Ltd**

**DECEMBER 2020**

Report author: Jason Lynch & Sarah Jones

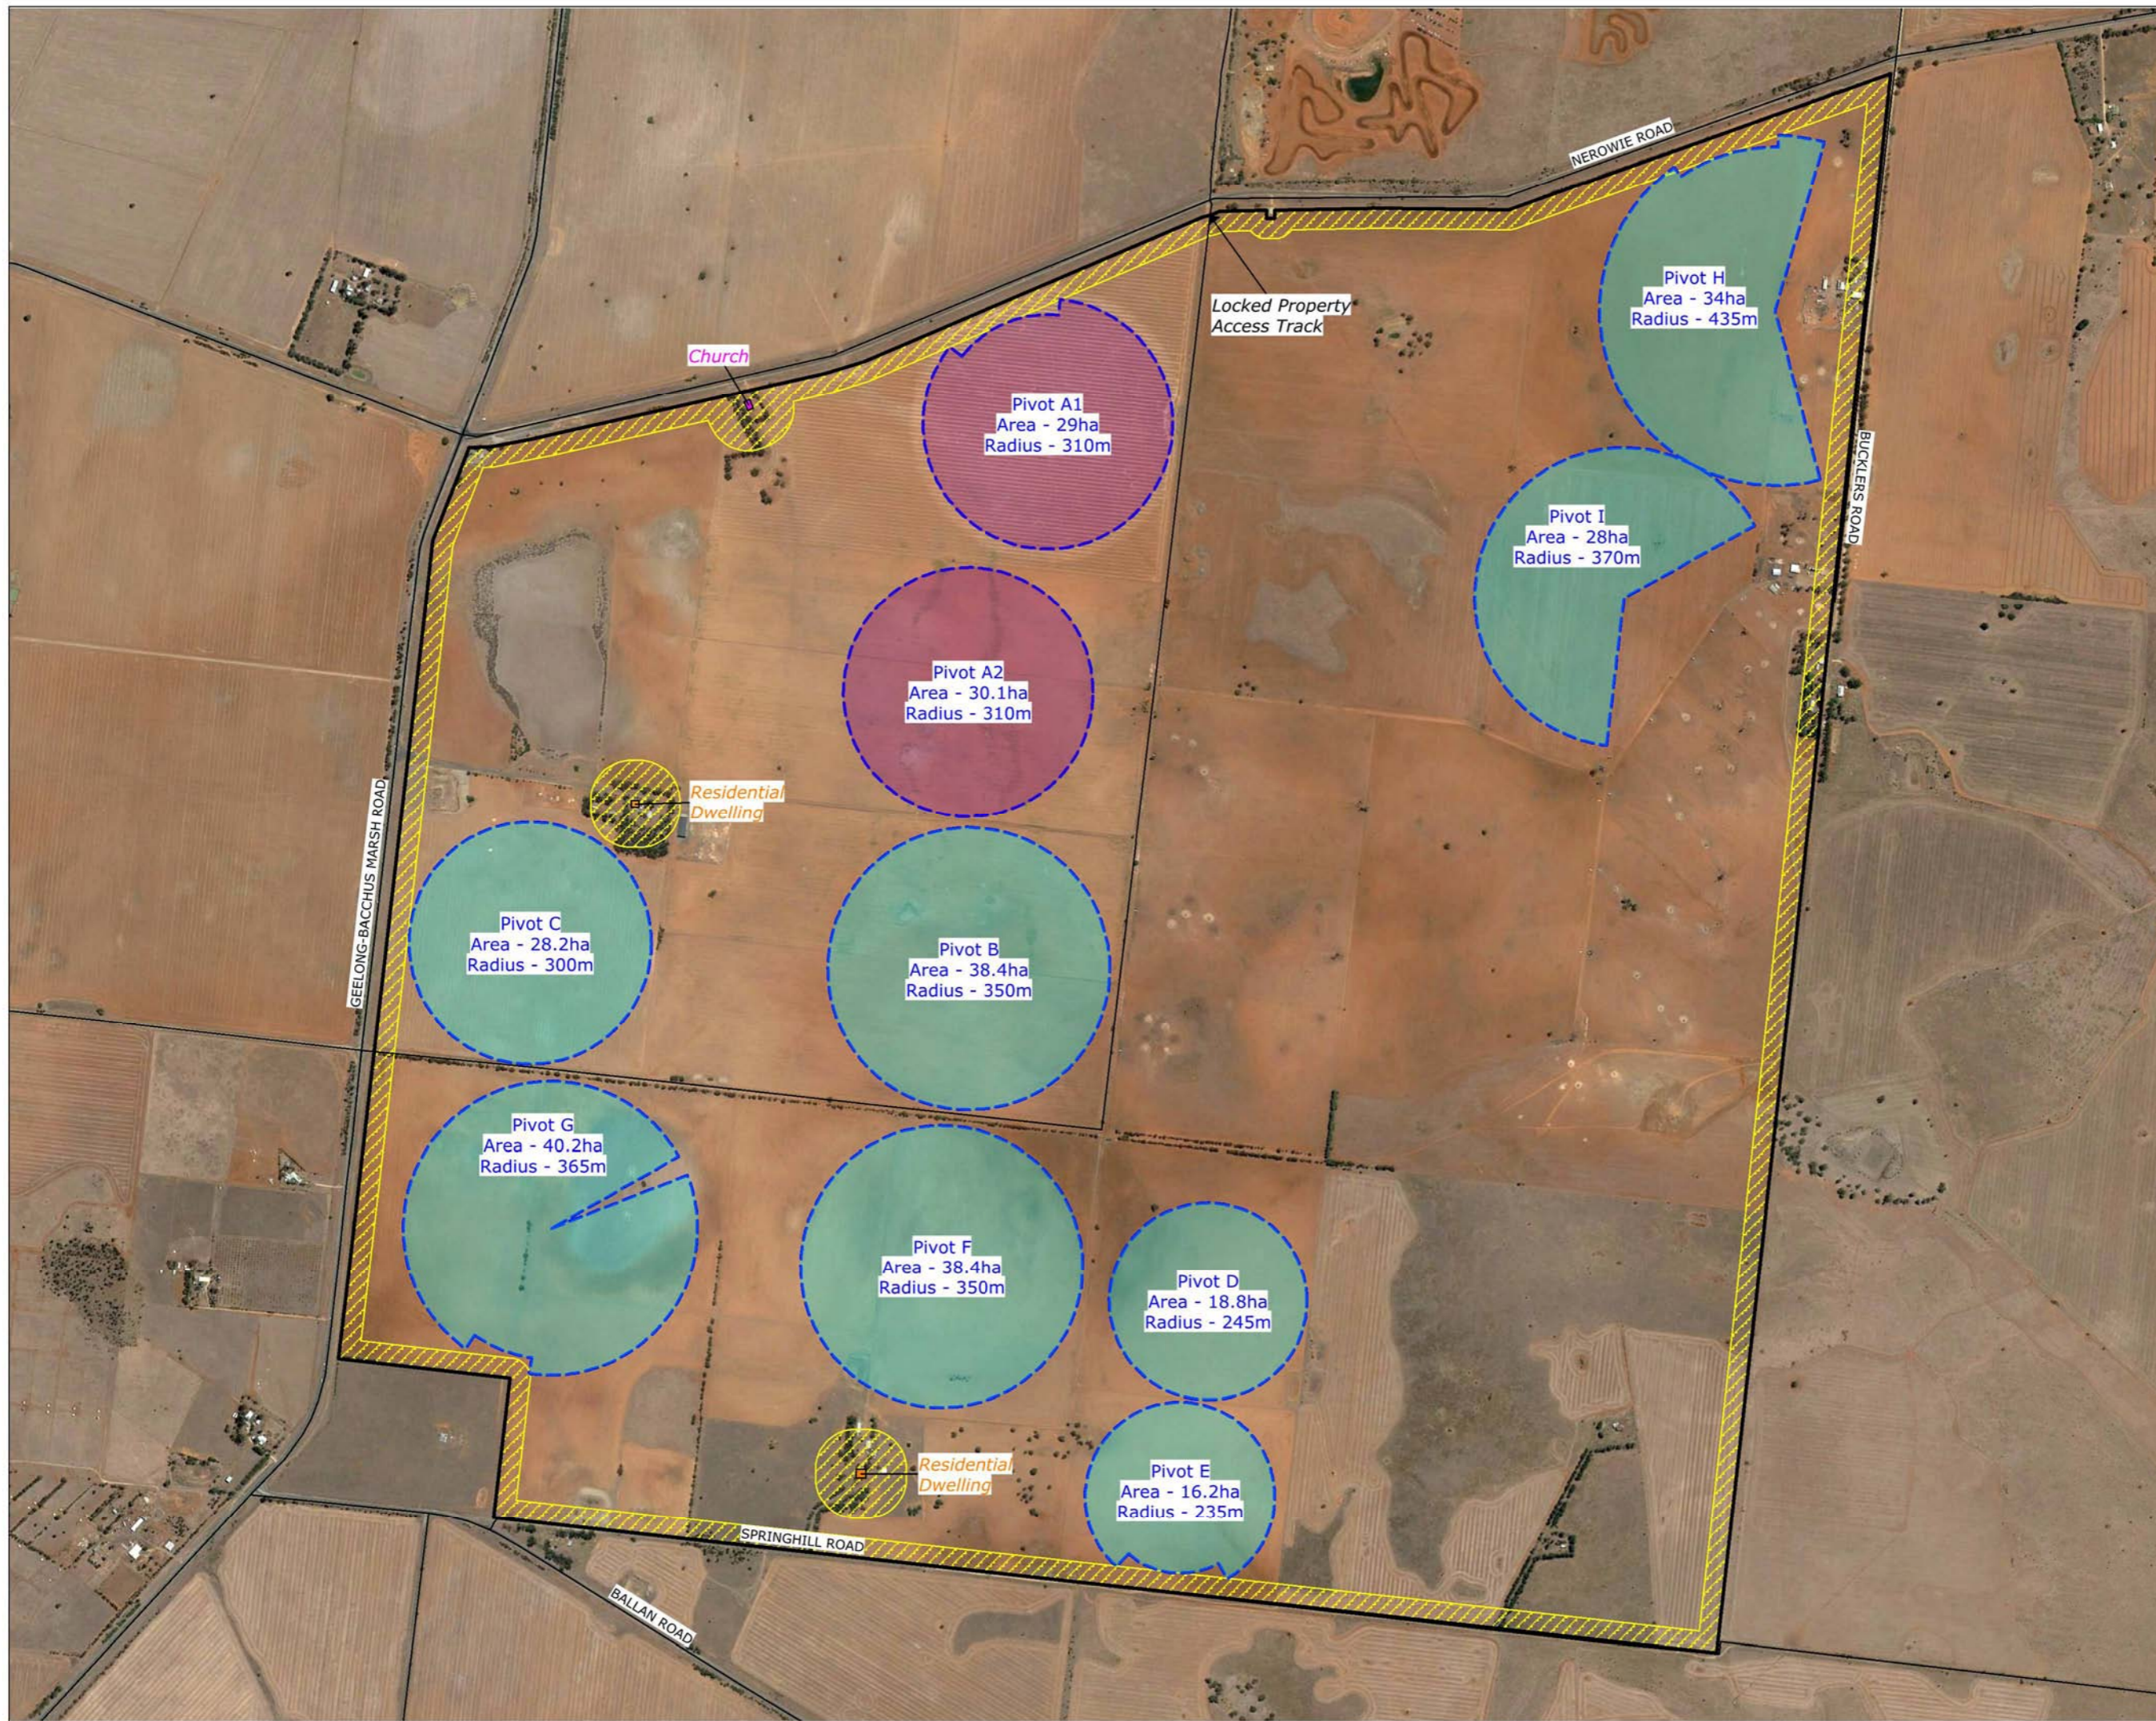
- Property Boundary
- Residential Dwelling
- Church
- Proposed Centre Pivot Irrigator
- Recycled Water Irrigation Area (242 ha)
- Existing Recycled Water Irrigation (59 ha)
- Road
- Recycled Water Buffer**
- 50m - External boundary
- 100m - Residential dwelling, Church

The irrigation concept design is attached as appendix A. The detail of the proposed irrigation plan is outlined in Table 8 which summarises potential water use of each pivot area.

In line with the *Guidelines for Environmental Management: Use of Reclaimed Water (EPA Victoria, 2003)* buffer zones, as identified in appendix A, are summarised in 9.

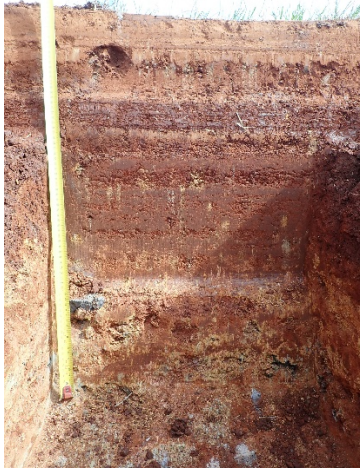
Table 12: Parwan test pit soil profile (Oct 2020)

Site	Soil description	Image
<p>Soil type:</p> <ul style="list-style-type: none"> <li>- red sodosol</li> </ul> <p>Landscape:</p> <ul style="list-style-type: none"> <li>- gently sloping ground with minimal stone and/or rock fragments (&lt;30mm) on the surface.</li> </ul> <p>Effective rooting depth:</p> <ul style="list-style-type: none"> <li>- 400mm.</li> </ul> <p>Drainage:</p> <ul style="list-style-type: none"> <li>- Moderate in the A horizon to poorly drained in the B horizon.</li> </ul>	<p>A1: red silty clay loam to 30cm, moderate crumb structure 3-5mm, moderately abundant fine roots, basalt gravels and rock fragments (&lt;20mm) present throughout with a clear boundary to:</p> <p>B1: red clay to 45cm, compact blocky structure, occasional fine roots, occasional basalt gravels and fragment (&lt;30mm) present, diffuse boundary to:</p> <p>B2: reddish brown clay to 55cm, blocky structure, occasional fine roots (maximum depth to 50cm), frequent large fragments (50+mm), diffuse boundary to:</p> <p>C: orange/light brown clay to 75cm, decomposing basalt overly basalt floaters at the base, limit of excavation</p>

The site inspection indicates the property is consistently covered by red sodosol soils, which features a silty clay A horizon over a clay B Horizon, with rock and stone fragments present in the soil profile overly decomposing basalt.
