Project Marinus

Nearshore Marine Benthic Characterisation of Tasmanian and Victorian Landfall Options

Technical Report

June 2021

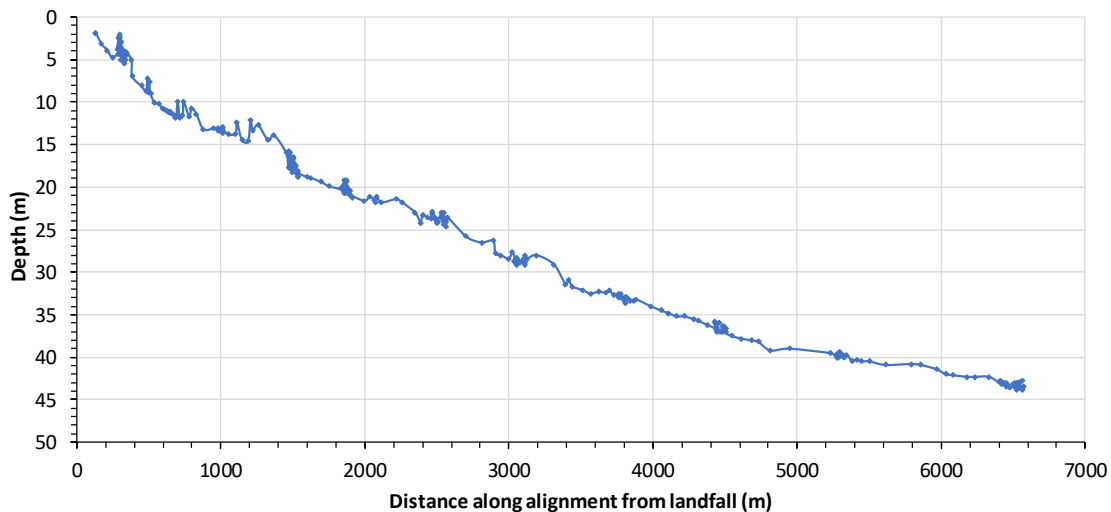
Figure 4.1: Depth profile along the Blythe River route, 2019

The seabed sloped at a slowly decreasing gradient from the coastline to the 40 m depth contour. Sharp changes in depth occurred at intervals from the coastline to 3 km offshore that indicate the presence of high relief reef habitat. Beyond 32 m depth and 3.5 km offshore the profile is relatively smooth and flat, reaching 40 m depth at approximately 6.5 km offshore.

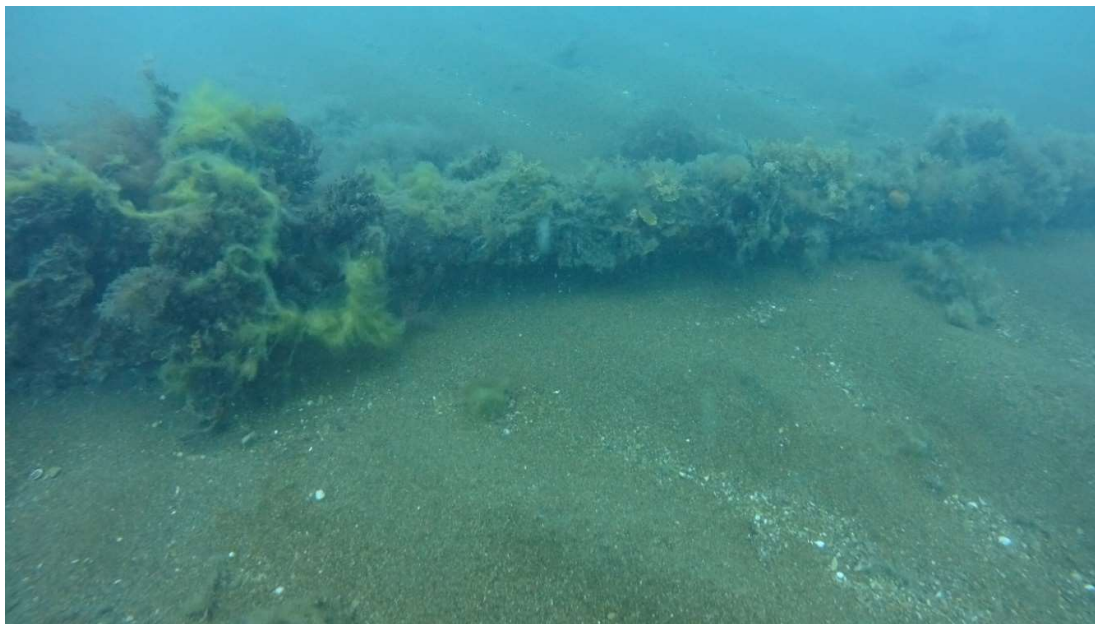
Figure 4.4: Dis-used Tioxide outfall pipeline at Blythe River
Top: at site W09, (12-13 m depth), bottom: at site W08 (15-16 m depth)

The dis-used Tioxide plant steel outfall pipeline at Blythe River was positioned predominantly over sandy seabed using concrete block anchors, as shown by towed video at sites Bly_W09 and Bly_W08 (Figure 4.5, Figure 4.4). This dis-used route along sandy seabed may be feasible for a transmission cable in the nearshore zone. The pipeline is around 10 m west of its charted position and two pipelines were identified near W08 (the pipeline had to be replaced during its lifetime).

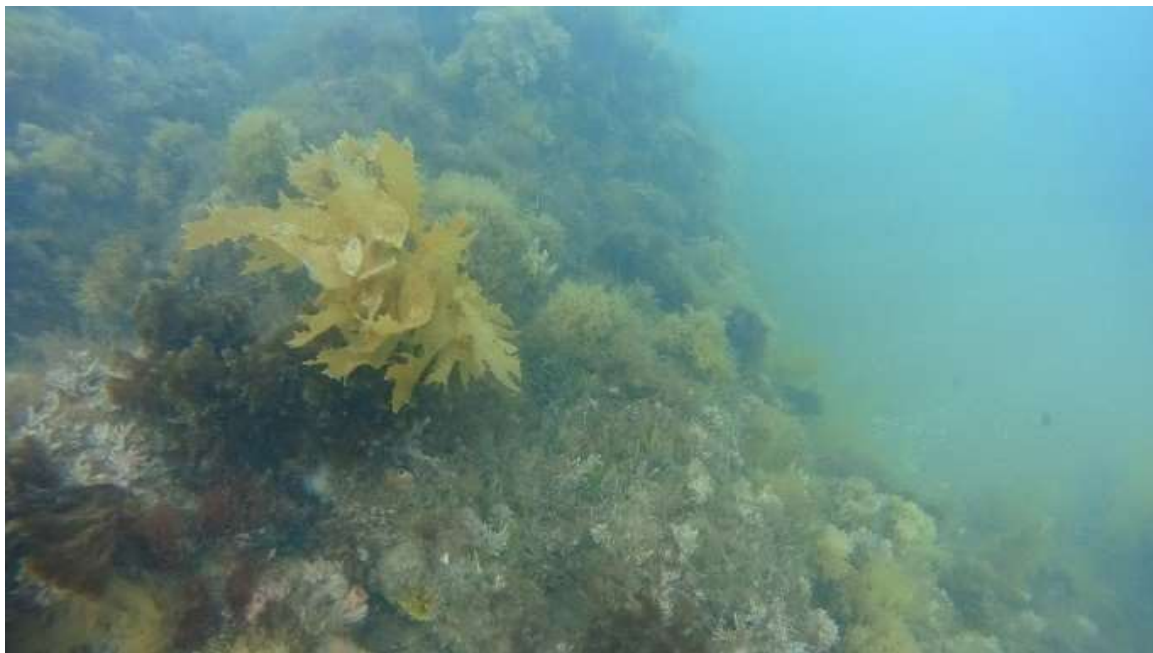
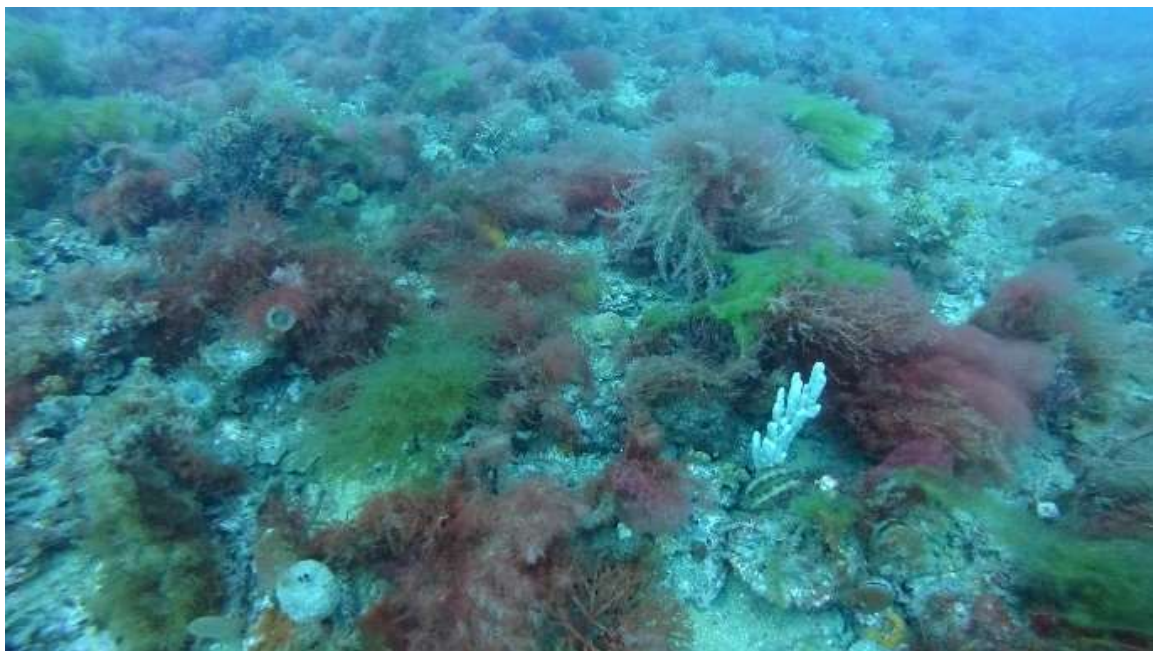
Figure 4.6: Biota on shallow reef (left, C11) and mid-depth cobble (right, C06) at Blythe River mouth

More stable boulder and reef habitat support a wide range of larger, more long-lived invertebrates and macroalgae. Large sponges and ascidians are abundant in these habitats at greater than 20 m depth (Figure 4.6 - right), while large brown algae are abundant in waters less than 20 m deep (Figure 4.6 - left).

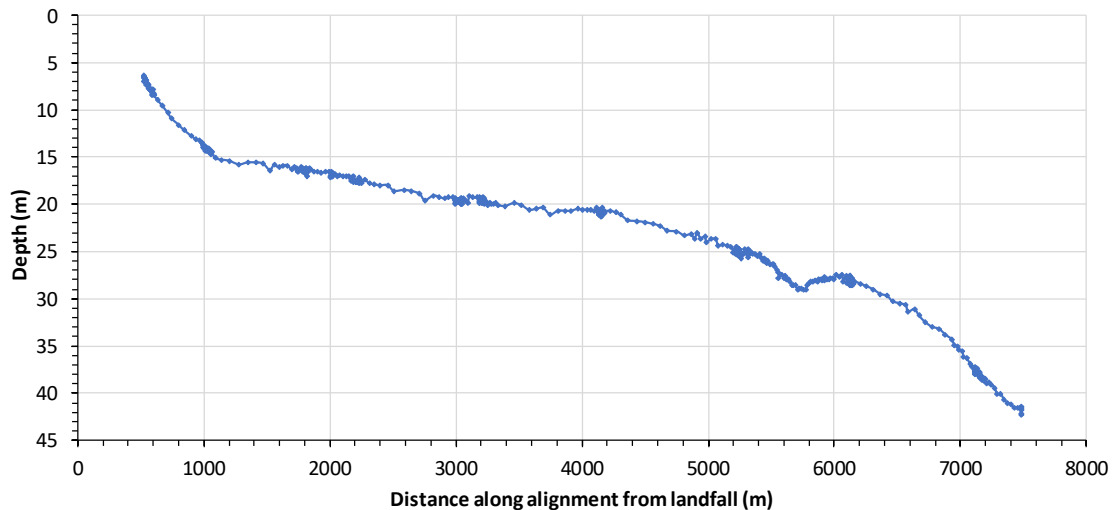
Figure 4.9: Seabed profile along Waratah Bay route, April 2019

The depth profile shows an initial steep increase in depth from 7 m to 15 m over the first 500 to 600 m of the section (gradient 1:70), followed by gently-sloping, flat seabed from 15 m to 25 m over approximately 4 km (gradient of 1 in 400), a longshore trough 5.8 to 5.9 km offshore followed by a relatively steep increase in depth from 30 m to 42 m over the last offshore 1000 m of the section (gradient of 1 in 80).
