Project :42662.01  
R.001.Rev2  
14 February 2019

The site is currently vacant and is adjacent to Broadcast Australia's AM radio mast. The aim of the investigation was to update the older 2010 report to reference current criteria, and confirm whether any changes have occurred to ground conditions between 2010 when the previous sampling was undertaken and 2019. This was undertaken by re-sampling approximately 30% of the original test locations (eight locations) as well as collecting samples from an area that was excluded from the 2010 testing. Comments are provided on the potential for contamination and the level of investigation required with reference to planning documentation.

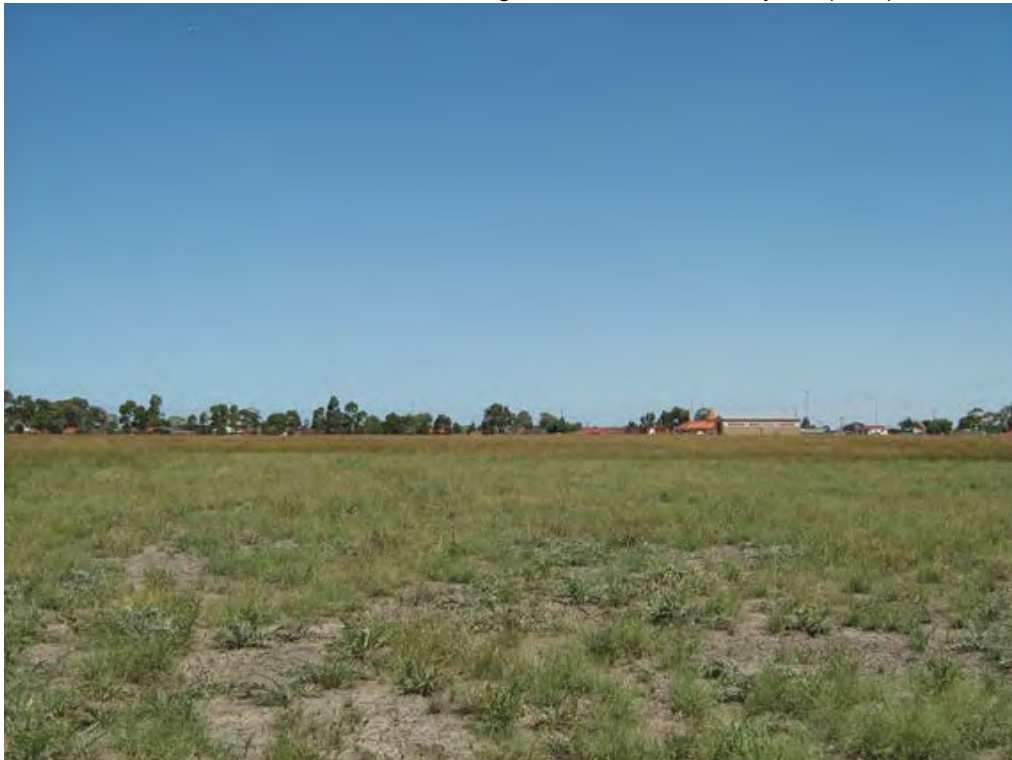
Photo 4 – View of the site looking south towards Taylors Road. The business selling bricks, roof tiles and pavers is visible in the south western corner of the site (2010).

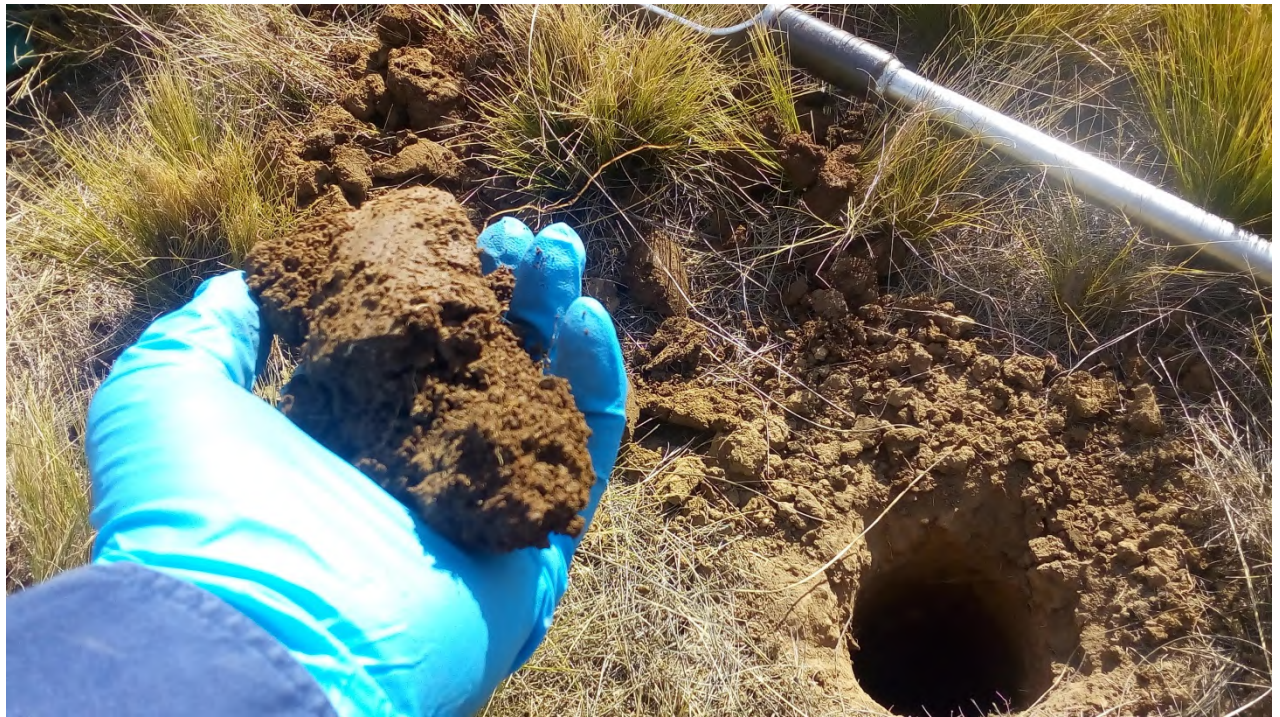
Photo 9 – Silt and Clay material observed across site, photo from location B6-A (2019).

The subsurface conditions encountered in the investigation were consistent with the broad geological setting of the area. The subsurface conditions generally comprised a shallow layer of natural silt ranging from 0.02 m to 0.2 m depth, overlying natural high plasticity basalt-derived silty clay. No visual or olfactory evidence of potential contamination, including the presence of imported filling material, staining or odours were observed during the field work. These findings were confirmed with the re-sampled locations. A layer of basalt gravel was present at the brick and tile shop in the south-western corner of the site overlying the same natural soil found elsewhere on site. This gravel is considered to be quarry sourced crushed rock and is not an imported filling material.

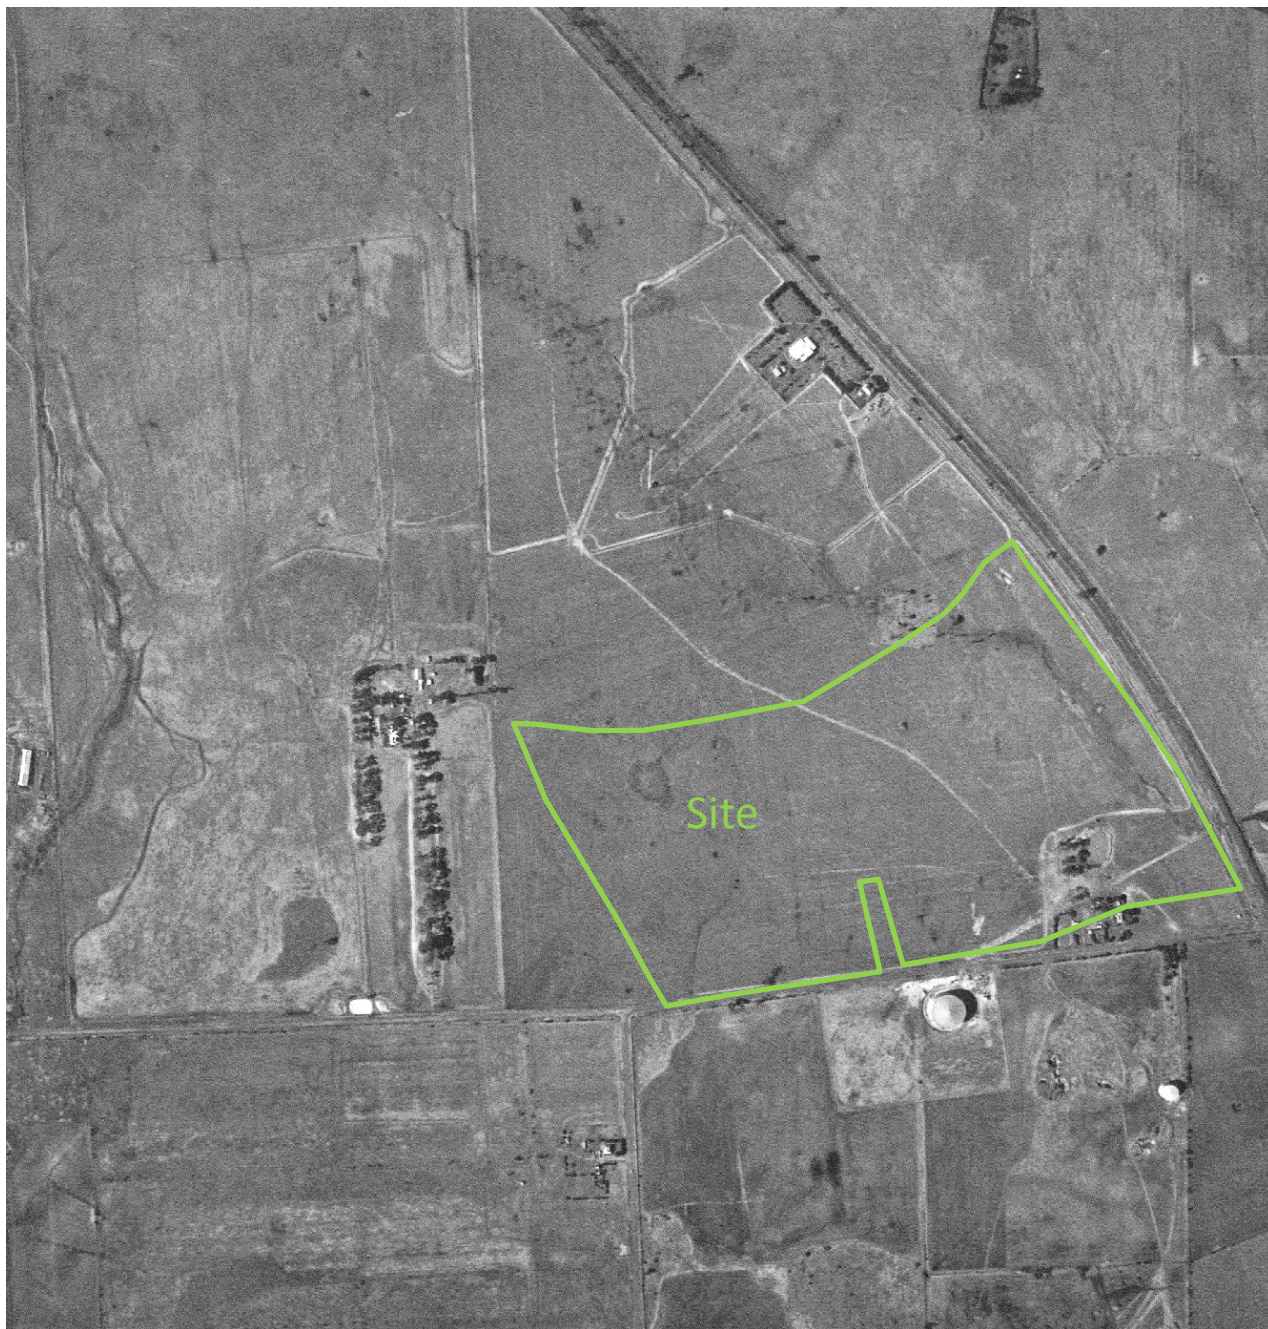
Aerial photograph from 1970,  
Sourced from DELWP  
Film 2364, 5,100 feet, Photo number 161

Aerial photography from 1970 indicates very little change to the site with the exception of the first signs of the area of trees observed in the north eastern section of the site during the site inspection. The former Melbourne and Metropolitan Board of Works (MMBW) water storage site had commenced operation with one large water tank visible to the south of the site beyond Taylors Road.
