# Appendix 5 Residential Visual Amenity

## Montrose Quarry Stage 2 Extension

Landscape and Visual Impact Assessment

Prepared for Boral Resources (VIC) Pty Ltd

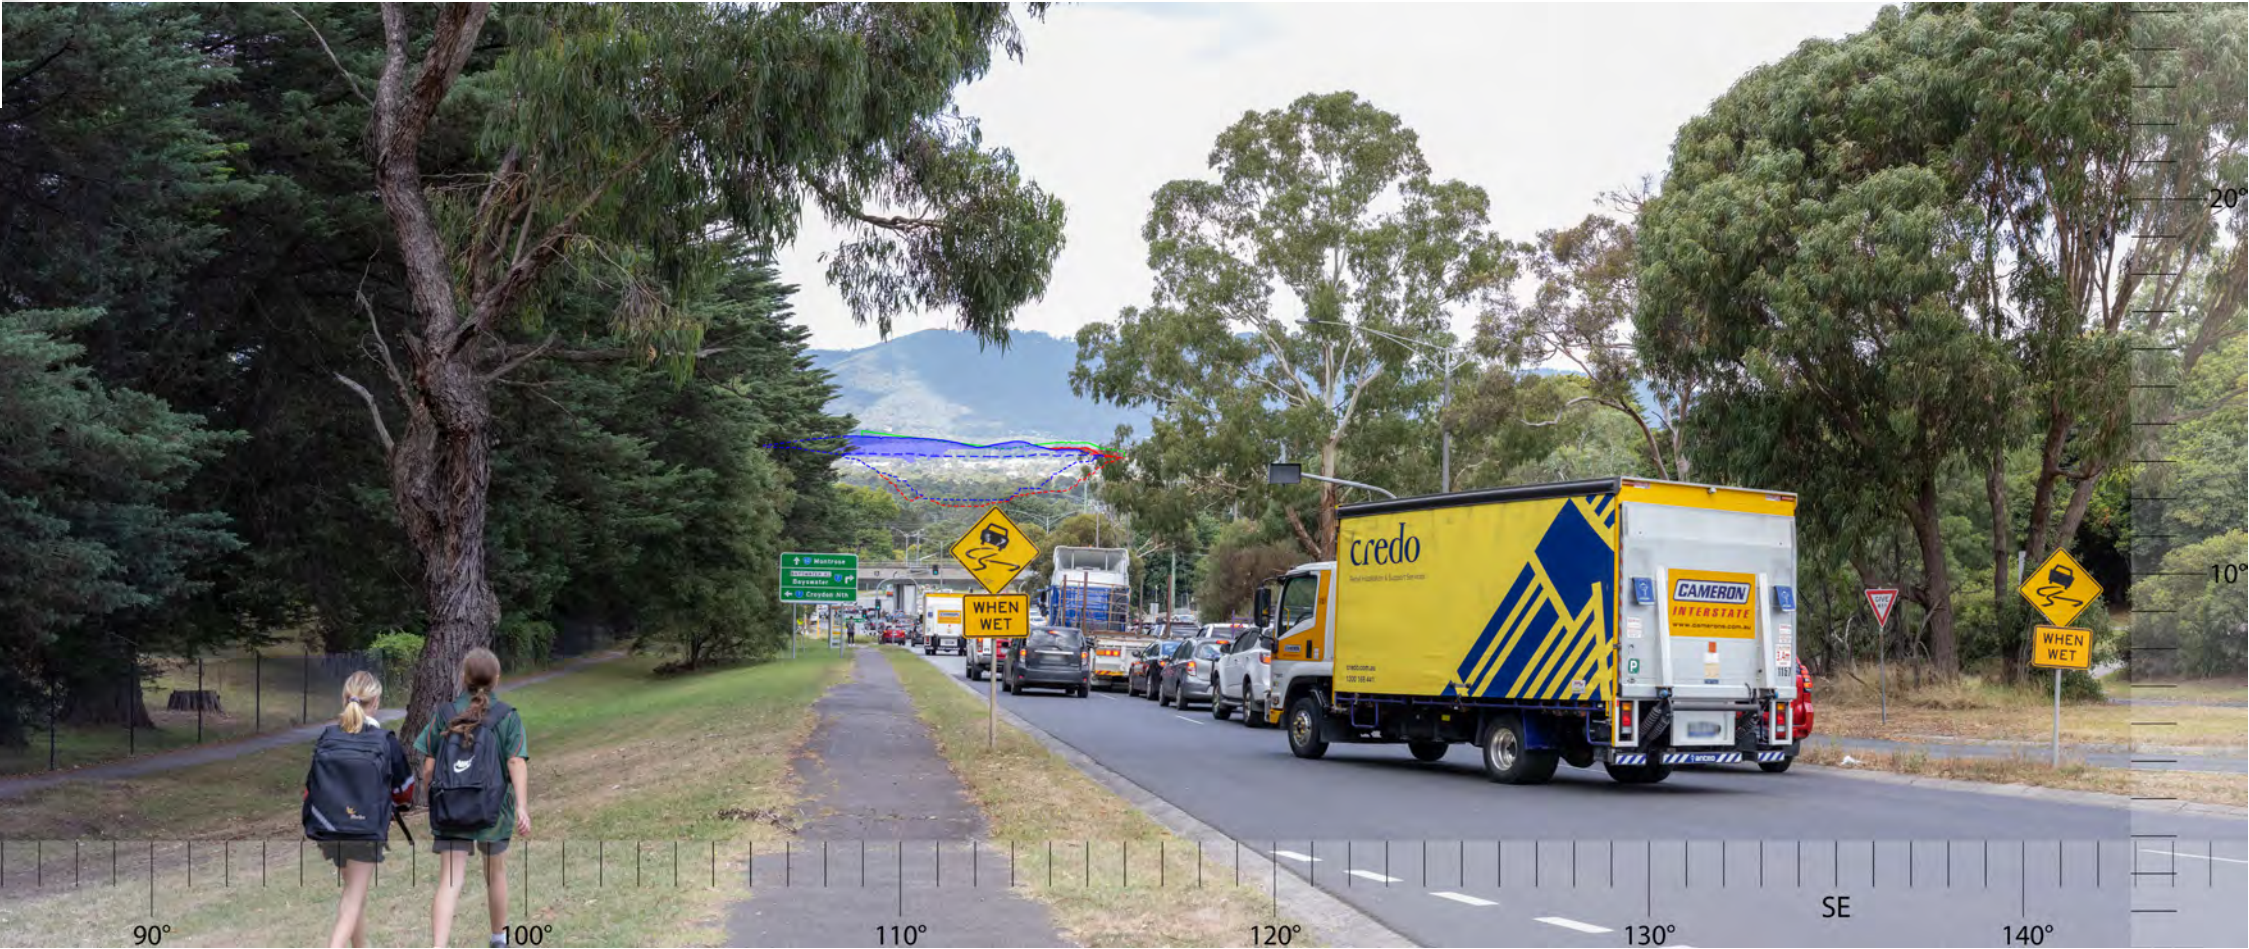
- Outline of existing quarry pot - top rim and pit
- Foreground edge of existing quarry rim
- Likely seen area within existing pit
- Unlikely seen vegetation
- Likely seen vegetation
- Likely seen area with new pit
- Outline of expanded quarry pit - top rim and pit
- Foreground edge of new quarry rim

Distance from Site Area: 5237.55m  
Bearing: 106 Degrees  
Viewpoint location: E:347730 N:5814969 ELEV:156.56m, EPSG:7855 - GDA2020/MGA zone 55  
Date and time of photograph: 07/03/2023, 2:17 PM  
Camera setup: Canon EOS R5, 50mm Lens

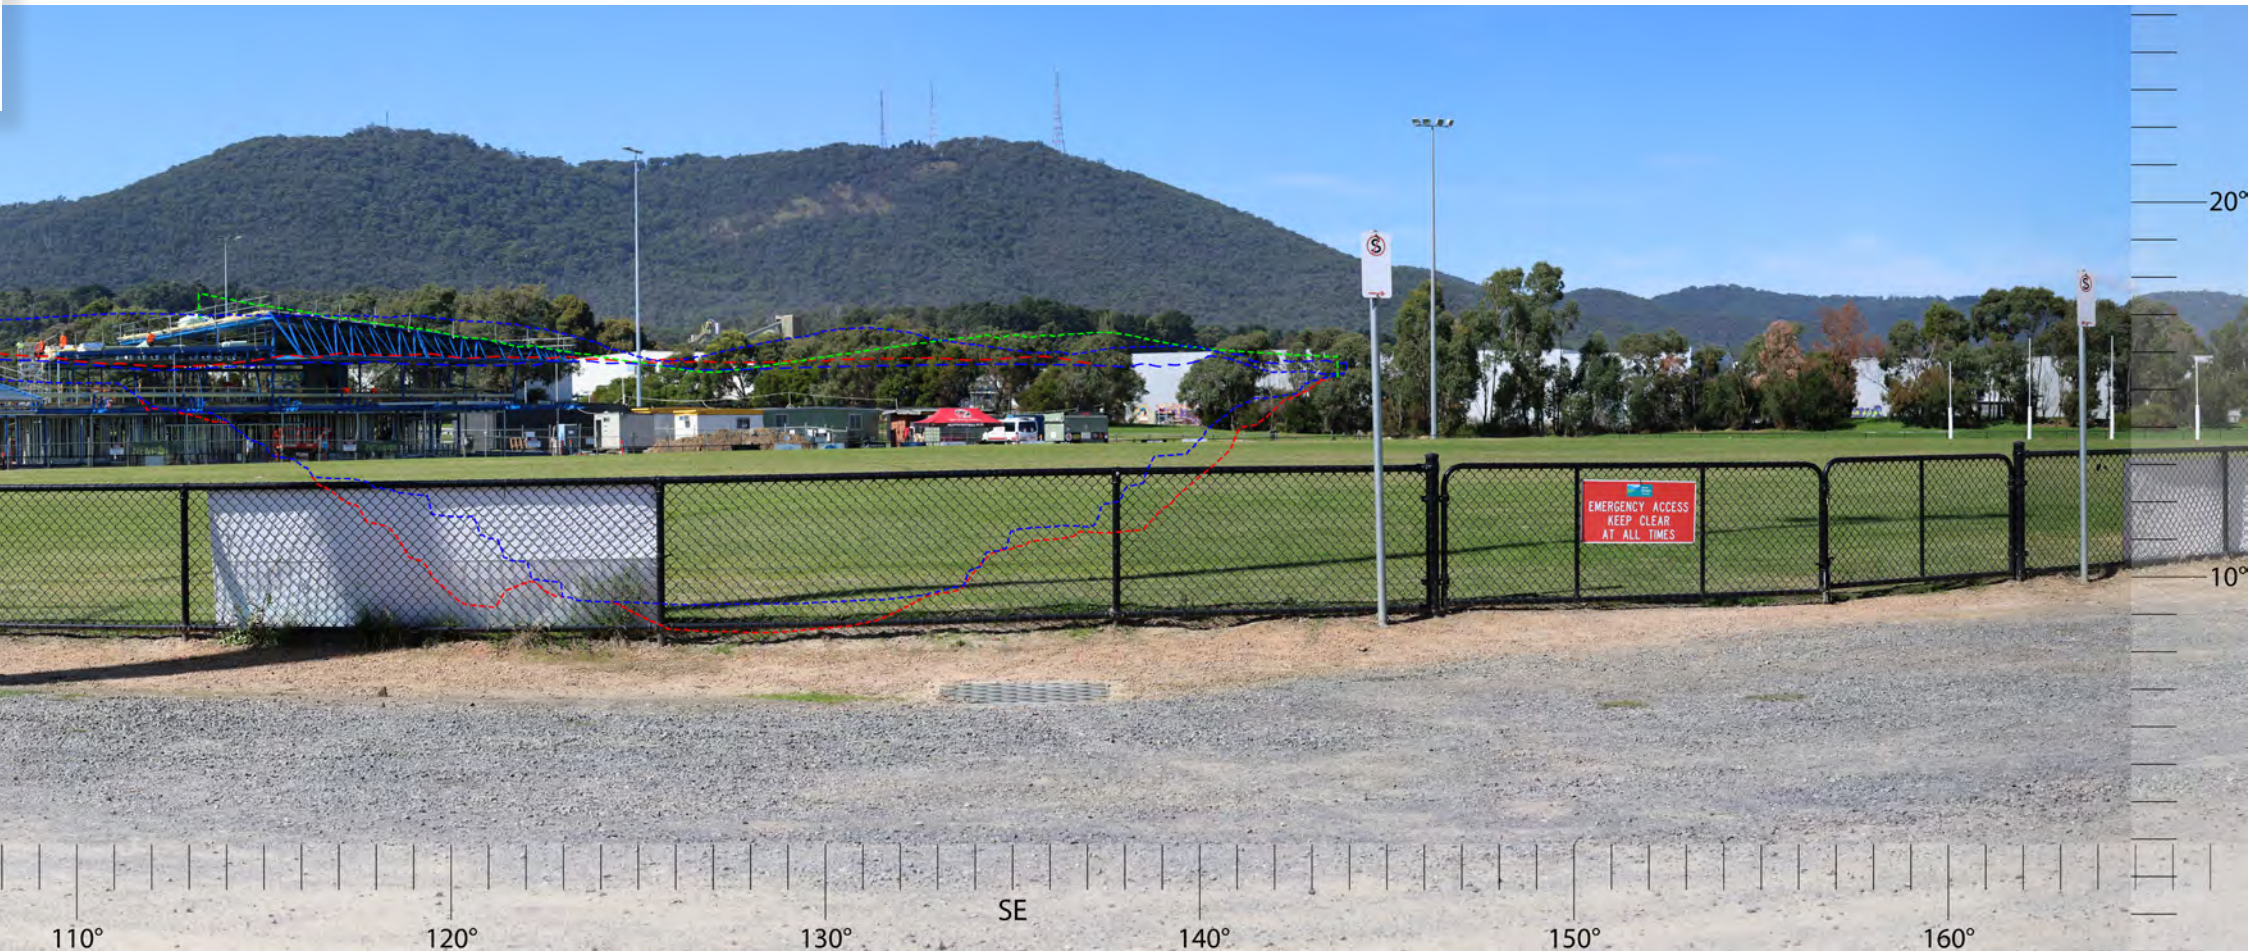
- Outline of existing quarry pot - top rim and pit
- Foreground edge of existing quarry rim
- Likely seen area within existing pit
- Unlikely seen vegetation
- Likely seen vegetation
- Likely seen area with new pit
- Outline of expanded quarry pit - top rim and pit
- Foreground edge of new quarry rim

Distance from Site Area: 858.79m  
Bearing: 128 Degrees  
Viewpoint location: E:351956 N:5813624 ELEV:126.98m, EPSG:7855 - GDA2020/MGA zone 55  
Date and time of photograph: 04/04/2023, 12:47 PM  
Camera setup: Canon EOS R5, 50mm Lens

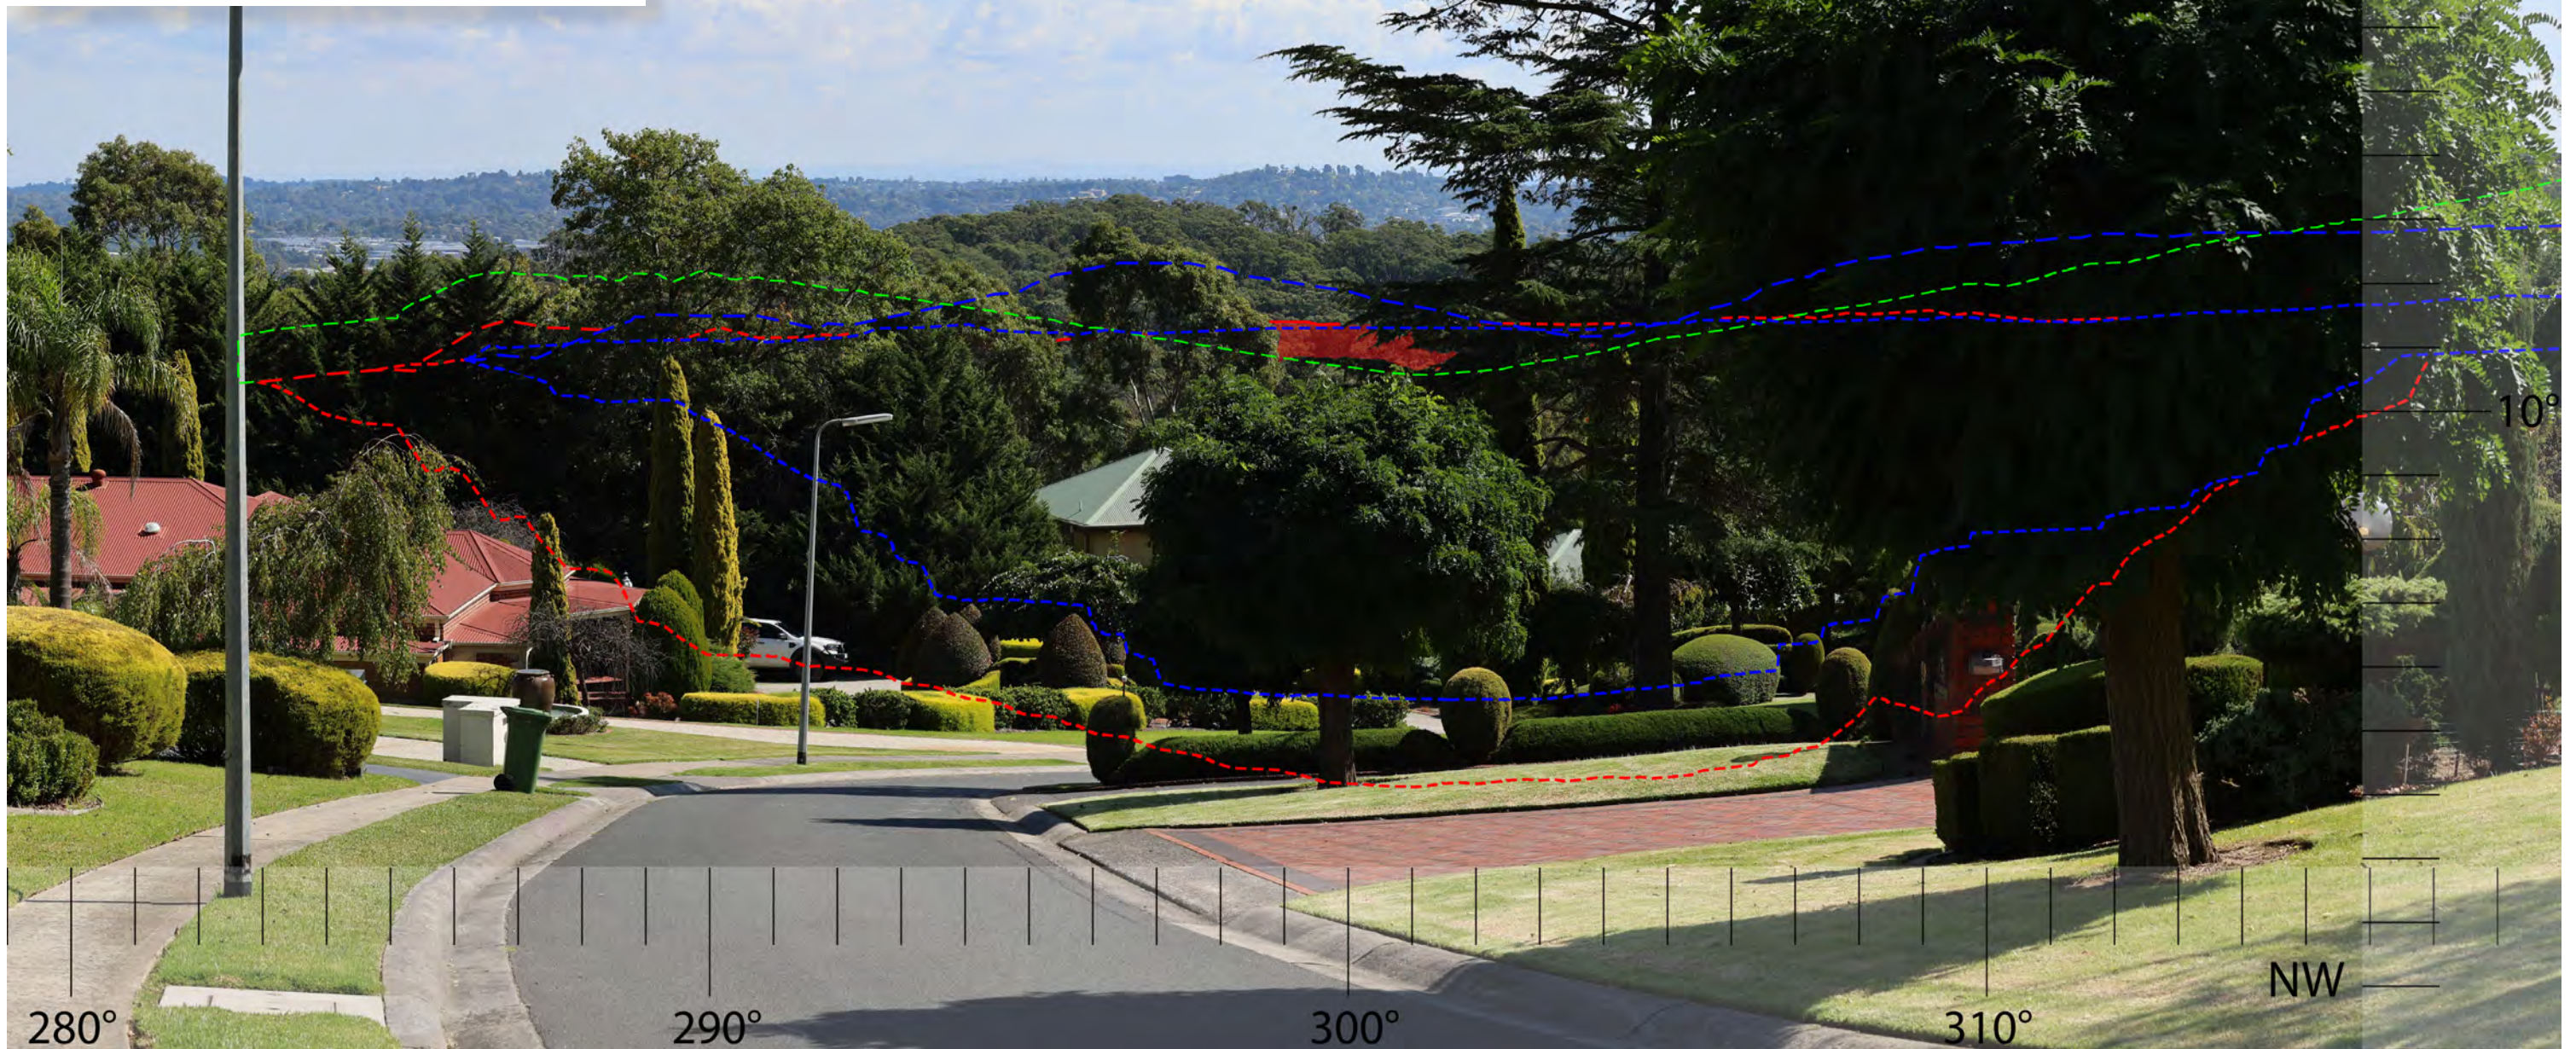
4.2.6 Viewpoint 7 80 Degree Panorama  
Existing and Proposed Conditions

- Outline of existing quarry pot - top rim and pit
- Foreground edge of existing quarry rim
- Likely seen area within existing pit
- Unlikely seen vegetation
- Likely seen vegetation
- Likely seen area with new pit
- Outline of expanded quarry pit - top rim and pit
- Foreground edge of new quarry rim

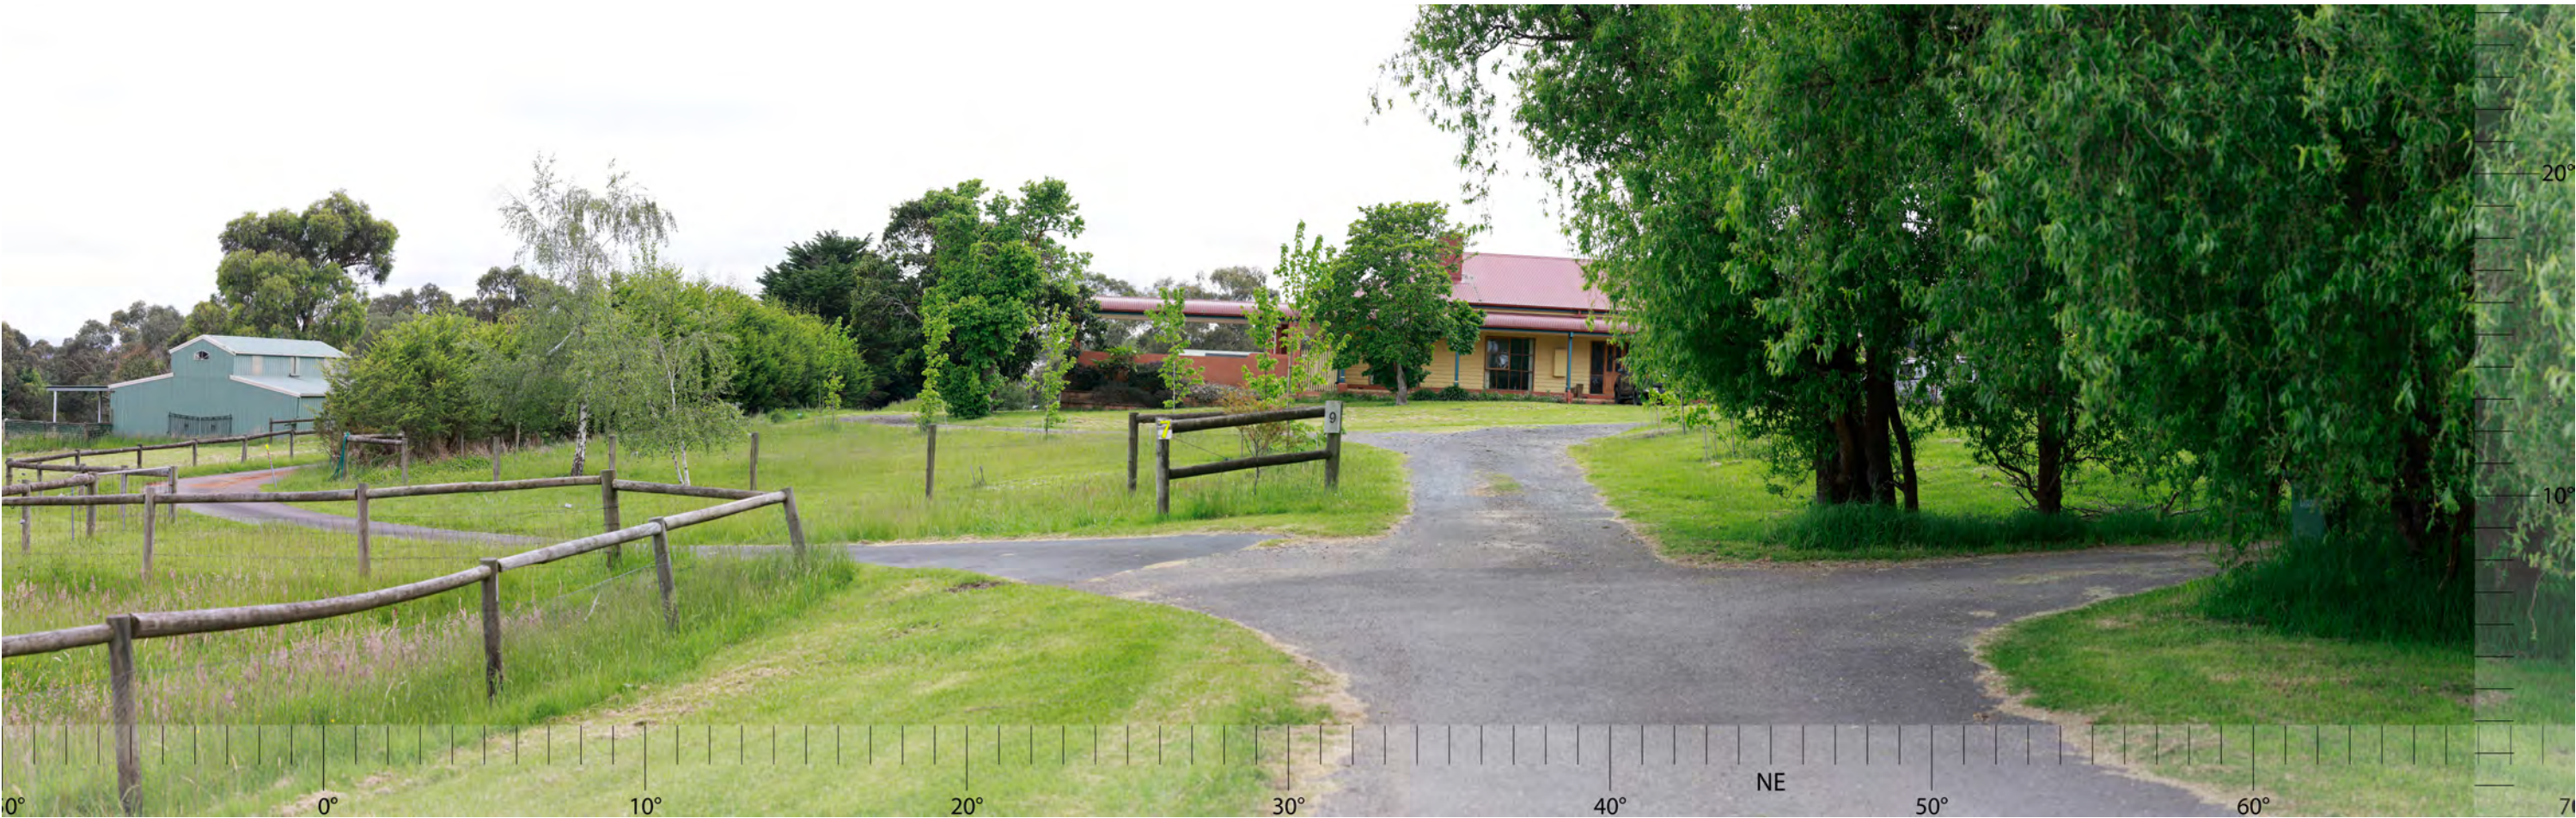
Distance from Site: 964.95m  
Bearing: 30 Degrees  
Viewpoint location: E:352384 N:5812010 ELEV:146m, EPSG:7855 - GDA2020/MGA zone 55  
Date and time of photograph: 30/10/2024, 10:32 AM  
Camera setup: Canon EOS R5, 50mm Lens

| Drawing Title | Project Name | Drawing No. | Revision | Date | Drawn | Checked | Project Principal | Scale |
|---|---|---|---|---|---|---|---|---|
| Residential Location 1: 9 Glasgow Road<br>Existing Conditions | Montrose Quarry LVIA | 322-0548-01-DR501 | 01 | 14.11.24 | AS | JC | AW | Page Display @ A3 |

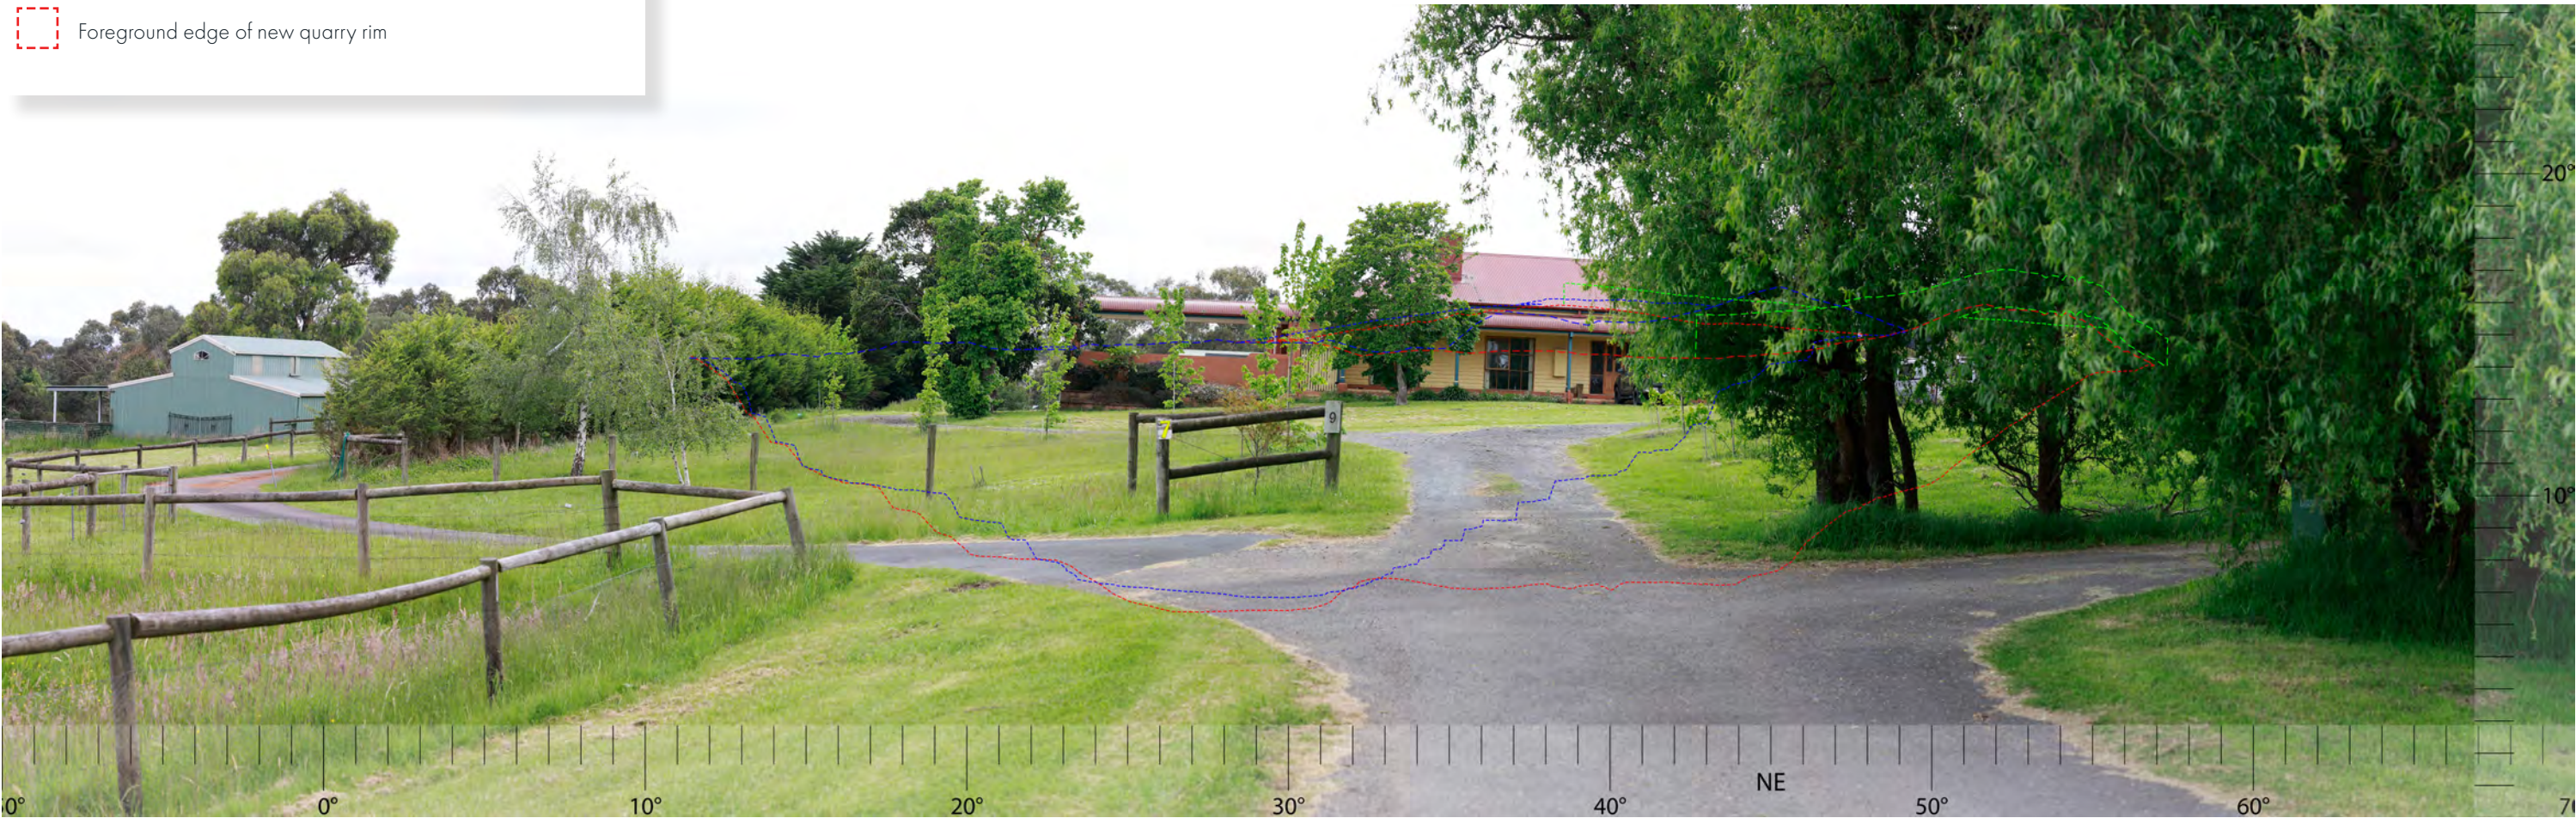
- Outline of existing quarry pot - top rim and pit
- Foreground edge of existing quarry rim
- Likely seen area within existing pit
- Unlikely seen vegetation
- Likely seen vegetation
- Likely seen area with new pit
- Outline of expanded quarry pit - top rim and pit
- Foreground edge of new quarry rim

Distance from Site Area: 964.95m  
Bearing: 30 Degrees  
Viewpoint location: E:352384 N:5812010 ELEV:146m, EPSG:7855 - GDA2020/MGA zone 55  
Date and time of photograph: 30/10/2024, 10:32 AM  
Camera setup: Canon EOS R5, 50mm Lens

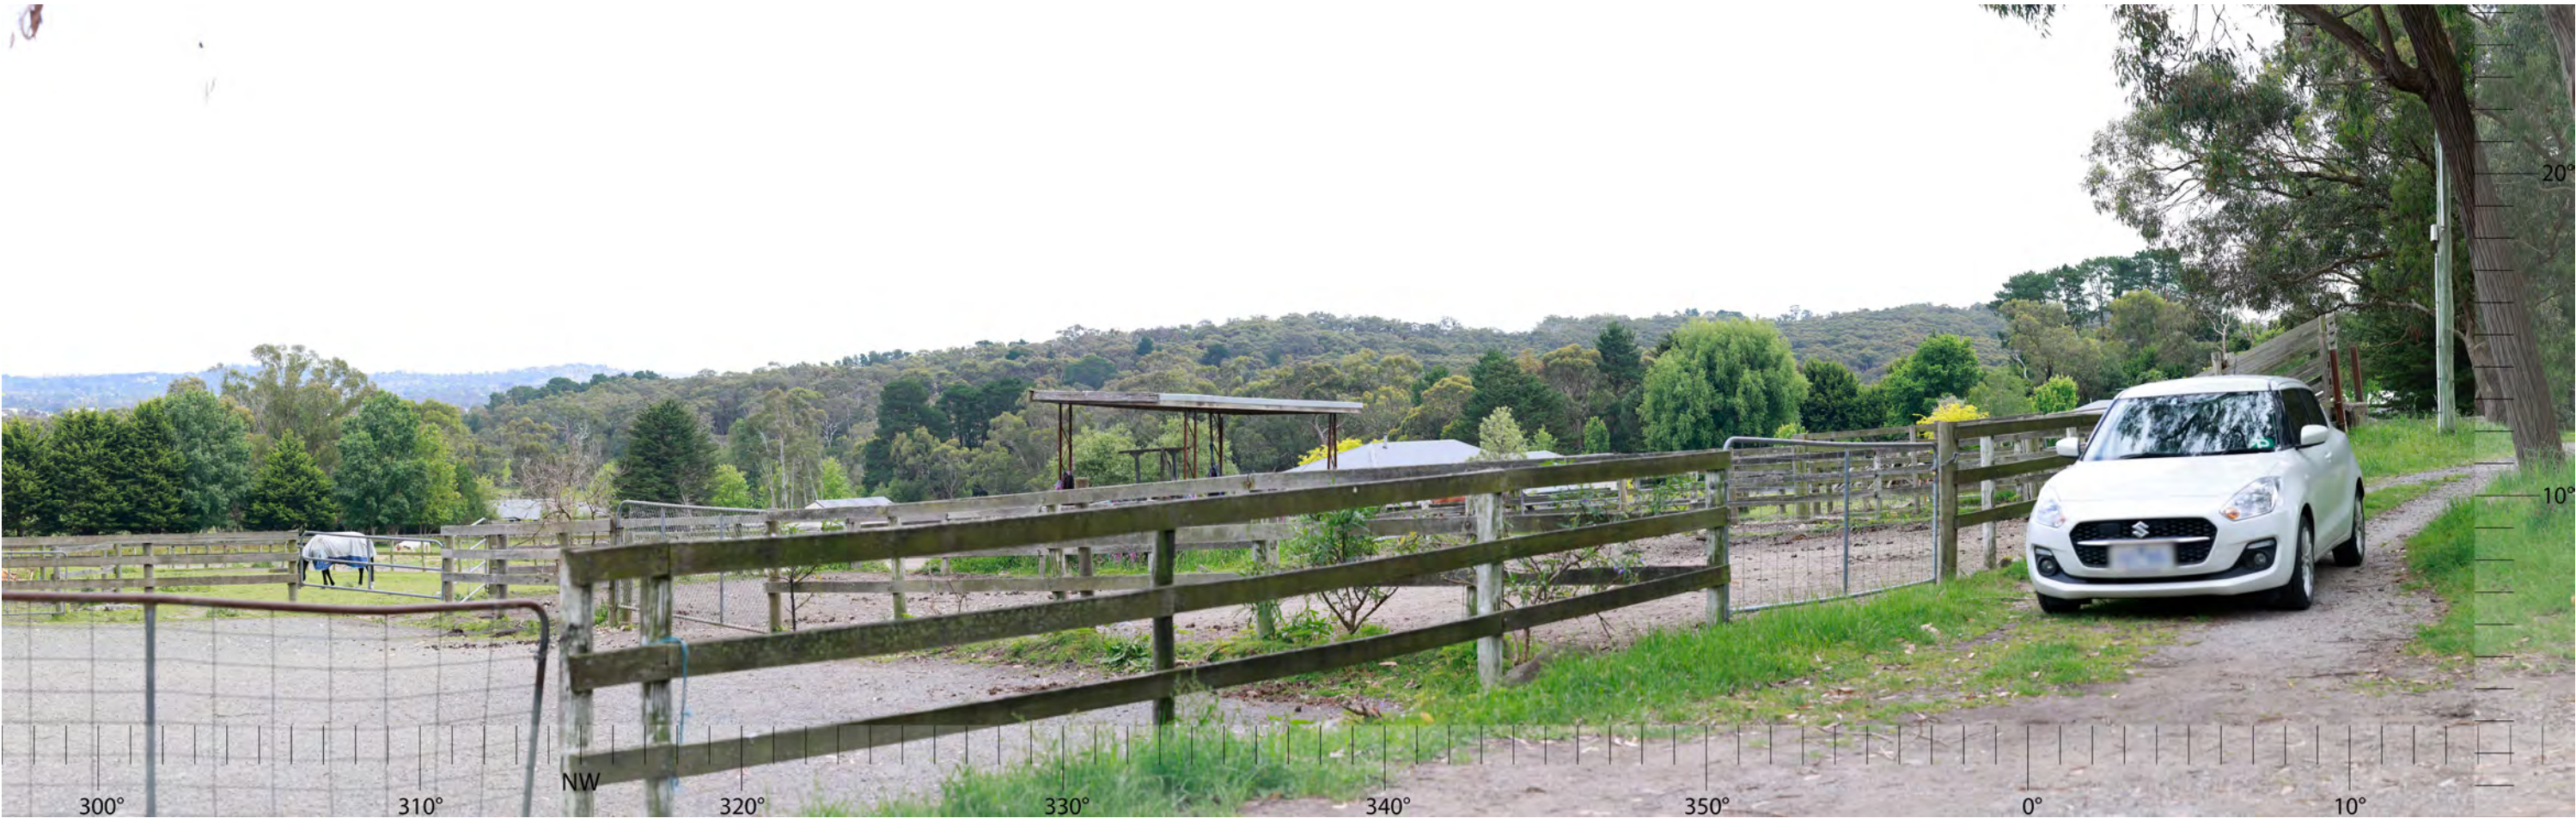
Distance from Site Area: 1165.91m  
Bearing: 337 Degrees  
Viewpoint location: E:353437 N:5811772 ELEV:182m, EPSG:7855 - GDA2020/MGA zone 55  
Date and time of photograph: 30/10/2024, 11:05 AM  
Camera setup: Canon EOS R5, 50mm Lens

| Drawing Title | Project Name | Drawing No. | Revision | Date | Drawn | Checked | Project Principal | Scale |
|---|---|---|---|---|---|---|---|---|
| Residential Location 2: 205 Sheffield Road<br>Existing Conditions | Montrose Quarry LVIA | 322-0548-01-DR503 | 01 | 14.11.24 | AS | JC | AW | Page Display @ A3 |

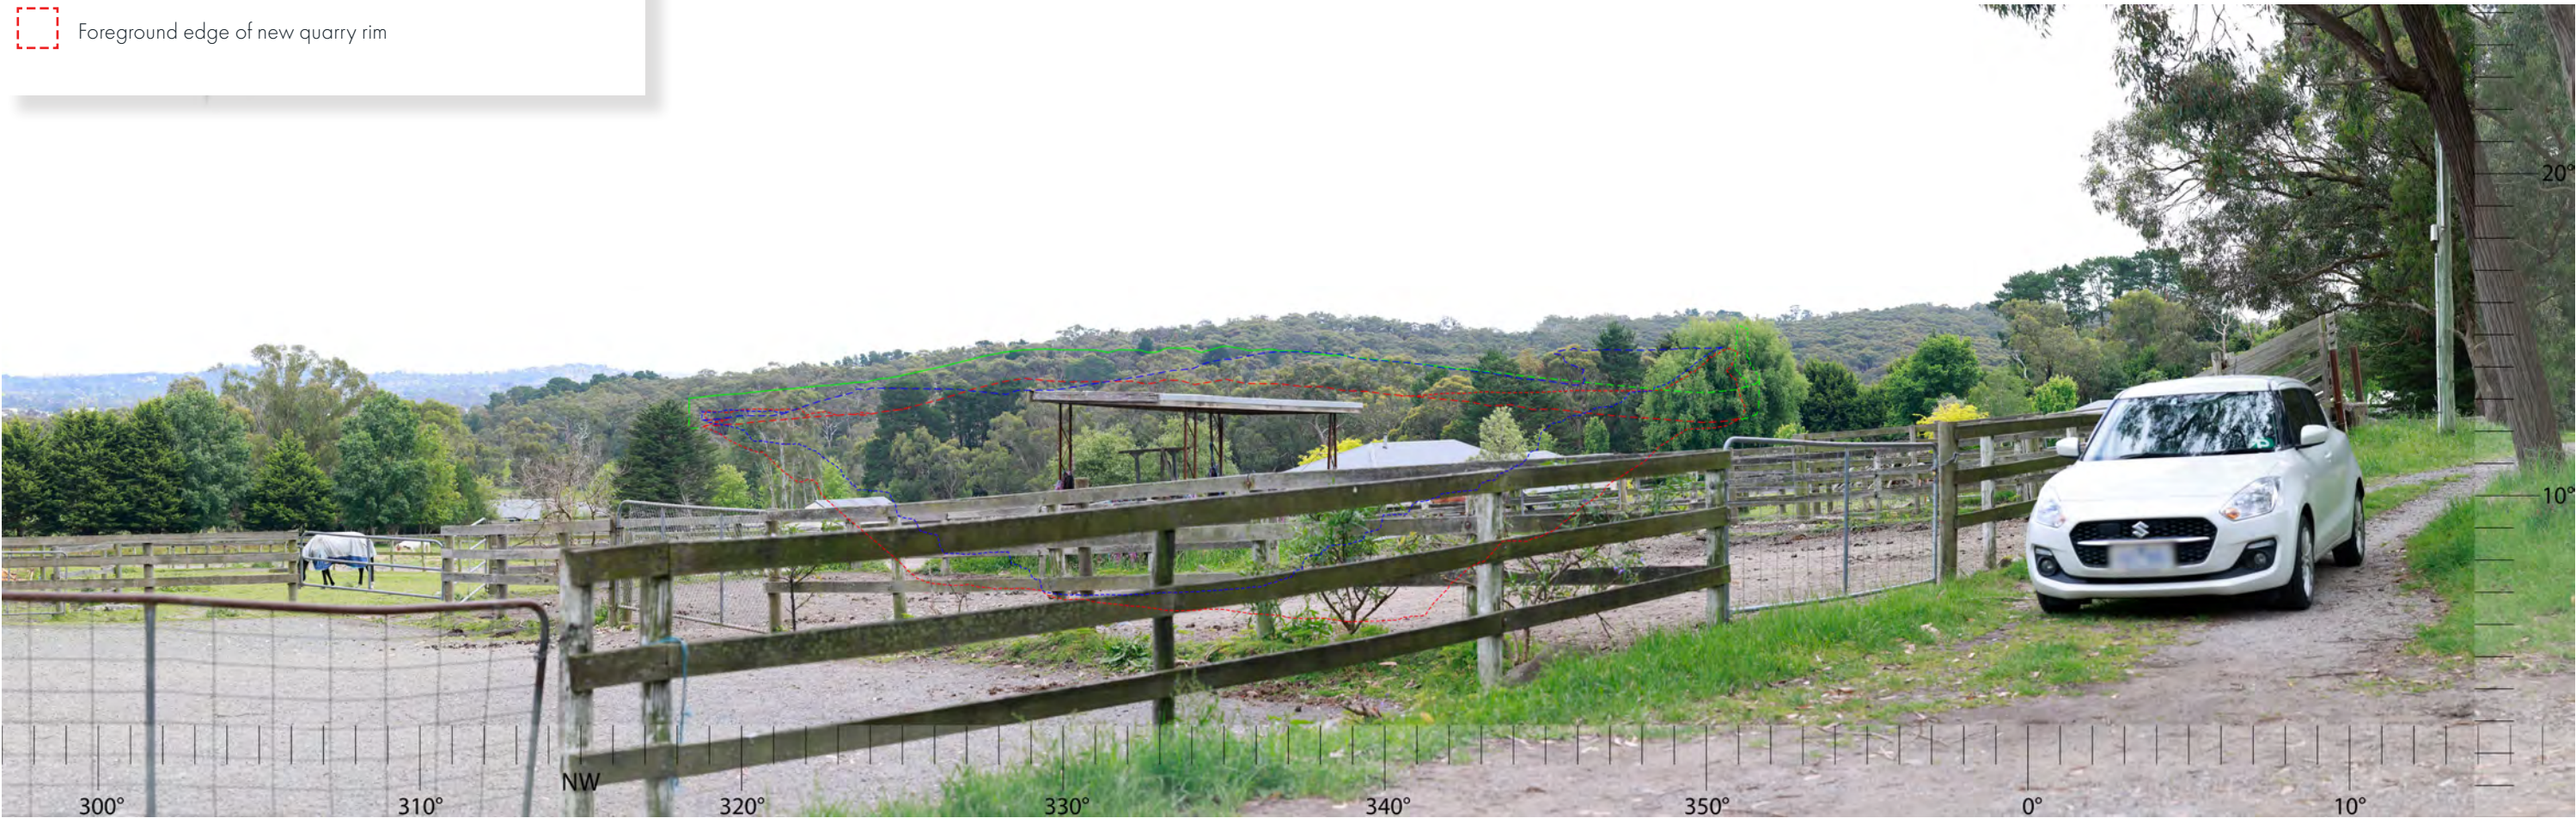
- Outline of existing quarry pot - top rim and pit
- Foreground edge of existing quarry rim
- Likely seen area within existing pit
- Unlikely seen vegetation
- Likely seen vegetation
- Likely seen area with new pit
- Outline of expanded quarry pit - top rim and pit
- Foreground edge of new quarry rim

Distance from Site Area: 1165.91m  
Bearing: 337 Degrees  
Viewpoint location: E:353437 N:5811772 ELEV:182m, EPSG:7855 - GDA2020/MGA zone 55  
Date and time of photograph: 30/10/2024, 11:05 AM  
Camera setup: Canon EOS R5, 50mm Lens

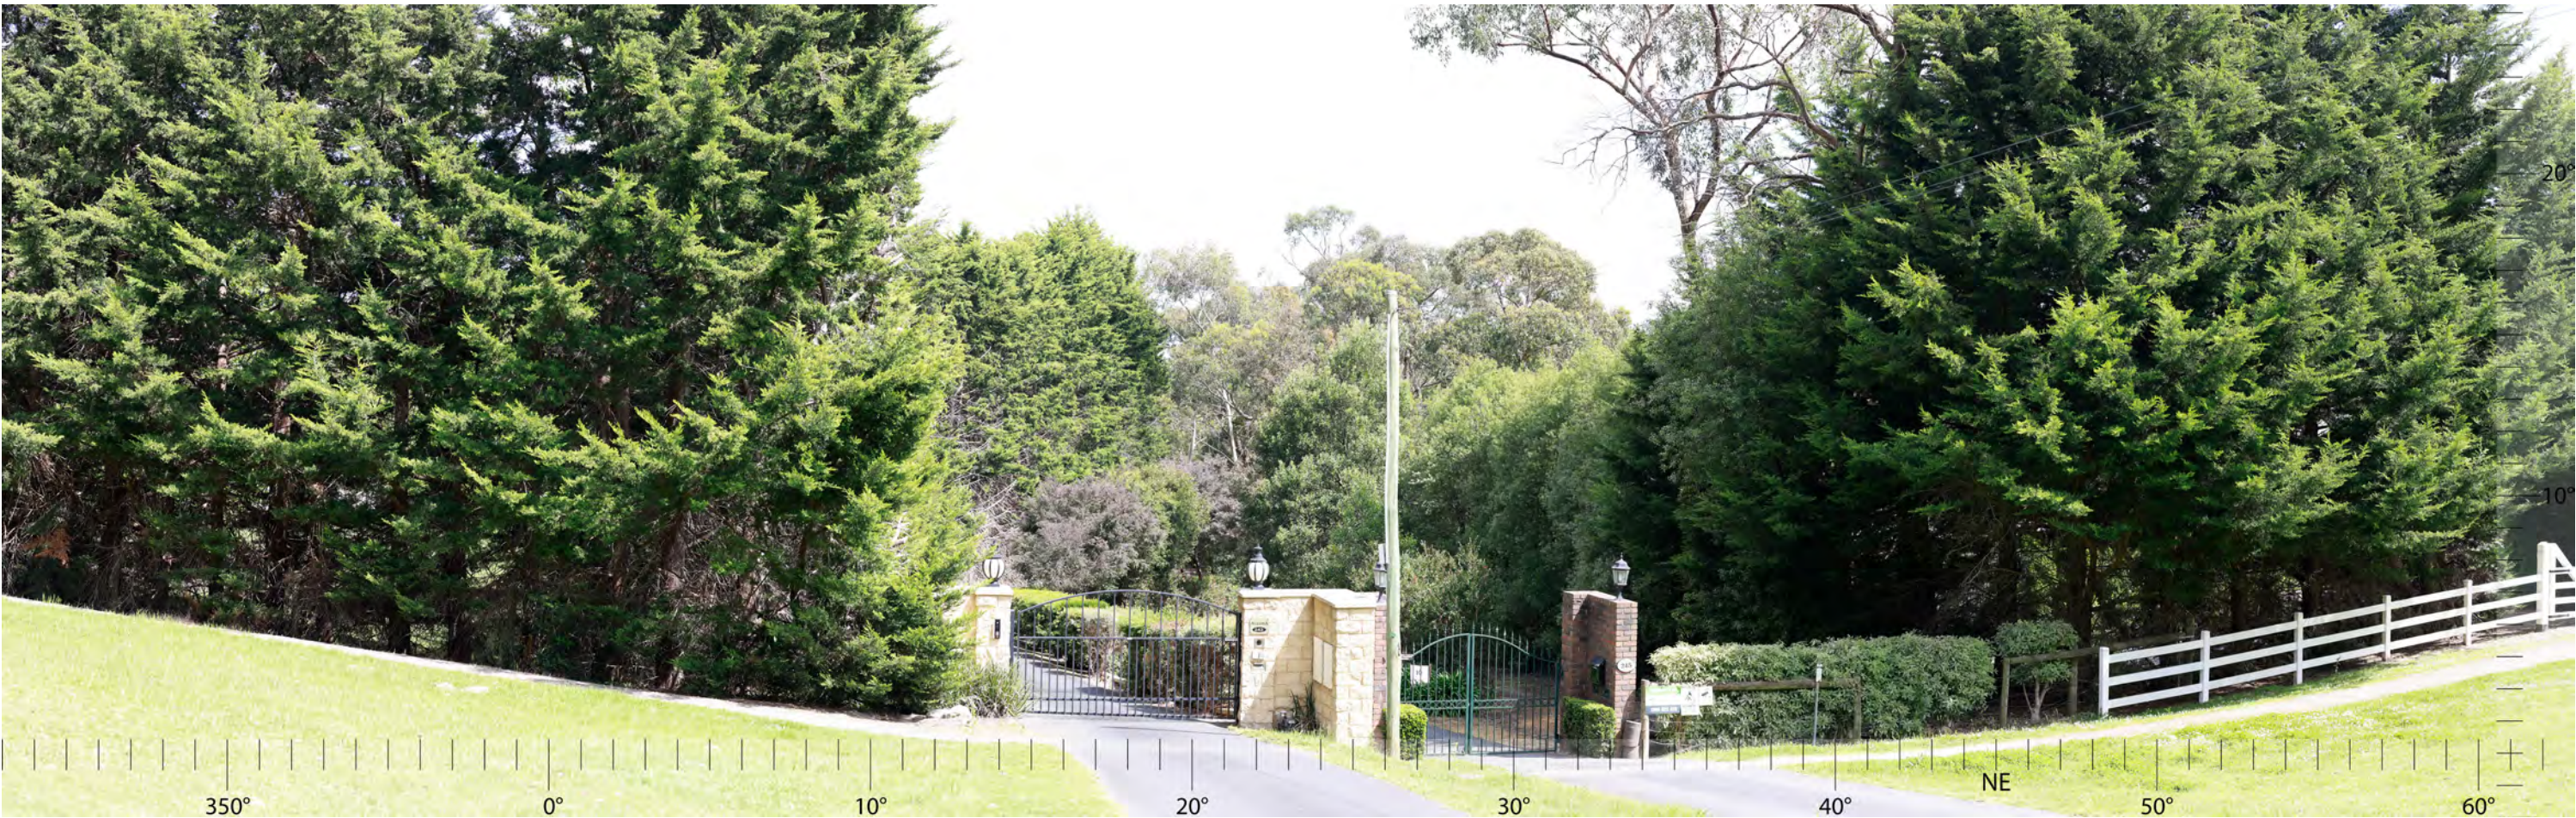
Distance from Site Area: 788.41m  
Bearing: 336 Degrees  
Viewpoint location: E:351824 N:5815793 ELEV:121.84m, EPSG:7855 - GDA2020/MGA zone 55  
Date and time of photograph: 30/10/2024, 11:21 AM  
Camera setup: Canon EOS R5, 50mm Lens

| Drawing Title | Project Name | Drawing No. | Revision | Date | Drawn | Checked | Project Principal | Scale |
|---|---|---|---|---|---|---|---|---|
| Residential Location 3: 243 Sheffield Road<br>Existing Conditions | Montrose Quarry LVIA | 322-0548-01-DR505 | 01 | 14.11.24 | AS | JC | AW | Page Display @ A3 |

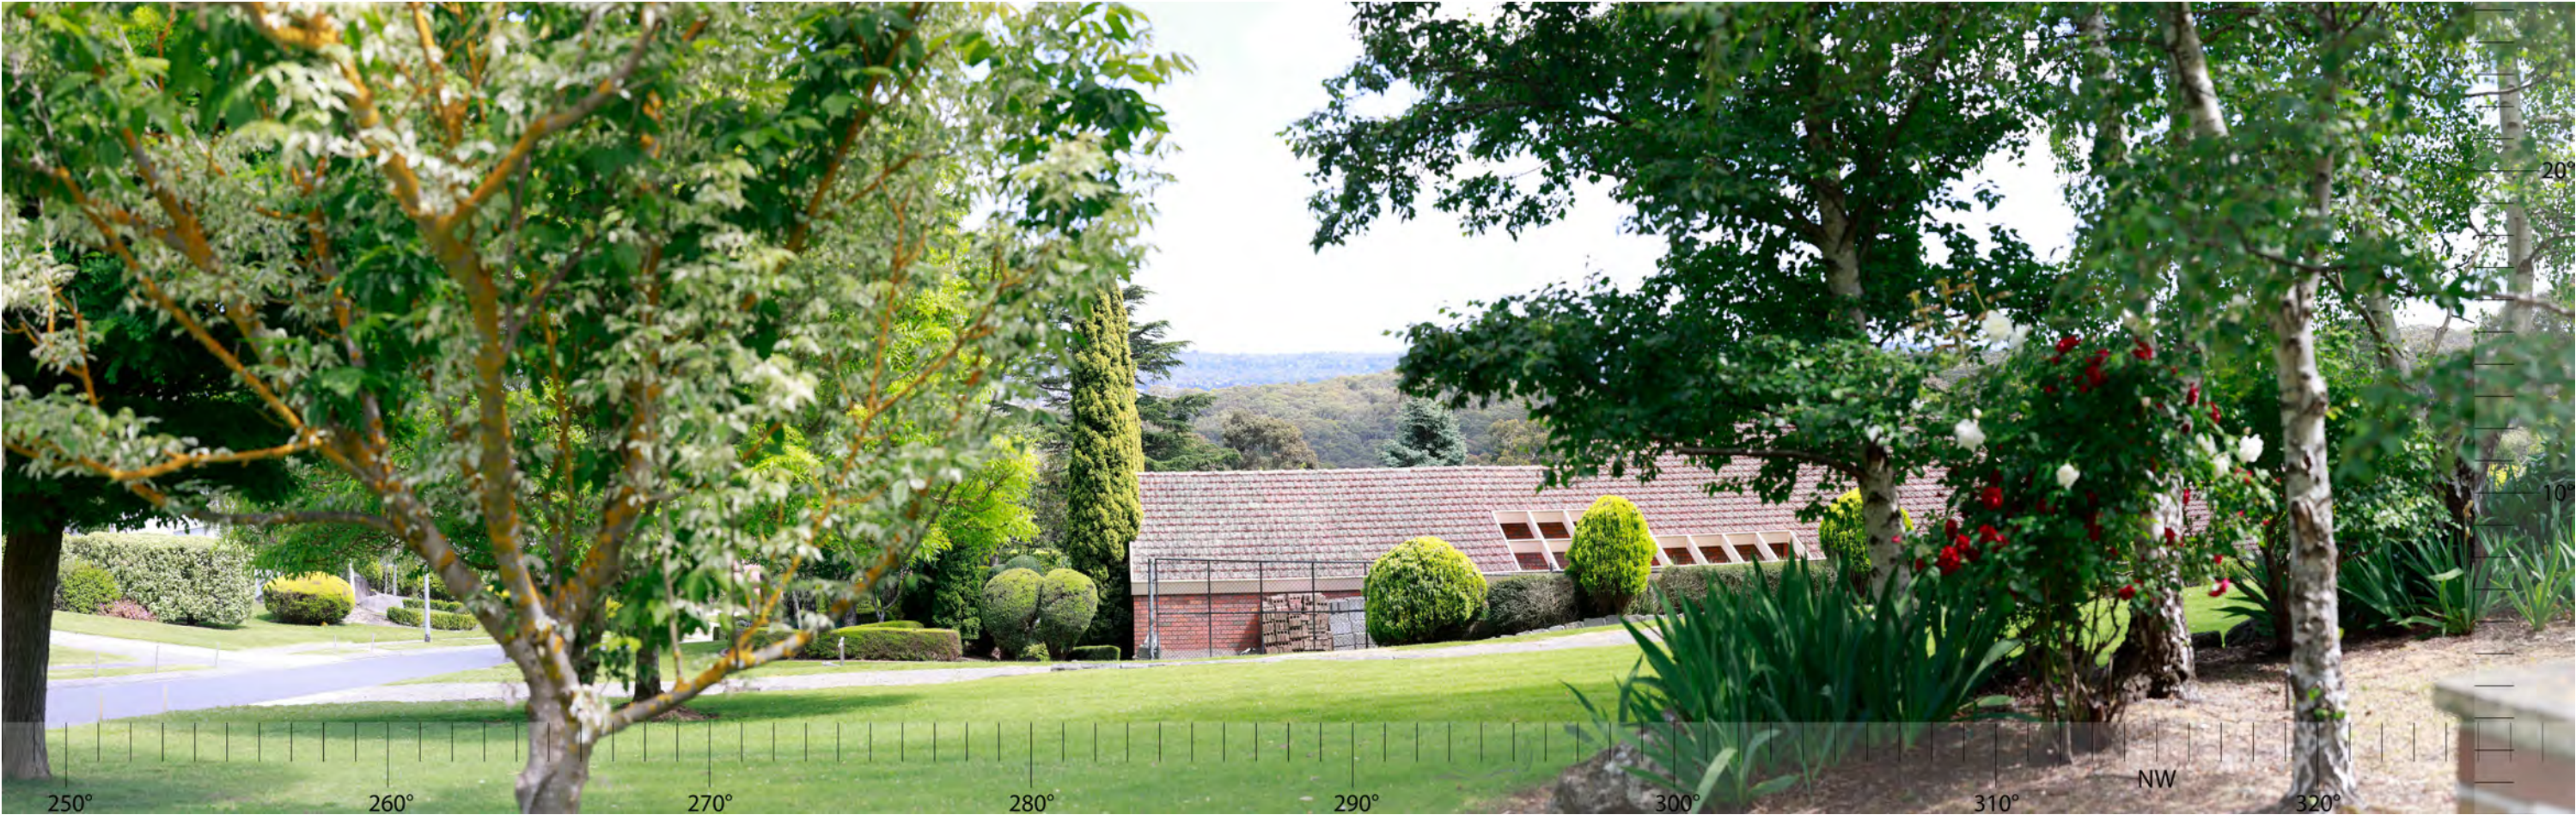
Distance from Site Area: 1270.92m  
Bearing: 288 Degrees  
Viewpoint location: E:354033 N:5812198 ELEV: 224m, EPSG:7855 - GDA2020/MGA zone 55  
Date and time of photograph: 30/10/2024, 11:35 AM  
Camera setup: Canon EOS R5, 50mm Lens

| Drawing Title | Project Name | Drawing No. | Revision | Date | Drawn | Checked | Project Principal | Scale | |
|---|---|---|---|---|---|---|---|---|---|
| Residential Location 5: 11 Taruna Rise<br>Existing Conditions | Montrose Quarry LVIA | 322-0548-01-DR507 | 01 | 14.11.24 | AS | JC | AW | | Page Display @ A3 |

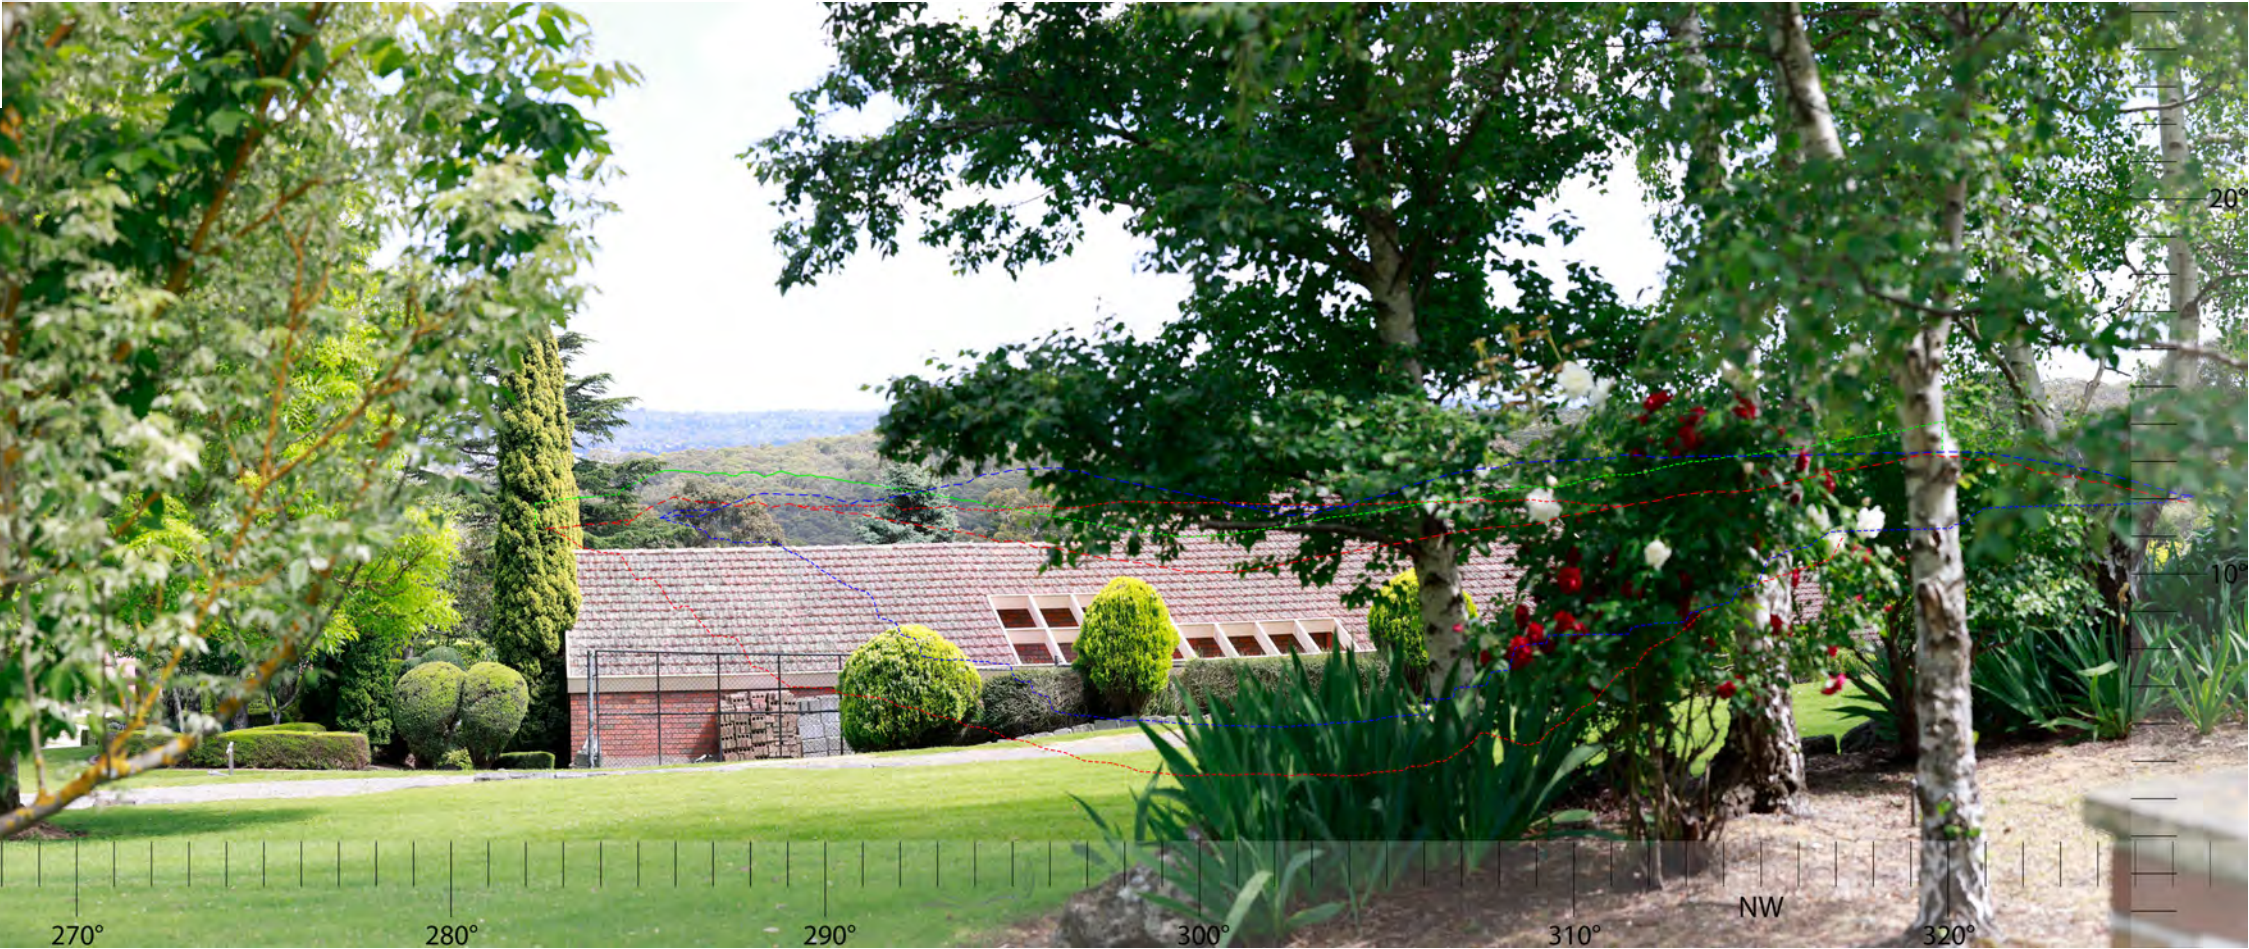
- Outline of existing quarry pot - top rim and pit
- Foreground edge of existing quarry rim
- Likely seen area within existing pit
- Unlikely seen vegetation
- Likely seen vegetation
- Likely seen area with new pit
- Outline of expanded quarry pit - top rim and pit
- Foreground edge of new quarry rim

Distance from Site Area: 1270.92m  
Bearing: 288 Degrees  
Viewpoint location: E:354033 N:5812198 ELEV: 224m, EPSG:7855 - GDA2020/MGA zone 55  
Date and time of photograph: 30/10/2024, 11:35 AM  
Camera setup: Canon EOS R5, 50mm Lens
