# Appendix 5 Residential Visual Amenity

## Montrose Quarry Stage 2 Extension

Landscape and Visual Impact Assessment

Prepared for Boral Resources (VIC) Pty Ltd

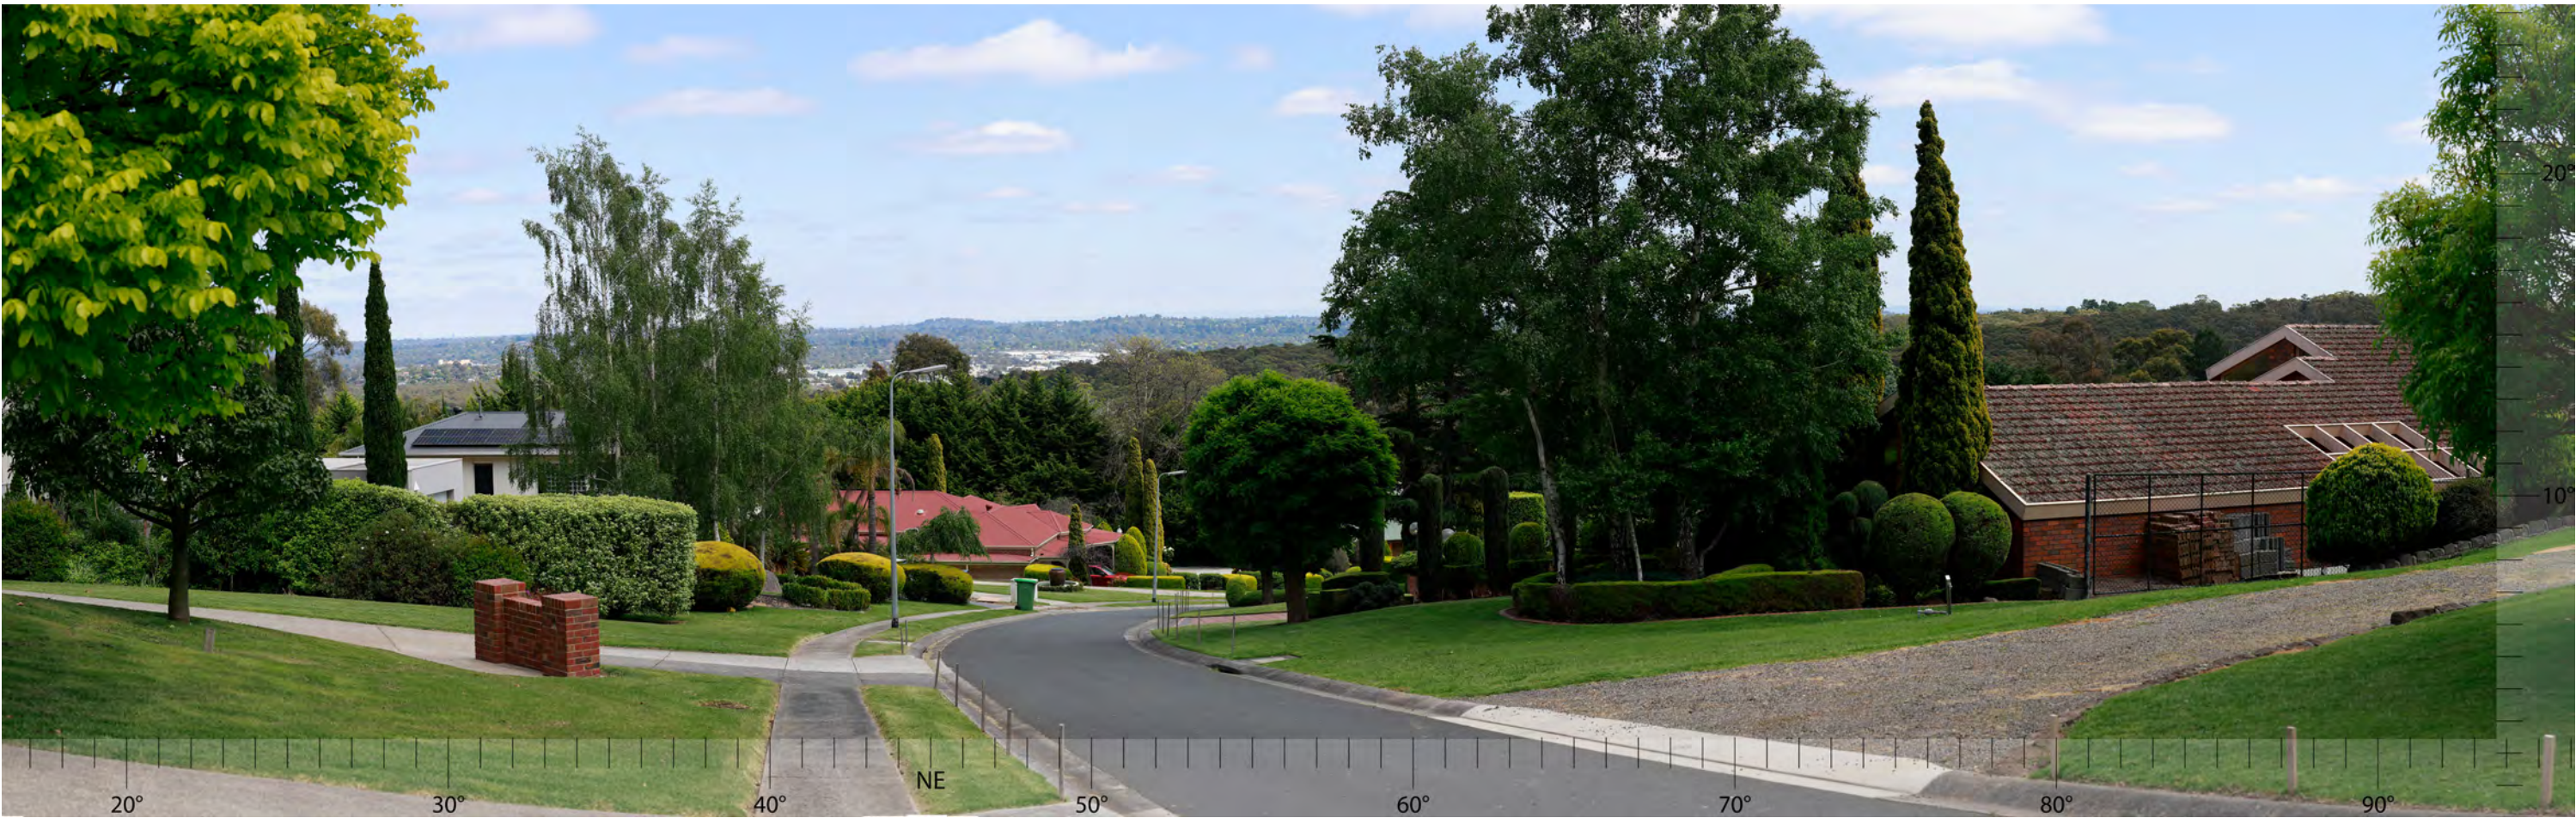
Distance from Site Area: 1268.46m  
Bearing: 303 Degrees  
Viewpoint location: E:351824 N:5815793 ELEV:121.84m, EPSG:7855 - GDA2020/MGA zone 55  
Date and time of photograph: 30/10/2024, 11:38 AM  
Camera setup: Canon EOS R5, 50mm Lens

| Drawing Title | Project Name | Drawing No. | Revision | Date | Drawn | Checked | Project Principal | Scale |
|---|---|---|---|---|---|---|---|---|
| Residential Location 6: 12 Taruna Rise<br>Existing Conditions | Montrose Quarry LVIA | 322-0548-01-DR509 | 01 | 14.11.24 | AS | JC | AW | Page Display @ A3 |

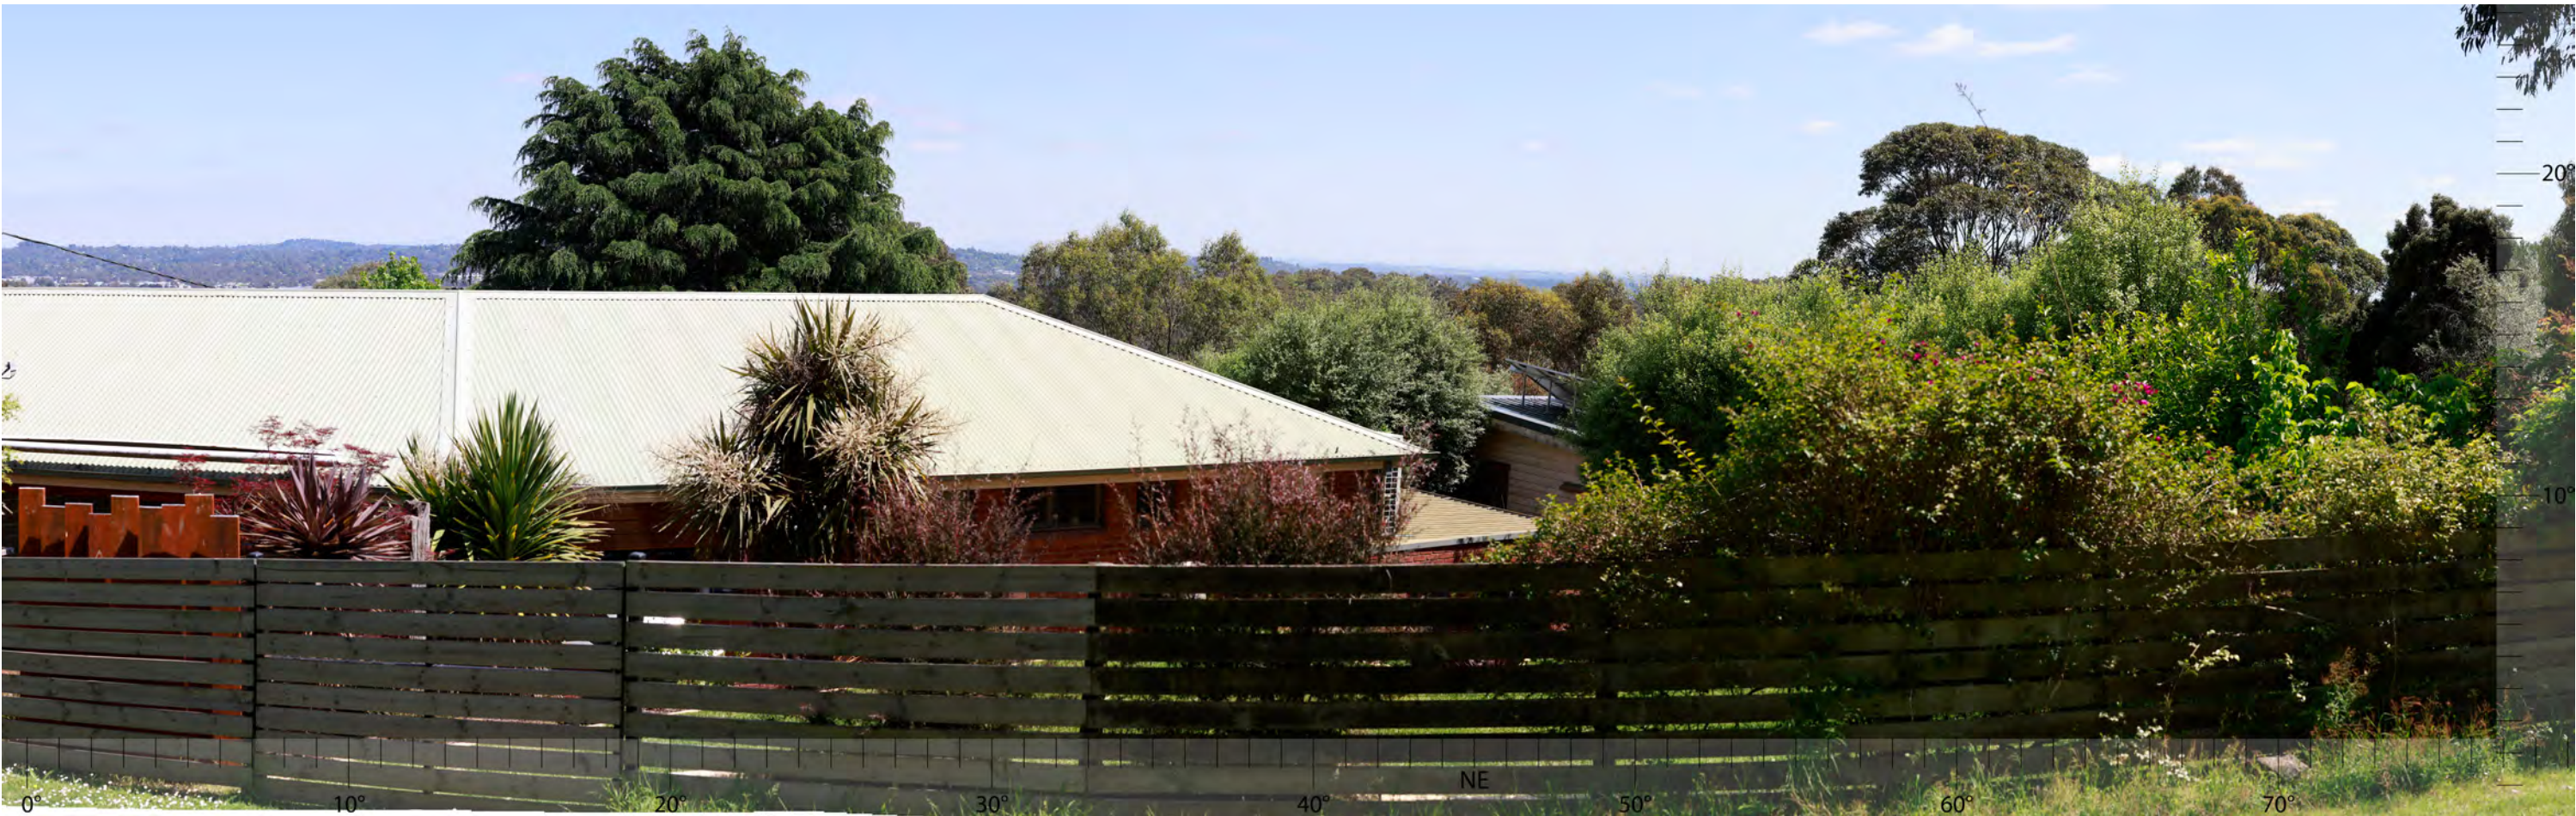
Distance from Site Area: 1212.51m  
Bearing: 320 Degrees  
Viewpoint location: E:351824 N:5815793 ELEV:121.84m, EPSG:7855 - GDA2020/MGA zone 55  
Date and time of photograph: 30/10/2024, 11:56 AM  
Camera setup: Canon EOS R5, 50mm Lens

| Drawing Title | Project Name | Drawing No. | Revision | Date | Drawn | Checked | Project Principal | Scale |
|---|---|---|---|---|---|---|---|---|
| Residential Location 7: 45 Gordon Avenue<br>Existing Conditions | Montrose Quarry LVIA | 322-0548-01-DR510 | 01 | 14.11.24 | AS | JC | AW | Page Display @ A3 |

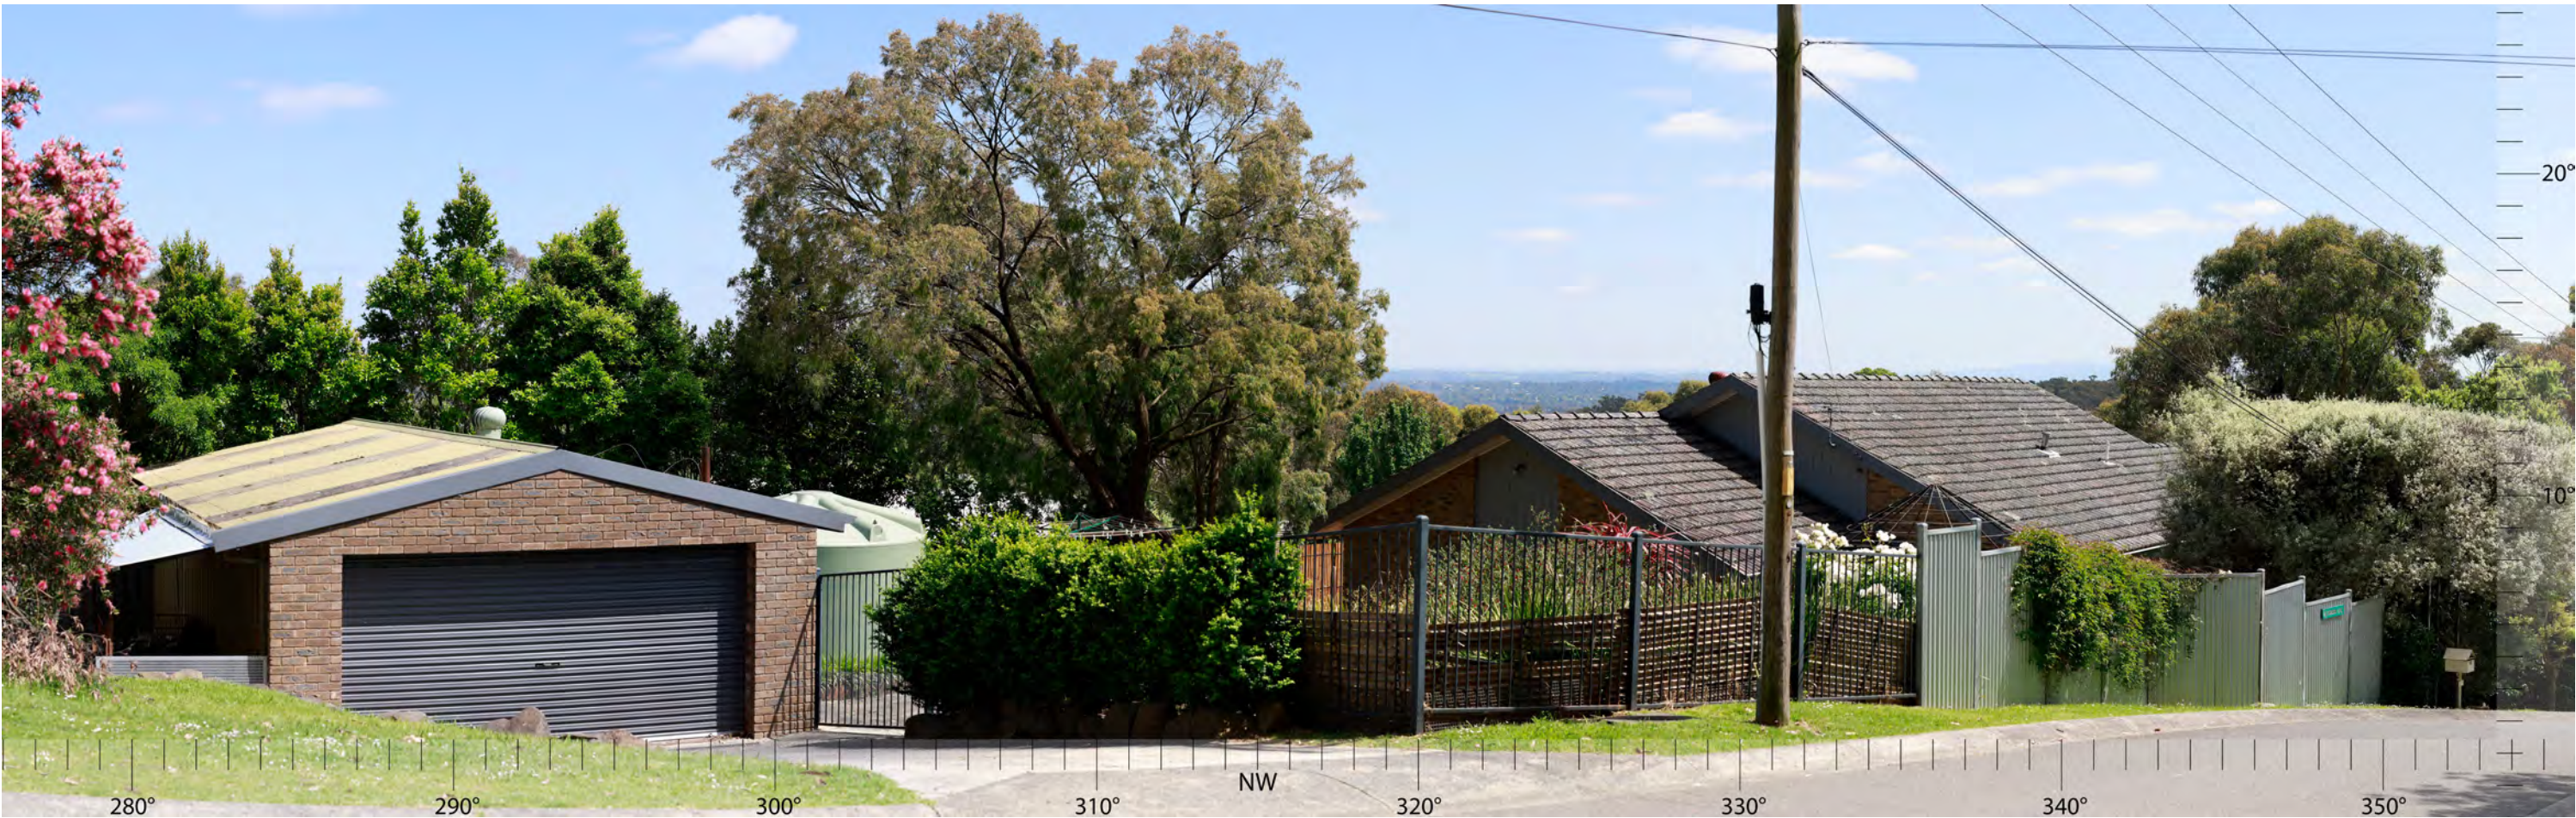
Distance from Site Area: 1352.15m  
Bearing: 316 Degrees  
Viewpoint location: E:351824 N:5815793 ELEV:121.84m, EPSG:7855 - GDA2020/MGA zone 55  
Date and time of photograph: 30/10/2024, 11:49 AM  
Camera setup: Canon EOS R5, 50mm Lens

| Drawing Title | Project Name | Drawing No. | Revision | Date | Drawn | Checked | Project Principal | Scale |
|---|---|---|---|---|---|---|---|---|
| Residential Location 8: 8 Bracken Avenue<br>Existing Conditions | Montrose Quarry LVIA | 322-0548-01-DR511 | 01 | 14.11.24 | AS | JC | AW | Page Display @ A3 |

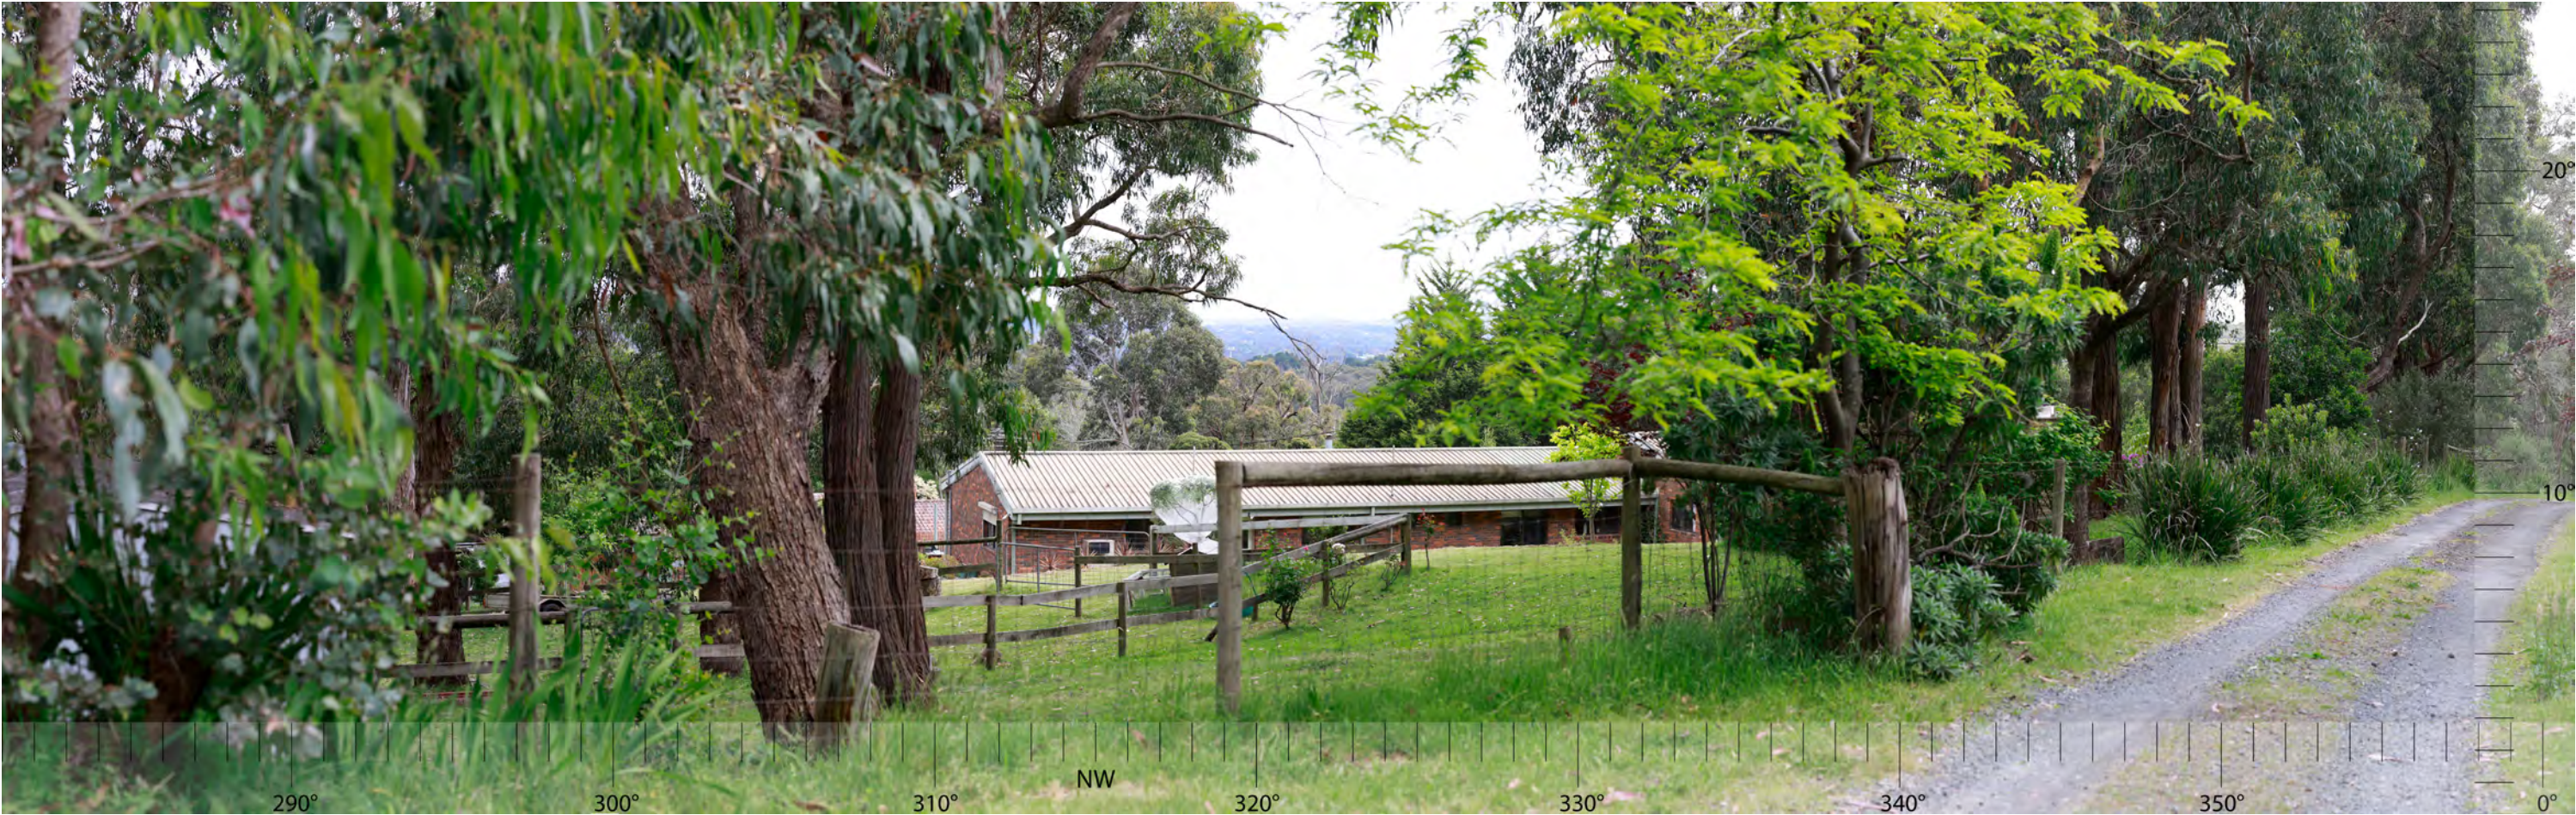
Distance from Site Area: 1629.87m  
Bearing: 321 Degrees  
Viewpoint location: E:353542 N:5811440 ELEV: 216m, EPSG:7855 - GDA2020/MGA zone 55  
Date and time of photograph: 30/10/2024, 10:53 AM  
Camera setup: Canon EOS R5, 50mm Lens

| Drawing Title | Project Name | Drawing No. | Revision | Date | Drawn | Checked | Project Principal | Scale | |
|---|---|---|---|---|---|---|---|---|--|
| Residential Location 9: 50-52 Glasgow Road<br>Existing Conditions | Montrose Quarry LVIA | 322-0548-01-DR512 | 01 | 14.11.24 | AS | JC | AW | Page Display @ A3 | |

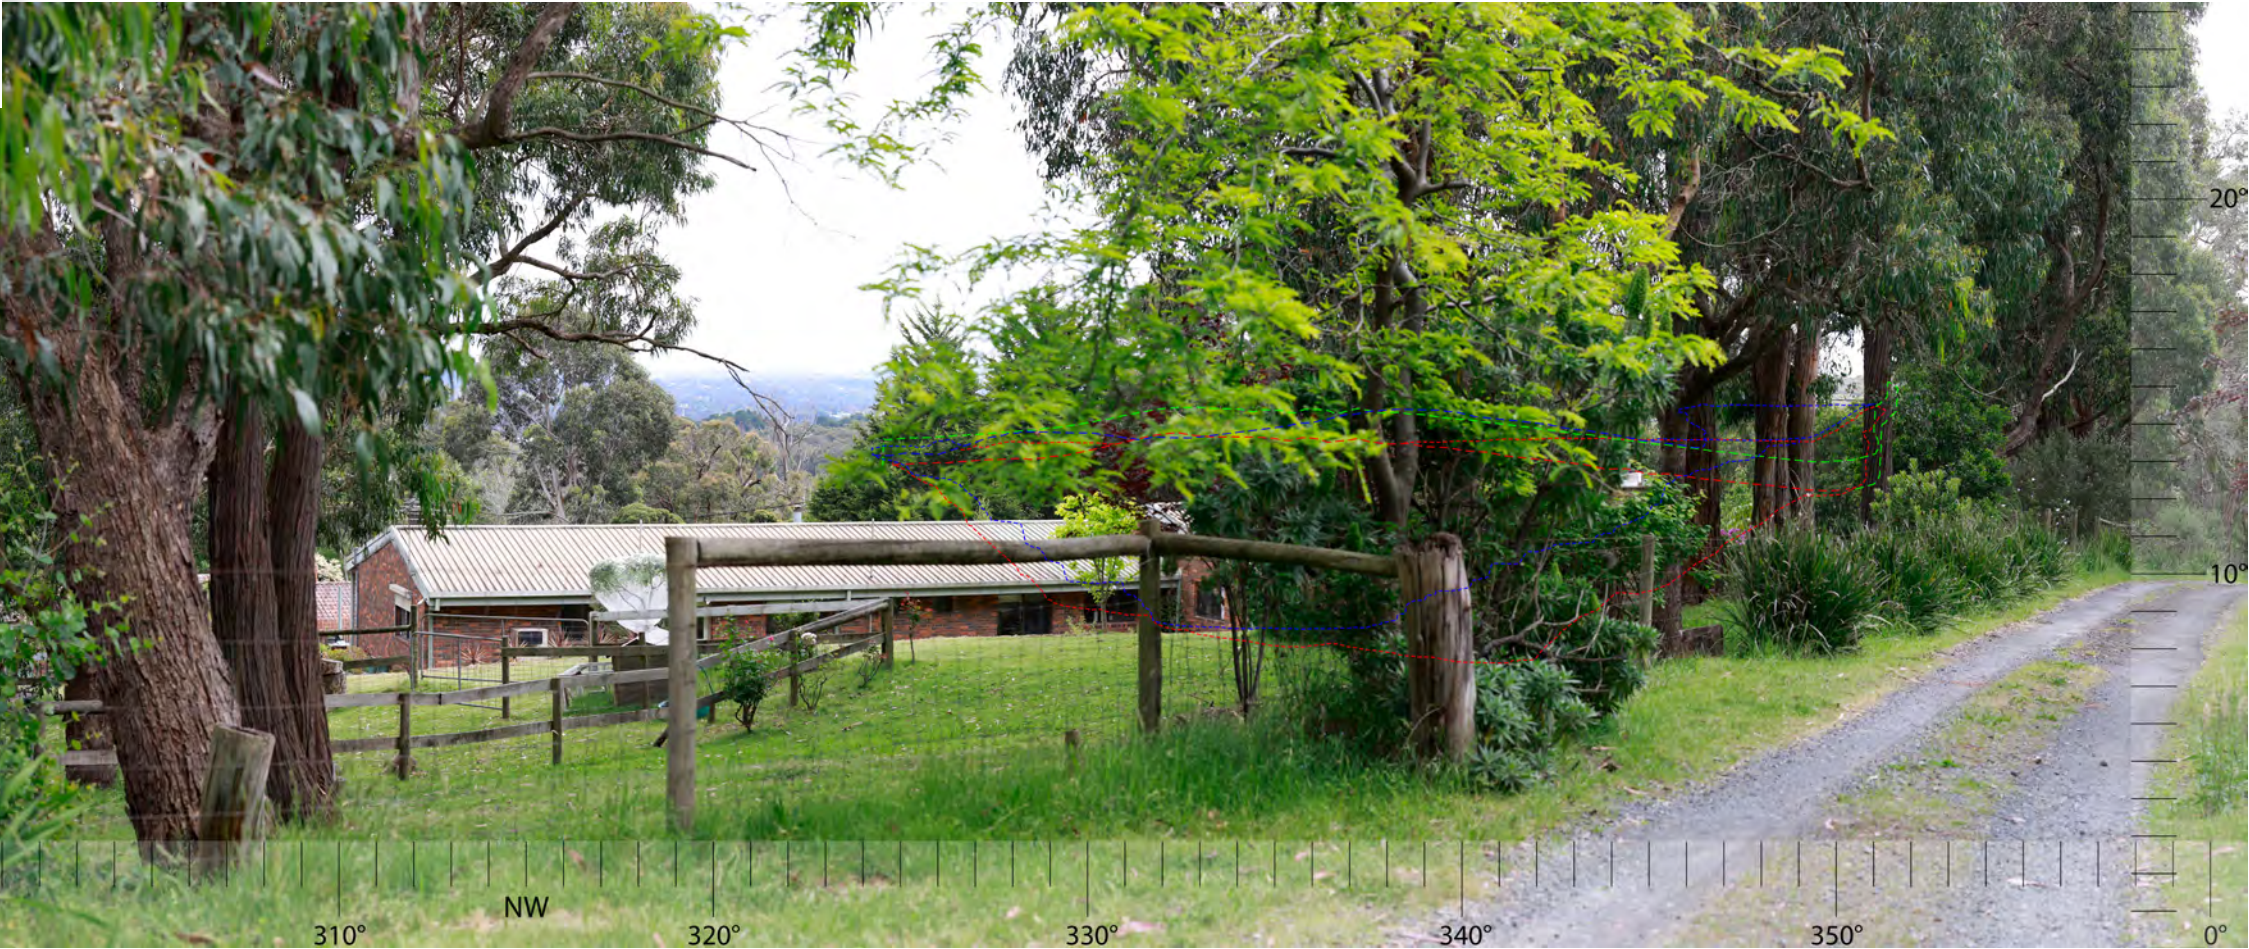
- Outline of existing quarry pot - top rim and pit
- Foreground edge of existing quarry rim
- Likely seen area within existing pit
- Unlikely seen vegetation
- Likely seen vegetation
- Likely seen area with new pit
- Outline of expanded quarry pit - top rim and pit
- Foreground edge of new quarry rim

Distance from Site Area: 1629.87m  
Bearing: 321 Degrees  
Viewpoint location: E:353542 N:5811440 ELEV: 216m, EPSG:7855 - GDA2020/MGA zone 55  
Date and time of photograph: 30/10/2024, 10:53 AM  
Camera setup: Canon EOS R5, 50mm Lens

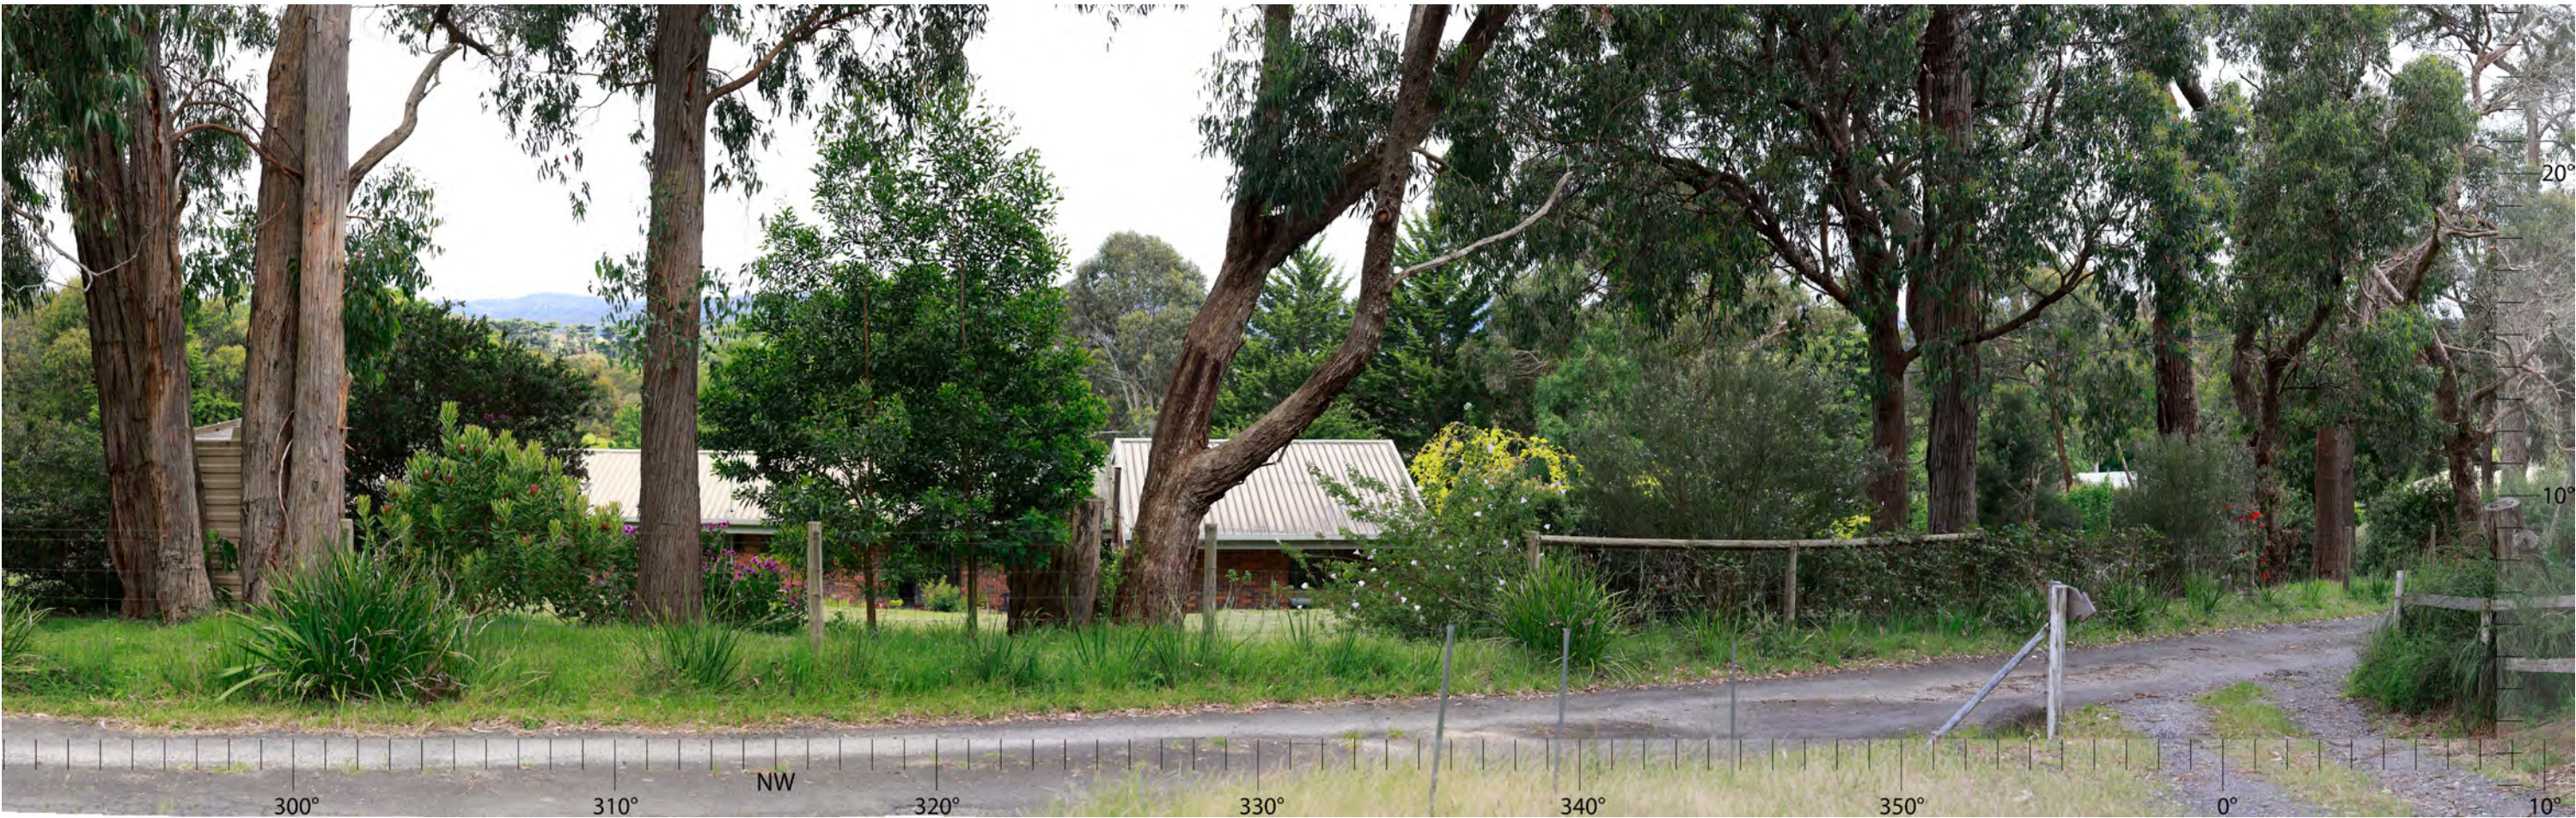
Distance from Site Area: 1569.55m  
Bearing: 335 Degrees  
Viewpoint location: E:351824 N:5815793 ELEV:121.84m, EPSG:7855 - GDA2020/MGA zone 55  
Date and time of photograph: 30/10/2024, 10:53 AM  
Camera setup: Canon EOS R5, 50mm Lens

| Drawing Title | Project Name | Drawing No. | Revision | Date | Drawn | Checked | Project Principal | Scale |
|---|---|---|---|---|---|---|---|---|
| Residential Location 10: 54-56 Glasgow Road<br>Existing Conditions | Montrose Quarry LVIA | 322-0548-01-DR514 | 01 | 14.11.24 | AS | JC | AW | Page Display @ A3 |
