Marinus Link Project

Maritime Archaeological Desktop Assessment

Bass Strait
Gippsland, Victoria and NW Tasmania

September 2021

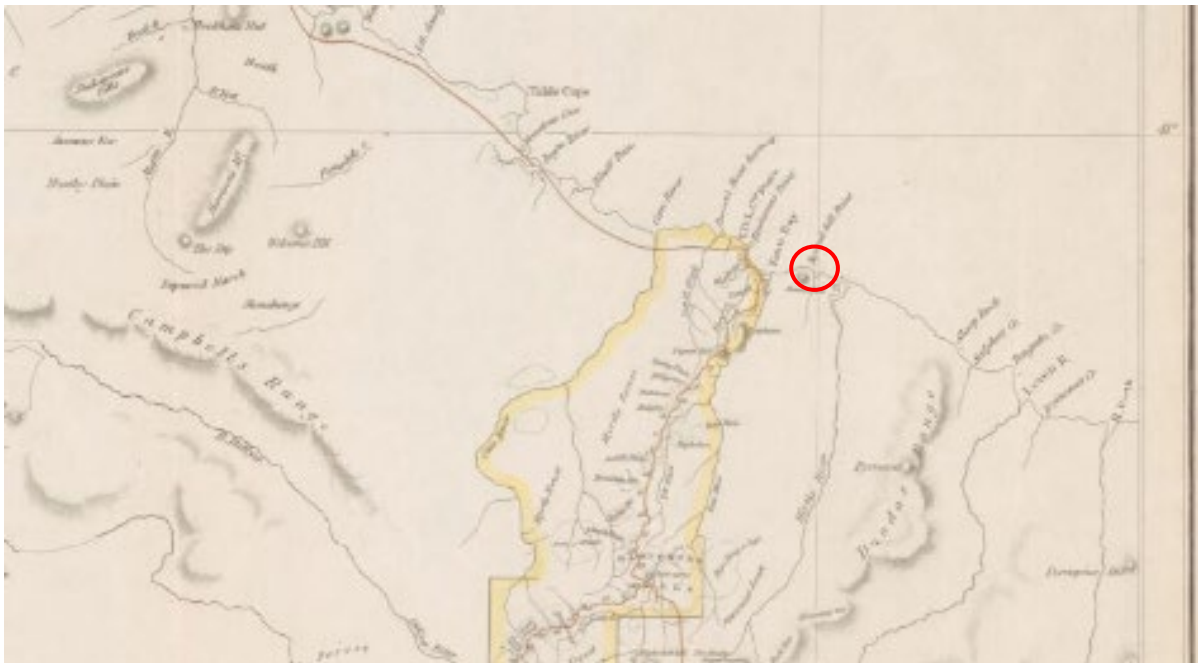
Figure 7: Map of the grants of land to the Van Diemen's Land Company in the North Western Area of Tasmania. VDLC land grant outlined in yellow, approximate dual conceptual Marinus Link subsea cable landfall circled in red¹¹

In 1824, the Van Diemen’s Land Company (VDLC) was founded in order to develop a sheepherding industry in Tasmania. The company applied for land and was granted 250,000 acres in the north western region of Tasmania (Figure 7). The company established a port at what is now Burnie, on Emu Bay, building a company store and a small jetty.

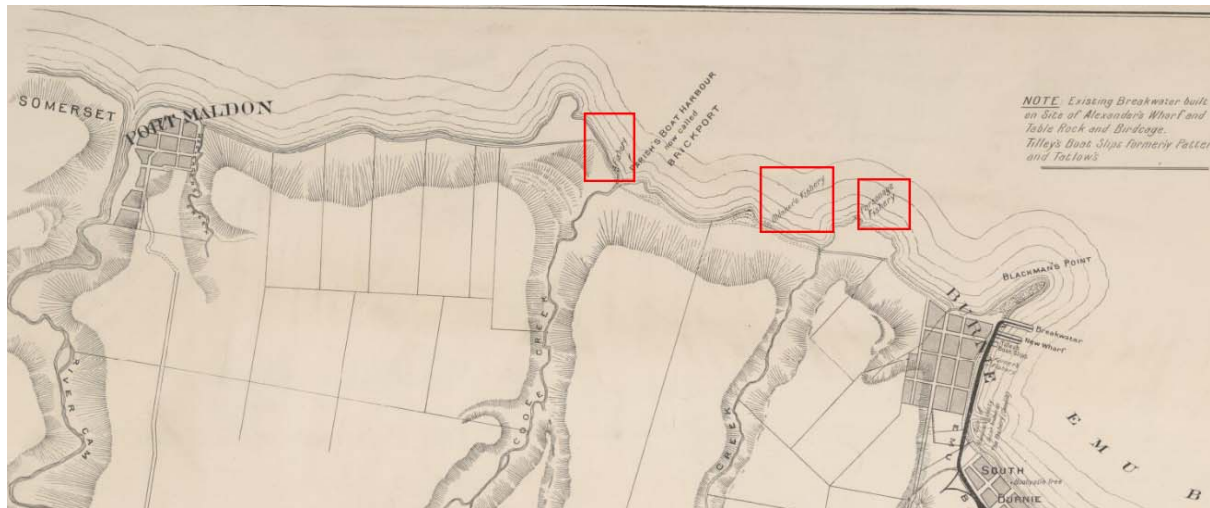
Figure 8: Fisheries located near Burnie, Tasmania. Fisheries shown in red.¹⁶

In addition to shipping and shipbuilding, the north coast was the site of a number of fisheries, including shore-based whaling from at least the early 1830s. Contemporary maps show numerous "fisheries" located on the nearshore and intertidal zones on the northwest coast, and the VDLC is known to have operated an unsuccessful whaling station near Circular Head from 1833 to 1834¹⁴ (Figure 8). A number of shore-based whaling sites have been archaeologically excavated, exhibiting similar characteristics towards the choice of location, and were frequently built near river mouths and headlands.¹⁵

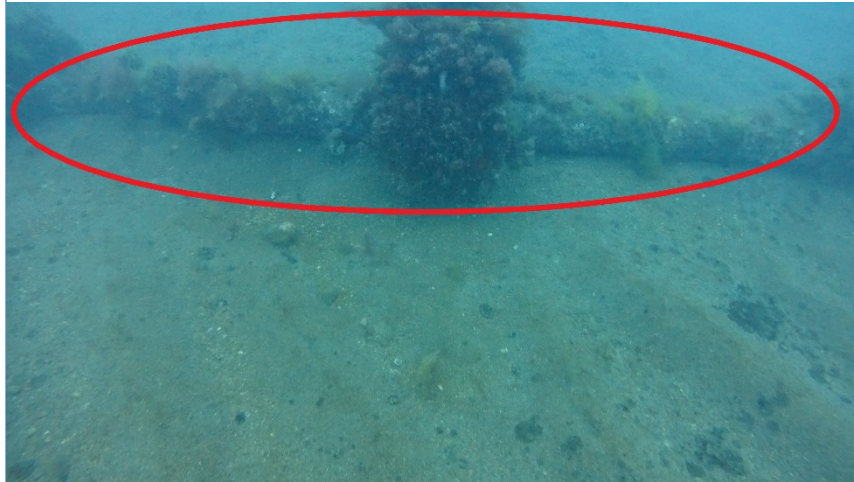
2	Blythe River mouth	HEY_W08	41.060540	145.987946	Pipe, potentially old tiioxide pipeline

Review marine geophysical data to inform whether or not this location is to be inspected (ROV or diving)
3	Blythe River mouth	HEY_W08	41.060456	145.987590	Pipe, potentially old tiioxide pipeline

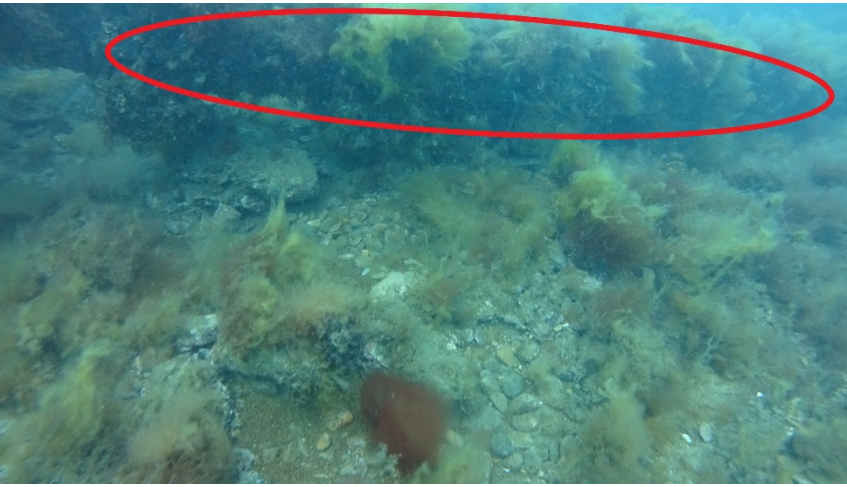
4	Blythe River mouth	HEY_W09	41.064275	145.985532	Pipe, potentially old tioxide pipeline

Review marine geophysical data to inform whether or not this location is to be inspected (ROV or diving)
5	Blythe River mouth	HEY_W09	41.064099	145.984916	Pipe, potentially old tioxide pipeline
