Victorian Murray Floodplain Restoration Project

Belsar-Yungera Historical Heritage Desktop Assessment

IS297762-AP-AP-RP-002 | 0

Lower Murray Urban and Rural Water Corporation

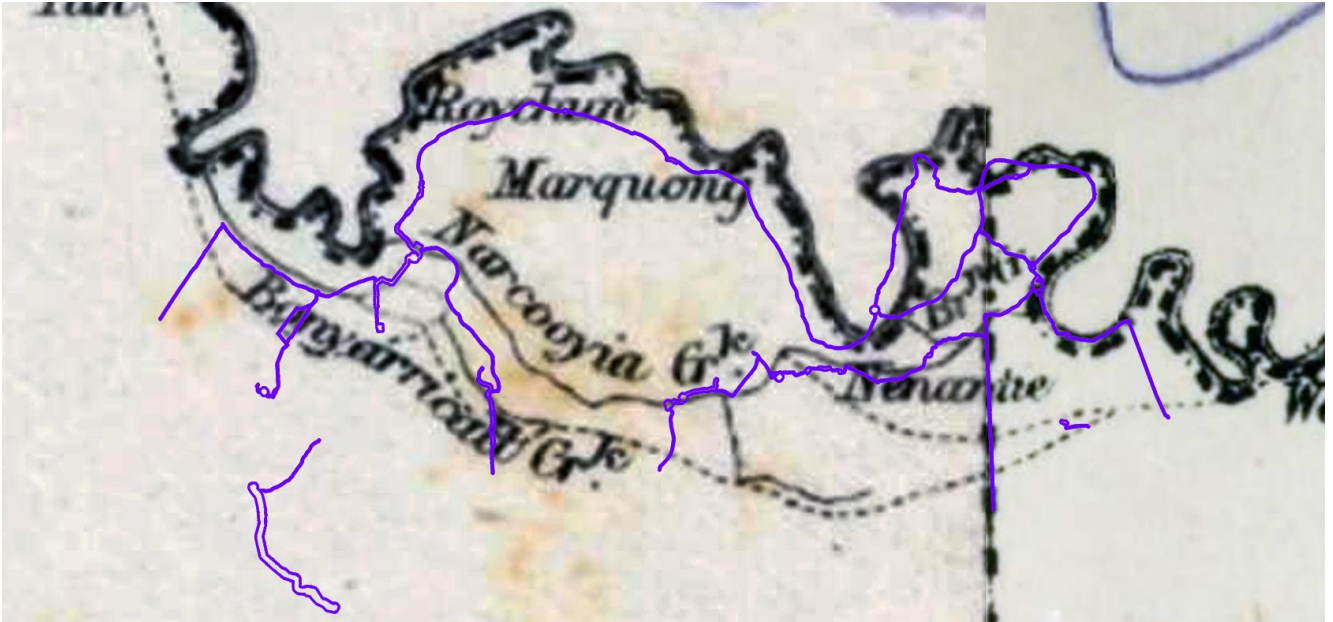
Figure 2.3: 1884 Karkarooc and Tatchera county maps, with approximate location of the area of investigation outlined in purple (Department of Lands and Survey 1884a; 1884b)

The County of Karkarooc and County of Tatchera maps from 1884 show that there were no townships extant along the Murray River near the area of investigation. Both the 1851 and 1884 maps show the locations of Narcooyia and Bonyaricall Creeks, and roadways in the area. There are no structures on the maps (Figure 2.3).
