Arboricultural Assessment Former Ruthven Primary School

Prepared for
Department of Education and Early Childhood Development

Prepared by David Phillips

16/01/2014

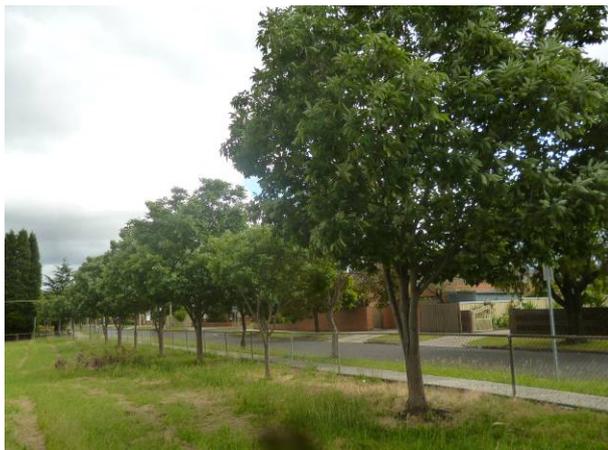
1

Photo 1: Shows the size, condition and location of Green Ashes (*Fraxinus ?pennsylvanica*) located along the eastern boundary. The majority of these trees were of Low arboricultural value due to being of relative small size. Some trees were developing suckers at the base of the rootstock.

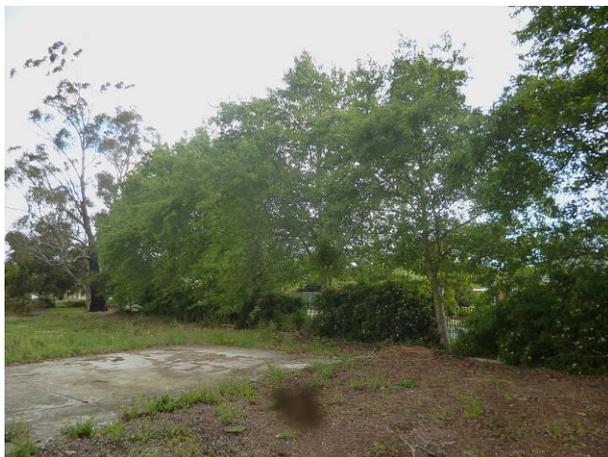
3

Photo 3: Shows several Oriental Plane Trees (*Plantanus orientalis*) planted along the western boundary as a screen. Retention of these trees would require crown uplift pruning to avoid potential damage from construction activities.

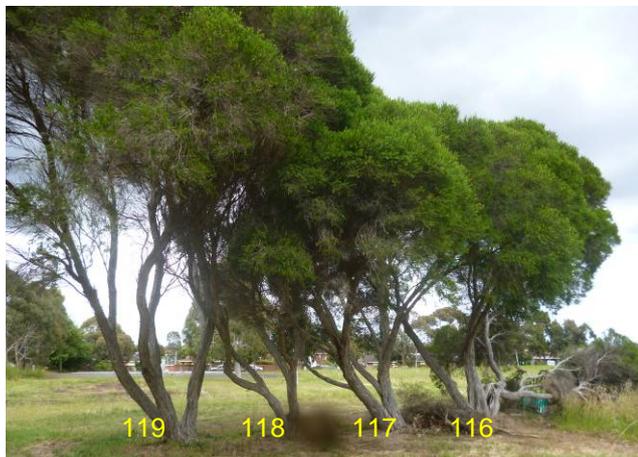
4

Photo 4: Shows the relative, size, condition and location of Trees 116 – 119, all mature Honey - bracelet Myrtles (*Melaleuca armillaris*) of Low arboricultural value. Tree 116 is of No arboricultural value because it is structurally declining. The useful life expectancy of Trees 116 – 119 will be short and these trees should not constrain reasonable development of the site.
