Environmental Audit Report

Southern Portion of Lot 38, Frankston- Flinders Road, Somerville Victoria

ENSR Australia Pty Ltd (HLA ENSR)

12 December 2007

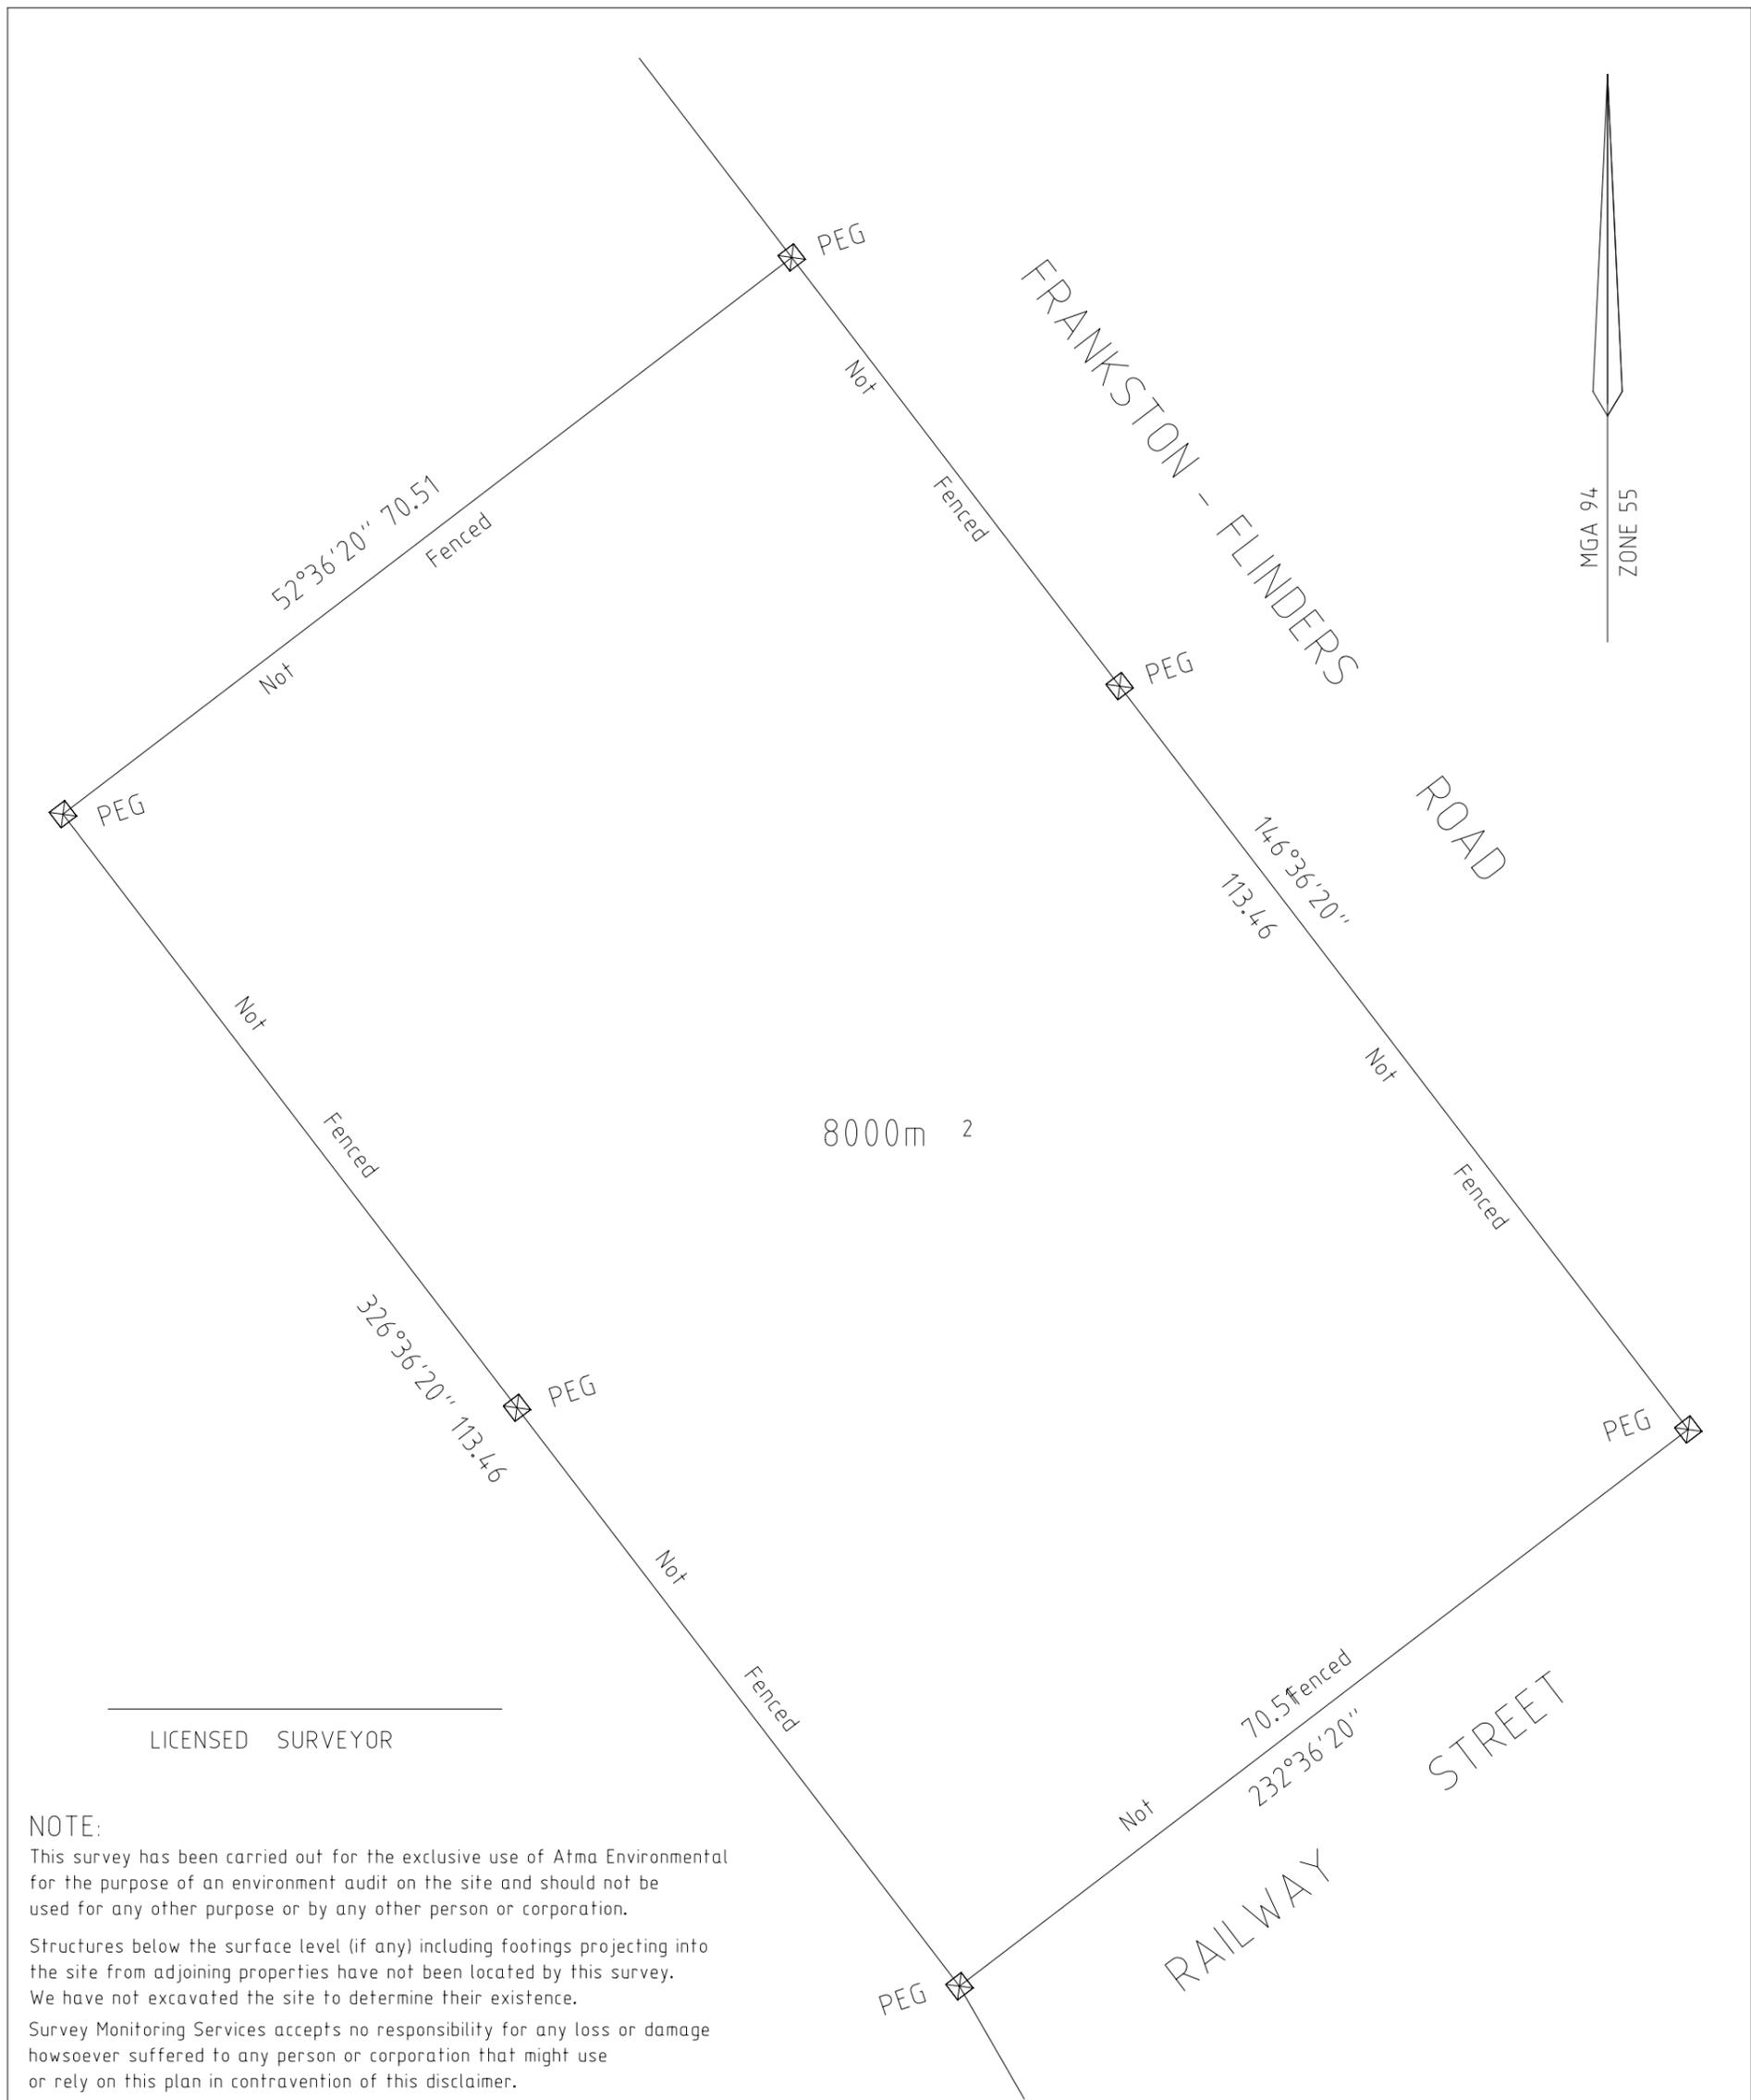
<p>LENGTHS ARE IN METRES</p> <p>DATE OF SURVEY: 21-12-2006 VERSION: 1</p>	<p>FRANKSTON - FLINDERS ROAD SOMERVILLE</p>	<p>PLAN OF ENVIRONMENT AUDIT AREA</p>	
<p>SMS survey monitoring services P/L</p> <p>13 Watersun Court, Sanctuary Lakes, VIC. 3030 Telephone: (0425) 700 060 Facsimile: (03) 9395 6624</p>		<p>SHEET 1 OF 1 SHEET</p>	<p>ORIGINAL SCALE 1:500</p>
		<p>ORIGINAL SHEET SIZE : A3</p>	<p>REF: 523</p>

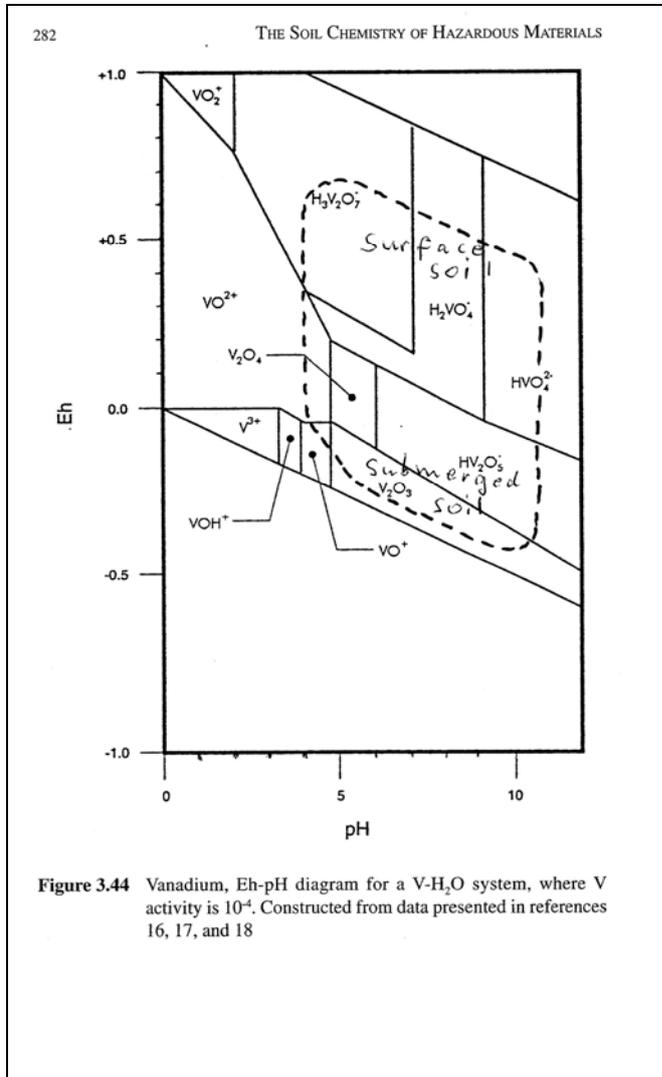
Figure 1 pH-Redox diagram for Vanadium

Vanadium has seven oxidation states from -1, 0, +1, +2, +3, +4, and +5, the latter being the most toxic. It can occur in cationic and anionic form. Figure 1 is taken from Dragun⁶ and illustrates the various species of vanadium in relation to pH and redox potential. Superimposed on the diagram are the outer boundaries of soil pH and soil redox potential found in natural soils.

Vanadate (V^{5+} ion in $H_2VO_4^-$ and HVO_4^{2-} species) is stable under oxidising conditions and vanadyl (V^{4+}) is associated with reducing conditions as VO^{2+} and $VO(OH)^+$ species.

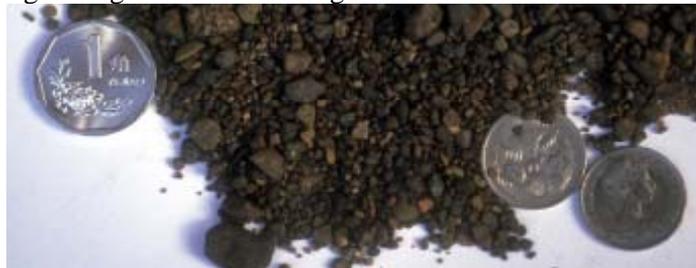
Figure 2 Ferruginous gravel from the Sugarloaf Reservoir.

Ferruginous gravels, “buckshot”, in the subsurface of very many Australian soils have similarly been formed by alternating periods of anaerobicity and aeration that cause Fe to precipitate around nuclei in the soil and form larger units of secondary iron oxides. They often have accumulated a range of other heavy metals that geochemically behave likewise. The shores of the Sugarloaf Reservoir have a beach of these ferruginous gravels that contain elevated arsenic and chromium in this case.
