## 7. Inundation Area vegetation ground-truthing assessment

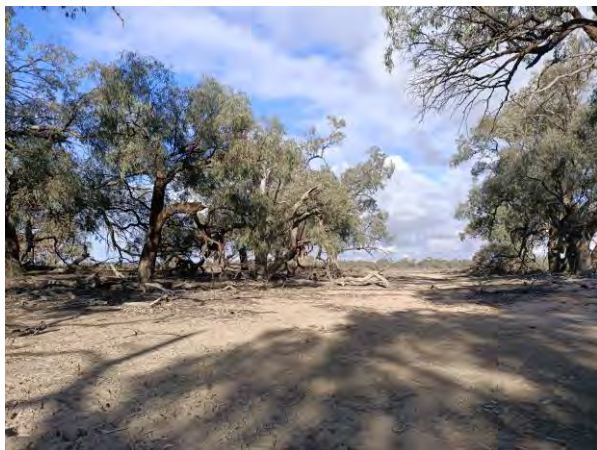
Plate 4 – Patch of vegetation identified by DELWP modelled mapping as containing EVC 97 – Semi-arid Woodland. The vegetation at this location consisted of Riverine Chenopod Woodland (EVC 103) dominated by *Eucalyptus largiflorens* (Black Box).

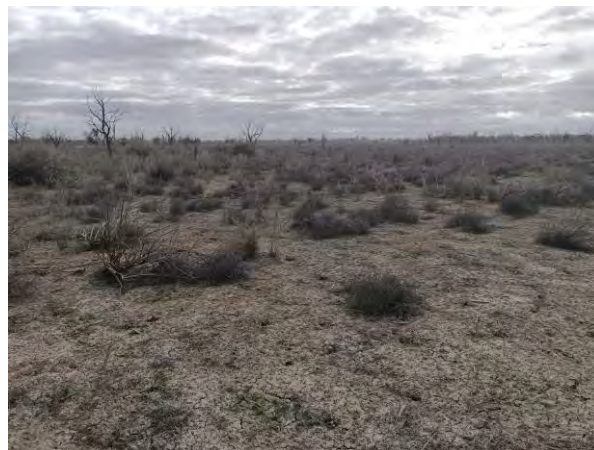
Plate 5 – Patch of vegetation unmapped by DELWP modelled mapping. The vegetation at this location consisted of Lignum Shrubland (EVC 808) dominated by *Duma florulenta* (Lignum).
