Montrose Quarry

Heritage Impact Assessment

Prepared for Boral

November 2024 - v1

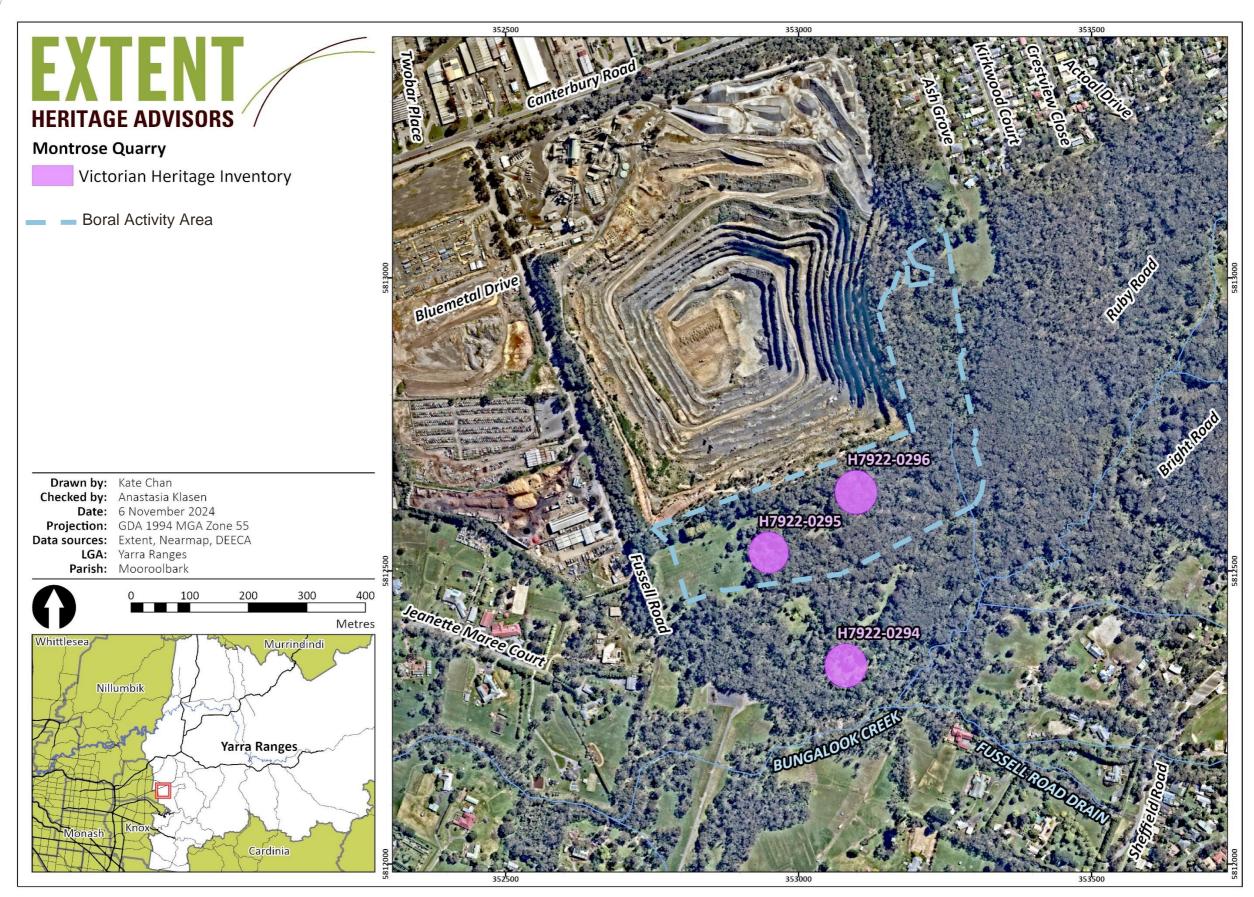
Figure 1. VHI sites in the vicinity of Montrose Quarry. Basemap source: Nearmap.

The study area includes two listings on the Victorian Heritage Inventory (VHI) (see Figure 1):

- House Site 1 (H7922-0295)
- Historic Dump 1 (H7922-0296).

VHI site H7922-0294 is not within the area impacted by the proposed quarry expansion.

The two VHI sites within Boral's activity area (Figure 1) have been assessed within this report to be of low significance due to being in very poor condition and not meeting the threshold of what determines archaeological value. Considering the very low heritage value of H7922-0295 and H7922-0296 as assessed in 6.3, the proposed expansion of the quarry is considered to have little impact upon heritage value and archaeological significance of the site.

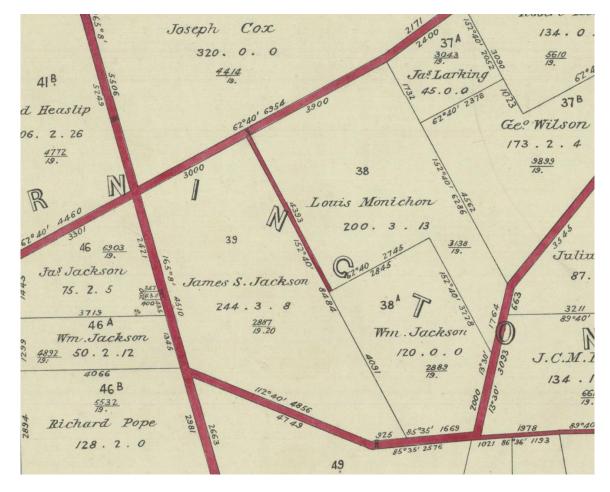
Figure 3. 1879 Parish of Mooroolbark map. Source: https://prov.vic.gov.au/archive/B82859A3-F843-11E9-AE98-015C802CD360?image=1

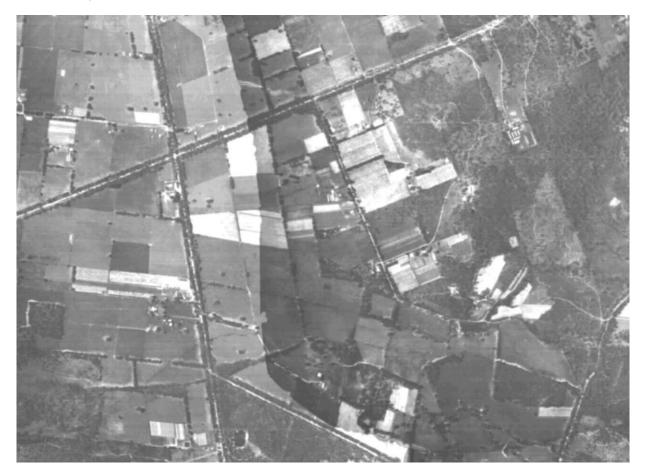
Development was slow to arrive in Montrose, largely due to the difficulty in accessing the area. Its access tracks remained unimproved throughout the nineteenth century (McLennan 1987, 42) and was located at a considerable distance from both the Belgrave and Lilydale railway lines. Services and amenities were slow to arrive too, retaining the area's rural atmosphere well into the twentieth century (Figure 4).

Figure 4. 1945 aerial image, illustrating agricultural land use. Source: https://spatialapps-prd-mapshare-platform-storage.s3-ap-southeast-2.amazonaws.com/WebmapMedia/HistoricPhotomap/RINGWOOD/849B3.jpg

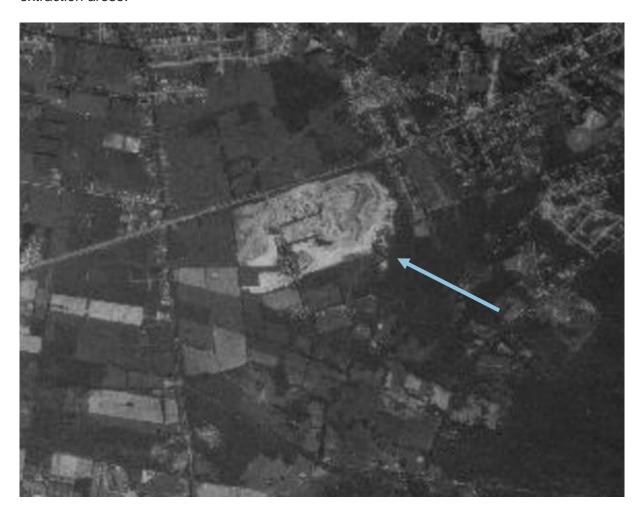
This stage aligned with a period of rapid increase in development and population in the Montrose area. The proliferation of the motor car in the post war environment necessitated improvement in road infrastructure, dramatically improving the accessibility of the area. The idyllic semi-rural location attracted families influenced by the 1950s push for decentralisation, initiating the area's transformation from a small country town to a growing suburb (McLennan 1987, 83) (Figure 5).

Figure 5. 1968 aerial image, quarry indicated by arrow. Reproduced from Geoscience Australia.

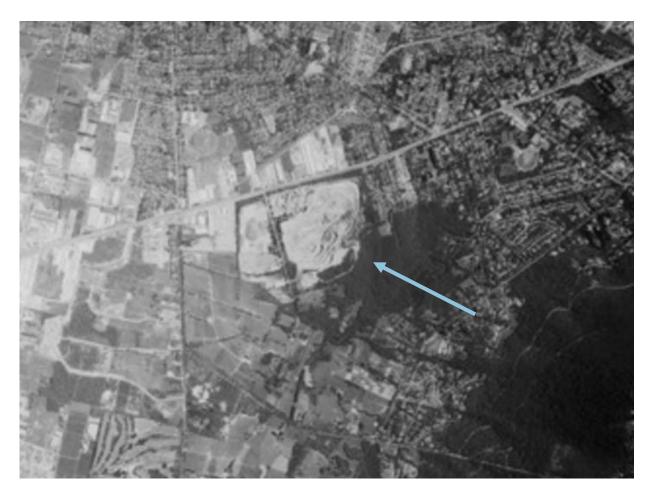
The 1968 departure of the Callam family closed the period of agricultural use of the property. Much of the dwelling was demolished, with the material and household appliances spread across the property. The lack of activity at the site since has meant there has been reduced disturbance and alteration since 1968, despite the rapidly densifying urban development across the surrounding region (Figure 6).

Figure 6. 1989 aerial image, quarry indicated by arrow. Reproduced from Geoscience Australia.

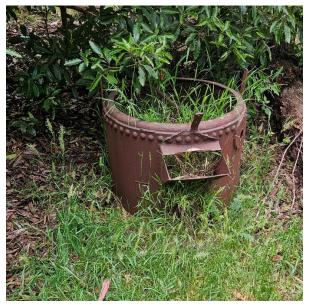
Spread around the remains of the dwelling, as far as 75m to the west and 20m to the east, were various household waste deposits. These included corrugated iron sheeting, wire, a bathtub (Figure 12), an abundance of used bricks (Figure 16), a 1950s oven and kettle (Figure 11), various scrap metal pieces likely associated with farming or household services (Figure 13 and Figure 15), broken window glass and oil drums. It is likely that the building material was dispersed across the study area at the time of the dwelling's demolition. The pile of bricks, found approximately 15m east of the dwelling, appeared to be the same type and era as those still remaining in the dwelling structure. Two bricks with different frog branding were uncovered from the pile of bricks. The 'Clifton' brick originated from the Clifton brick company based in Preston and was approximately dated to the 1950s (Figure 17). The 'Iris' brick originated from the Glen Iris Brick Company in Thornbury and was approximately dated to sometime between 1956-1970 (Figure 18). This approximate period aligns with the settlement of the Callam's at the site, indicating that the registered site is dated no earlier than 1950.

Figure 15. Household metal waste, east of the dwelling.

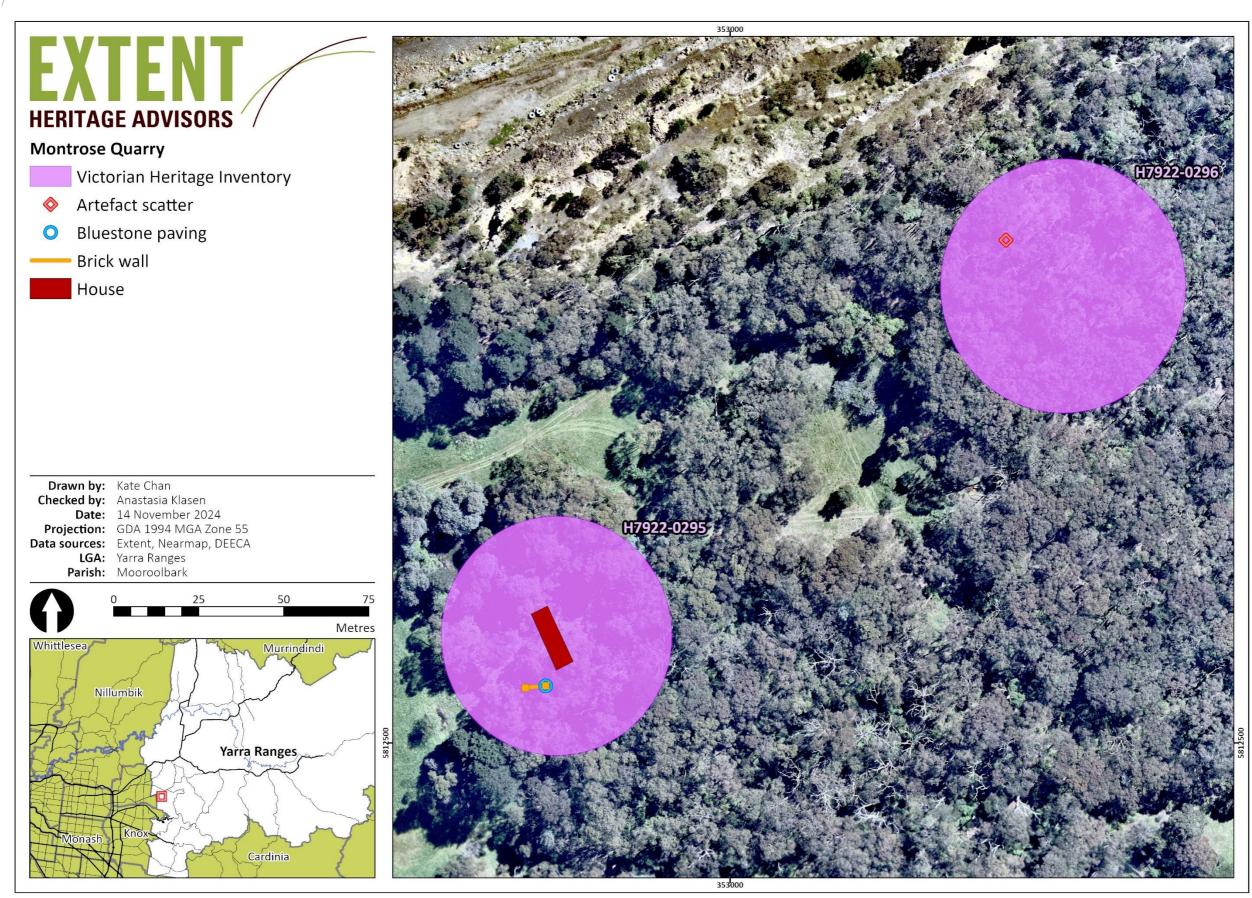
Figure 26. Extent of fabric associated with VHI listings. Basemap source: Nearmap.

Based upon the assessment within this report, it is recommended that H7922-0295 and H7922-0296 be delisted from the VHI under Section 119 of the Heritage Act 2017 (s. 85 Heritage Amendment Bill 2023).
