Victorian Murray Floodplain Restoration Project

Guttrum Benwell Historical Heritage Desktop Assessment

IS297705 | Rev 0

Lower Murray Urban and Rural Water Corporation

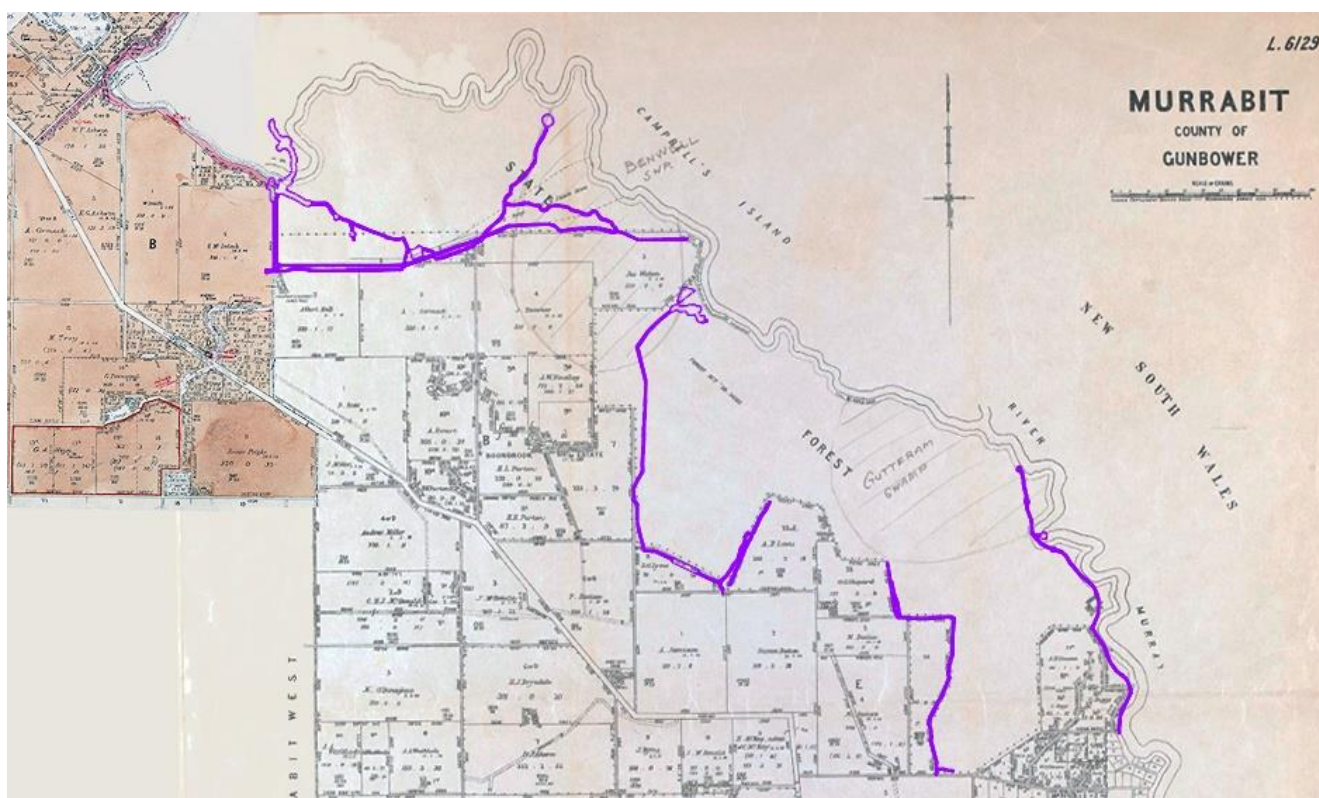
Figure 2.6: 1931 Parish of Murrabit and 1934 Parish of Murrabit West map composite, showing allotments and approximate location of the area of investigation (Victoria Department of Crown Lands and Survey 1931)

While little had changed by 1930s, the 1931 Parish of Murrabit map has the outline of both Benwell Swamp and 'Guttrum' (Guttrum) Swamp annotated on the map. The area of investigation intersects with much of the area marked as Benwell Swamp, and a small section Guttrum Swamp at its eastern edge. While Guttrum Swamp is primarily within State Forest, Benwell Swamp extends into allotments owned by Jas Watson (allotment 5), J Taverner (allotment 4), and AW Findlay (allotment 9B, part of Koondrook Estate) (Figure 2.6).

The 1931 Parish of Murrabit West map shows that there are two allotments situated immediately to the west of the area of investigation. These comprised allotments 2 and 5A, both originally owned by E McIntosh. The township of Myall is visible to the southwest of the area of investigation, to the south of McIntosh's rural allotments (Figure 2.6).

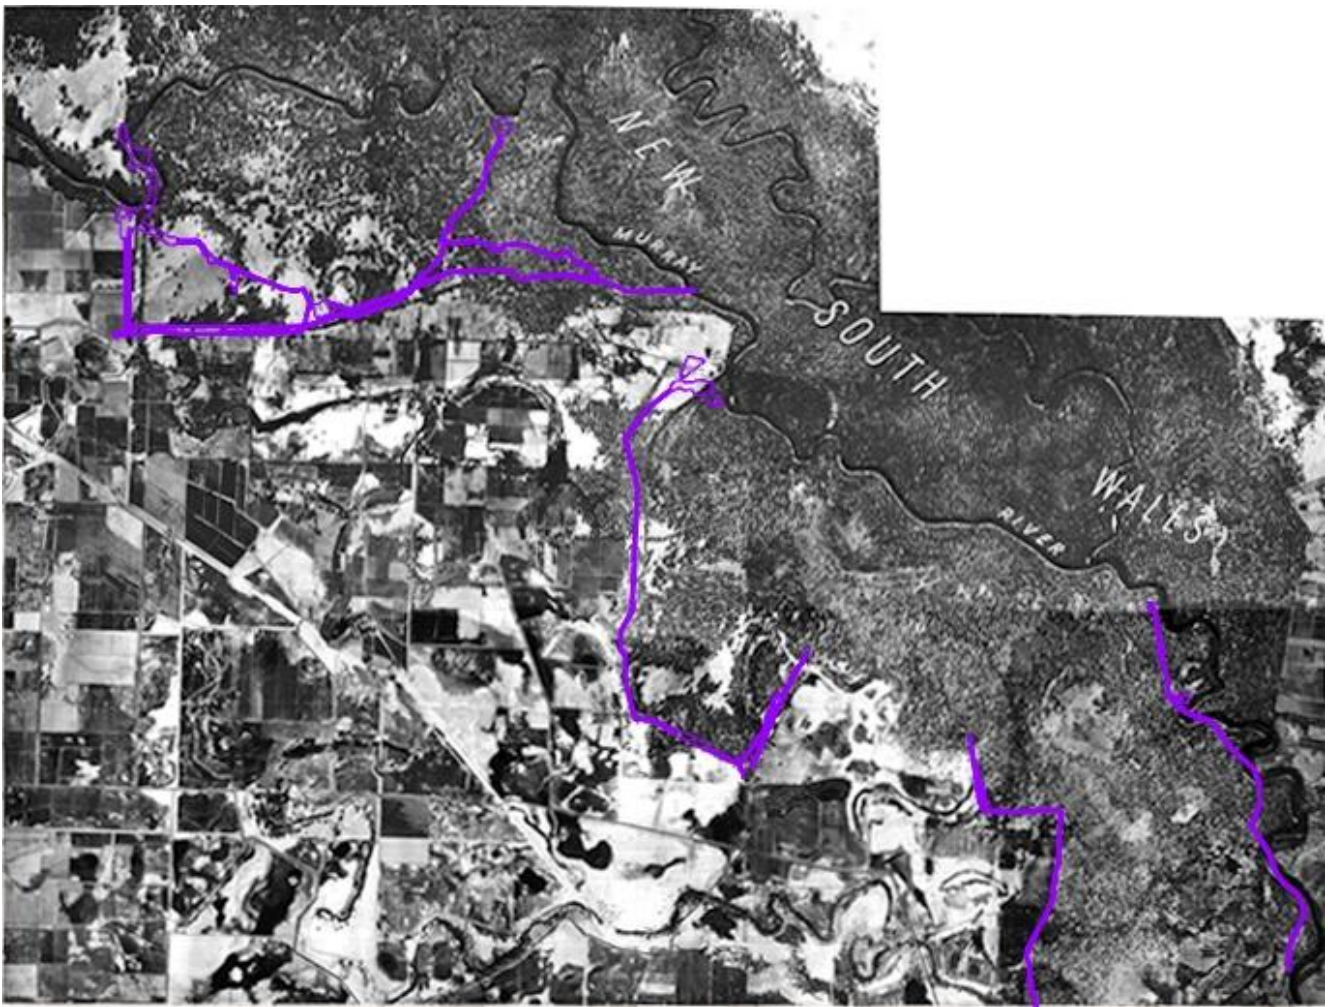
Figure 2.8: 1945 aerial imagery with approximate location of the area of investigation outlined in purple (Aerial Survey of Victoria 1945)

Aerial imagery from 1945 shows that area of investigation comprises floodplain between the Murray River and the Koondrook-Murrabit Road, with Benwell Swamp and Southwest Benwell Swamp in the Benwell State Forest, and Guttrum, Red Bed, and Little Red Bed Swamps in the Guttrum State Forest, and several smaller unnamed waterways, flood runners, lagoons and billabongs throughout. The two state forests are predominantly covered in trees, excepting in the southwestern corner of the Benwell State Forest. Outside of these forests, the land is a patchwork of farmland, waterways and irrigation channels to the north of Koondrook-Murrabit Road (Figure 2.8).

In both aerial images, the area of investigation skirts the edges of both State Forests along roadways or rural property lines, except where it crosses through the Benwell State Forest in the northwest. There are no apparent structures visible within the area of investigation, although some pathways are visible within the tree-covered areas of both historical aerials. There may have been bridges present where tracks cross creeks and other waterways.

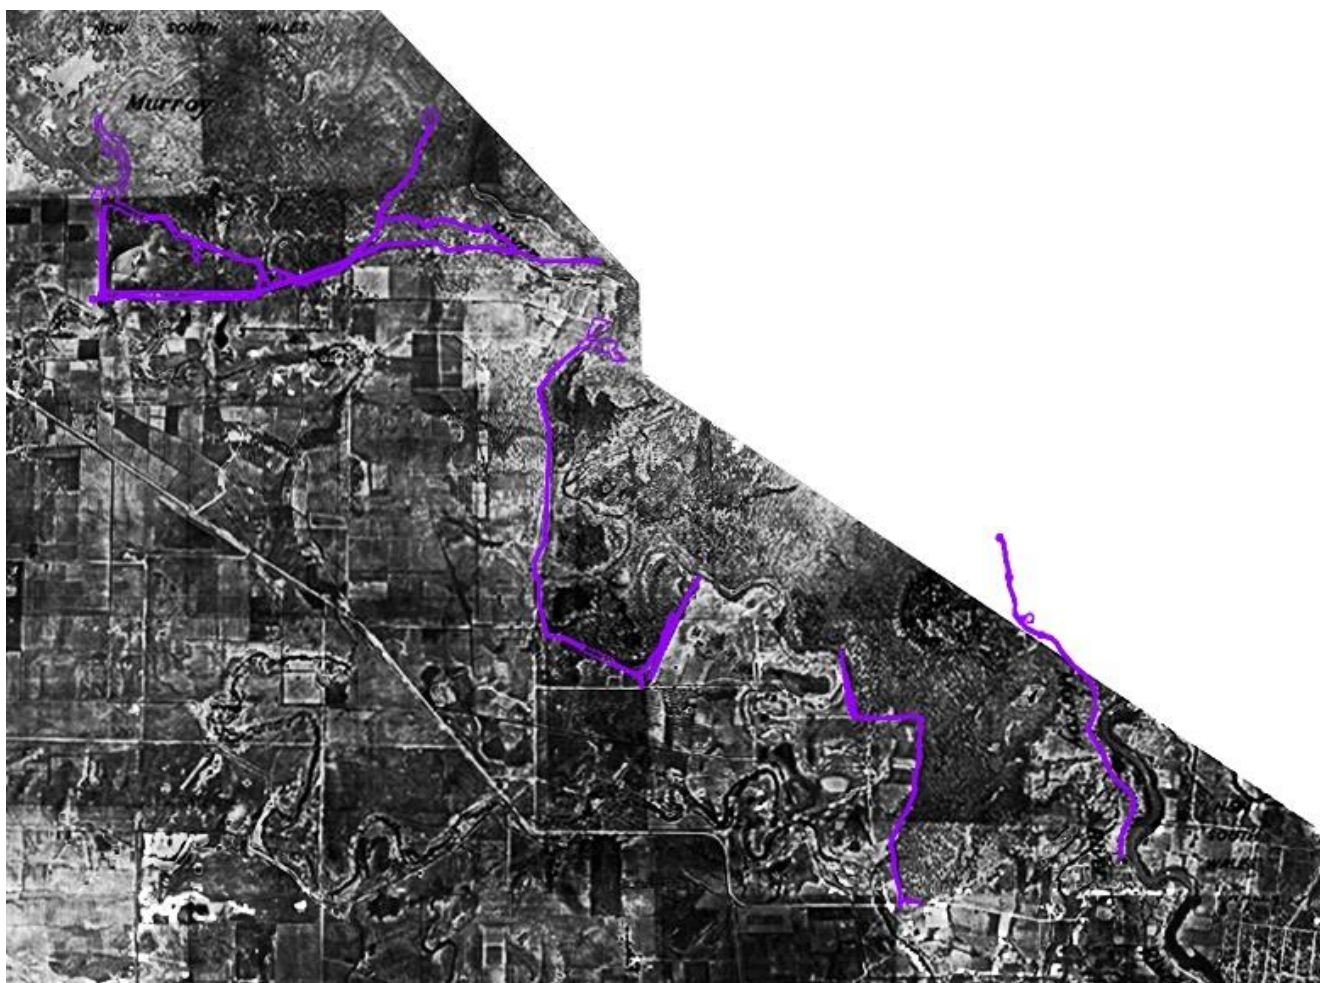
Figure 2.9: 1958 aerial imagery with approximate location of the area of investigation outlined in purple (Aerial Survey of Victoria 1958a; 1958b)

Aerial imagery dating to 1958 shows that little has changed since 1945, although there appears to have been some further tree growth in the cleared section of the Benwell State Forest (Figure 2.9).
