# **Victorian Murray Floodplain Restoration Project**

## **Vinifera Historical Heritage Desktop Assessment**

**Lower Murray Water**

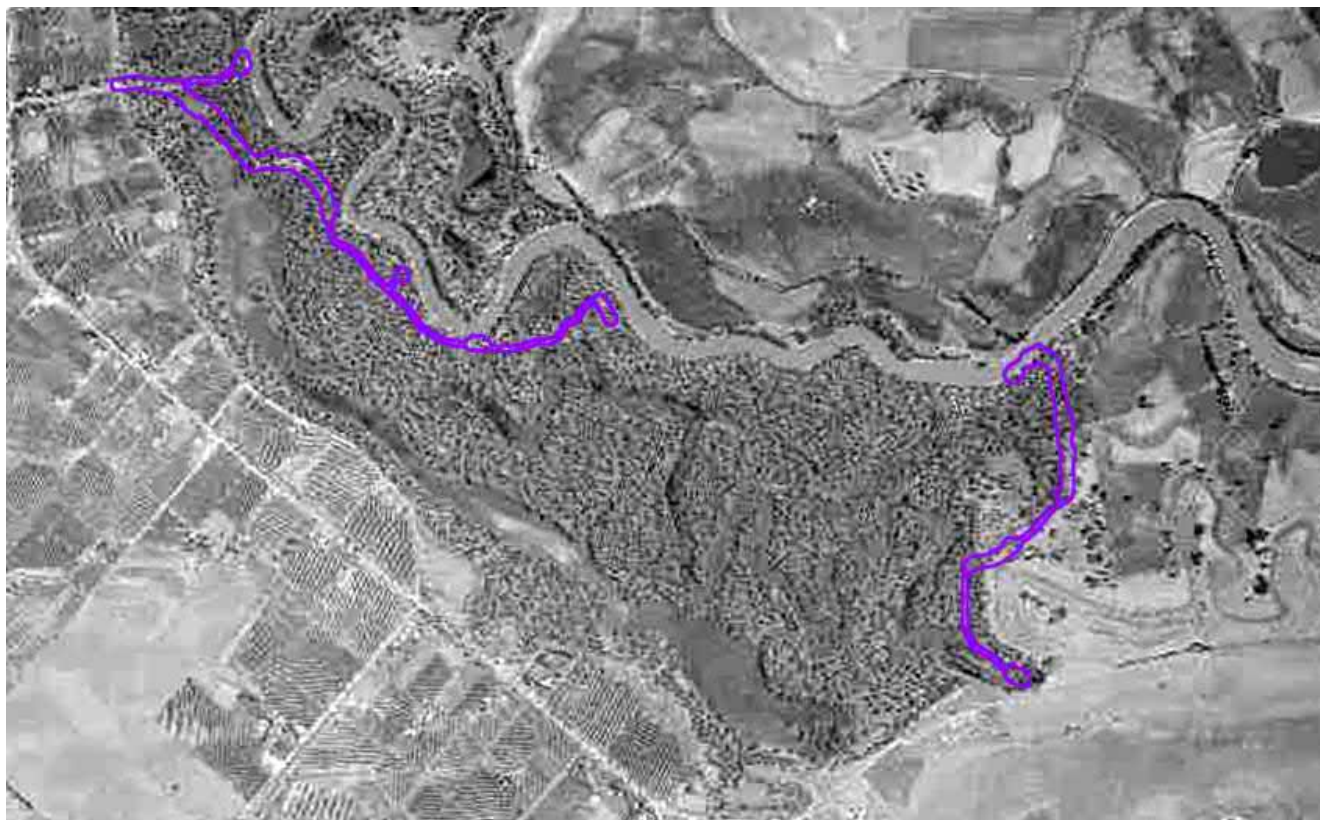
Figure 2.6: 1972 aerial imagery of the area of investigation, outlined in purple (Department of Environment 1972)

Aerial imagery dating to 1972 shows that the Vinifera State Forest is covered in dense foliage, with little evidence of allotments 45, 46 and the western portion of 47 visible (Figure 2.6). The forest now aligns with the area of investigation in the east, and some pathways are visible through the forest along different portions of the area of investigation routes. No settlement is visible within the present-day boundary of the forest.

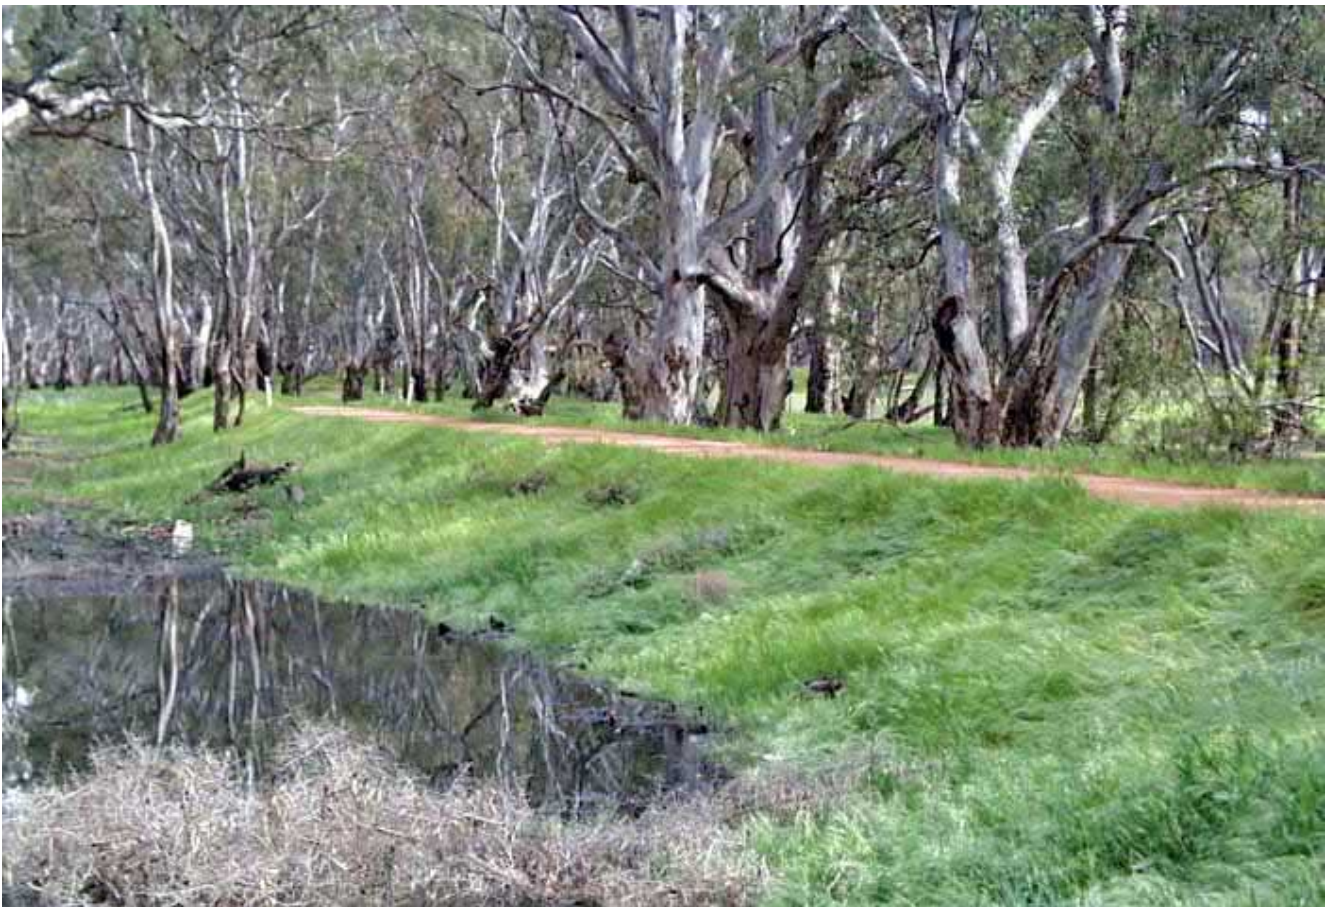
Figure 2.7: Takasuka Levee Bank (HO186 / NT B6238), located within the Vinifera State Forest, Forest / Takasuka Road reserve, and part of the immediately adjacent farmland (Allom Lovell and Associates 2001c, p. 501)

The heritage boundary of the Takasuka Levee Bank (HO186 / NT B6238) appears to comprise a tree-covered area and access path, within allotment 68T~1\PP3676 and the Forest / Takasuka Road reserve, and a small section of the adjacent farmland within allotment 48\PP3676. The *Rural City of Swan Hill Heritage Study Stage II: Volume 2, Part II - Heritage Place Datasheets: S-Z* (Allom Lovell and Associates 2001c) provides an image of the levee bank dating to 2000 (Figure 2.7). In this heritage study, it describes the start of the levee bank as running 'parallel to the forest roadway for approximately 500 metres', with the remnant portion extending 'for several kilometres' through the Vinifera State Forest (Allom Lovell and Associates 2001c, pp. 502-503); but the HO boundary is a 45 m by 370 m rectangular outline, and therefore does not encompass the entire levee bank. As modern aerial imagery cannot confirm the location of this levee bank within the HO186 boundary, the location of the levee bank will need to be ground-truthed to determine where the heritage place intersects with the area of investigation.
