# Montrose Quarry Extension

## Groundwater Dependent Ecosystem Assessment: Field summary

Prepared for Prepared for Boral Resources (VIC) Pty Ltd

June 2025

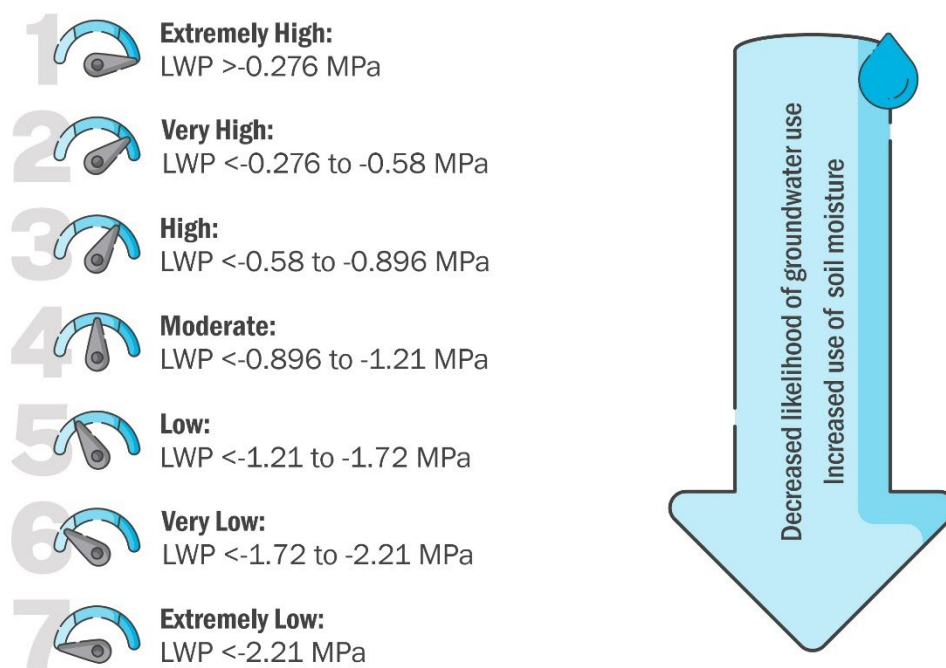
**Figure 5.2** LWP as a measure of water availability

The following categories in Figure 5.2 have been applied as a measure of relative water availability.

While the defining values of these categories are arbitrary in nature, they are intended to provide an indication of the likely degree and nature of groundwater dependence or interaction. The 'Extremely High' category would indicate the potential for interaction with an extremely fresh source of groundwater, with the degree of groundwater interaction decreasing through to the 'Moderate' category that may indicate either utilisation of soil moisture from the vadose zone or interaction with saline groundwater. Categories of 'Low' to 'Extremely Low' are considered unlikely to be utilising groundwater to any degree, regardless of salinity. It should also be stressed that soil moisture in the 'Extremely High' category can also be supplied directly from unsaturated portions of the soil profile depending on moisture availability and the soils physical properties, which can be assessed by measuring SMP. It is important to note that LWP alone only indicates water availability, and not where the water is coming from.

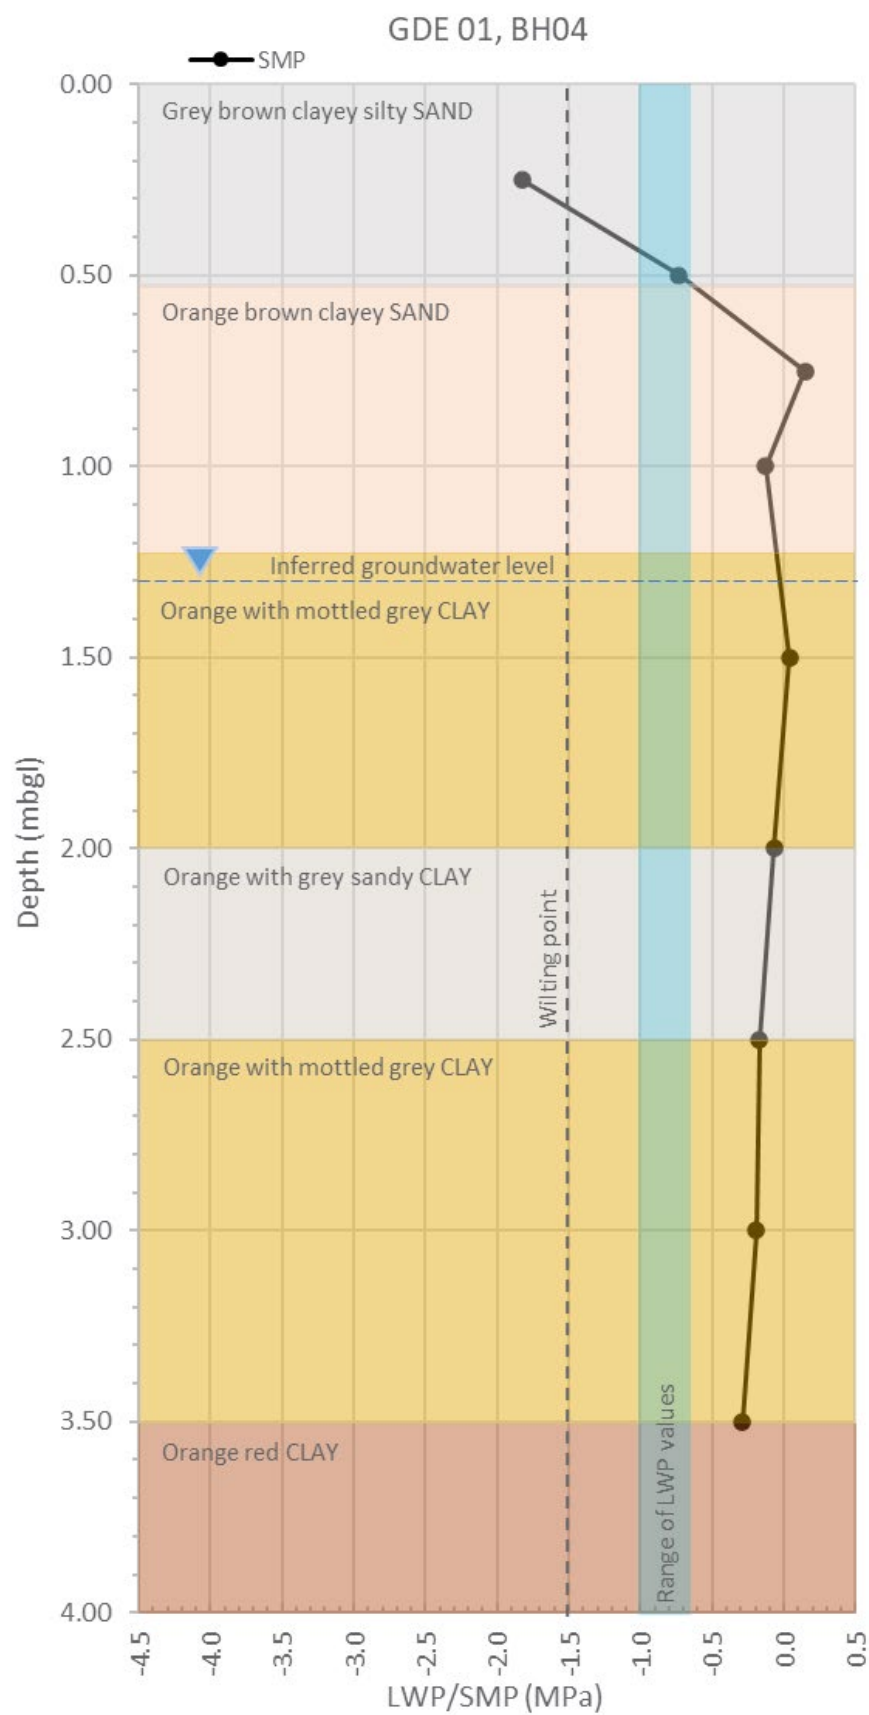
**Figure 6.3** BH04 profile from Transect 1, site GDE 01

- The auger hole at site GDE 01 (BH04) was arrested at 3.5 mbgl after refusal on hard clay. The soil down the profile was noted to be slightly moist to approximately 1 mbgl, turning moist to 3.5 mbgl. There is a correlation between LWP and SMP at 0.5 mbgl (Figure 6.3), inferring this is a zone of water uptake for the trees assessed at this site. From 0.5 mbgl to 3.5 mbgl the soil moisture is above the LWP value range indicating there is more water availability in the soil than may be needed by the vegetation at this site. Soil moisture below 3.5 mbgl cannot be determined and isotope analysis will be used to help interpret depths below this point.

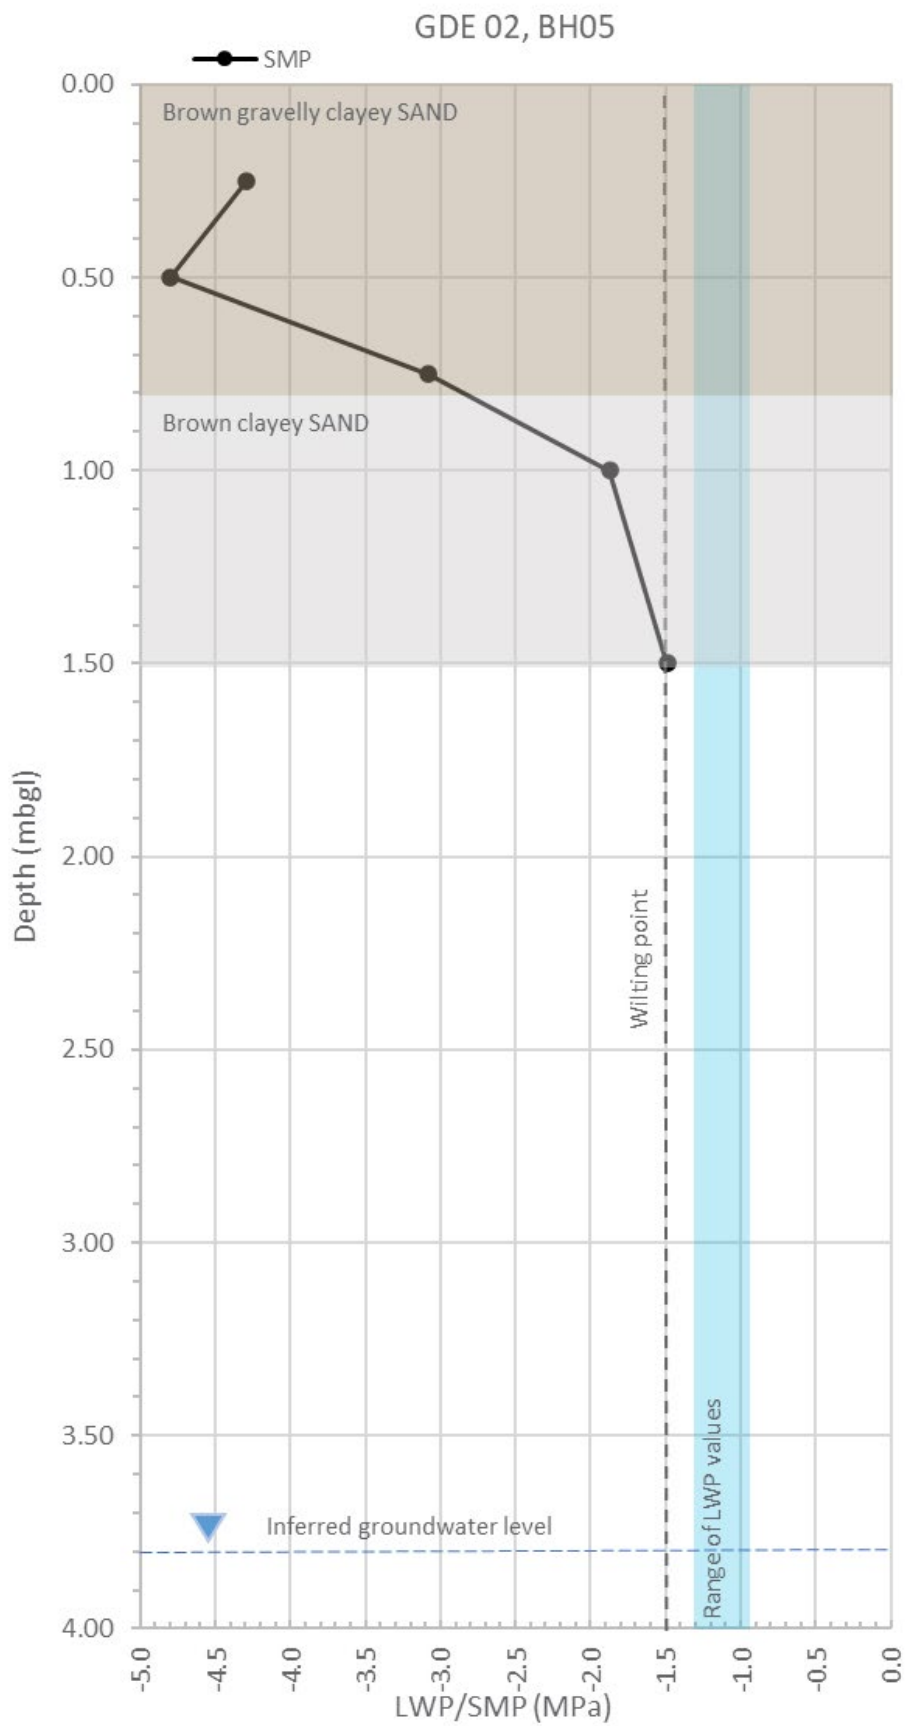
**Figure 6.4** BH05 profile from Transect 1, site GDE 02

- Due to refusal on large tree root, auguring was arrested at 1.5 mbgl at site GDE 02. At these shallow depths, the SMP is strongly negative and much more negative than the LWP indicating root water uptake is not occurring at these shallow depths (Figure 6.4). Further isotope analysis to confirm the moisture sources below 1.5 mbgl are discussed in Section 6.4.

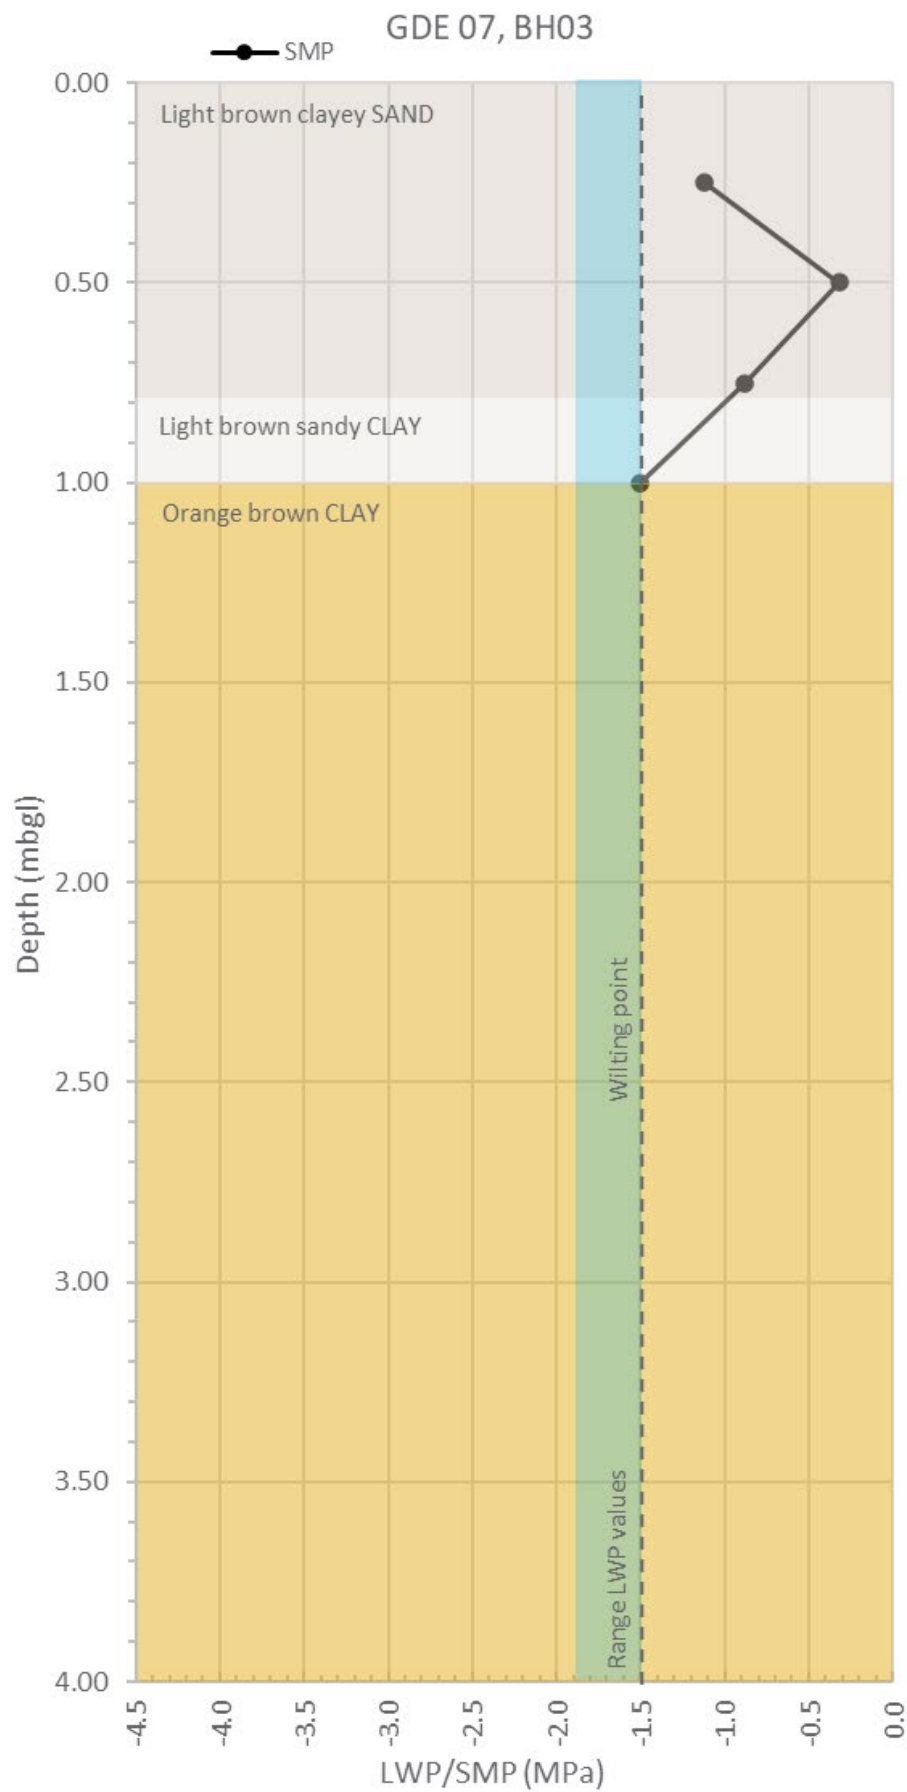
**Figure 6.5** BH03 profile from Transect 2, site GDE 07

- The auger hole at site GDE 07 (BH03) was arrested at 1.0 mbgl after refusal on hard clay. The soil was noted to be moist from approximately 0.75 mbgl to 1.0 mbgl. LWP is more negative than SMP across the profile (Figure 6.5), inferring this is a shallow zone of water uptake for the trees assessed at this site. The soil moisture within the shallower depths of the profile is above the LWP value range indicating more water availability in the soil than may be needed by the vegetation at this site. Soil moisture below 1.0 mbgl cannot be determined and isotope analysis will be used to help interpret depths below this point.

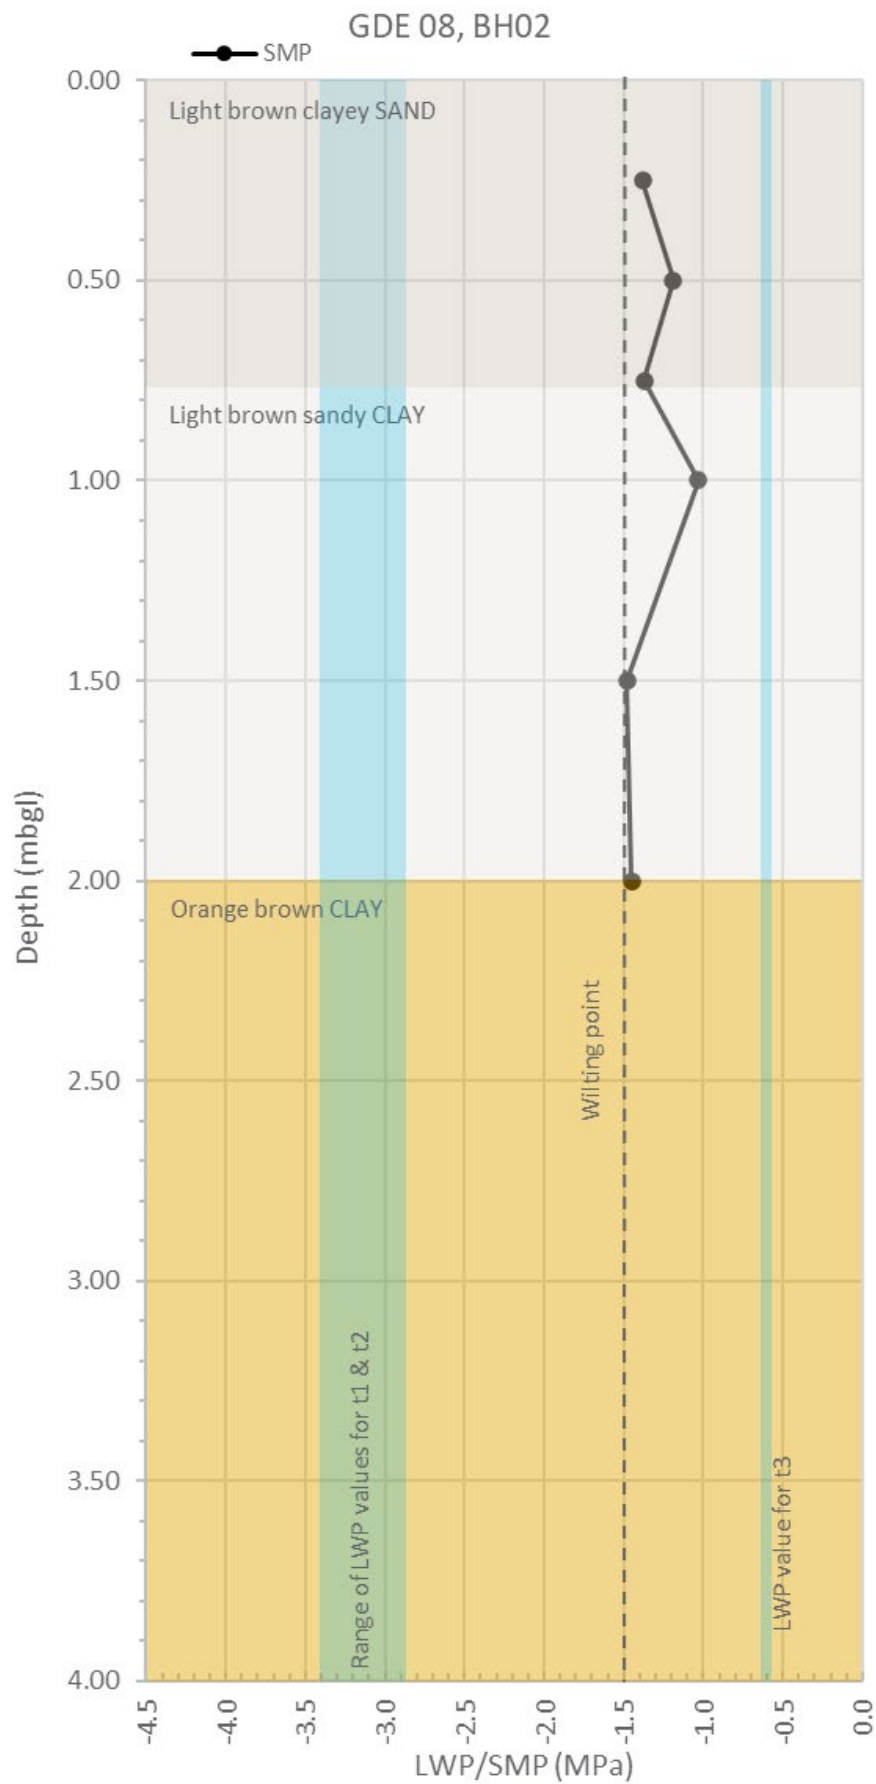
**Figure 6.6** BH02 profile from Transect 2, site GDE 08

- The auger hole at site GDE 08 (BH02) was arrested at 2.0 mbgl after refusal on hard clay. The soil was noted to be moist from approximately 1.0 mbgl to 2.0 mbgl. There is no correlation between LWP and SMP throughout the soil profile (Figure 6.6), and there is a significant difference in LWP values between tree 1 (t1) and tree 2 (t2) (Extremely Low) compared to tree 3 (t3) (High). The SMP values in the soil profile are significantly higher than LWP values for t1 and t2, indicating that soil moisture is available to the vegetation, if the LWP values are not erroneous. The SMP values are lower than the LWP value for t3, indicating that this tree has high water availability and may be accessing water from deeper in the soil profile, or groundwater. Isotope analysis is required to determine the source of water stress (t1 and t2) and source of moisture utilised by vegetation in this area.

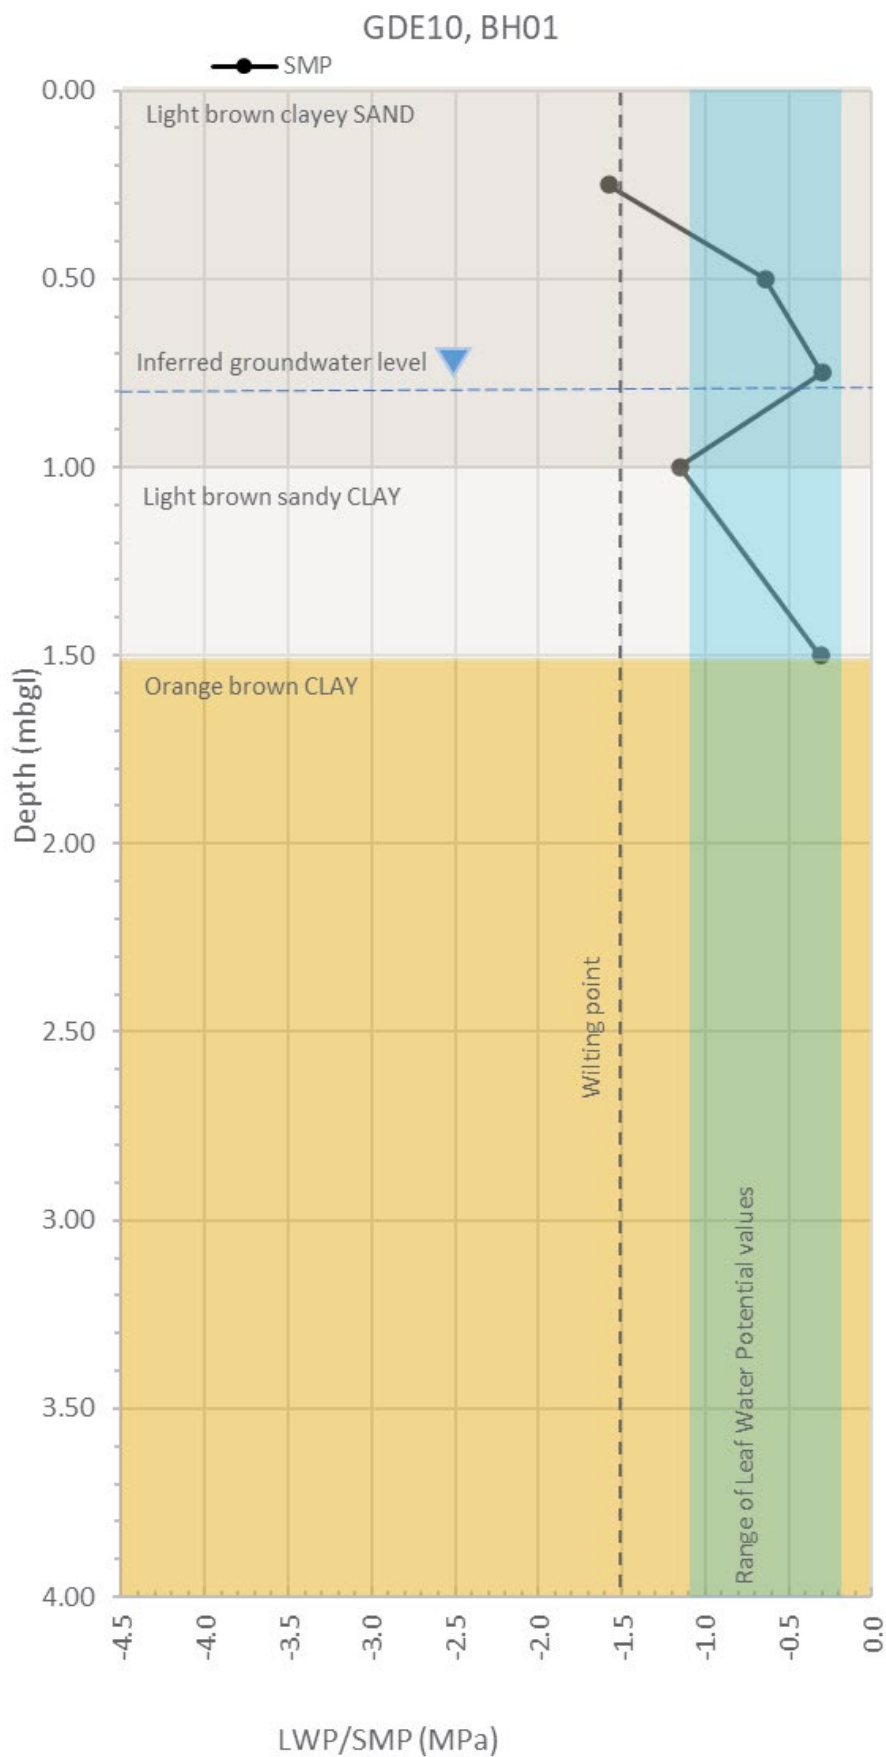
**Figure 6.7** BH01 profile from Transect 3, site GDE 10

- The auger hole at site GDE 10 (BH01) was arrested at 1.5 mbgl after refusal on hard clay. The soil was noted to be slightly moist from throughout the soil profile. There is a clear correlation between LWP and SMP throughout the soil profile (Figure 6.7), inferring that the soil moisture within the top 1.5 mbgl is a zone of water uptake for the trees assessed at this site. Soil moisture below 1.5 mbgl cannot be determined and isotope analysis will be used to help interpret depths below this point.

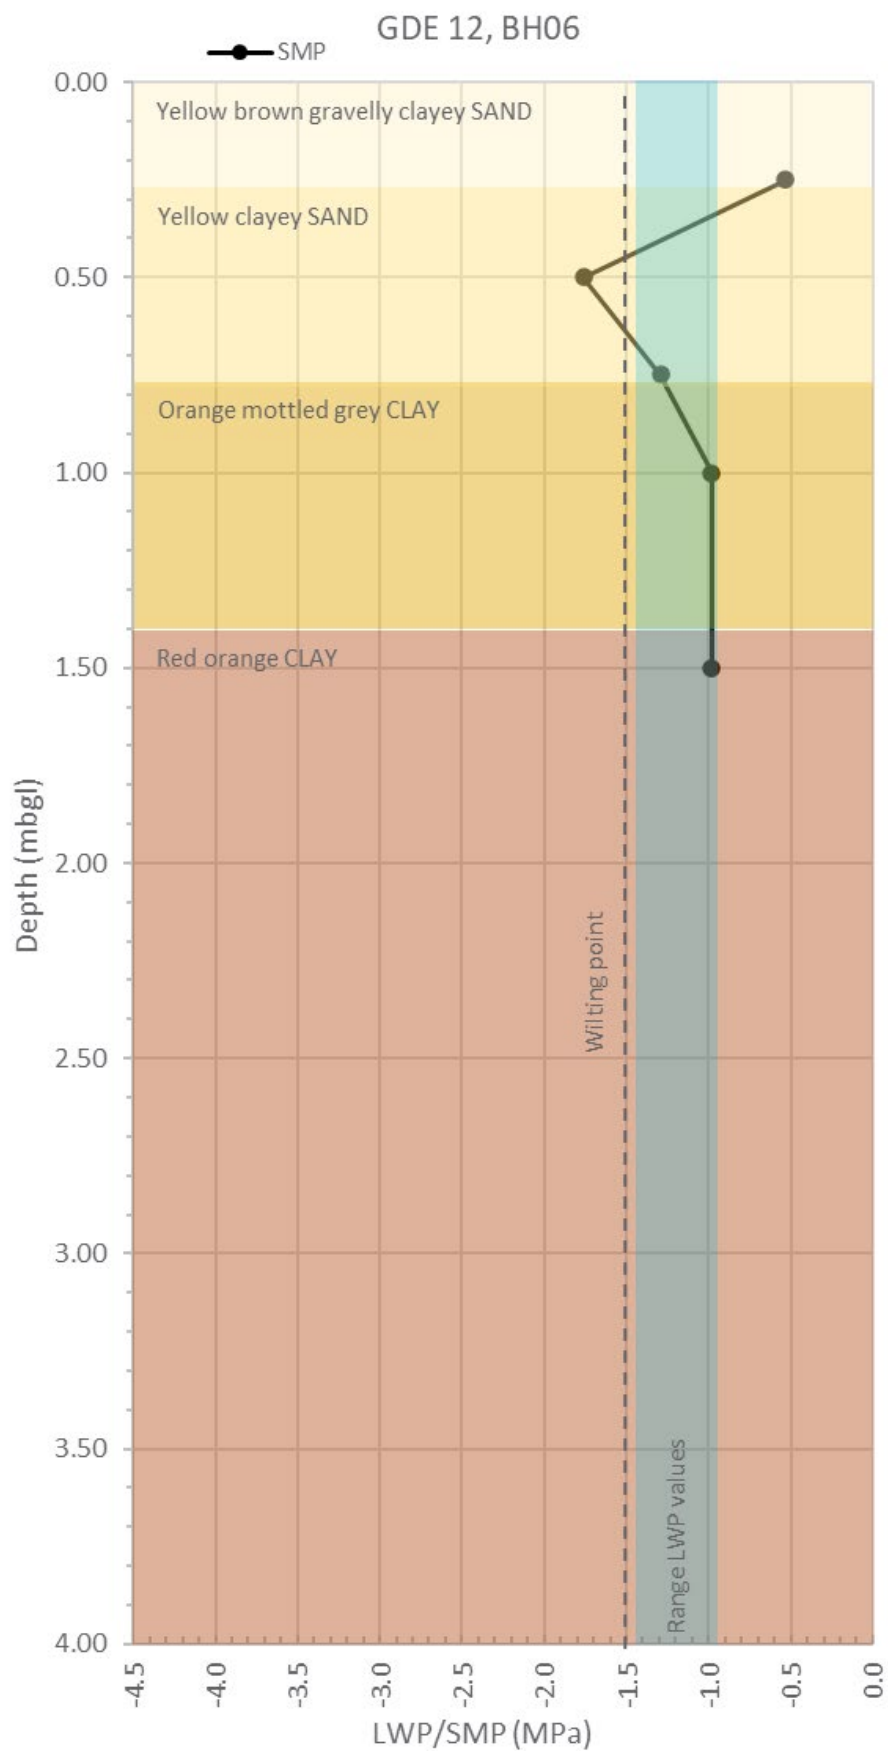
**Figure 6.8** BH06 profile from Transect 3, site GDE 12

- The auger hole at site GDE 12 (BH06) was arrested at 1.5 mbgl after refusal on hard clay. The soil down the profile was noted to be slightly moist from approximately 0.5 mbgl to 1.0 mbgl and moist from 1.0 mbgl to 1.5 mbgl. There is a clear correlation between LWP and SMP from 0.75 mbgl to 1.5 mbgl (Figure 6.8), inferring this is a zone of water uptake for the trees assessed at this site. Soil moisture below 1.5 mbgl cannot be determined and isotope analysis will be used to help interpret depths below this point.

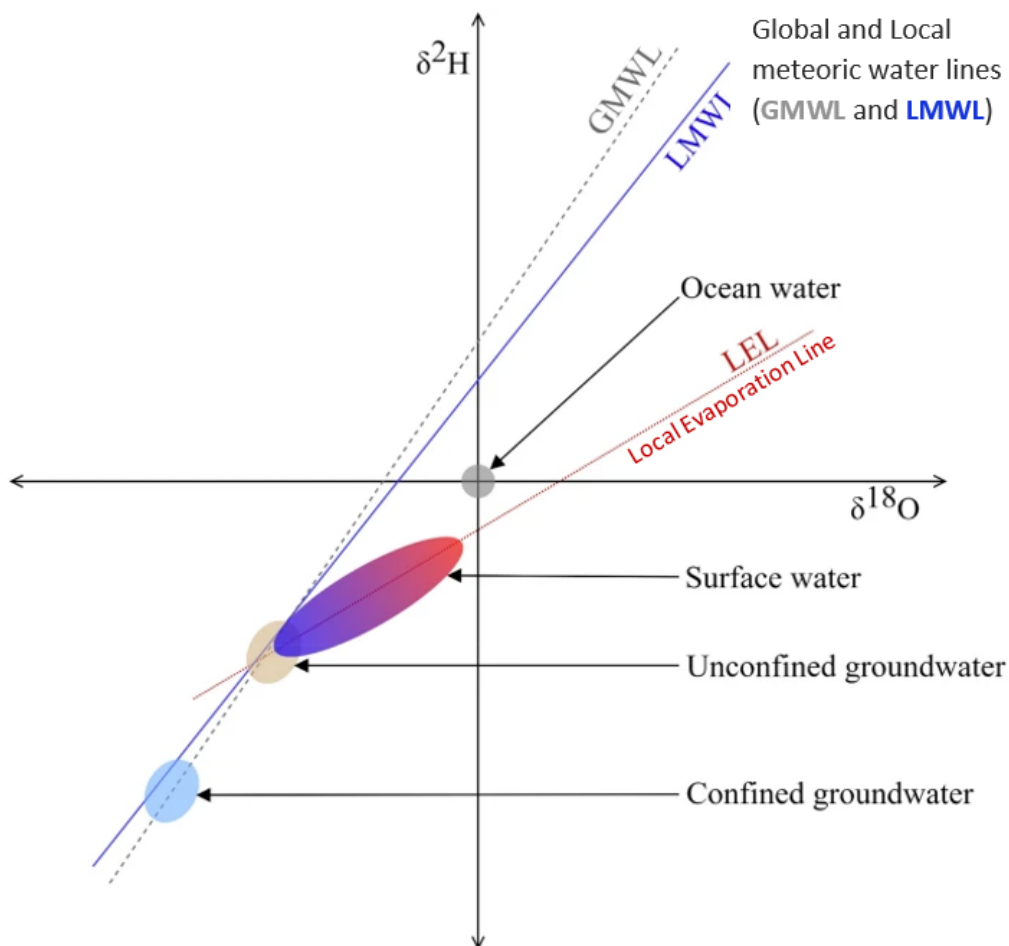
**Figure 6.9** Example distribution groundwater and the surface water within the isotope ratio (modified from de Wet *et. al.*, 2020)

Essentially the closer the points are to the LMWL the younger the isotopes are, suggesting they are closely linked to recent rainfall and atmospheric conditions. Whereas when the points move to the right of the LMWL, the isotopes are older and more likely to relate to groundwater that has been separated from the surface climate. In this context, samples which plot closer to the top right corner of the graph means that the samples have been exposed to more evaporative enrichment (Local Evaporation Line) which could be through surface evaporation process and or transpiration. Soil water uptake by plant roots occurs predominantly without significant isotopic fractionation, so the stable isotope composition of water in twig xylem reflects that of water taken up by roots (Dawson, Mambelli, Plamboeck, Templer, & Tu, 2002; Penna et al., 2018). Therefore, comparison of the stable isotope composition of plant xylem water with that of possible water sources (Figure 6.9) can help identify the uptake of different water sources (Ogle, Tucker, & Cable, 2014).

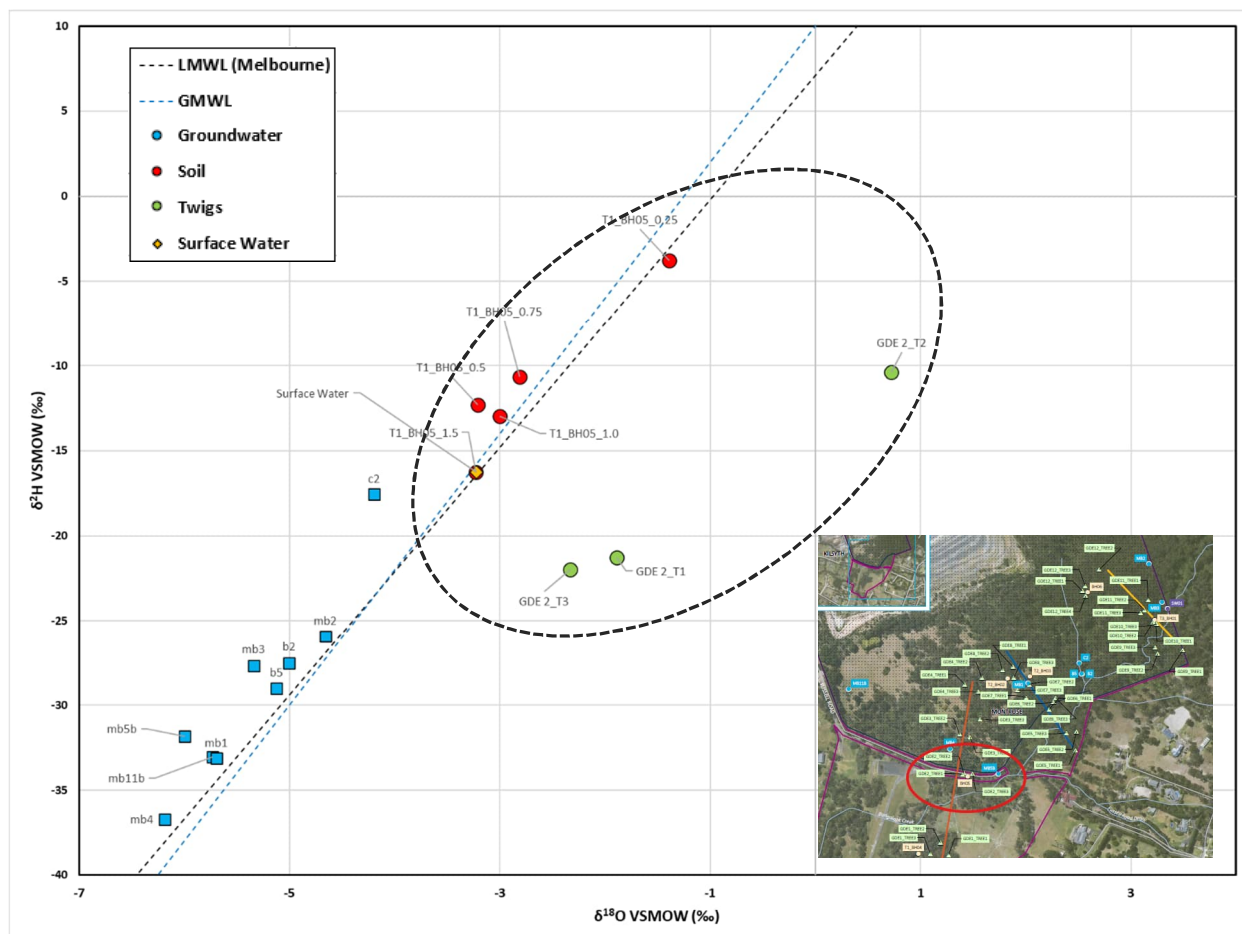
Figure D2 GDE 2 isotope results

GDE 2 is located on the northern side of Bungalook Creek with a DTGW between 5-10 mbgl. The isotope results indicate the soil moisture is potentially replenished mainly by precipitation rather than surface water and groundwater at this location. There is also no correlation between vegetation and groundwater use at GDE 2.

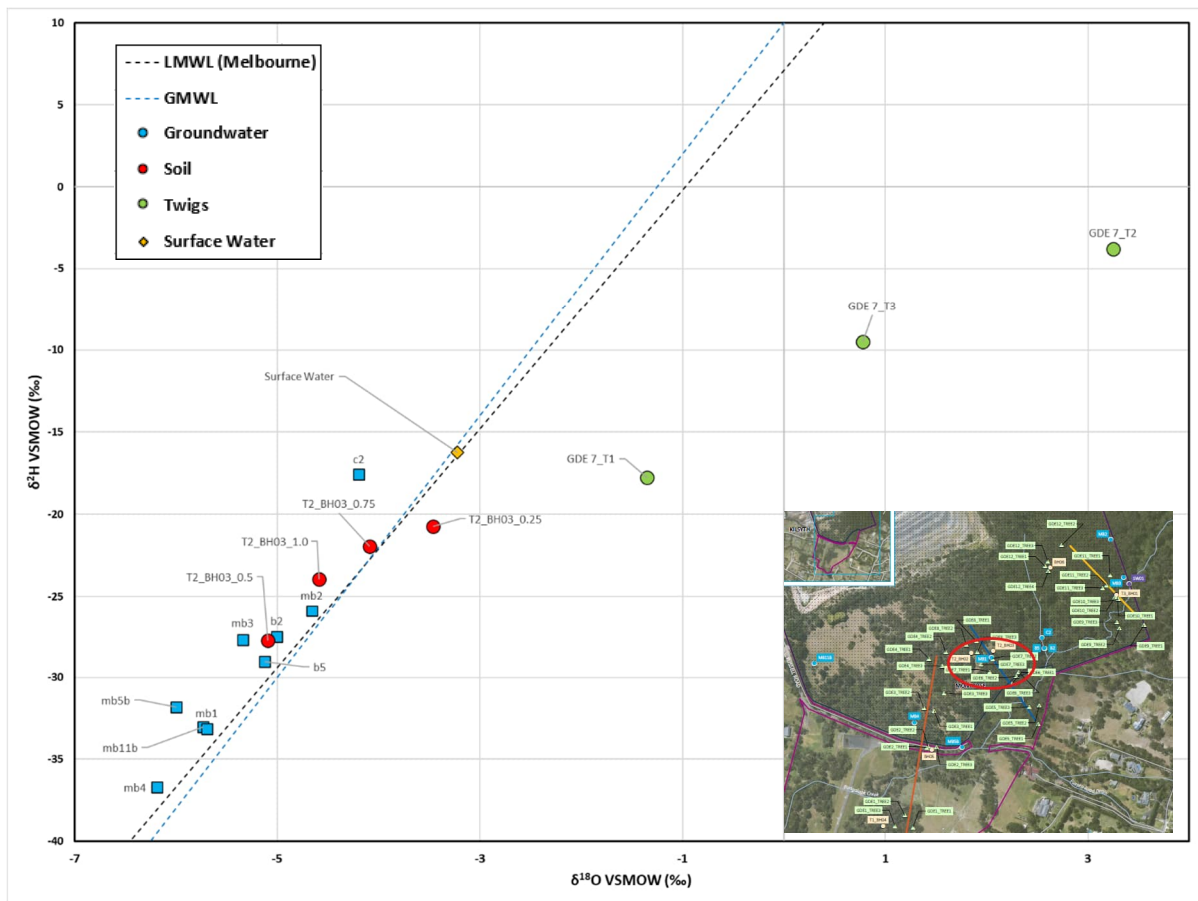
Figure D4 GDE 7 isotope results

GDE 7 is south of GDE 8 with a DTGW between 15-25 mbgl. The isotope results indicate there is no correlation between vegetation and groundwater therefore it is likely that vegetation within this area is utilising soil moisture. However, the plant xylem isotopes have been altered more by evaporative fractionalisation than the soil sample isotopes which could indicate the source of the soil moisture is further down in the soil profile than where the soil samples have been collected from.

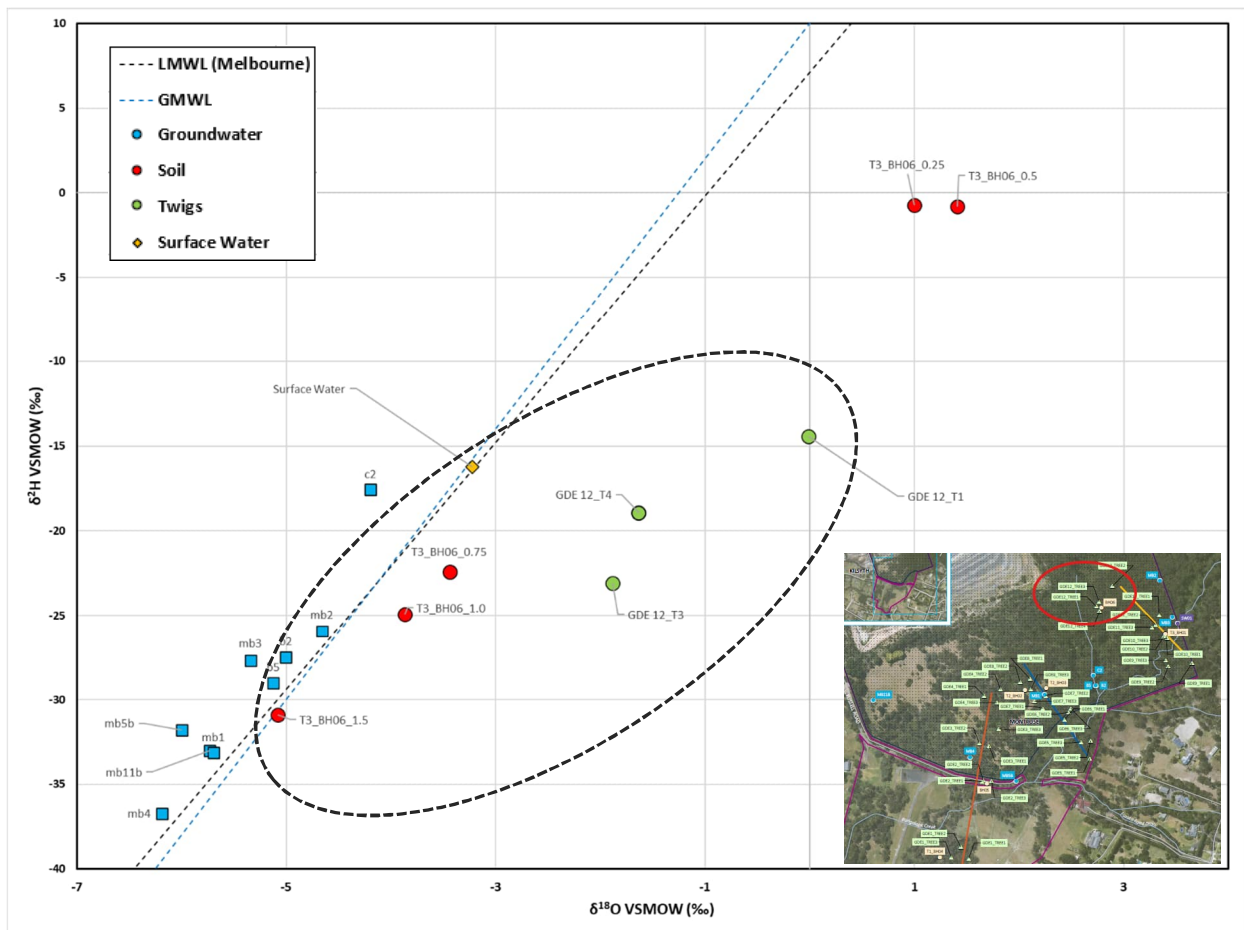
Figure D6 GDE 12 isotope results

GDE 12 is located south of the Montrose Quarry with a DTGW between 25-50 mbgl. The isotope results indicate that the vegetation is preferentially utilising soil moisture over groundwater, potentially from 0.75 mbgl to deeper in the soil profile. There is no correlation between plant xylem isotope data and groundwater isotope data.
