Groundwater Dependent Ecosystem Assessment for Montrose Quarry

Assessment Report

Boral

19 August 2025

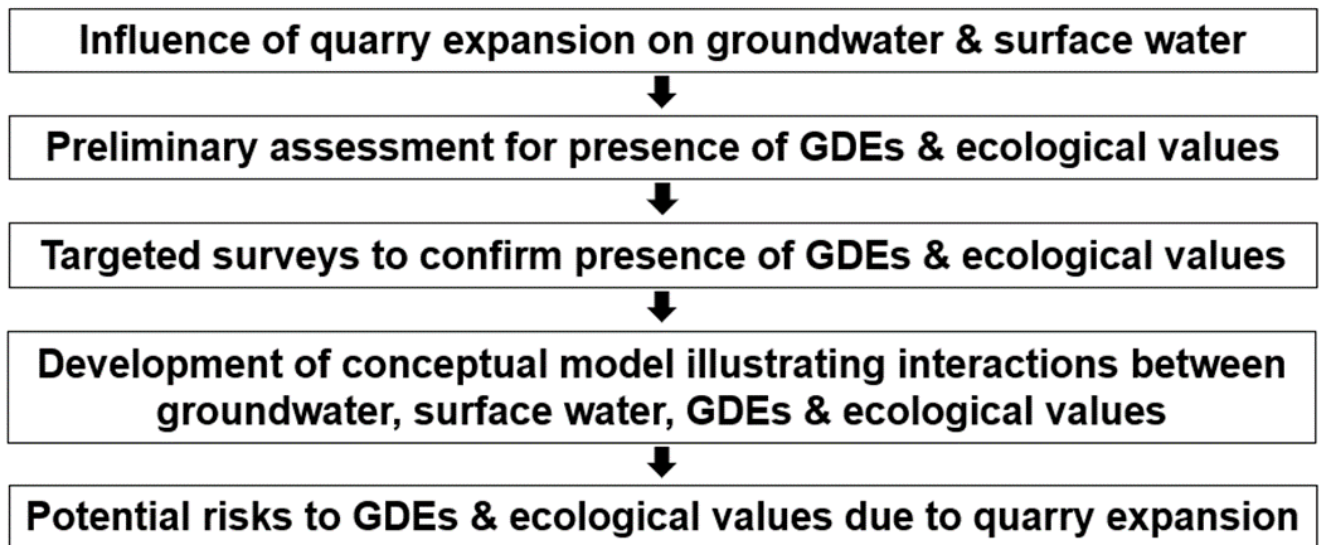
The Australian Government *Australian Groundwater-Dependent Ecosystems Toolbox Part 1: Assessment Framework* (Richardson et al. 2011) includes a three-stage approach to identify GDEs, determine the reliance of those ecosystems on groundwater, and determine possible changes to ecosystem state or function due to changes in the groundwater environment. Similarly, the NSW Government *Risk Assessment Guidelines for Groundwater Dependent Ecosystems* (Serov et al. 2012) provides detailed methods for defining, identifying, and assessing ecological values associated with GDEs. In this assessment a modified method has been used based on these two approaches, with the main stages presented in Figure 2. The approach adopted for each of these stages is discussed in the following sections.

Figure 2 Stages used in the GDE assessment

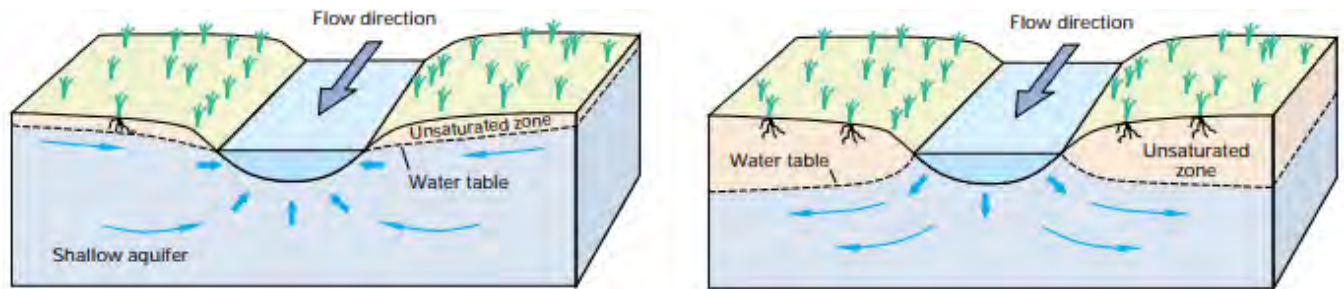
Interactions between groundwater and surface water are complex. Figure 3 shows a thin deposit of alluvial and colluvial sediments, which are generally laterally restricted from the present-day course of Bungalook Creek and other waterways in the study area. Where groundwater levels are above the creek, groundwater would discharge into the creek (i.e., gaining stream). Where the creek bed is above the water table, the creek may lose water to the aquifer (i.e., losing stream). However, this flow direction can change over time due to rainfall and flooding, growth of riparian vegetation (i.e., additional evapotranspiration), or potentially due to changes in groundwater levels associated with quarry operations. Adjacent to waterways, where groundwater levels may be closer to the surface, groundwater losses may also occur through evapotranspiration (i.e., riparian vegetation reduces water levels).

Figure 3 Groundwater and surface water interactions showing a gaining stream (left) and a losing stream (right)

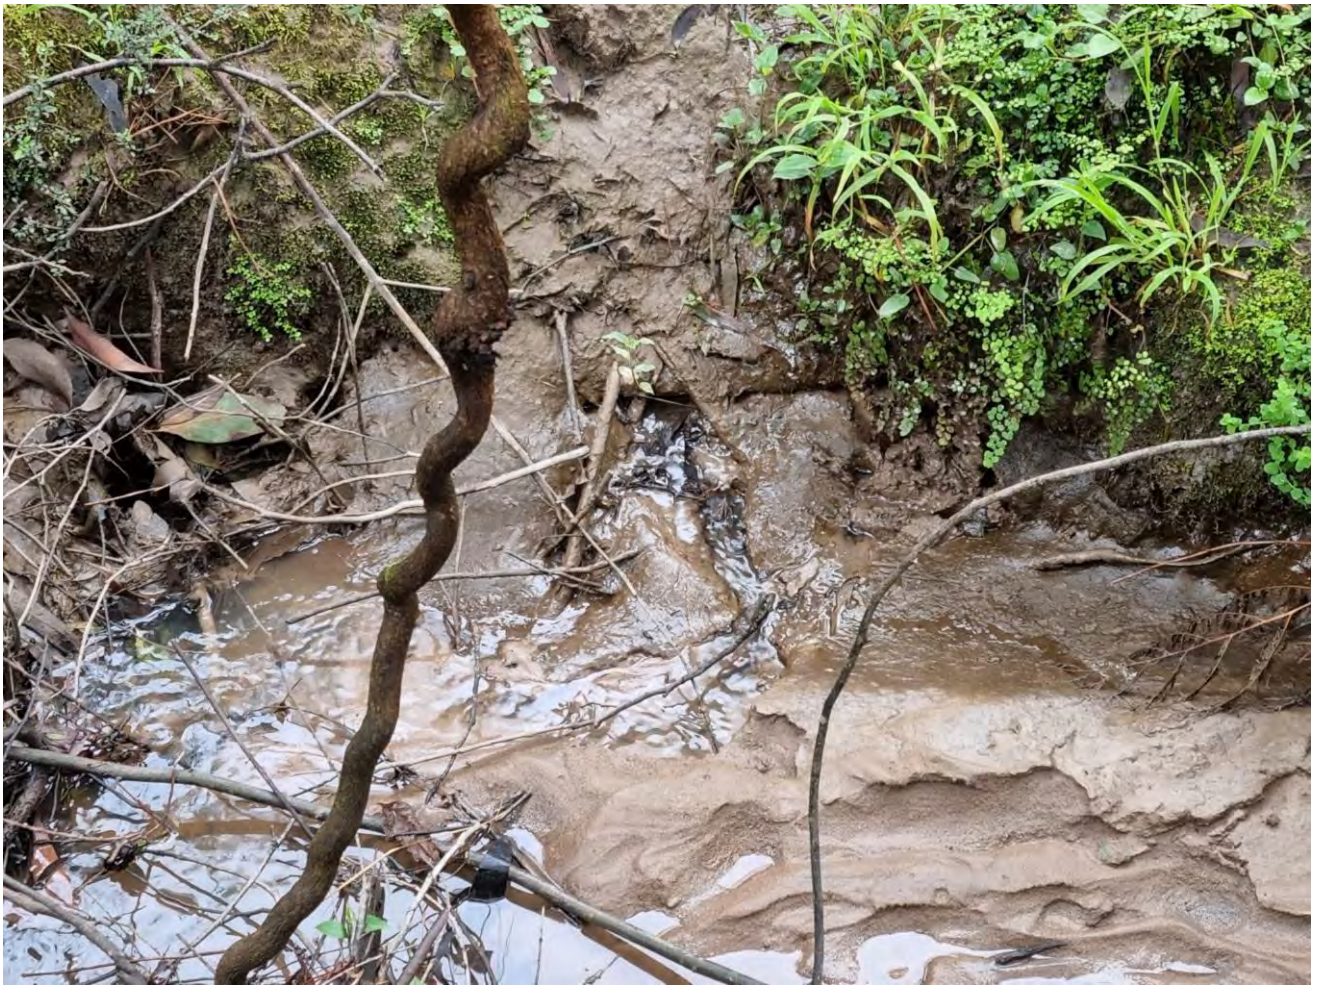
Figure 4 *Interflow observed during site assessment of Bungalook Creek*

Overall, GHD (2023) determined that Bungalook Creek is likely to be generally losing at the upstream end of the quarry adjacent to bore MB3, likely to become gaining at the downstream end adjacent to bore MB5b (see Figure 1). Between these two areas there is likely a transitional zone adjacent to bore AS2 where the elevation of the creek and groundwater levels are similar. In this transitional zone the creek is in a loosely gaining or baseflow neutral condition. Furthermore, during the targeted surveys to confirm the presence of GDEs and ecological values, evidence of interflow was also observed (Figure 4). The surveys occurred following a period of high rainfall and there was an obvious discharge of water from the bank into the creek in some areas.

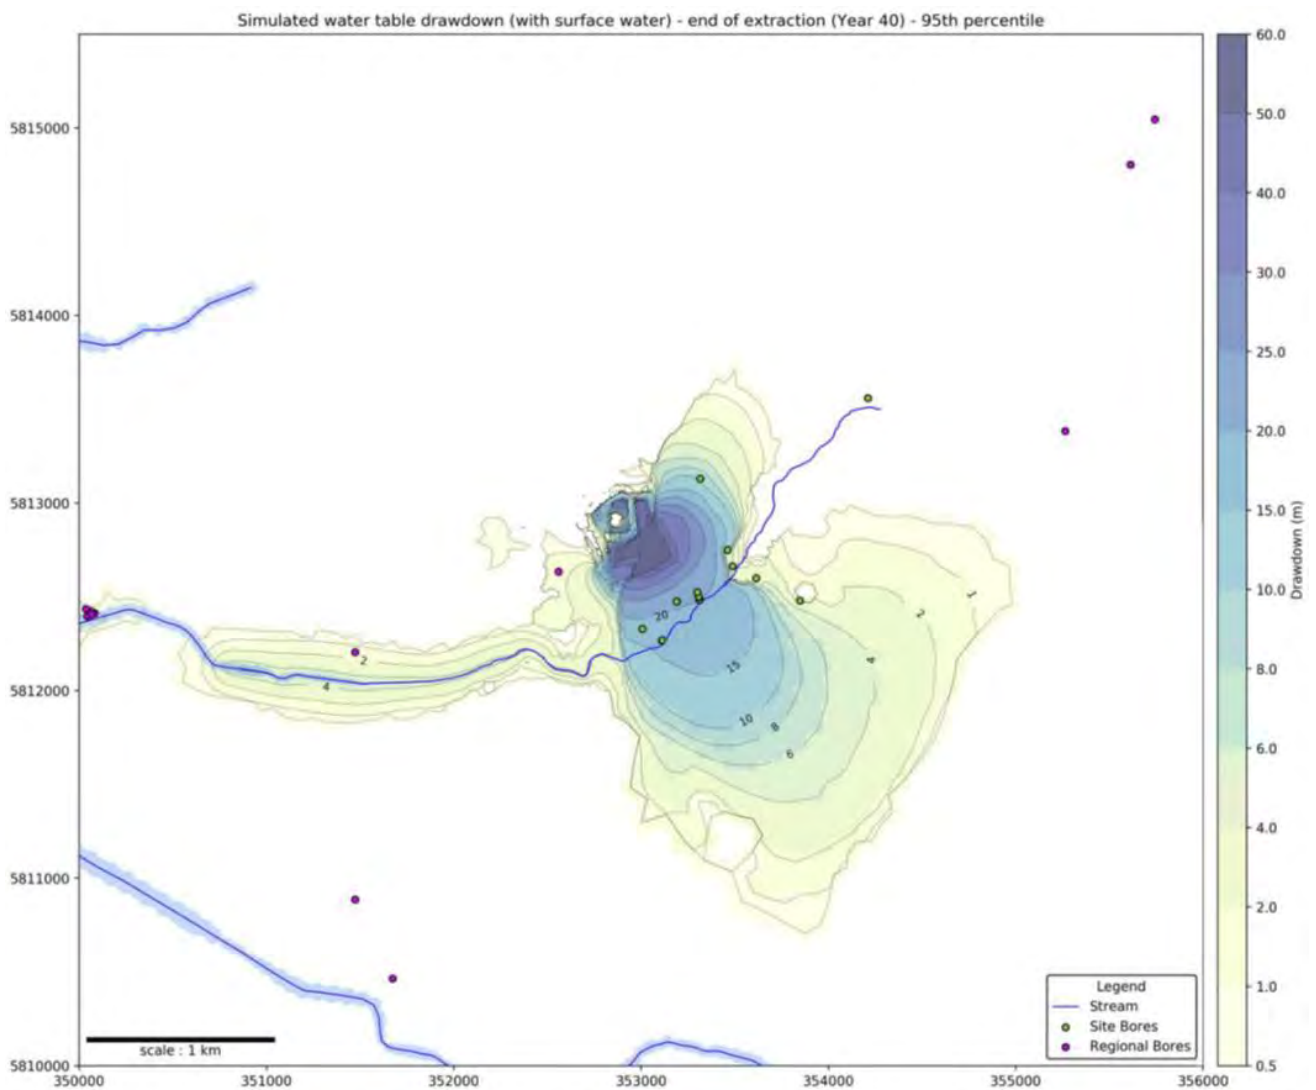
The drawdown predicted along Bungalook Creek by year 40 is around 10 m or less (Figure 5). It is limited to this because when the watertable is lowered below the creek level and there is sufficient surface flow, recharge to the watertable occurs from the creek. However, as described above, this recharge leads to less flow reaching the downstream section of Bungalook Creek, resulting in localised drawdown along the creek including a maximum drawdown of around 4 m along Fussell Road.

Figure 5 Simulated water table drawdown at the end of the extraction period based on 95th percentile (Sourced from GHD 2023)

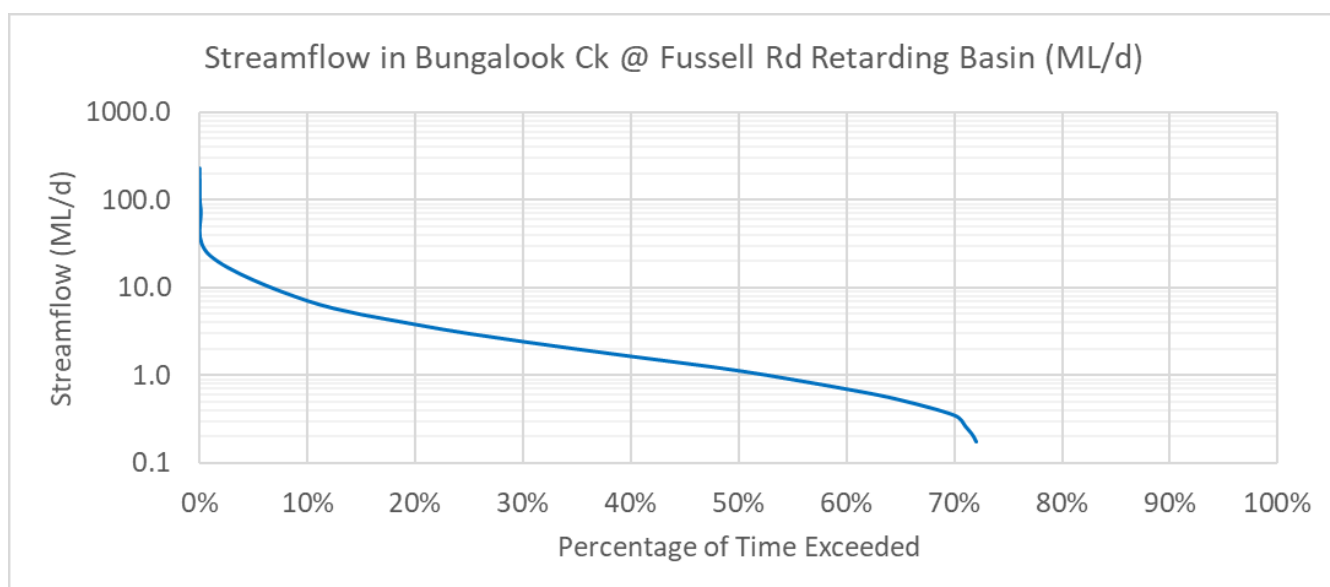
GHD (2023) determined that during dry periods, when the total flow is less than 10 L/s, all of the flow is lost as leakage due to the expansion of the quarry and associated drawdown of the watertable. During these low flow periods, the loss of flow in the upstream section of Bungalook Creek results in localised drawdown along the downstream section. The locations of the downstream losses and localised drawdown are shown in Figure 5. A flow of 10 L/s is roughly equivalent to 0.86 ML/day and a flow duration curve for Bungalook Creek indicates that under existing conditions, there is less than 10 L/s for 43% of the time (Figure 6). Given further seepage from the creek into the groundwater is predicted following expansion of the quarry, it is likely all flow in Bungalook Creek will be lost more frequently.

Figure 6 Bungalook Creek flow duration curve

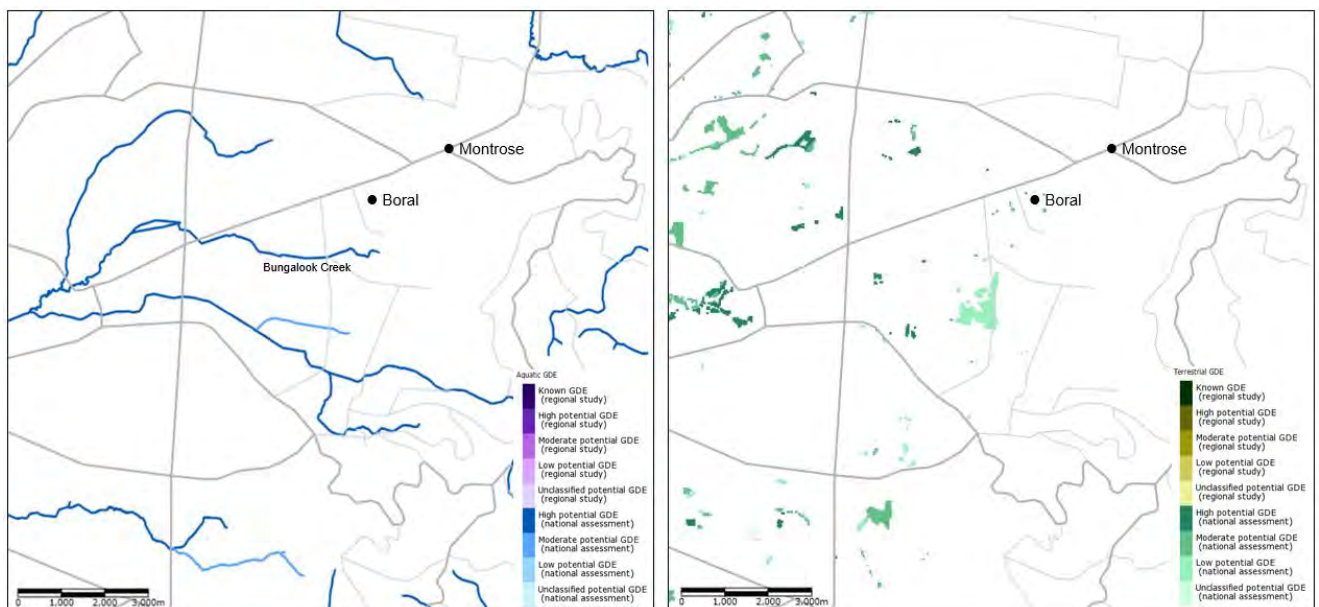
The Bureau of Meteorology GDE Atlas suggests that Bungalook Creek has a high potential of being a GDE, and that there are some areas of vegetation in the vicinity of the quarry with low to moderate potential of being GDEs (Figure 8).

Figure 8 Bureau of Meteorology GDE Atlas results showing potential locations of aquatic GDE (left) and terrestrial GDEs (right)

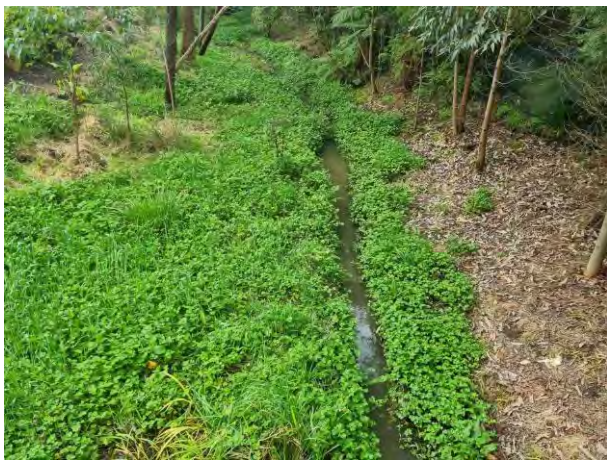
Plate 1 Bungalook Creek upstream Dr Ken Leversha Reserve (Site BUN01)

Upstream of the Dr Ken Leversha Reserve, the waterway flows through semi-urban areas with limited riparian vegetation in some areas (Site BUN01 (Figure 9; Plate 1 & Plate 2)). There is limited instream vegetation in this area and the banks are typically weedy and degraded. There is only low value habitat for aquatic fauna. Further downstream within Dr Ken Leversha Reserve, the riparian vegetation resembles a more natural condition and there is a greater proportion of habitat complexity in the form of large woody debris and over-hanging vegetation along both banks (BUN02 (Figure 9; Plate 3 & Plate 4)). An increase in shading due to the canopy cover has contributed to an increase in moss and is expected to reduce water temperatures and associated decreases in dissolved oxygen during hotter periods. The presence of undercut banks provides further habitat complexity and overall, this area contains suitable habitat for small-bodied native fish and other aquatic fauna.

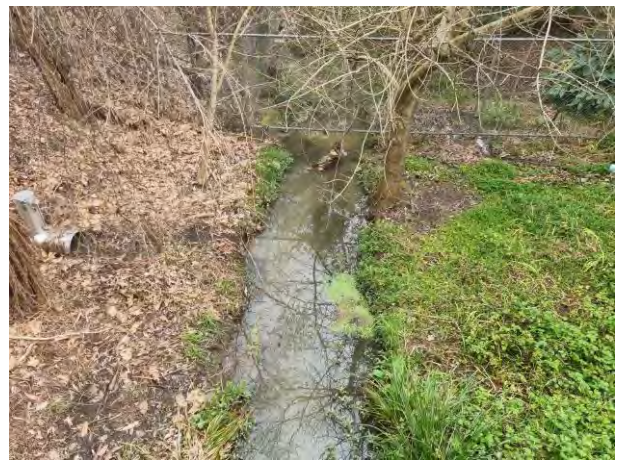
Plate 2 Bungalook Creek upstream Dr Ken Leversha Reserve (Site BUN01)

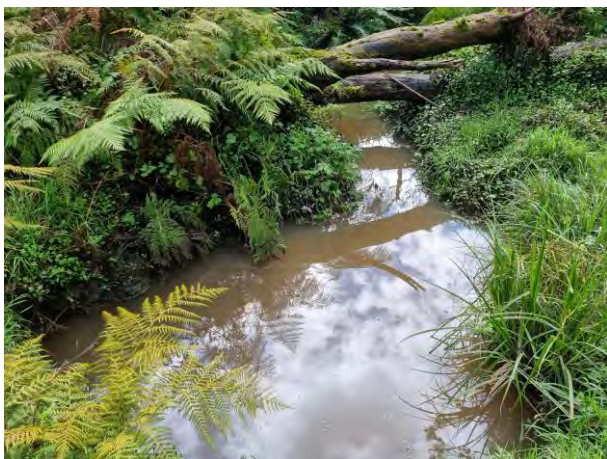
Plate 5 Pool in Bungalook Creek adjacent to Montrose quarry (Site BUN03)

Similar to areas within Dr Ken Leversha Reserve, Bungalook Creek adjacent to the Montrose quarry also contains a largely native riparian zone that contributes to habitat complexity (Sites BUN03 and BUN04 (Figure 9; Plate 5 - Plate 8)). However, a greater proportion of weeds are present in this area, when compared to the Dr Ken Leversha Reserve. The creek is generally narrow and mainly composed of shallow run/riffle areas although there were some deeper pool areas in several locations that may provide a drought refuge for aquatic fauna during low flow periods (Site BUN03 (Figure 9; Plate 5 & Plate 6)). There were also some areas where the channel had braided (Plate 9) and at the end of Fussell Road there was a swampy area with dense stands of vegetation including Common Reeds (*Phragmites australis*) and Cumbungi (*Typha* sp.) (Plate 10). This was the only area that contained native instream vegetation that was observed between Fussell Road and the upstream extent of Bungalook Creek.

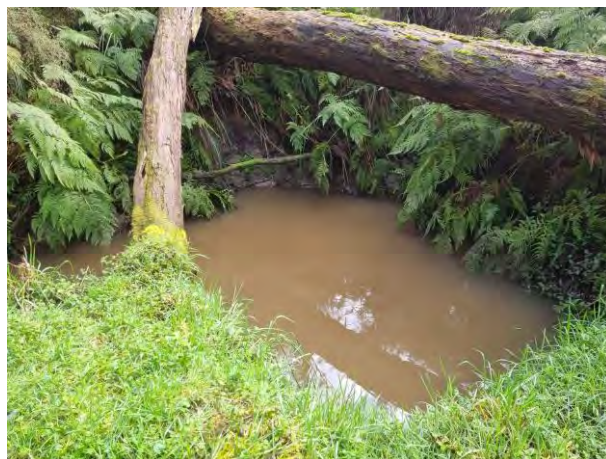
Plate 6 Pool in Bungalook Creek adjacent to Montrose quarry (Site BUN03)

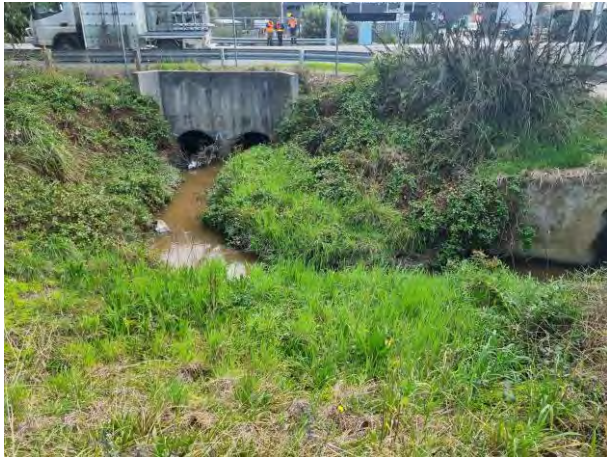
Plate 11 Bungalook Creek upstream from Liverpool Road (Site BUN05)

Further downstream at Liverpool Road the creek entered a more developed area including residential and industrial land uses (Site BUN05 (Figure 9; Plate 11 & Plate 12)). This area of the creek was highly disturbed, with evidence of deep incision, little riparian vegetation and the banks dominated by weeds and exotic vegetation. Downstream of Liverpool Road the channel has been artificially straightened with the banks stabilised with rocks. The influence of the more urbanised area was apparent, with an increase in litter. There was little quality aquatic habitat in this area.

- pH values at all sites were within the range specified by the Victorian Government (2021) Environment Reference Standard (ERS).
- Conductivity/salinity concentrations were elevated above the ERS objective at sites BUN01 and BUN02 – possibly an indication of groundwater or a point-source input at these localities.
- Dissolved oxygen saturation was below the ERS objective at sites BUN01 and BUN04, noting that these results may be an artefact of sample measurements being taken in the morning, when photosynthesis is lower.
- Turbidity levels were elevated above the ERS objective at sites BUN05 and BUN06 – potentially as a result of road run-off and or erosion of bare banks (e.g. see Plate 11 and Plate 13).

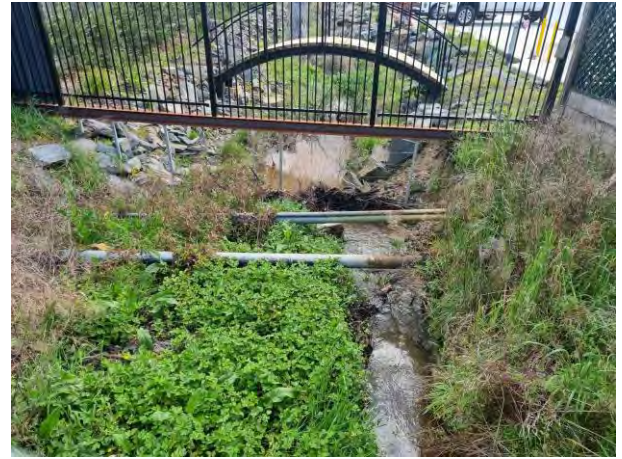
Plate 12 Bungalook Creek at Liverpool Road

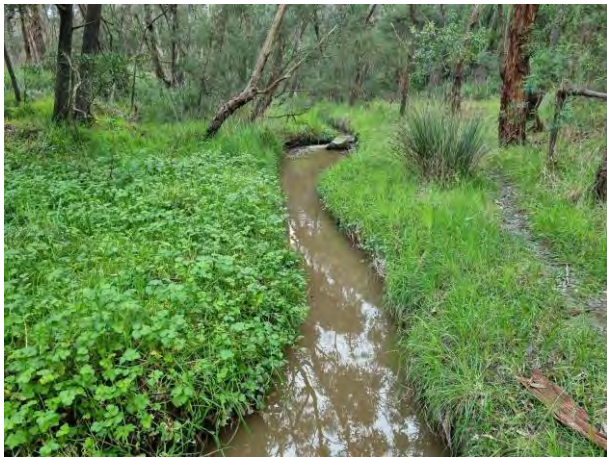
Plate 13 Bungalook Creek upstream retarding basin (Site BUN06)

Prior to entering the Melbourne Water retarding basin near Colchester Road there was less understorey vegetation along the banks of Bungalook Creek and little instream habitat (Site BUN06 (Figure 9; Plate 13)). With the exception of some native trees and shrubs, most of the vegetation along the banks was terrestrial species and weeds. The retarding basin itself was dominated by dense vegetation including Common Reeds (*Phragmites australis*) and Cumbungi (*Typha* sp.).

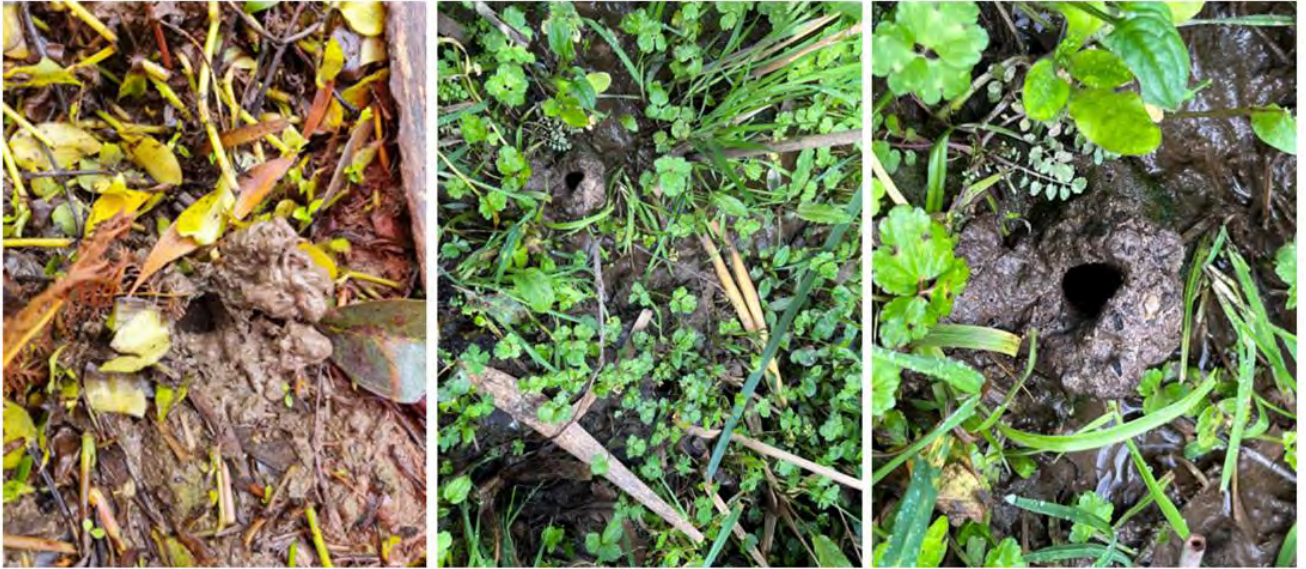
The survey focused on the potential drawdown area, as indicated by GHD (2023). Within this area (~1000 m²) approximately 50 burrow openings were observed (Plate 16).

Plate 16 Engaeus sp. crayfish burrows observed along Bungalook Creek

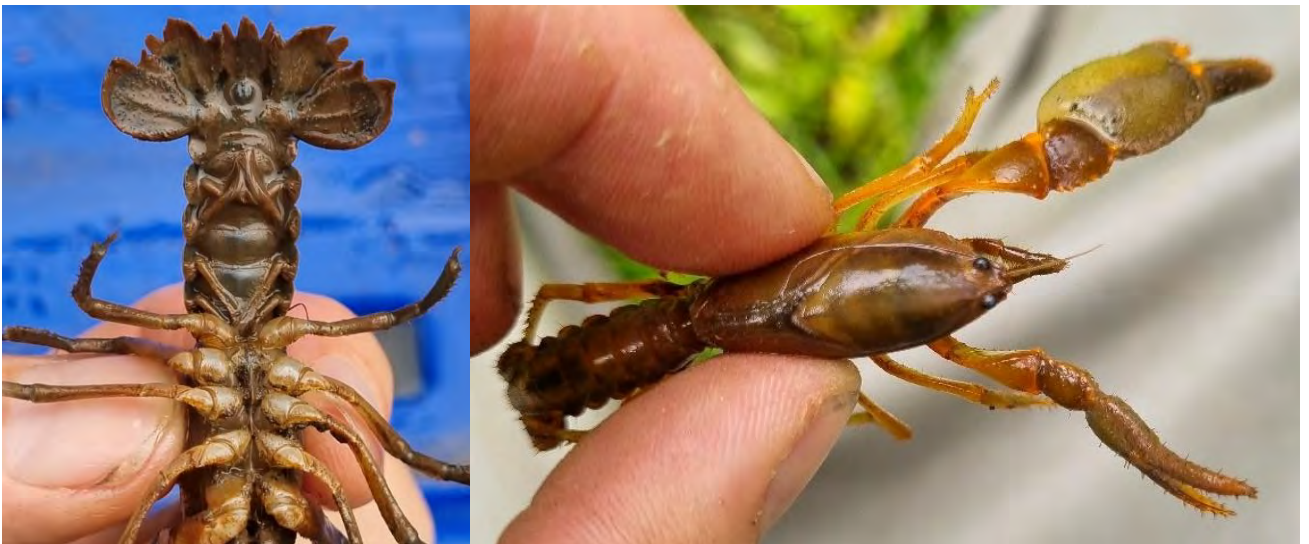
Plate 17 Central Highlands Burrowing Crayfish Engaeus affinis – Bungalook Creek, 13 December 2023

Two specimens of the non-threatened Central Highlands Burrowing Crayfish (*Engaeus affinis*) were recorded (Figure 9). Identification was based on a lack of sternal pores (Plate 17, left) and antennae extending beyond the carapace, presence of long bristle setae and rostrum shape (Plate 18, right).

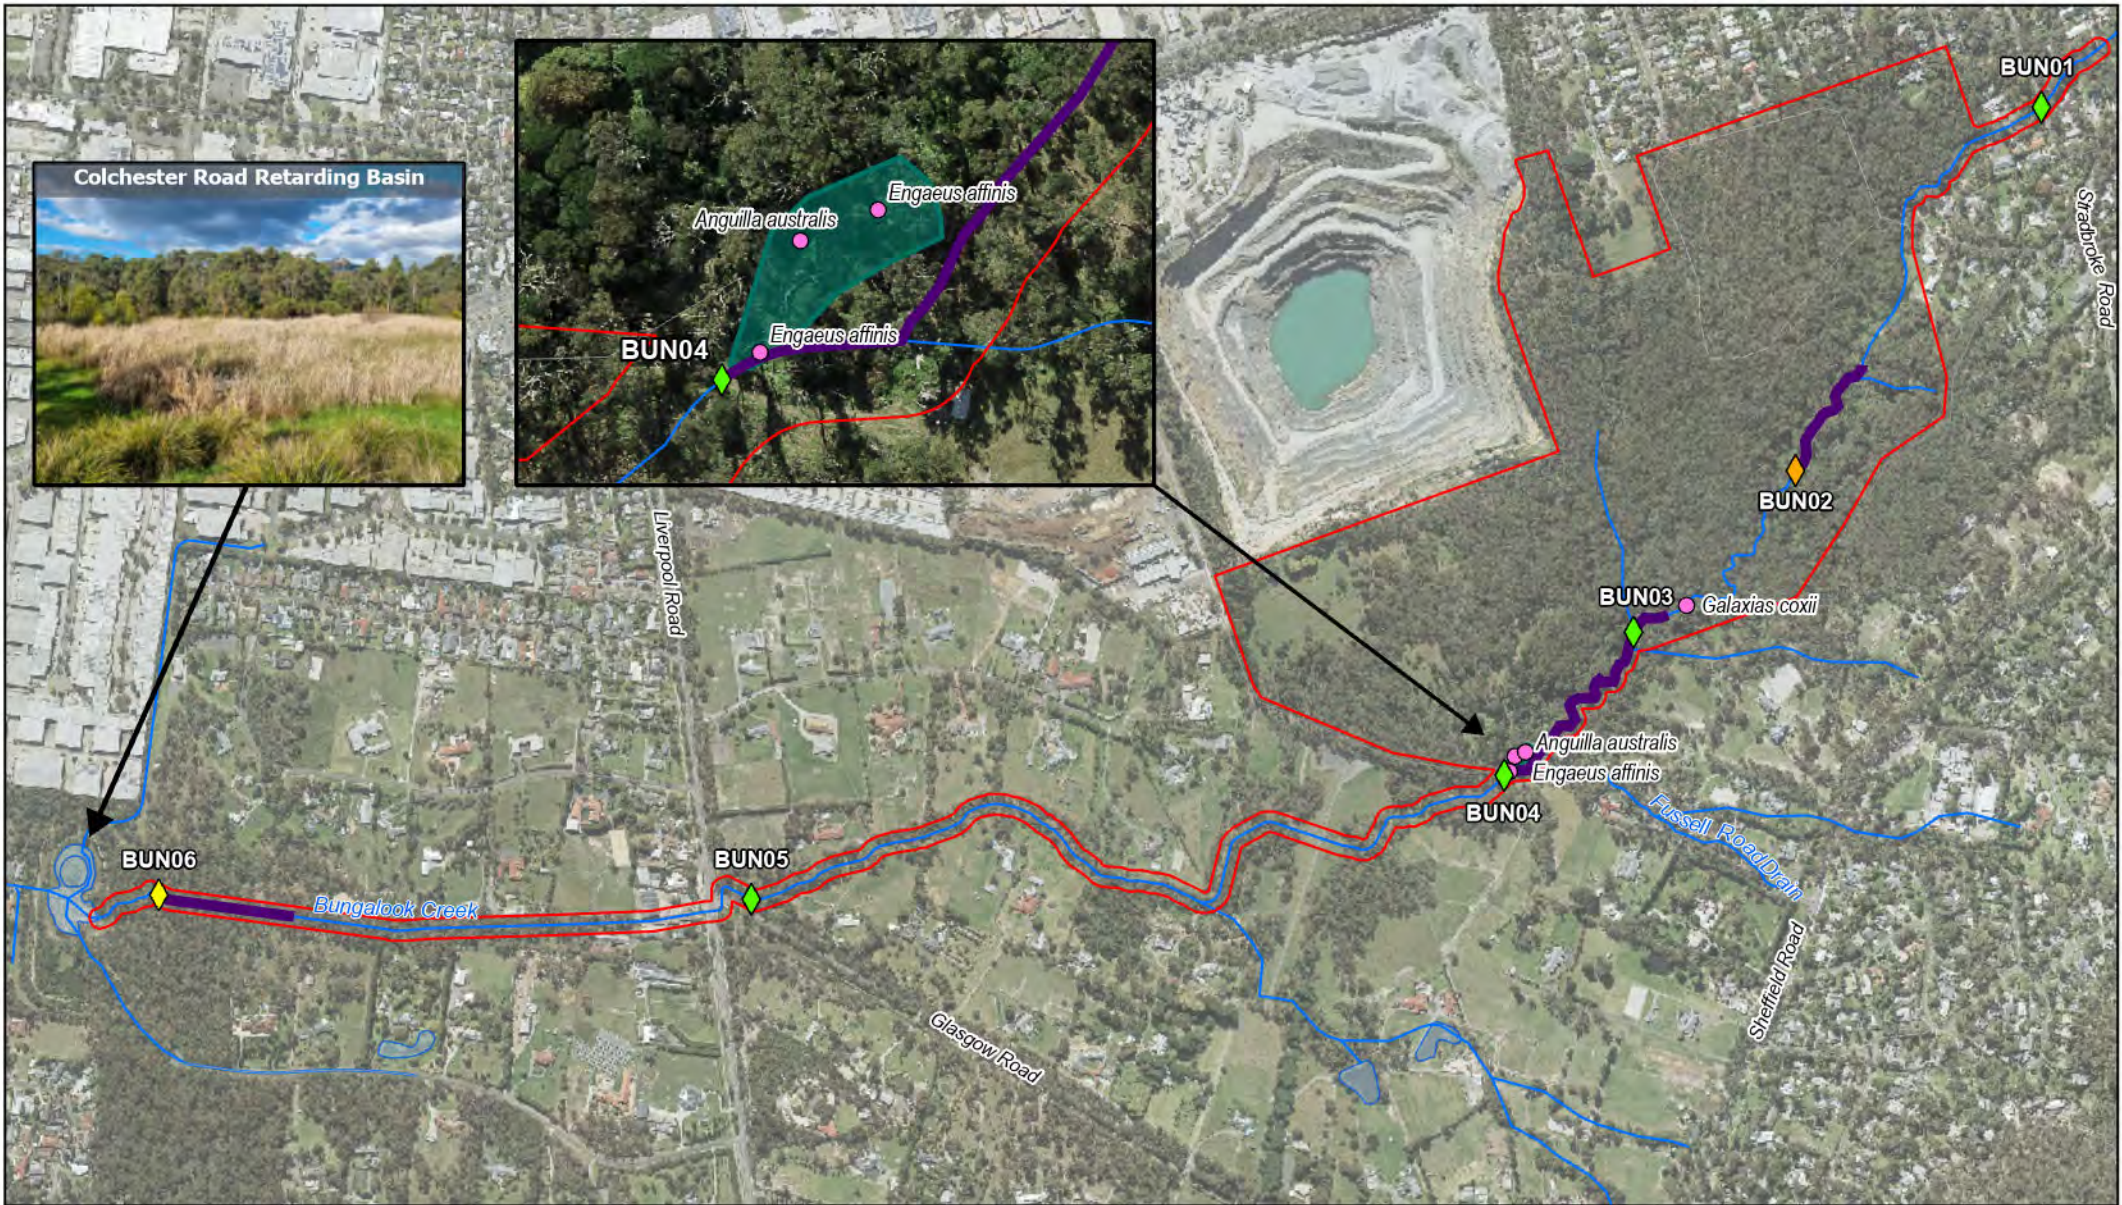
- ▬ Study Site
- ▬ Fish survey
- Recorded species
- ▬ Burrowing crayfish trapping location
- ▬ Waterbody
- ▬ Watercourse

Two fish species were recorded during the fish survey at Site BUN04 (Figure 9).

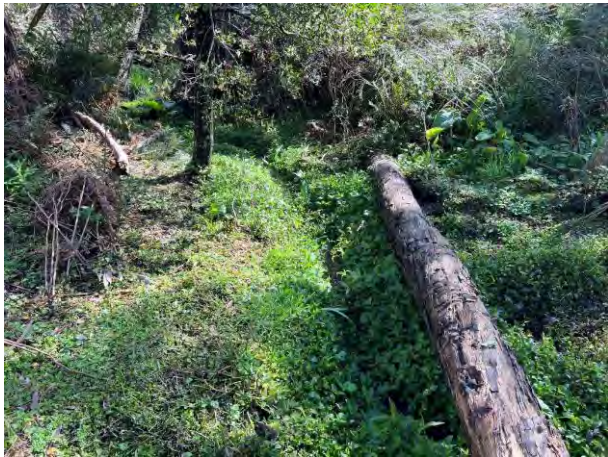
Plate 22 An example of weedy understorey

Some parts of the forest/woodland habitat had a notably weedy understorey (Plate 22), particularly along Bungalook Creek, and there were signs of dieback in some of the trees near Fussell Road (Plate 23) and evidence of disturbance and degradation in some areas (Plate 24 and Plate 25).

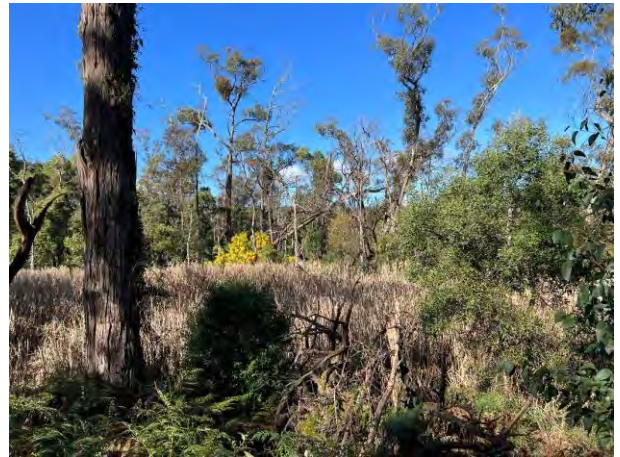
Plate 23 Evidence of dieback in trees

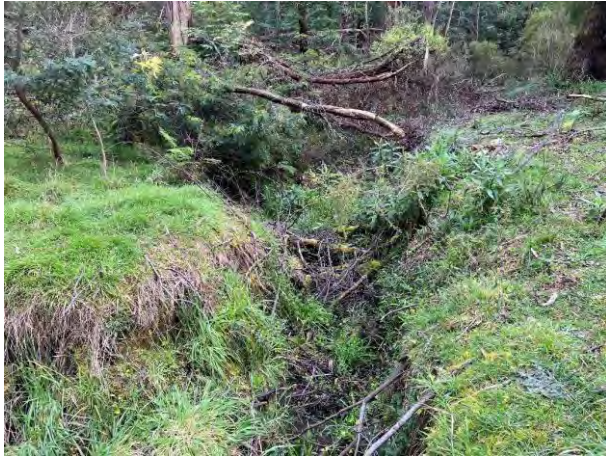
Plate 24 A degraded gully

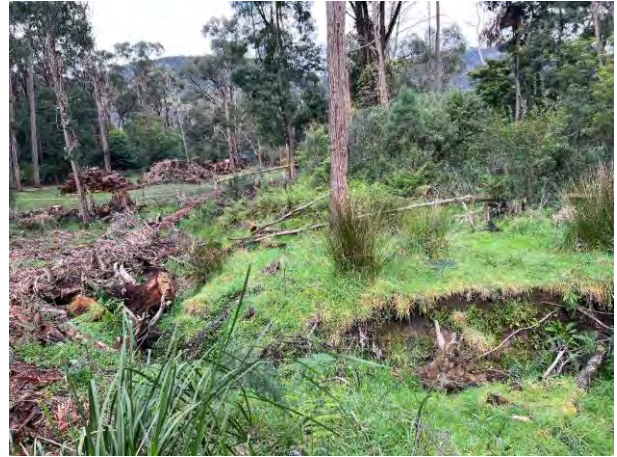
Plate 25 Evidence of forest/woodland disturbance

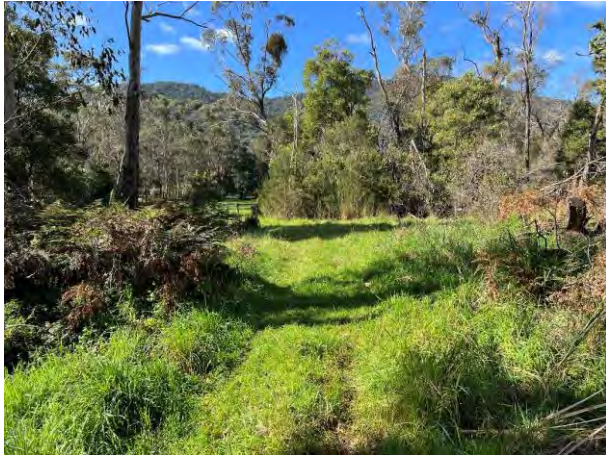
Plate 33 Weedy creekline habitat upstream of Dr Ken Leversha Reserve

Within and alongside the forested areas, there are also small and cleared patches which are now dominated by grassland (Plate 33 and Plate 34). Because these patches are derived and small, they tend to be of low value to the fauna that use the treed habitats that naturally occur in this area. However, because of their proximity to forest and dense understorey, these grassland patches may be used by a small number of threatened species, such as Blue-winged Parrot (*Neophema chrysostoma*), Lace Monitor (*Varanus varius*) and Glossy Grass Skink (*Pseudemoia rawlinsoni*).

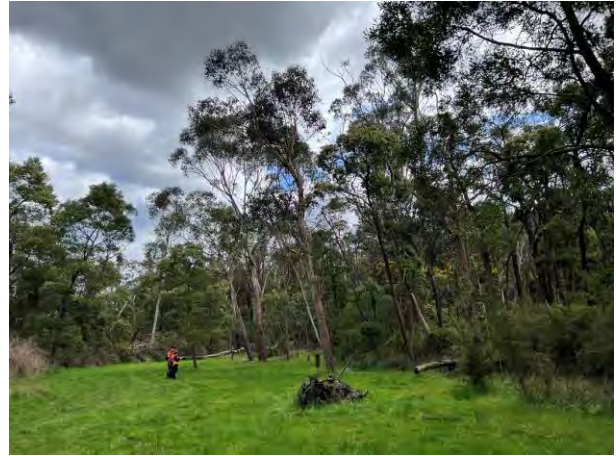
Plate 34 Waterway habitat through the forested section, with more weedy understorey

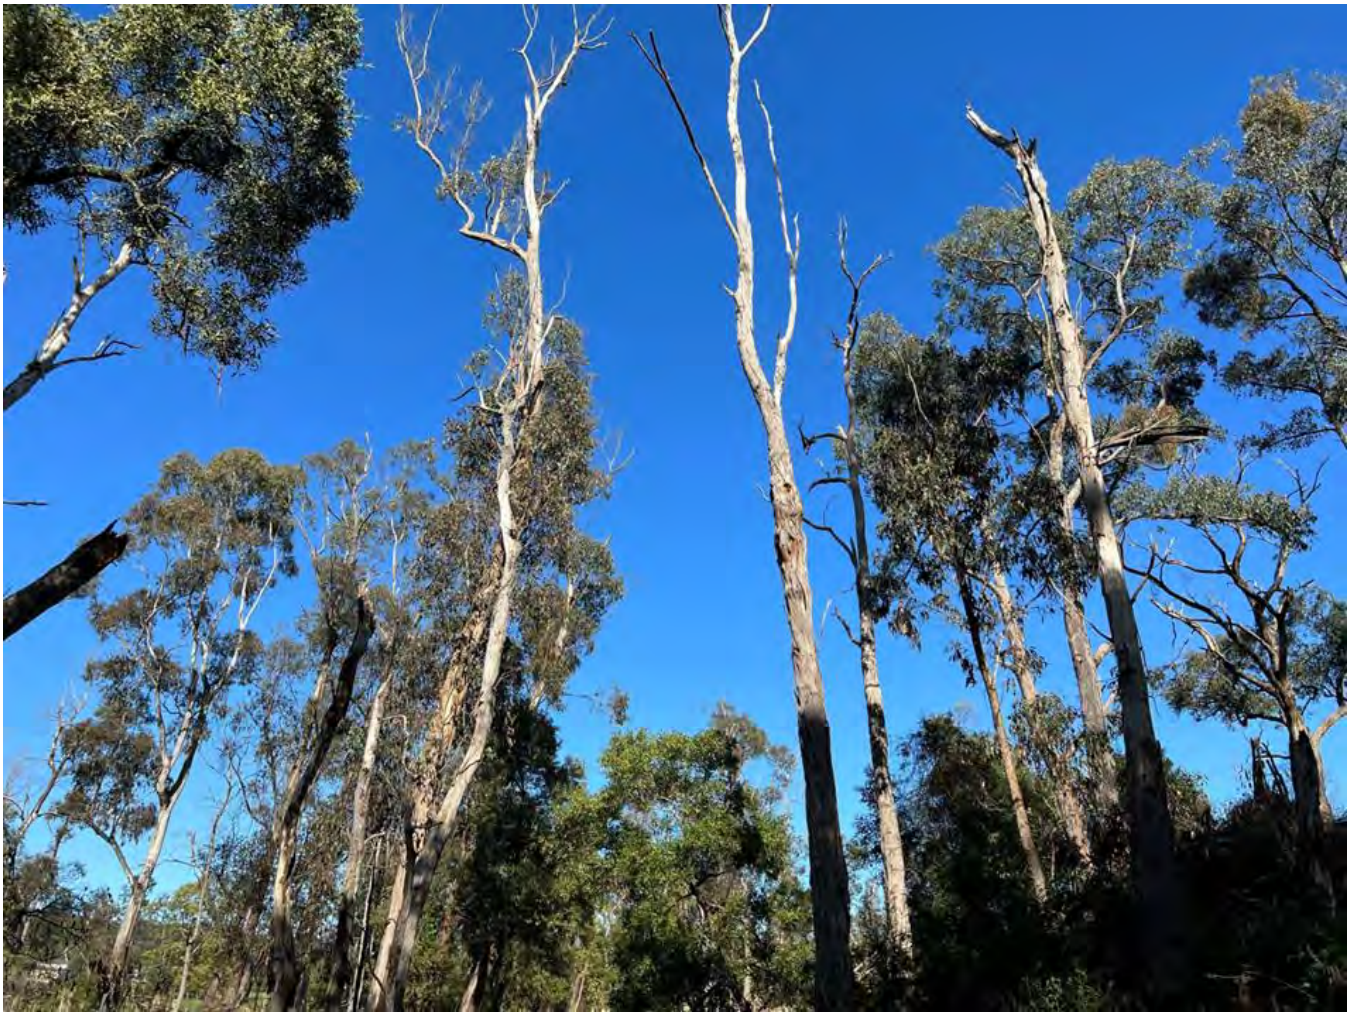
Plate 35 Tree dieback observed along Bungalook Creek near Fussell Road

Tree health transects were established in 2023 to collect data on tree health prior to the upgrade of the quarry. Results are presented in Appendix C. One of the transects was intentionally located within the area where trees had recently died or are showing signs of dieback (T2) to capture current condition before the upgrade of the quarry takes place. Living trees only were included in the baseline monitoring.

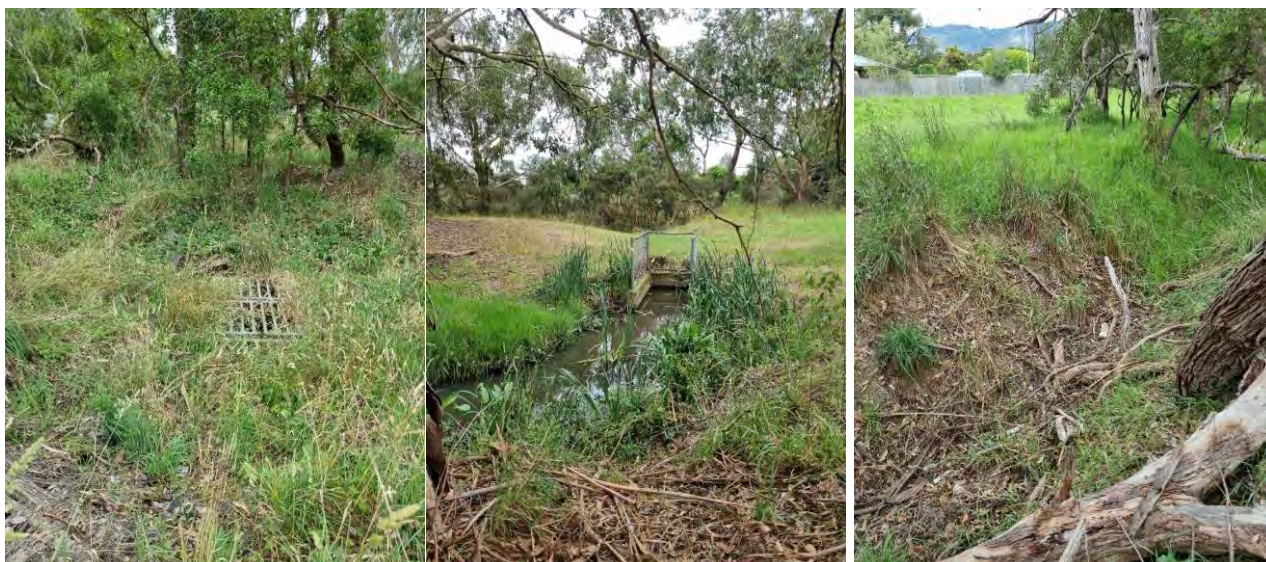
Examples of drains/barriers to passage are provided in Plate 36.

Plate 36 Examples of existing drains (left, centre) and dry reach on Bungalook Creek where flows bypass natural channel and flow underground (right). Located approximately 3 km downstream from project site

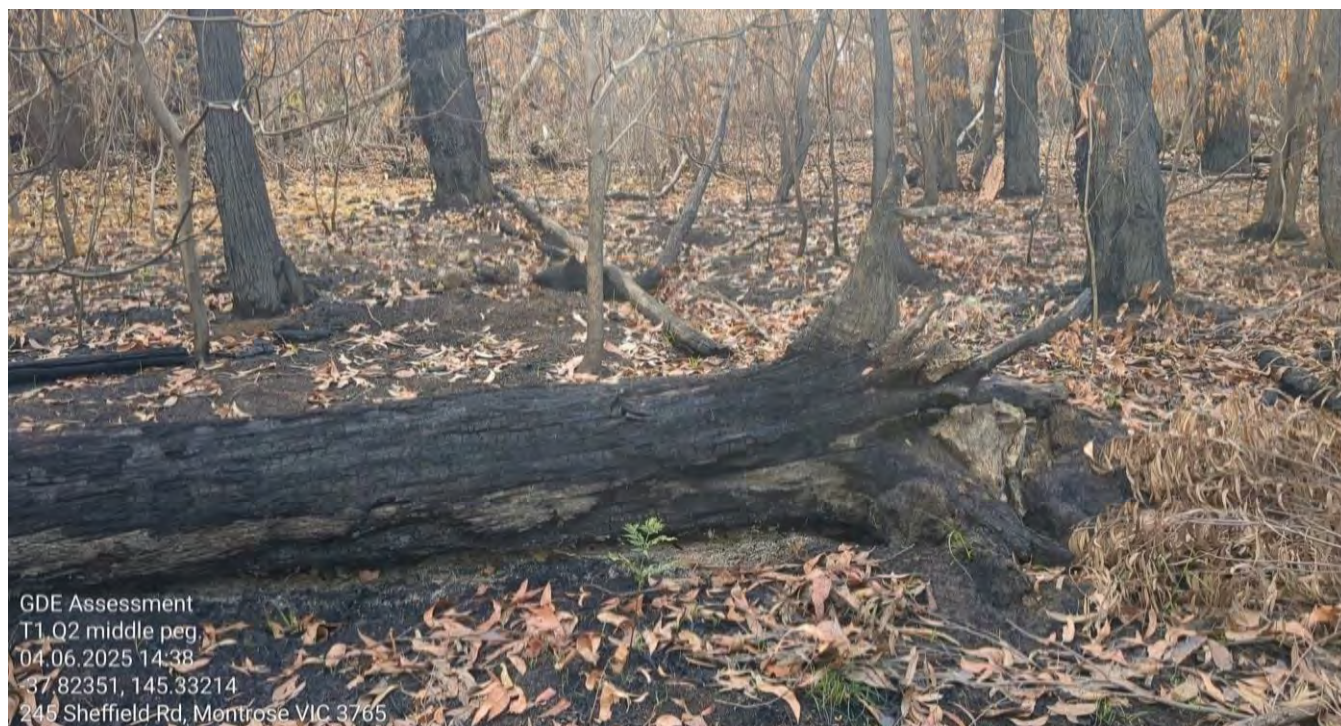
In March 2025, an out-of-control bushfire started in the adjacent Ken Leversha Reserve and quickly encroached the study site. Vegetation within monitoring transects and quadrats was burnt, example photo below and is now in a phase of recovery.

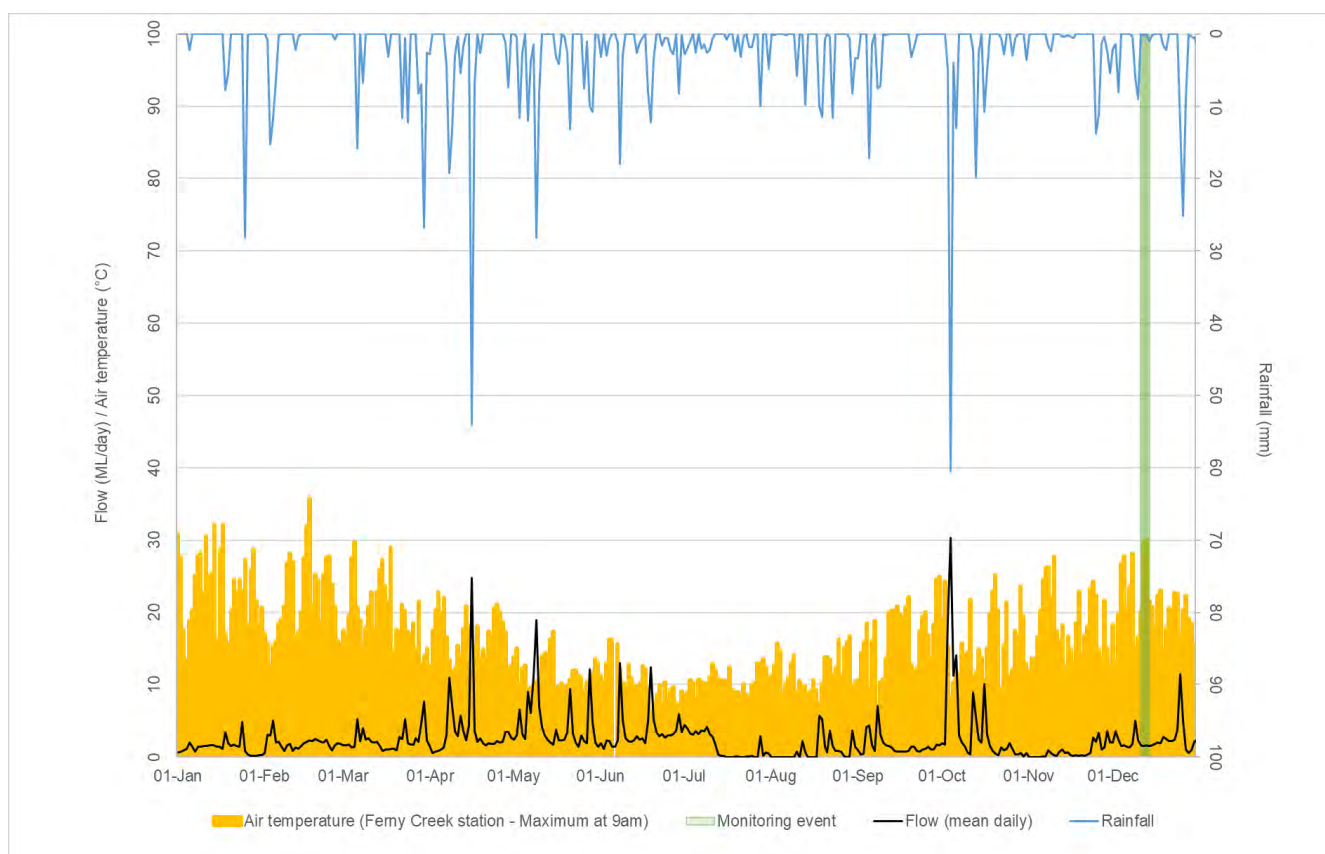
- This indicates that air temperatures during the surveys were high relative to historical records – close to the highest on record for December between 2015 and 2023.

Figure B1 Site hydrology and weather conditions – 2023

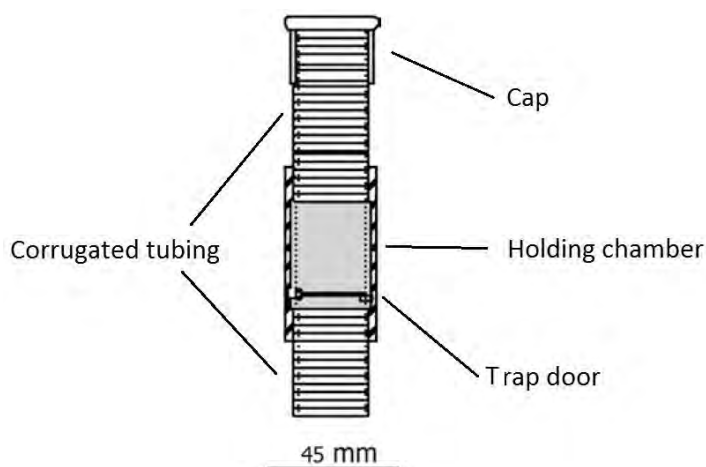
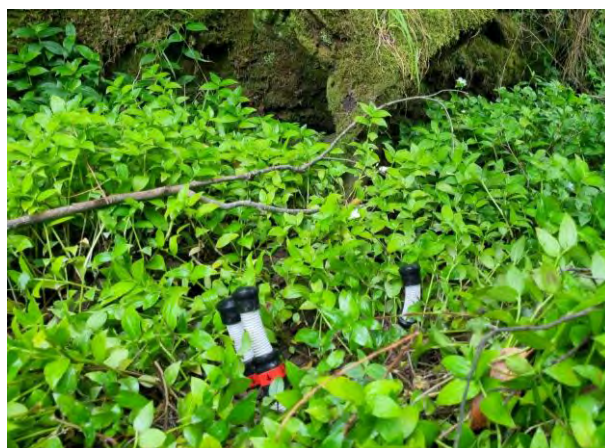
Burrowing Crayfish (*Engaeus* sp.) burrows were observed during the preliminary site assessment. As such, trapping surveys were undertaken in the area where the greatest potential drawdown was predicted by GHD (2023). Over three consecutive nights, 35 Norrocky traps (modified after Bryant et al. 2012 – Figure B2) were deployed and retrieved the following morning. Burrows that showed signs of recent crayfish activity, in the form of fresh ejecta around the mouths of burrows, were prioritised. Captured Crayfish were identified in the field, photographed, and the associated burrow location documented. The captured specimens were returned to their original burrows. Identification was completed using keys provided by Horwitz (1990). Capture rates were calculated by dividing the number of Burrowing Crayfish captured by the number of traps set and expressed as a percentage.

Figure B2 Modified Norrocky trap design and placement adjacent to Bungalook Creek

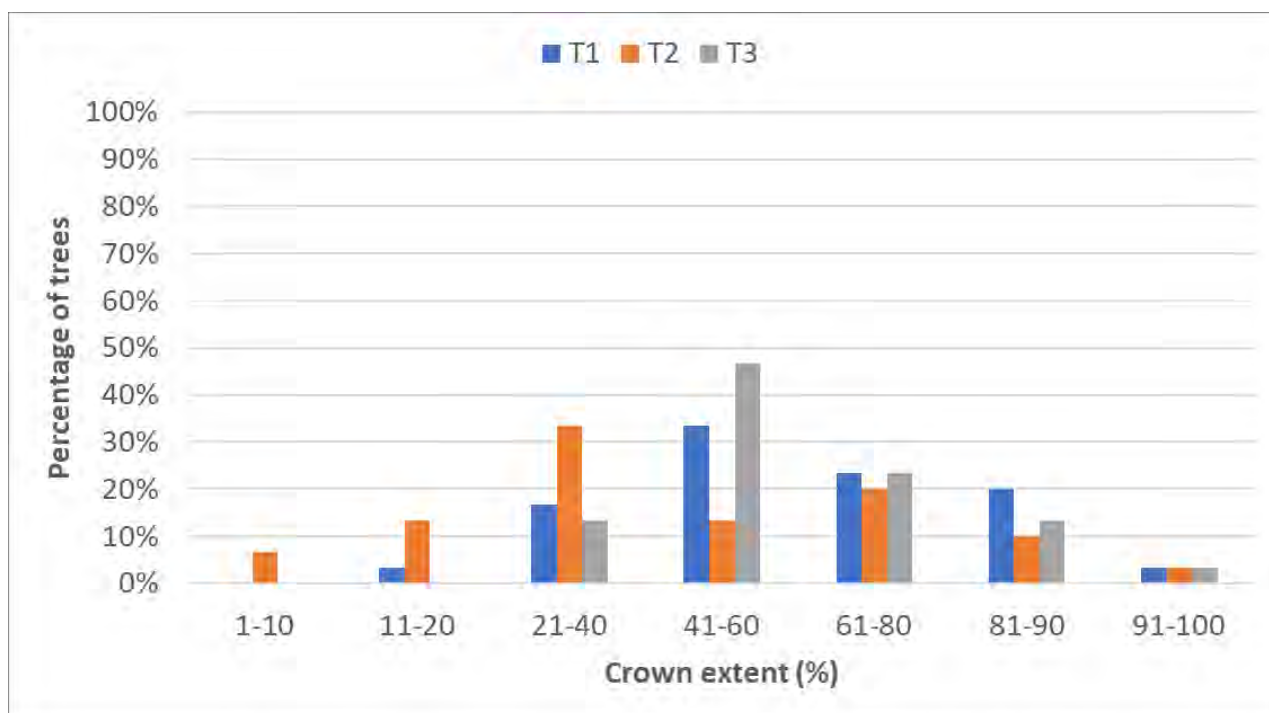
Figure C1 Percentage of trees in each crown extent category at Bungalook Creek by transect
