Groundwater Dependent Ecosystem Assessment for Montrose Quarry

Assessment Report

Boral

19 August 2025

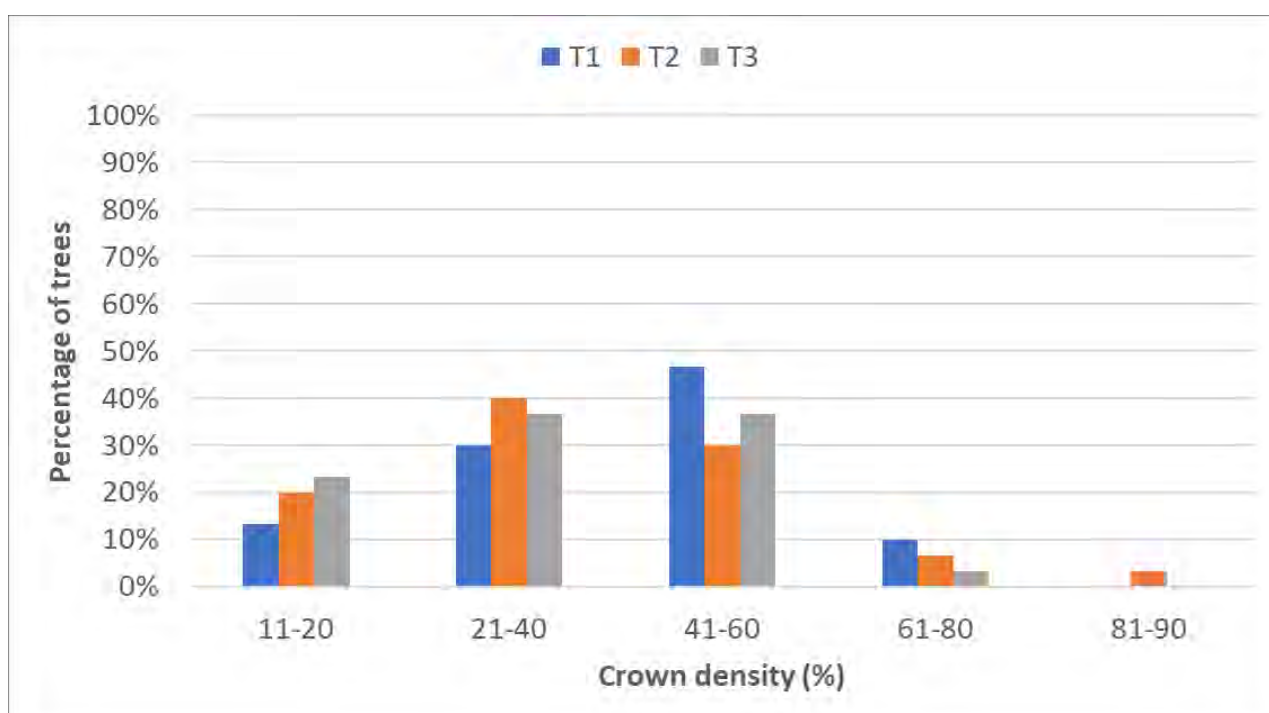
Figure C2 Percentage of trees in each crown density category at Bungalook Creek by transect

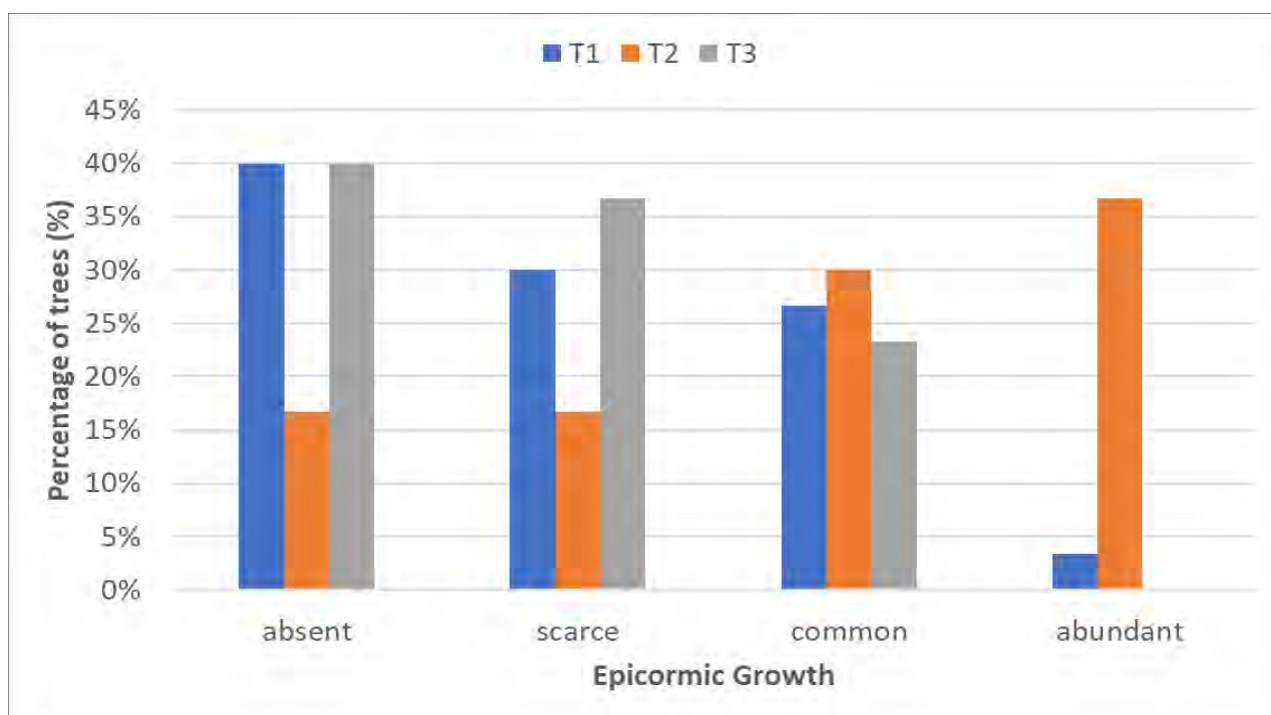
Figure C3 Percentage of trees in each epicormic growth category at Bungalook Creek by transect

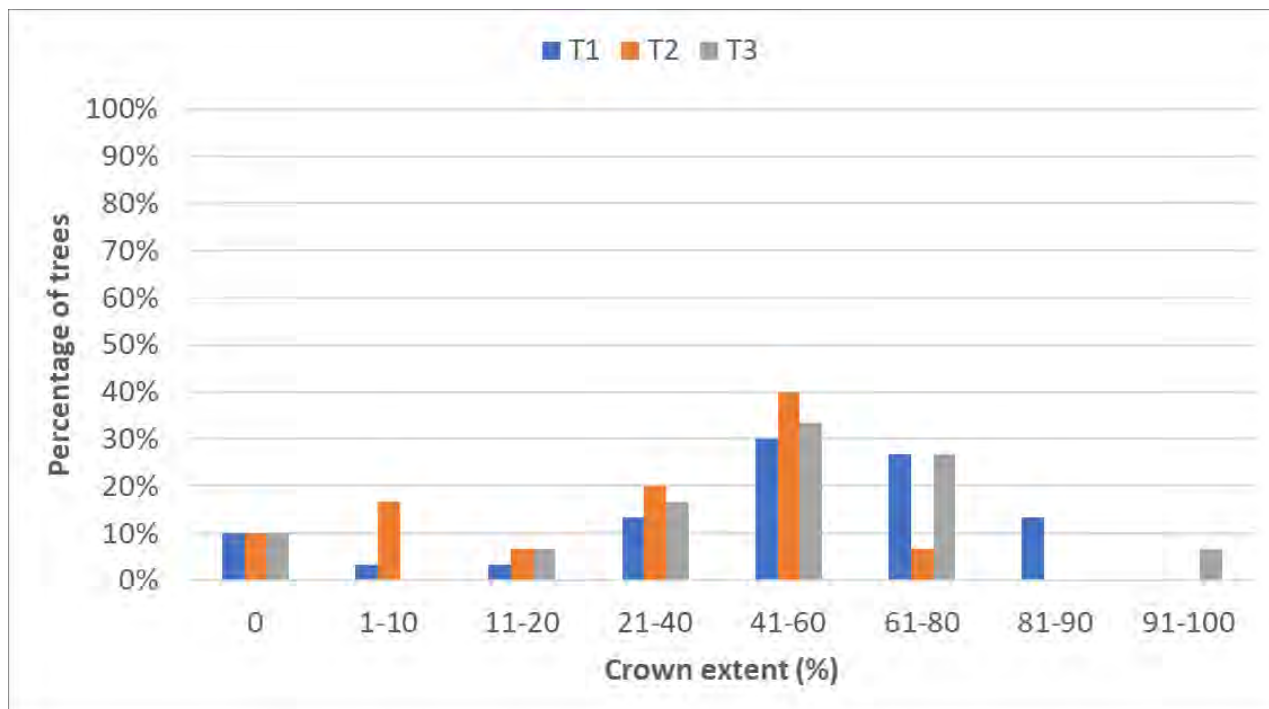
Figure C4 Percentage of trees in each crown extent category at Bungalook Creek by transect in 2025 post bushfire

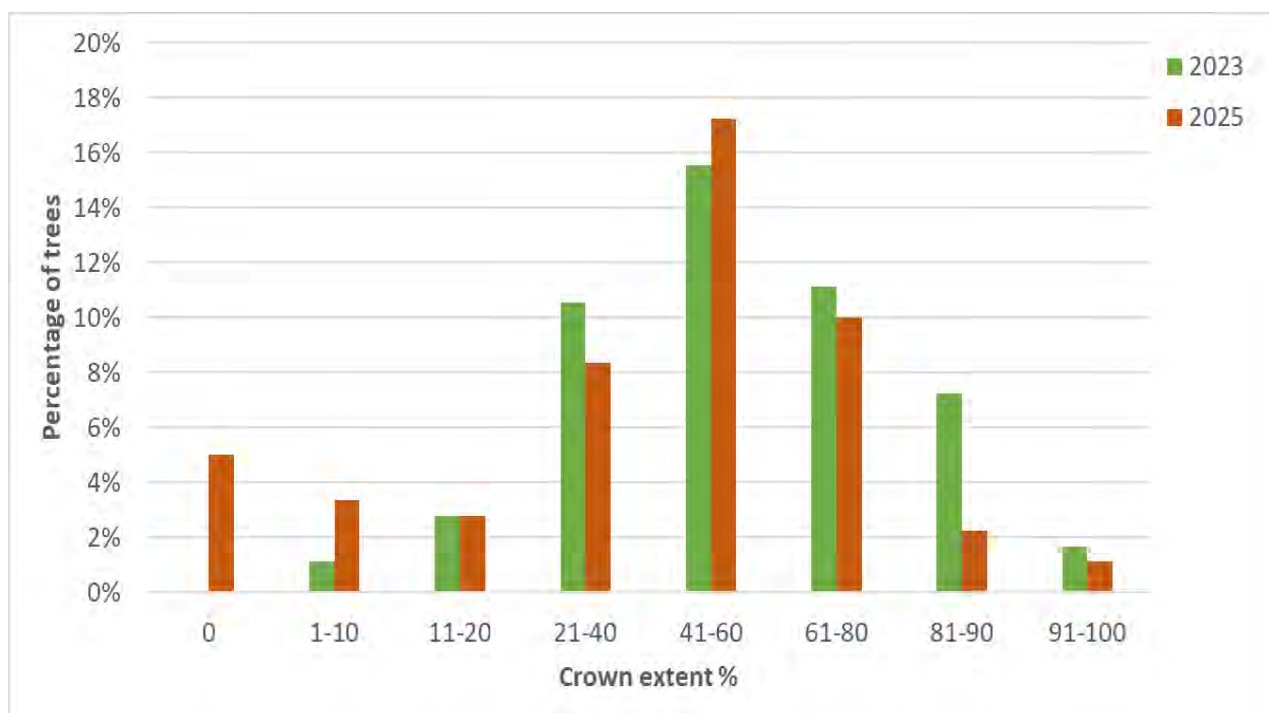
Figure C5 Comparison of percentage of trees in each crown extent category at Bungalook Creek between 2023 (pre bushfire) and 2025 (post bushfire)

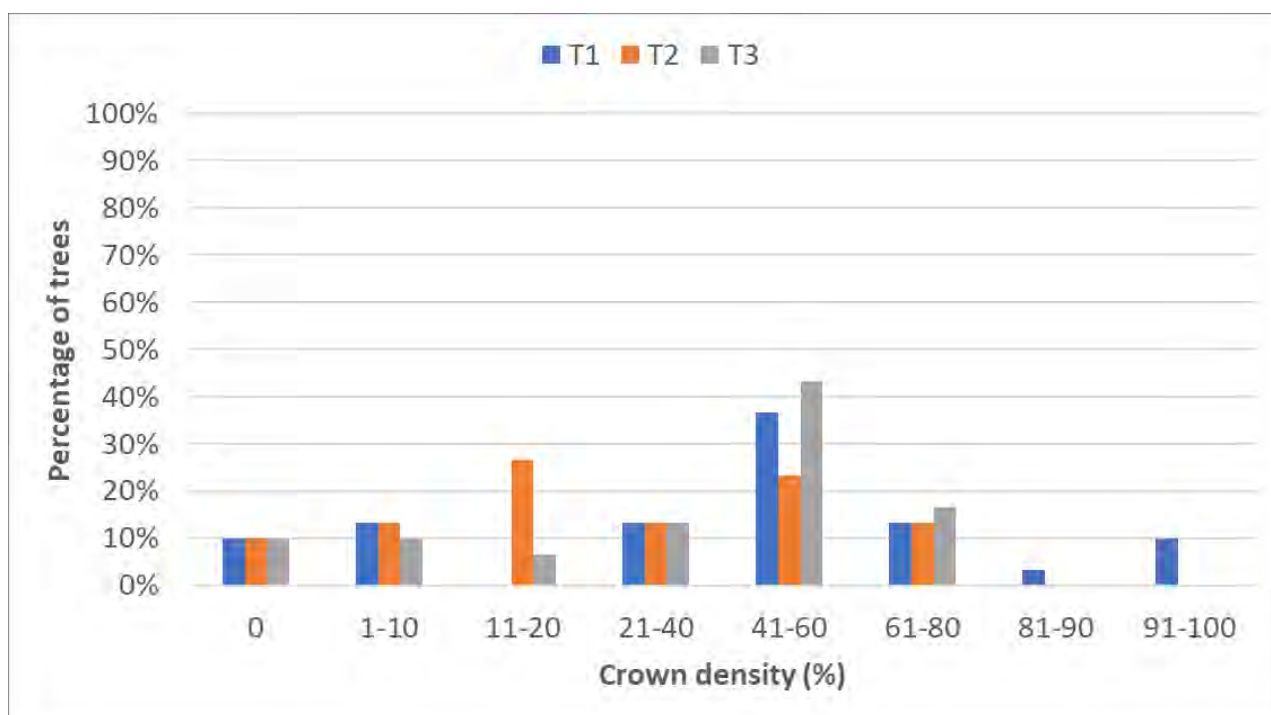
Figure C6 Percentage of trees in each crown density category at Bungalook Creek by transect in 2025 post bushfire

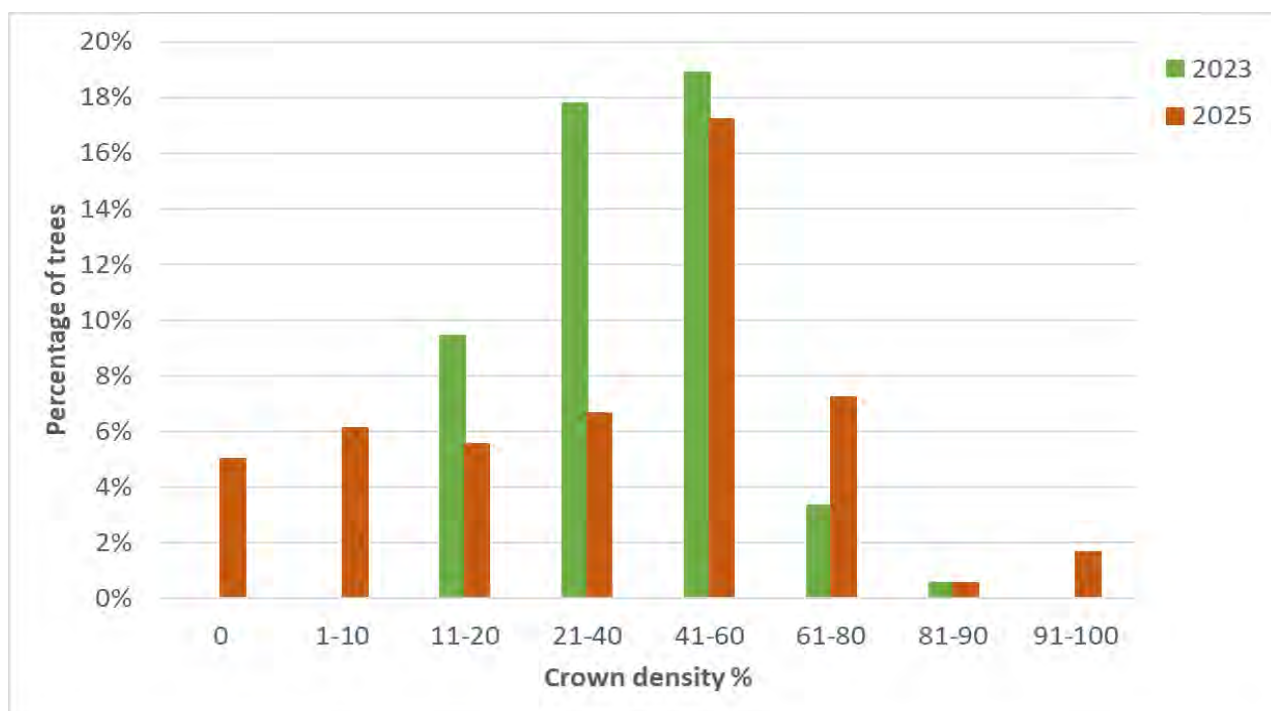
Figure C7 Comparison of percentage of trees in each crown density category at Bungalook Creek between 2023 (pre bushfire) and 2025 (post bushfire)

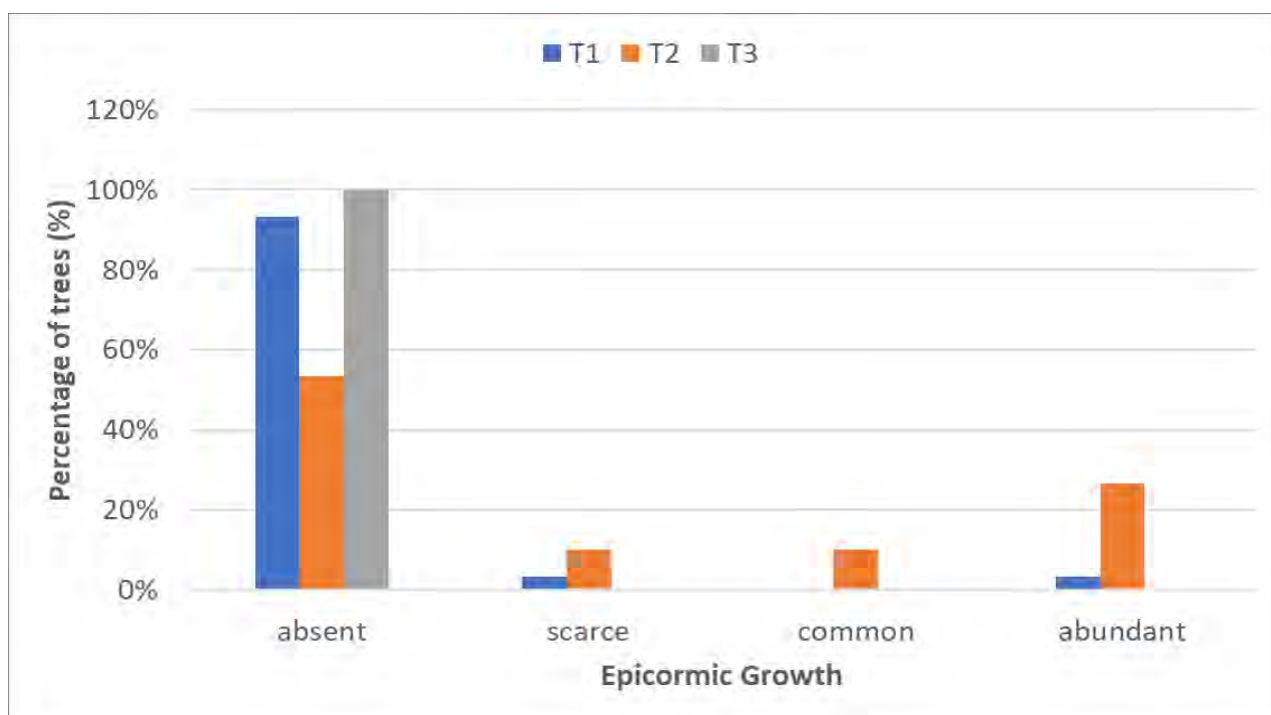
Figure C8 Percentage of trees in each epicormic growth category at Bungalook Creek by transect in 2025 post bushfire

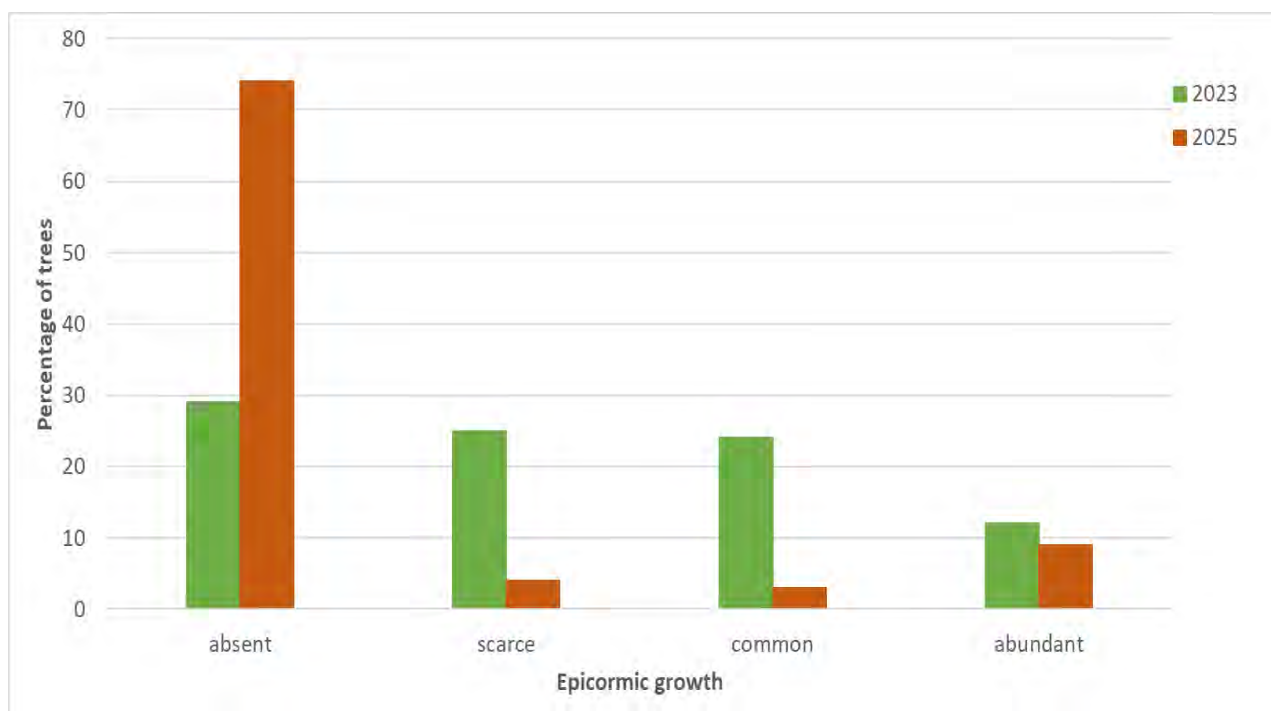
Figure C9 Comparison of percentage of trees in each crown density category at Bungalook Creek in 2023 pre bushfire and 2025 post bushfire

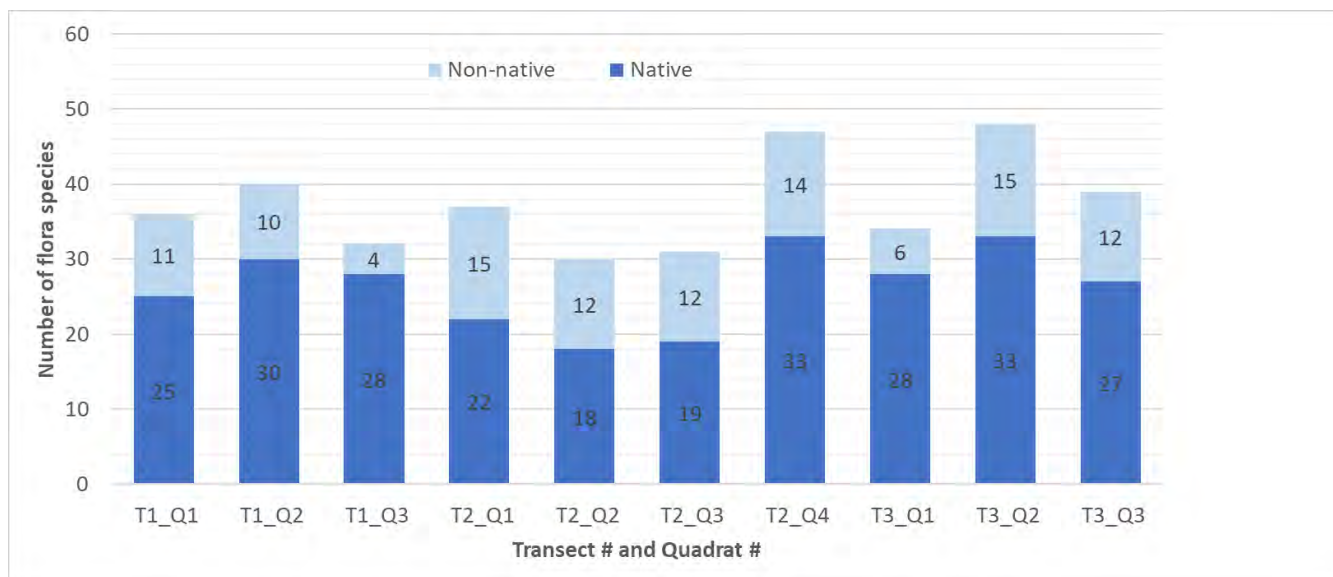
Figure C10 Number of native and non-native flora species recorded in each quadrat 2023
