Appendix 8 – Arborist report

Hygge Property – Preliminary Arboricultural Tree Assessment Report

Location: Wombat Park, 4719 Midland Hwy, Daylesford
Client: Hygge Property
Date: 18 February 2022

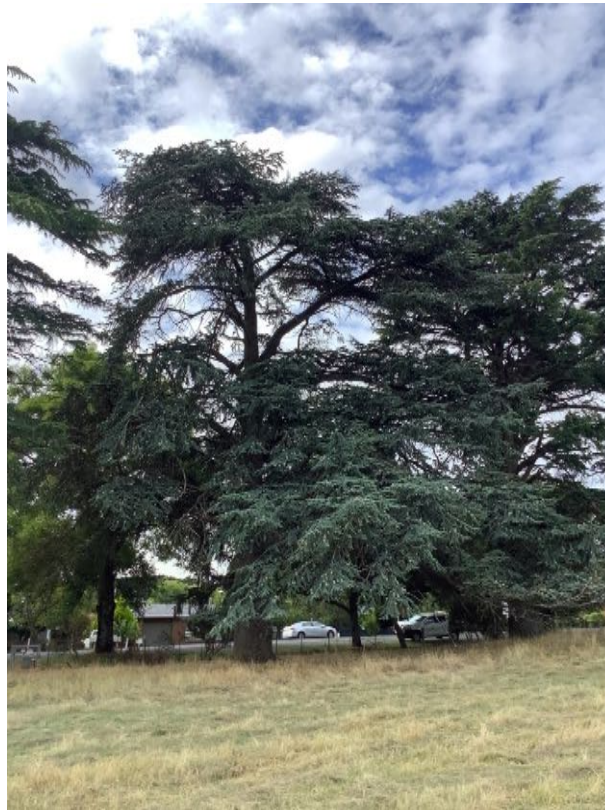
Tree ID: 16
Botanical Name: *Cedrus deodara*
Common Name: Himalayan Cedar
Easting: 144.156768
Northing: -37.340122
Datum: GDA1994 MGA Zone 55

Health: Good
Structure: Good
Comment: Multiple hangers and deadwood throughout canopy

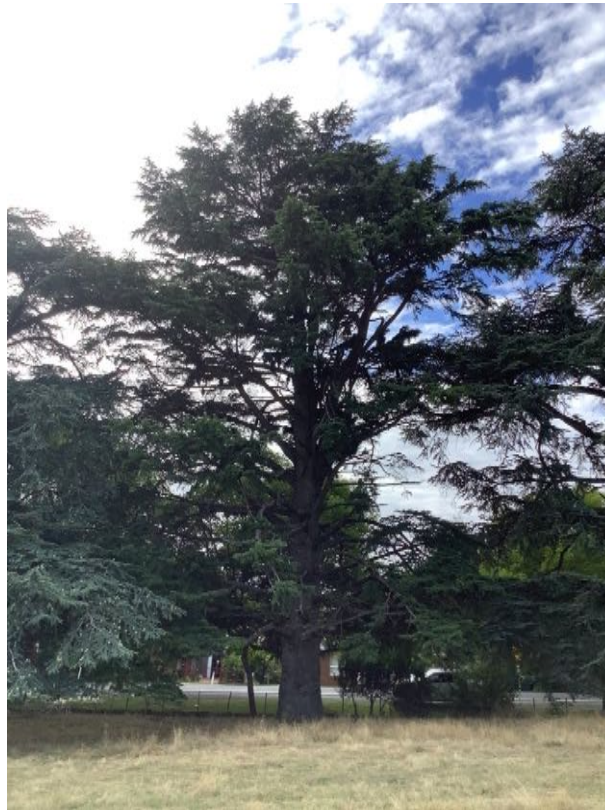
Tree ID: 17
Botanical Name: *Cedrus atlantica*
Common Name: Atlas Cedar
Easting: 144.156637
Northing: -37.340197
Datum: GDA1994 MGA Zone 55

Health: Good
Structure: Good
Comment: Multiple hangers and deadwood throughout canopy

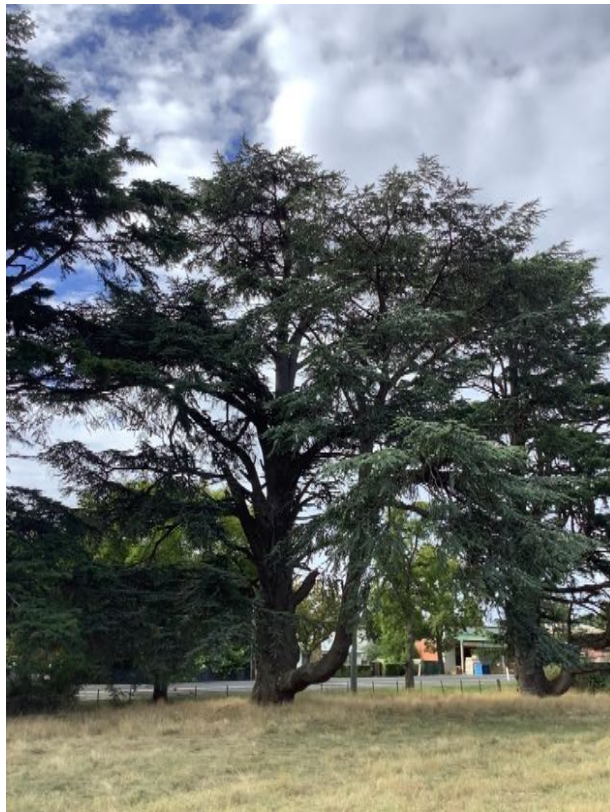
Tree ID: 18
Botanical Name: *Cedrus deodara*
Common Name: Himalayan Cedar
Easting: 144.156533
Northing: -37.340270
Datum: GDA1994 MGA Zone 55

Health: Good
Structure: Good
Comment: Multiple hangers and deadwood throughout canopy

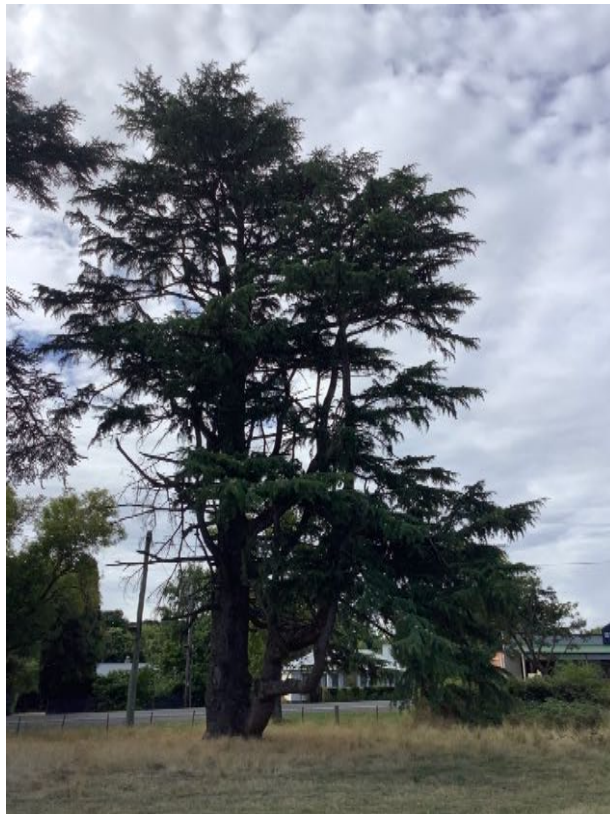
Tree ID: 19
Botanical Name: *Cedrus deodara*
Common Name: Himalayan Cedar
Easting: 144.156287
Northing: -37.340420
Datum: GDA1994 MGA Zone 55

Health: Good
Structure: Good
Comment: Multiple hangers and deadwood throughout canopy

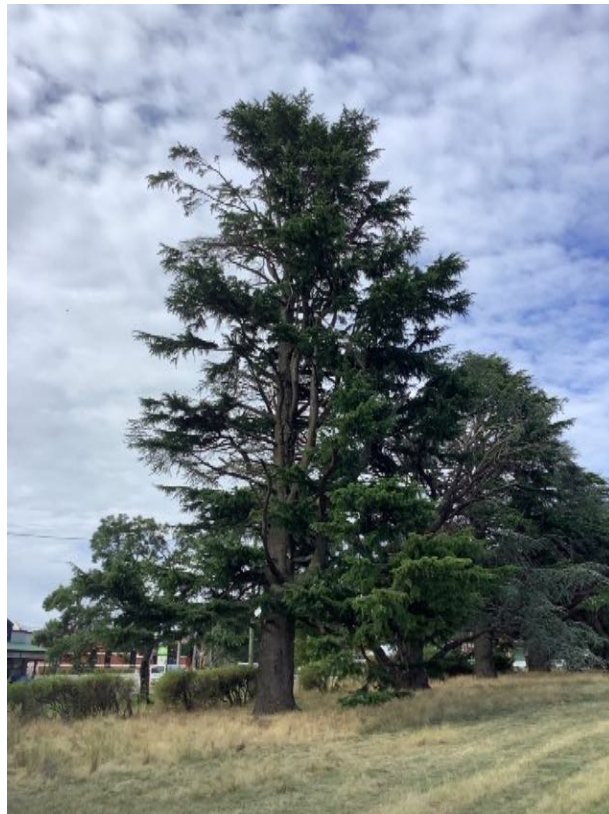
Tree ID: 20
Botanical Name: *Cedrus atlantica*
Common Name: Atlas Cedar
Easting: 144.156160
Northing: -37.340492
Datum: GDA1994 MGA Zone 55

Health: Good
Structure: Good
Comment: Multiple hangers and deadwood throughout canopy

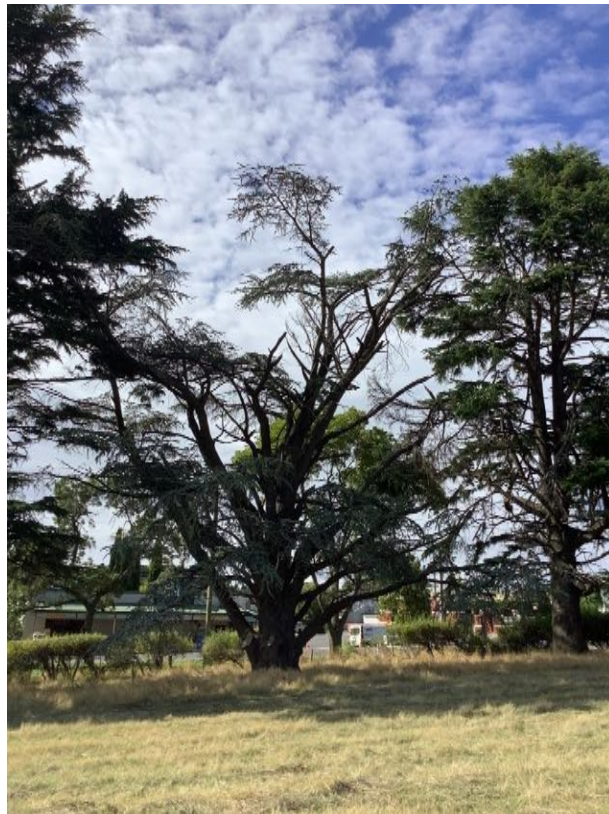
Tree ID: 21
Botanical Name: *Cedrus deodara*
Common Name: Himalayan Cedar
Easting: 144.156038
Northing: -37.340570
Datum: GDA1994 MGA Zone 55

Health: Fair
Structure: Fair
Comment: Multiple hangers and large dead branches throughout canopy

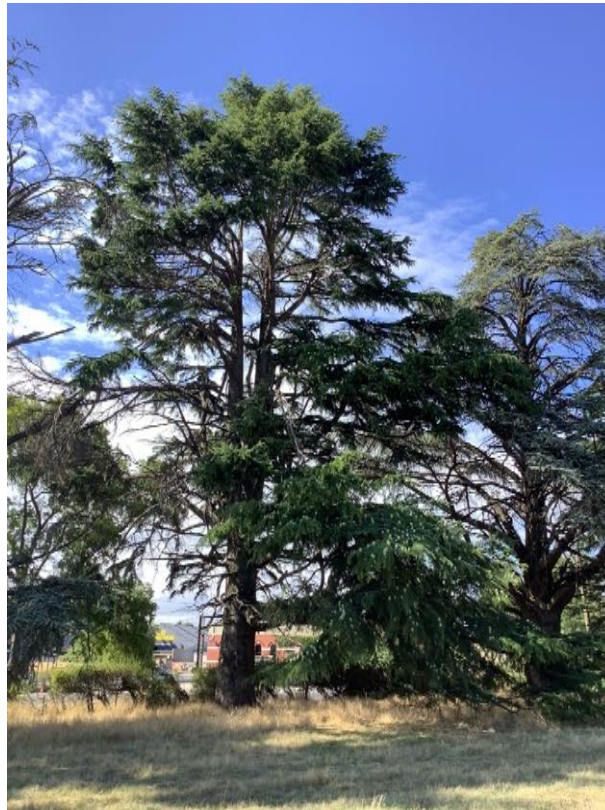
Tree ID: 22
Botanical Name: *Cedrus atlantica*
Common Name: Atlas Cedar
Easting: 144.155907
Northing: -37.340637
Datum: GDA1994 MGA Zone 55

Health: Good
Structure: Good
Comment: Multiple hangers and deadwood throughout canopy

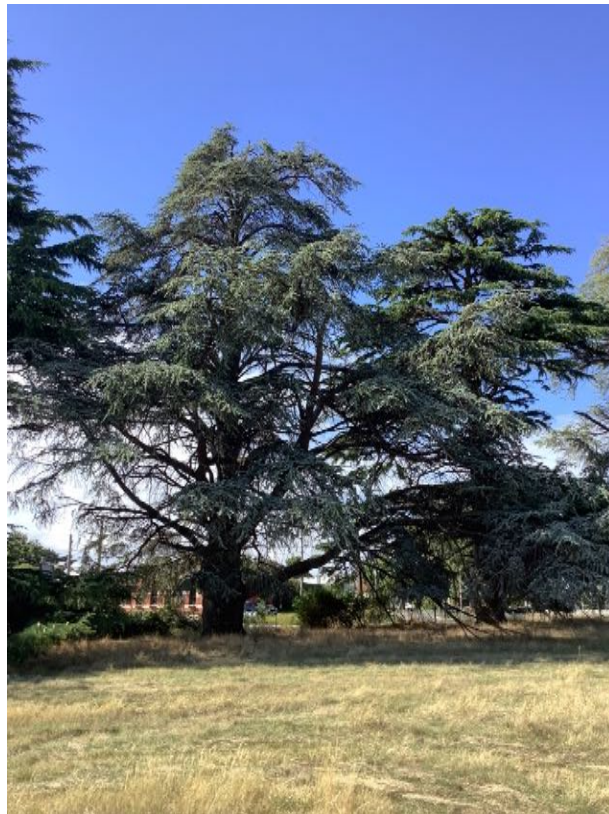
Tree ID: 23
Botanical Name: *Cedrus deodara*
Common Name: Himalayan Cedar
Easting: 144.155789
Northing: -37.340715
Datum: GDA1994 MGA Zone 55

Health: Good
Structure: Fair
Comment: Multiple hangers and large dead branches throughout canopy

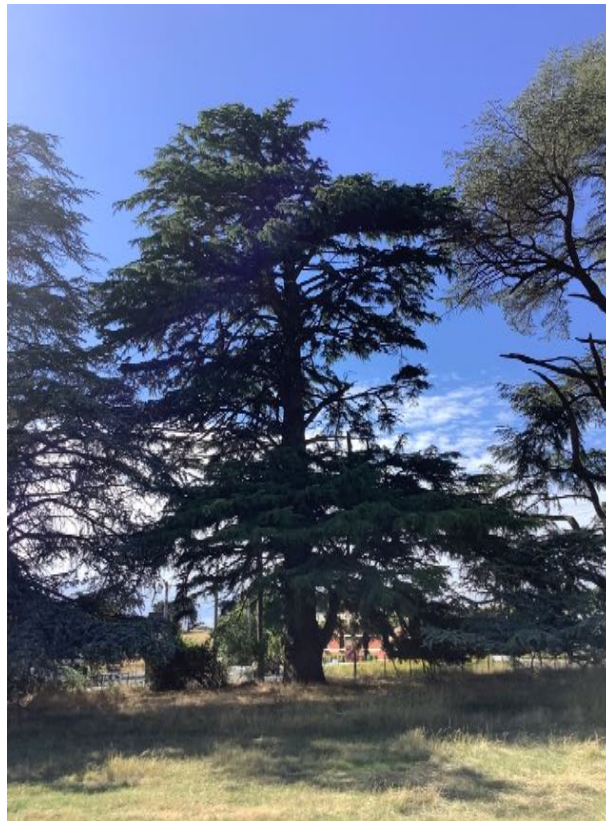
Tree ID: 24
Botanical Name: *Cedrus atlantica*
Common Name: Atlas Cedar
Easting: 144.155672
Northing: -37.340796
Datum: GDA1994 MGA Zone 55

Health: Good
Structure: Good
Comment: Multiple hangers and deadwood throughout canopy

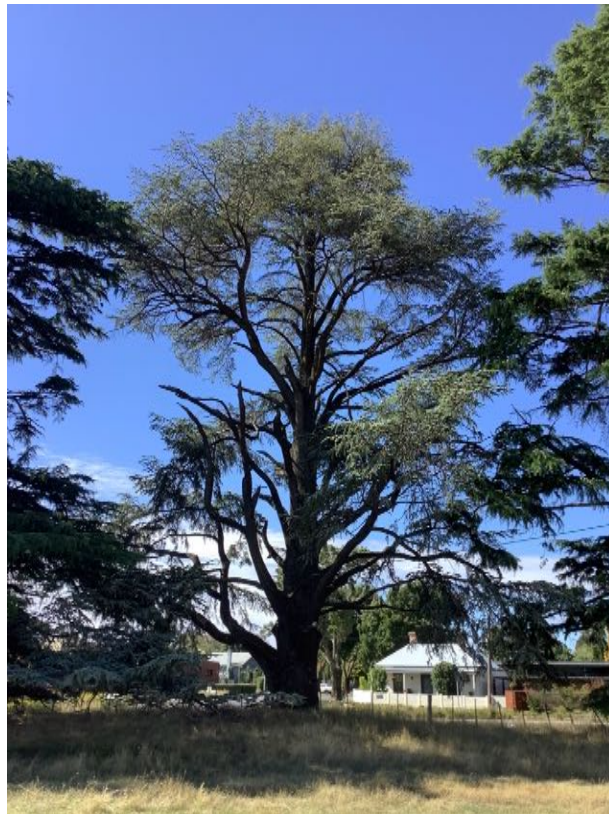
Tree ID: 25
Botanical Name: *Cedrus deodara*
Common Name: Himalayan Cedar
Easting: 144.155536
Northing: -37.340778
Datum: GDA1994 MGA Zone 55

Health: Good
Structure: Fair
Comment: Multiple hangers and large dead branches throughout canopy

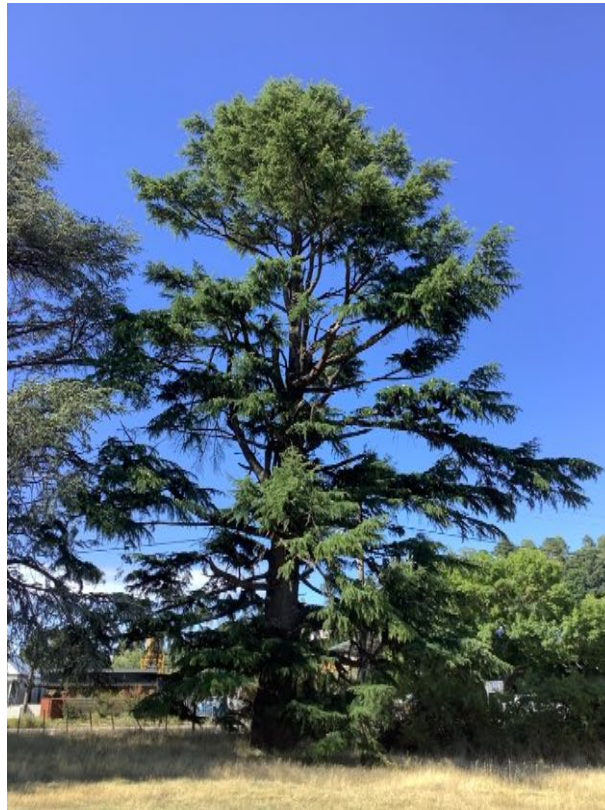
Tree ID: 26
Botanical Name: *Cedrus atlantica*
Common Name: Atlas Cedar
Easting: 144.155073
Northing: -37.340728
Datum: GDA1994 MGA Zone 55

Health: Good
Structure: Good
Comment: Multiple hangers and deadwood throughout canopy

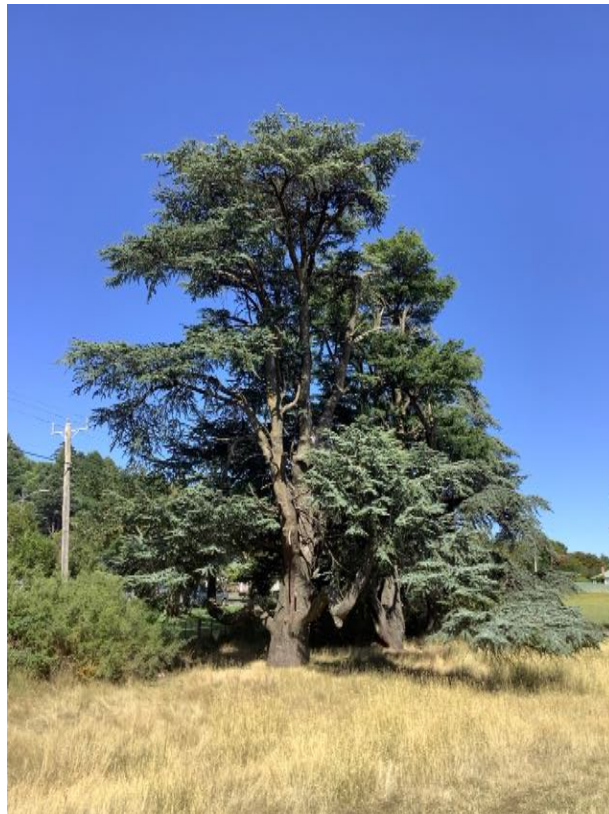
Tree ID: 27
Botanical Name: *Cedrus deodara*
Common Name: Himalayan Cedar
Easting: 144.154947
Northing: -37.340705
Datum: GDA1994 MGA Zone 55

Health: Good
Structure: Good
Comment: Multiple hangers and deadwood throughout canopy

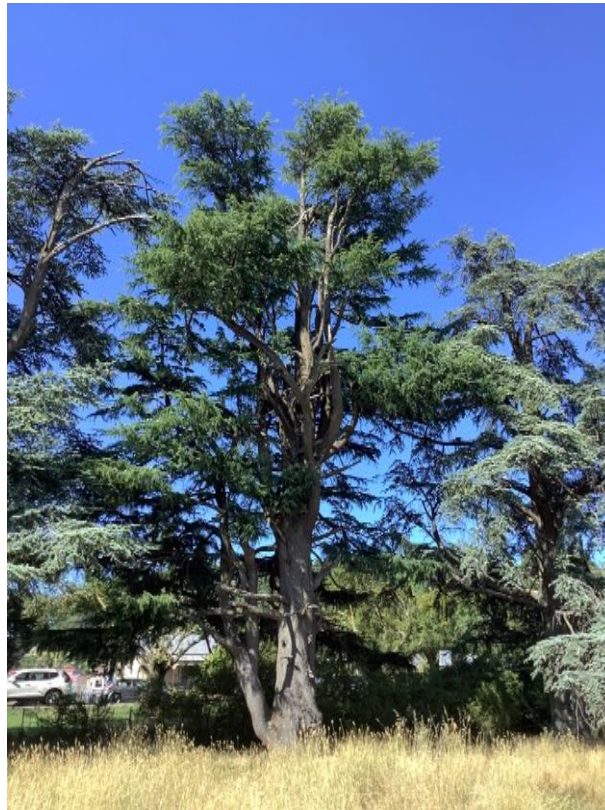
Tree ID: 28
Botanical Name: *Cedrus atlantica*
Common Name: Atlas Cedar
Easting: 144.154822
Northing: -37.340698
Datum: GDA1994 MGA Zone 55

Health: Good
Structure: Good
Comment: Multiple hangers and deadwood throughout canopy

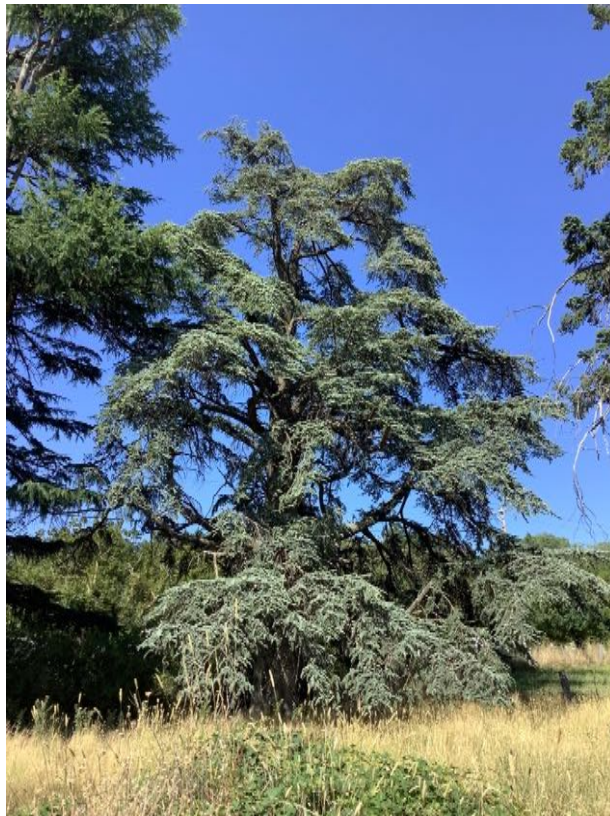
Tree ID: 29
Botanical Name: *Pseudotsuga menziesii*
Common Name: Douglas Fir
Easting: 144.154825
Northing: -37.340561
Datum: GDA1994 MGA Zone 55

Health: Good
Structure: Good
Comment: Multiple hangers and deadwood throughout canopy

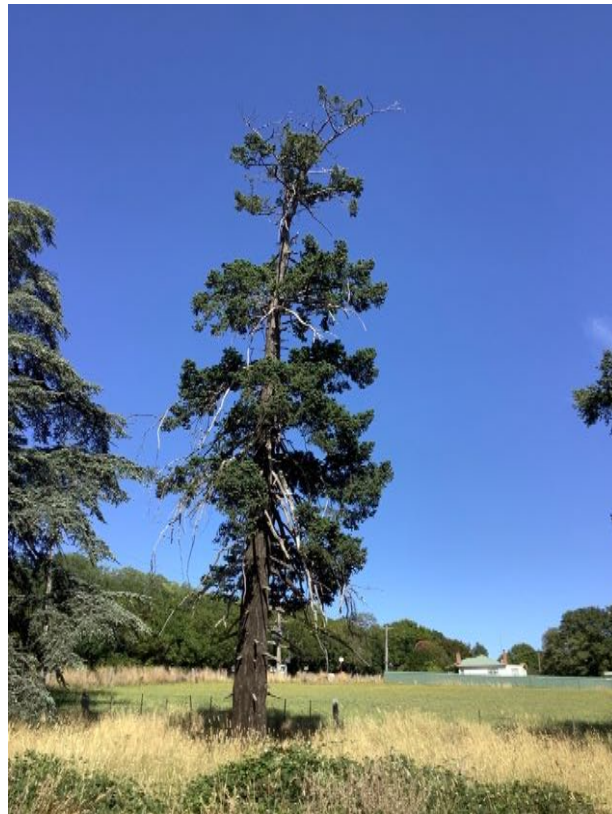
Tree ID: 30
Botanical Name: *Pseudotsuga menziesii*
Common Name: Douglas Fir
Easting: 144.154867
Northing: -37.340420
Datum: GDA1994 MGA Zone 55

Health: Poor
Comment: Deadwood throughout canopy

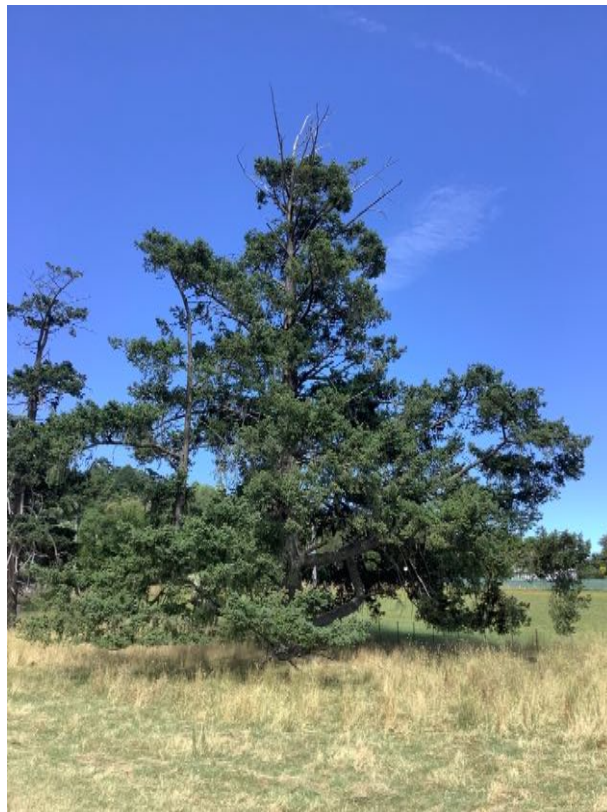
Tree ID: 31
Botanical Name: *Pseudotsuga menziesii*
Common Name: Douglas Fir
Easting: 144.155092
Northing: -37.339213
Datum: GDA1994 MGA Zone 55

Health: Fair
Structure: Good
Comment: Psyllid infestation and deadwood throughout canopy

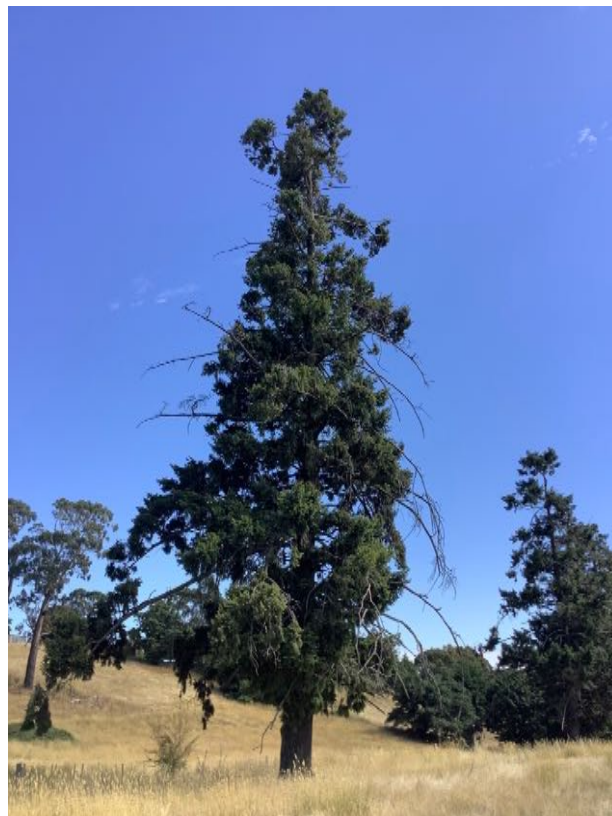
Tree ID: 32
Botanical Name: *Pseudotsuga menziesii*
Common Name: Douglas Fir
Easting: 144.155069
Northing: -37.339353
Datum: GDA1994 MGA Zone 55

Health: Fair
Comment: Deadwood throughout canopy

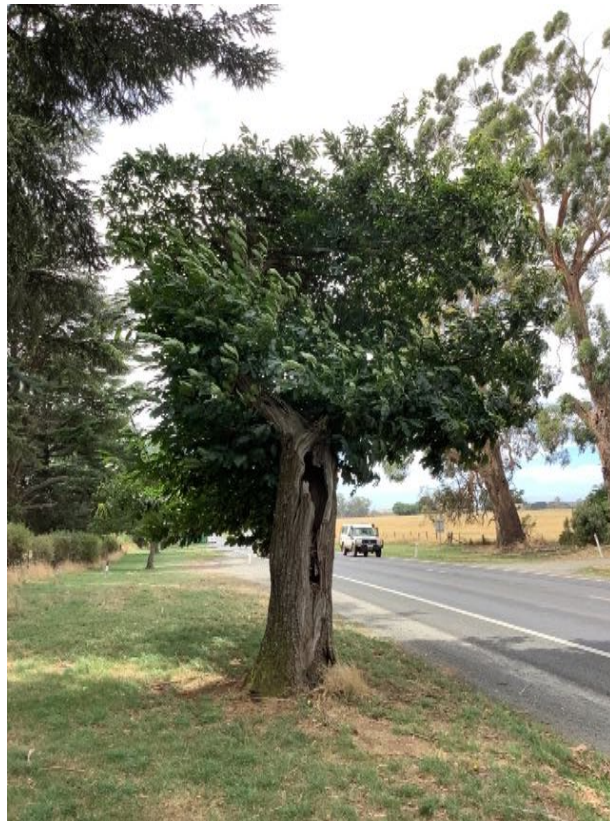
Tree ID: 36
Botanical Name: *Castanea sativa*
Common Name: Sweet Chestnut
Easting: 144.157844
Northing: -37.339635
Datum: GDA1994 MGA Zone 55

Comment: Hollow stem. Minimal crown sail effect. Appears structurally sound currently.

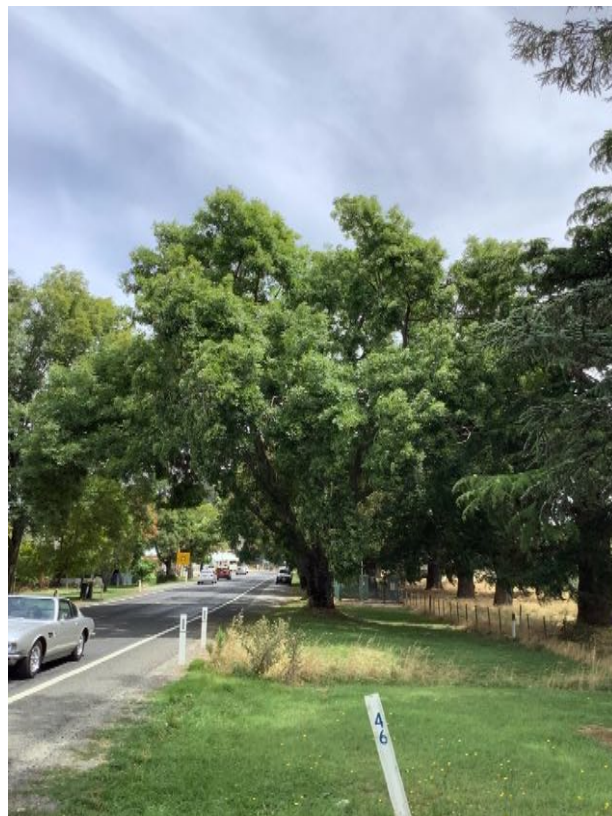
Health: Good
Comment: No major defects visible

Structure: Good

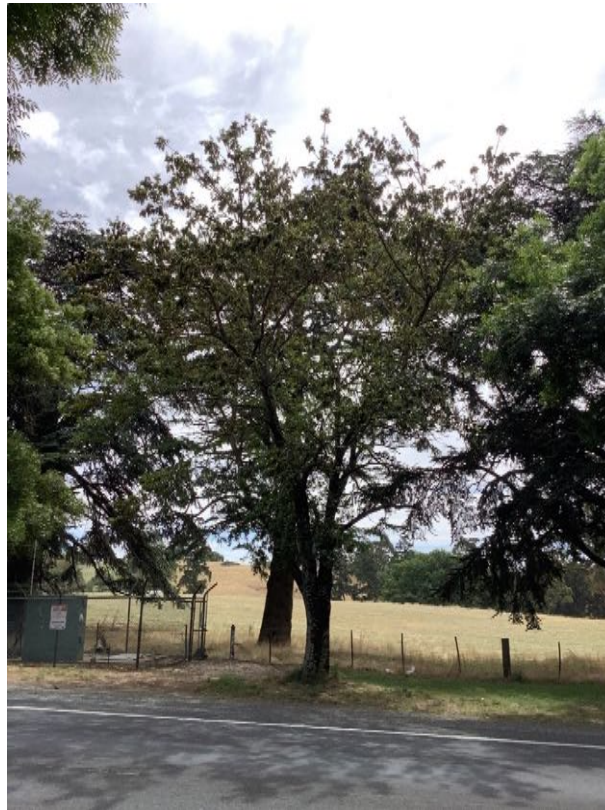
Tree ID: 39
Botanical Name: *Fraxinus angustifolia* subsp. *angustifolia*
Common Name: Narrow-leaved Ash
Easting: 144.157155
Northing: -37.340049
Datum: GDA1994 MGA Zone 55

Health: Fair
Comment: No major defects visible

Structure: Good

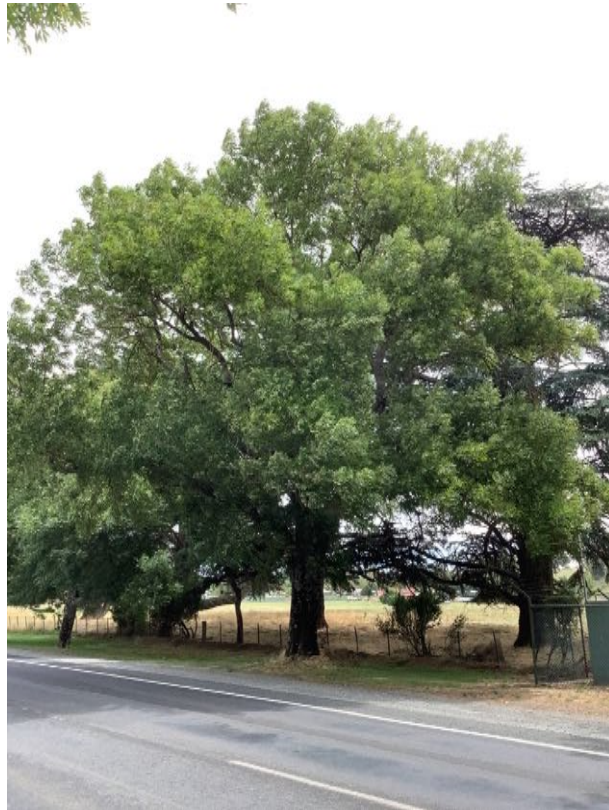
Tree ID: 40
Botanical Name: *Fraxinus angustifolia subsp. angustifolia*
Common Name: Narrow-leaved Ash
Easting: 144.157022
Northing: -37.340139
Datum: GDA1994 MGA Zone 55

Health: Good
Comment: No major defects visible

Structure: Good

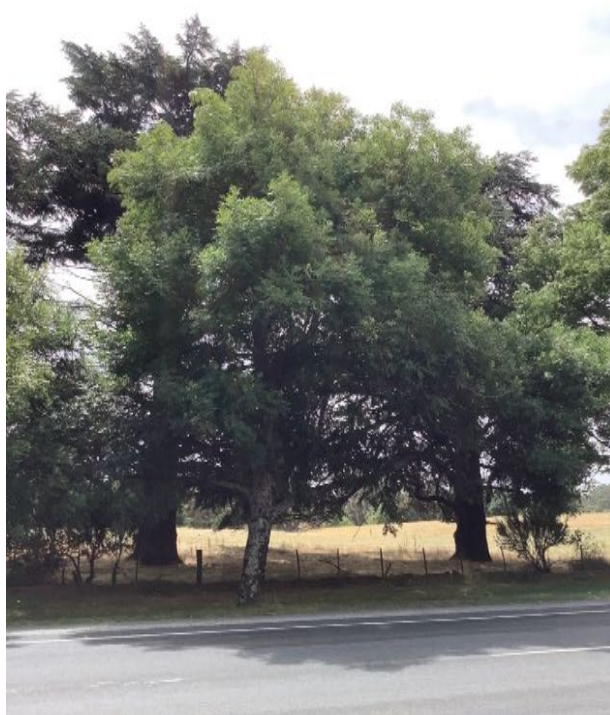
Tree ID: 41
Botanical Name: *Fraxinus angustifolia subsp. angustifolia*
Common Name: Narrow-leaved Ash
Easting: 144.156874
Northing: -37.340218
Datum: GDA1994 MGA Zone 55

Health: Good
Comment: No major defects visible

Structure: Good

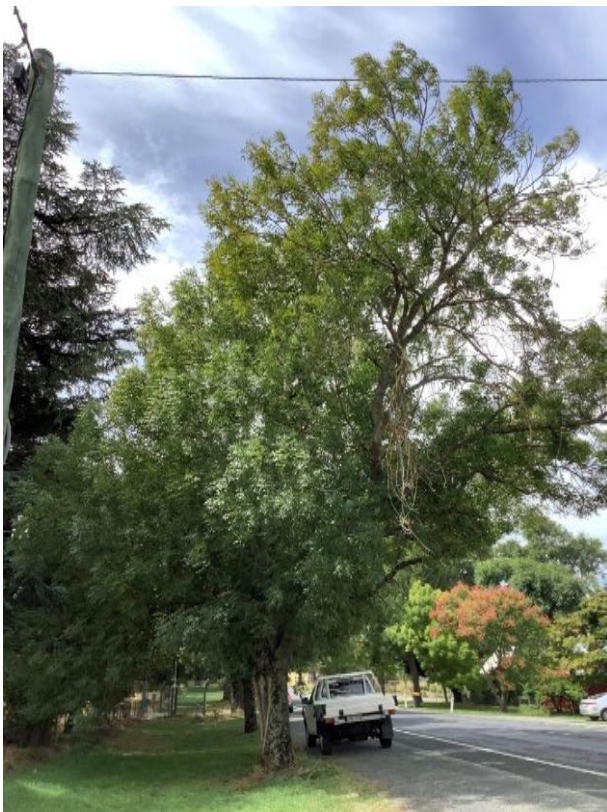
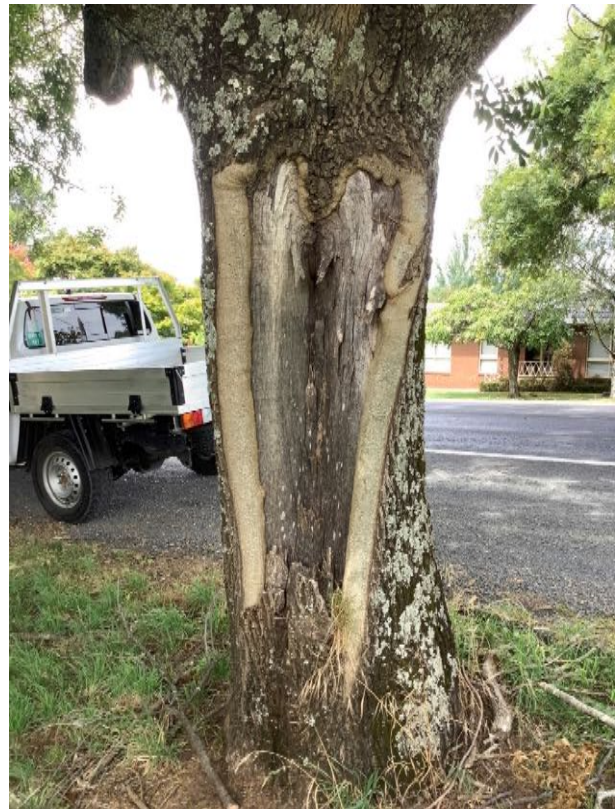
Tree ID: 42
Botanical Name: *Fraxinus angustifolia* subsp. *angustifolia*
Common Name: Narrow-leaved Ash
Easting: 144.156727
Northing: -37.340307
Datum: GDA1994 MGA Zone 55

Health: Good
Structure: Good
Comment: Historic tearout, appears structually sound

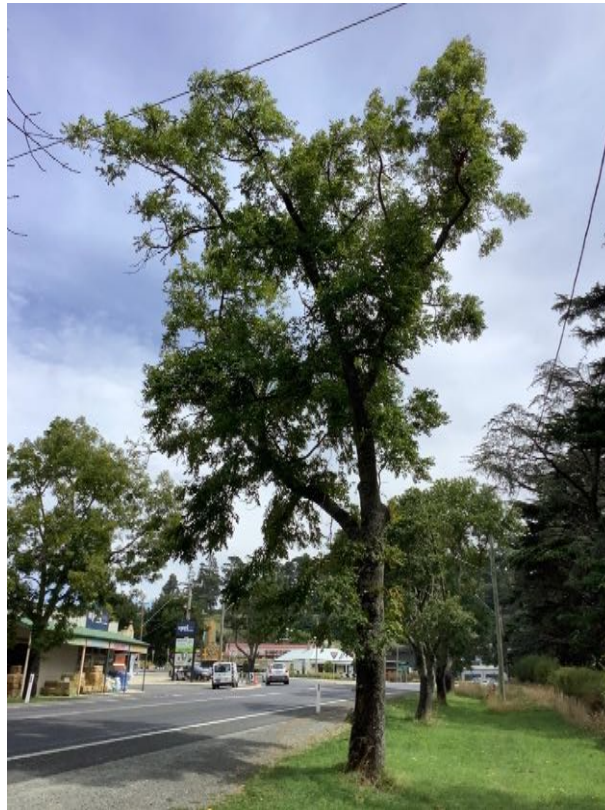
Tree ID: 43
Botanical Name: *Fraxinus angustifolia subsp. angustifolia*
Common Name: Narrow-leaved Ash
Easting: 144.156583
Northing: -37.340398
Datum: GDA1994 MGA Zone 55

Health: Fair
Comment: No major defects visible

Structure: Good

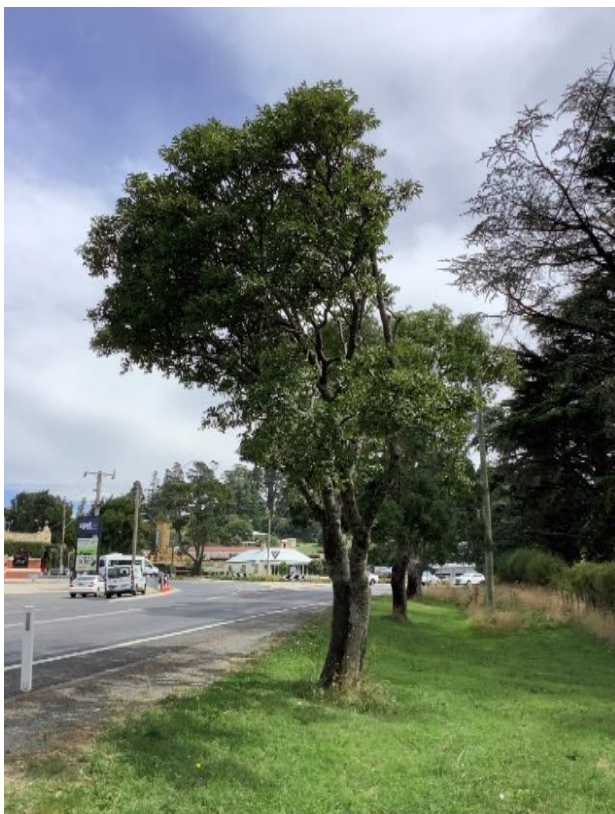
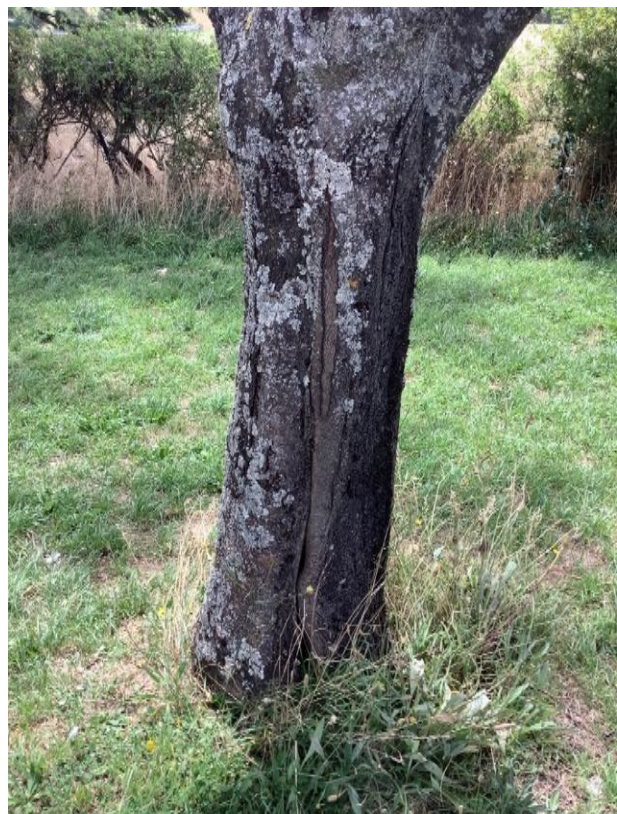
Tree ID: 44
Botanical Name: *Fraxinus angustifolia subsp. angustifolia*
Common Name: Narrow-leaved Ash
Easting: 144.156441
Northing: -37.340485
Datum: GDA1994 MGA Zone 55

Health: Good
Comment: No major defects visible

Structure: Good

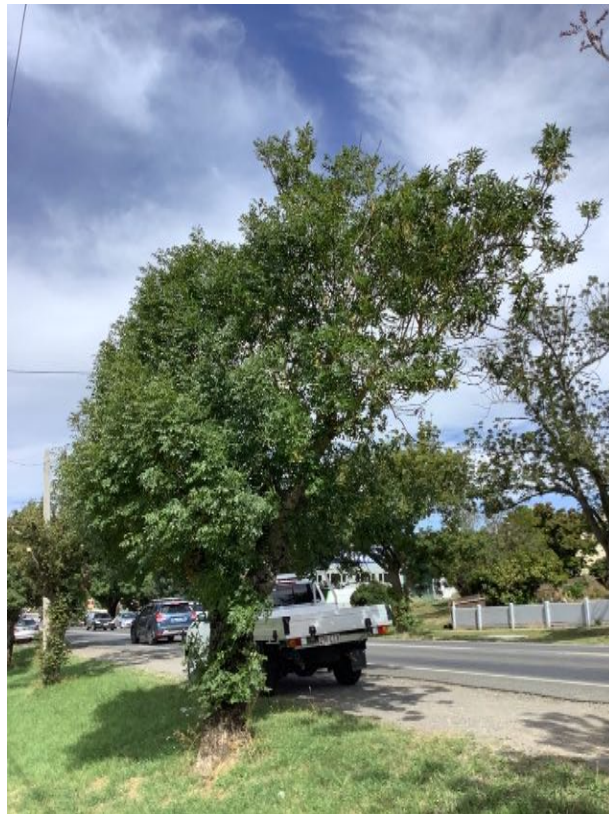
Health: Good
Comment: No major defects visible

Structure: Good

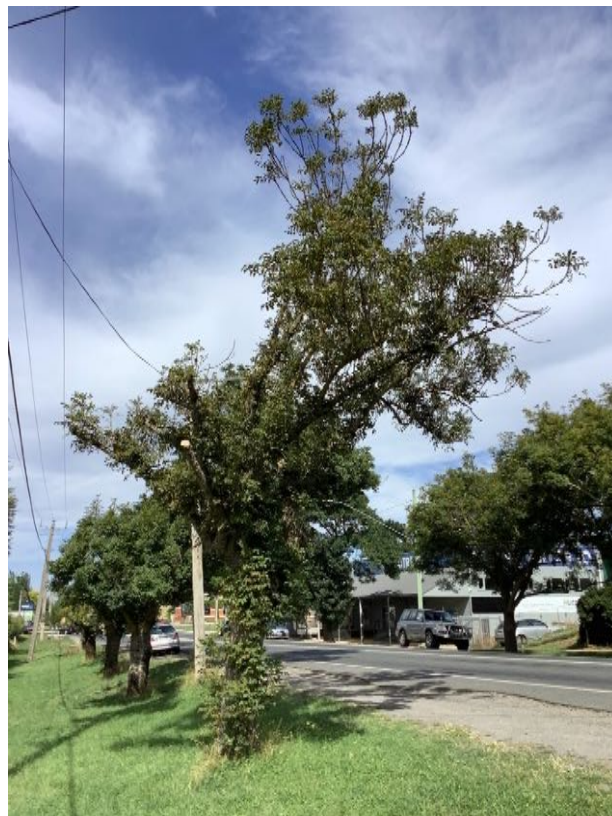
Tree ID: 48
Botanical Name: *Fraxinus angustifolia subsp. angustifolia*
Common Name: Narrow-leaved Ash
Easting: 144.154516
Northing: -37.340797
Datum: GDA1994 MGA Zone 55

Health: Fair
Comment: No major defects visible

Structure: Good

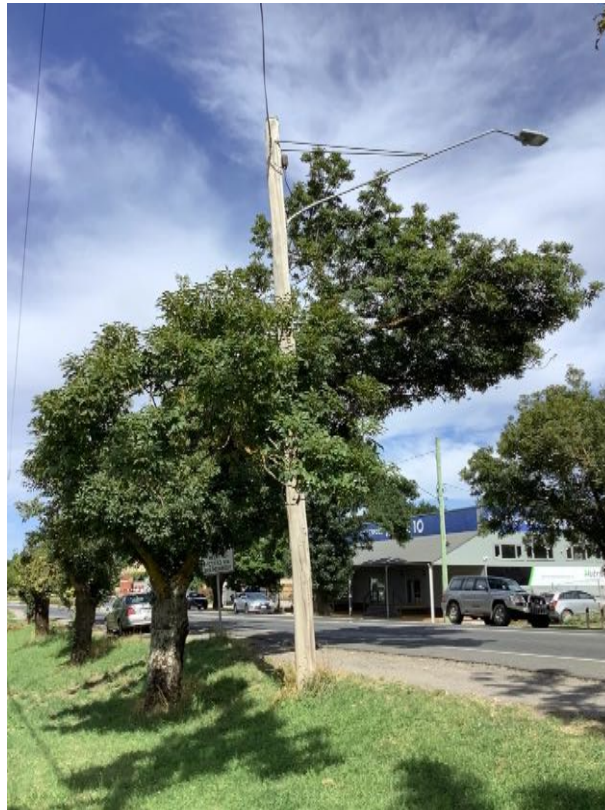
Tree ID: 49
Botanical Name: *Fraxinus angustifolia subsp. angustifolia*
Common Name: Narrow-leaved Ash
Easting: 144.154659
Northing: -37.340807
Datum: GDA1994 MGA Zone 55

Health: Good
Comment: No major defects visible

Structure: Good

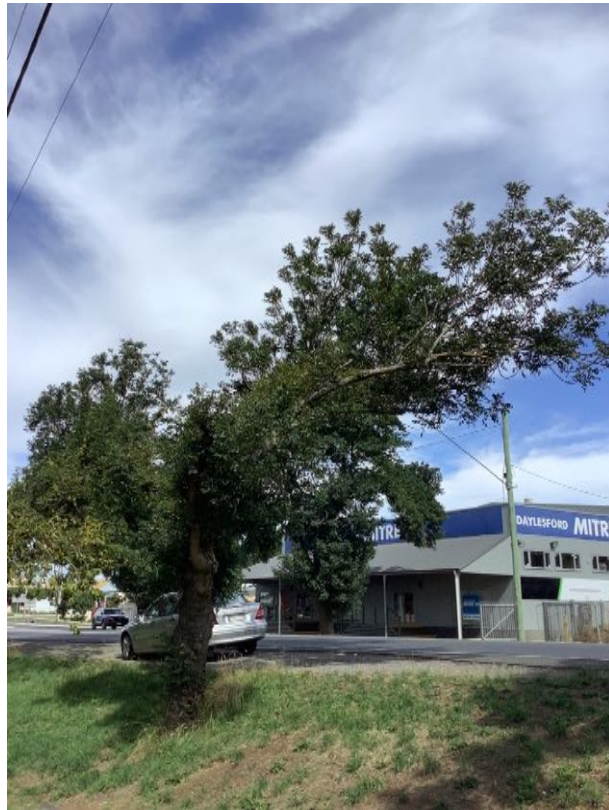
Tree ID: 50
Botanical Name: *Fraxinus angustifolia subsp. angustifolia*
Common Name: Narrow-leaved Ash
Easting: 144.154772
Northing: -37.340830
Datum: GDA1994 MGA Zone 55

Health: Good
Structure: Good
Comment: Heavily pruned for powerline clearances

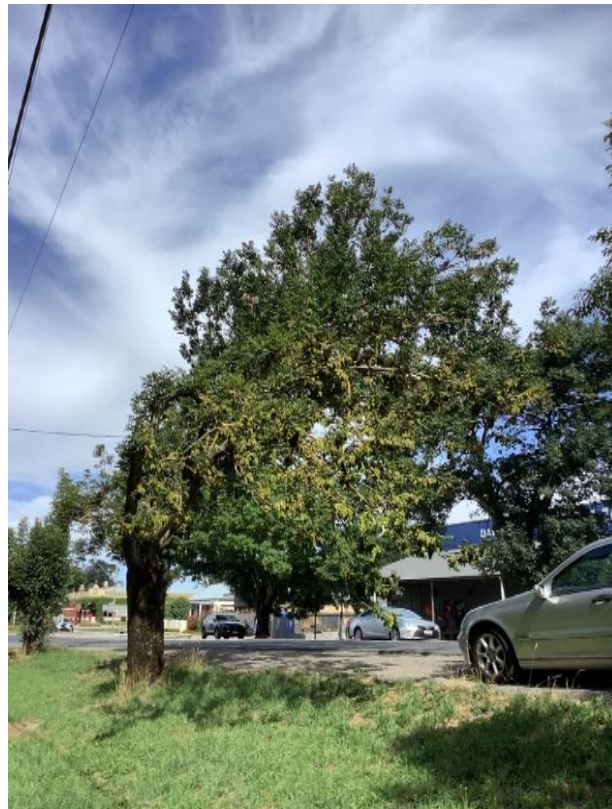
Tree ID: 51
Botanical Name: *Fraxinus angustifolia subsp. angustifolia*
Common Name: Narrow-leaved Ash
Easting: 144.154926
Northing: -37.340834
Datum: GDA1994 MGA Zone 55

Health: Good
Structure: Good
Comment: Heavily pruned for powerline clearances.

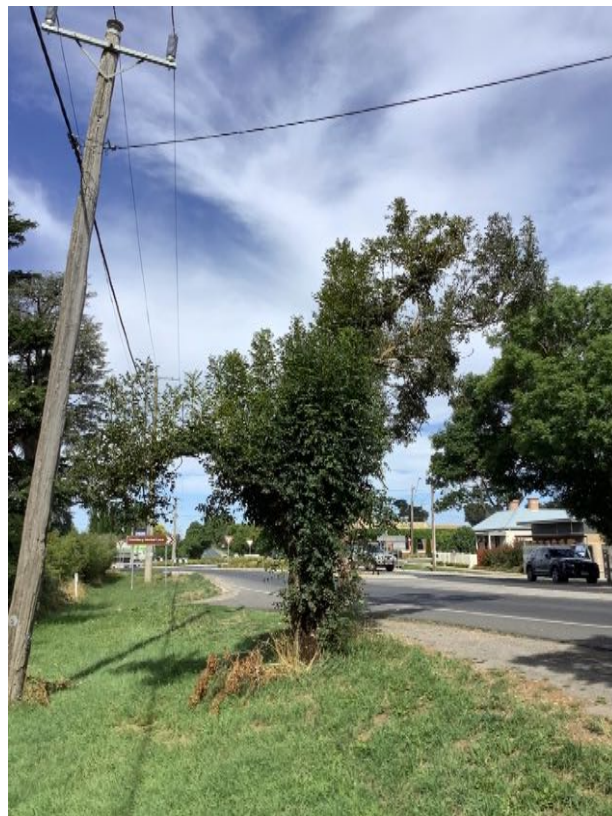
Tree ID: 52
Botanical Name: *Fraxinus angustifolia subsp. angustifolia*
Common Name: Narrow-leaved Ash
Easting: 144.155044
Northing: -37.340848
Datum: GDA1994 MGA Zone 55

Health: Good
Comment: No major defects visible

Structure: Good
