# Great Ocean Road Trail

## *Geotechnical Hazard Assessment*

**Golder Associates Pty Ltd**

21468192-001-R-Rev0

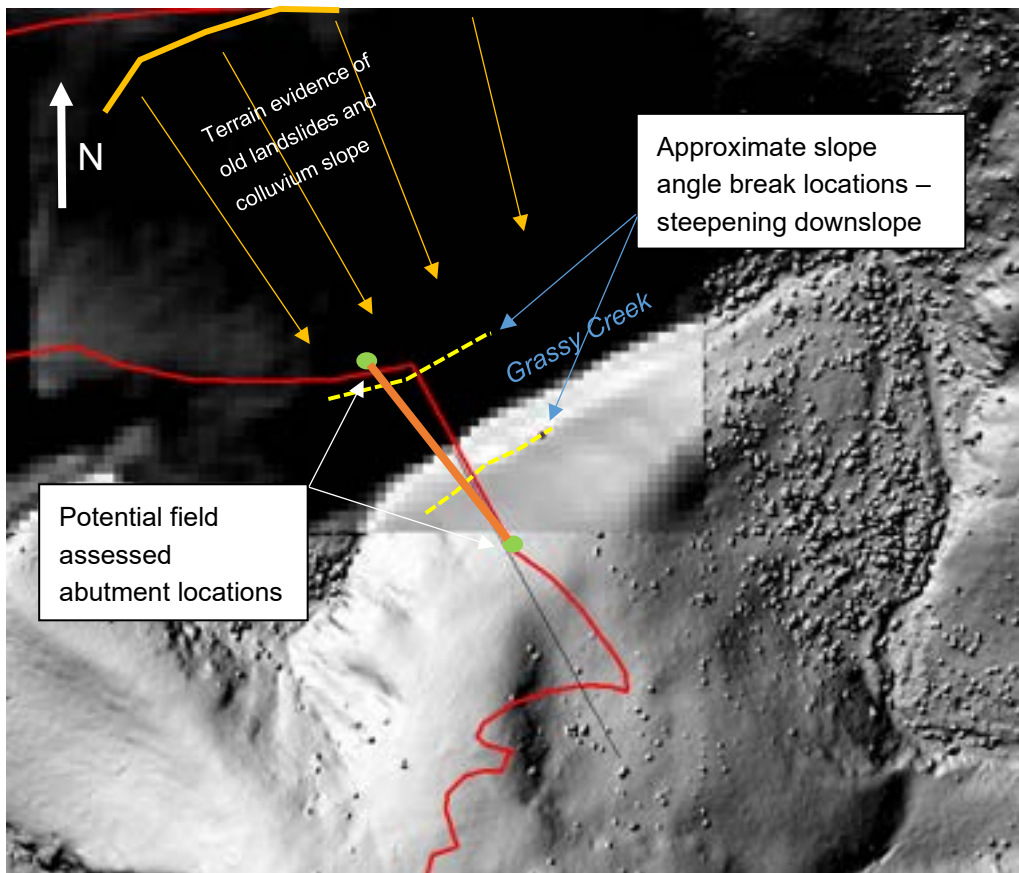
During the site visit, considering signs of slope instability were not observed and the inferred underlying colluvium cannot be avoided, the potential location for the northern abutment was assessed primarily based on slope angle and located slightly upslope of where the slope steepens in the vicinity of the creek. The elevation of the location was also similar to World Trails' proposed location for the southern side with the location measurement based on hand-held GPS (nominal horizontal accuracy of 5 m) shown in Figure 4. The approximate position of the potential abutment location is also shown on the cross section in Figure 5. Further investigation work will be required to investigate the geotechnical properties of the colluvium and to further assess footing requirements. If the proposed bridge abutment location is underlain by deep colluvium, there may be a requirement to provide deep piled footings.

The southern abutment area appears to have relatively shallow sandstone rock at some locations as outcropping was occasionally observed. Outcrops were not observed in the relatively shallow gullies in the slopes. Signs of slope instability were not present, however small areas of scree with cobble sized rocks, likely to be reasonably shallow, were observed on the slopes above the proposed abutment location. The characteristics of the rock, including intact strength, defects, bedding, etc. could not be fully assessed based on the site observations.

**Figure 4: Hillshade terrain representation showing approximate trail route and proposed Bridge 0 abutment locations**

However, as a general comment we expect that where rock is present it is likely to be practical to design abutment footings (e.g., anchored pad footings or piles) founding on or within the rock and subject to analysis and design to mitigate potential slope instability.

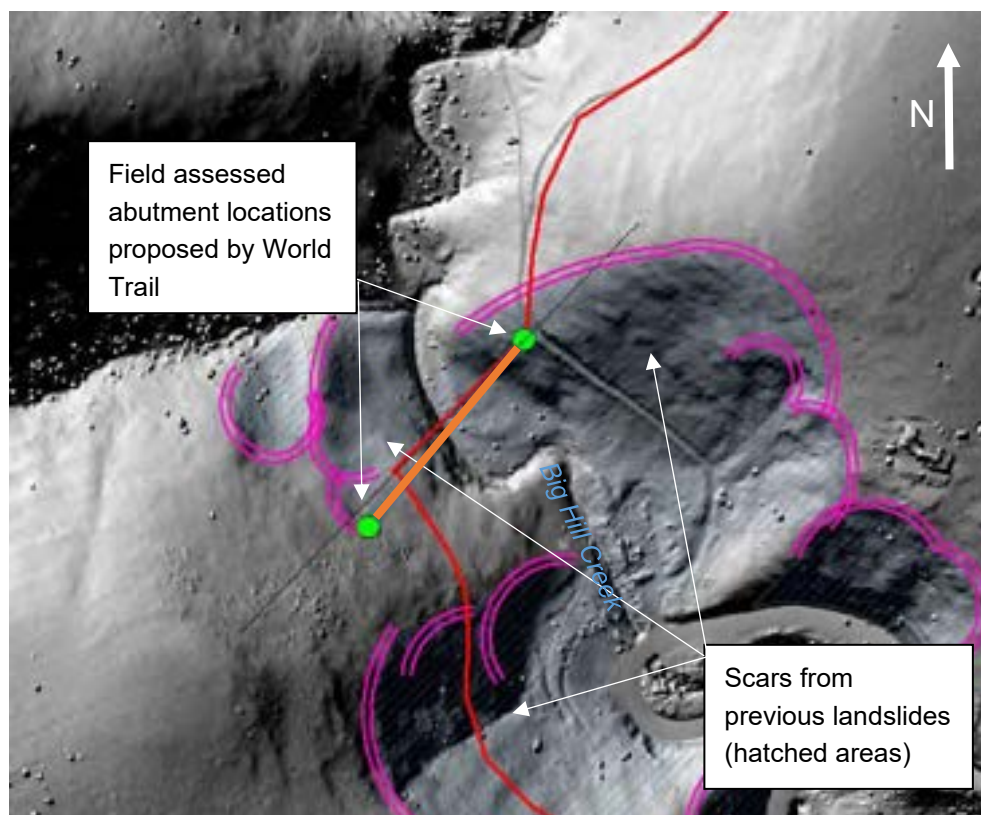
Slopes on the western side of the valley are between 20° and 22° with an increase in slope angle up to 32° below the escarpment of an old slide on the creek flank. The proposed abutment location is approximately 12 m from this observed scarp. Trees below the scarp were observed to be leaning downslope, indicating possible ongoing slope instability. An older landslide scar was also observed approximately 12 m north of the proposed abutment which was evident by a surface depression and also identified in the landslide hazard maps as indicated in Figure 9.

**Figure 9: Extract from landslide hazard map at the proposed Bridge 1 location**

Due to the proximity of the observed landslide features, it is recommended the south west abutment is moved further upslope. A preferred location was assessed, approximately 20 m upslope from the escarpment on the creek flank. Slope angles in this location are more consistent and lack undulations, hummocks or distinct breaks in slope, as indicated in Figure 8. However, a lack of outcrops or cuttings anywhere in the vicinity of the abutment made it difficult to assess the depth to rock, although an estimate is provided in Table 7.

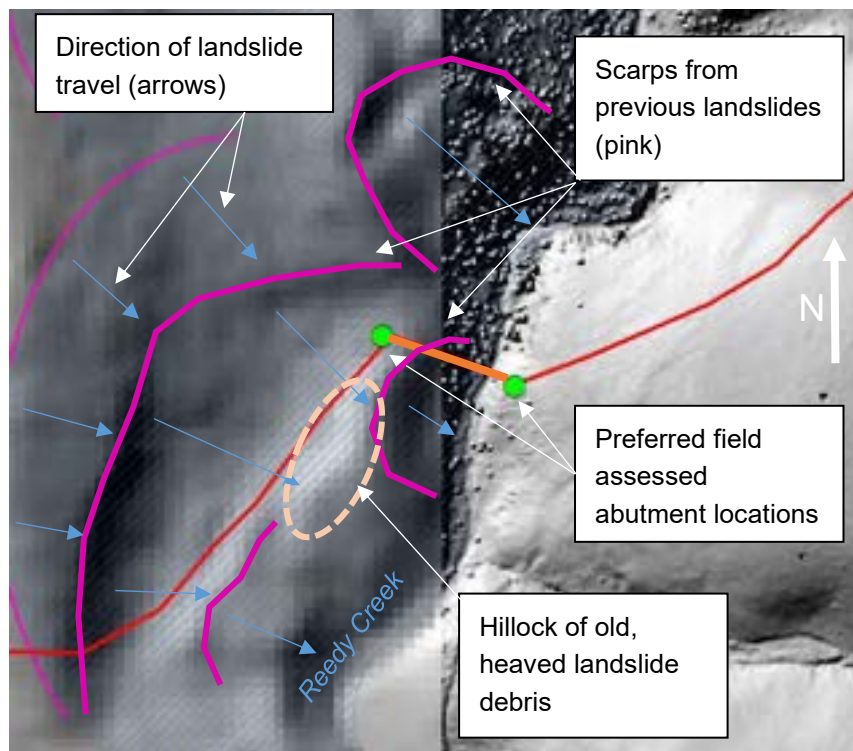
The western slope of the valley appears to have undergone extensive landsliding of varying scales, including relatively large ground movements. The evidence for landslides on the western hillslope is shown in Figure 11.

It can be inferred that based on the large scale landsliding on the western slope and the absence of landsliding on the eastern slope, that the sandstone bedding is likely to dip down towards the east, which would reduce the potential for landsliding on the eastern slope.

**Figure 11: Extract from landslide hazard map at proposed Bridge 2 location**

Based on the landforms observed, it is inferred that rock will be relatively shallow in the vicinity of the proposed eastern abutment location, with overlying layers of residual soil and possibly a relatively thin surface covering of colluvium present. It appears likely to be practical to design abutment footings (e.g., anchored pad footings or piles) founding on or within the rock.

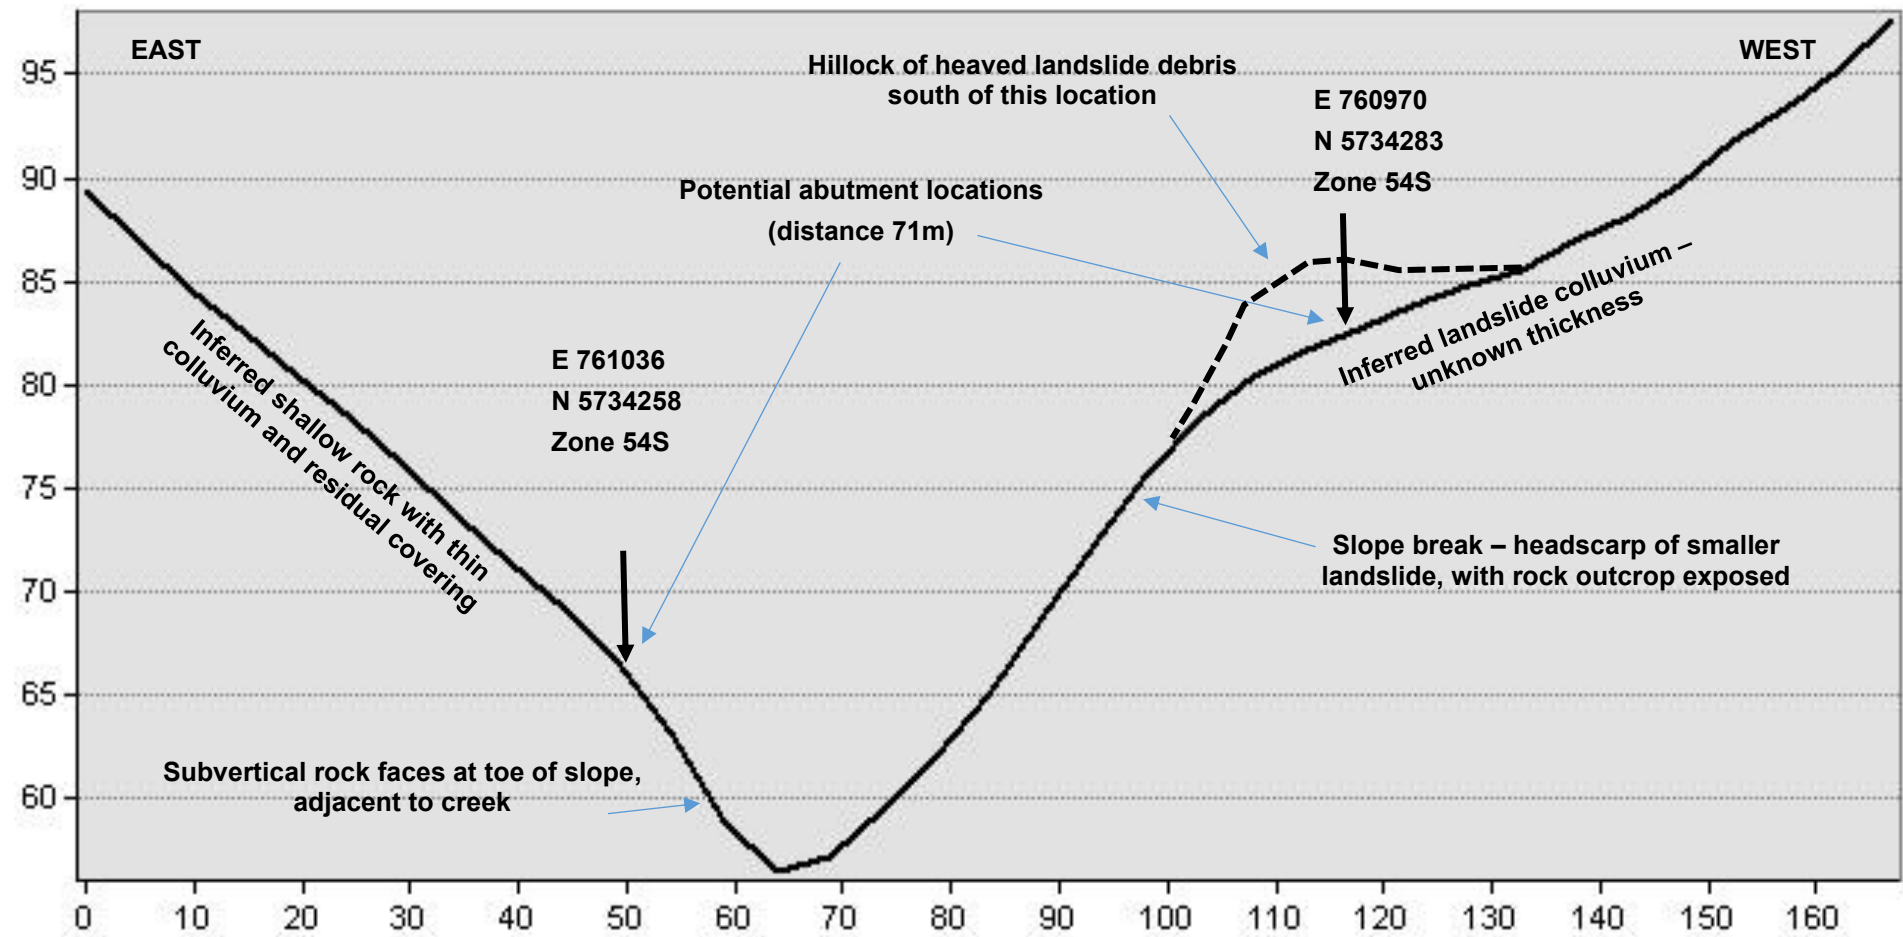
Based on the hazard mapping and site observations set out above, Figure 12 presents a cross section along the proposed bridge indicating abutment locations positioned to avoid potentially unstable ground. We note that these locations are indicative only and that intrusive site investigation will be required to inform detailed design. Other pertinent observations at each bridge location are also presented on Figure 12.

Figure 12: Terrain cross section at the potential Bridge 2 abutment location, looking south (axes in m)

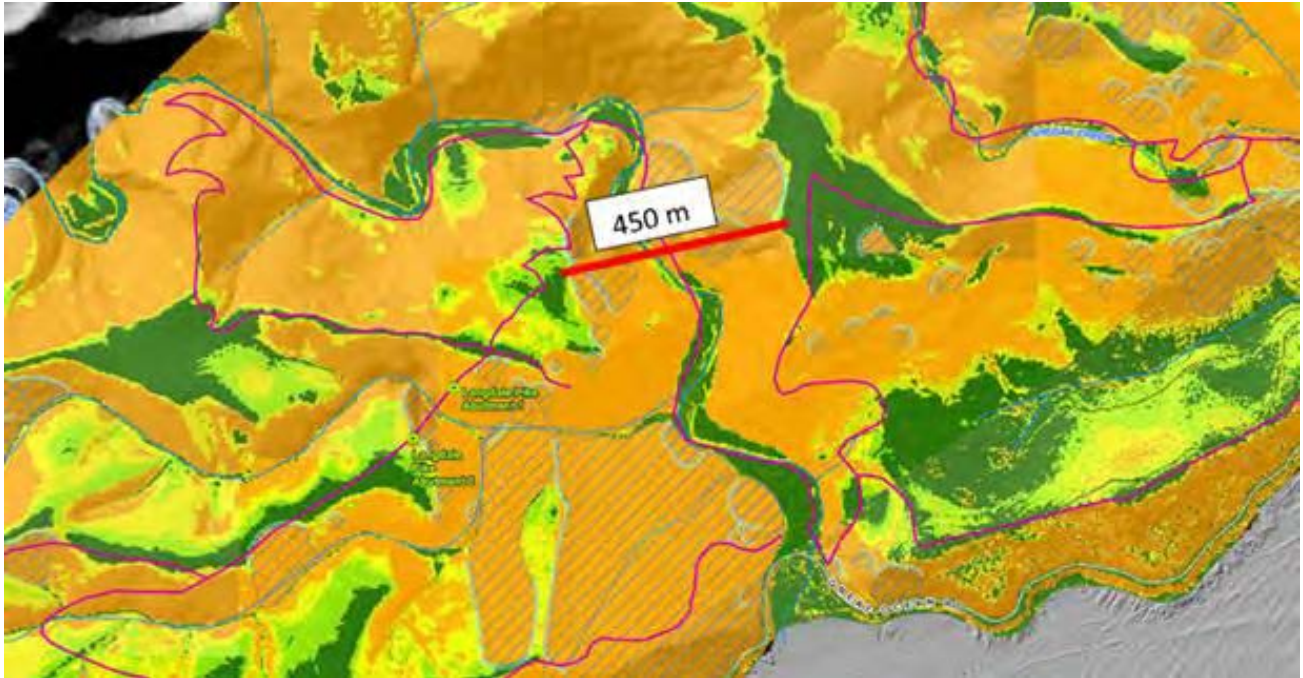
Bridge 3 spans the Cumberland River. This site was not visited due to accessibility constraints. However, assessment of the bridge based on remote mapping (Figure 13) suggests it would require a length of about 450 m so that the abutments are located within areas that are not susceptible to mapped hazards.

**Figure 13: Shallow soil landslide hazard map extract showing approximate location and length of the proposed Cumberland River bridge**

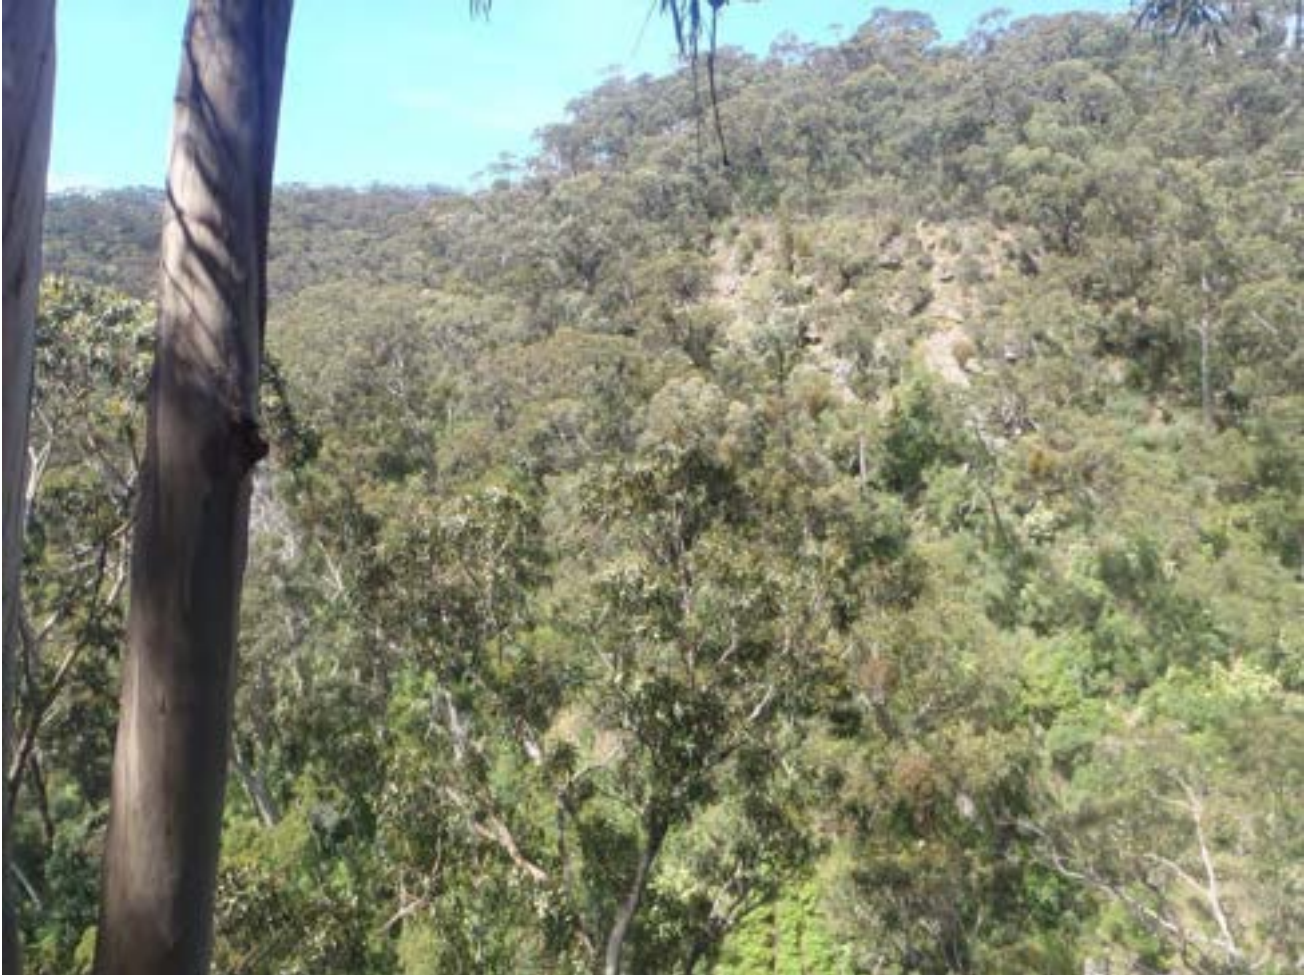
Bridge 4 spans a steep-sided valley, the sides of which expose flat-dipping Cretaceous rock as indicated in Figure 14.

**Figure 14: View towards south west along proposed bridge alignment**

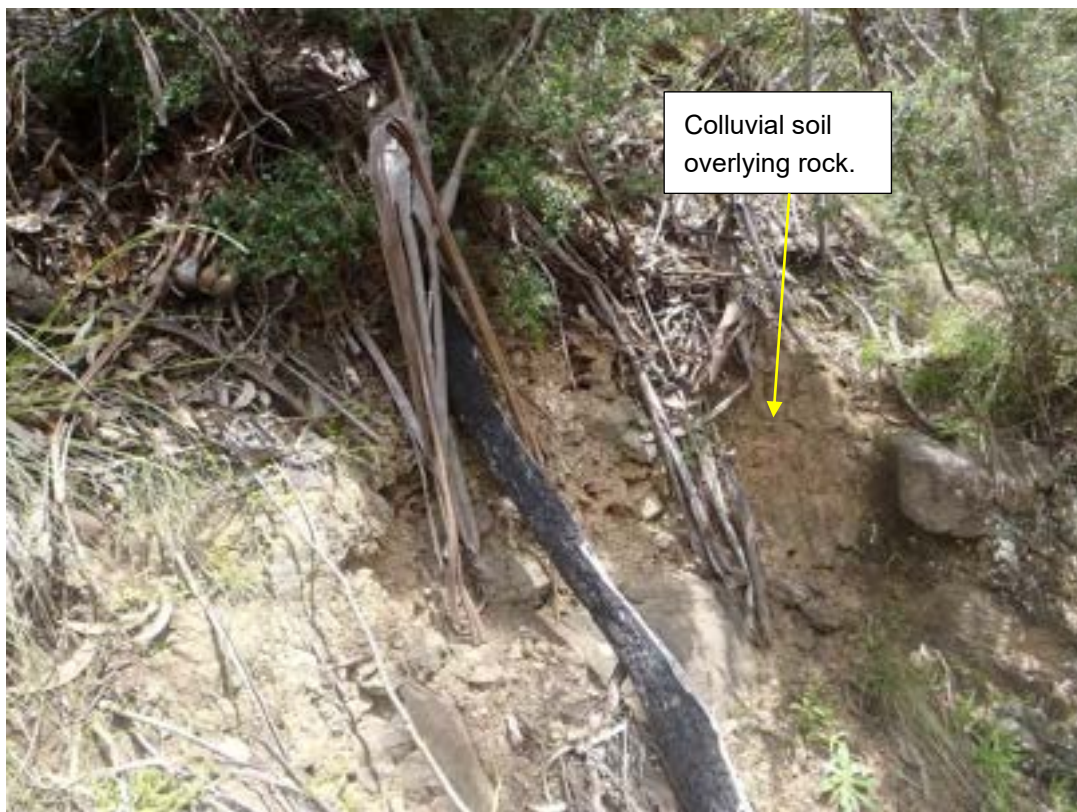
**Figure 19: Break in slope at south west bridge abutment**

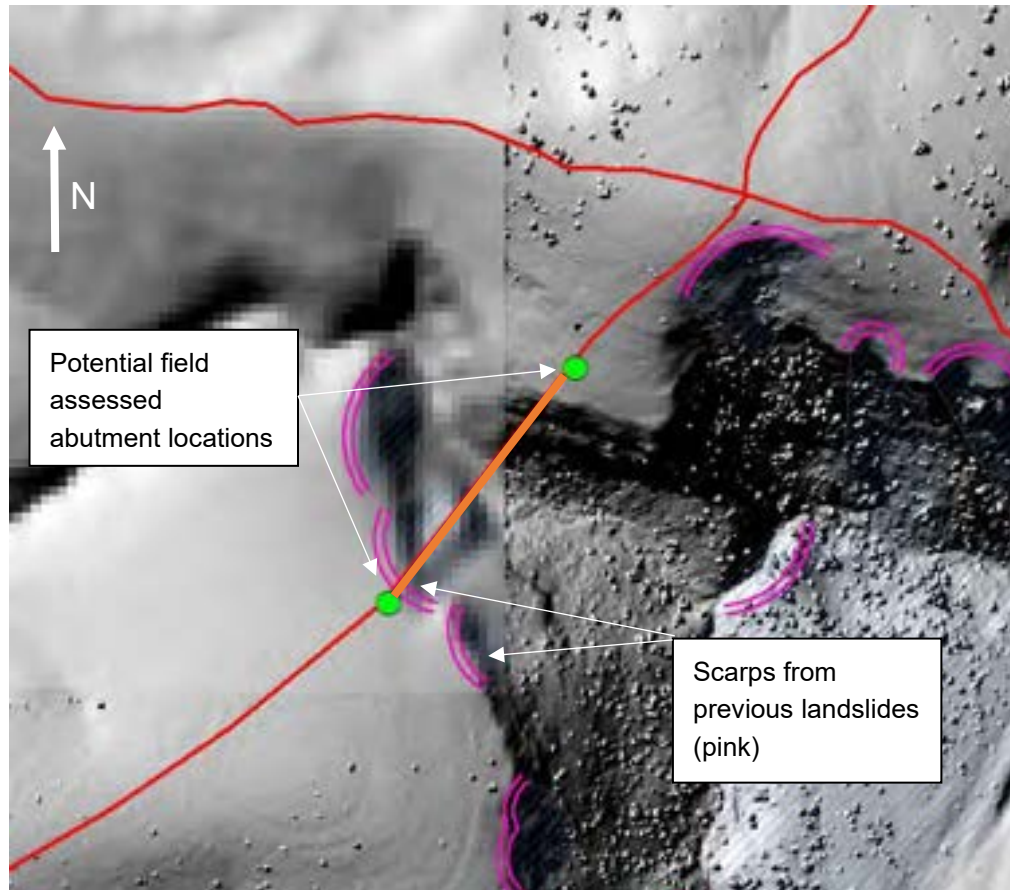
The landslide hazard map indicates the valley to be susceptible to landslides as indicated in Figure 20. This observation was confirmed by site observation, with the prominent landslide scarp as indicated in Figure 20 observed in the field.

Figure 20: Extract from landslide hazard map at proposed Bridge 4 location

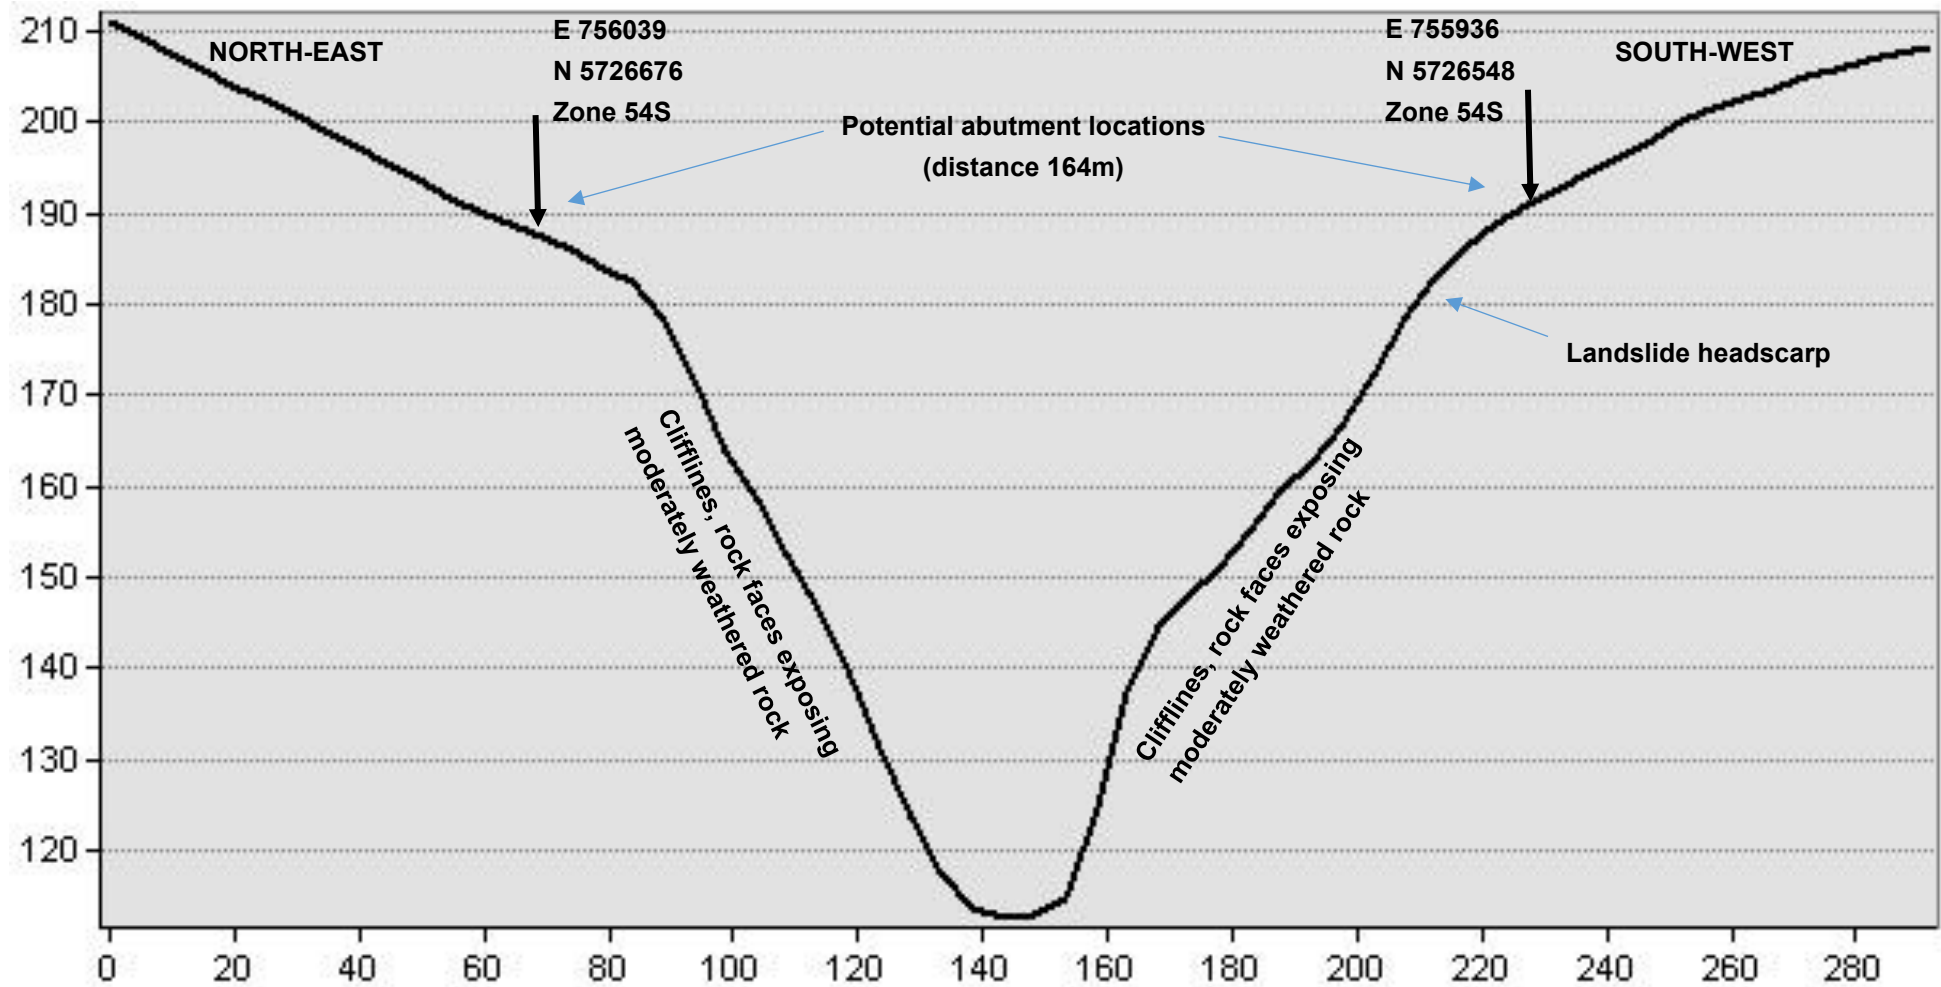
A location at which no evidence for past ground movement is evident was identified about 30 m back from the escarpment. Its location is indicated in Figure 21.

Figure 21: Cross section along proposed Bridge 4 indicating suggested abutment locations

Based on the hazard mapping and site observations set out above, Figure 21 presents a cross section along the proposed bridge indicating abutment locations positioned to avoid potentially unstable ground. We note that these locations are indicative only and that intrusive site investigation will be required to inform detailed design. Other pertinent observations at each bridge location are also presented on Figure 21. Based on this assessment, the bridge span between abutments would need to be a minimum of 164 m.

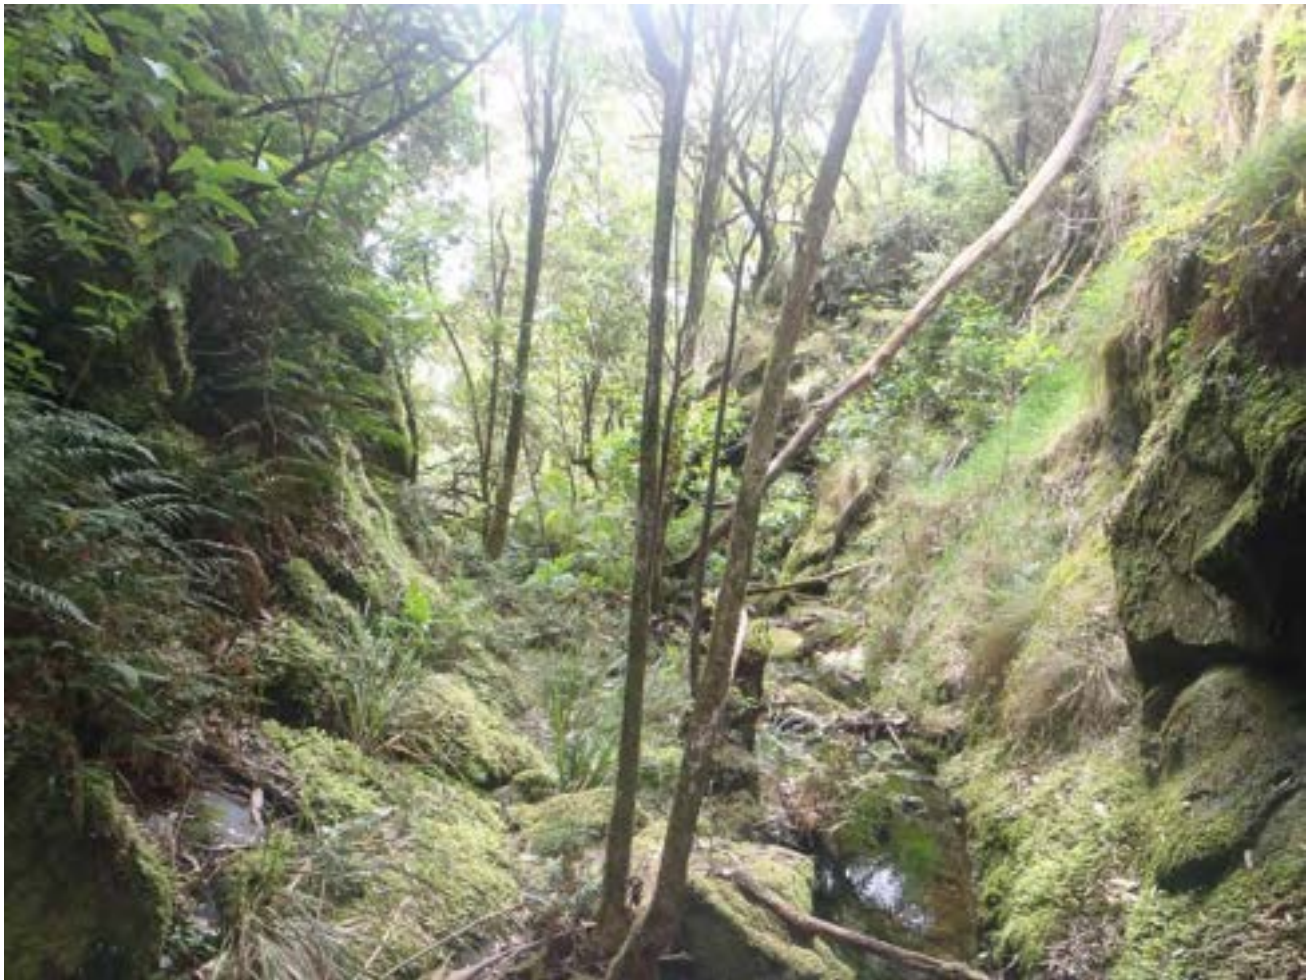
Bridge 5 spans an unnamed creek which flows south east off Mount Defiance to the coast, entering the sea near the Mount Defiance lookout on the Great Ocean Road. Due to thick vegetation at this location, it was difficult to obtain photographs that show geological and geomorphological features. The creek over which the bridge spans is indicated in Figure 22.

**Figure 22: View to south east along creek over which proposed Mount Defiance bridge spans**

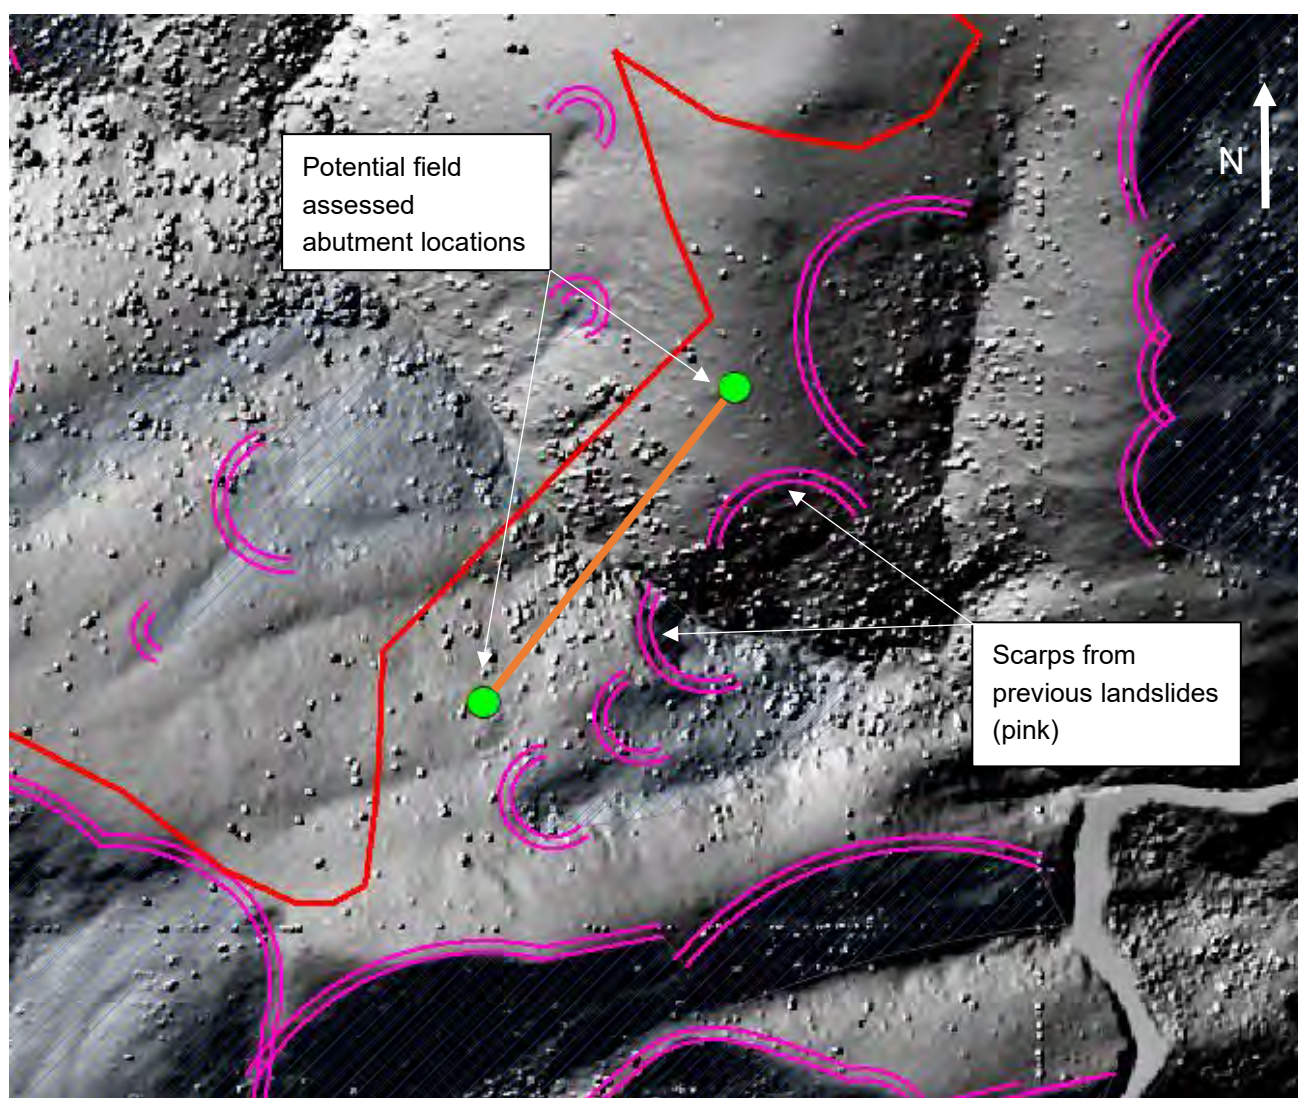
Figure 23 presents an extract from the landslide hazard map and indicates mapped landslides on the edges of the valley. The map indications are consistent with ground observations with features in the landscape indicative of past landslides observed at the same locations indicated on the hazard maps.

**Figure 23: Extract from landslide hazard map at proposed Bridge 5 location**

Breaks in slope at the Mount Defiance bridge site are less well defined compared to at other sites. Slopes on either side of the bridge are convex, with increasing slope angle down towards the creek. Slopes vary between about 20° and 24° about 50 m from the base of the creek, increasing to about 35° in the vicinity of the landslides as indicated in Figure 23 and near vertical at the creek where rock is exposed (Figure 22).

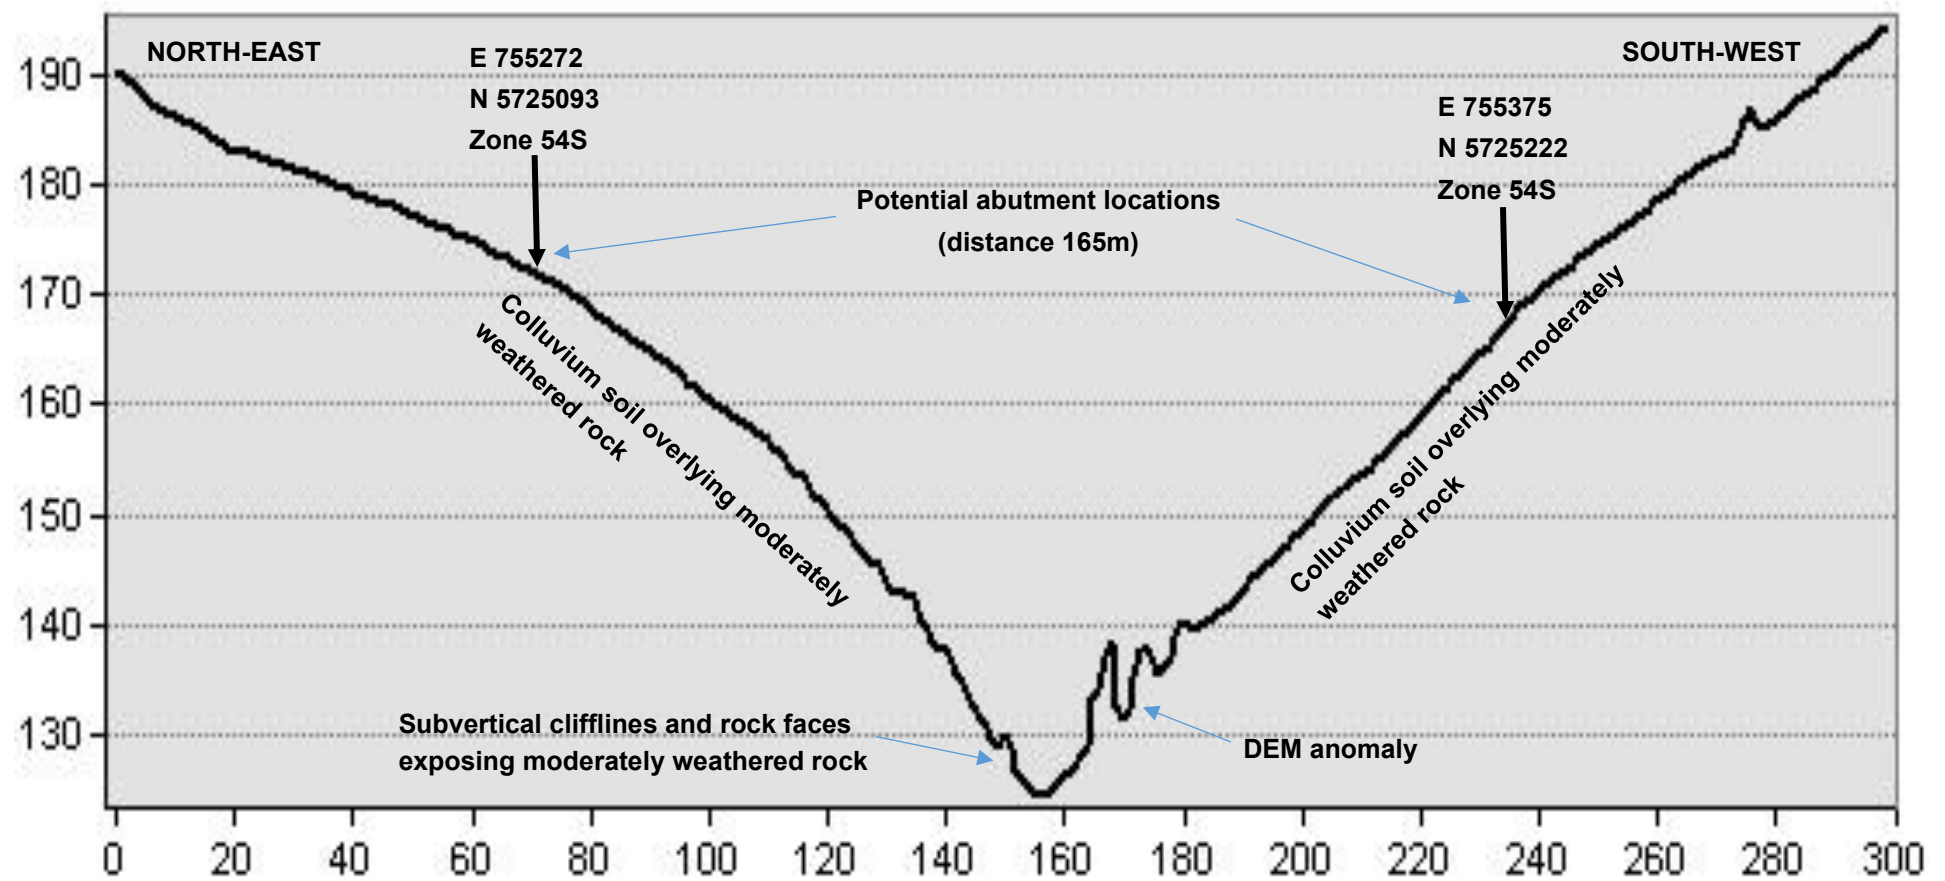
Figure 25: Cross section along proposed Bridge 5 indicating potential abutment locations

Based on the hazard mapping and site observations set out above, Figure 25 presents a cross section along the proposed bridge indicating abutment locations positioned to avoid potentially unstable ground. We note that these locations are indicative only and that intrusive site investigation will be required to inform detailed design. Other pertinent observations at each bridge location are also presented on Figure 25. Based on this assessment, the bridge span between abutments would need to be about 165 m.

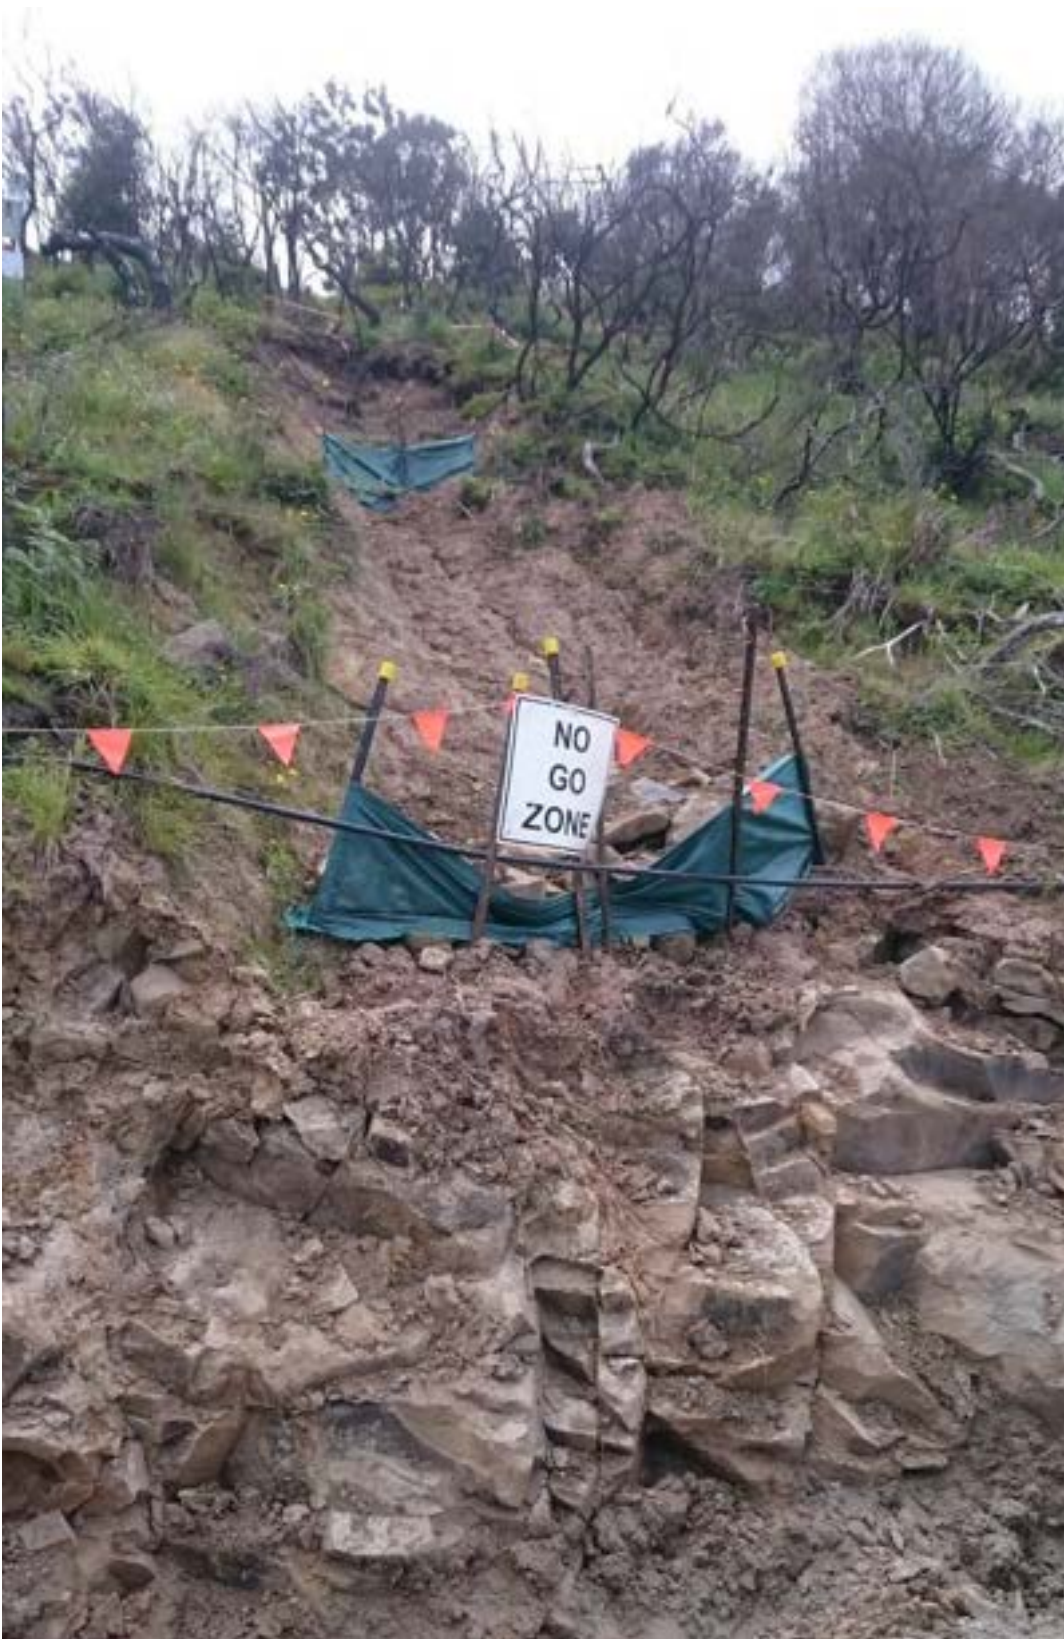
**Figure B22: Example of shallow soil landslide in 2016, which occurred above the Great Ocean Road and affected a significant length of Paddy's Path at Wye River (the landslide extends further across the hillside than the photograph extents. Note the rock bedding dipping downslope)**

The Wye River Paddy's Path landslide is located below the proposed trail alignment. This landslide moved in September 2016, resulting in significant remedial works and the relocation of the path. The path had also previously been relocated in response to landslides.
