Mawsons Concrete & Quarries

Groundwater Drilling and Well Construction Report

Blue Hills Quarry

November 2023

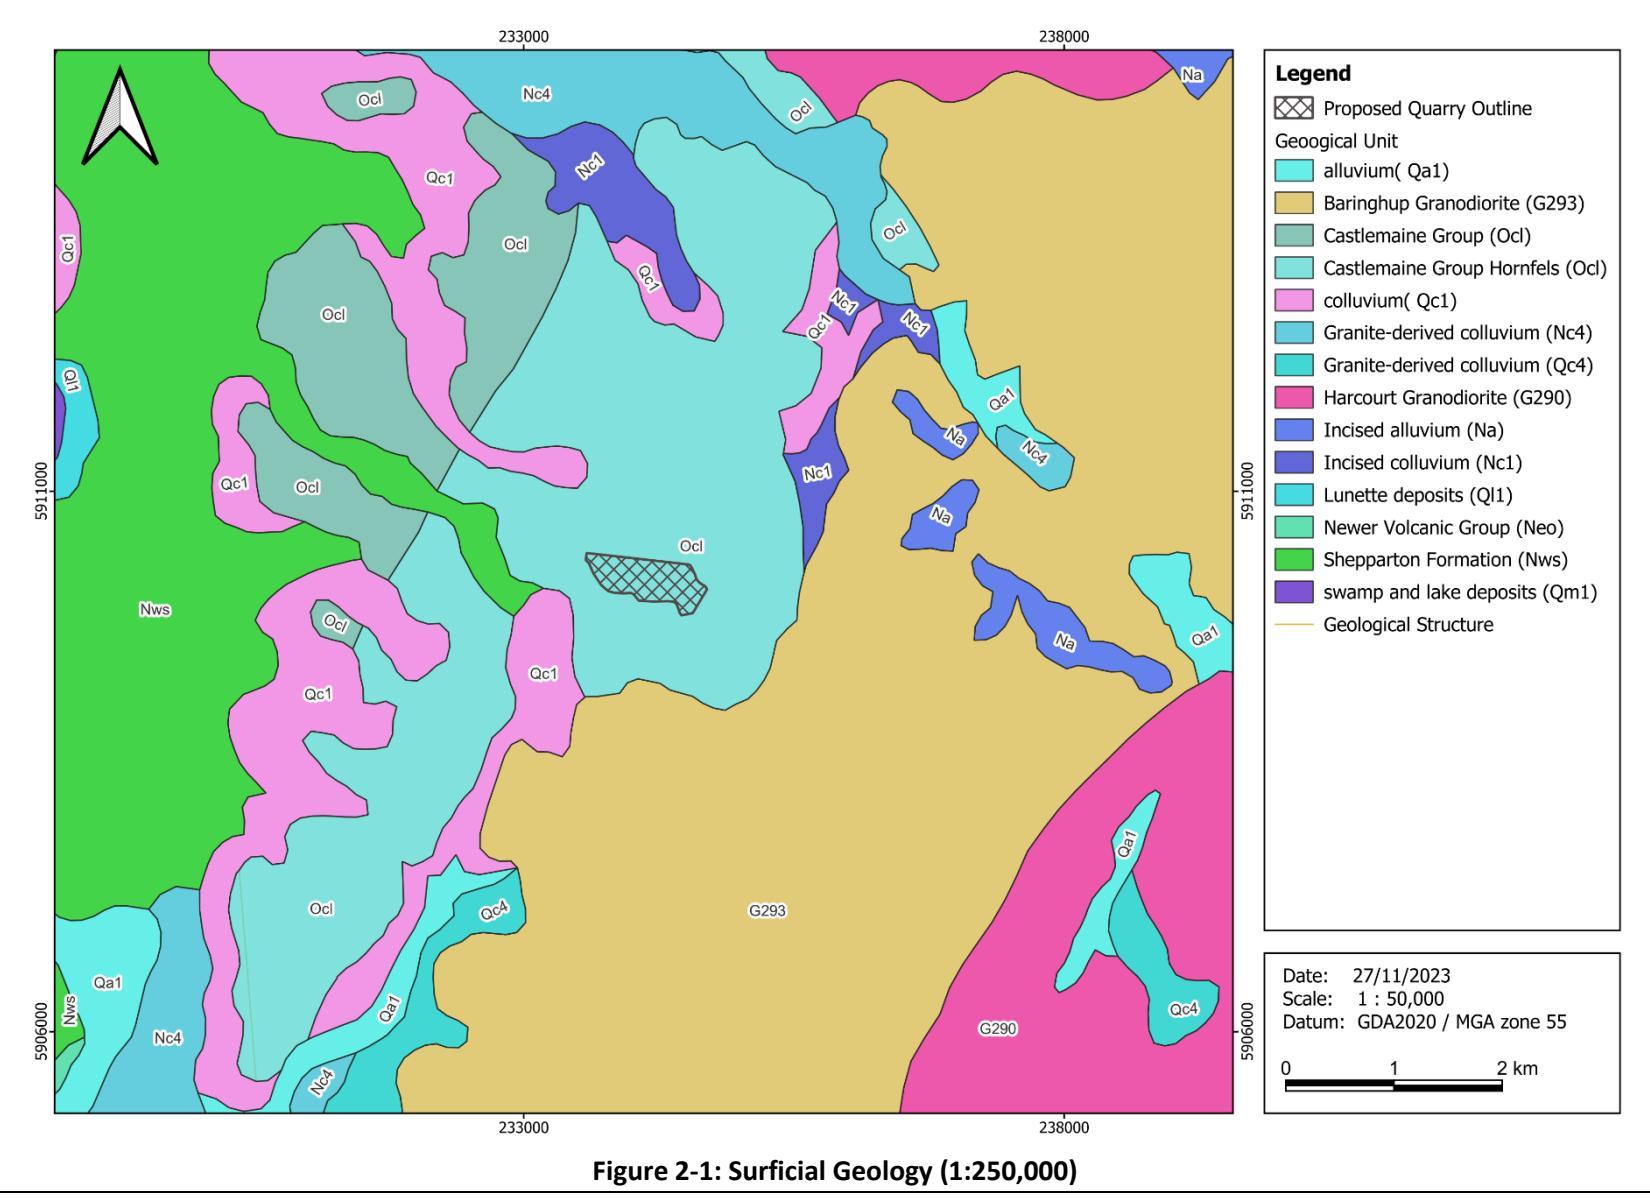
The proposed quarry Site is situated on rocks of the Ordovician Castlemaine Group, which are regionally characterised by marine sandstone, mudstone, siltstone, shale and chert. The late Devonian Baringhup Granodiorite exists to the east and south of the Site, characterised by fine to medium grained, slightly porphyritic granodiorite. The intrusion of the granodiorite during the late Devonian period created a zone of contact metamorphism to the east, resulting in the development of cordierite hornfels, biotite hornfels and calc-silicate hornfels which are the target quarry material.

Quaternary and Tertiary sediments cover the Castlemaine Group to the west of the Site. These sediments include Quaternary colluvium consisting of diamictite, gravel, sand, silt, clay and rubble and Tertiary Shepparton Formation sediments consisting of clay, sand and silt. The proposed quarry location is shown in Figure 2-1 overlain on the Bendigo 1:250,000 geological map sheet (GeoScience Victoria, 2014).

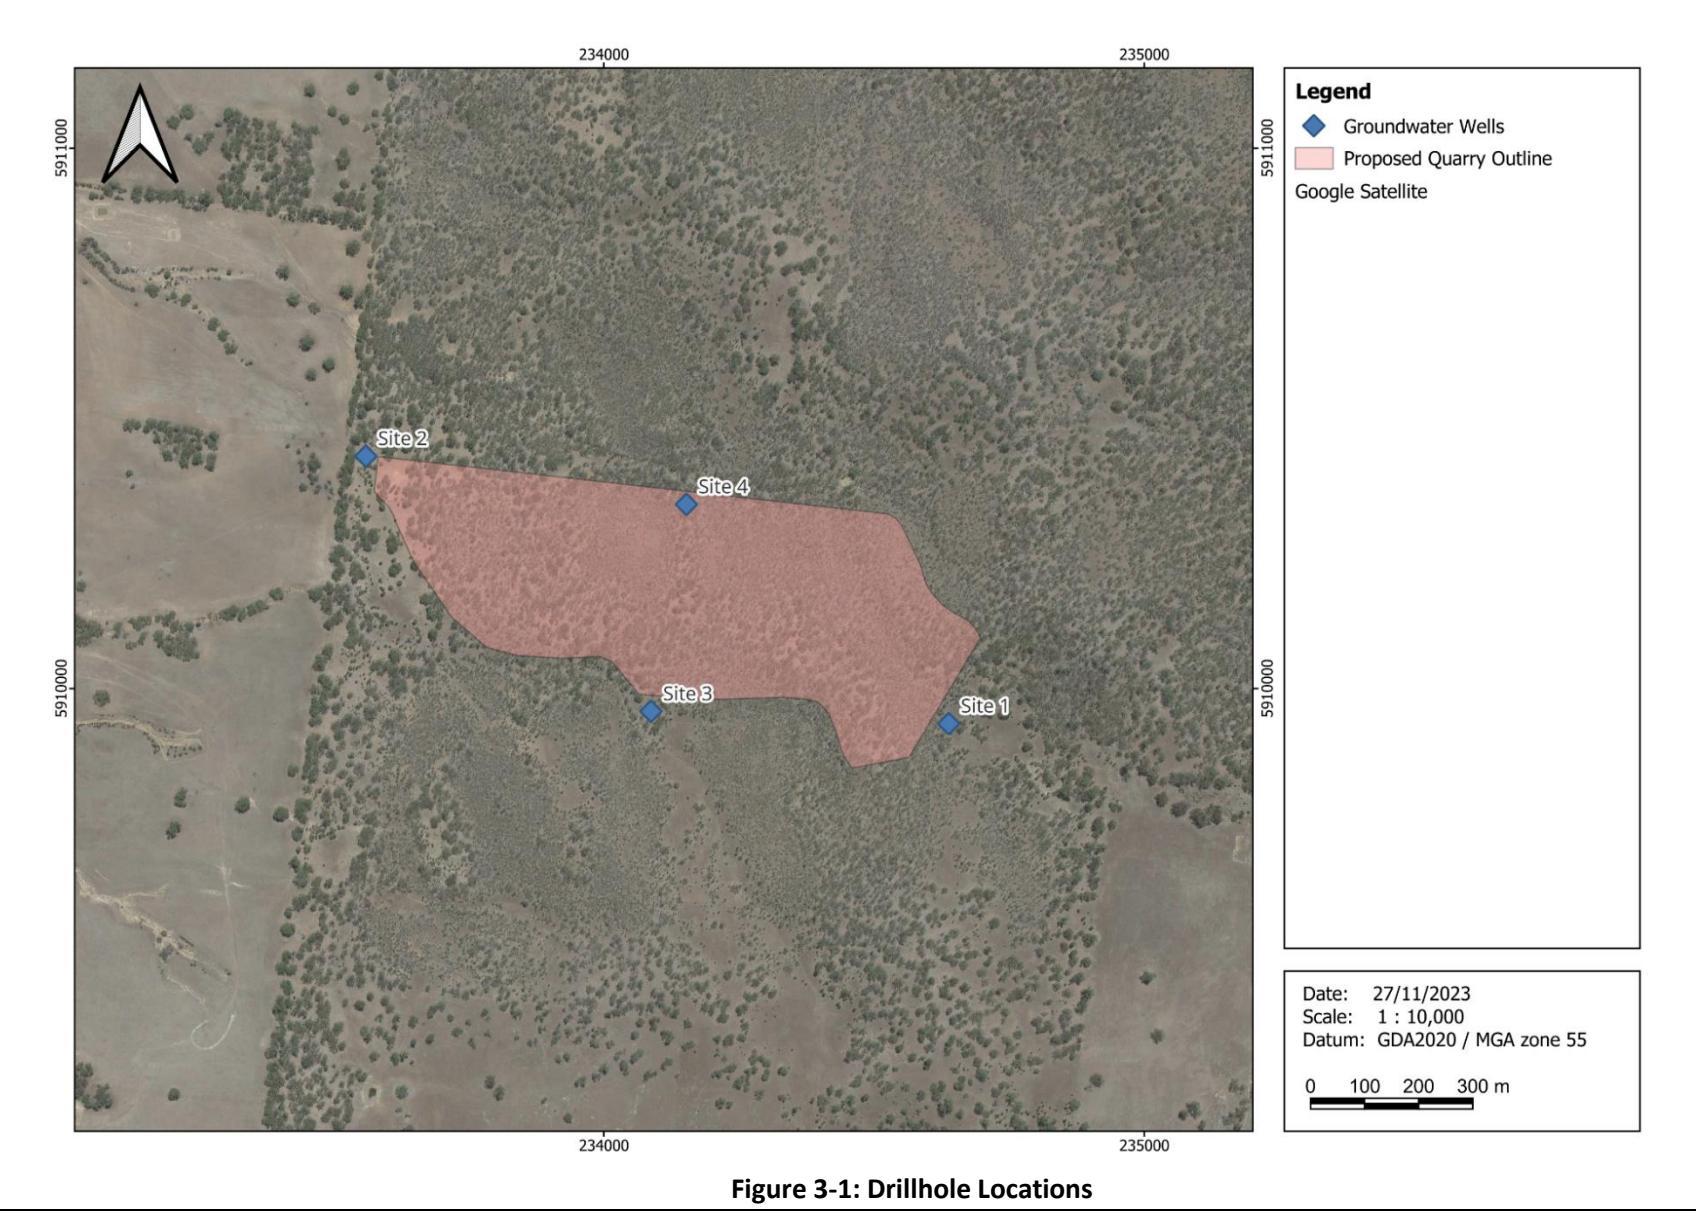
Site 1 was drilled and constructed southeast of the proposed quarry pit (Figure 3-1). Site 1 intersected weathered Castlemaine Group sediments from 0 to 3 m followed by hornfels of the Castlemaine Group from 3 m to a total depth of 117 m. Groundwater was intersected at 52 m, 57 m and 67 m. A seep was also noted at 30 m below ground level. The cumulative yield of the well was estimated to be 1.5 litres per second (L/s). The well was screened from 54 - 60 m, 66 - 78 m and 108 - 114 m below ground level.

Site 2 was drilled and constructed west of the proposed quarry pit (Figure 3-1). Site 2 intersected Quaternary sediments (0-12 m), Tertiary sediments (12-27 m) and hornfells of the Castlemaine Group (27-85 m). Groundwater was intersected at 44 m below ground level. The cumulative yield of the well was estimated to be 0.25 L/s, indicating a low permeability. The well was screened from 41 - 53 m and 75 - 85 m below ground level.

Site 3 was drilled and constructed south of the proposed quarry pit (Figure 3-1). Site 3 intersected weathered Castlemaine Group sediments from 0 to 3 m followed by hornfels of the Castlemaine Group from 3 m to a total depth of 111 m. Groundwater was intersected at 27 m and 69 m. The cumulative yield of the well was estimated to be 0.5 L/s. The well was screened from 27 - 33m, 45 - 51 m and 105 - 111 m below ground level.

Site 4 was drilled and constructed on the northern edge of the proposed quarry pit (Figure 3-1). It was unable to be located outside of the proposed pit footprint due to access constraints. Site 4 intersected weathered Castlemaine Group sediments from 0 to 3 m followed by hornfels of the Castlemaine Group from 3 m to a total depth of 111 m. There were no noted water cuts at Site 4, suggesting a very low permeability at this site. Water was observed to seep into the hole at 21 m following a break in drilling from 07 - 08/11/23. The well was not actively producing water, and the yield is best described as a seep (< 0.1 L/s). The well was screened from 27 - 33m, 61 - 63 m and 81 - 111 m below ground level.

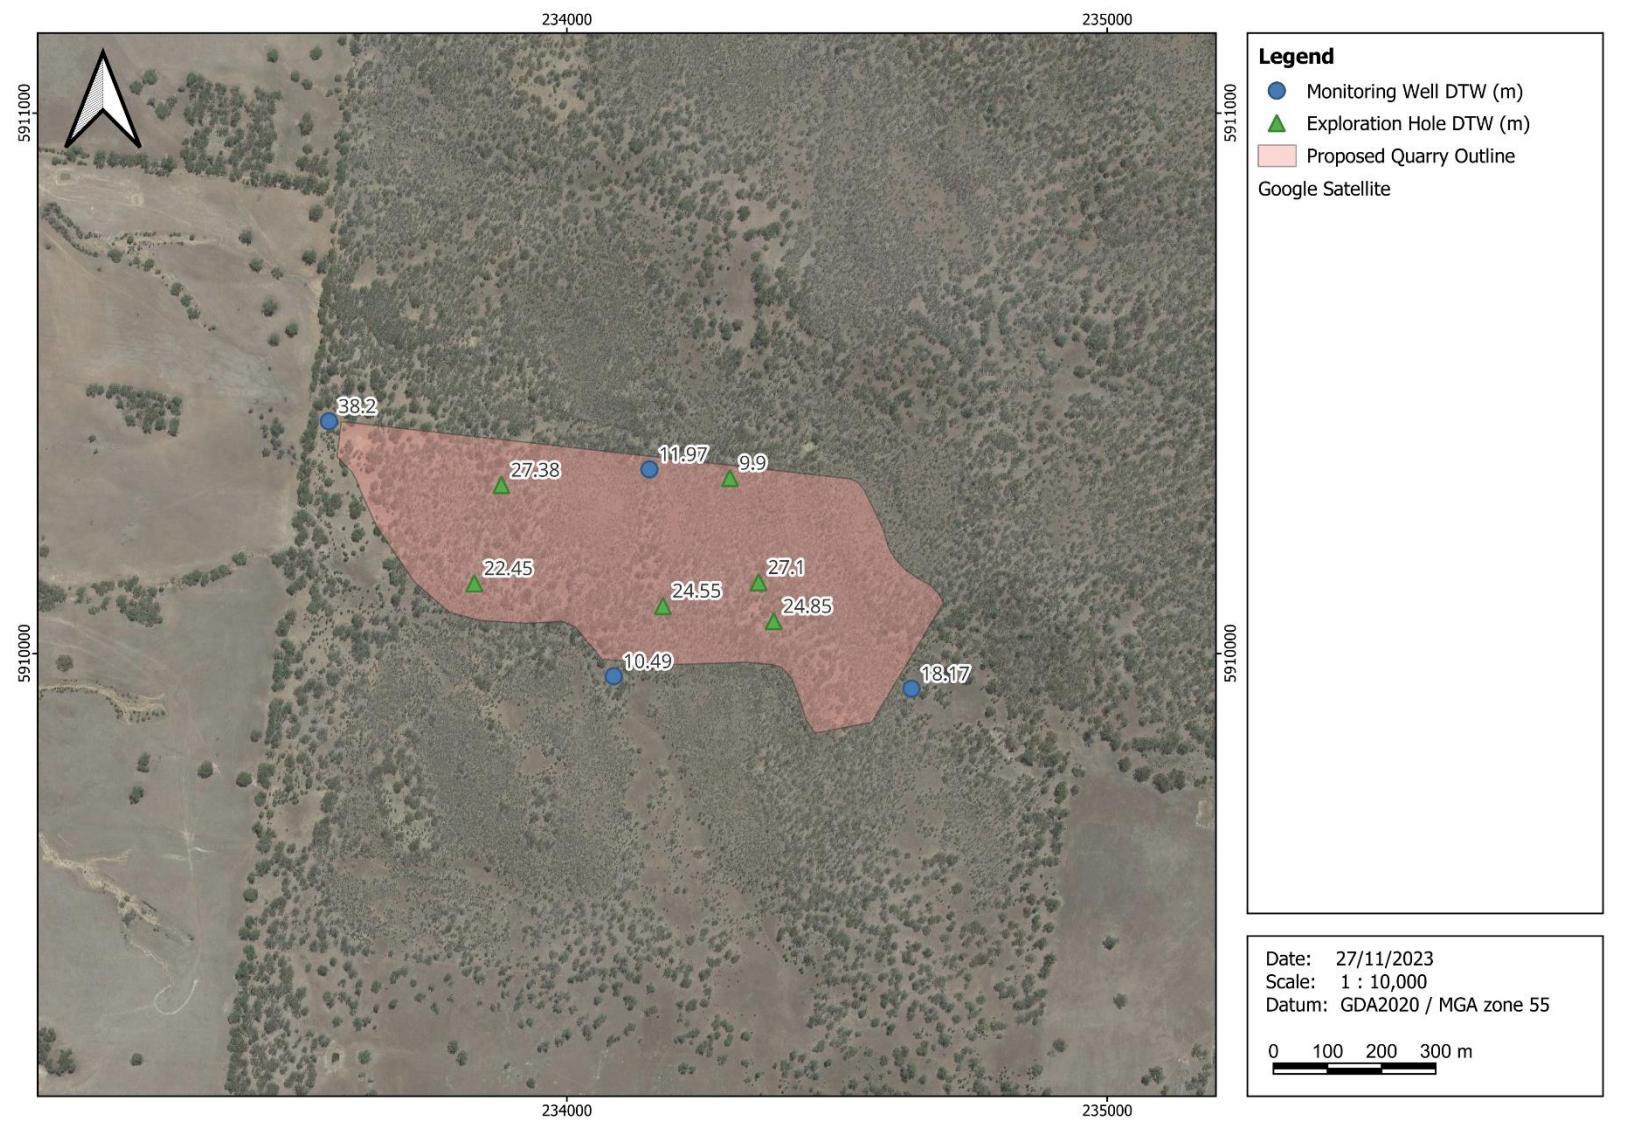
Figure 4-1: Depth to Groundwater November 2023

The combined well and exploration hole data indicates a westerly groundwater flow direction with a hydraulic gradient of around 0.063 m/m. The groundwater flow direction is consistent with the Site topography, which is common in fractured rock aquifer settings. Groundwater depths are deepest through the middle of the proposed pit where surface elevation is highest. Shallower groundwater depths are observed near drainage lines south and north of the proposed pit.

Groundwater depths were found to be variable ranging from 9.9 m up to 38.2 m below ground level based on the data collected from the four constructed wells and six exploration holes. The depth to groundwater is deepest in the elevated areas through the centre of the proposed quarry footprint and shallowest to the north and south of the proposed quarry. Groundwater flow is from east to west, consistent with the topographic gradient at the Site. Groundwater flow is interpreted to occur via fractures and faults, though these appear to be limited in extend and connectivity based on the observations made during drilling. The primary porosity of the rock mass is expected to be very low.

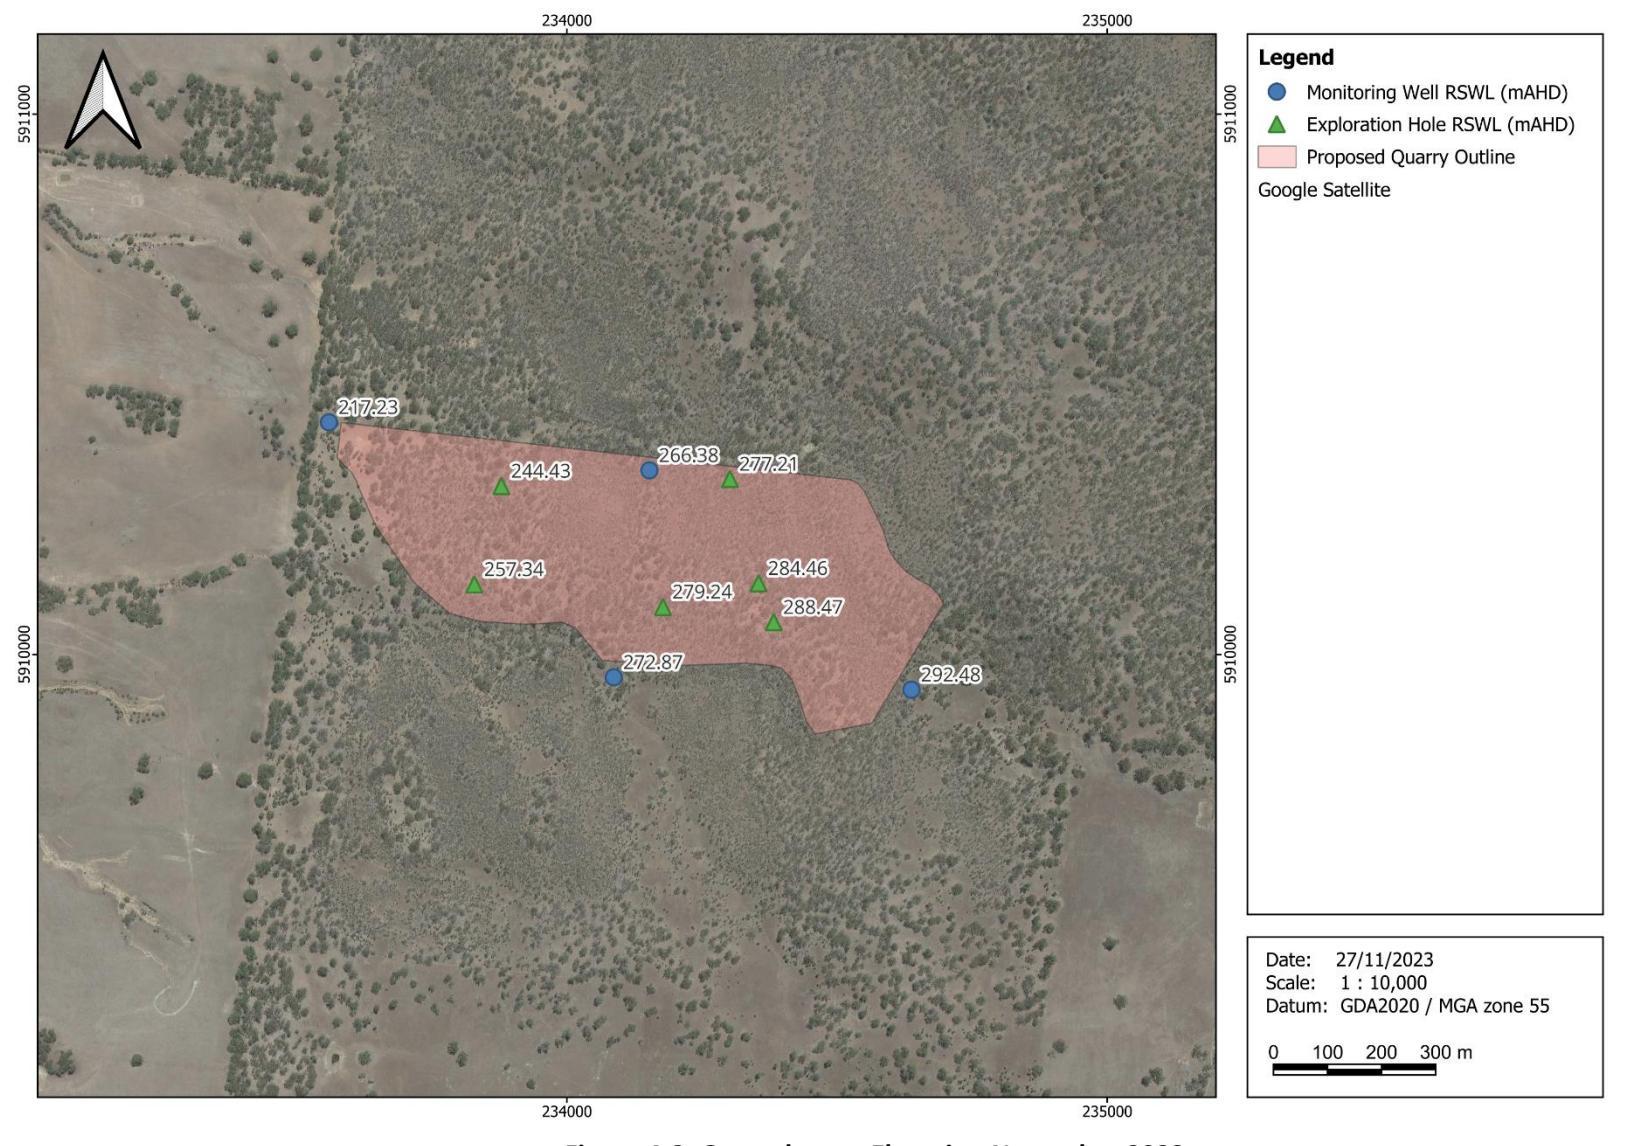
Figure 4-2: Groundwater Elevation November 2023

Groundwater levels in the fractured rock aquifer were measured at the end of the field program in the four completed wells (Table 4-1). Measurements were taken from the top of the casing, which is commonly referred to as the wells reference point. Depth to groundwater measurements were corrected to reduced standing water levels (RSWL) relative to the Australian Height Datum (AHD) using 50 cm resolution LiDAR elevation data (supplied by Groundwork Plus). Depth to groundwater measurements ranged from 10.49 m to 38.20 m below ground level (Table 4-1 and Figure 4-1). Groundwater elevations from the four completed wells range from 292.48 at Site 1 to 217.23 mAHD at Site 2 (Figure 4-2).

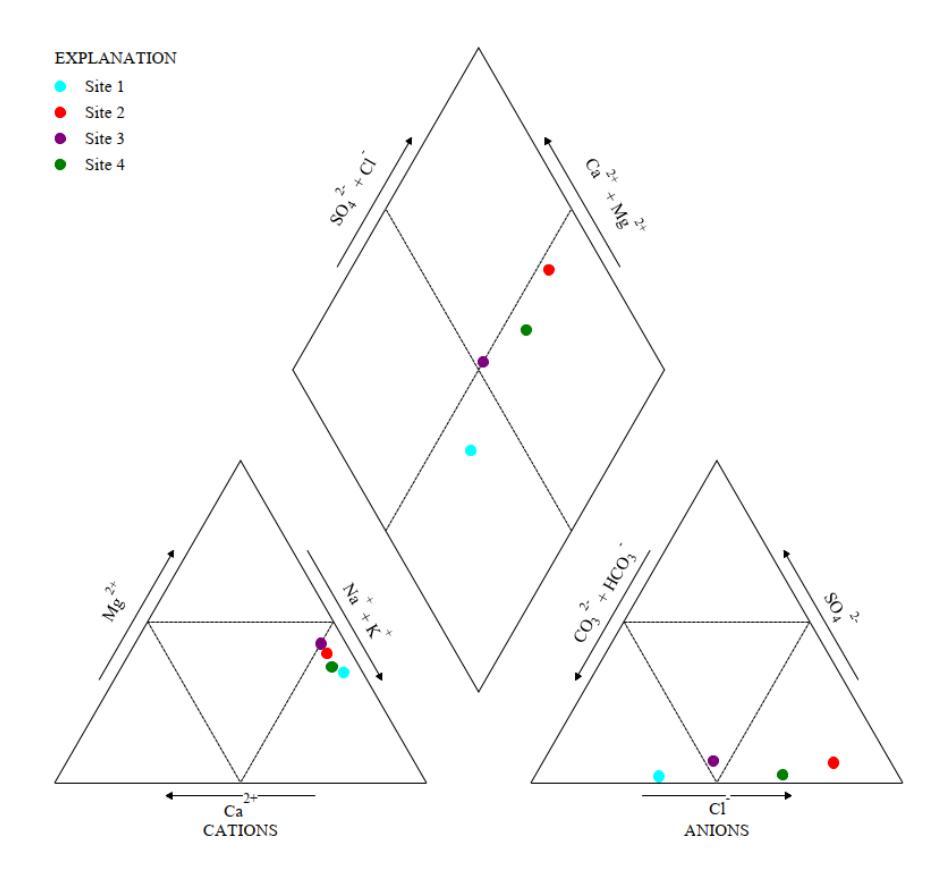
Figure 4-3: Piper Diagram

- The four sites exhibit slightly different ionic compositions suggesting the aquifer may be compartmentalised (Figure 4-3). The following water types are interpreted from the piper diagram (Figure 4-3):

- \circ Na-K-HCO₃ at Site 1.
 - \circ $\,$ Na-Cl at Site 2 and 4.
 - No dominant type (i.e. mixed) at Site 3.

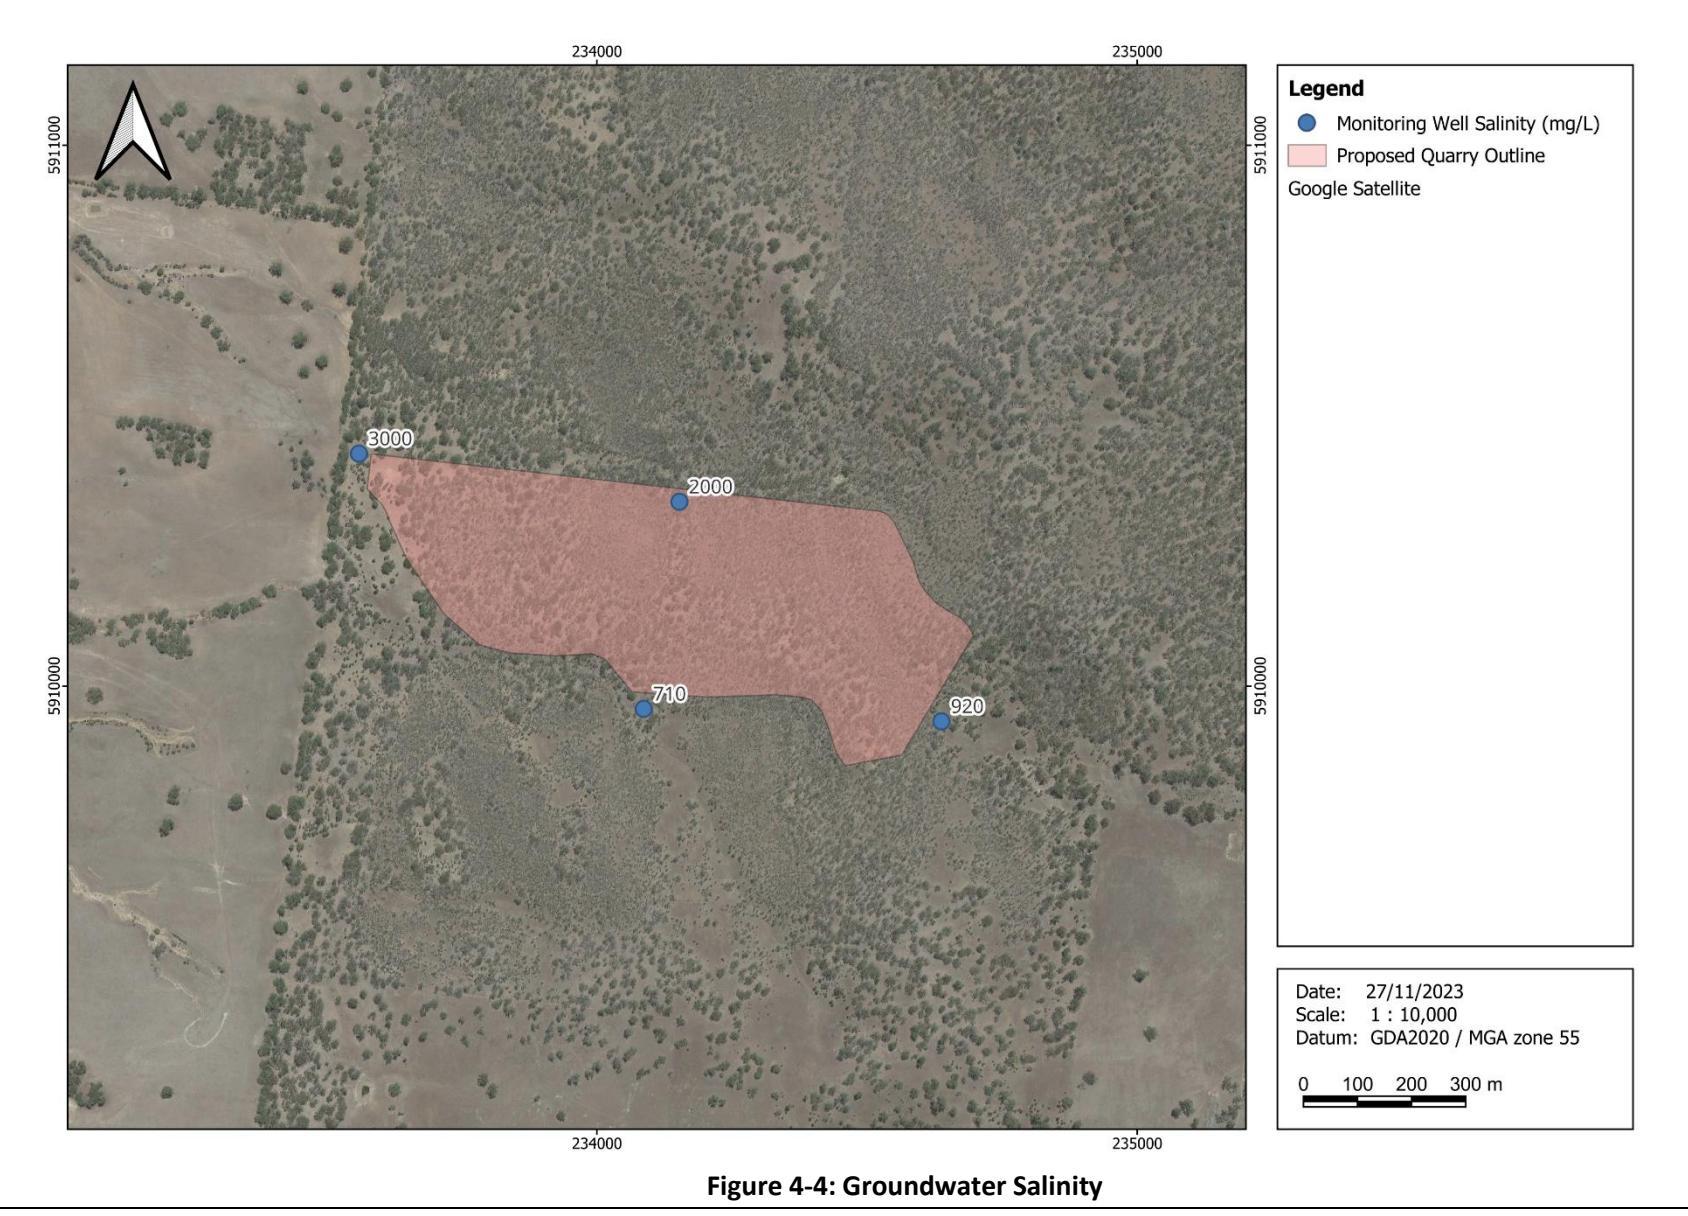
- Groundwater salinity at the site is fresh to brackish, ranging from 710 mg/L at Site 3 up to 3,000 mg/L at Site 2 (Table 4 3 and Figure 4-4).
- Groundwater salinity at Sites 1 and 3 meets the salinity guideline for each of the Environment Reference Standard (ERS, 2022) environmental values except potable water supply (desirable) which has a salinity limit of 0-600 mg/L.

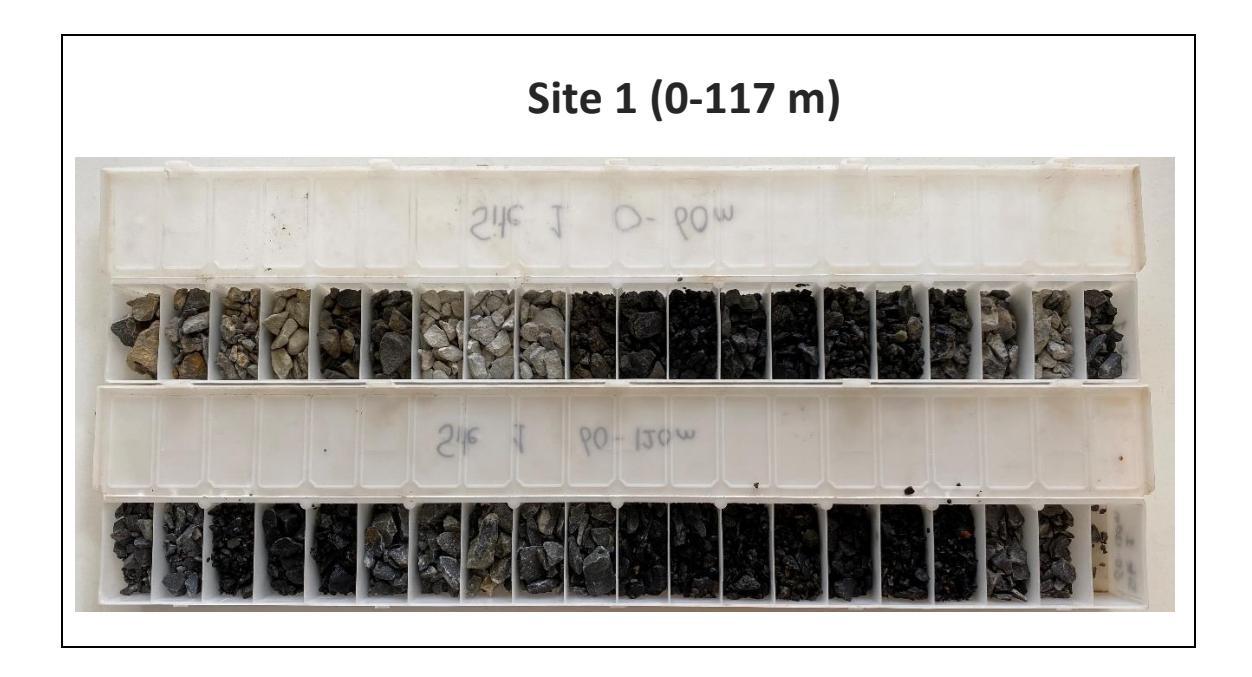
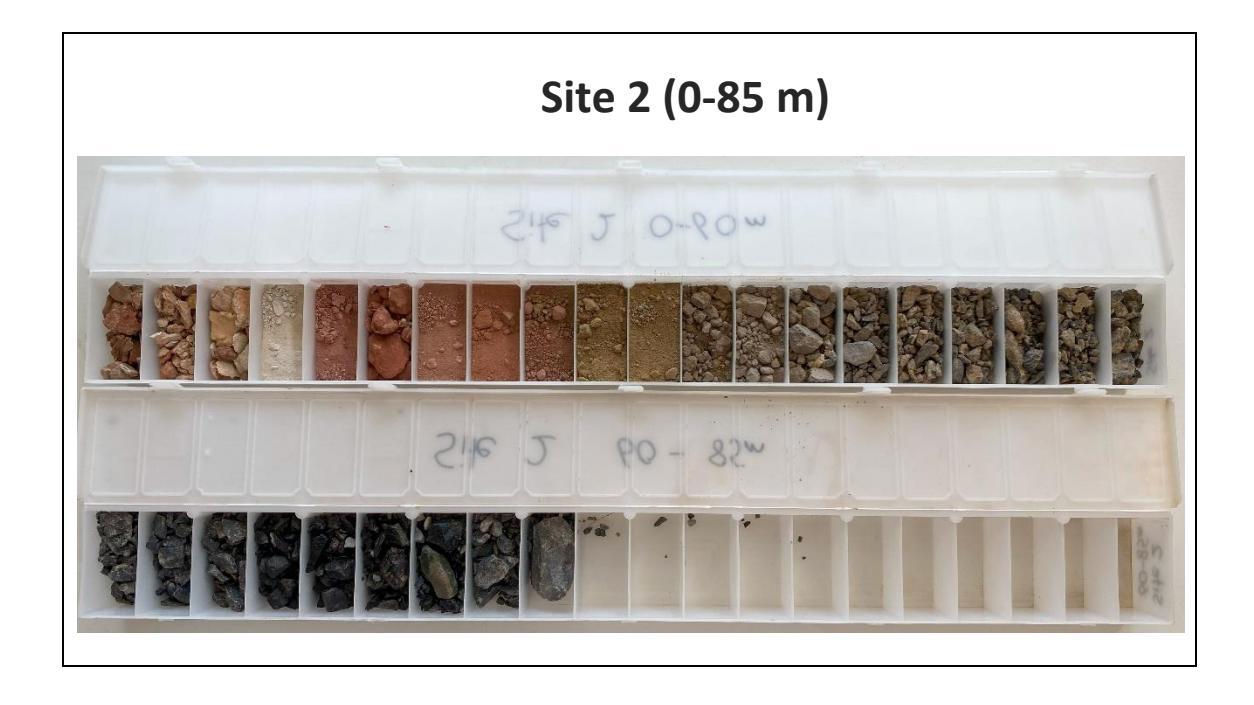
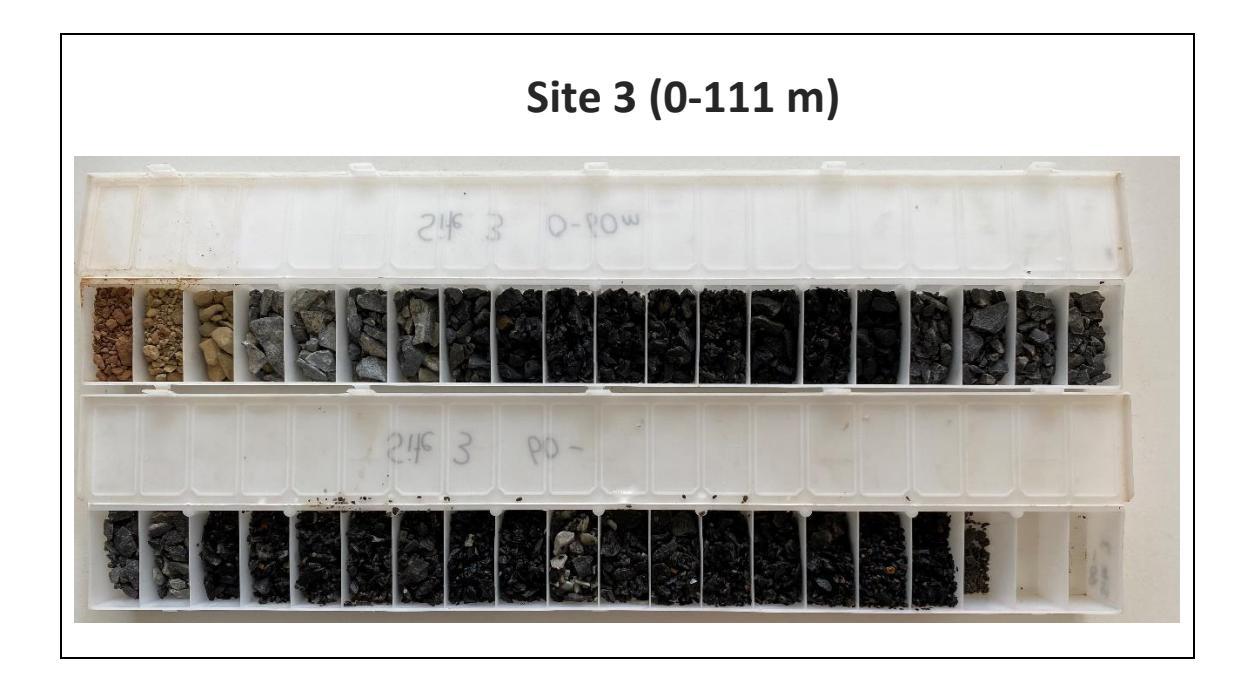
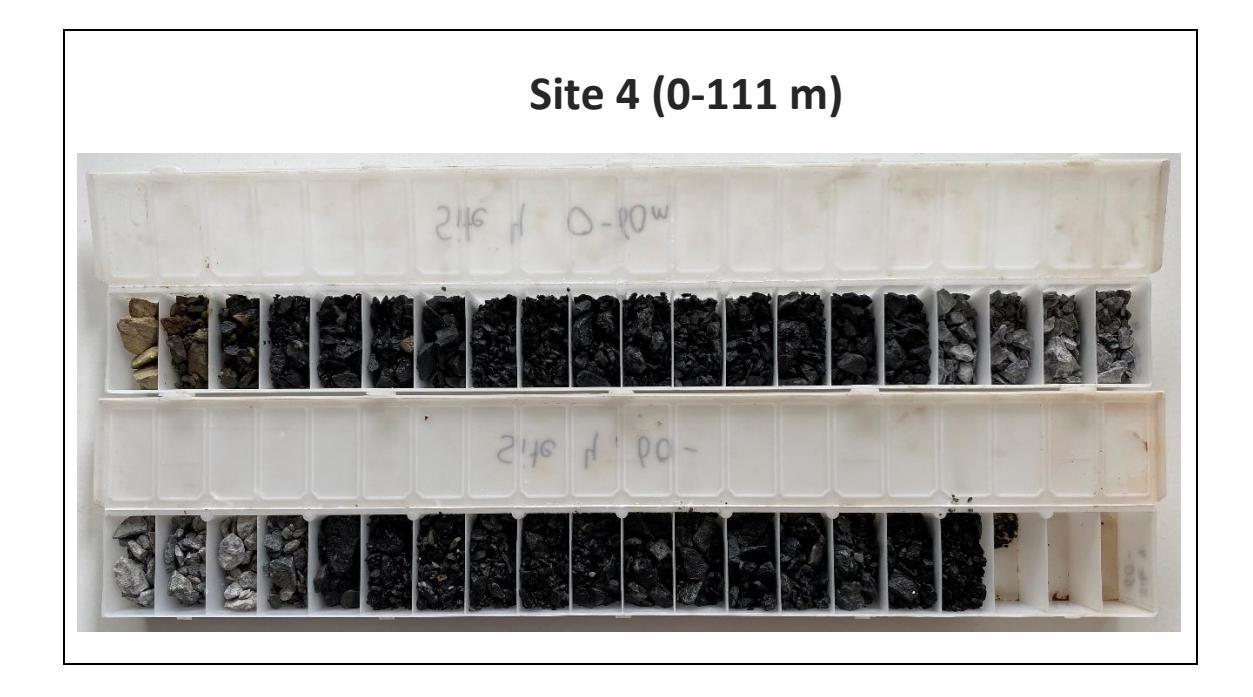
Appendix C: Photographic Logs

Representative lithological samples were collected and placed in chip trays at 3 m intervals. Photographic logs of the chip trays are provided in Appendix C.
