Victorian Murray Floodplain Restoration Project

Flora and Fauna Assessment - Belsar-Yungera Floodplain Restoration Project

IS297762-AP-AP-RP-0012 | Rev 0 22 June 2020

Lower Murray Urban and Rural Water Corporation

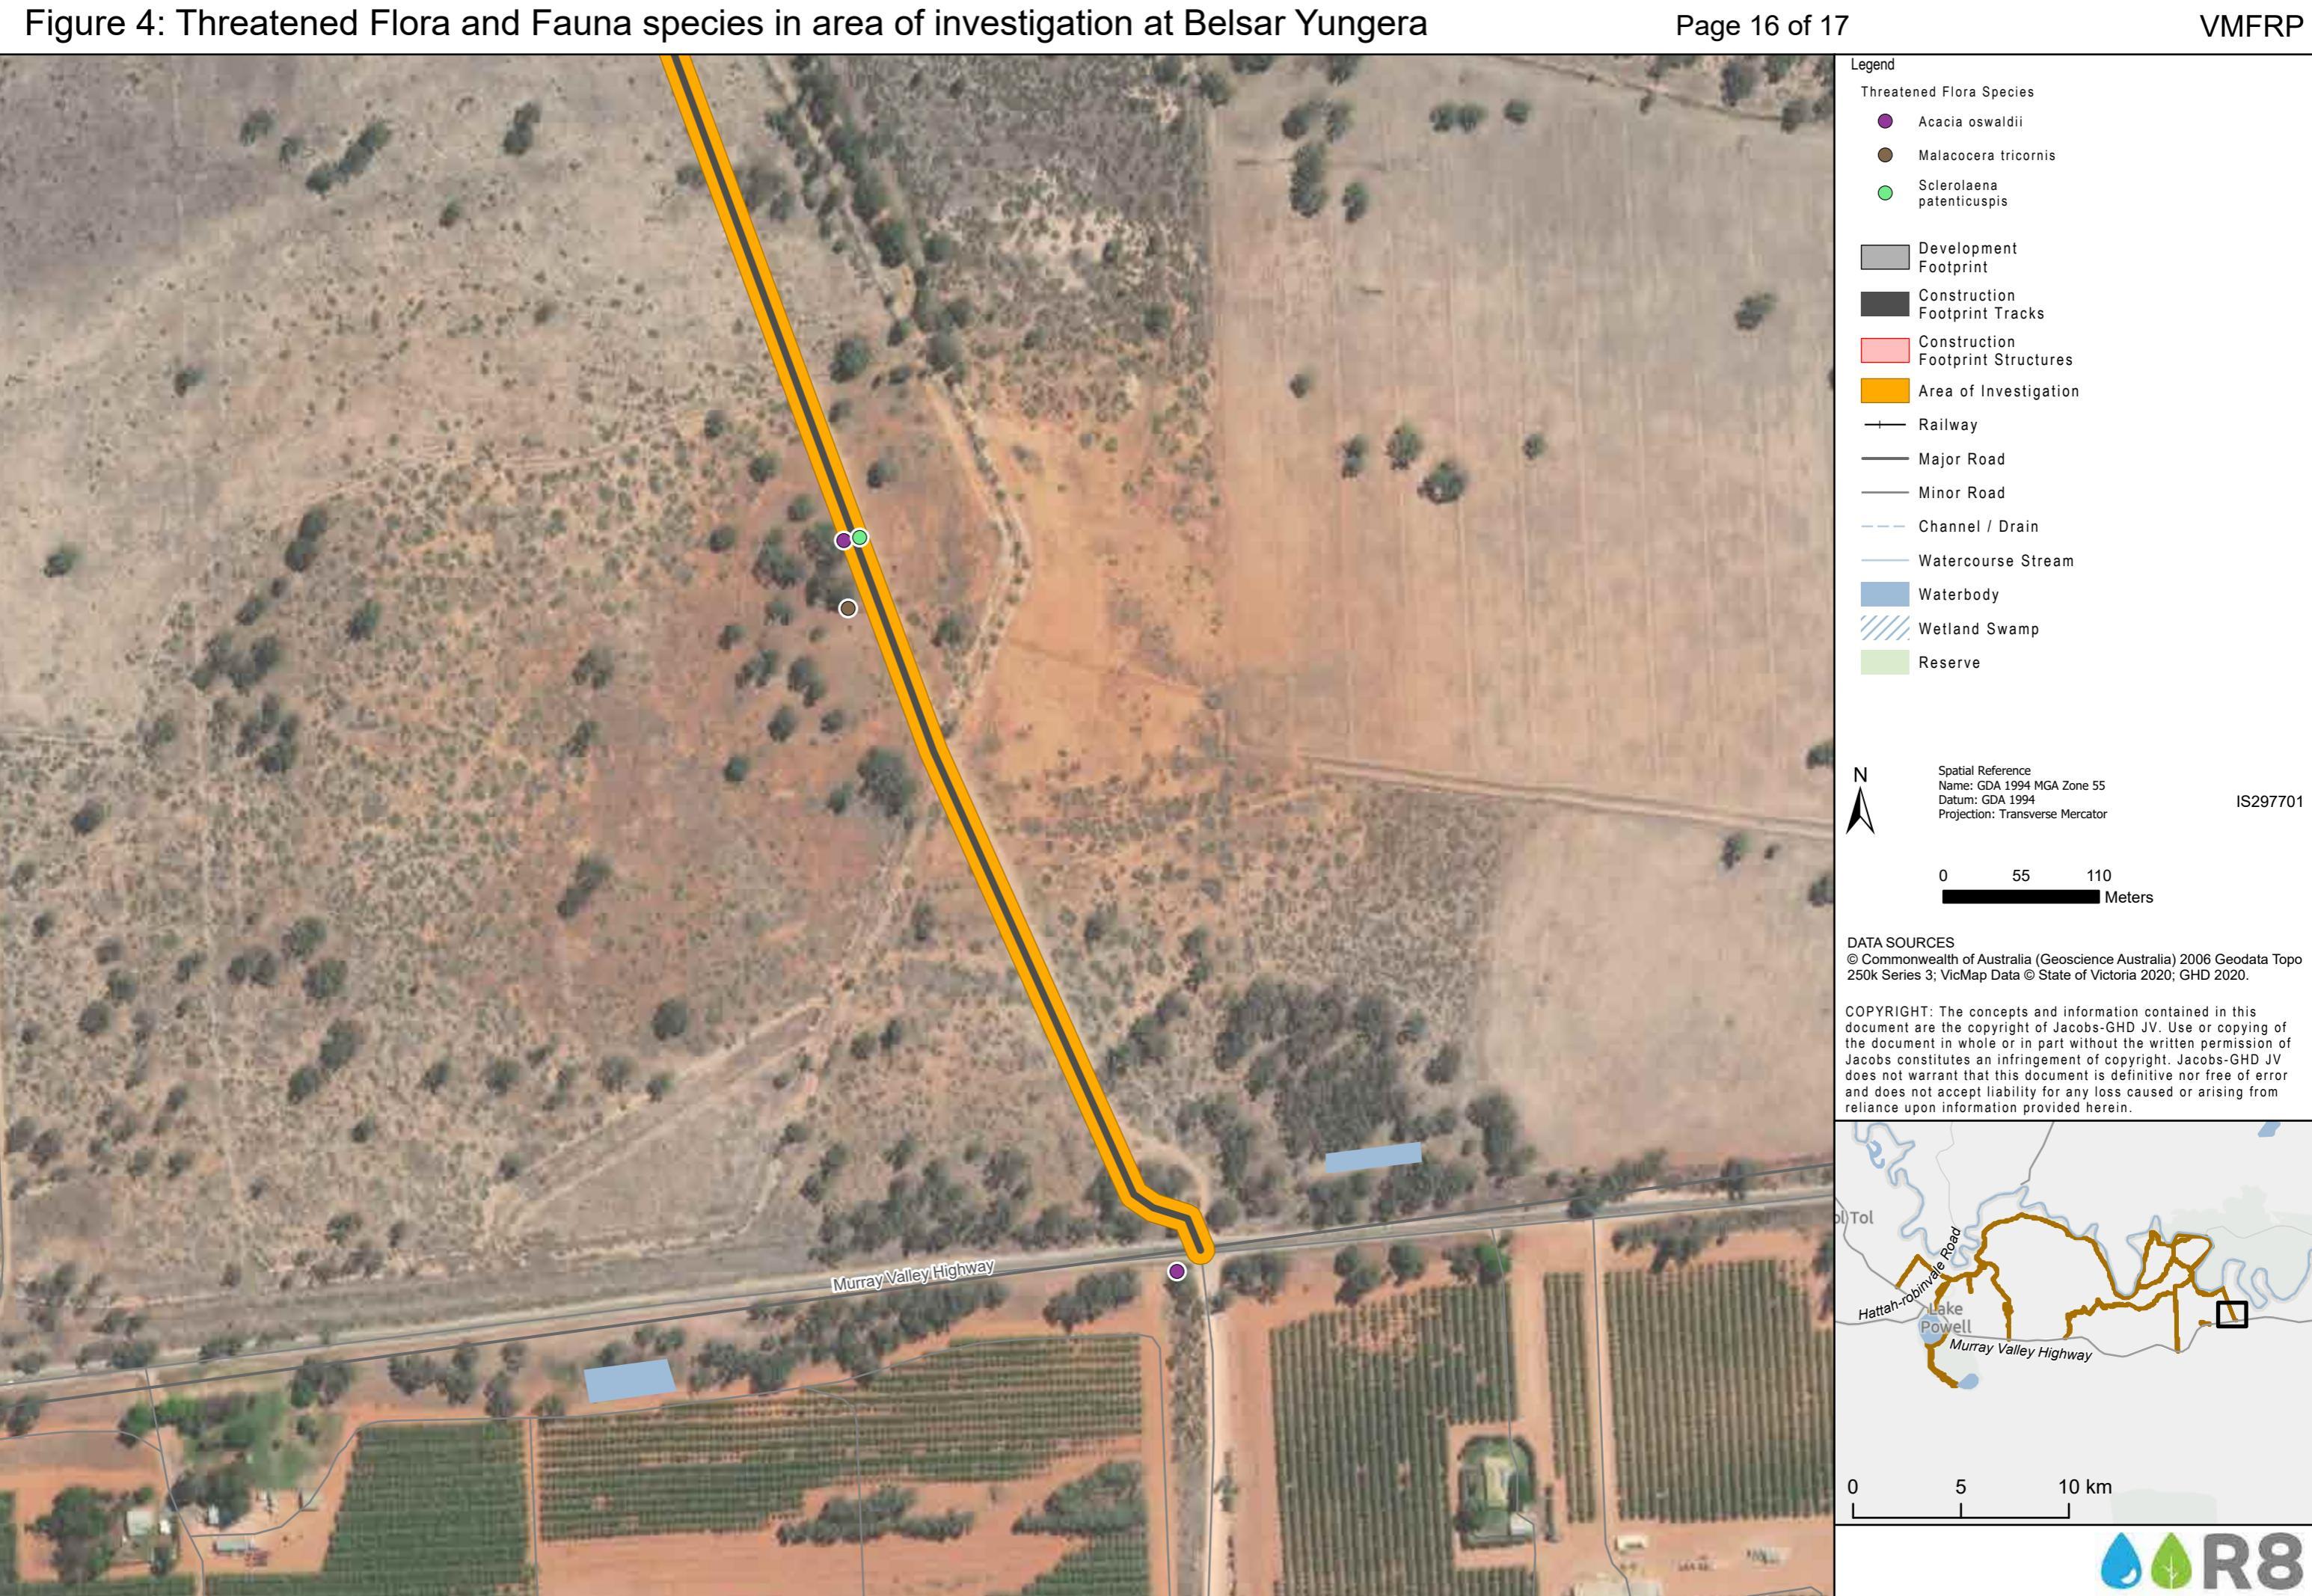
Figure 4: Threatened Flora and Fauna species in area of investigation at Belsar Yungera

Thirty-seven targeted surveys for Regent Parrot nests using the standardised THPS method (**Figure 4Error! Reference source not found.**) were completed at Construction Footprints identified as containing habitat with potential for Regent Parrot nesting – specifically large River Red-gum trees with hollows (Table 5). During the combined 74 hours and 37 THPS of surveys completed across the five key Construction Footprint areas, much Regent Parrot activity was observed, with birds regularly resting in trees and moving through, in and out of the area, no behaviour conducive to breeding was observed. Nor were any young Regent Parrots (notable due to their short tails and drab plumage) observed within the survey areas during all surveys. Results of the surveys are provided in detail in Appendix N.

Across all targeted threatened fauna surveys 10 separate records of a total of 102 Regent Parrots were recorded (Appendix N). This species was found to be widespread, and was regularly observed throughout the broader area, including while travelling to and between survey sites.
