# Esso Pipeline Replacement Project-Giant Gippsland Earthworm Survey Report

January 2014

Prepared for Biosis Pty, Ltd,

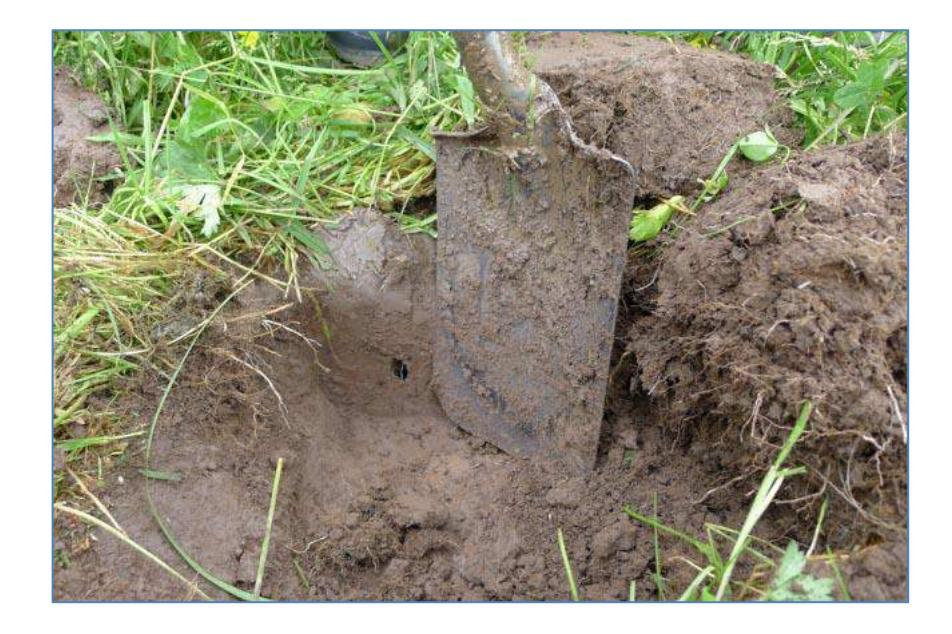
Plate 2 GGE sampling quadrat with earthworm burrow

• Digging small soil quadrats to a maximum depth of approximately 30 cm<sup>3</sup> to look for GGE burrows and cast (waste) material (Plate 2). GGE burrows are much larger than those of other earthworm species (up to 2.5 cm in diameter) and generally have the earthworm's annuli or rings, imprinted on the inside of the burrows (Plate 3). Wet burrows indicate an earthworm is currently occupying the burrow.

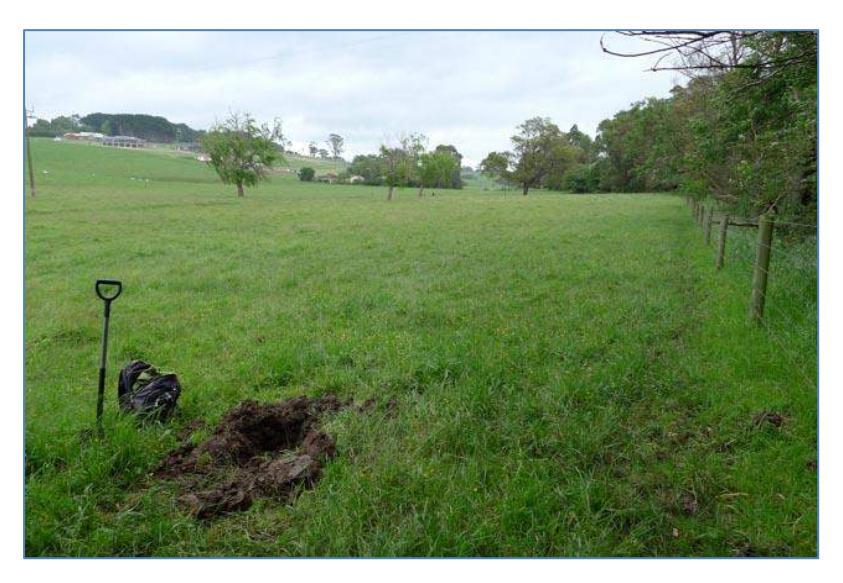
Plate 4 GGE habitat adjacent to fence line at property #11550

GGEs were identified along the north eastern boundary of this property, adjacent to Cameron's Rd (Figure 3). Evidence of GGEs extended approximately 10-15 metres into the pasture but did not extend to the drainage line which traverses east-west through the property (Plate 4). While burrows were located, it was difficult to determine the status of the colony as no gurgles were heard. The land owner had not heard the worms for around 10 years when he collected a live individual while doing drainage works along the fenceline. While GGEs occur within the study area, they are unlikely to occur within the existing pipeline easement which is situated much higher above a north-west facing slope of the property.

Property File Number	Description	GGE habitat and buffer in relation to existing pipeline easement	Recommended mitigation (in order of preference)	
11550	GGE occur within study envelope adjacent to Cameron's road.	GGE colony is approximately 400 m north-west of existing pipeline easement.	<ol> <li>Avoid any excavation and major disturbance to identified GGE habitat and associated roadside verge along Cameron's Rd.</li> <li>Install 30 m buffer to current GGE habitat.</li> <li>If GGE habitat cannot be avoided, trenchless construction is required for any trenching works.</li> </ol>	
11600	Potential for some individuals to occur between existing pipeline easement and Mattzed/Serine Close.	Current pipeline easement intersects northern section of 30 m buffer.	<ol> <li>Use trenchless construction below GGE habitat (minimum 3 m) as a precaution if disturbance to occur in area identified as current GGE habitat.</li> <li>Restrict survey envelope and soil disturbance to as small as feasible.</li> <li>Avoid excavation and soil disturbance to identified GGE habitat, (between Serine Close and existing pipeline easement) and GGE relocation sites.</li> <li>Keep machinery and stockpiling above (north) of existing pipeline easement.</li> <li>If open trenching, excavate to north of existing pipeline to reduce impacts on GGE buffer.</li> <li>Reinstate pre-construction drainage patterns.</li> </ol>

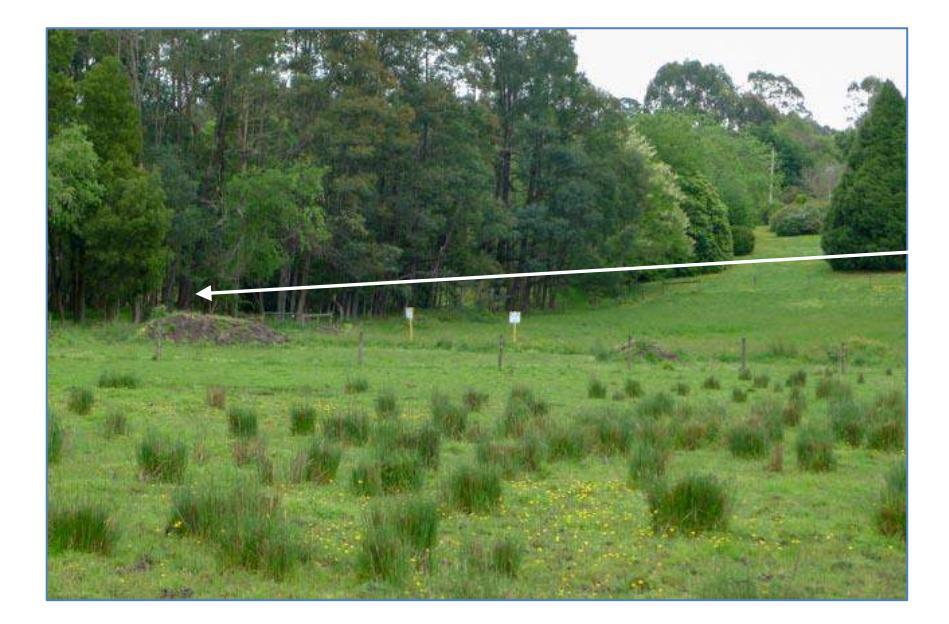
Plate 7 GGE habitat among vegetation adjacent to the southern boundary of survey envelope at property #11610

While no evidence of GGE was found within the survey envelope, a large colony was located adjacent to the southern boundary of the survey envelope (Figure 4, Plate 7) where they occurred extensively within the vegetated area and associated creek bank. It is likely that the colony extends into the survey envelope along its southern boundary, under the tree canopy where suitable conditions were found (Plate 8).

GGE colony adjacent to survey envelope

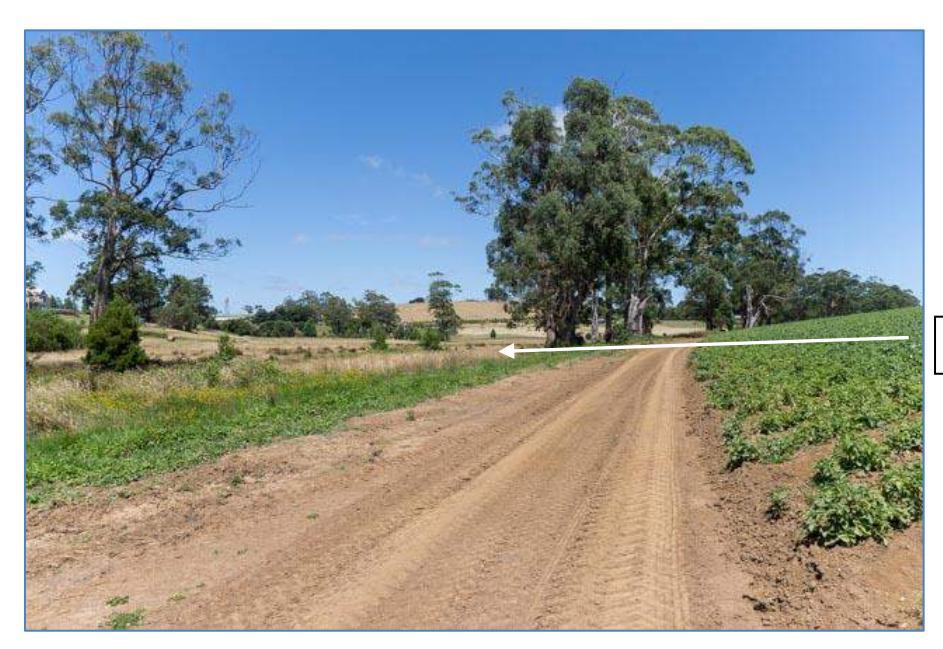
Plate 9 GGE habitat among Swampy Woodland at property #11740

Evidence of GGEs was located among stand of Swampy Woodland Ecological Vegetation Class (EVC) (pers. com Matt, Dell, Biosis) in the northern section of the survey envelope (Figure 6, Plate 9). The colony extended over an area of approximately 75 m east-west and 30 m south from the track to the edge of the water-logged wetland. However, the highest density of burrows was restricted to a smaller area of moist soil in the eastern section of the identified habitat.

GGE colony

Property File Number	Description	GGE habitat and buffer in relation to existing pipeline easement	Recommended mitigation (in order of preference)
11740	GGE found under Swampy Woodland within northern section of survey envelope.	Alignment may intersect southern section of GGE buffer zone.	<ol> <li>Avoid any excavation and soil disturbance to identified current GGE habitat.</li> <li>Install a 30 m buffer around GGE habitat.</li> <li>Trenchless construction where pipeline intersects buffer zone (min. 3 m depth).</li> <li>Install appropriate buffers for launching and retrieval pits (min. 30 m).</li> <li>Engage specialist to be present if any excavation impacts on current GGE habitat identified.</li> <li>Implement Contingency Plan if GGE encountered during works.</li> <li>Keep all associated works and vehicle traffic east of the existing pipeline easement in GGE buffer zone.</li> </ol>

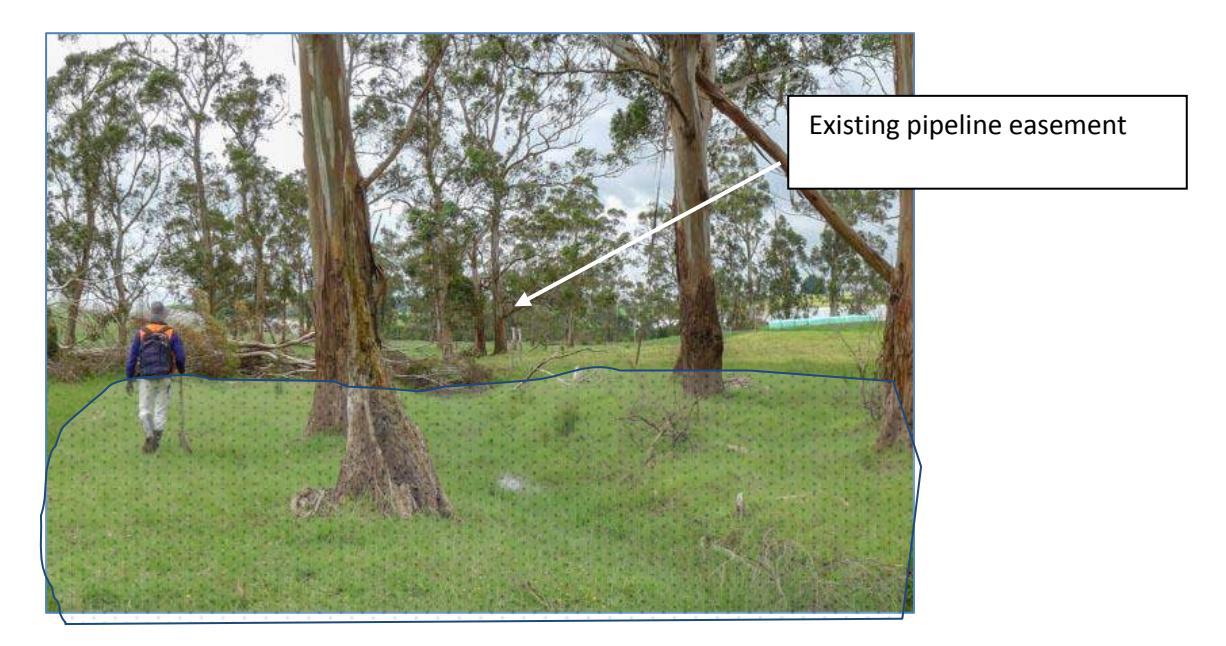
Plate 10 GGE habitat extending to the southern edge of the survey envelope at property #11840

GGEs (including empty egg cocoon) were located in and around a large stand of Damp Forest EVC (pers.com. Matt Dell, Biosis). GGE habitat was located within and adjacent to the southern edge of the survey envelope, around King Parrot Creek (Figure 7, Plate 10 & 11). Burrows did not appear to occur directly within the existing pipeline corridor.

Property File Number	Description	GGE habitat and buffer in relation to existing pipeline easement	Recommended mitigation (in order of preference)
11840	A large GGE colony extends into the southern section of the survey envelope.	Entire survey envelope and current pipeline easement intersects GGE buffer zone and possibly current GGE habitat.	<ol> <li>Avoid any excavation or soil disturbance to current GGE habitat south of the survey envelope.</li> <li>Use trenchless construction below creek and associated GGE habitat (min. depth 3 m) and</li> <li>install appropriate buffers for launching and retrieval pits (min. 30 m).</li> <li>Restrict corridor footprint and soil disturbance to as small as feasible adjacent to GGE habitat.</li> <li>Ensure creek banks within GGE habitat and buffer zone remain intact.</li> <li>Keep all associated works and vehicle traffic to the north of the existing pipeline easement where GGE habitat is less suitable.</li> </ol>

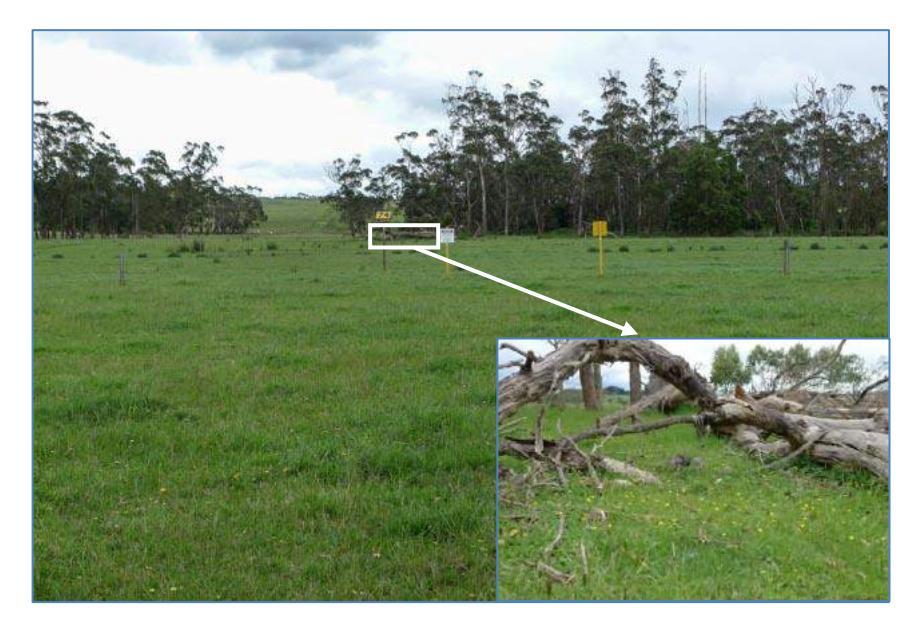
Plate 12 GGE habitat within and adjacent to stand of vegetation at #11860

One GGE colony was identified from within the study envelope. The colony was found in the open areas of the stand of remnant vegetation and extended approximately 8 m into the pasture around the edges of the vegetation (Figure 8, Plate 12). Two additional sites outside the survey envelope were identified as containing potential GGE habitat, but no evidence was found (Plate 13 & 14).
