Davidson Design Studio

Fulham Solar Farm Visual Impact Assessment

September 2021

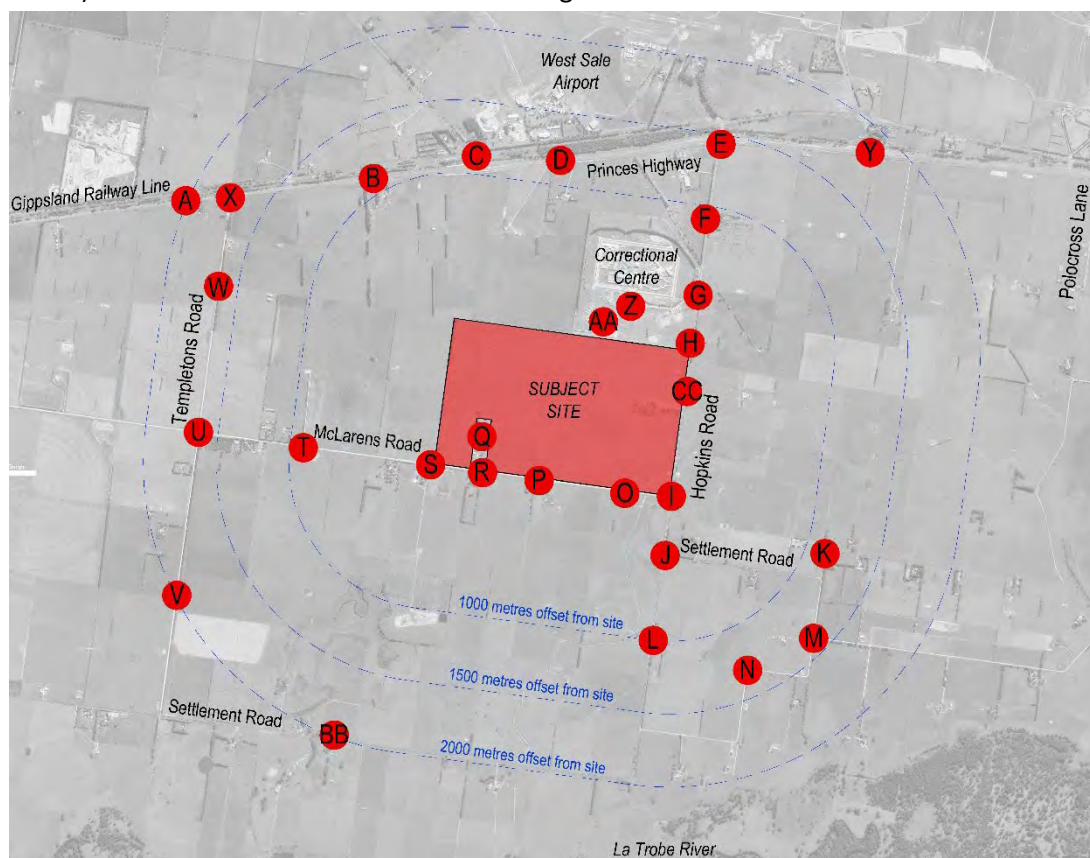
Figure 11: Map illustrating desktop sites selected for viewing potential.

A desktop evaluation was undertaken prior to conducting a site visit to determine zones of visual influence. The zone of visual influence is the theoretically defined area where modification to the subject site, as a result of the proposal, could be potentially discernible to the naked eye. Review of aerial photography, topographical data and documented landforms and features identified 29 (A-CC) potential viewing locations within a 2.5-kilometre radius from the subject site. Topographical data was sourced from the Level and Feature Survey prepared by One Plan Land Development Consultants (11.08.2020). This information is contained within Figure 4.

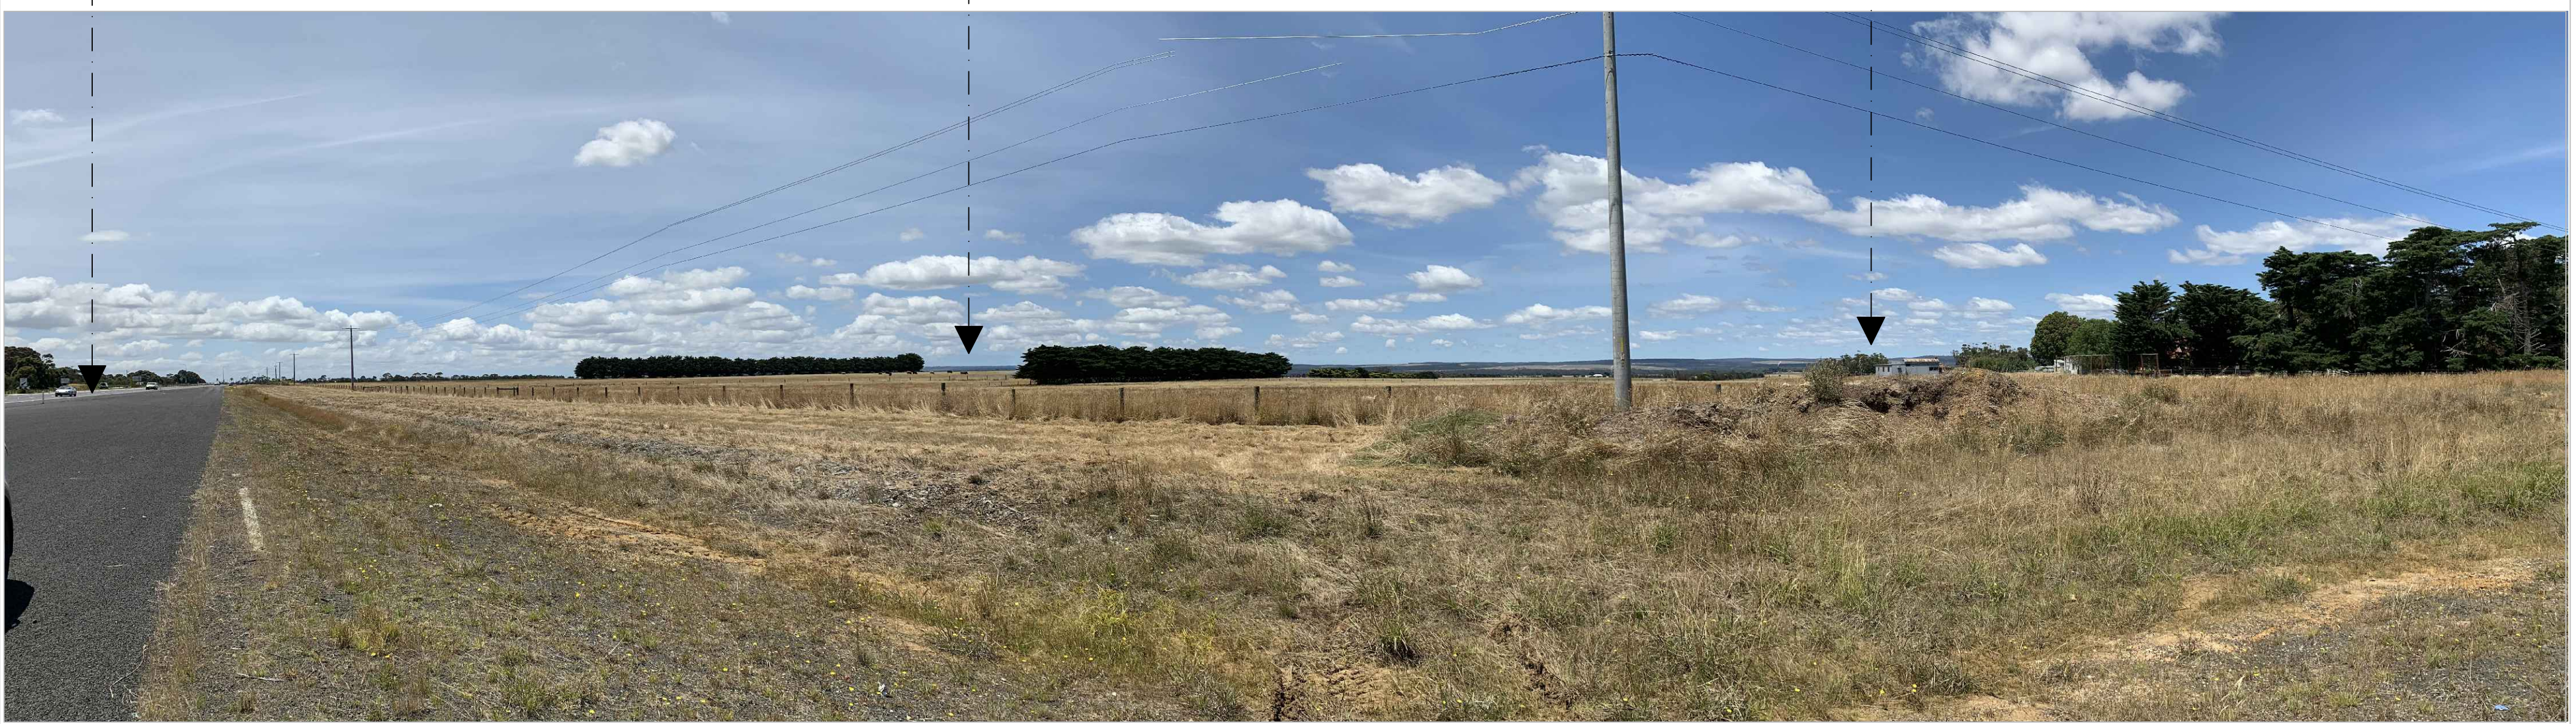
Existing View

Infrastructure, a flat plain, a high level of land alteration and high weed cover define this sensitivity of view as being **low**. Occasional windrows of exotic vegetation and the monotony of a highly altered agricultural landscape further characterize the view.

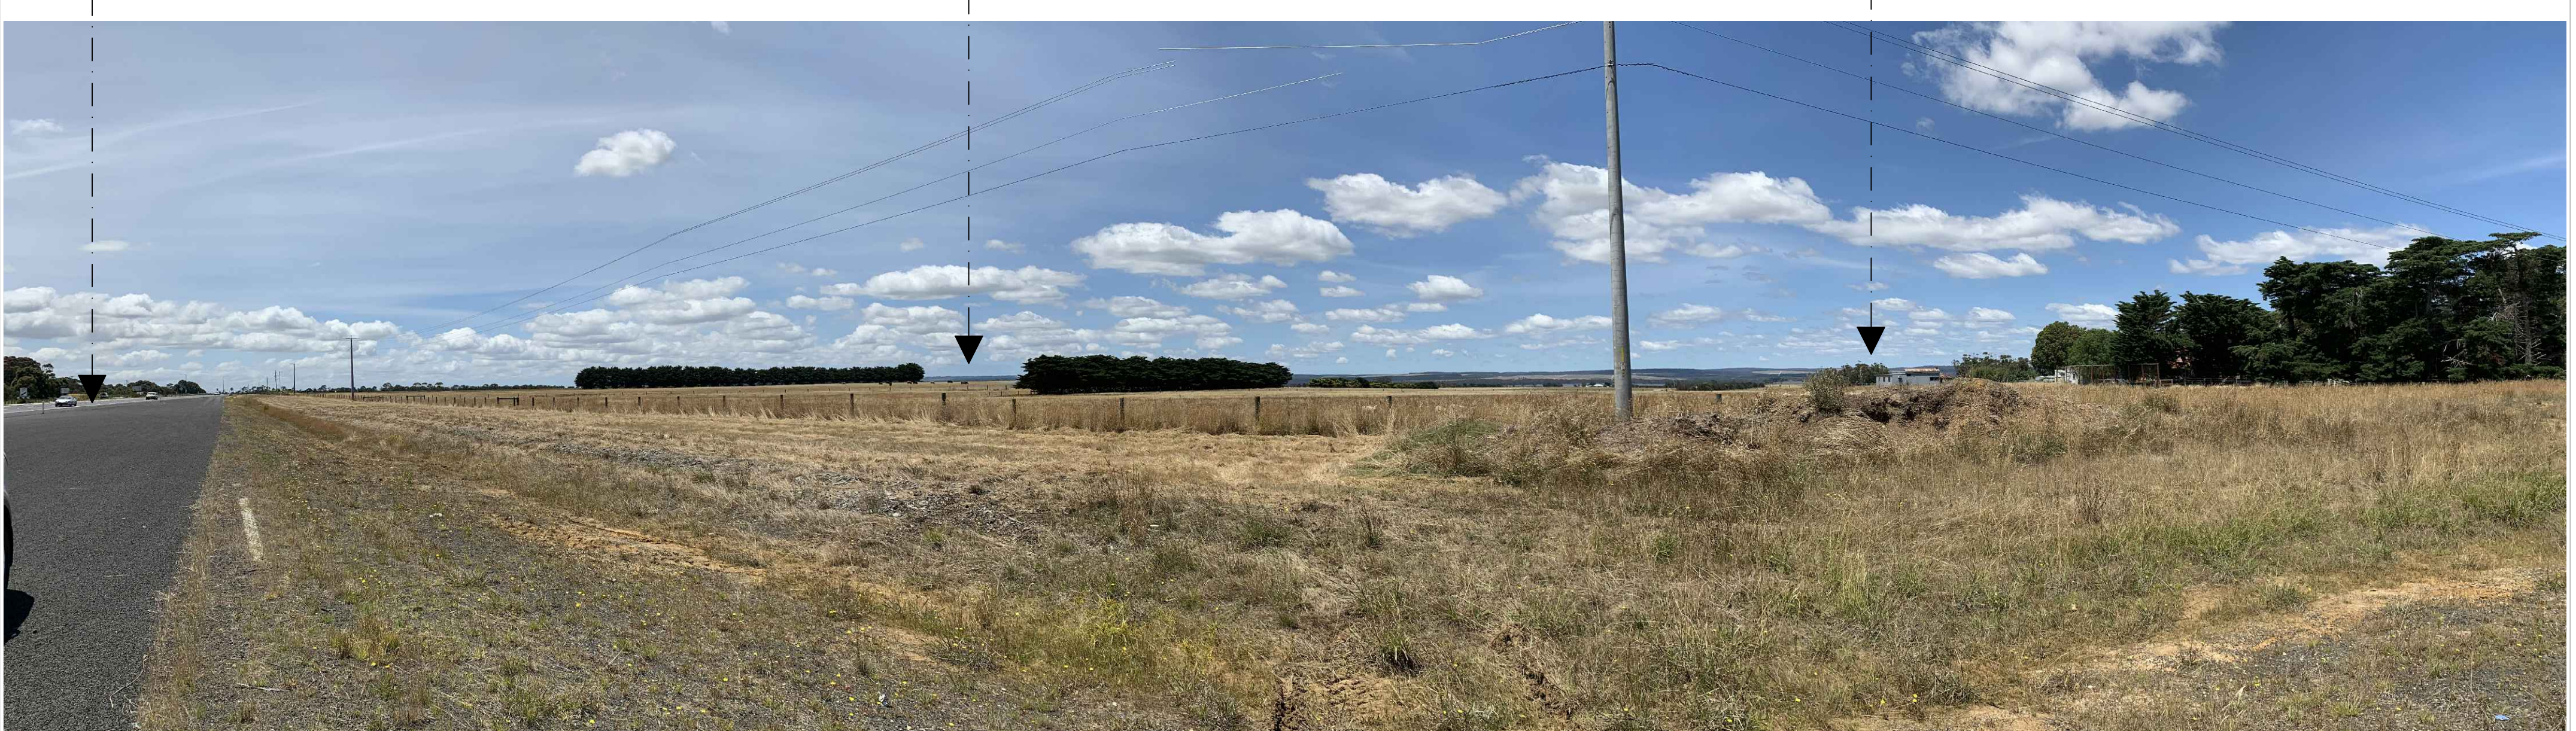
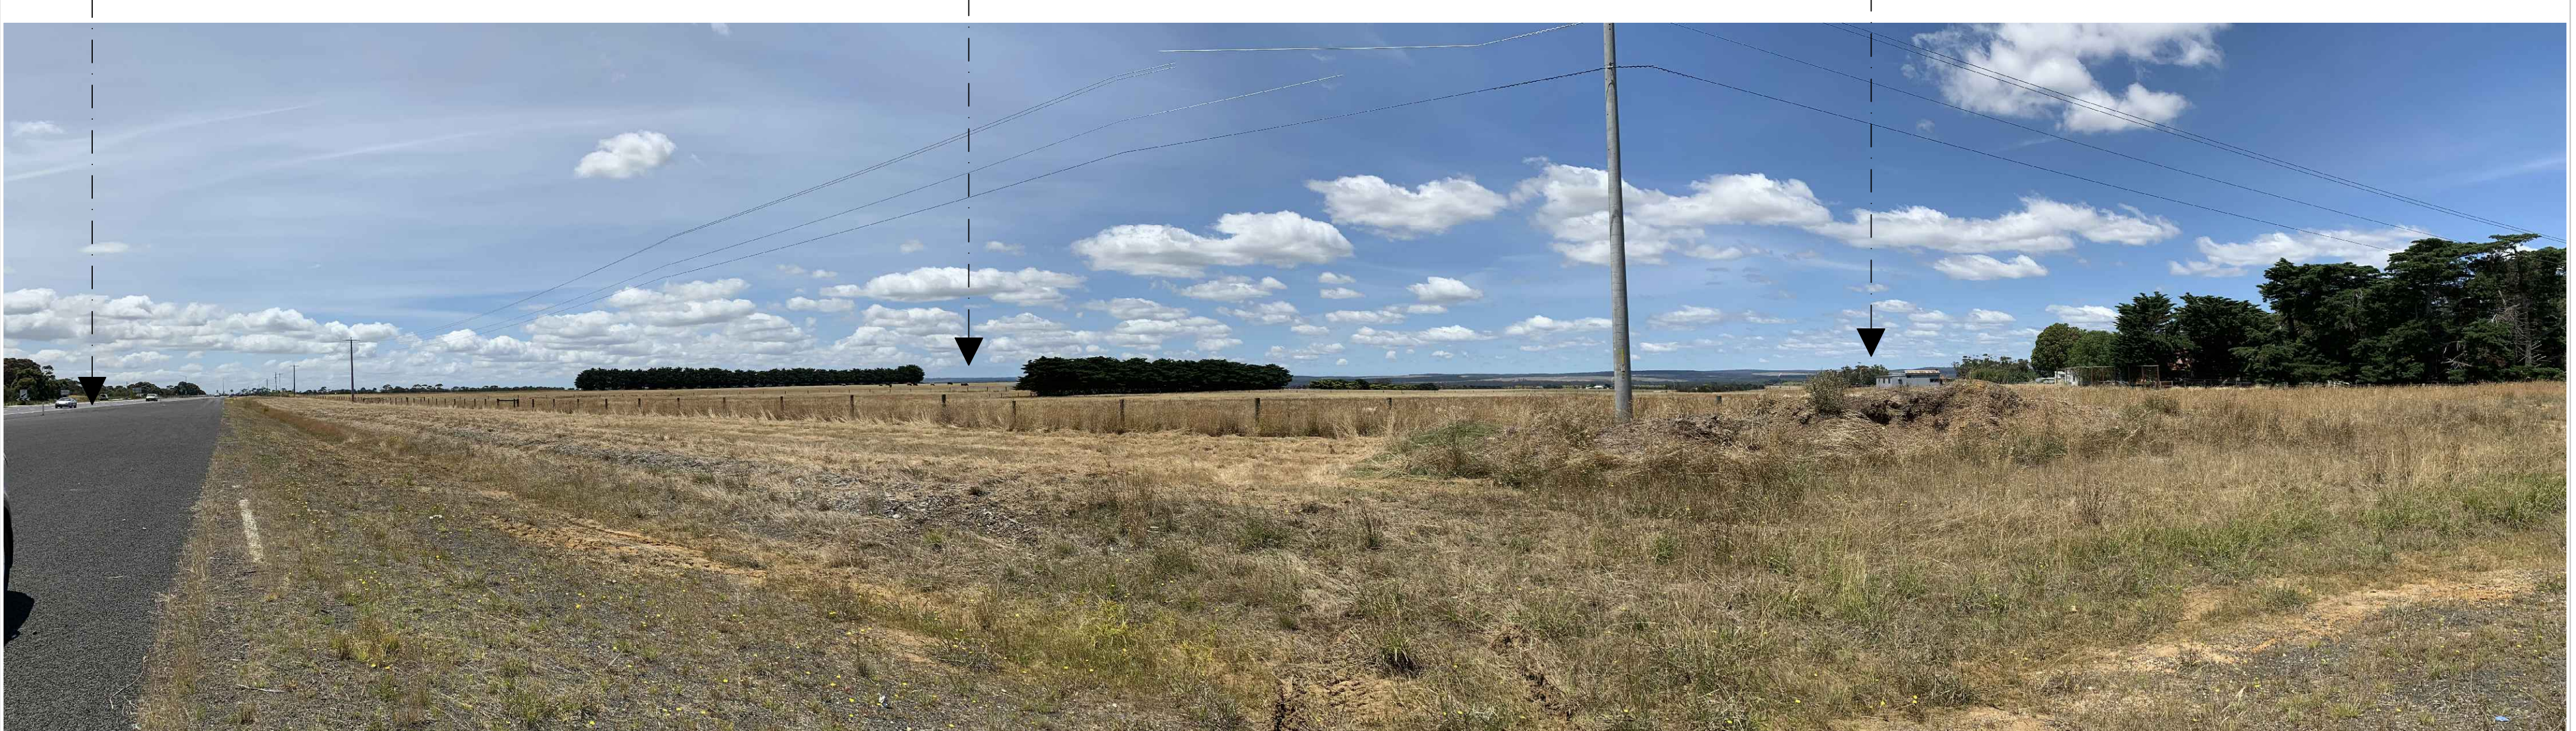
Photomontage without Intended Landscape

The proposed landscape buffer on the northern boundary of the subject site can be seen just below the horizon in the above visual representation. The solar panels are scarcely visible from this location and the associated infrastructure of the facility is not visible at all. It is therefore deemed the proposal would cause little to no discernable deterioration in the existing view. This classifies the magnitude of change as **very low**. When the low sensitivity of view is applied to this magnitude of change, the resulting visual impact is **very low**.

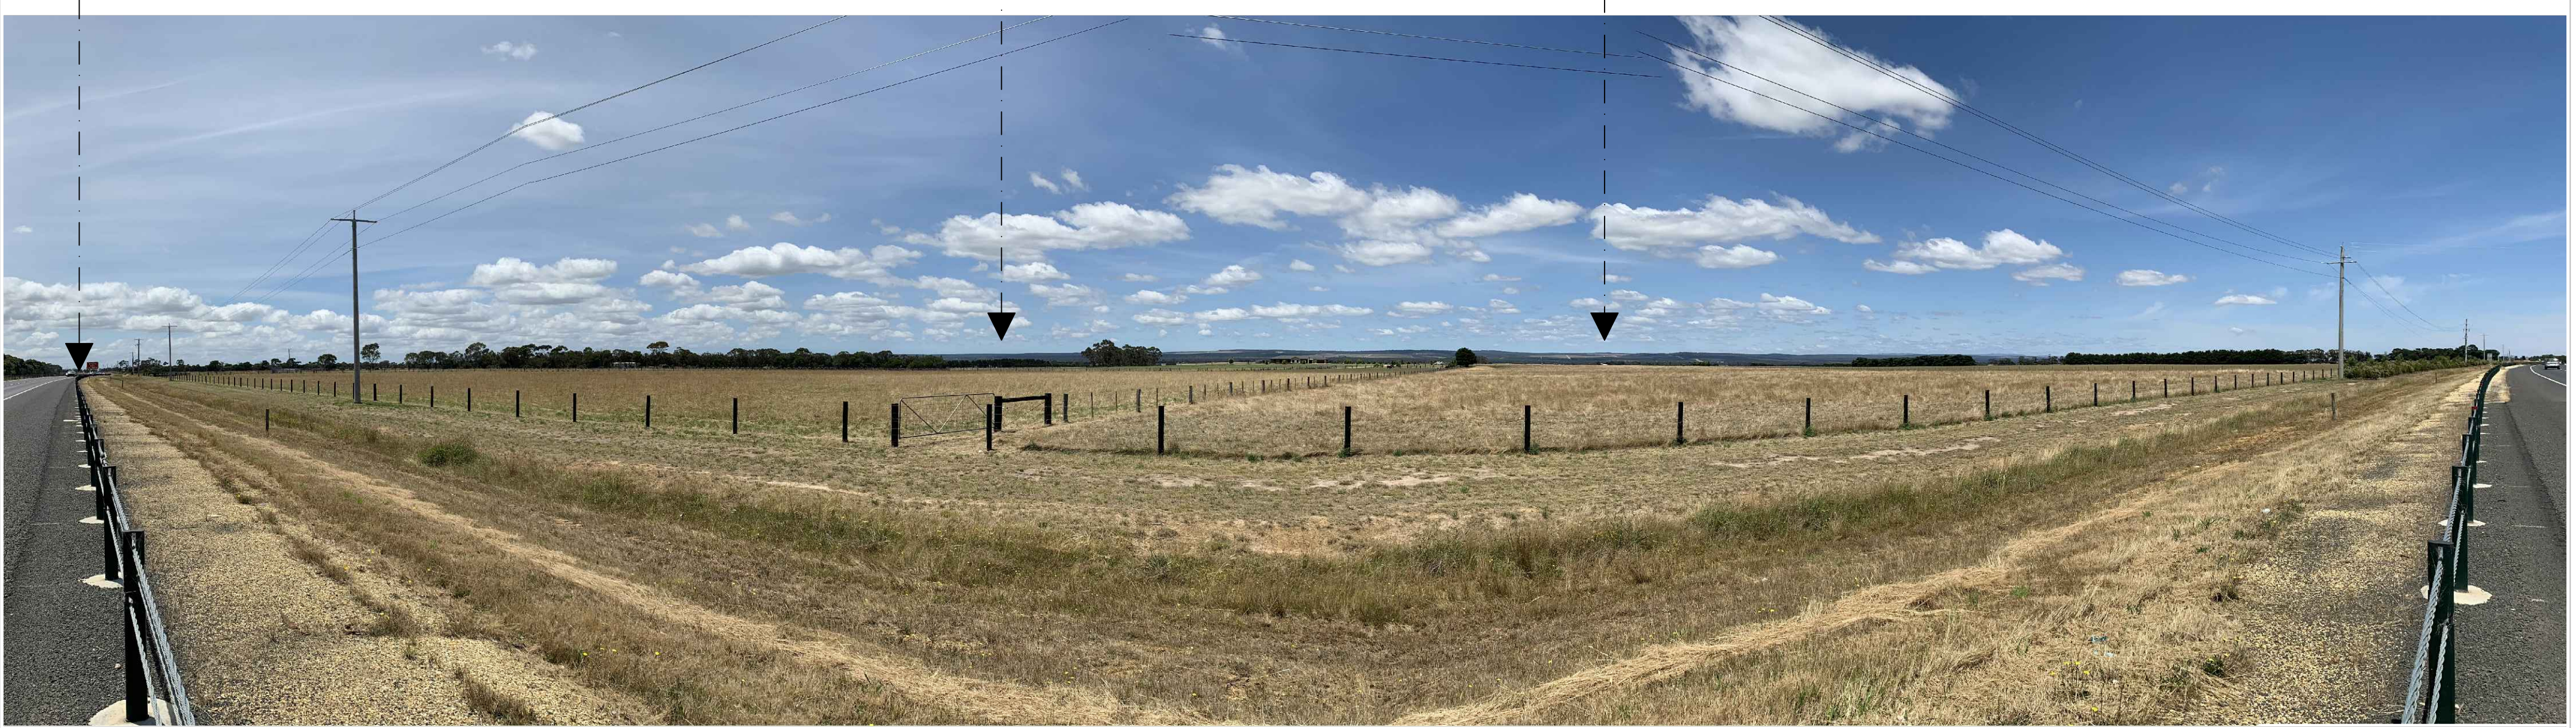
Existing View

Infrastructure, a flat plain, a high level of land alteration and a moderate weed cover define this sensitivity of view as being **low**. Despite the presence of native vegetation and distant views and the visual absence of erosion, salinity and poor drainage, the dominant characteristics of this view is of a highly altered agricultural landscape.

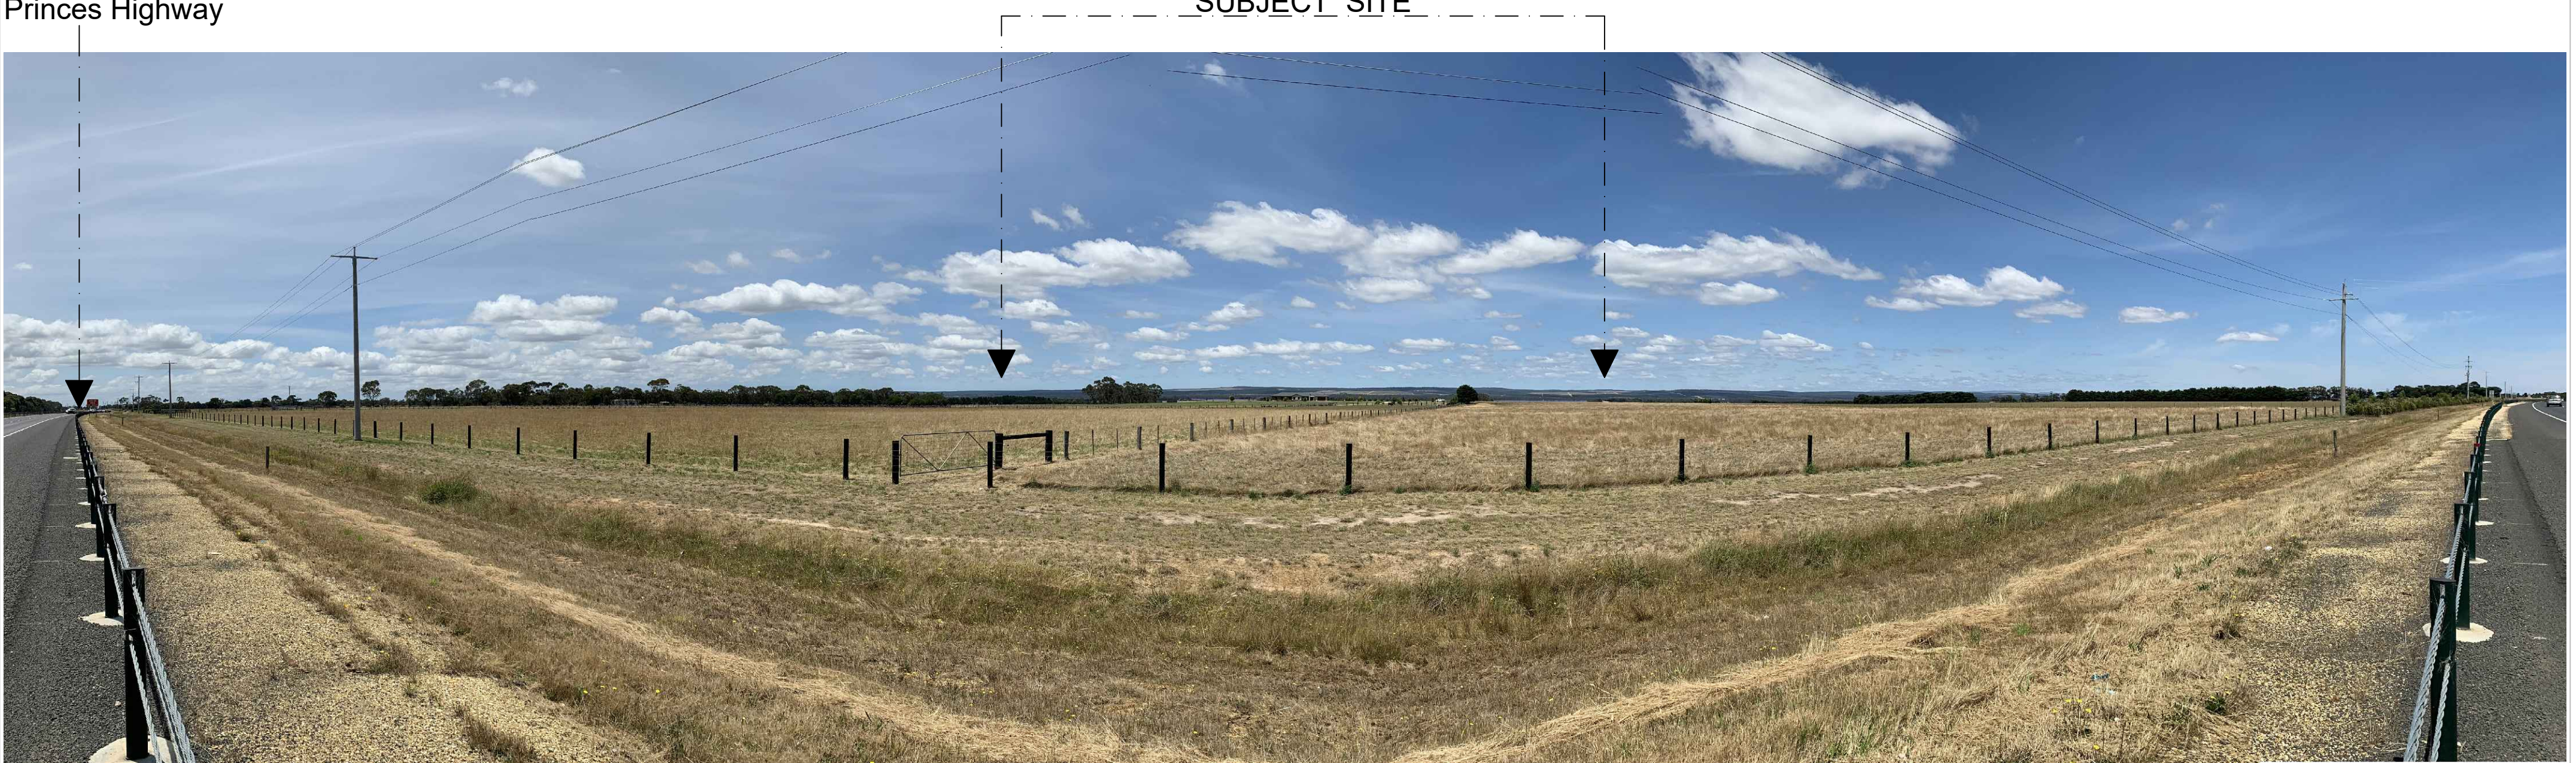
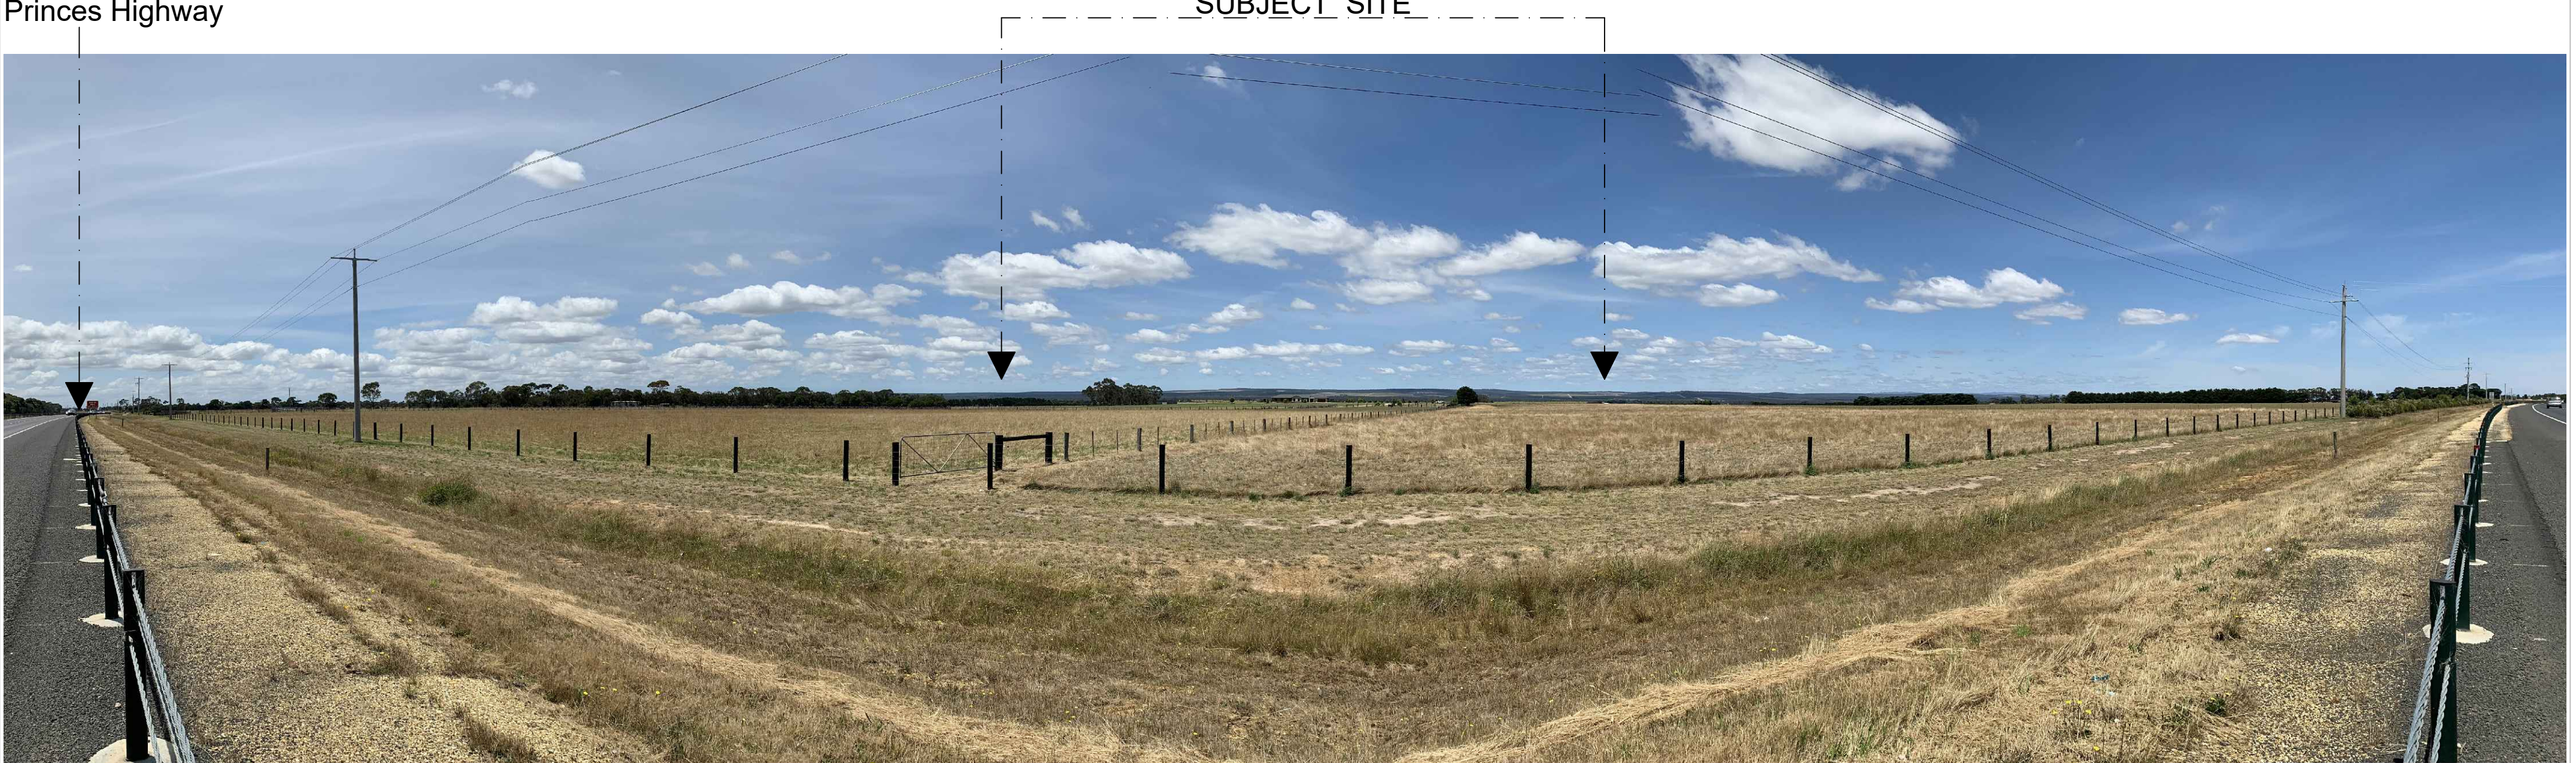
Photomontage without Intended Landscape

The proposed landscape buffer on the northern boundary of the subject site can be seen below the horizon in the above visual representation. The solar panels are not visible from this location nor is the associated infrastructure of the facility. It is therefore deemed the proposal would cause little to no discernable deterioration in the existing view. This classifies the magnitude of change as **very low**. When the low sensitivity of view is applied to this magnitude of change, the resulting visual impact is **very low**.

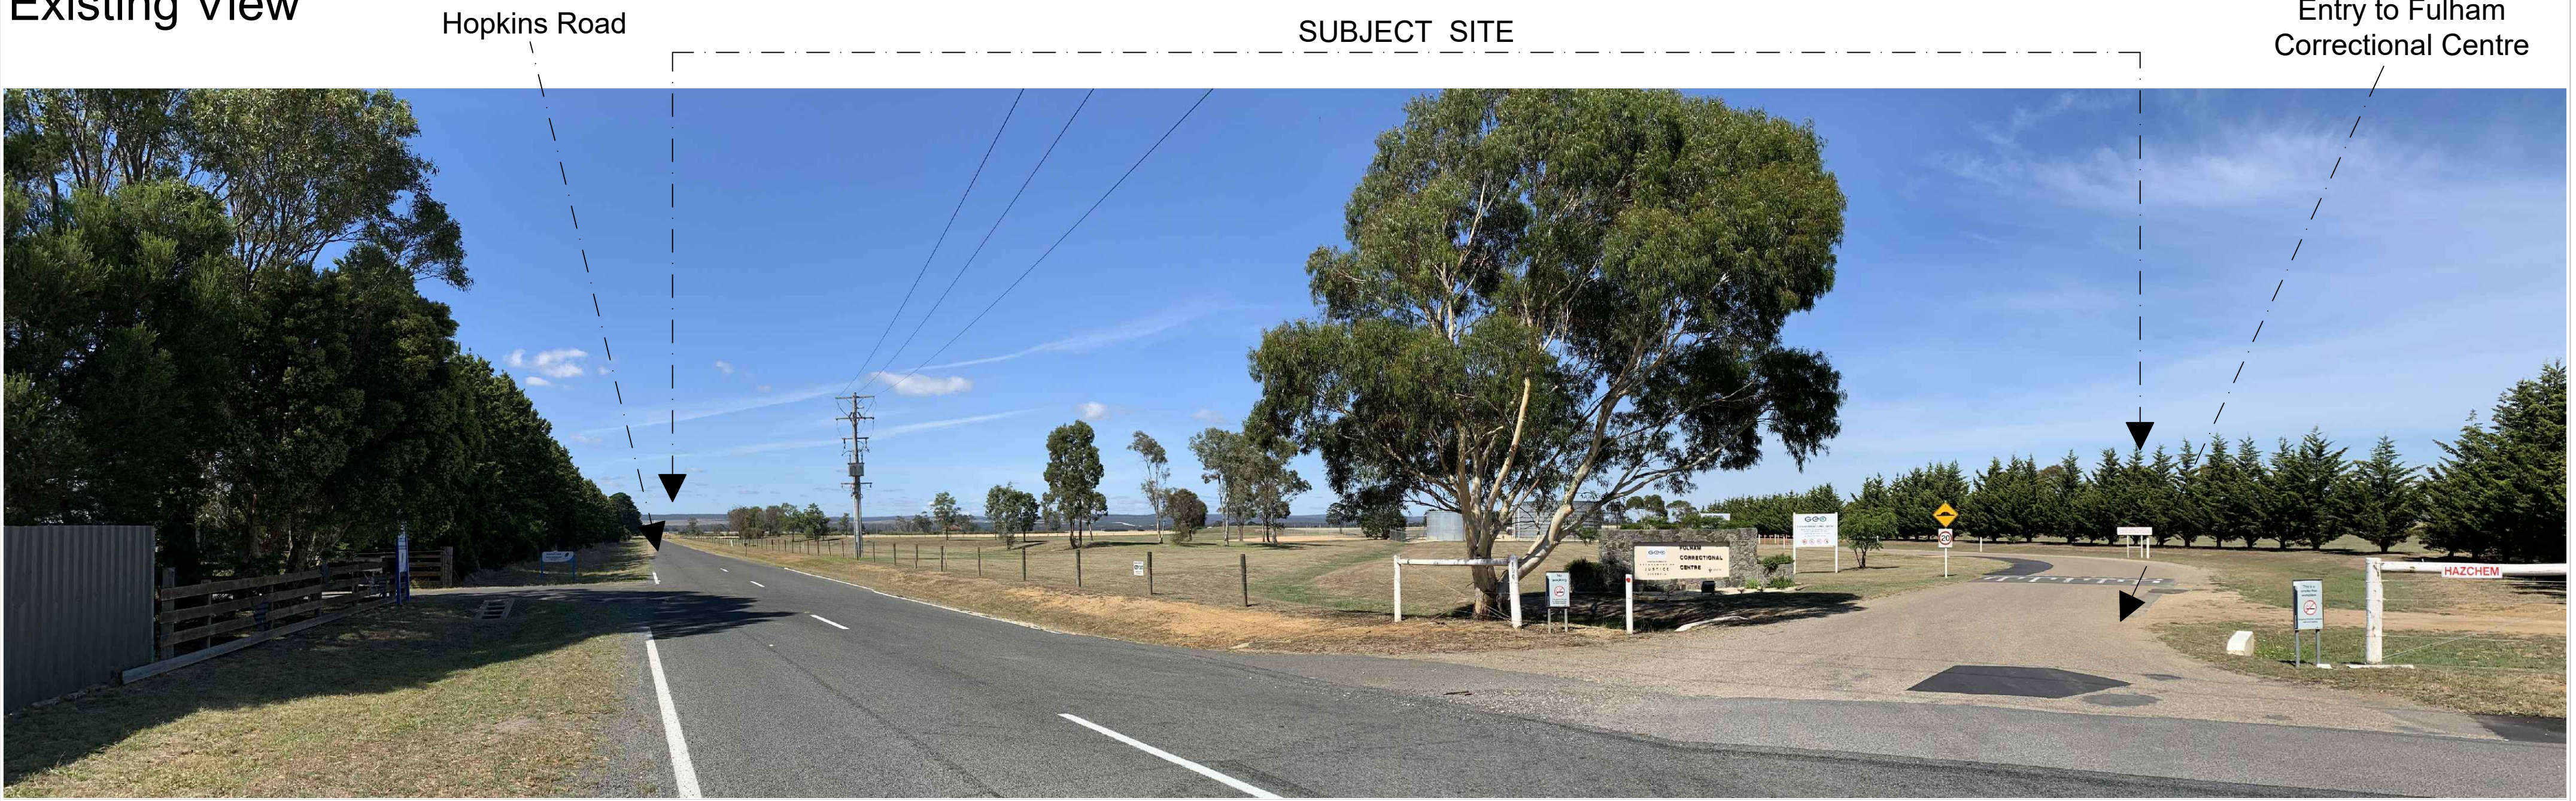
Existing View

Scattered plantings of native vegetation and exotic windrows frame the view; however, signage clutter in the foreground and infrastructure dominate the landscape. This sensitivity of view is classified as being **low**. The land is cleared, there is minor evidence of erosion and drainage in the foreground and the visual dominance of the infrastructure associated with the correctional facility is significant.

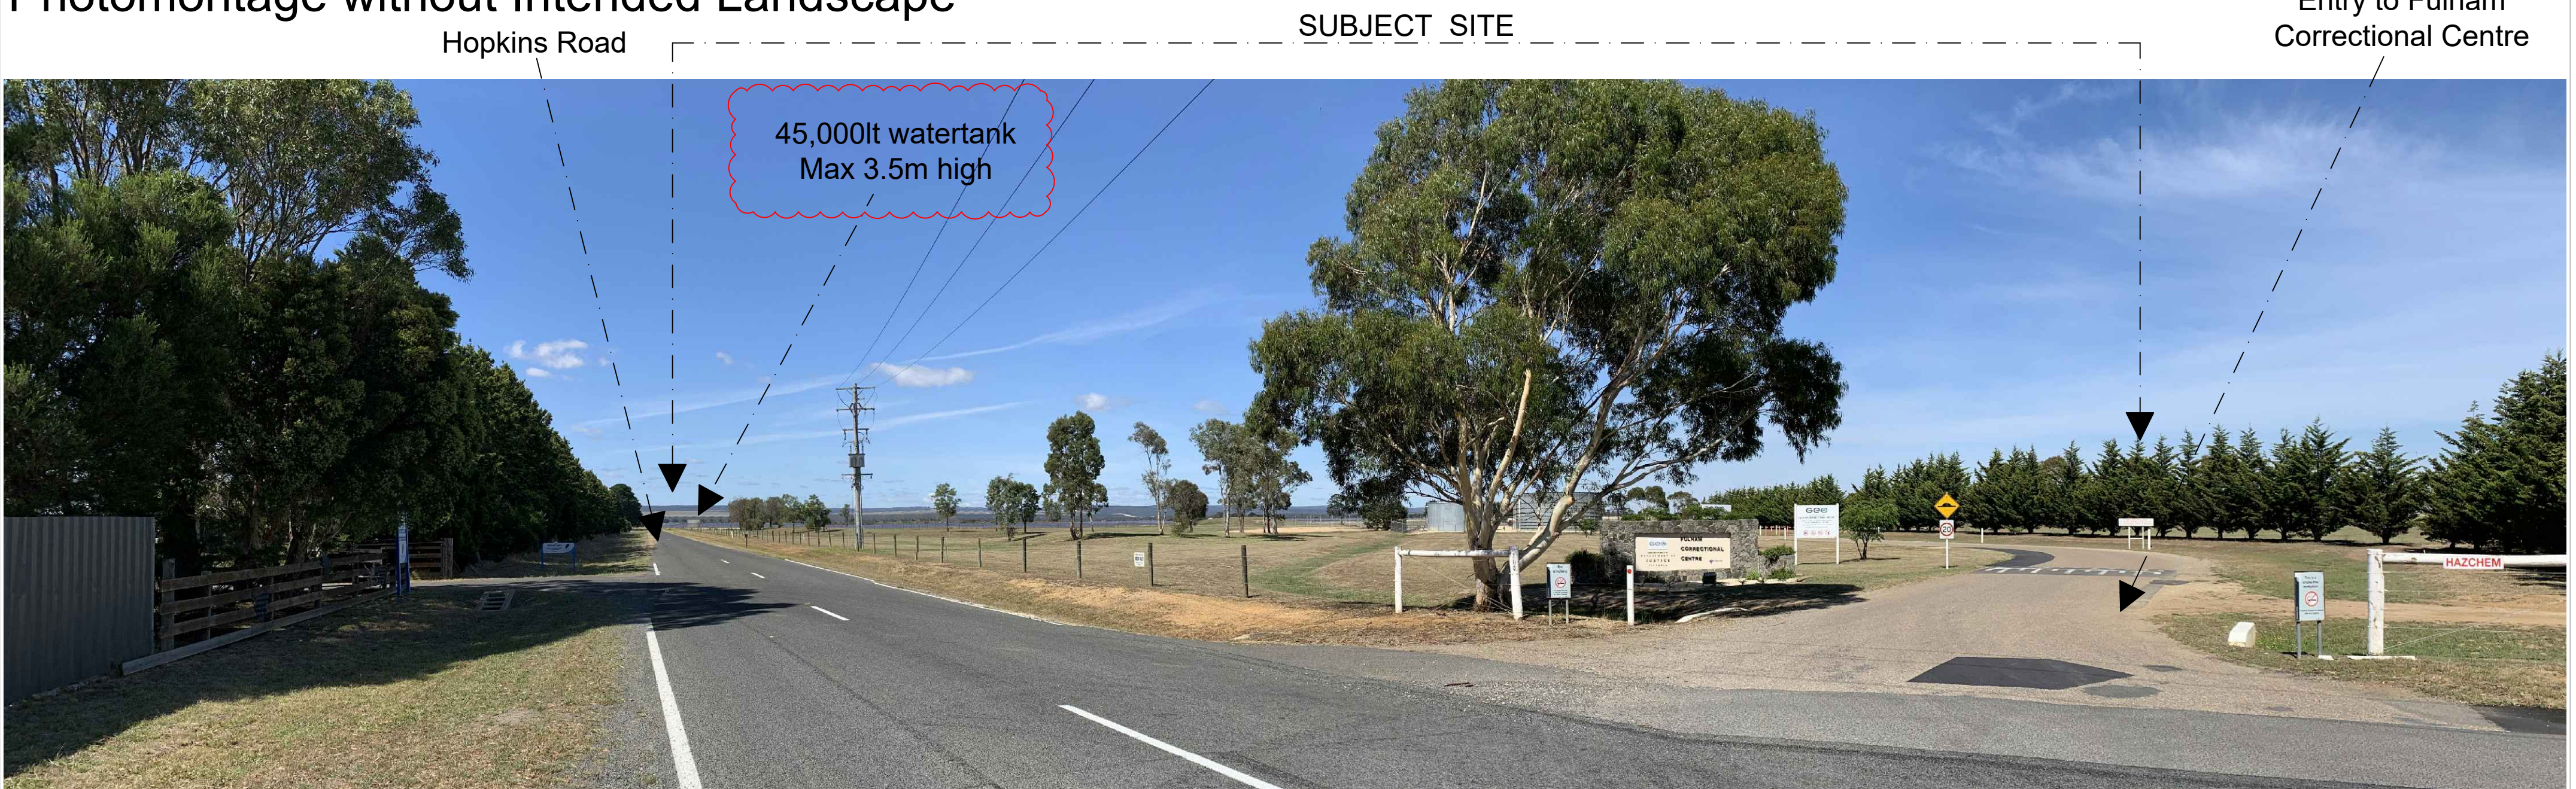
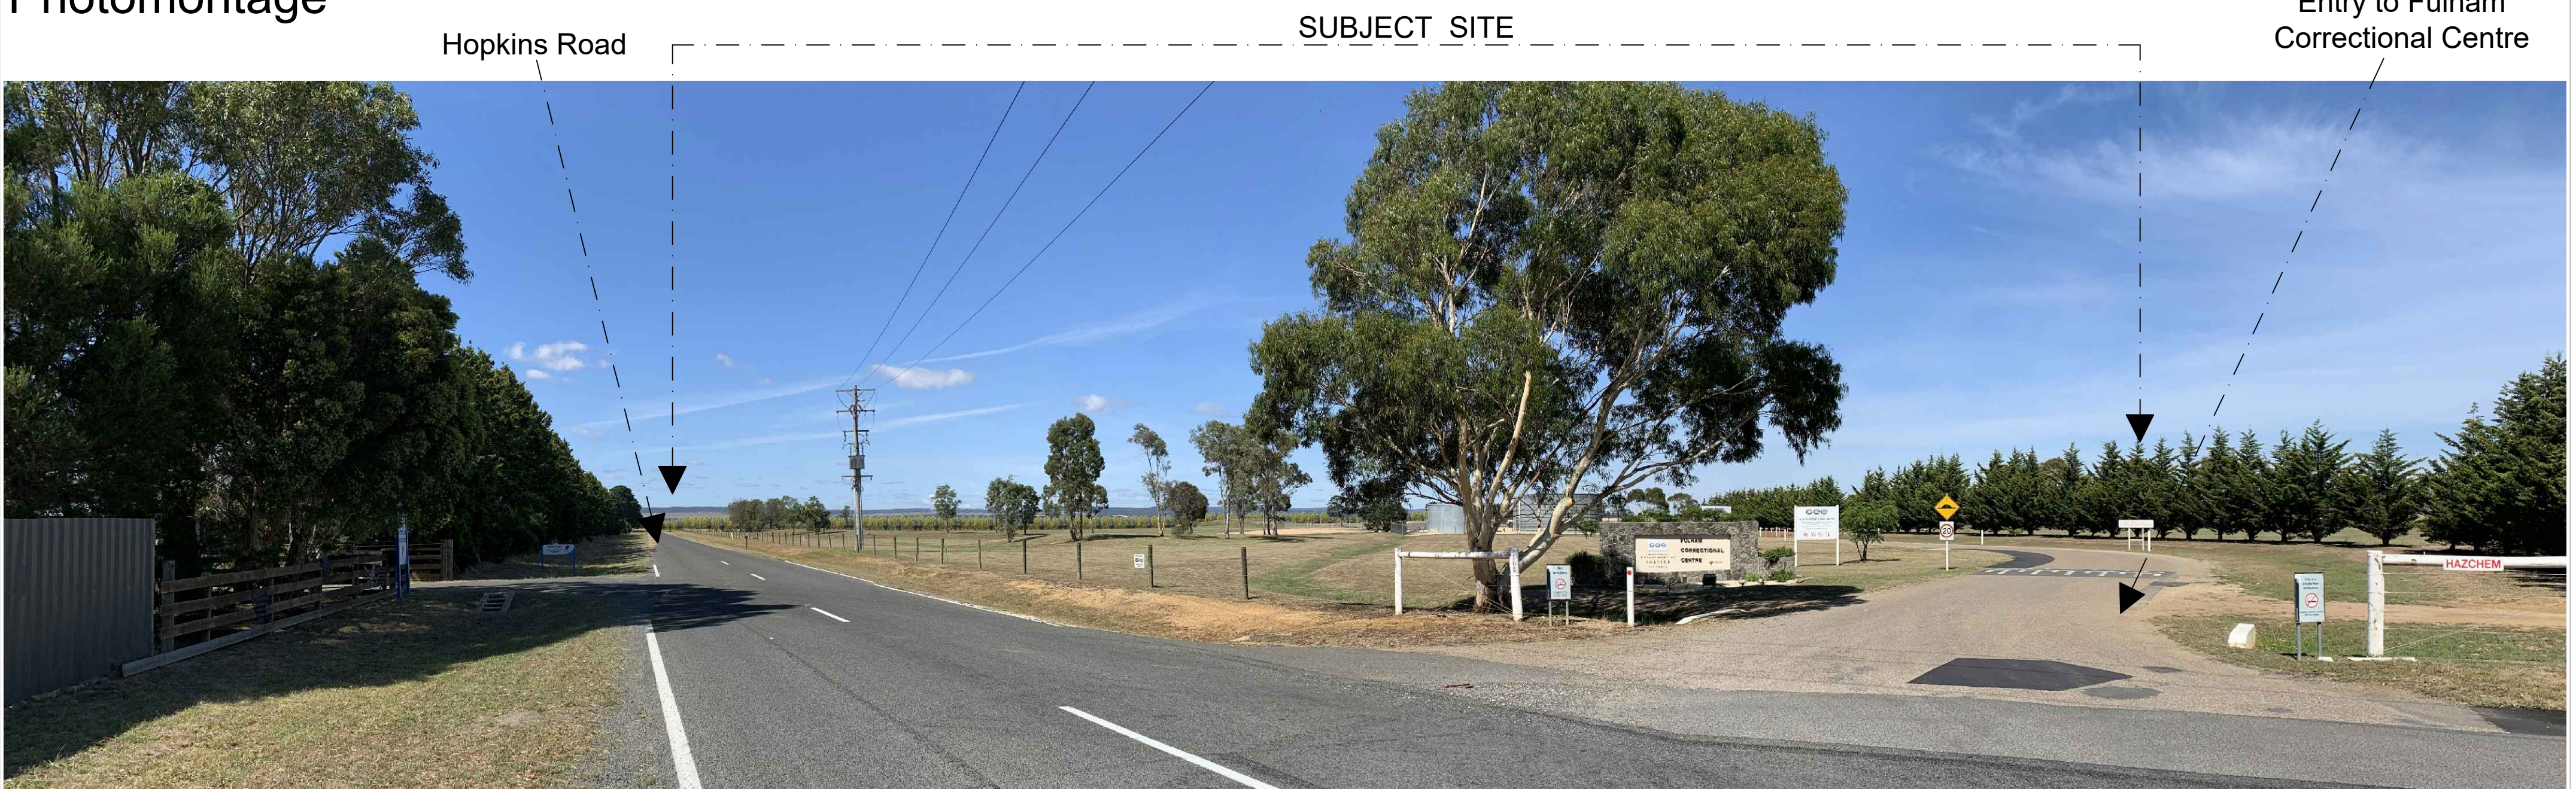
Photomontage without Intended Landscape

The proposed landscape buffer, water tank and boundary fencing on the northern and eastern boundaries of the subject site is clearly visible at this receptor. The correctional facility, located immediately north of the subject site, contributed to the low sensitivity of view classification for this receptor. Long views to the La Trobe River are retained and the boundary planting frames the Hopkins Road viewline. The proposal does not deteriorate this view any further and therefore has been deemed a **low** magnitude of change with the resulting visual impact being **low**.
